Geneva Community Unit School District #304
Operations and Maintenance
7 Year Capital Improvement Plan

March 9, 2020

Introduction

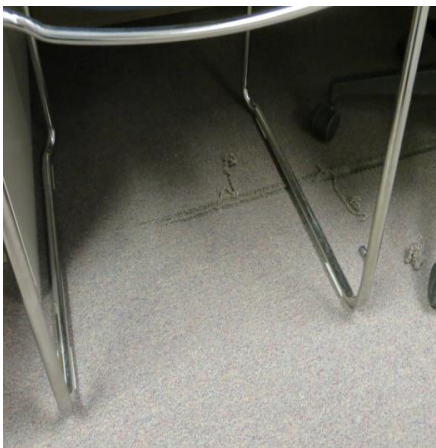
The carpet is starting to fray and cause trip hazards.

Carpet will need to be replaced.

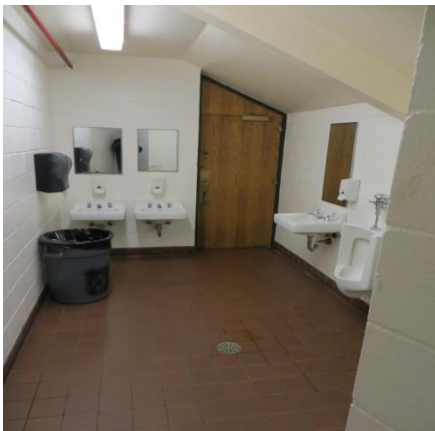
Cafeteria and Stagecraft Bathrooms

Bathrooms are 45 years old.

Showing significant wear.

Need to update.

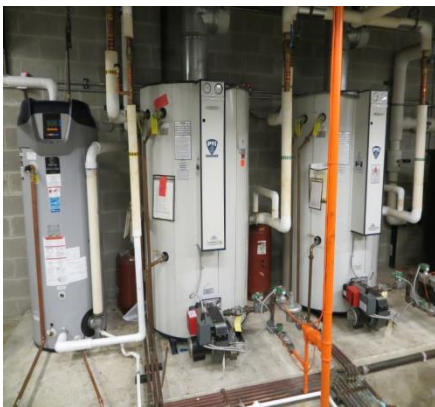
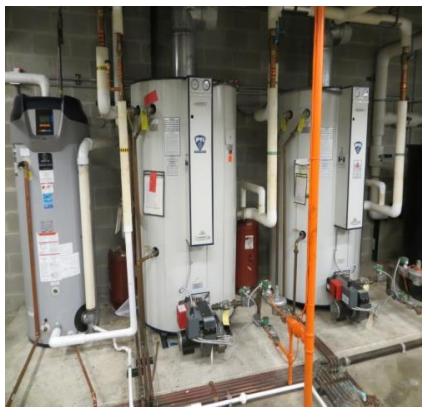
Hot Water Heaters

The two 500 gallon PVI water heaters are nearing the end of their life cycle.

Replacement will be needed within the next four years.

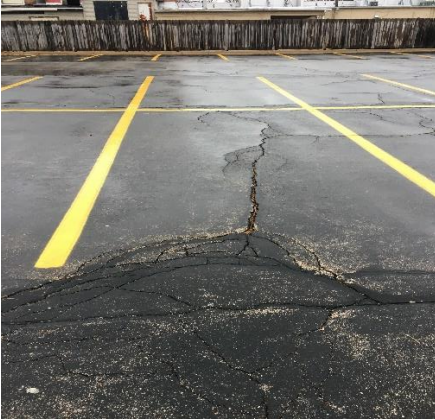
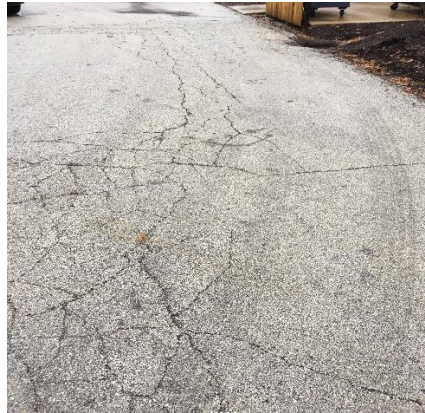
Parking lot

Several areas with extreme cracking.

Sealcoating and crack filling will be needed.

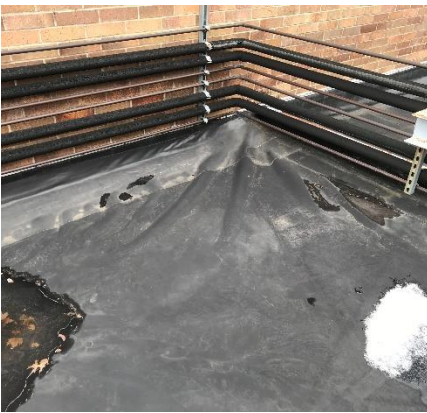
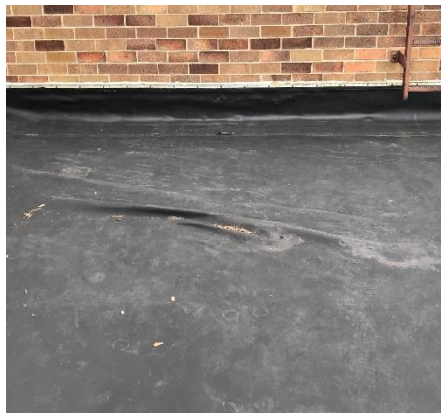
The roof is 19+ years old and many sections are in poor condition and need repair.

Roof replacement/restoration will be needed in the next one to three years.

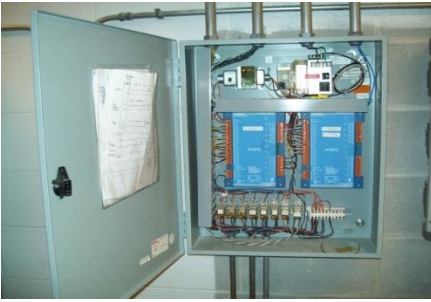
Lon Controller

Lon controls throughout the building.

Outdated and costly to repair.

Replace Lon to BACnet.

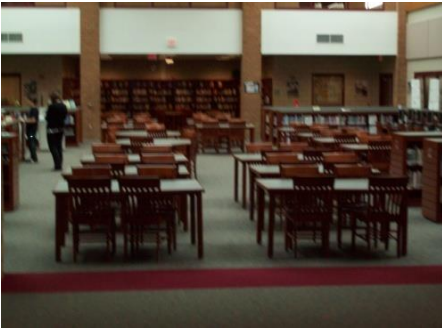
LMC

AHU is undersized for space.

Only two VAV boxes serving the space.

Recommend increasing the capacity of the AHU and adding four to six VAV boxes with controls to increase comfort and control humidity.

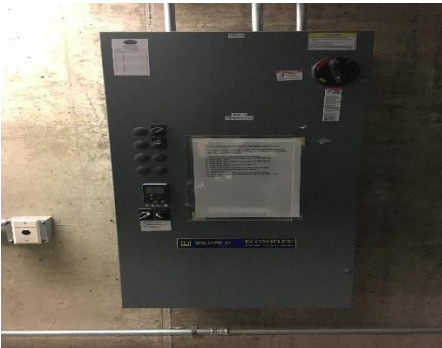
Variable Frequency Drive (VFD)

Needs replacing in the next 3 years.

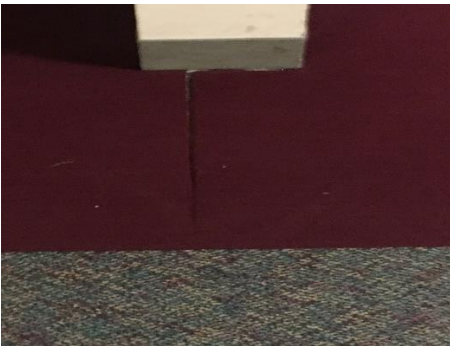
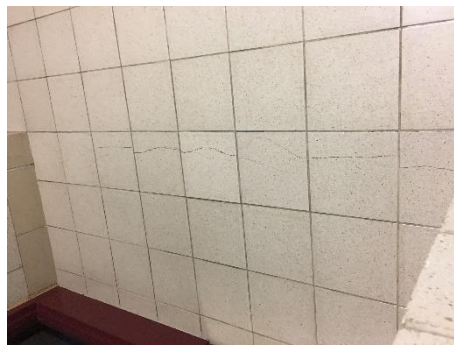
Flooring Replacement

Carpet is starting to show wear and seams are starting to pull apart.

Tile is lifting and cracking in several areas.

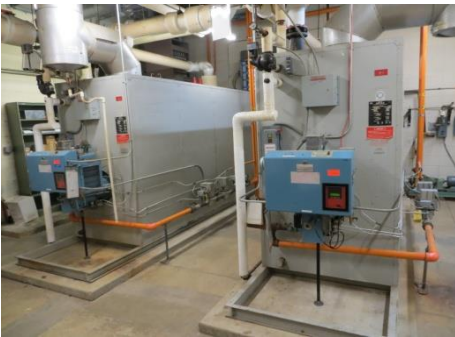
Boiler Replacement

26-year old boilers are inefficient and nearing the end of their estimated service life as per ASHRAE.

Replace with new high efficiency boilers.

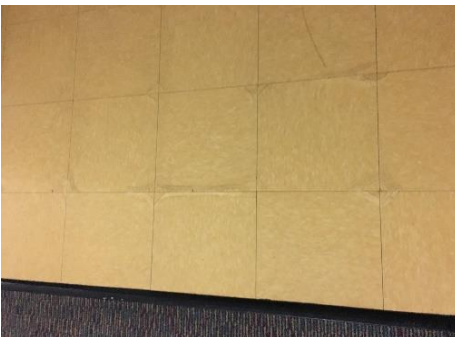
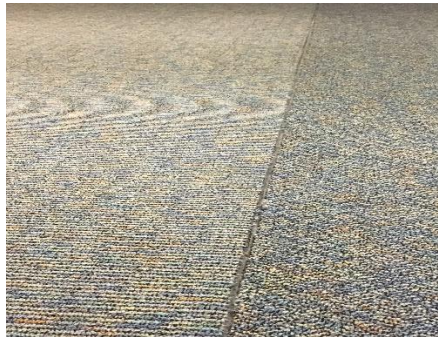
Flooring Replacement

Carpet is starting to show wear and seams are starting to pull apart.

Tile is lifting and cracking in several areas.

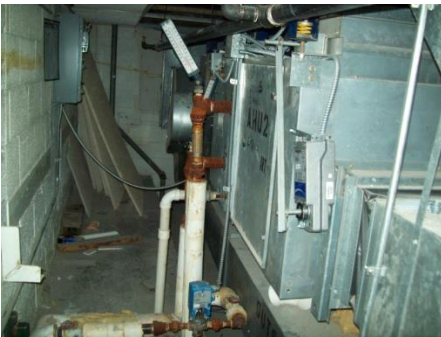
Air Handling Unit

Needs rebuilding or possible replacement.

New motor, shaft, bearings and controls needed.

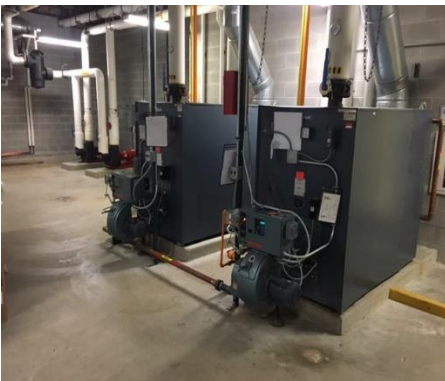
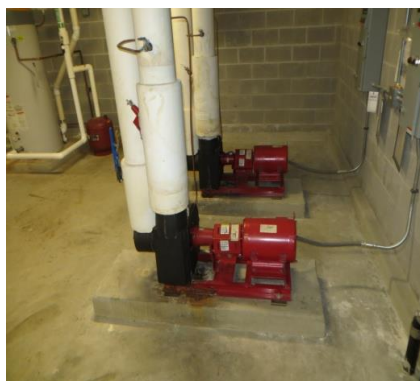
Boiler and Secondary Pumps Replacement

21 years old boilers and pumps nearing end of their estimated service life as per ASHRAE.

Need to be replaced with energy efficient design.

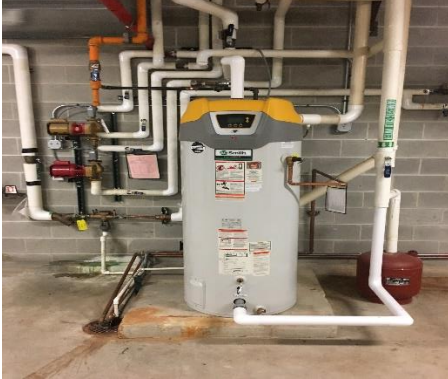
Hot Water Heater

The 100- gallon A.O. Smith water heater is nearing the end of its life cycle.

Replacement will be needed.

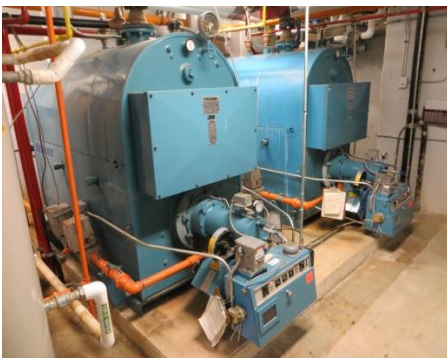
Boiler Replacement

Boilers are 24 years old and original to the building.

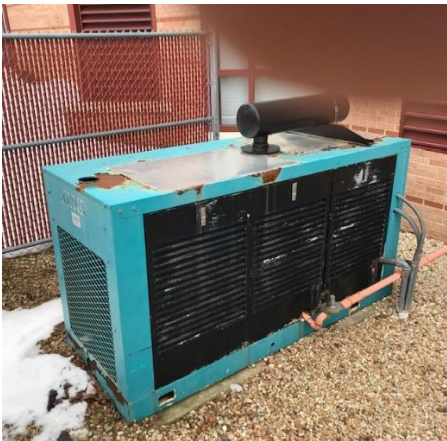
Generator Replacement

100KW generator is 24 years old and needs to be replaced in the next two to three years.

Escalating repair costs and consistent breakdowns.

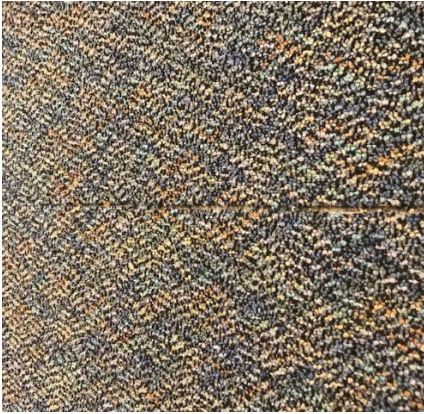
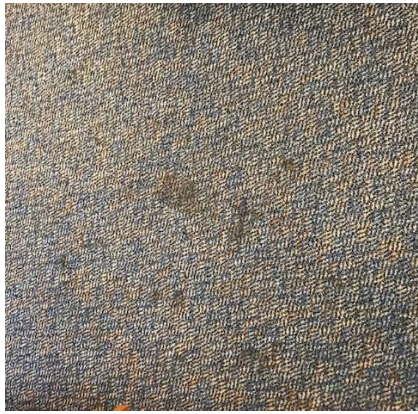
Flooring Replacement

Carpet is starting to show wear and staining that we are unable to remove.

Life cycle of carpet is 12-20 years.

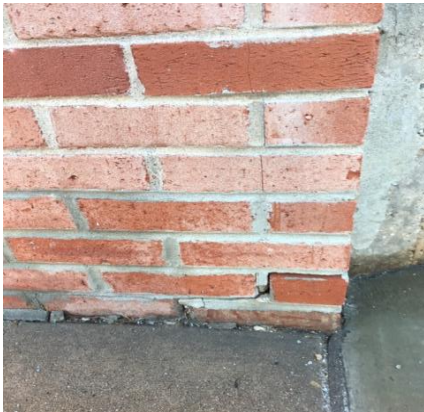
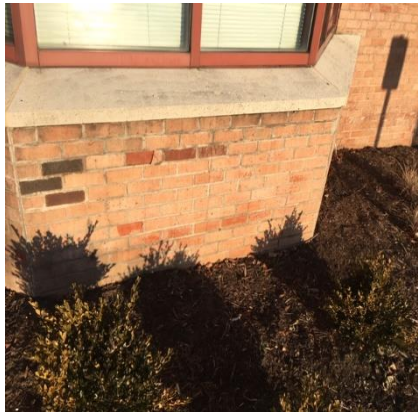
Tuckpointing

Cracked and missing mortar joints and bricks will need to be repaired.

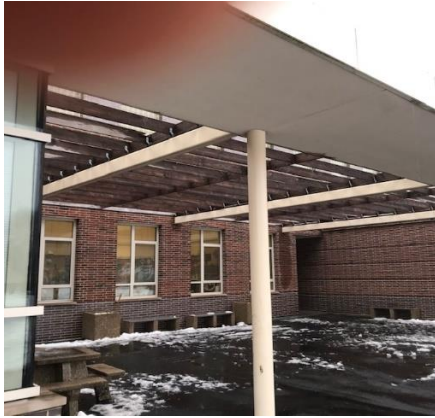
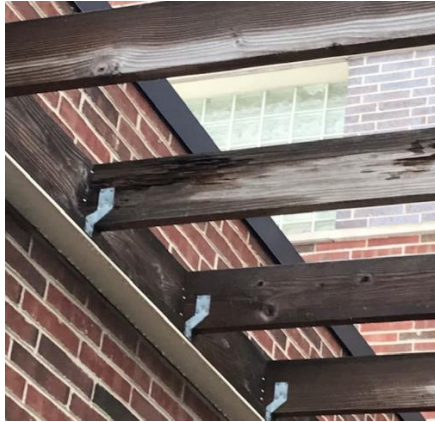
Wood Trellis/Pergola

Wood is deteriorating and many damaged sections.

Replace with a more weather resistant material.

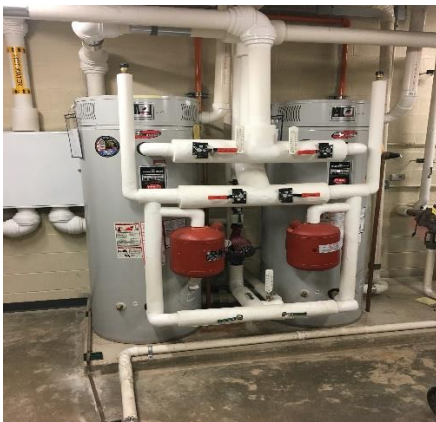
Hot Water Heaters

The two 100- gallon Bradford White water heaters are nearing the end of their life cycle.

Replacement will be needed within the next two to five years.

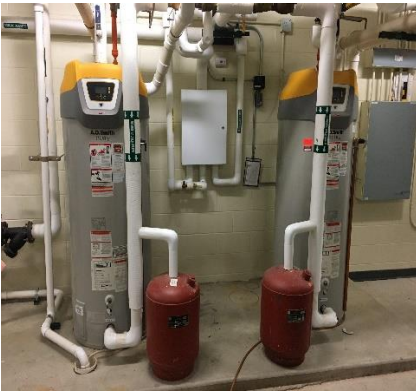
Hot Water Heaters

The two 100- gallon A.O. Smith water heaters are nearing the end of their life cycle.

Replacement will be needed within the next three to seven years.

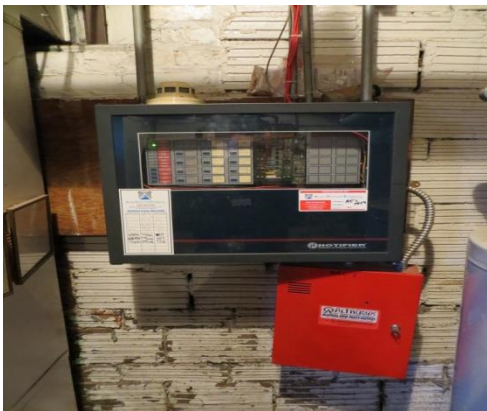
Fire Alarm System

Notifier 5000 fire alarm panel will need to be updated to meet current NFPA code requirements.

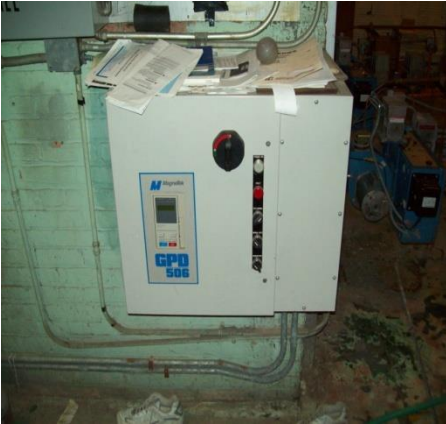
Variable Frequency Drive

VFD has failed and needs to be replaced.

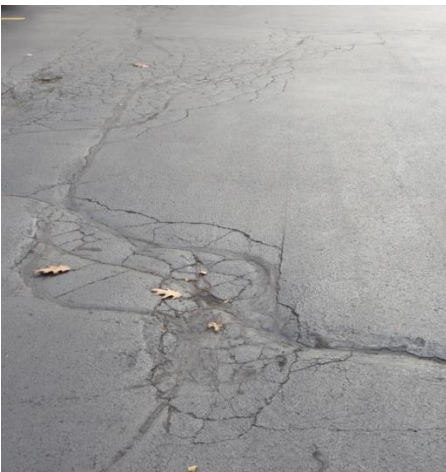
Parking Lot

Several areas with extreme cracking.

Resurfacing will be needed.

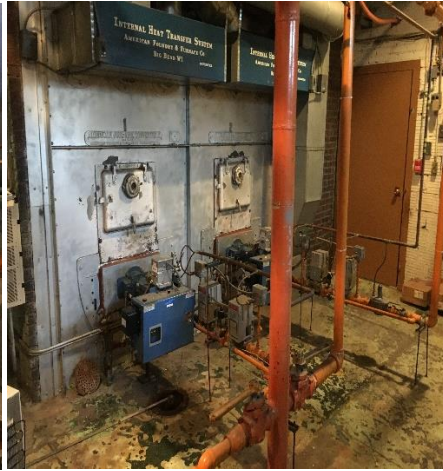
Forced Air Furnace Burners

Burners are 20 years old.

Nearing the end of their estimated service life as per ASHRAE.

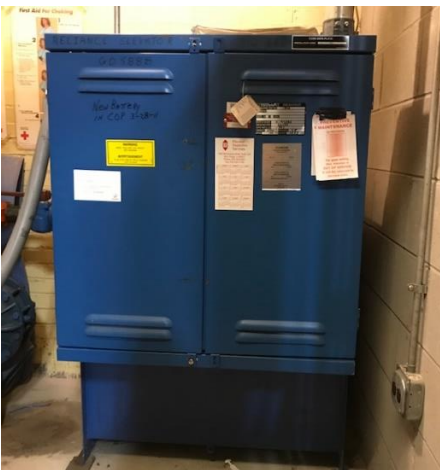
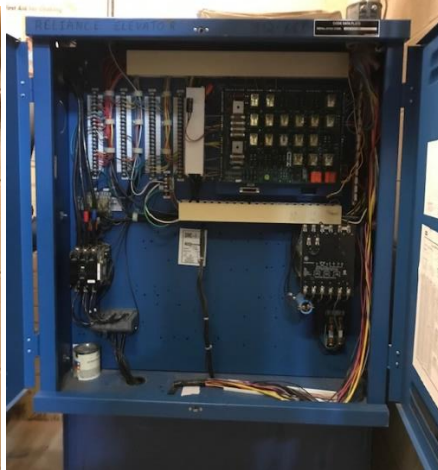
Elevator Control System Upgrade

The current elevator control system parts are becoming obsolete and no longer available for repairs.

Control upgrades will be needed in the next two to three years.

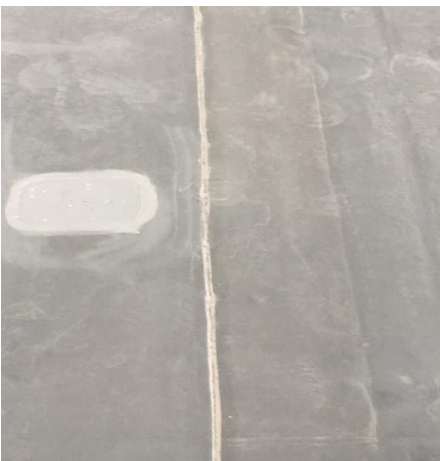
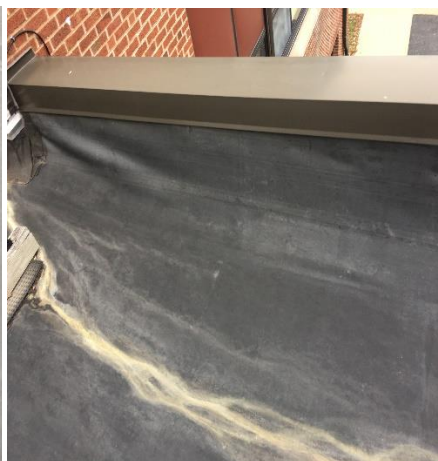
The roof is 18 years old and many sections are in poor condition.

Roof replacement will be needed in the next two to four years.

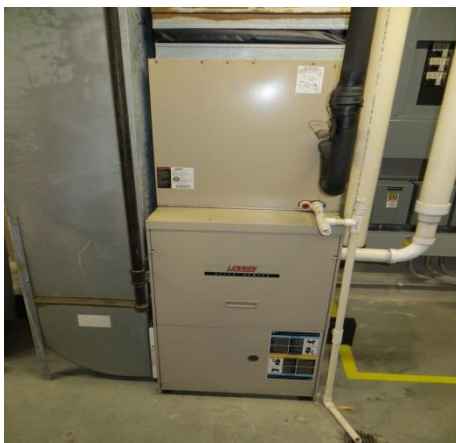
HVAC Split System

The 3 Lennox split systems are nearing their ASHRAE recommended service life.

Replacement will be needed within the next four years.

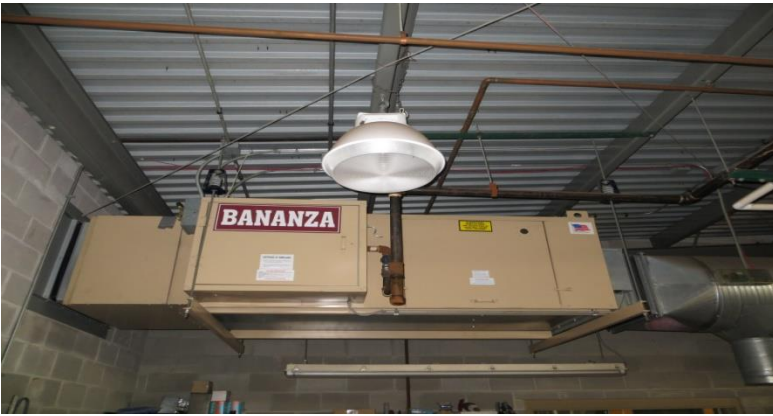
Air Handling Unit

The three Bananza make-up air units are nearing their ASHRAE recommended service life.

Replacement will be needed within the next four years.

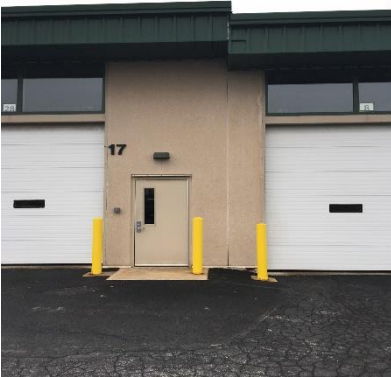
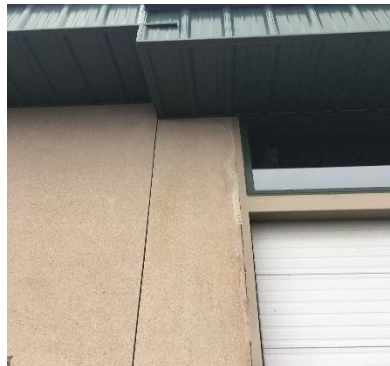
Architectural Precast Wall Panel

The exterior architectural precast wall panel has cracked and will need to be replaced.

Replacement will be needed within the next two years.
