Item Title: Work Authorization for Structural Repairs of Sams Memorial Stadium -Green, Rubiano & Associates X Action Information Discussion

Sams Memorial Stadium
1 Boulevard of Champions
Brownsville, TX 78520

Visual Concrete Structure Evaluation of Sams Memorial Stadium

Prepared by:
Mr. Rolando R. Rubiano, P.E.
Green, Rubiano and Associates
1220 W Harrison
Harlingen, TX 78550

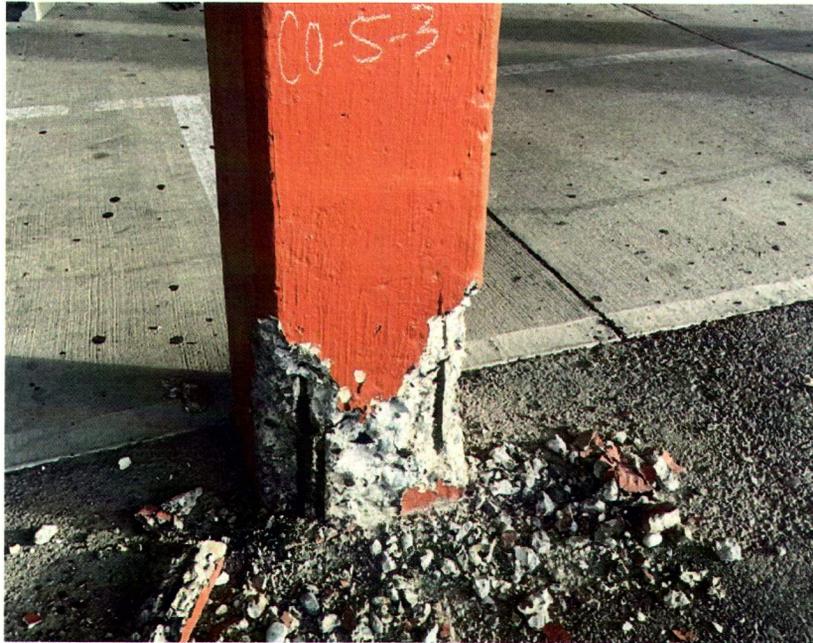
Multiple columns appeared to have spalling and exposed rebar. In some instances, the exposed rebar showed signs of moderate corrosion.

Photo #1: Column is Experiencing Spalled Concrete and Exposed Rebar.

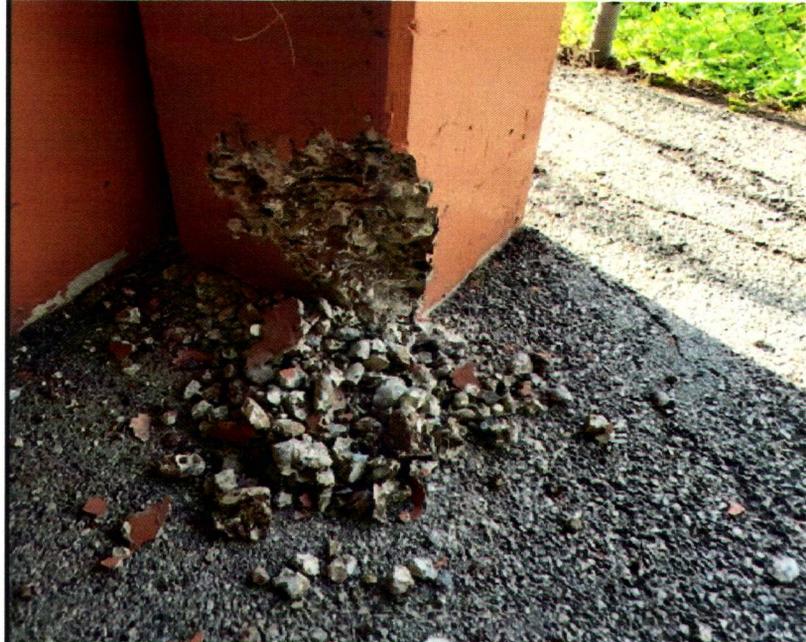
Photo #2: Column is Experiencing Spalled Concrete.

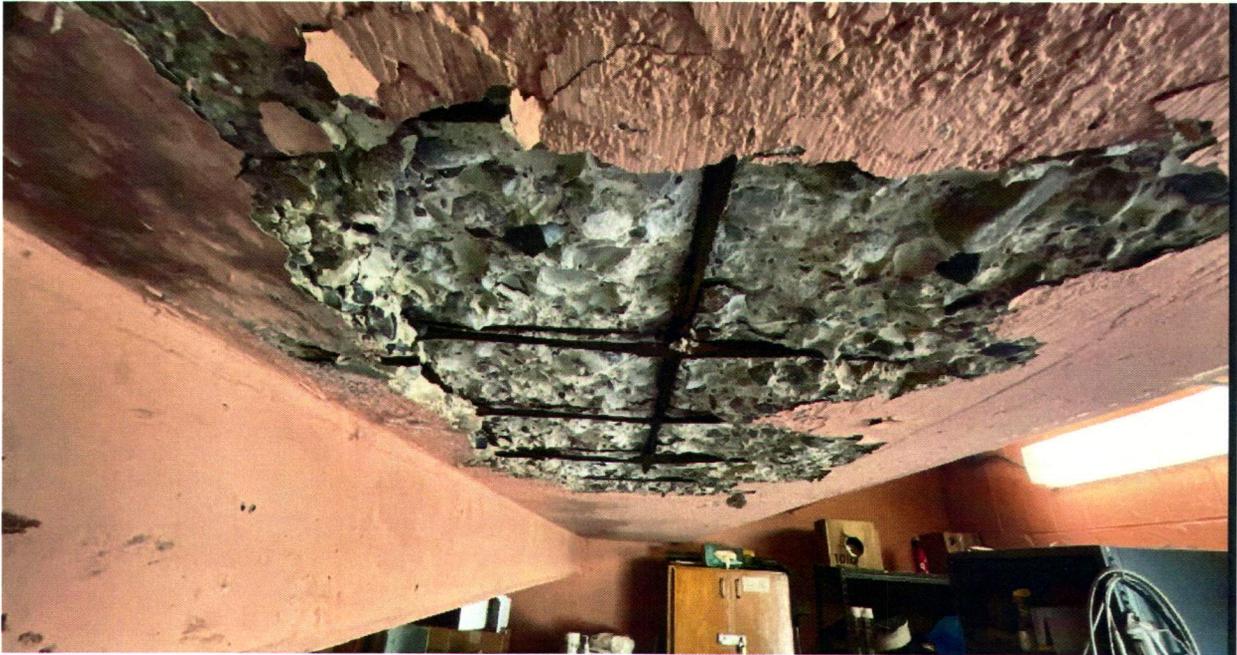
At multiple locations on both the topside and underside of the bleacher beams, exposed rebar and instances of spalling could be seen. Exposed rebar was present in several locations with moderate corrosion due to weather exposure. Efflorescence was present on several bleacher beams underside at the West stands. In one location within section Q, two bleacher beams appear to have significant spalling and exposed rebar with extensive corrosion. These bleacher beams are supported by a CMU wall located beneath them.

Photo 3: West Stands Bleacher Beam Underside Showing Exposed Rebar with Extensive Corrosion.

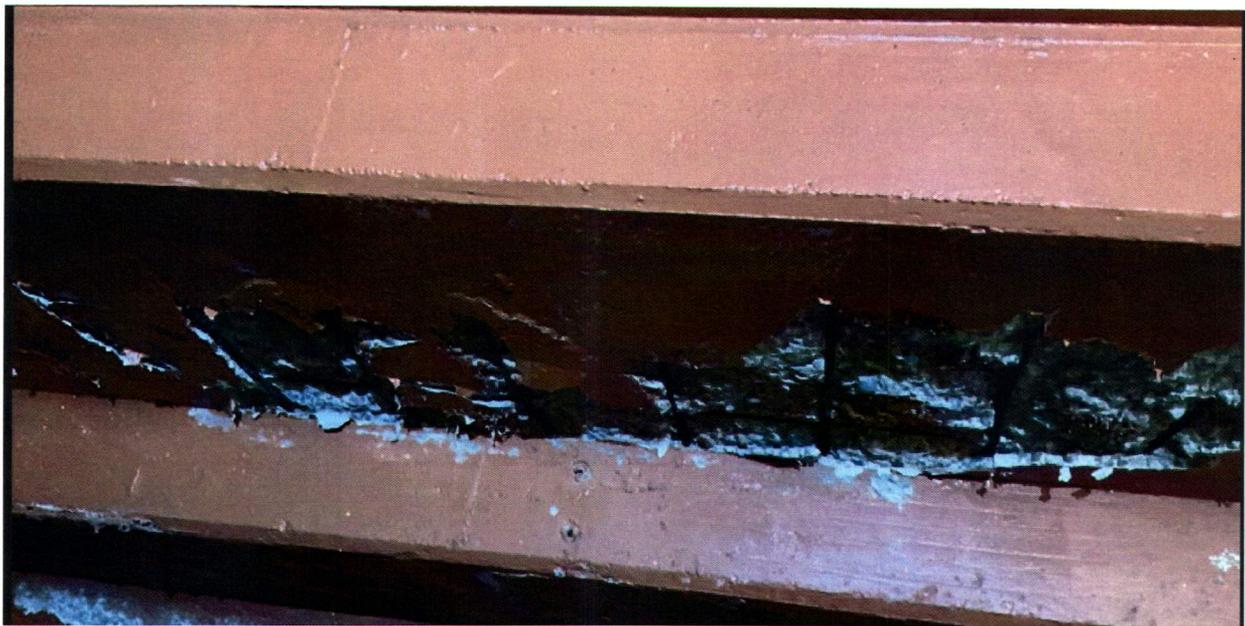
Photo 4: East Stands Bleacher Beam Underside Showing Delamination and Spall with Moderate Corrosion.

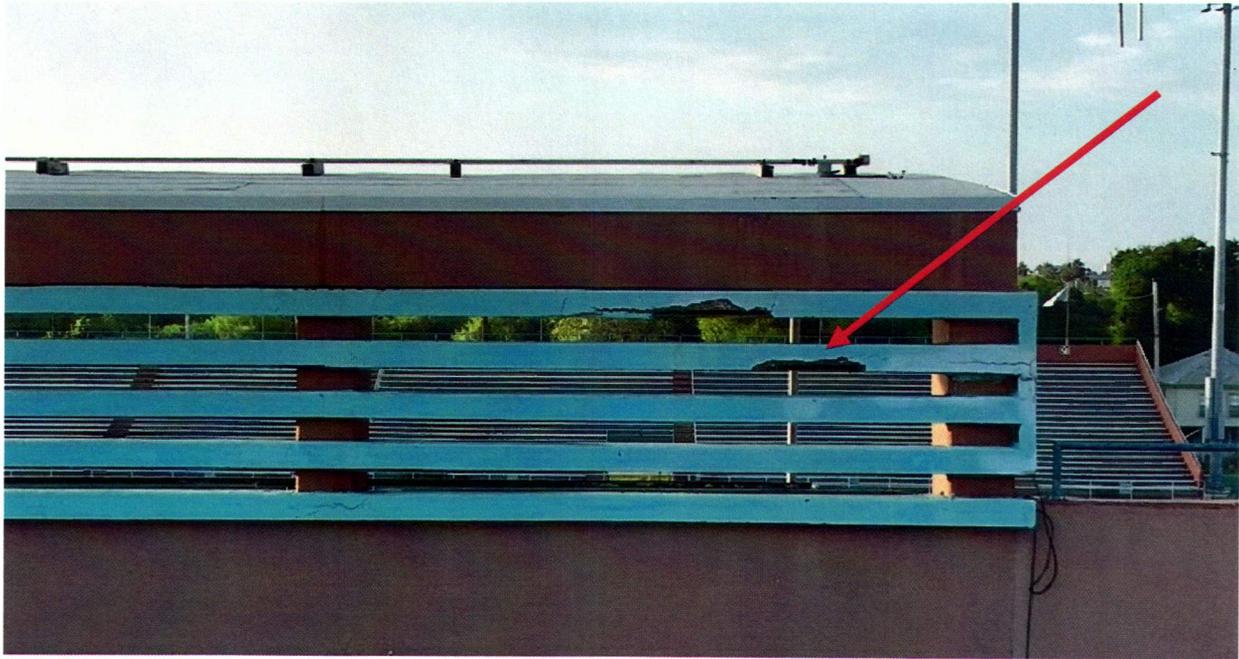
Photo 5: Louver on Press box Showing Exposed Rebar with Minor Oxidation.

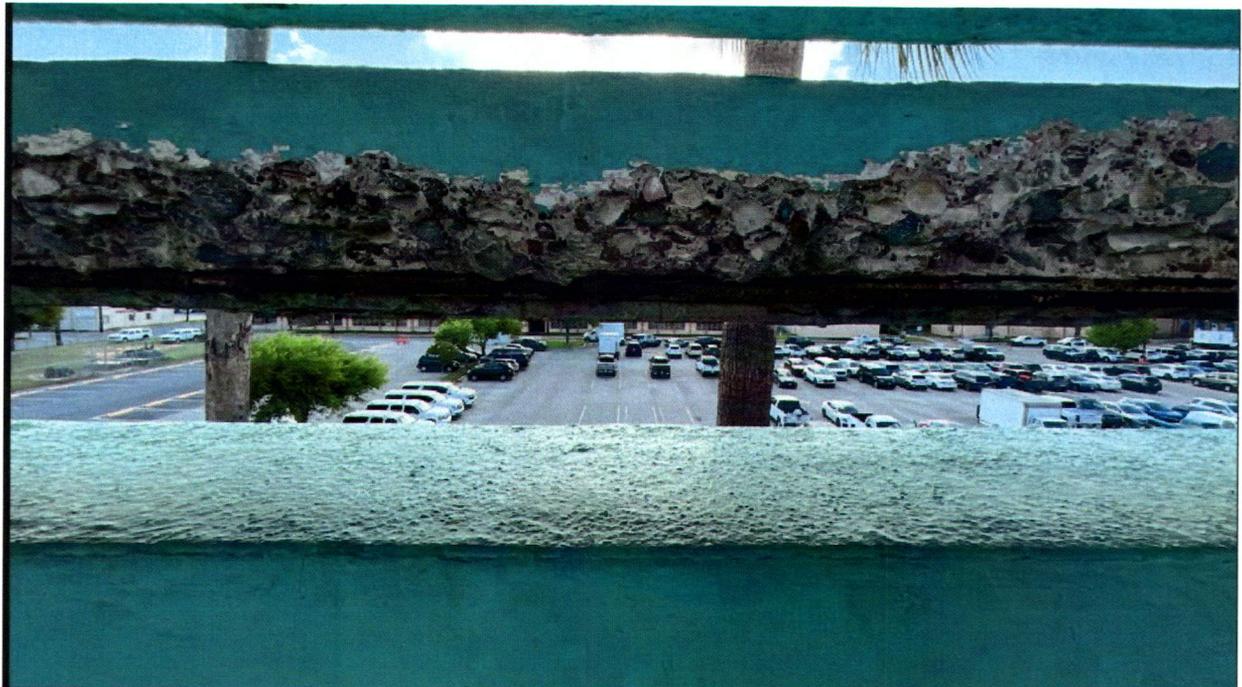
Photo 6: Zoomed In Photo of Louver on Press box Showing Exposed Rebar with Minor Oxidation.

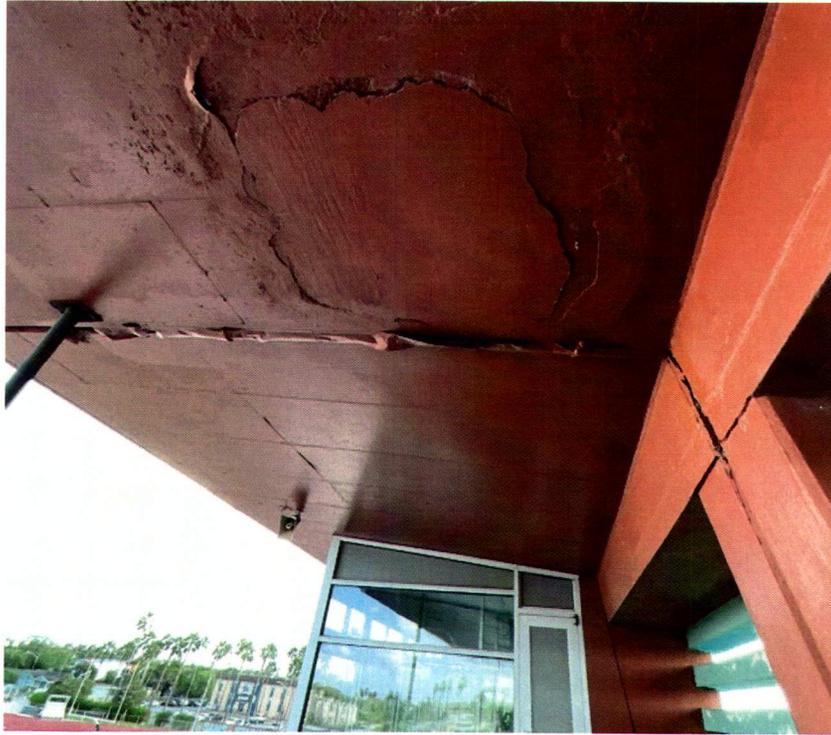
The majority of the press box slab and walls appeared to be in good condition with minor cracks. In two locations of the press box roof slab, about 30 square feet of patching seemed to be present. Based on the record drawings it appears that these repairs were caused by the removal of two light poles. Several louver concrete beams have spalling and exposed rebar with moderate corrosion. Multiple concrete columns supporting the press box roof slab appeared to have minor spalling, and steel pipe columns supporting the press box roof slab appeared to be in good condition.

Photo 7: Patch of Roof Slab Underside due to Removal of Light Pole. Patch is Suspect to poor Adhesion and Posing a Potential Hazard of Becoming Falling Debris.

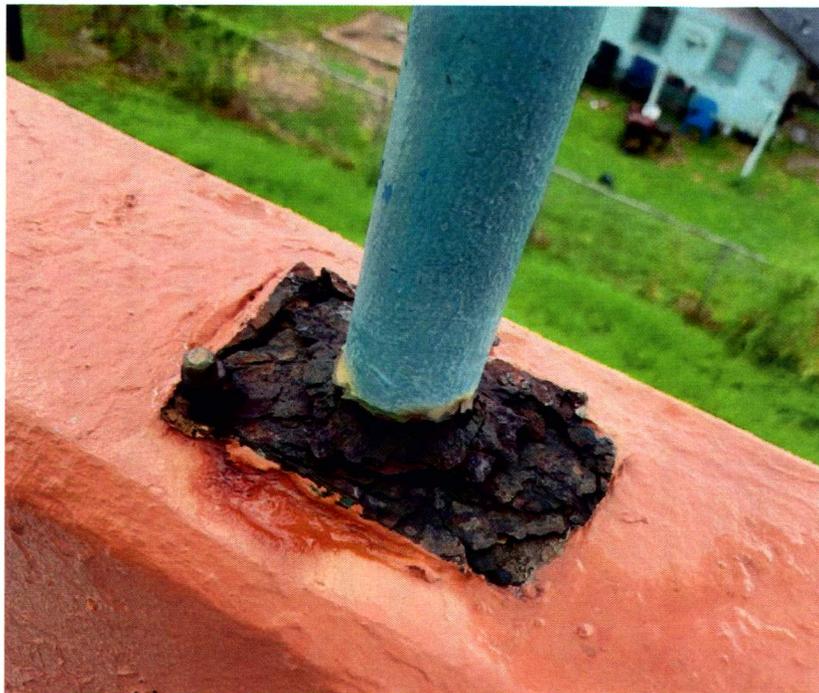
The stem walls along the perimeter appeared to be in good condition throughout the home and visitors' bleachers. At multiple locations, base plates of the guard rails above perimeter stem walls appeared to have severe oxidation at both the home and visitors' bleacher sides. At the

Photo 8: Guard Rail Base Plate showing Severe Corrosion.

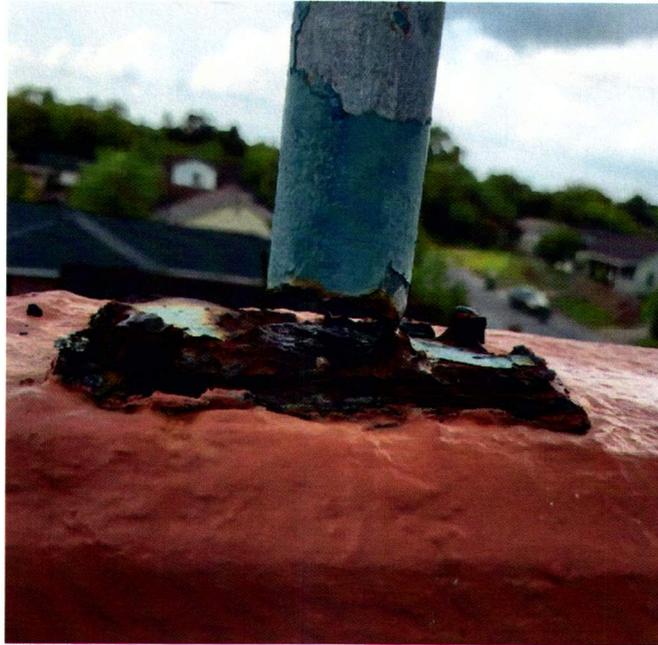
Photo 9: Guard Rail Base Plate Showing Severe Corrosion.

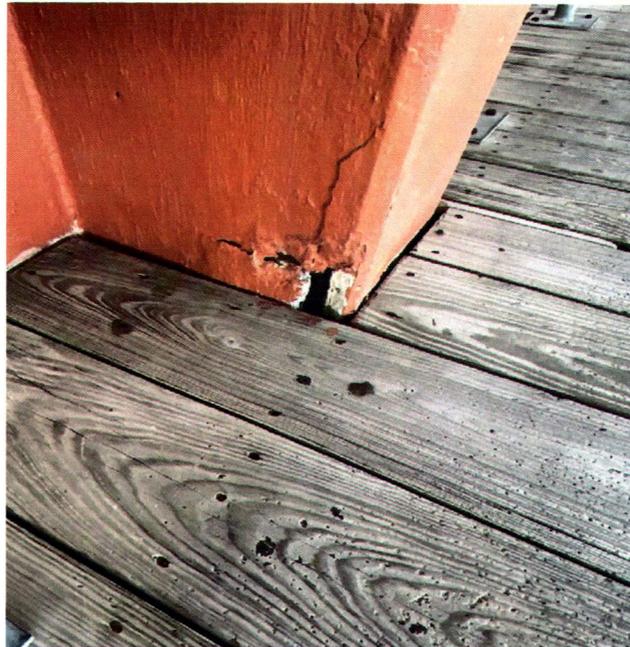
Photo 10: Pressbox Column Showing Spalling.

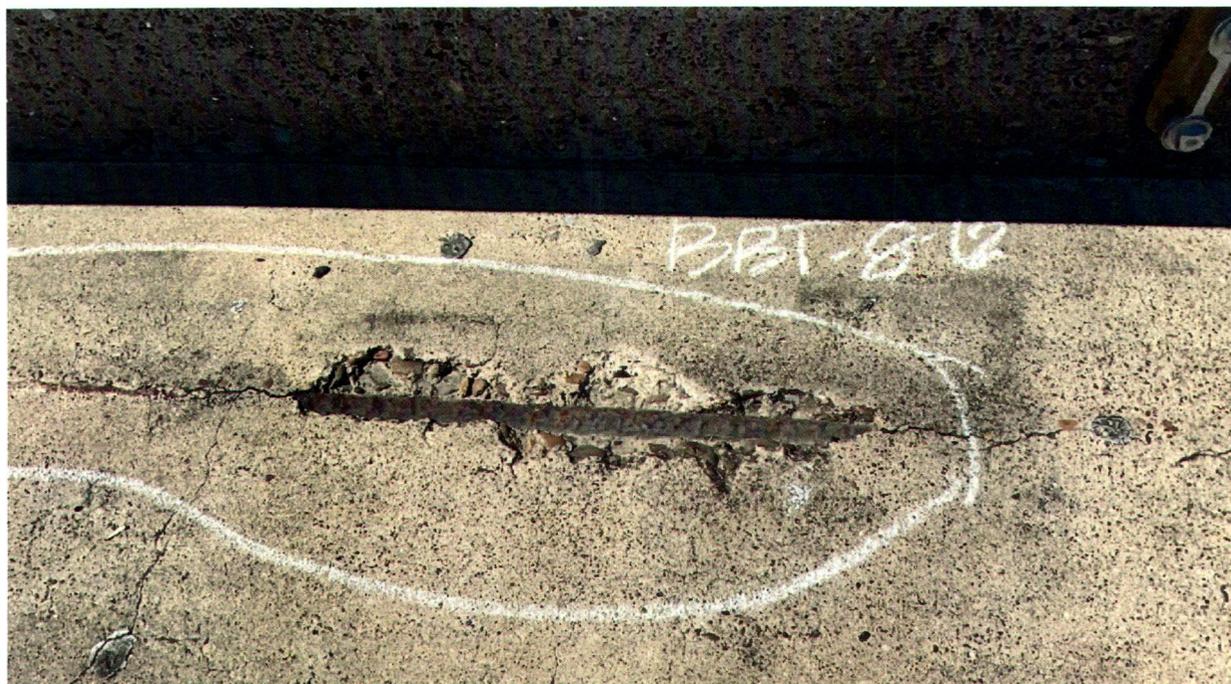
Photo 11: Bleacher Beam Topside Showing Exposed Rebar.

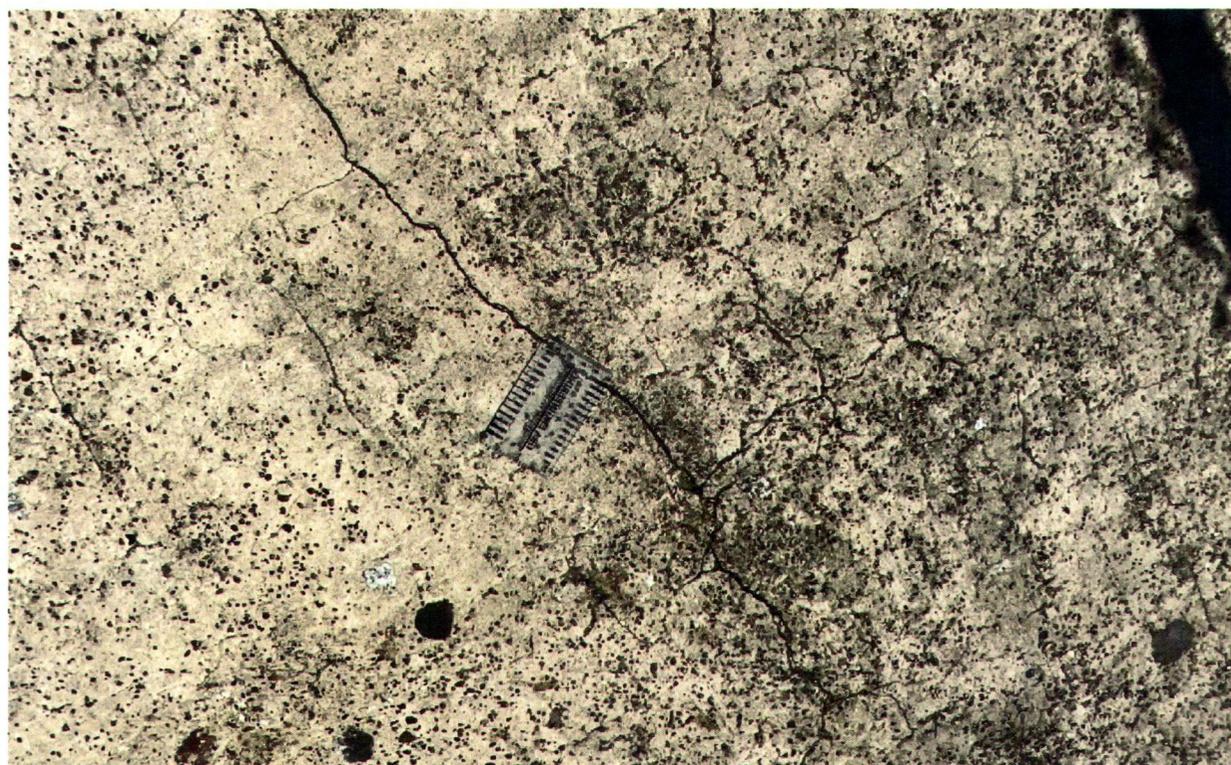
Field observations revealed the presence of cracks throughout various elements of the concrete structure, but these cracks were minimal in nature, due to the natural process of concrete shrinkage. In-between seating sections along the step line, shallow depth cracks were found with no visible sign of rebar exposure. Shallow depth cracks were found spanning parallel to the bleacher beams with no visible sign of exposed rebar.

Photo 12: Shrinkage Cracking on Slabs.
