Geneva CUSD 304 5-yr Capital Improvement Plan 2012

Geneva Community Unit School District #304

July 30, 2012

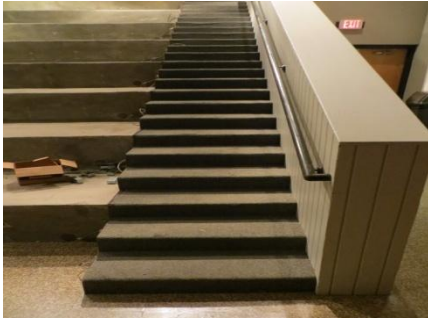
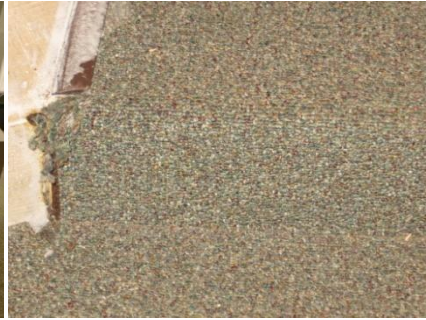
Auditorium Carpeting

Replace worn and fraying carpeting

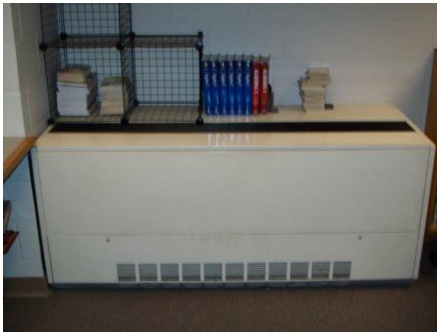
Unit Ventilator in B Hallway - 13

Oversized, cycles on/off frequently causing humidity and comfort issues.

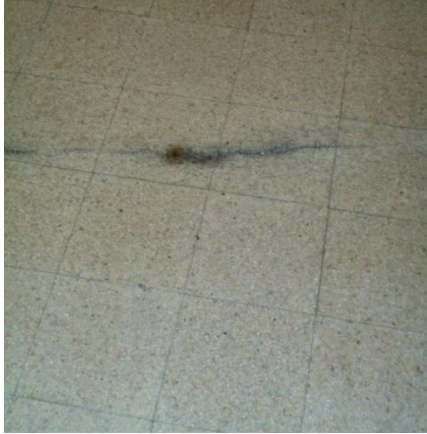
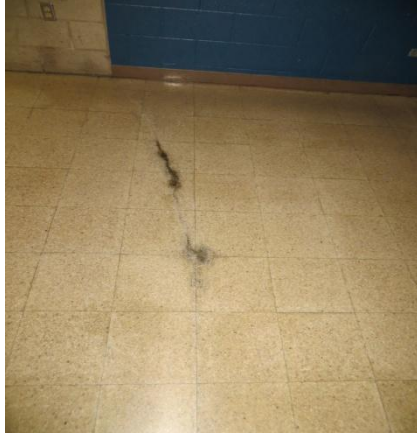
Flooring

Existing quartz tile is cracking and has faded. Creates trip hazards.

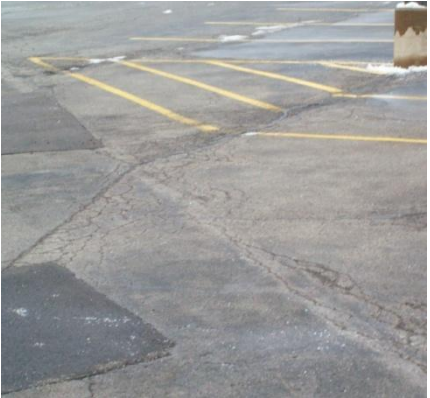
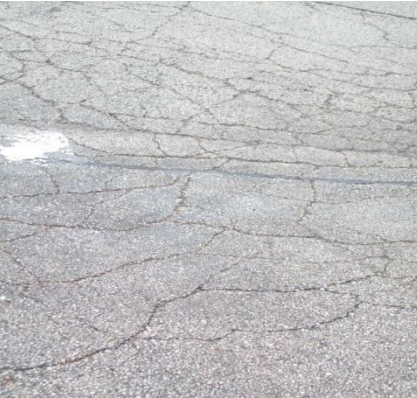
Burgess Parking Lot

Cracks and patches throughout.

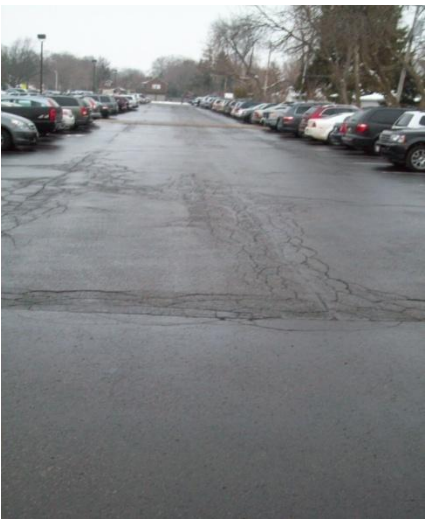
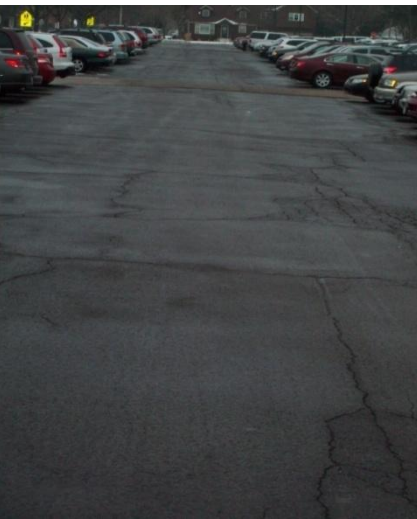
McKinley Parking Lot

Deep cracks throughout.

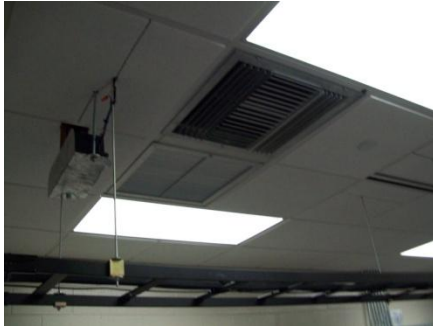
IT Server A/C

Oversized for heat load of space. Cycles on and off continually causing condensation issues and premature equipment failure.

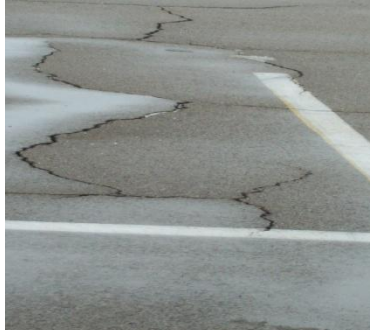
Parking Lot

Multiple deep cracks. Seal coating and crack filling was done this summer to extend life of parking lot. Resurfacing may be required within 5 years.

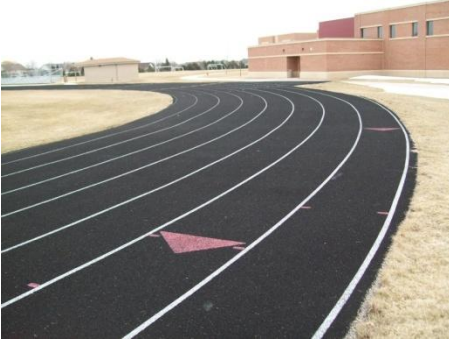
Track – installed in 2005

Track resurfacing is normally required every 8-10 years. Excessive wear spots are apparent.

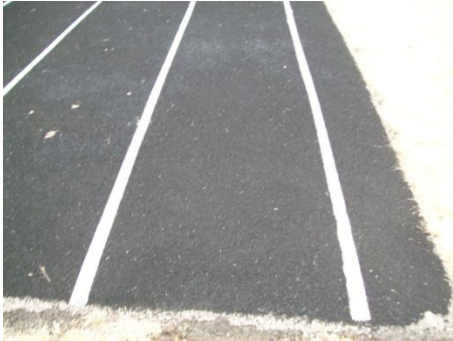
Track – installed in 2005

Track resurfacing is normally required every 8-10 years. Excessive wear spots are showing through.

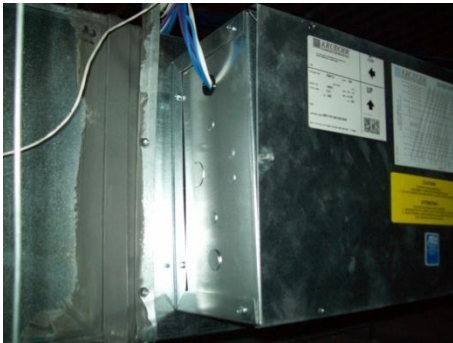
VAV Box

First Box-No Reheat coil and piping

Second Box-Reheat coil with supply/return hot water piping with controls

Provides control and comfort to classroom spaces with proper ventilation

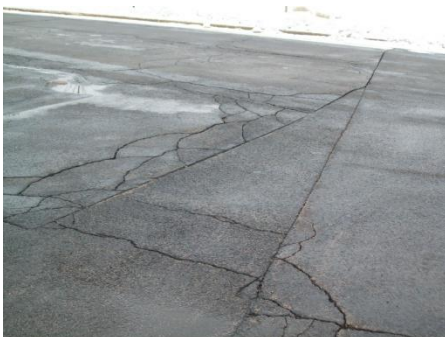
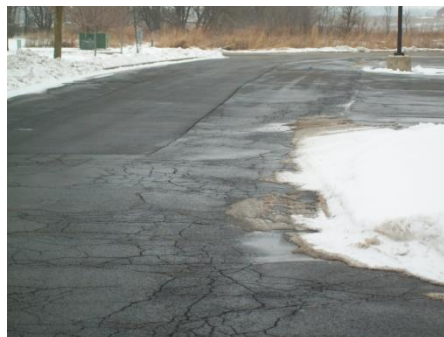
Parking Lot

Cracks filled and lot seal coated two years ago.

Partial patching seen on right picture.

Resurfacing needed this year.

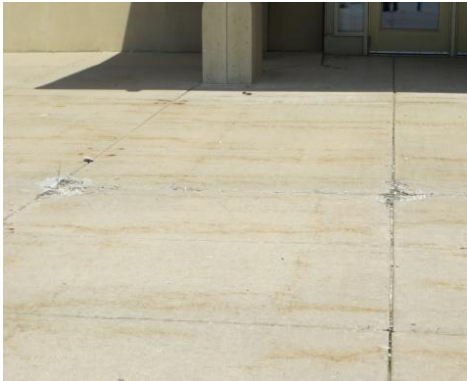
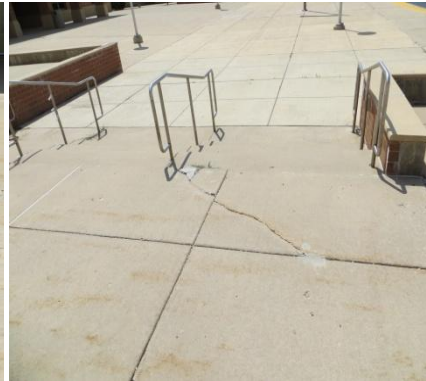
Main Entrance Sidewalk Cracks

Repair concrete cracks and address heaving. This creates a safety issue.

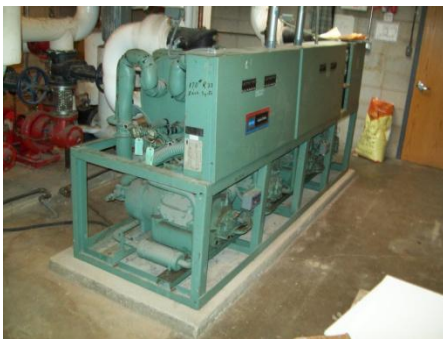
23 year old Chiller is inefficient and repairs are becoming more frequent.

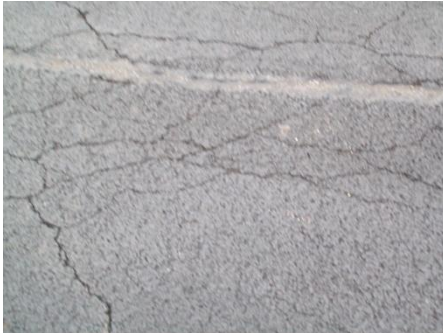
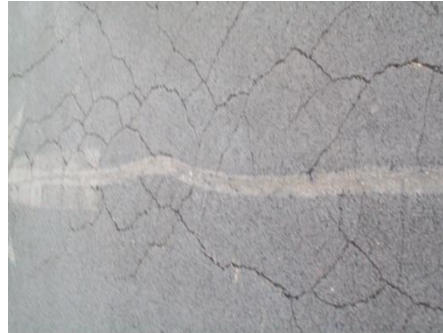
Parking Lot

Multiple deep cracks. Resurfacing will be required in the next five years.

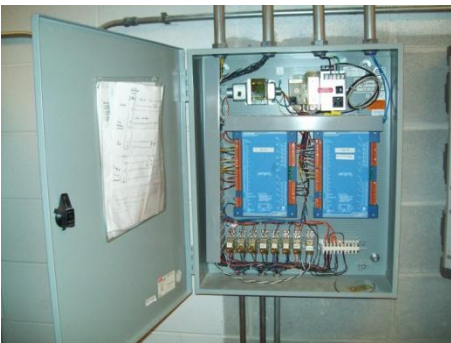
Lon Controller - Lon controls throughout the building

Outdated and costly to repair

Doesn't communicate with the rest of the District's Controls communication protocol

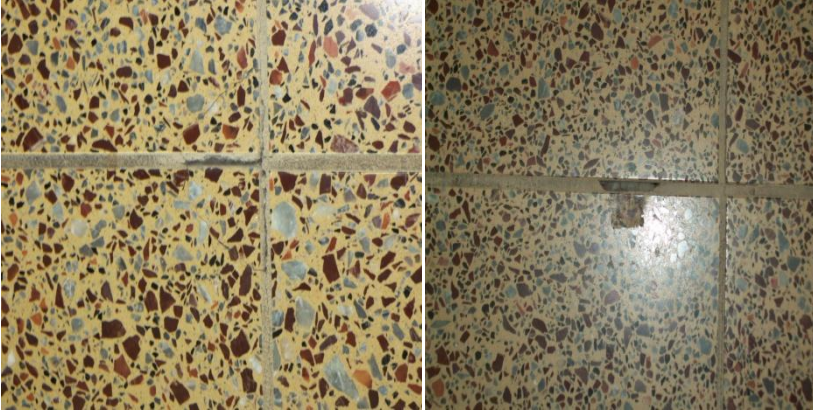
Floor Tile

Terrazzo tile repair/replacement. Tile did not properly bond to the floor and is cracking.

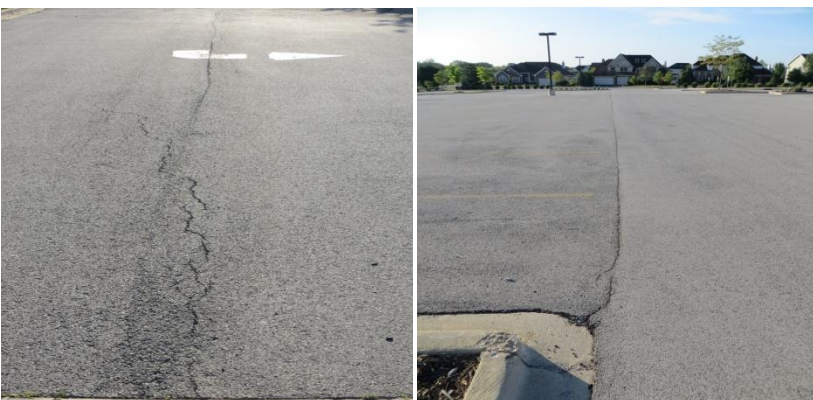
Parking Lot

Several areas starting to show cracking. Crack filling and seal coating will be needed within the next five years.

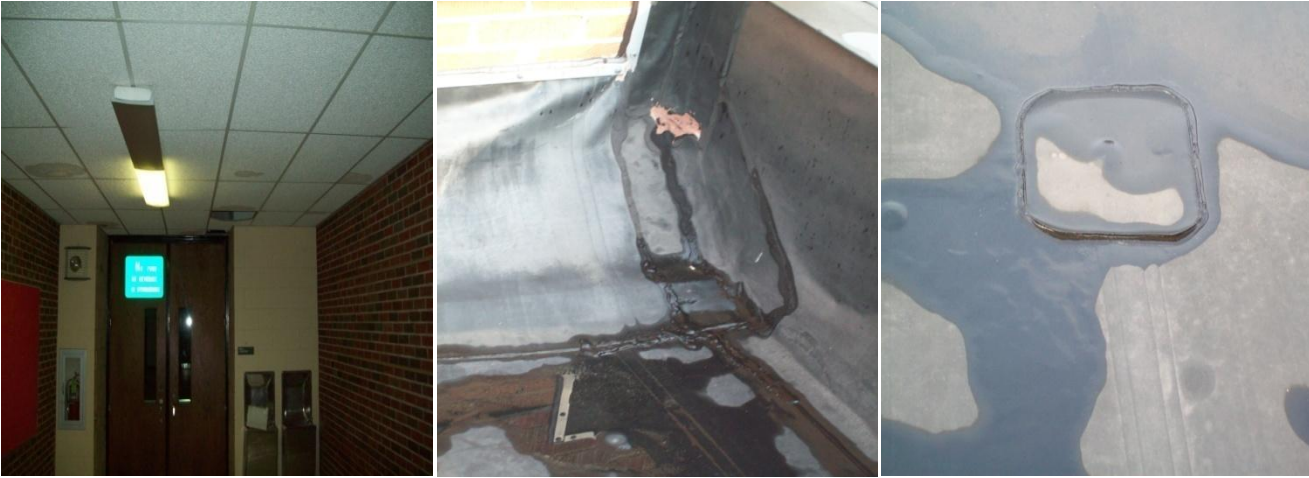
The original **roof** was constructed with single-ply membrane roofing with rigid insulation on wood decking on wood rafters and steel beams. The additions are single-ply membrane roofing with rigid insulation on steel decking on steel joists and beams. Most of the roof is in good condition. Regular maintenance will prolong the life of the good roof. According to the life-safety report of 2005, approximately 20% of the roof needs replacing. We are experiencing leaks in these areas, including the cafeteria area.

Roof – Several leaks throughout. Rubber membrane is beginning to fail, patches are coming apart.

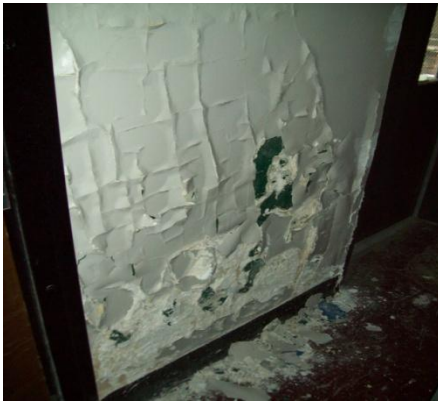
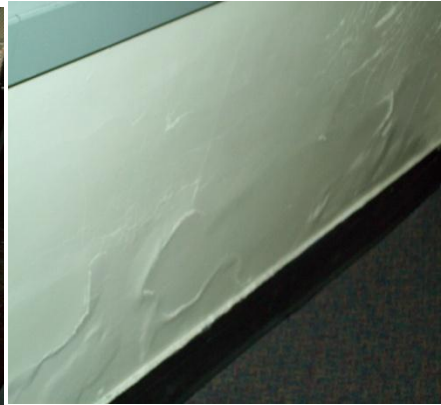
Crumbling Plaster

Due to moisture getting into the building

Tuck Pointing will alleviate this problem

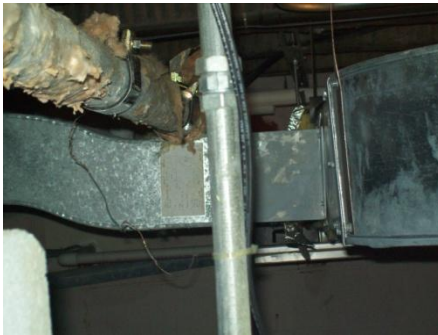
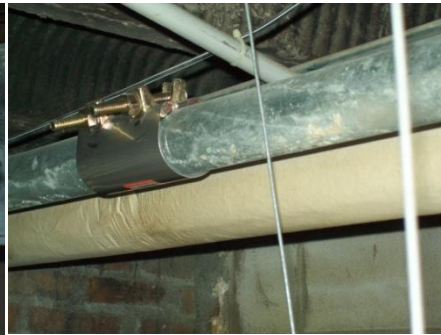
Domestic Water Piping

The building's **domestic water system** is galvanized steel piping. There are many leaks that have been repaired with clamps and the scale build up has reduced pressure and flow availability and the entire system needs to be replaced. The water fountains throughout the building are not ADA compliant.

Utilized pipe clamps to stop leaks throughout.

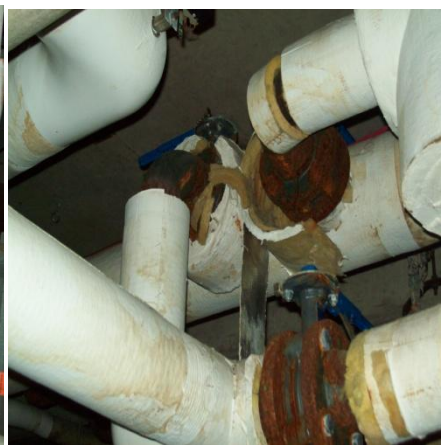
HVAC Piping

Air separator, heating valves and pipe showing signs of excessive rust.

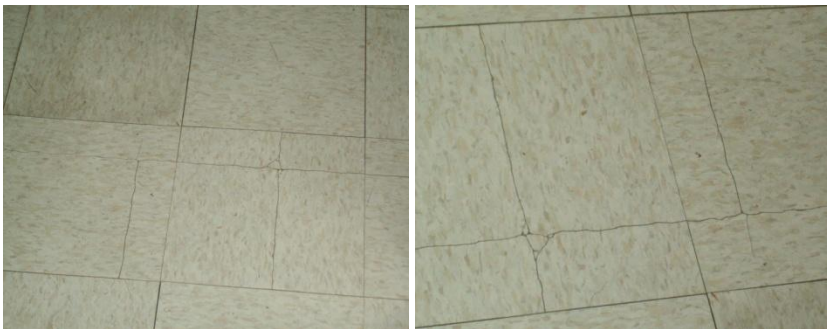
Floor Tile

12" x 12" VCT over 9" x 9" Asbestos tile. Tile is cracking and the 9 x 9 is showing through. Will have to be encapsulated or remediated.

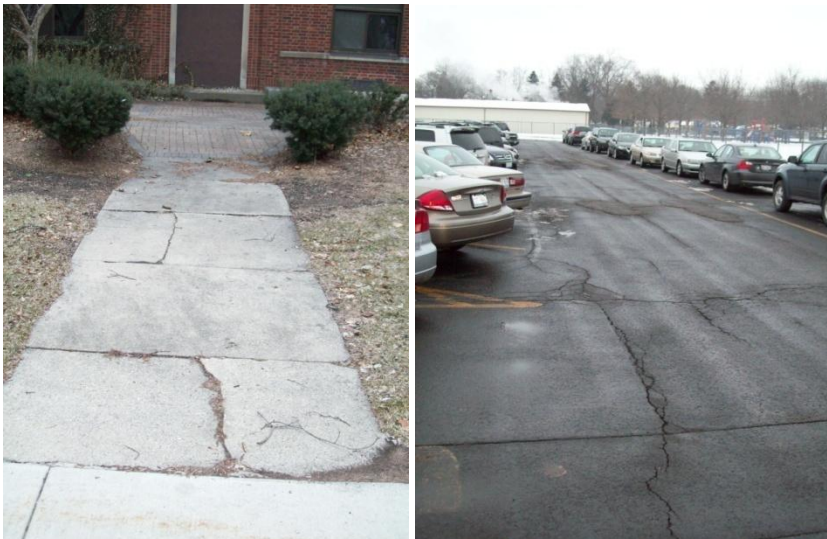
Sidewalk and Parking Lot

Sidewalks are in need of repair or replacement.

Parking lot is in need of patching or replacement. Was patched and seal coated last year.

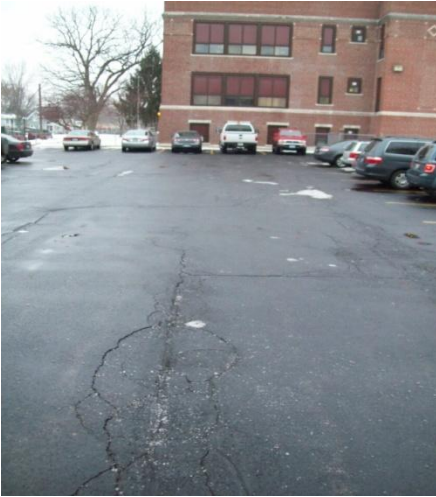
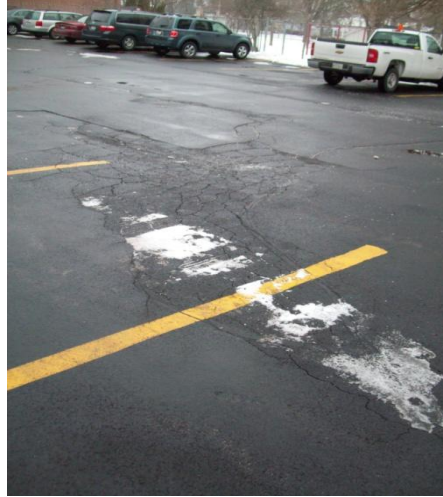
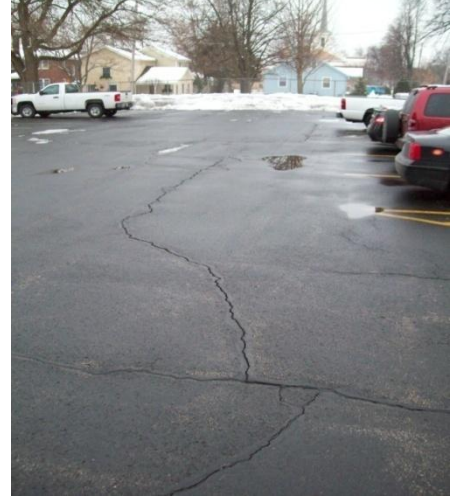
Parking Lot

Several areas need patching. The entire lot may need to be replaced within 5 years.

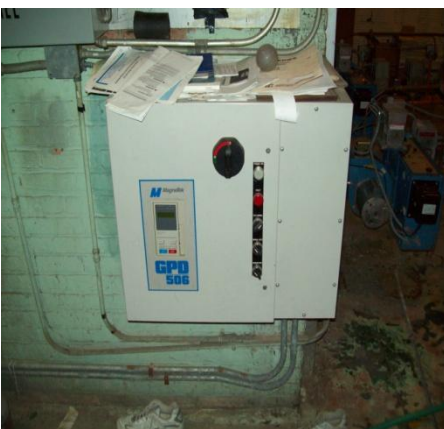
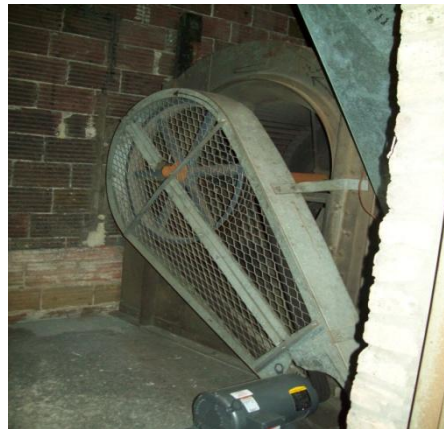
VFD and Fan for the Furnace

VFD doesn't work and fan for furnace is at least 35 years old.

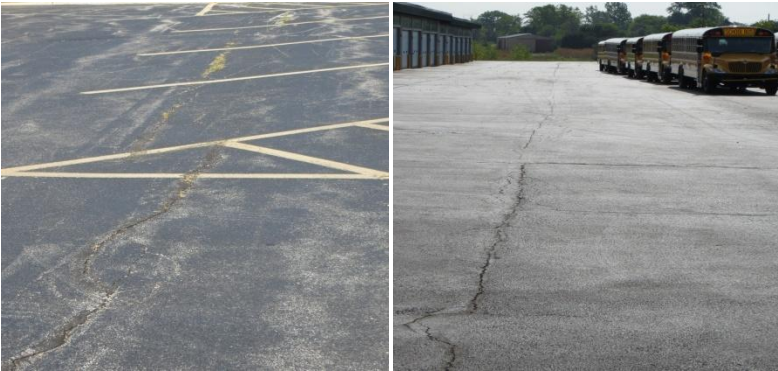
Parking Lot

Several areas starting to show cracking. Crack filled and seal coated last summer. Crack filling and seal coating within the next five years.
