DULL OLSON WEEKES
architects inc.

PARKROSE
SCHOOL DISTRICT

FACILITY REPORT

JUNE 2009

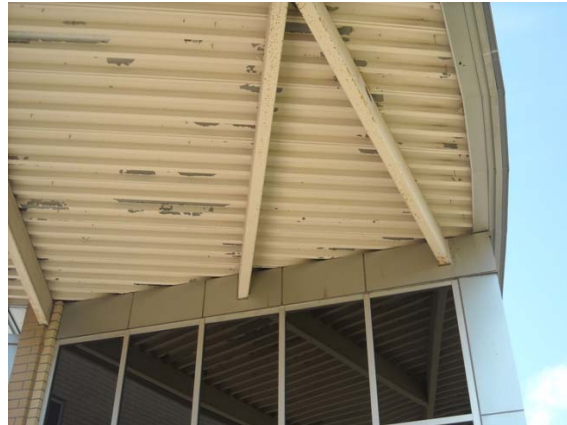
Water damaged soffit and ceiling

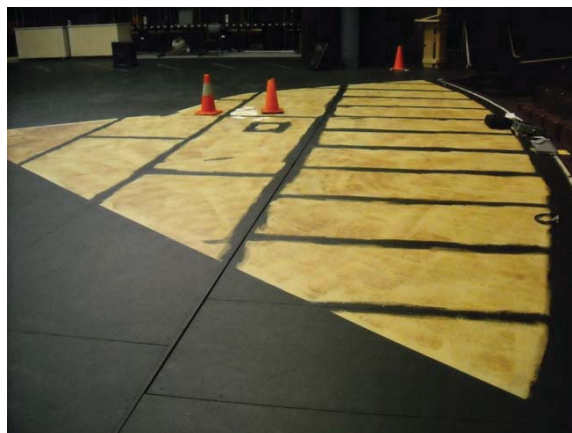
Replace the temporary electrical wiring with permanent wiring at the front of the stage in the theater. Repair the MDF stage floor wherever damaged and refinish to match. Since there are very frequent maintenance issues an alternative to consider would be to replace the entire stage floor with a new stage floor.

Temp wiring at stage

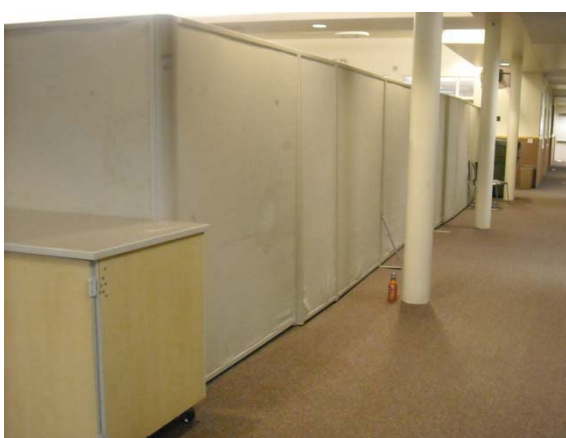
Leaks at ceiling

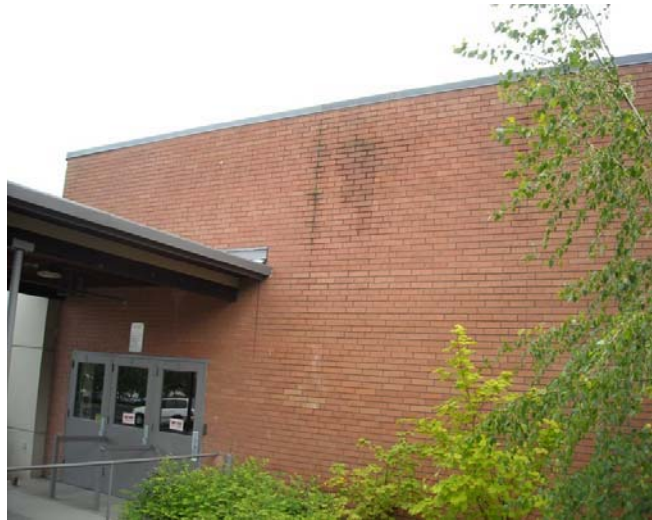
Leaking downspout

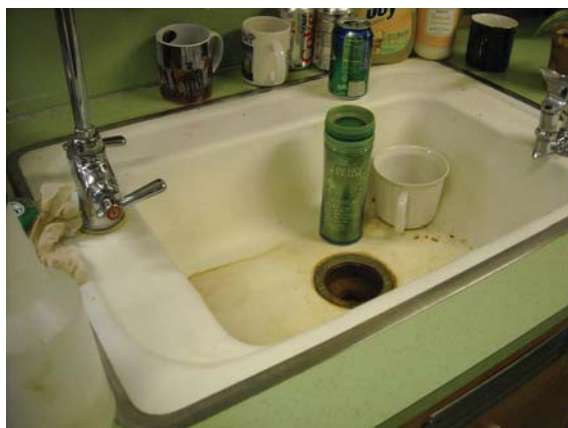
Refinish casework / new counter top

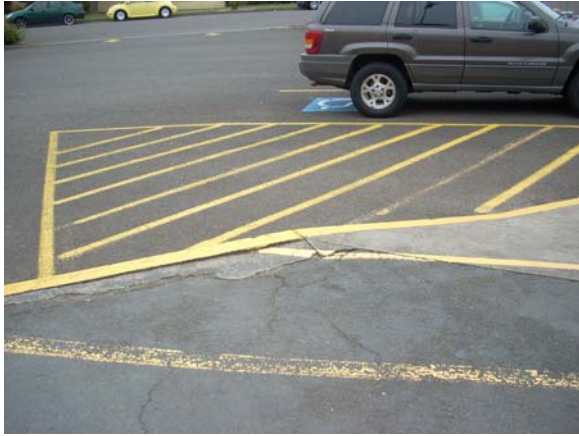
Damaged curb at main entry

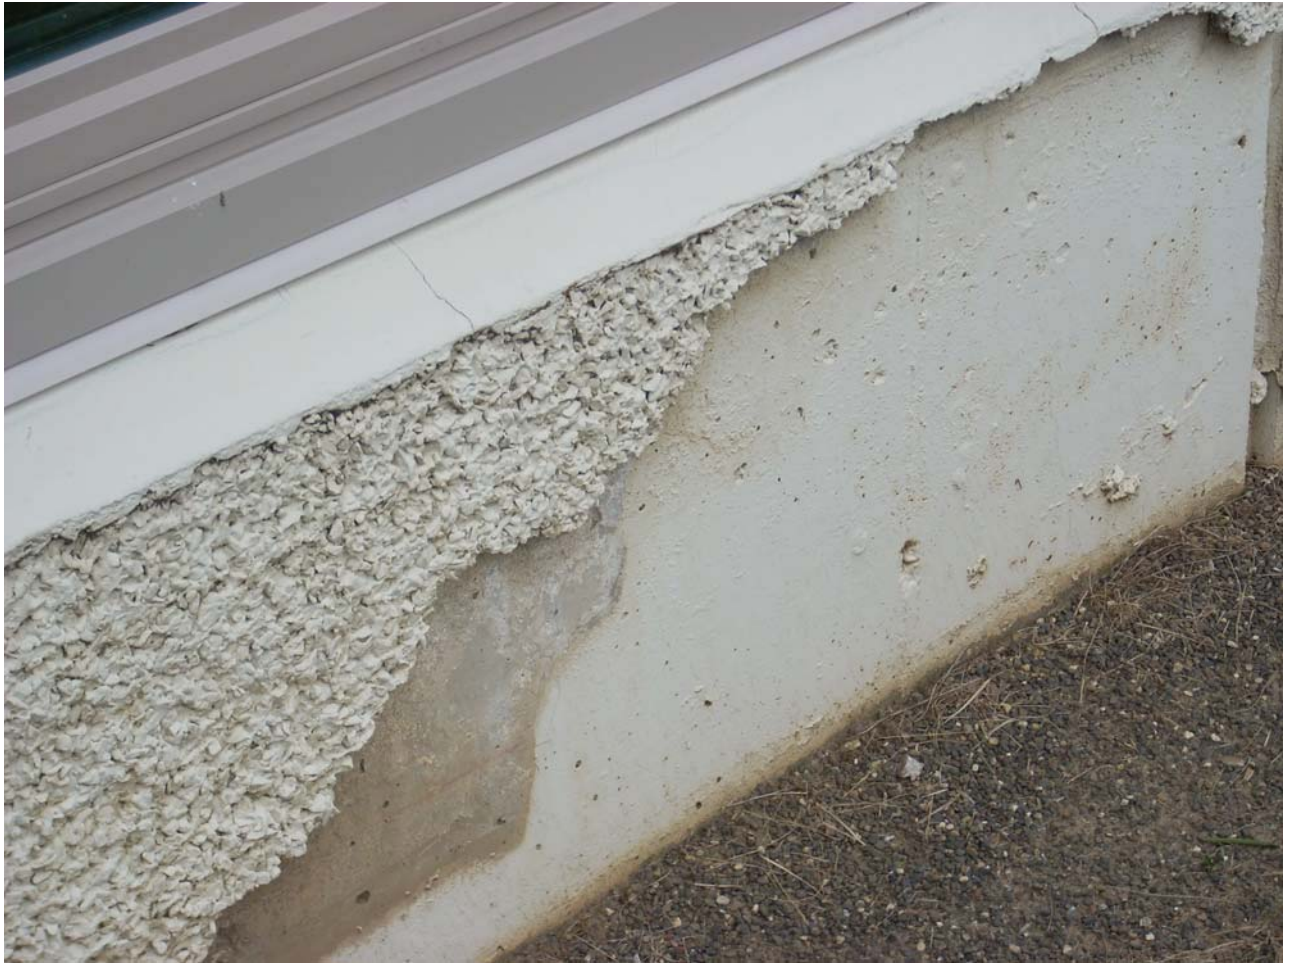
Damaged exterior

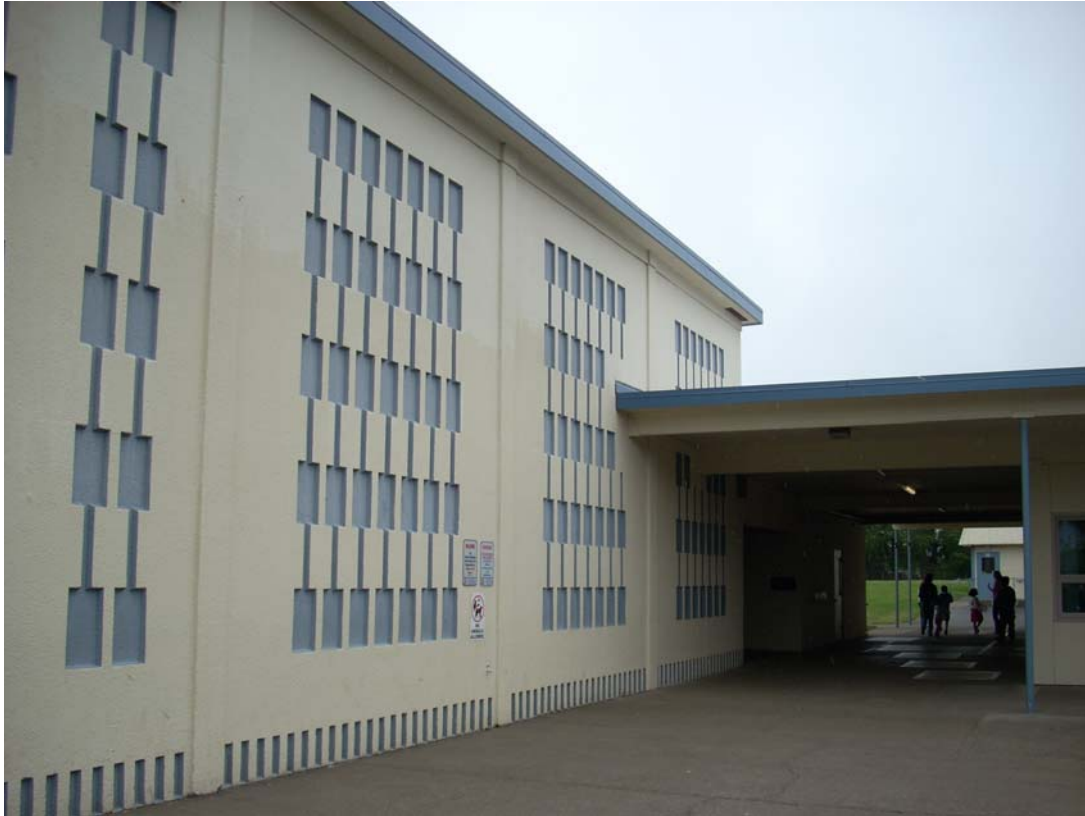
Main entry – office has no visibility to parking

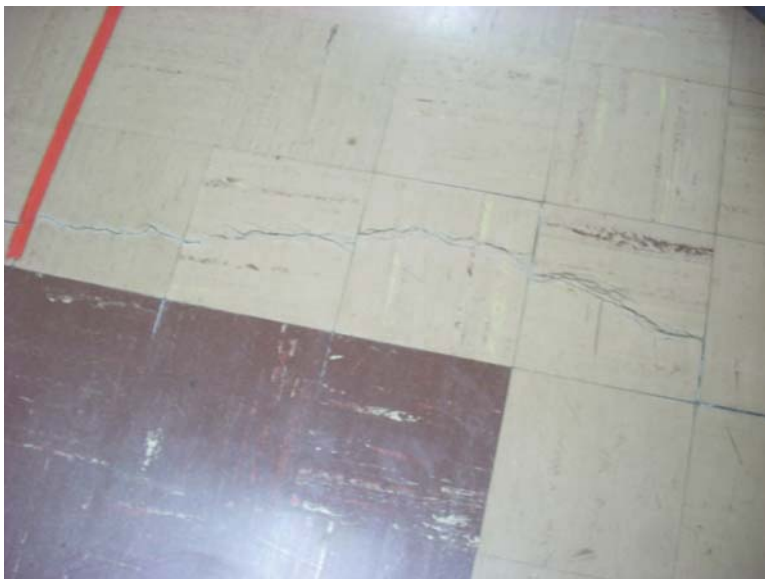
Interior – flooring

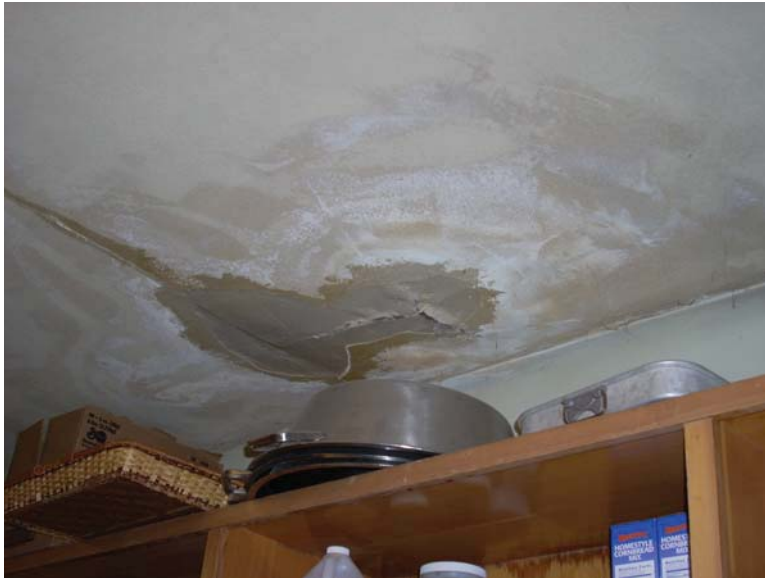
Kitchen storage room – ceiling damage

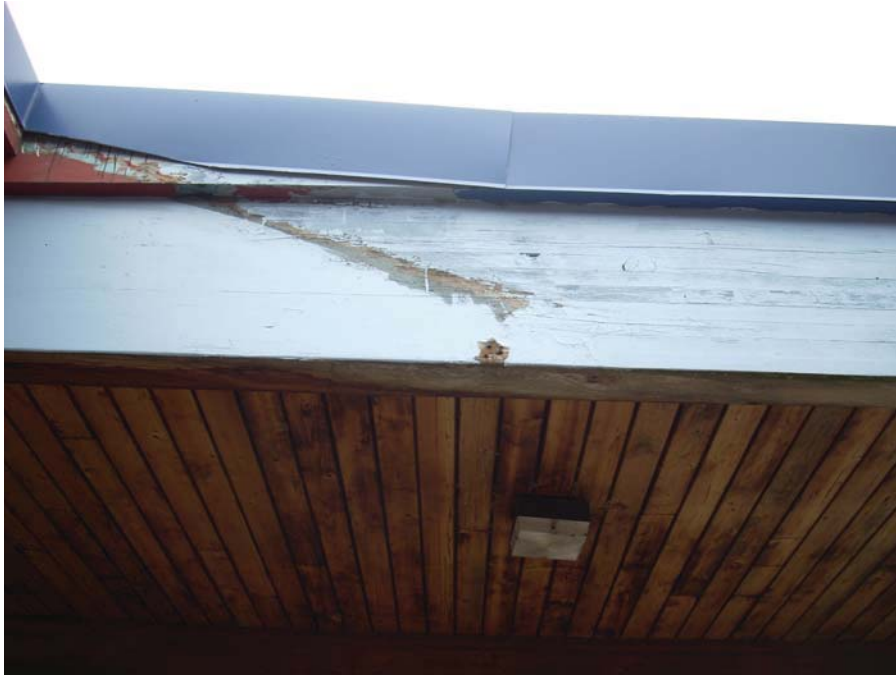
Damaged exterior

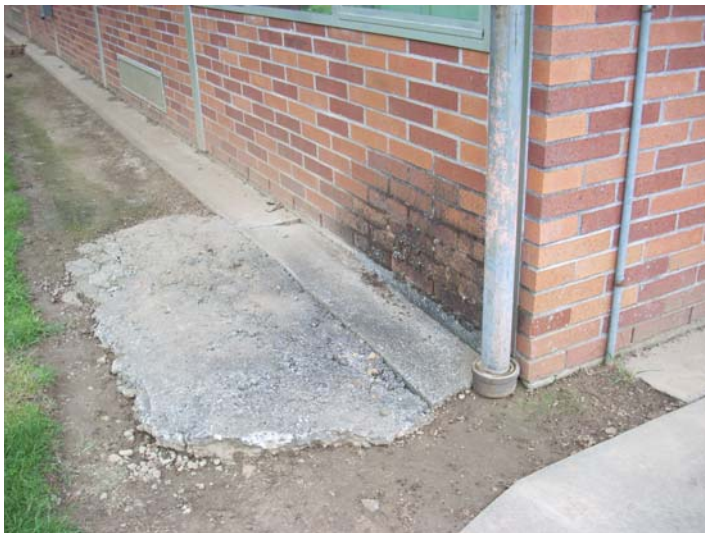
Wall / sidewalk under roof leak

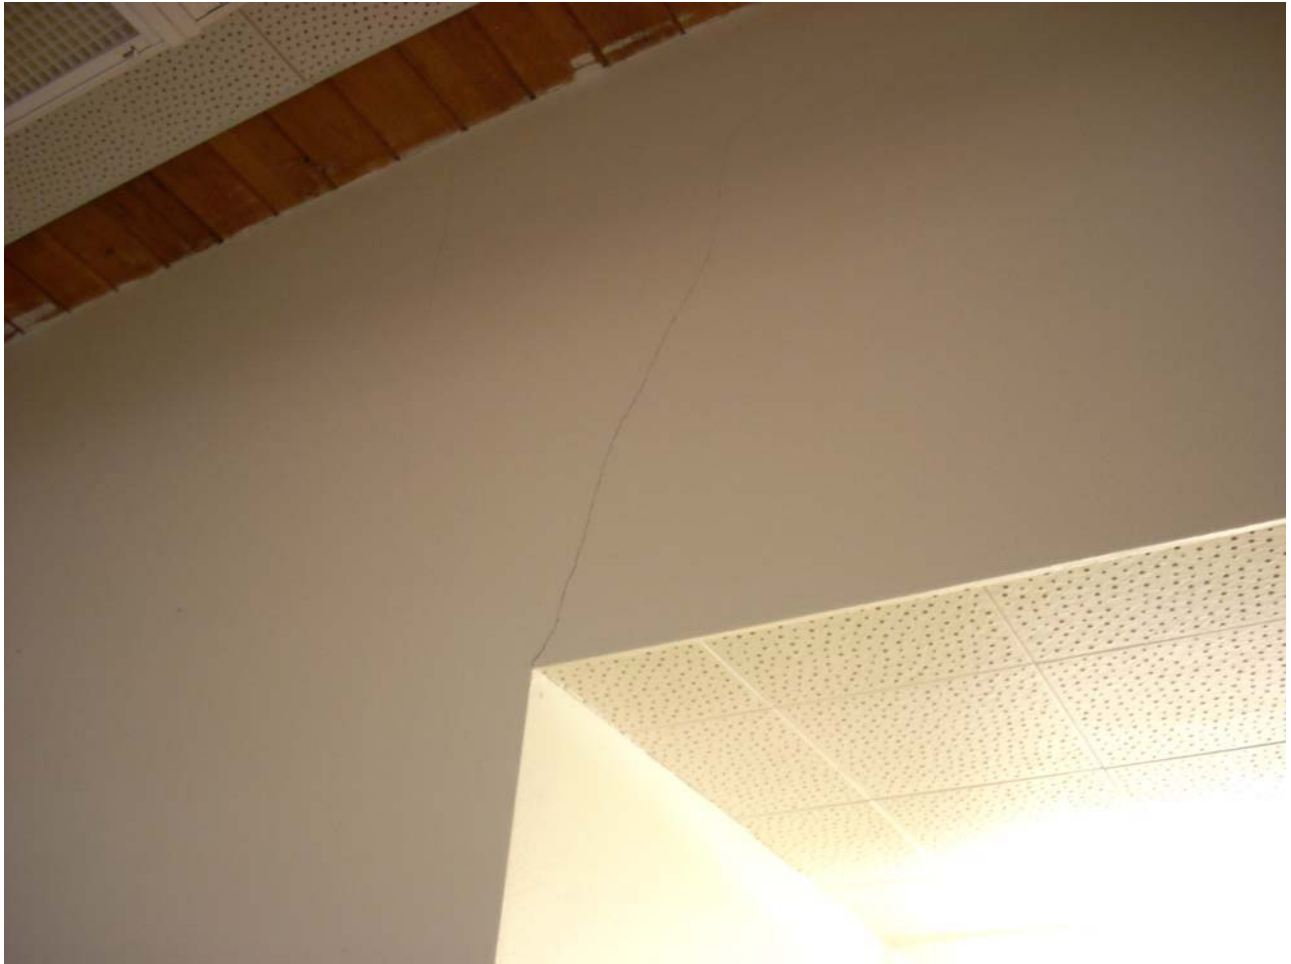
Wall crack in Main Office

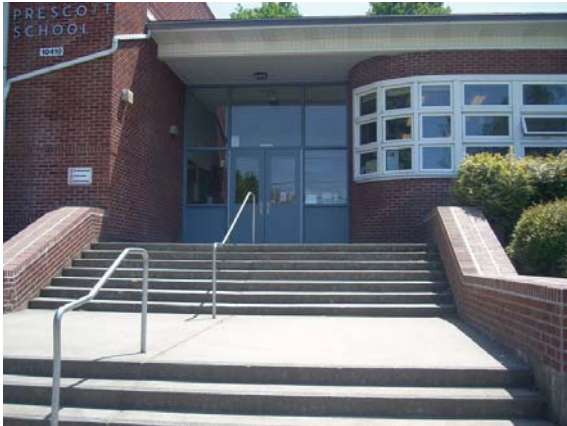
Non ADA entry

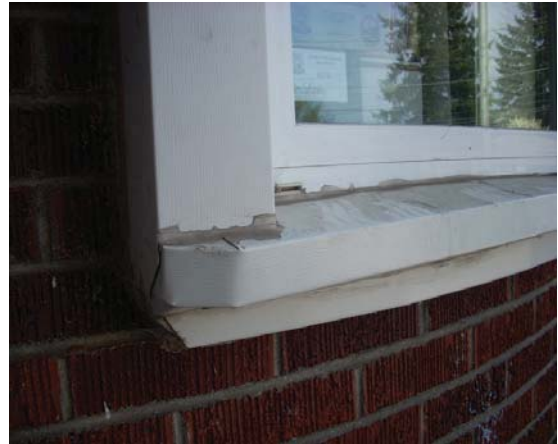
Damaged sealant at new windows

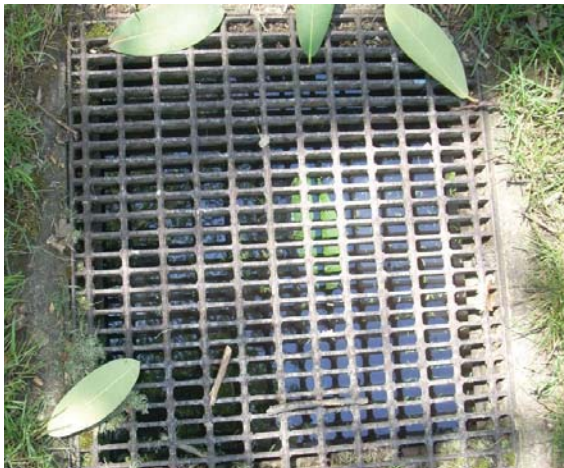
Clogged catch basin

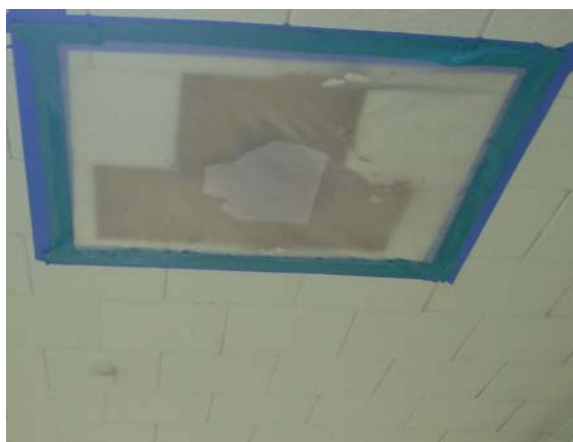
Ceiling under repair

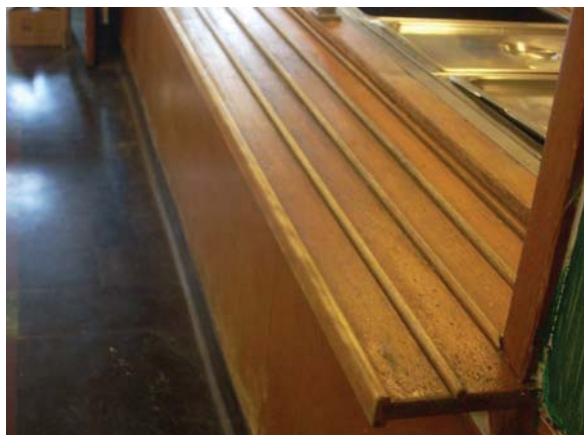
Original kitchen needs remodeling

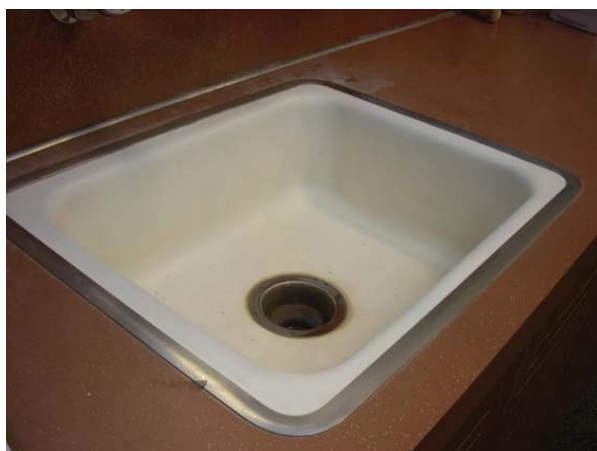
Original sink to be replaced

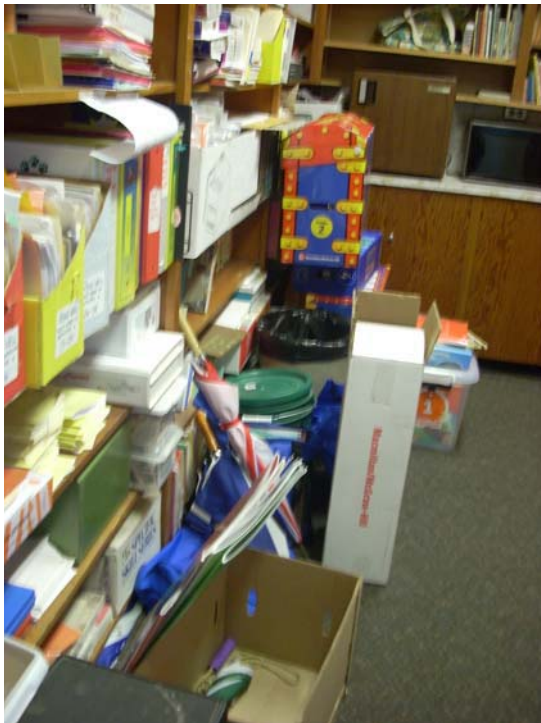
Requires additional storage

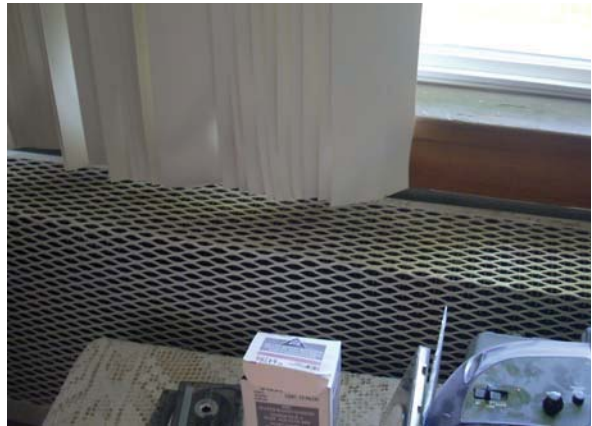
Blinds damaged from heat

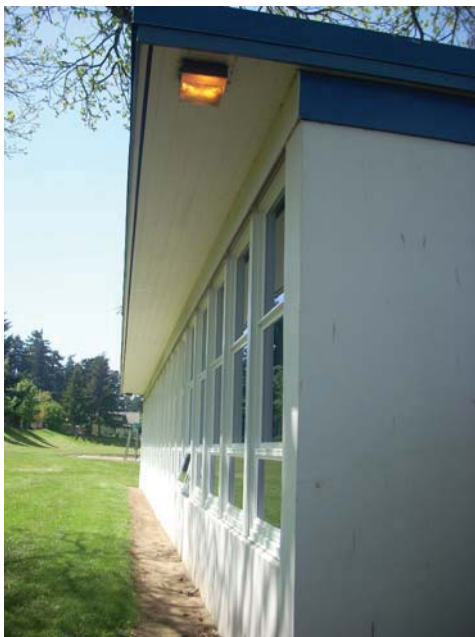
Daylight sensors required

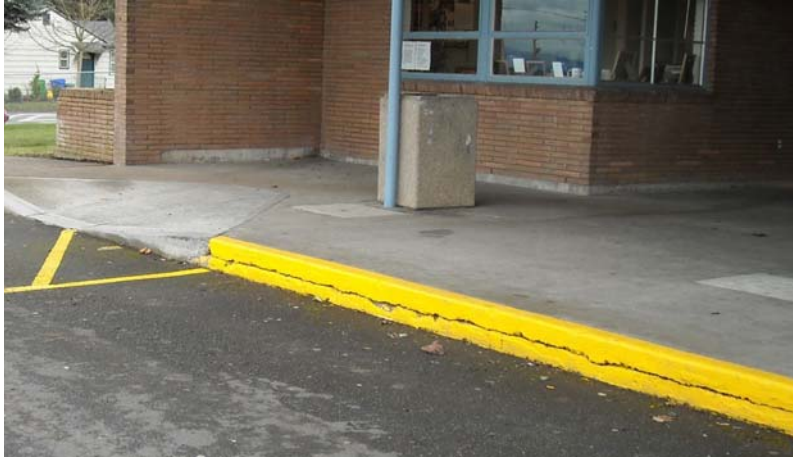
Damaged curb at Main Entry

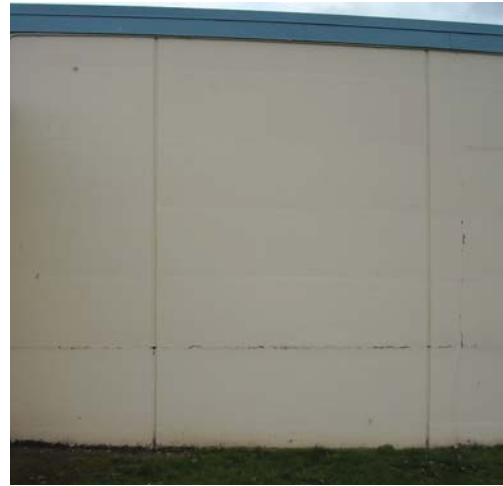
Cracked walls

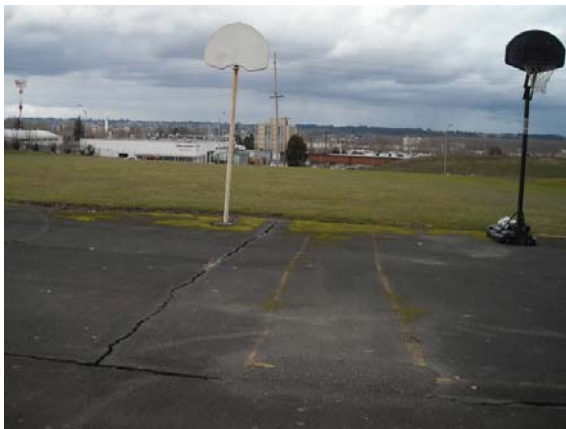
Damaged basketball court

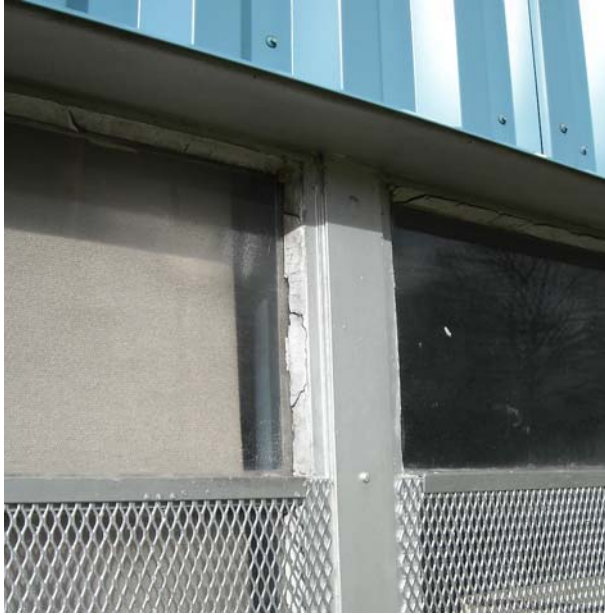
Damaged sealants at window

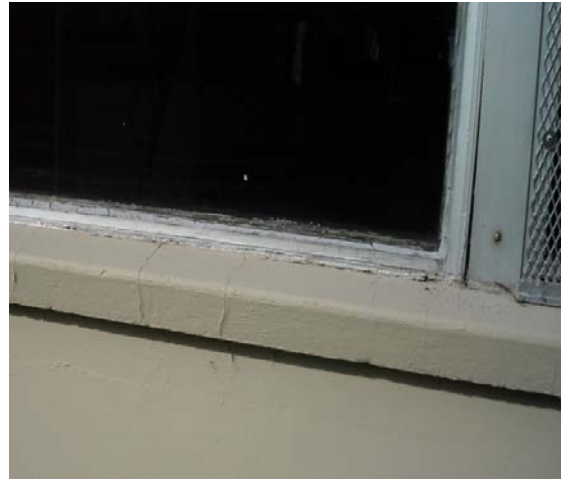
Damaged sill at window

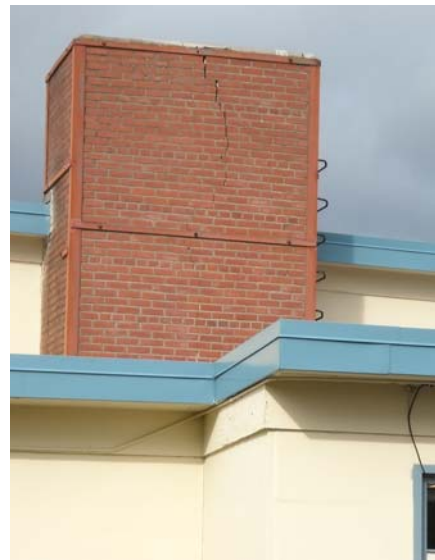
Damaged brick chimney

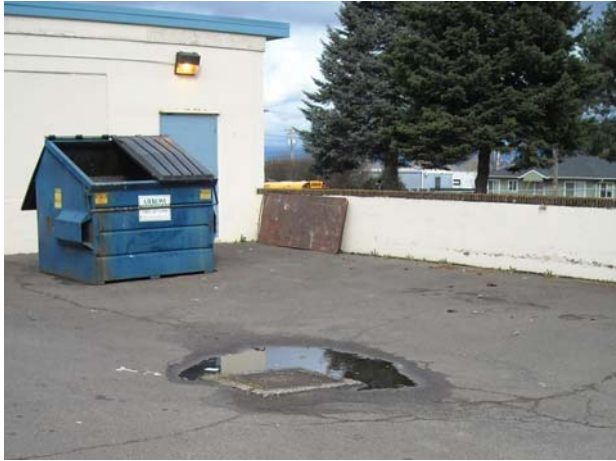
Puddle at drain and damaged driveway

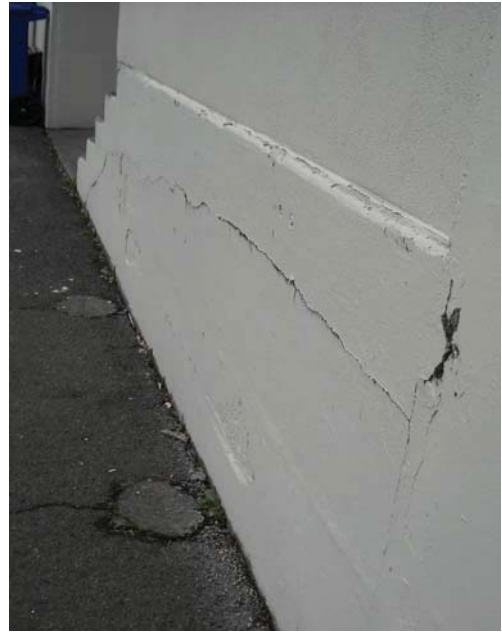
Cracked exterior wall

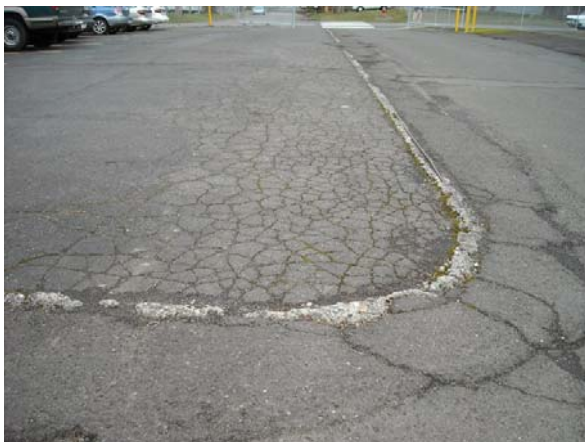
Damaged parking lot – rear side

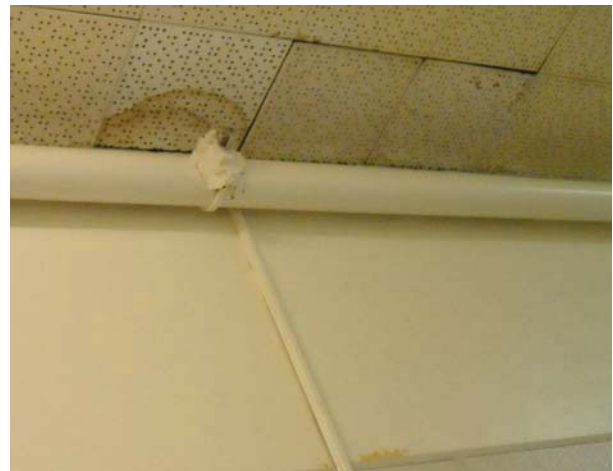
Leakage in roof

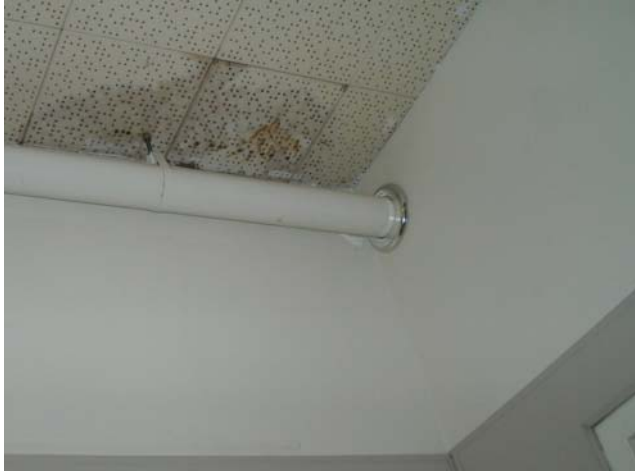
Leakage in roof

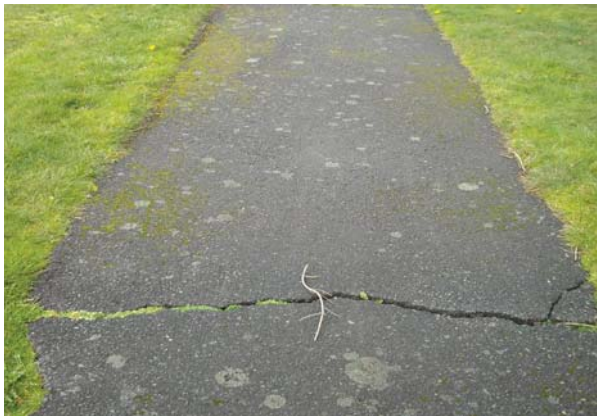
Damaged pathway

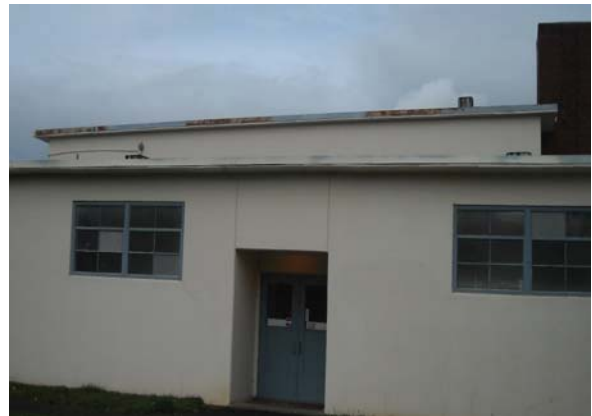
Rusted eave flashing

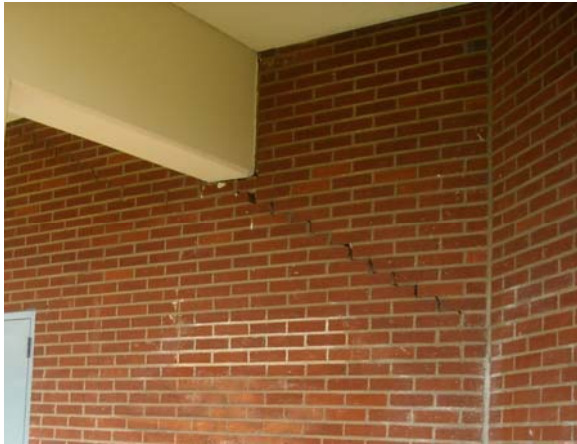
Cracked brickwork

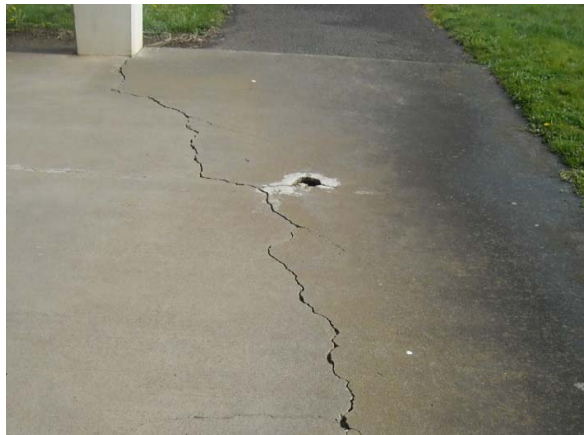
Damage at covered walkway

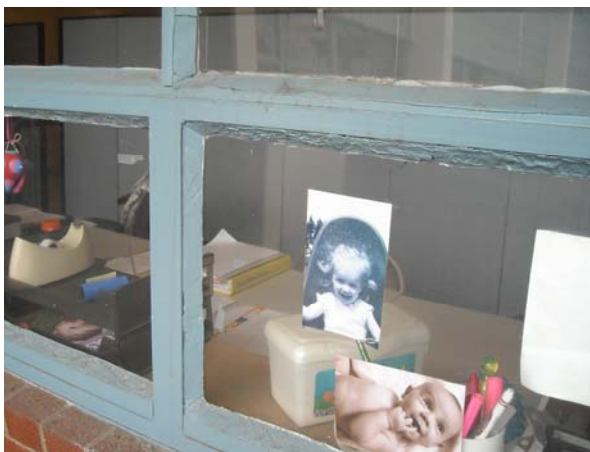
Damaged sealants @ single pane window

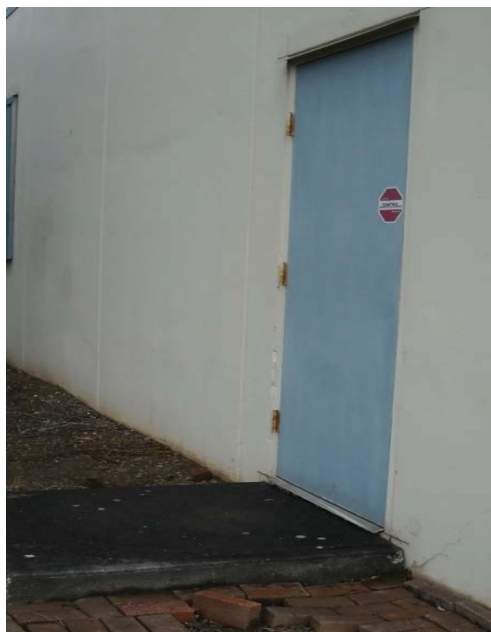
Rusted hinges at exterior door

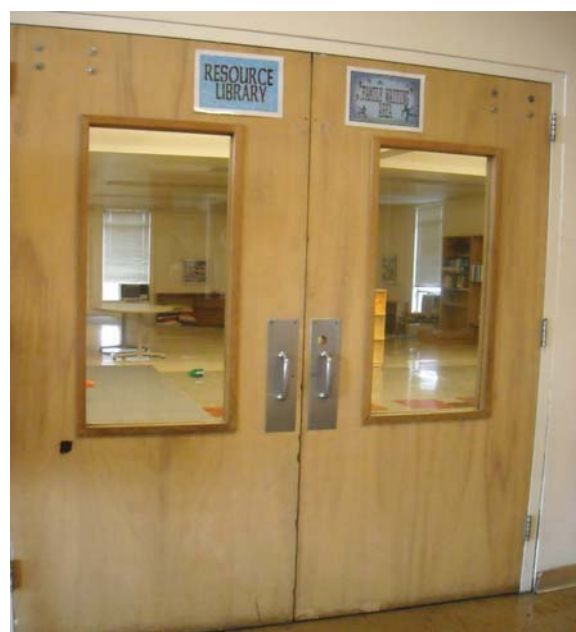
Adequate signage is needed.

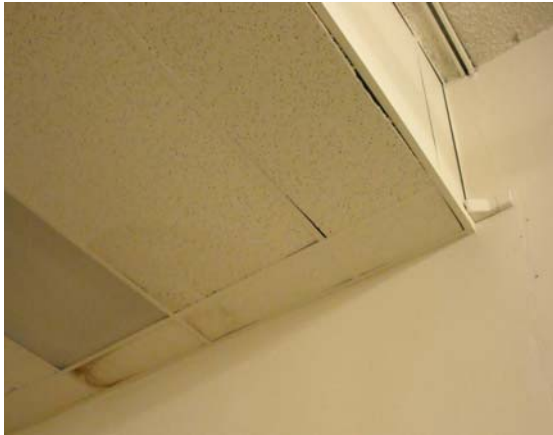
Leaks in library ceiling

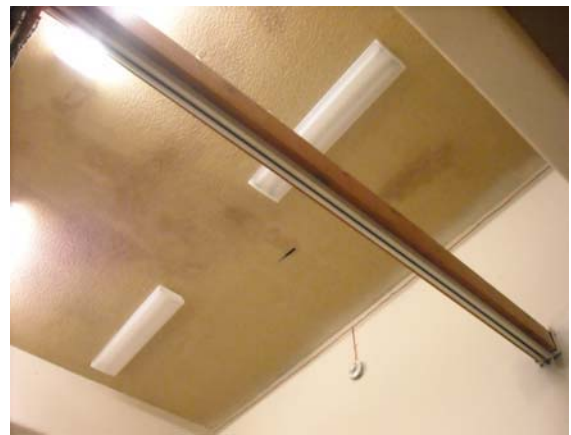
Leaks in main stage ceiling

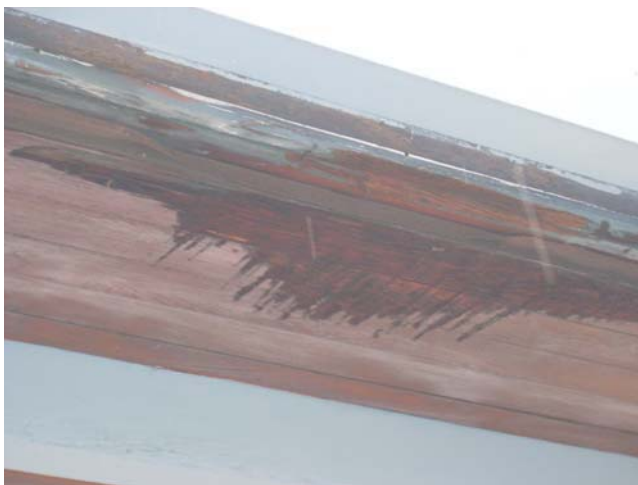
Damage at canopy

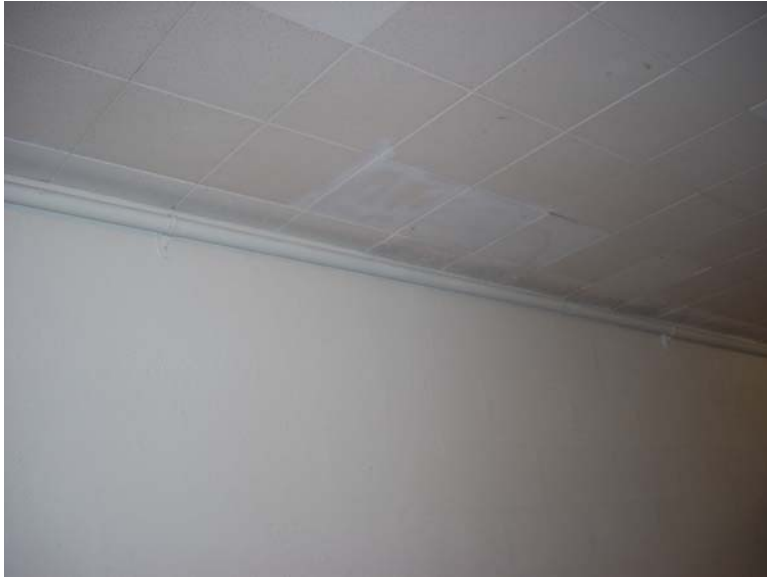
Damaged ceiling

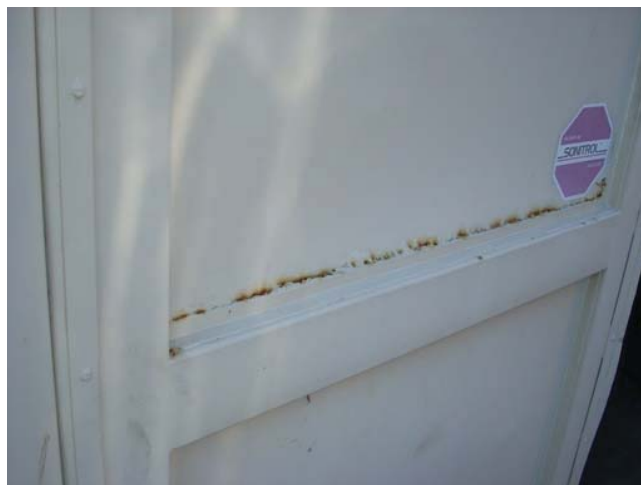
Overhead doors need repair

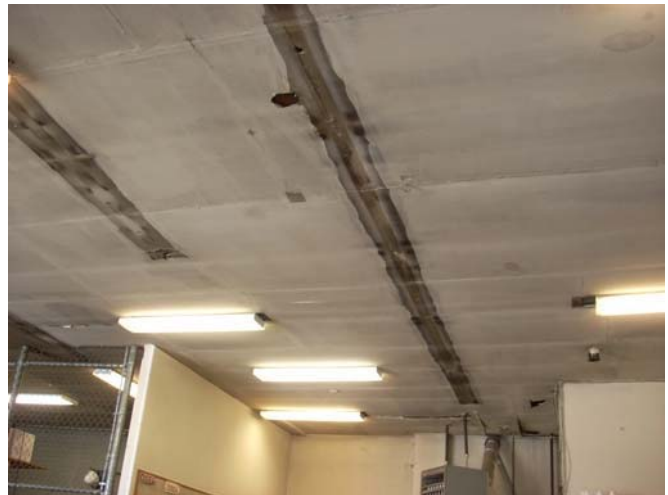
Ceiling to be replaced in Maintenance Shop
