Sams Memorial Stadium
1 Boulevard of Champions
Brownsville, TX 78520

Visual Concrete Structure Evaluation of Sams Memorial Stadium

Prepared for:
Brownsville Independent School District
1900 E Price Road,
Brownsville, TX 78521

Prepared by:
Mr. Rolando R. Rubiano, P.E.
Green, Rubiano and Associates
1220 W Harrison
Harlingen, TX 78550

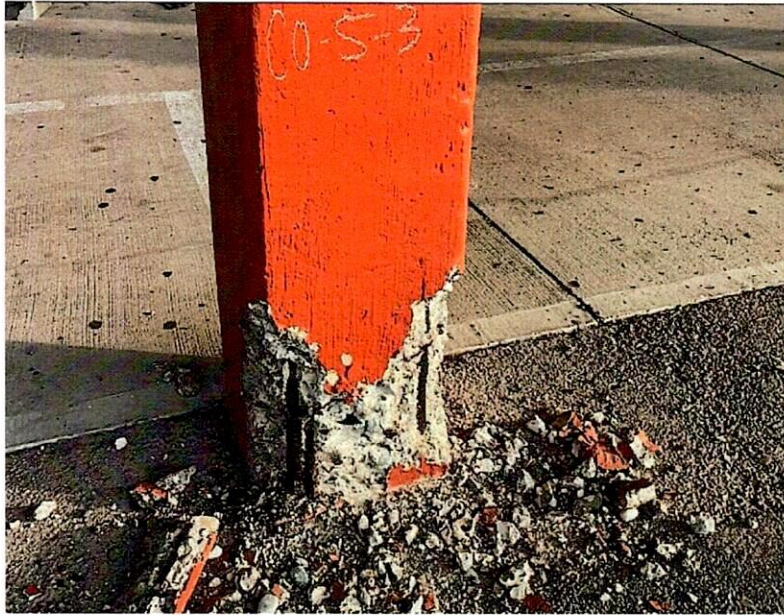
Multiple columns appeared to have spalling and exposed rebar. In some instances, the exposed rebar showed signs of moderate corrosion.

Photo #1: Column is Experiencing Spalled Concrete and Exposed Rebar.

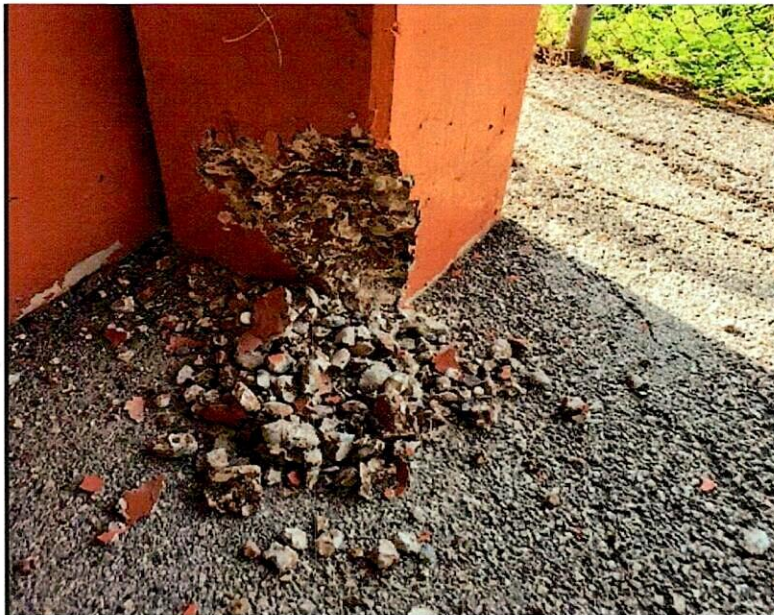
Photo #2: Column is Experiencing Spalled Concrete.

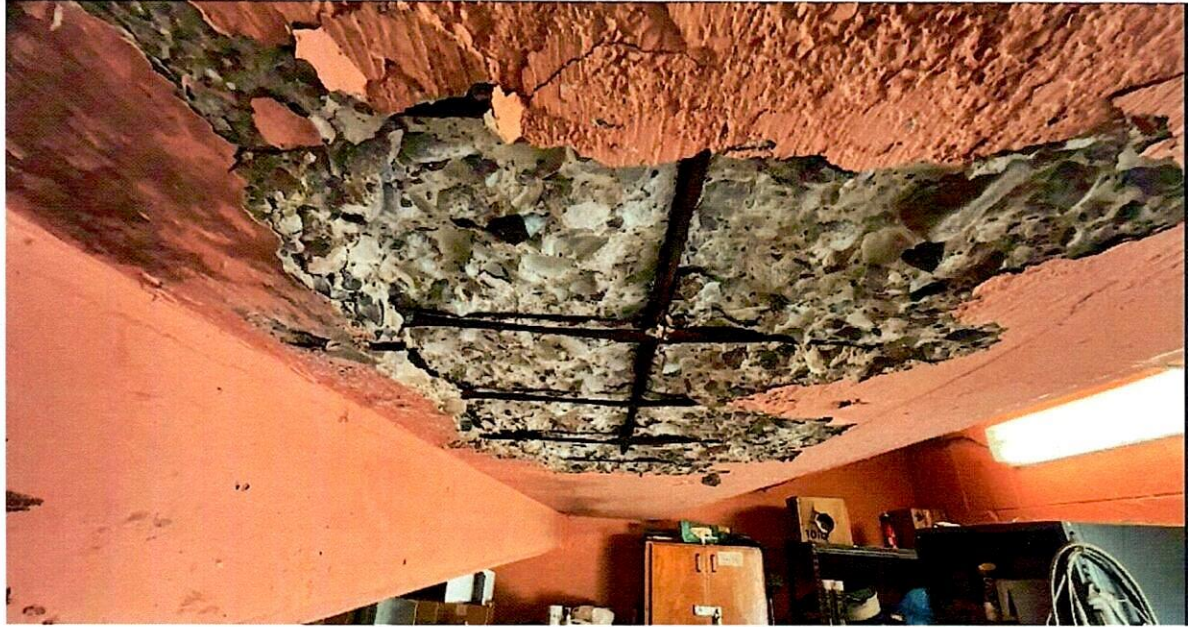
At multiple locations on both the topside and underside of the bleacher beams, exposed rebar and instances of spalling could be seen. Exposed rebar was present in several locations with moderate corrosion due to weather exposure. Efflorescence was present on several bleacher beams underside at the West stands. In one location within section Q, two bleacher beams appear to have significant spalling and exposed rebar with extensive corrosion. These bleacher beams are supported by a CMU wall located beneath them.

Photo 3: West Stands Bleacher Beam Underside Showing Exposed Rebar with Extensive Corrosion.

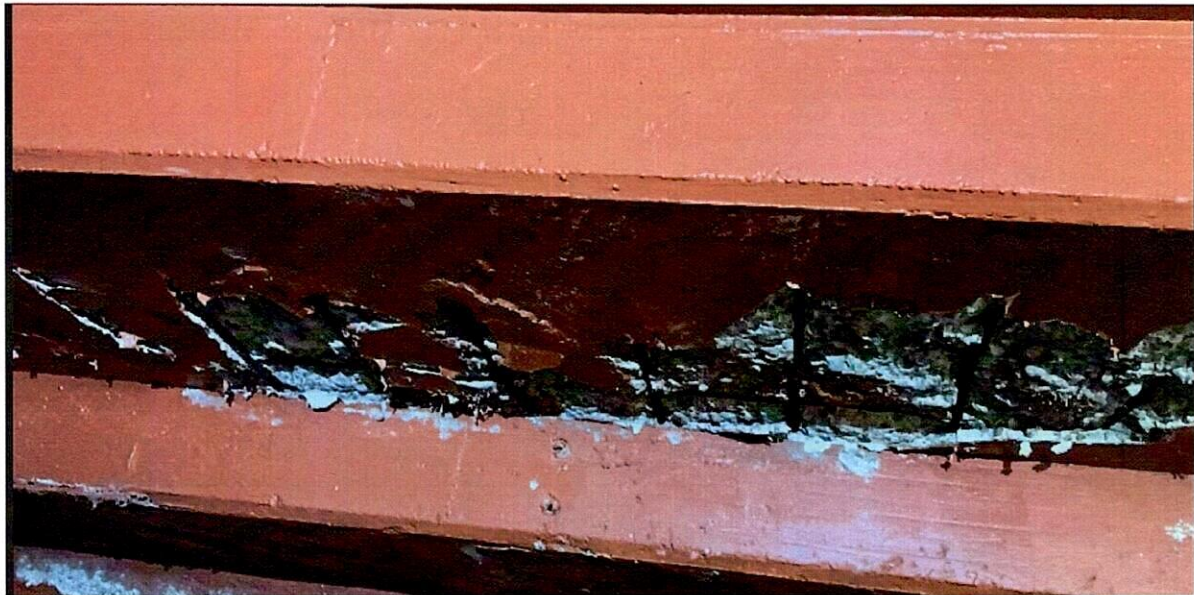
Photo 4: East Stands Bleacher Beam Underside Showing Delamination and Spall with Moderate Corrosion.

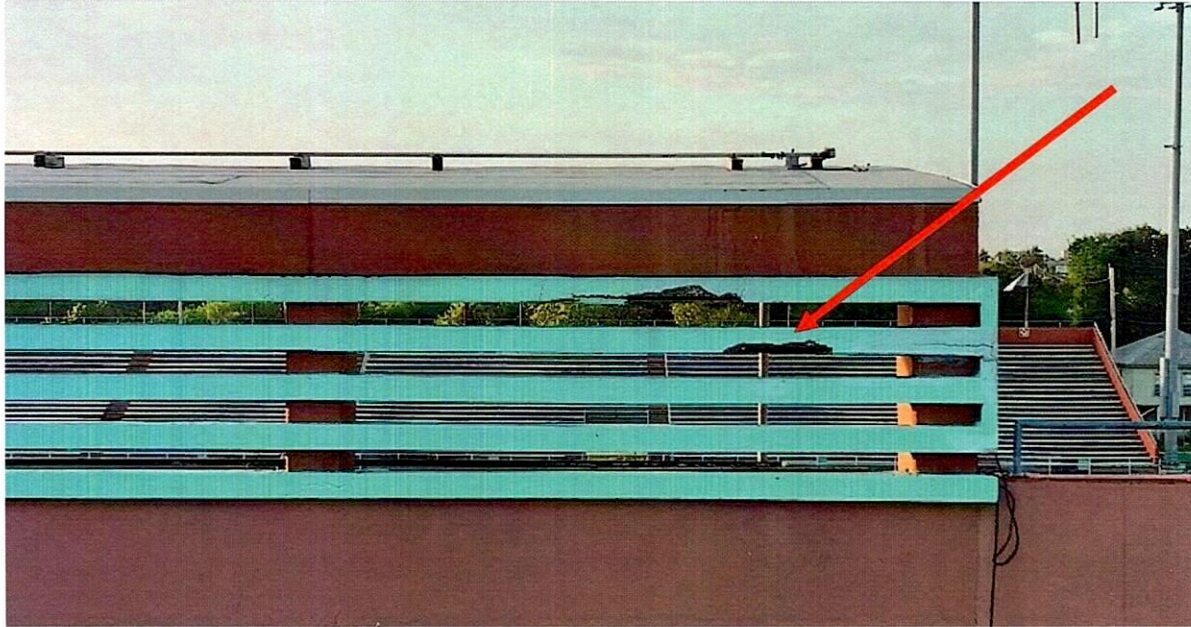
Photo 5: Louver on Press box Showing Exposed Rebar with Minor Oxidation.

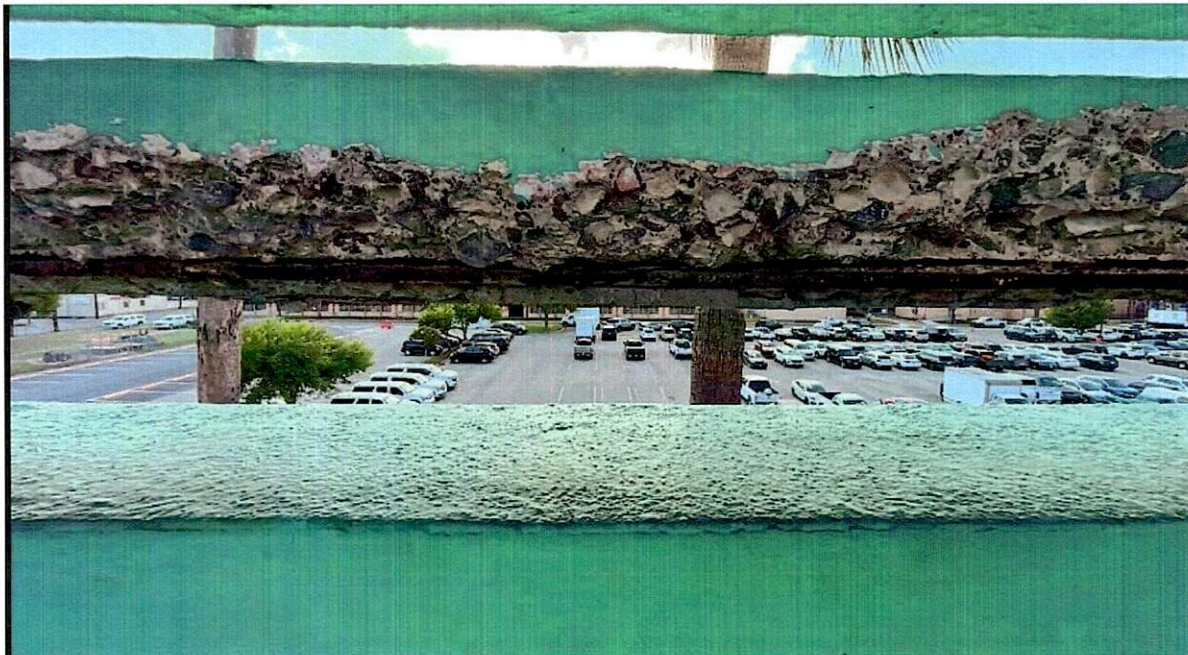
Photo 6: Zoomed In Photo of Louver on Press box Showing Exposed Rebar with Minor Oxidation.

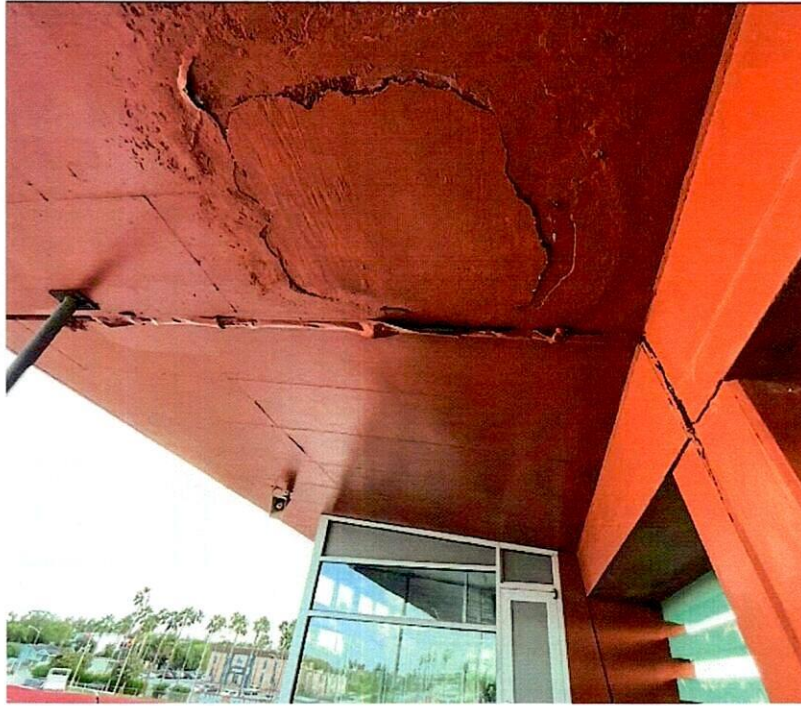
The majority of the press box slab and walls appeared to be in good condition with minor cracks. In two locations of the press box roof slab, about 30 square feet of patching seemed to be present. Based on the record drawings it appears that these repairs were caused by the removal of two light poles. Several louver concrete beams have spalling and exposed rebar with moderate corrosion. Multiple concrete columns supporting the press box roof slab appeared to have minor spalling, and steel pipe columns supporting the press box roof slab appeared to be in good condition.

Photo 7: Patch of Roof Slab Underside due to Removal of Light Pole. Patch is Suspect to poor Adhesion and Posing a Potential Hazard of Becoming Falling Debris.

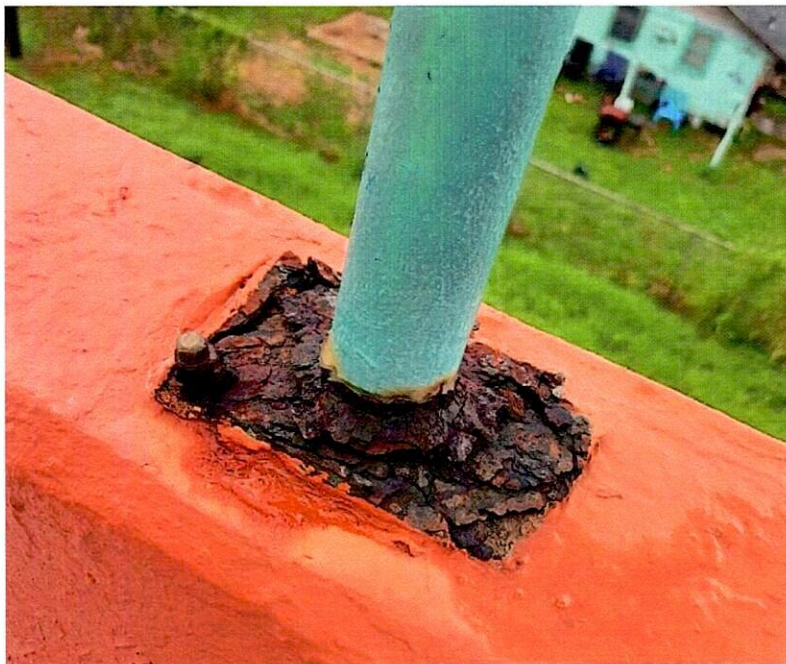
The stem walls along the perimeter appeared to be in good condition throughout the home and visitors' bleachers. At multiple locations, base plates of the guard rails above perimeter stem walls appeared to have severe oxidation at both the home and visitors' bleacher sides. At the

Photo 8: Guard Rail Base Plate showing Severe Corrosion.

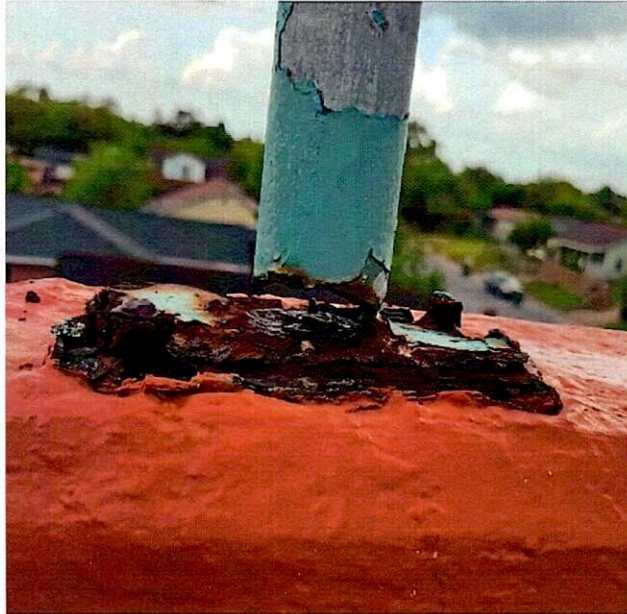
Photo 9: Guard Rail Base Plate Showing Severe Corrosion.

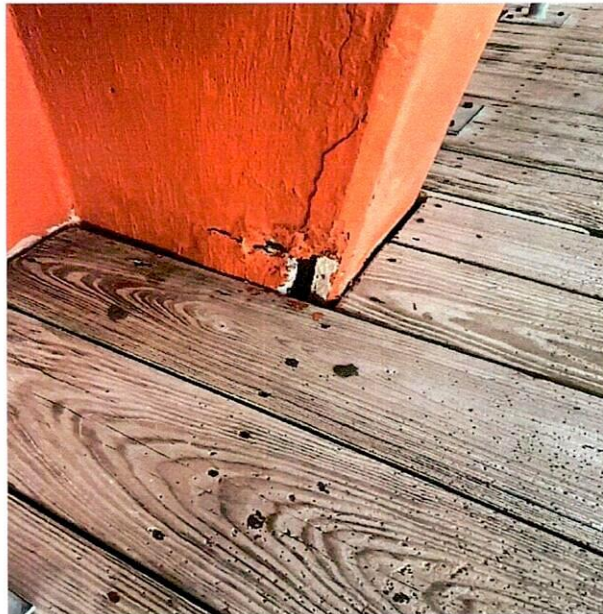
Photo 10: Pressbox Column Showing Spalling.

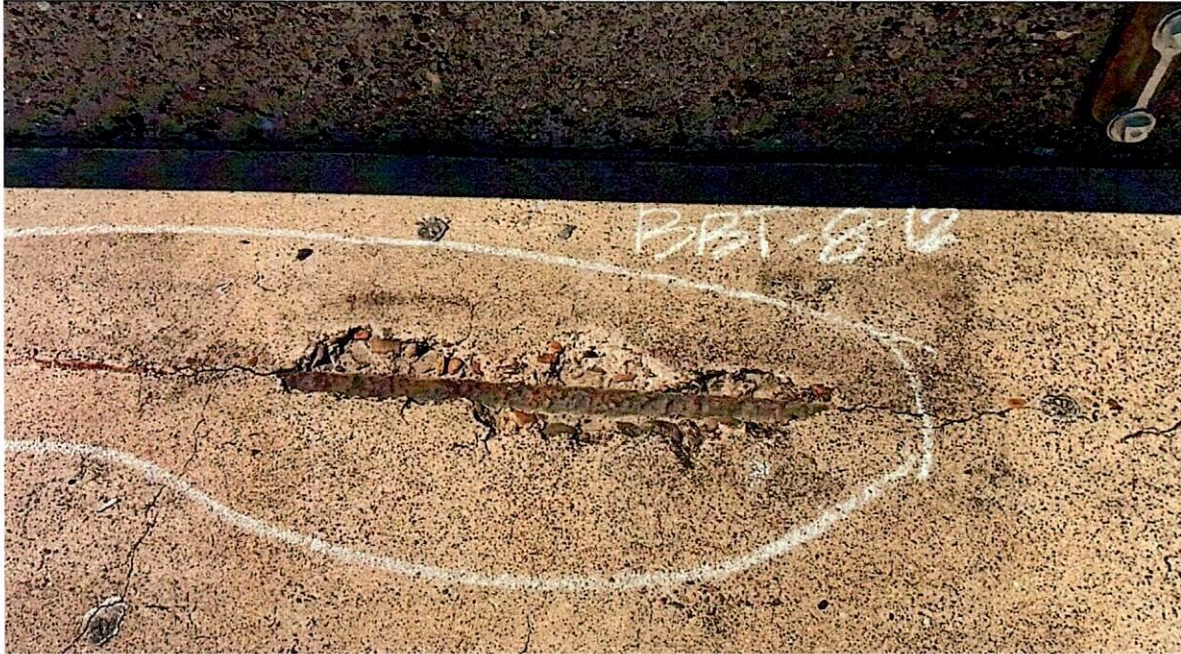
Photo 11: Bleacher Beam Topside Showing Exposed Rebar.

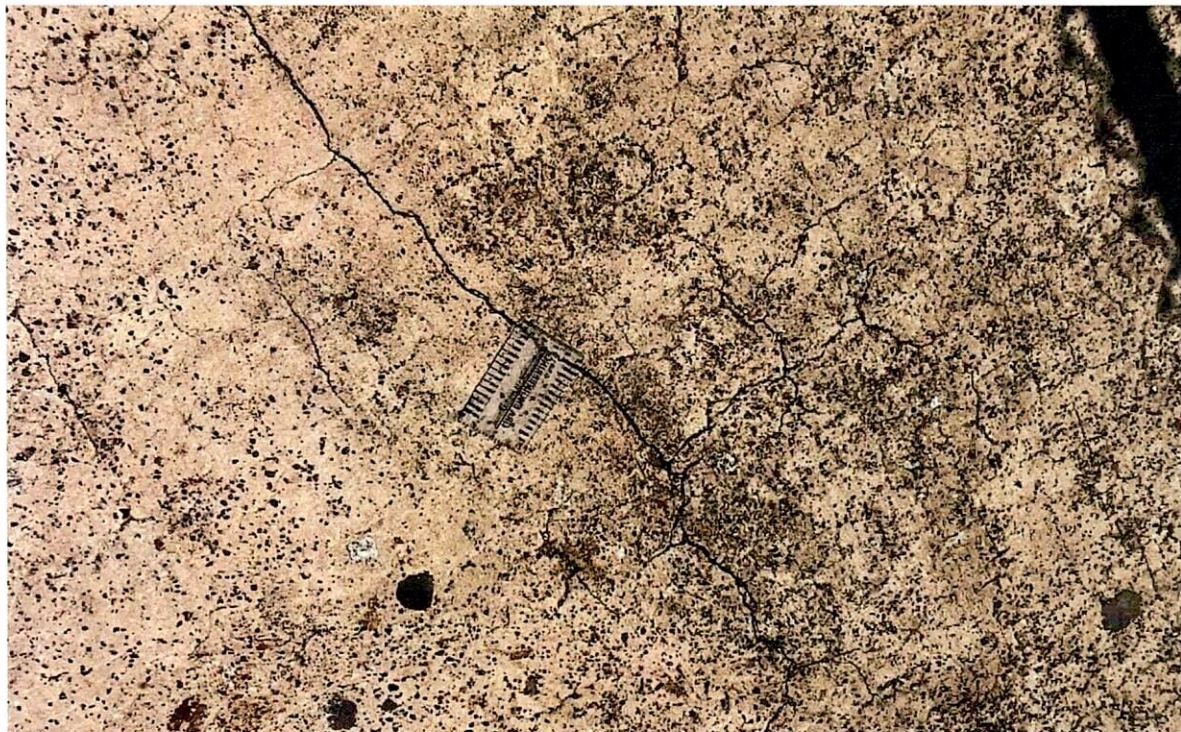
Field observations revealed the presence of cracks throughout various elements of the concrete structure, but these cracks were minimal in nature, due to the natural process of concrete shrinkage. In-between seating sections along the step line, shallow depth cracks were found with no visible sign of rebar exposure. Shallow depth cracks were found spanning parallel to the bleacher beams with no visible sign of exposed rebar.

Photo 12: Shrinkage Cracking on Slabs.
