**HAROLD KAVEOLOOK**

**KAKTOVIK  
AREAWIDE MECHANICAL AND ELECTRICAL  
BUILDING ASSESSMENT AND INVENTORY SURVEY REPORT**

**August 19, 2024**

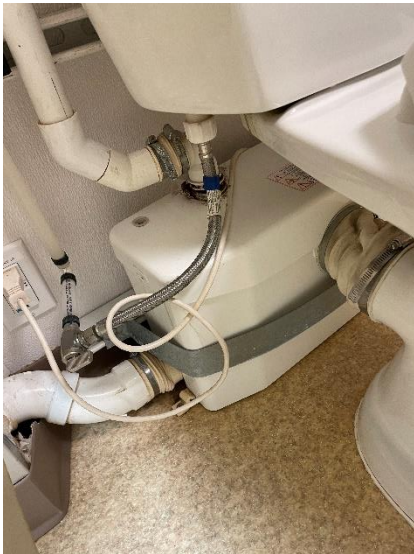
The plumbing fixtures are generally in good condition. The water closets are Sanivite toilets that have integral lift stations behind the toilet. The remain plumbing fixtures: lavatories, janitor's sinks, and kitchen equipment fixtures are standard fixtures that use either the adjacent toilet lift station or separate lift station.

Photo M1 – Toilet and Lift Station

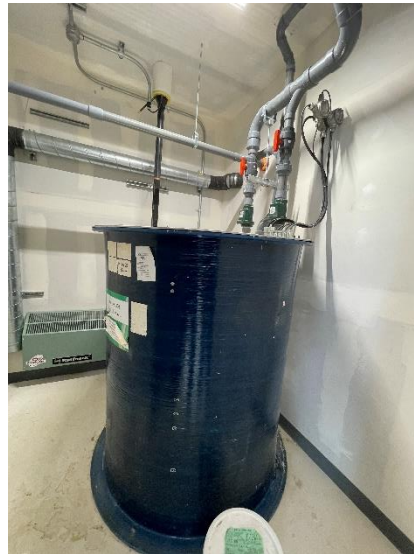
Photo M2 – Area Lift Station

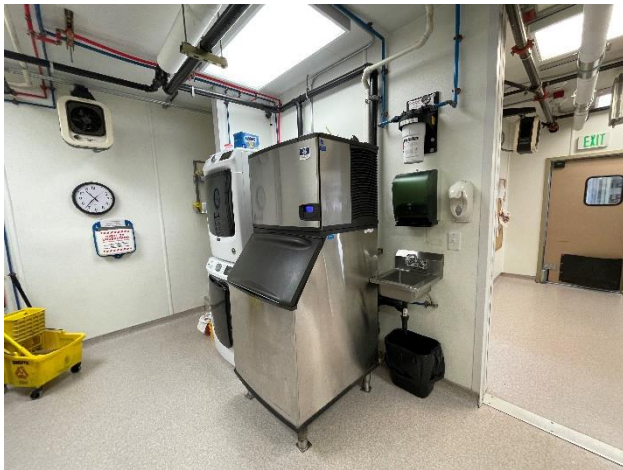
Photo M3 – Icemaker and Lift station

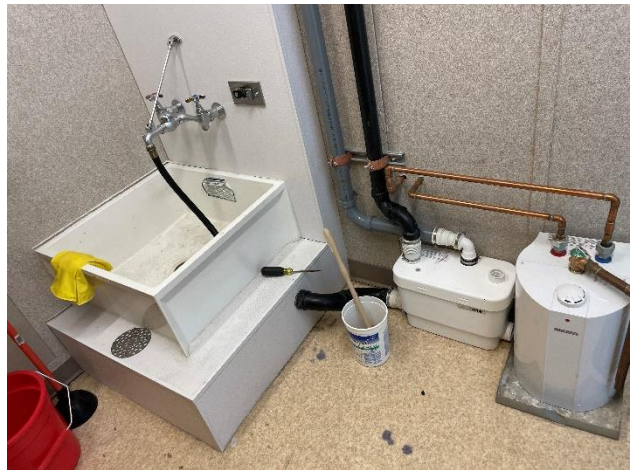
Domestic hot water for the kitchen area is provided by an 54kw / 120-gallon electrical hot water heater. Domestic hot water for the boy's and girls' rooms in the classroom wing are provided by 2-gallon electric hot water heaters located in the adjacent janitor's room. Standalone lavatories and sinks hot water are provided with point of use under counter electric hot water heaters. All the hot water heaters are in good condition.

Photo M4 – Janitor's Sink Lift Station and Water Heater.

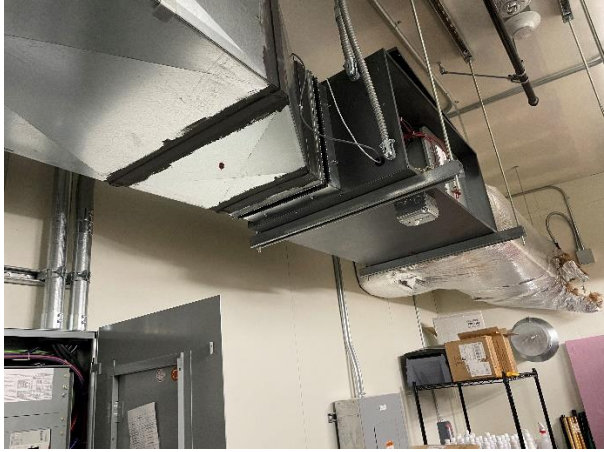
The typical classroom module is heated and ventilated with a ceiling mounted AHU with integral electric heat coil. The AHUs are typically located in small mechanical rooms adjacent to the classrooms; one AHU serves each classroom. The AHU's supply air is ducted overhead to ceiling supply air diffusers. The AHUs have an outside air connection to provide fresh air into the space. Each classroom has a relief opening to relieve the fresh air back to the exterior. All intakes and relief air openings have arctic hoods to help prevent snow infiltration. The heating and ventilation system for the classrooms are in good condition.

*Photo M5 – AHU w/Electric Coil*

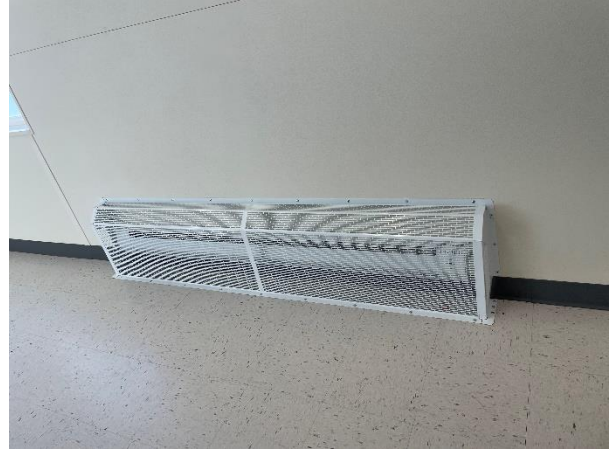
Mechanical spaces, janitor's closets, restrooms, and corridors are heated using either baseboard heaters, small wall mounted electric heaters, or electric unit heaters. The baseboard, wall heaters, and unit heaters are in good condition.

*Photo M6 – Corridor Electric Baseboard*

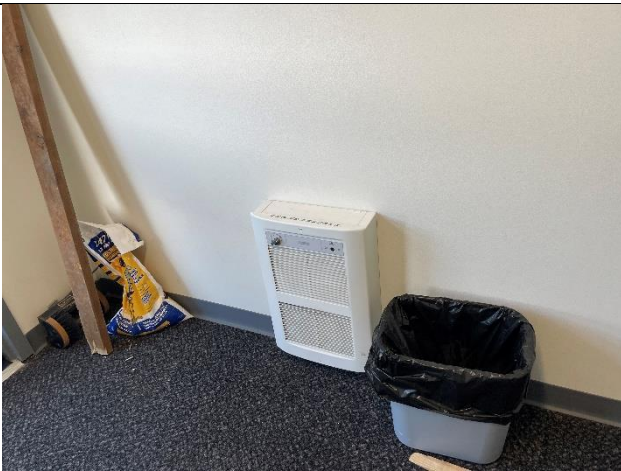
*Photo M7 – Electric Wall Heater*

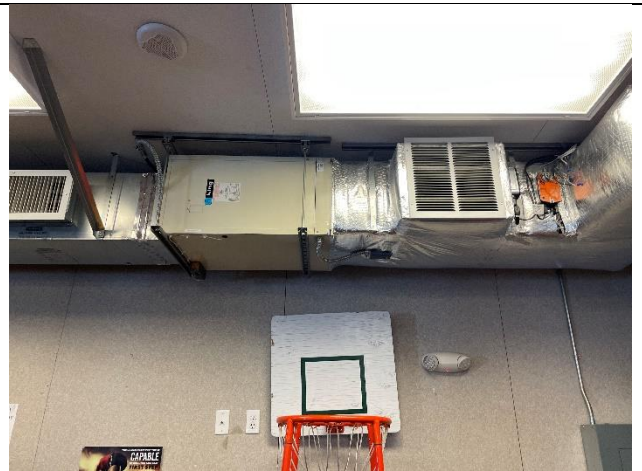
The recreation and exercise modules are heated and ventilated in a similar fashion the classrooms, except the AHU's and ductwork are exposed in the spaces. The heating and ventilation system for the recreation and exercise modules are in good condition.

*Photo M8 – AHU in Recreation Area*

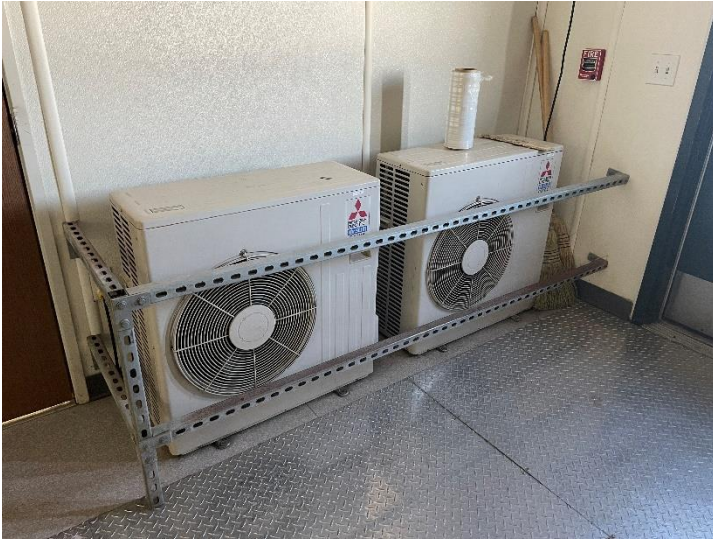
The electrical / MDP (F110) has two wall mounted AC units with associated condensing units located in the storage / loading dock area adjacent to the room. The units are in fair condition. The I.T. space has a small portable AC unit located on the floor. The heat discharge is ducted the exterior. The unit is in good condition.

Photo M9 – Electrical Room Condensing Units

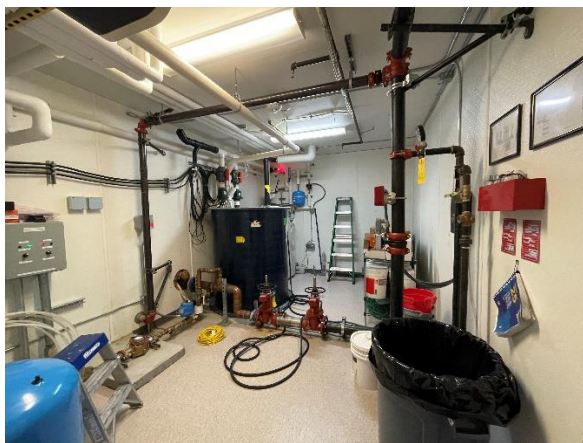
The fire protection system is a wet sprinkler system and is supplied from the city water utility. The sprinkler is separated from the domestic water system with isolation valves and a double check valve backflow preventor. The system is in good condition. No issues were reported with the system.

*Photo M13 – Sprinkler Riser*

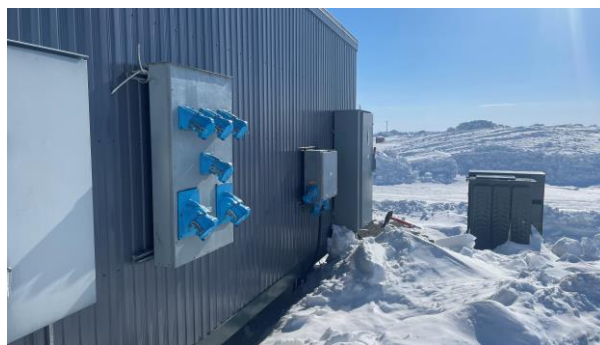
All the 208V and 480V distribution panels have exterior connection boxes with plugs for external connection for alternate power source (see photo 4). There is a generator conex with ATS and portable cable connections available however we did not have access at the time of our inspection. From onsite discussions this generator has damaged windings and can no longer provide power in standby operation but the engine still functions. The generator is 750KW, 480V, 3-phase, 4-wire Detroit V12.

Photo E4 – Exterior service and standby connections

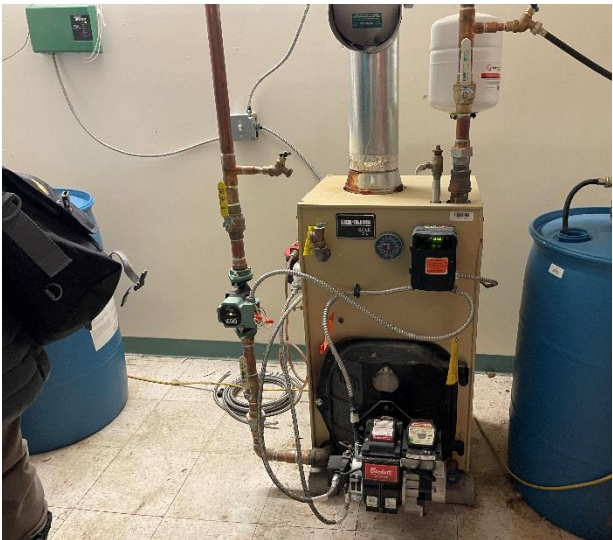
The old school building is heated by a single new residential oil-fired boiler and pump that are in good condition. Depending on how the building is remodeled the boiler may need to be relocated or replaced. Heat is distributed throughout the old school building using the existing piping baseboard fin tube, cabinet unit heaters, and unit heaters. The piping and terminal heating equipment are all in poor condition and will need to be replaced when the building is remodeled.

*Photo M15 – Old School Boiler*

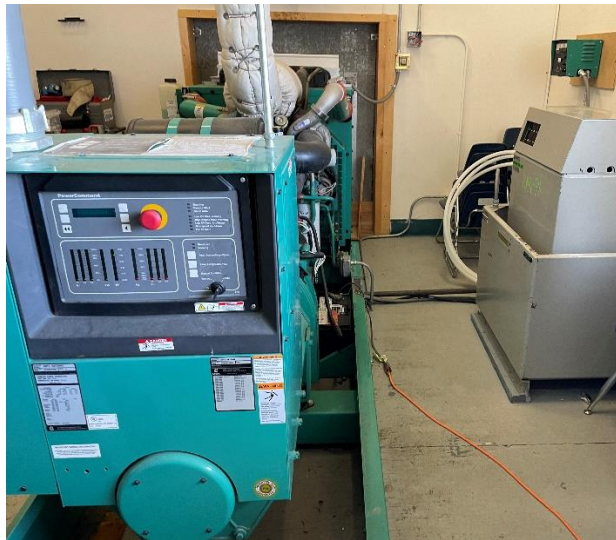
A fuel oil tank for the old school building sits just outside the generator room and serves the generator and fuel oil boiler. The fuel tank is a single wall tank in poor condition. There is a new double walled tank on site that is schedule to be installed this year.

*Photo M16– Old School Generator / Day Tank*

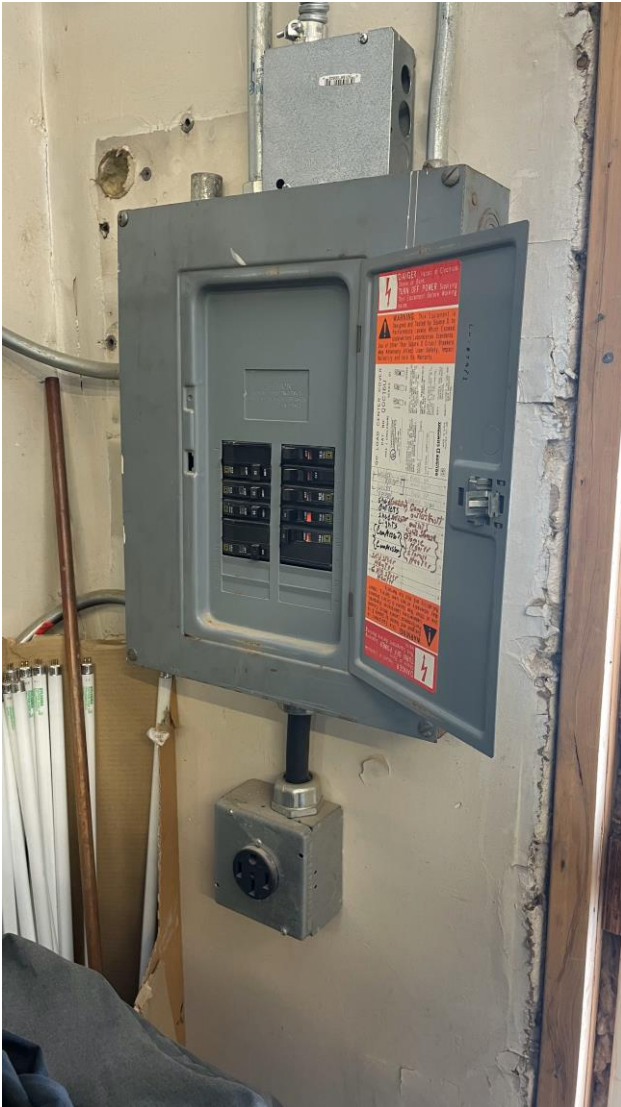
The equipment storage is the same circuiting issue as the vehicle storage requiring dedicated over-current protection for the lighting, receptacles, and electric unit heater. It would also require a dedicated grounding electrode. The conductors are also undersized for the over-current protection as there is only #10 with is rated to maximum of 30A per NEC. These conductors would need to be upsized or the breaker rating reduced to meet code.

Photo E3 – Garage Loadcenter

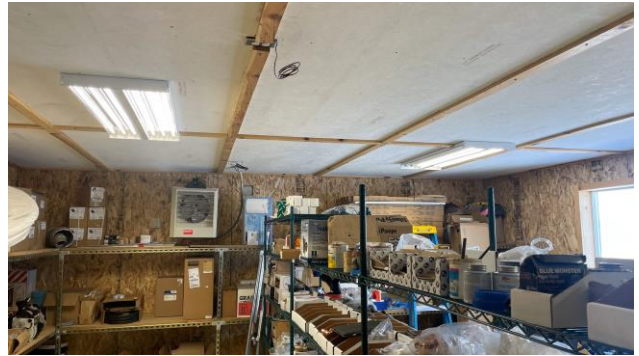
Photo E4 – Storage Lighting

Lighting is all linear fluorescent type in the existing school building, the garage, and storage buildings. For school building is surface or pendant-mounted type such as wrap arounds and strip lights. The garage and vehicle storage use a strip light type surface-mounted fixture. The equipment storage facility is using a surface-mounted T5HO type fixture. The T8 type fixtures are all at end of light and there are some with missing lenses and a re-lamp would be recommended. The T5HO fixtures are in excellent condition but are over lighting the area giving the number of lamps and low mounting height.

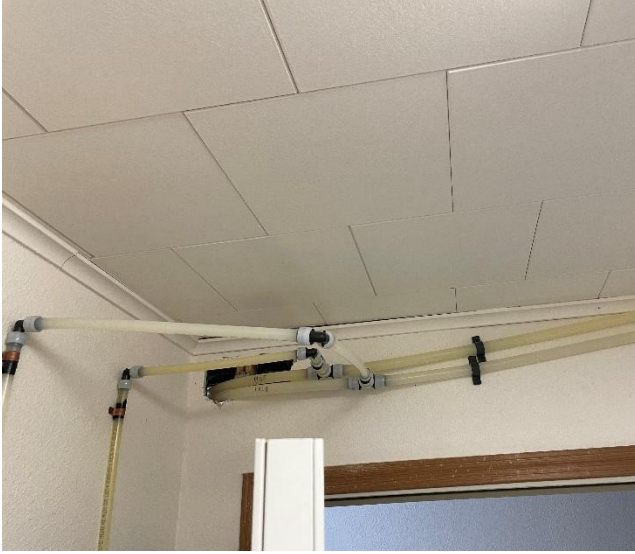
***The domestic water plumbing piping burst during the freeze up and has been replaced with exposed pex piping. The water piping is somewhat unsightly but is functional.***

Photo M17– Exposed Pex Piping

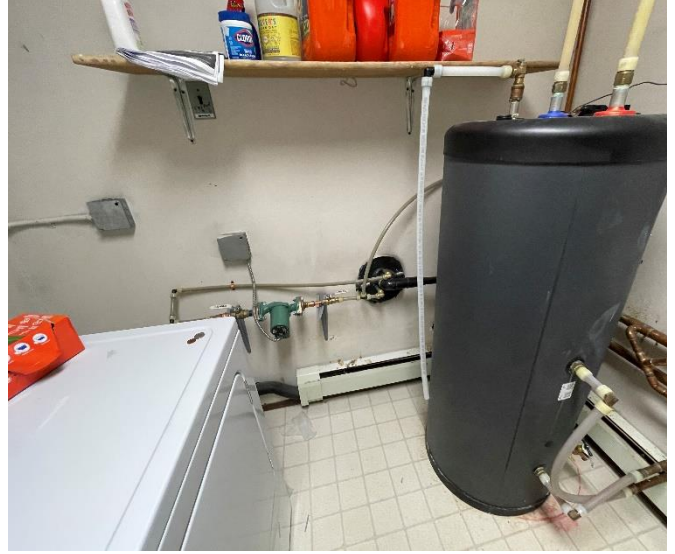
***Domestic hot water is provided by a hot water generator in each residence. The hot water generators where replace during the freeze up repairs and are in good condition.***

Photo M16– Hot Water Generator

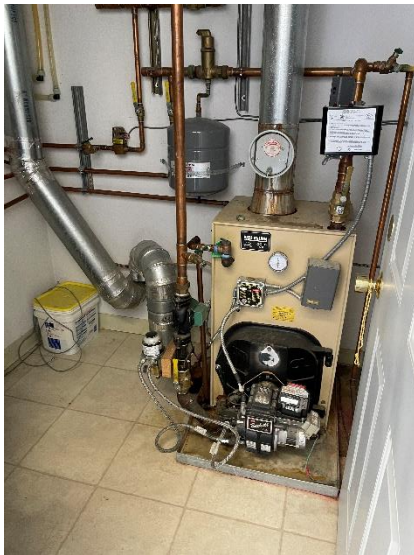
The heating system consists of one fuel oil cast iron sectional boiler for each unit. The boilers in unit #321 and #325 are Burnham boilers rated at 119,000 BTU/hr output each. The boilers in #321 and #325 are at the end of their useful life expectancy and should be scheduled for replacement. The boilers in unit #323 and #327 are Weil McClain boilers rated at 115,000 BTU/hr output each. New burners had been recently installed on the boilers in unit #321 and #327. The boilers are in fair condition and estimated to 20 years old. The boilers are piped primary only with one circulation pump with zone valves for heating in the residence. There is no provision for minimum flow through boiler to prevent overheating of glycol. The piping in the boiler room consists of uninsulated copper piping. The rooms are heated by finned tube. There is no combustion air for the boilers. The piping, heating system pumps and fin tube is in fair to poor condition in the units and is at the end of its useful life expectancy. The storage room added to each unit does not have adequate heat. Additional heating capacity should be added for the storage room as part of heating system upgrades.

Photo M18 – Boiler

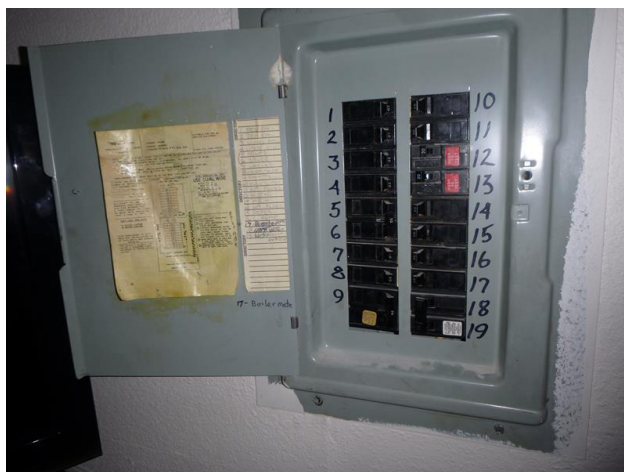
Each residence contains a 100A, 120/208V, 1-Phase, 3-Wire loadcenter. Units #321 and #325 have older Murray loadcenters (*Photo E2*) that are no longer manufactured and should be replaced with new. Units #323 and #327 contain Square D loadcenters and are in good condition with spare parts readily available.

*Photo E2– Murray Loadcenter*

| E5 | 6 | 3 | Single<br>Family<br>Residence<br>#321 | Discontinued<br>panel type. | No change noted. |

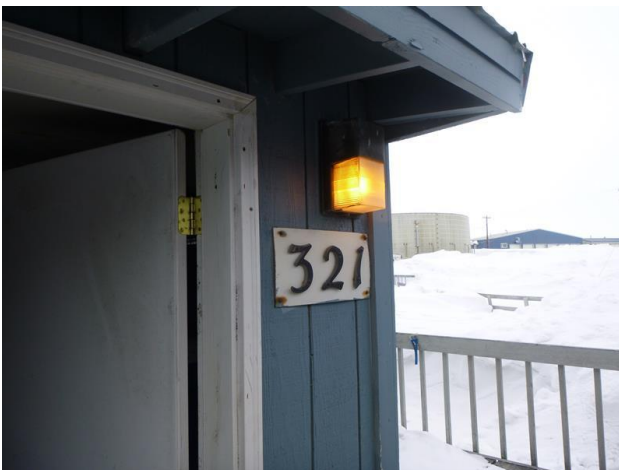
The exterior fixtures were primarily HPS type wall pack fixtures (*Photo E3*) that should be replaced with newer energy efficient LED type fixtures.

*Photo E3 – Typical Exterior Lighting*

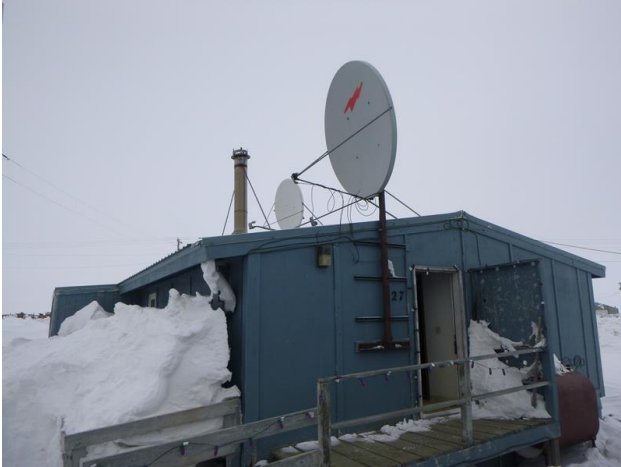
*Photo E5 – Typical Satellite Dish*

Satellite TV service is provided from a roof-mounted dishes on with #327 and routed to each building with coaxial cable into the units (*Photo E5*). It is unclear if the two dishes provide all TV service to each building. In some cases, these satellites may be abandoned in place and replaced with resident’s own Starlink satellites.

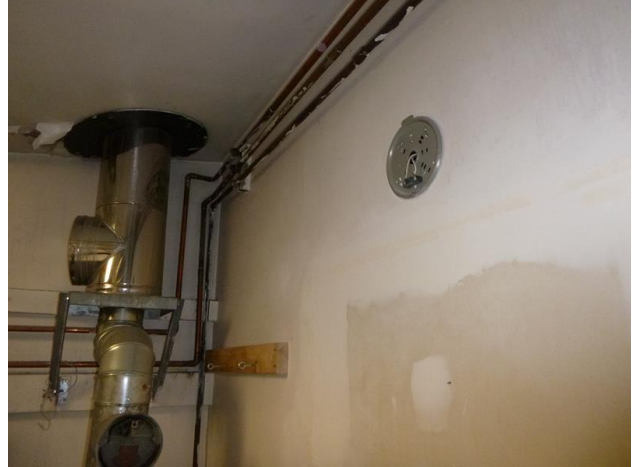
*Photo E6 – Typical Missing Smoke Detector*

Fire alarm systems in the building consisted of battery powered smoke detectors in the bedrooms and the common area outside the bedrooms. Many of the smoke detectors were missing from their bases (*Photo E6*). A few carbon monoxide detectors were noted in some of the units (*Photo E7*); however, they should be provided in all bedrooms and within the areas outside of each bedroom per IFC requirements.

| E1 | 1 | 1 | All<br>Housing | Smoke/CO<br>Detectors<br>Missing | No change noted. |
