# Roof Inspection

Feb 06, 2020

| Project:<br>Bellville ISD | Address:<br>7453 Ernst Pkwy, Industry, TX |
| Roof Area:<br><br>Approximately 19,700 sq. ft. | Roof Type:<br><br>Main Roof – Asphalt Built-Up Roof Membrane<br>over Fiber Insulation and Wood Roof Deck |

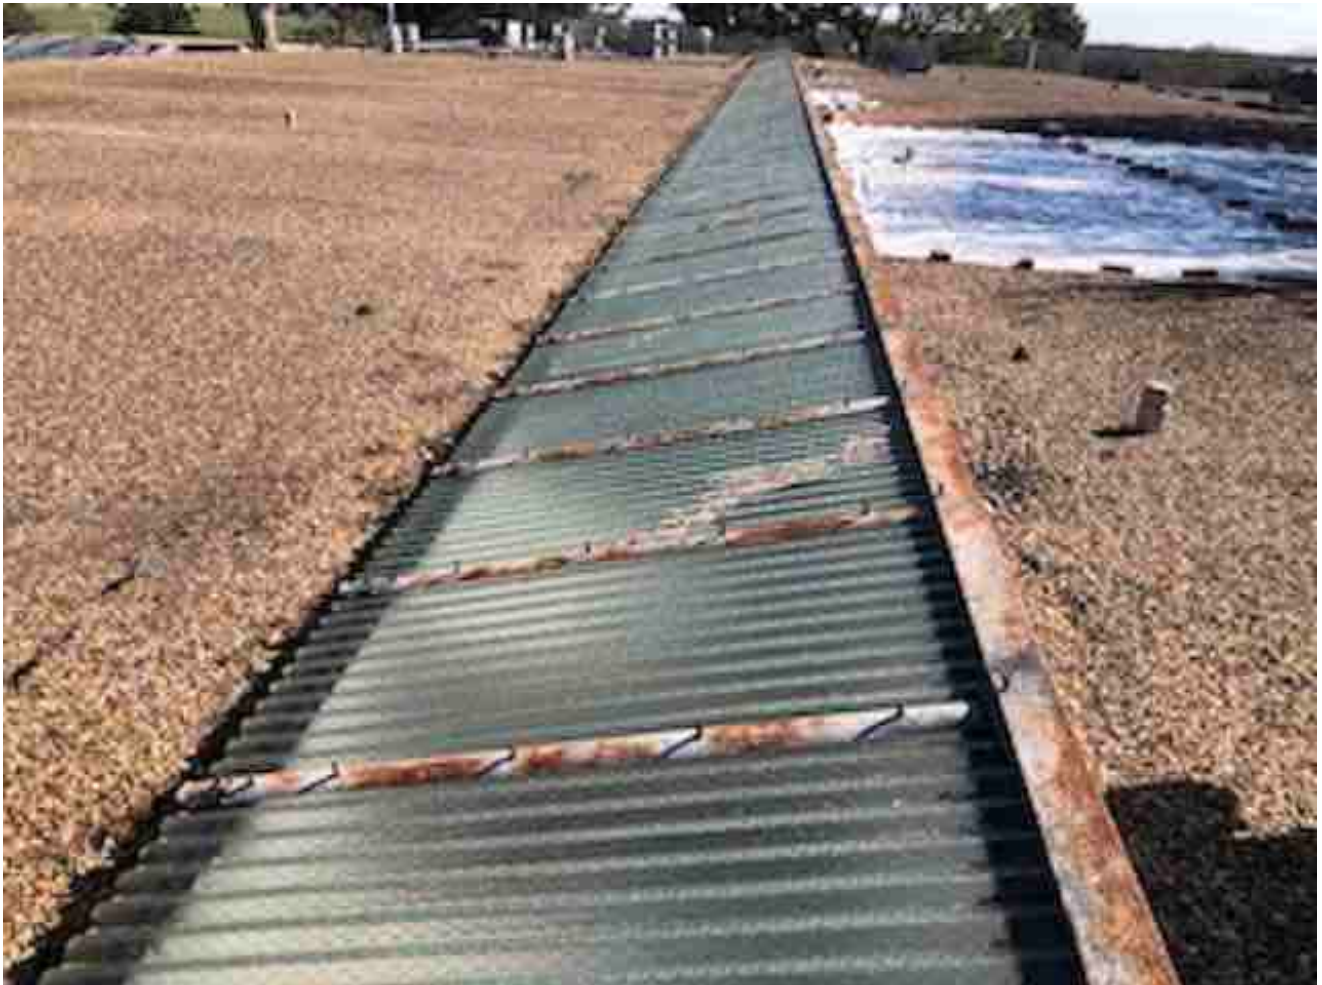
Photo shows overview roof area. Note plastic on roof to discourage leakage.

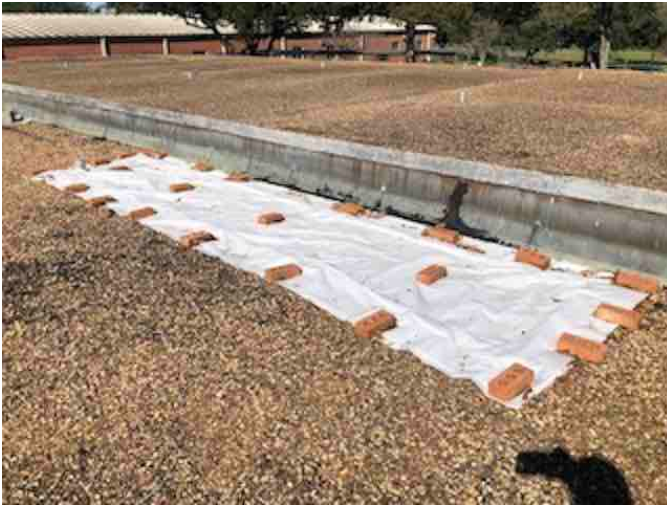
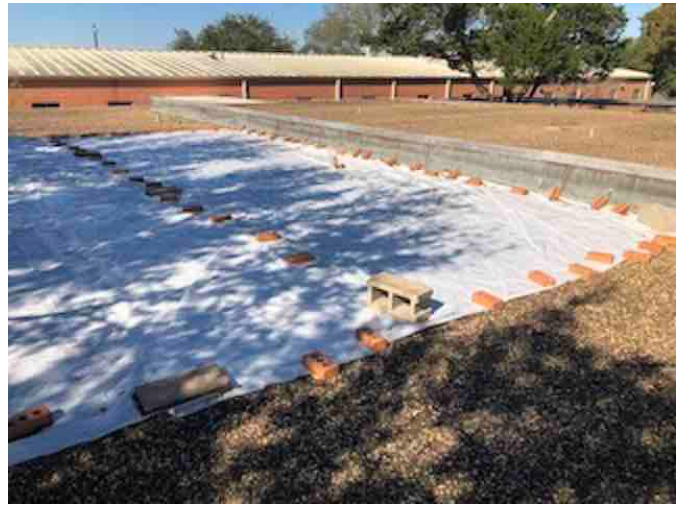
Photos show tarps placed on roof to discourage leakage.

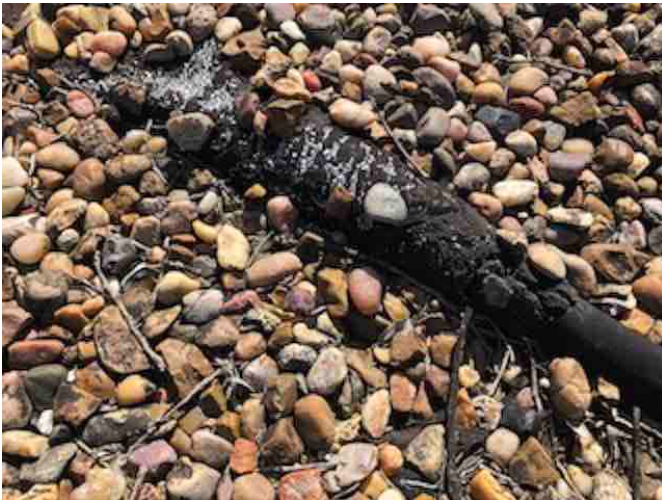
Photo on left shows exposed reinforcement matting at end of expansion joint cover. Photo on right shows plant growth on roof.

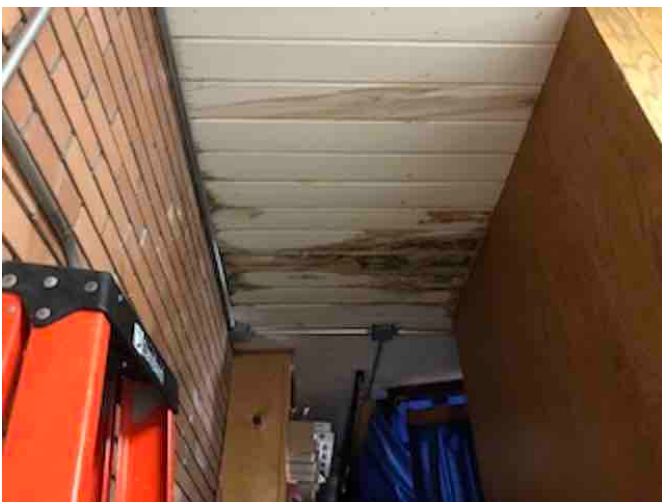
Photo on left shows evidence of leakage. Photo on right shows deck damage at roof drain area.

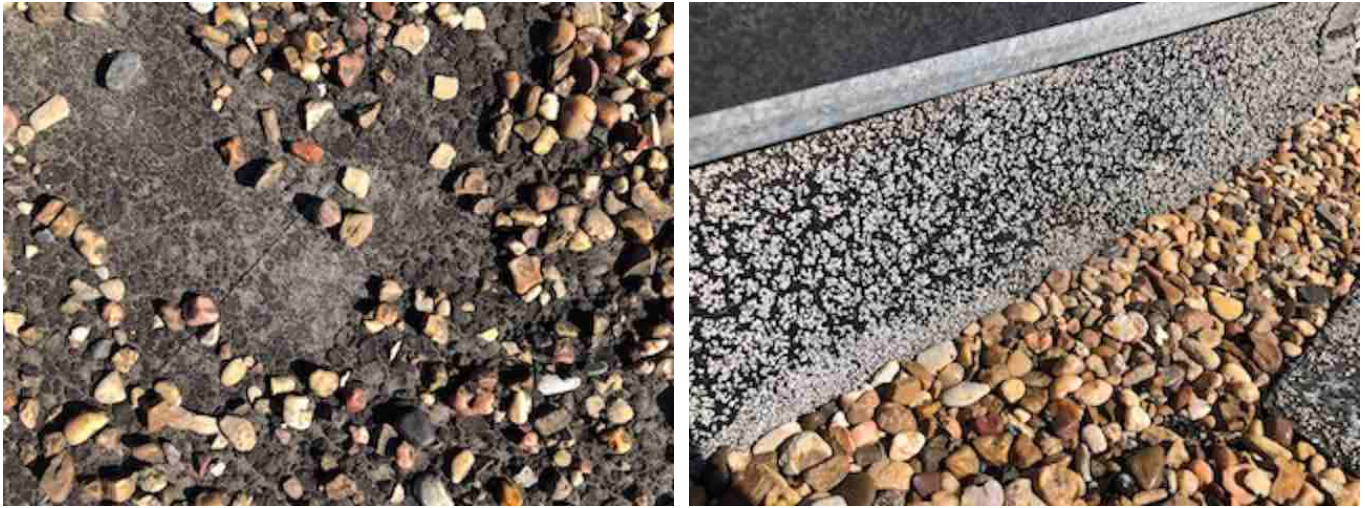
Photo on the left shows an area of exposed membrane. Membrane was noted to be in poor overall condition and at the end of its service life. Photo on the right shows typical base flashing condition at curbs, and walls. There is significant granule loss and age-related damage.

With this in mind, it appears that the roof on the building should be considered for replacement or be recovered with a new assembly, as soon as reasonably possible.

Replacement would entail removing existing membrane and insulation down to the wood roof decking and installing a new roof assembly with new R25 insulation installed above the roof deck to accommodate the energy code. The new insulation height would require raising some of the roof curbs and installing more wood blocking at perimeters and penetrations.
