Geneva Community Unit School District #304
Operations and Maintenance
7 Year Capital Improvement Plan

Finance Advisory Committee

April 10, 2023

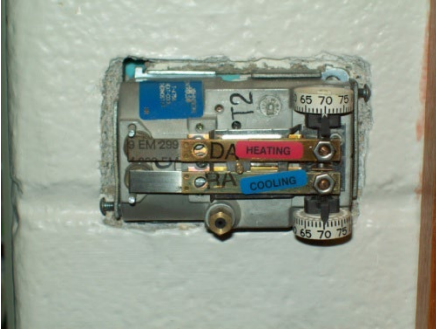
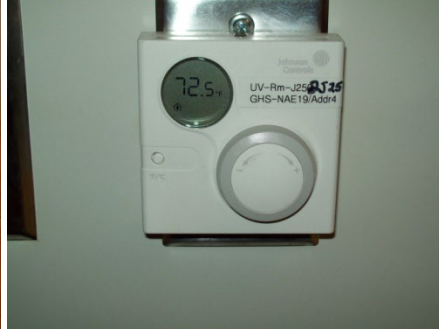
HVAC Controls

Pneumatic to Digital conversion will be computer based, allowing for tighter control of temperature, setback features, and alarming features.

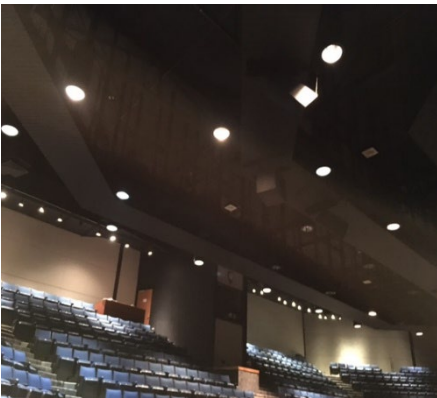
Auditorium Lighting Replacement

Parts for lighting panel are becoming obsolete and starting to fail.

Replace with energy efficient fixtures and lighting panel.

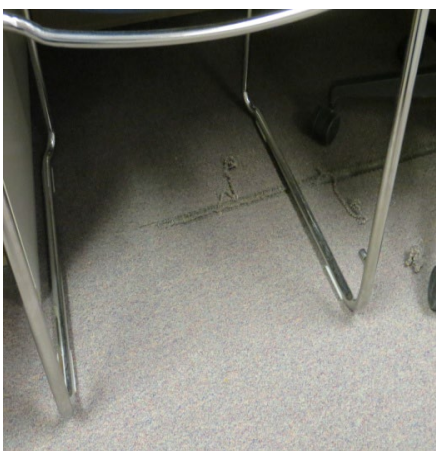
The carpet is starting to fray and cause trip hazards.

Carpet will need to be replaced.

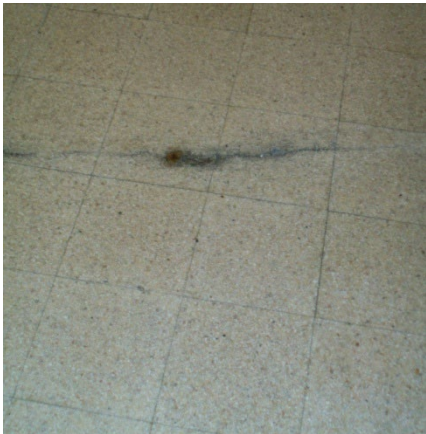
Flooring

Existing quartz tile is cracking and has faded.

Replace tile in phases.

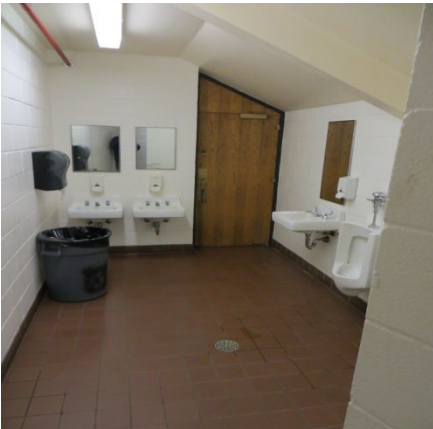
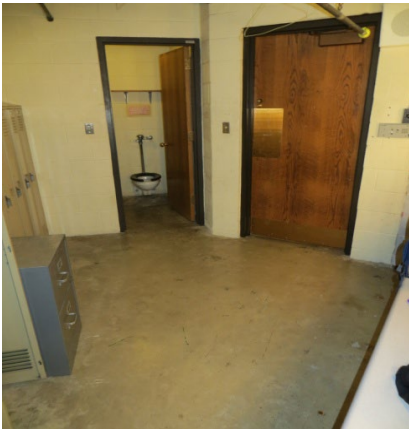
Cafeteria and Stagecraft Bathrooms

Bathrooms are 48 years old.

Showing significant wear.

Need to update.

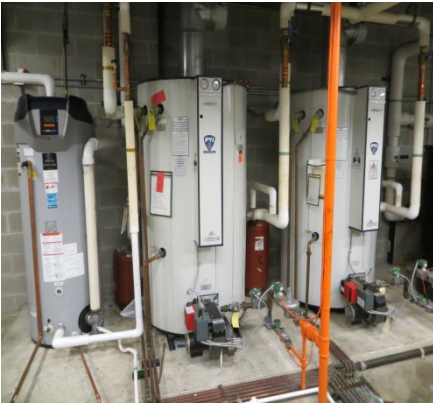
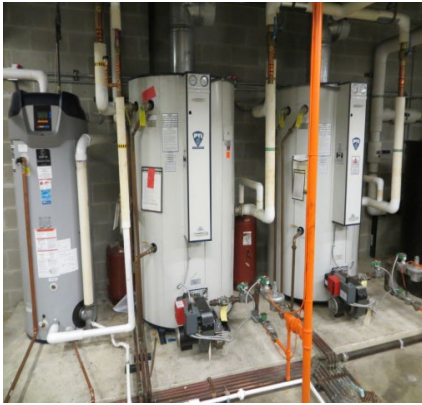
Hot Water Heaters

The two 500-gallon PVI water heaters are nearing the end of their life cycle.

Replacement will be needed within the next four years.

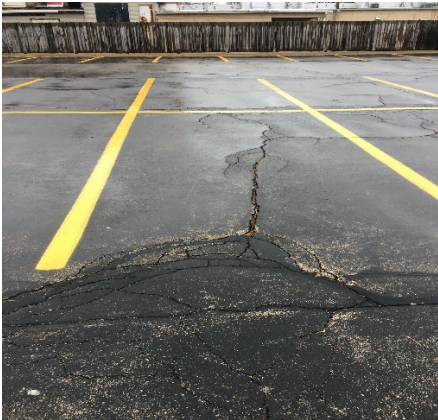
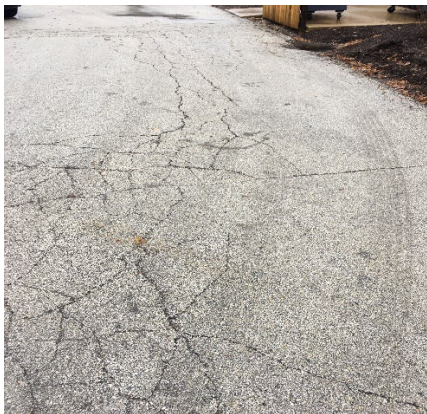
Parking lot

Several areas with extreme cracking.

Sealcoating and crack filling will be needed.

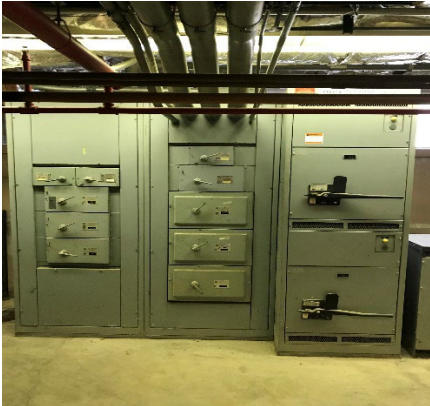
Switchboard

The 2,500-amp switchboard is 48 years old and does not operate properly.

The switchboard will need to be replaced or rebuilt.

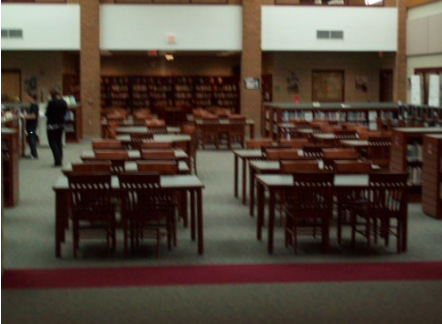
LMC

AHU is undersized for space.

Only two VAV boxes serving the space.

Recommend increasing the capacity of the AHU and adding four to six VAV boxes with controls to increase comfort and control humidity.

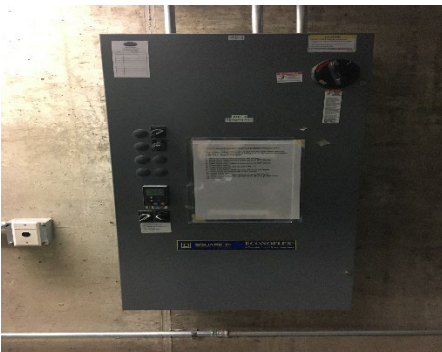
Variable Frequency Drive (VFD)

Needs replacing this year.

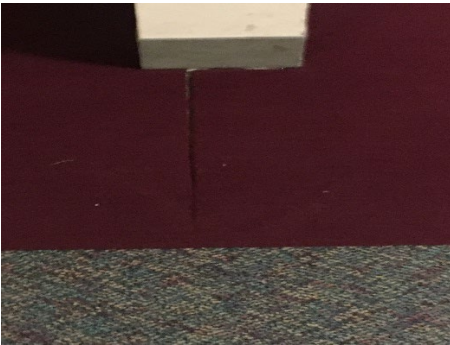
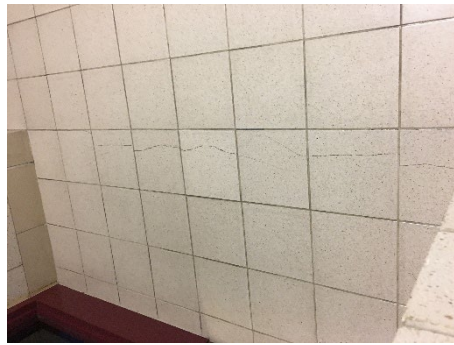
Flooring Replacement

Carpet is starting to show wear and seams are starting to pull apart.

Tile is lifting and cracking in several areas.

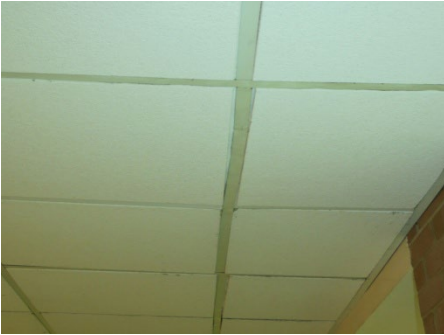
Ceiling Tile

Ceiling grid and tile are starting to show excessive discoloration and wear.

Replace ceiling grid and tile.

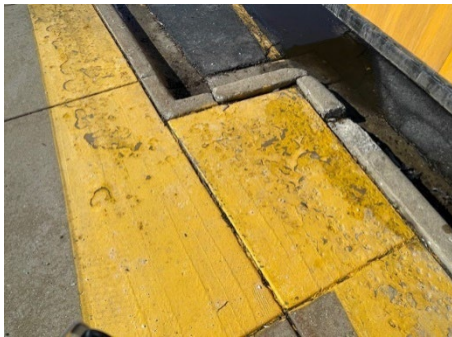
Concrete Sidewalk/Curb Replacement

Several sections are heaving, cracking, and spalling.

Replace sections for safety concerns.

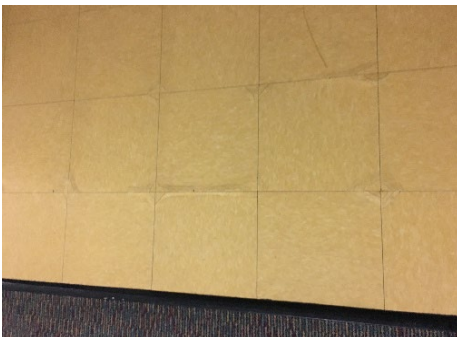
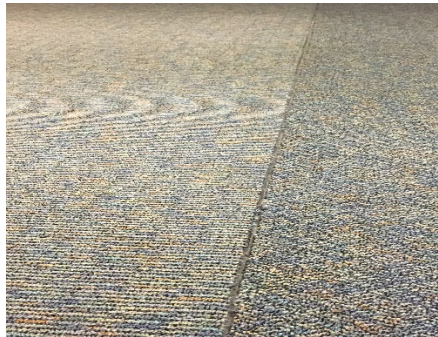
Flooring Replacement

Carpet is starting to show wear and seams are starting to pull apart.

Tile is lifting and cracking in several areas.

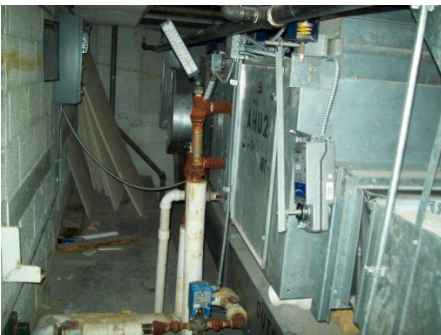
Air Handling Unit

Needs rebuilding or possible replacement.

New motor, shaft, bearings and controls needed.

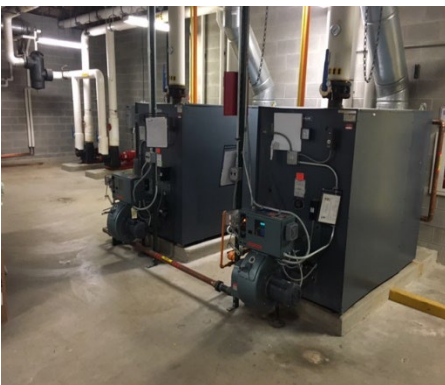
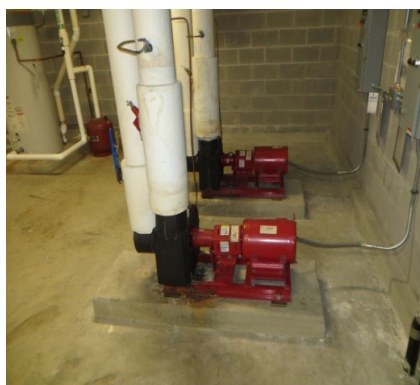
Boiler and Secondary Pumps Replacement

24 years old boilers and pumps nearing end of their estimated service life as per ASHRAE.

Need to be replaced with energy efficient design.

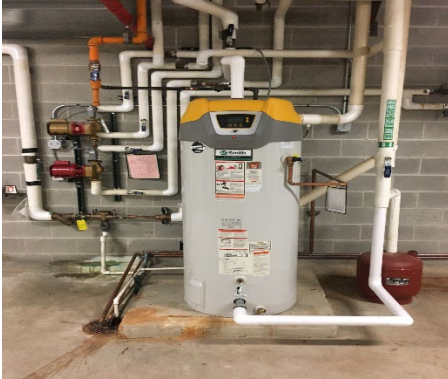
Hot Water Heater

The 100-gallon A.O. Smith water heater is nearing the end of its life cycle.

Replacement will be needed.

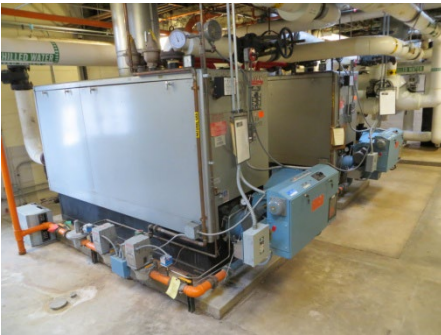
Boiler Replacement

33-year-old boilers are inefficient and nearing the end of their estimated service life as per ASHRAE.

Replace with new high efficiency boilers.

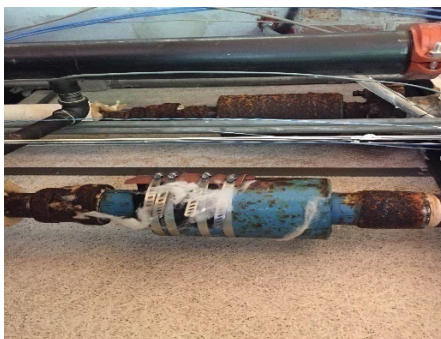
HVAC Piping Replacement

Chilled and hot water HVAC piping is original to the building.

Showing excessive rust and starting to leak.

Replace with new dual temperature piping and insulation.

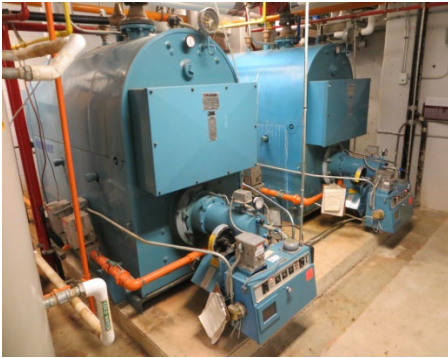
Boiler Replacement

Boilers are 27 years old and original to the building.

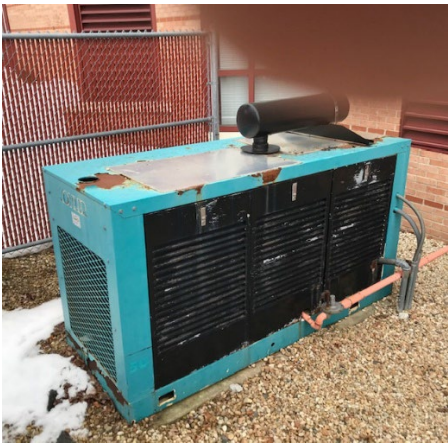
Generator Replacement

100KW generator is 27 years old and needs to be replaced.

Escalating repair costs and consistent breakdowns.

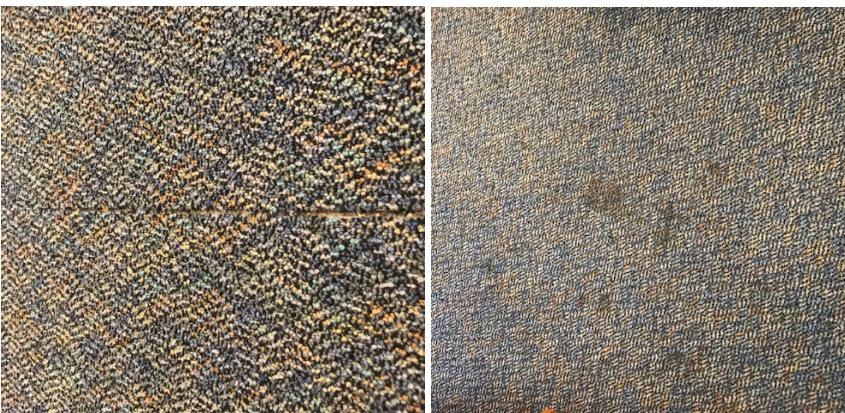
Flooring Replacement

Carpet is starting to show wear and staining that we are unable to remove.

Life cycle of carpet is 12-20 years.

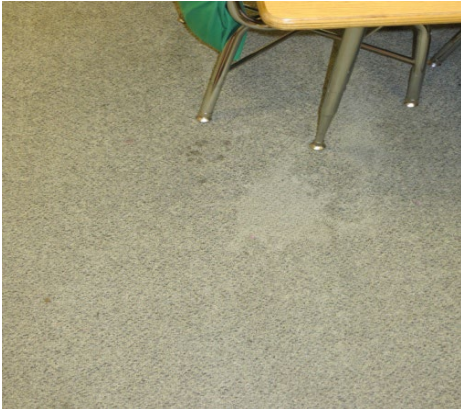
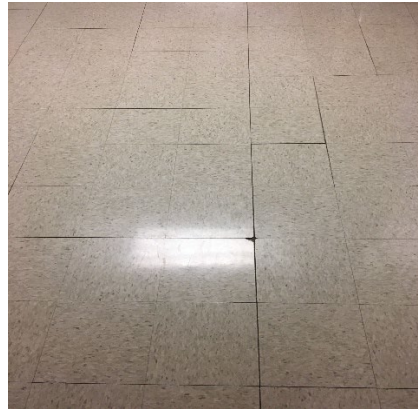
Flooring Replacement

Carpet is starting to show wear and staining that we are unable to remove.

Tile is lifting and cracking in several areas.

Flooring will need to be replaced.

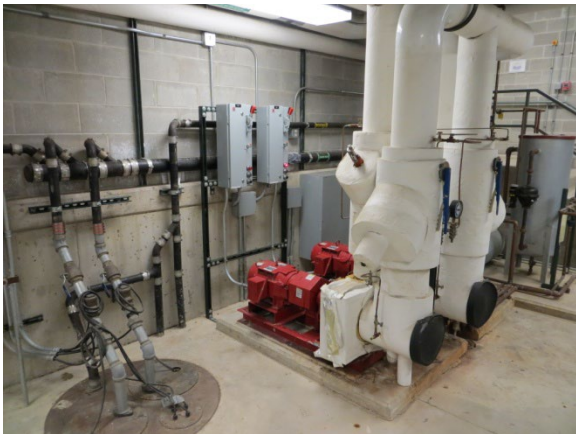
Chilled Water Pumps (2) – Add VFD

Original to the building.

Variable Frequency Drives will greatly increase energy efficiency and lengthen the life of the pumps.

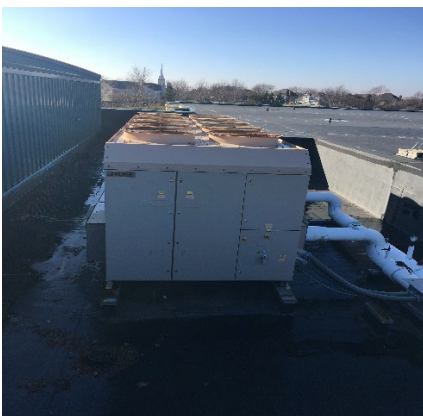
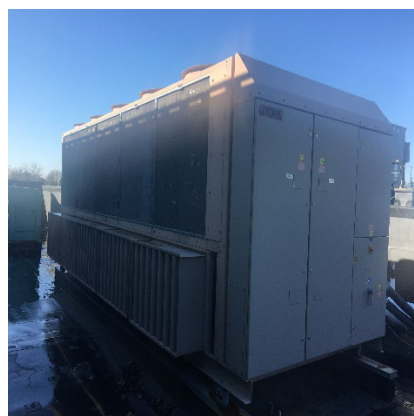
Chiller

21 years old chiller and nearing the end of its service life as per ASHRAE.

Repairs are becoming more frequent.

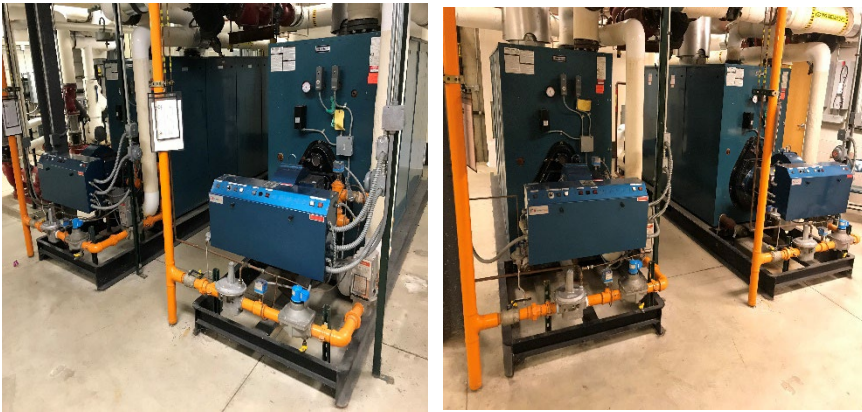
Boilers and Primary Pumps Replacement

Boiler and primary pumps are 21 years old and original to the building.

Nearing the end of their estimated service life as per ASHRAE.

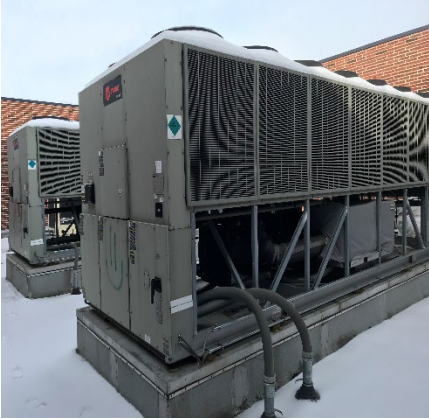
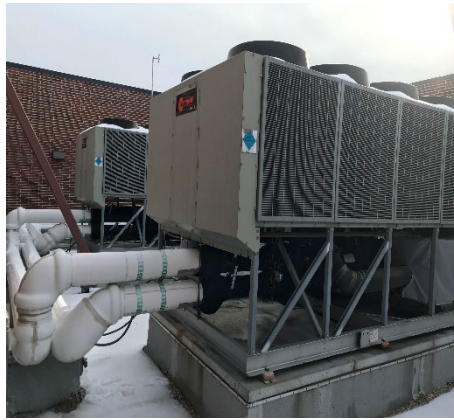
Trane Chillers

15 years old chillers are nearing the end of their service life as per ASHRAE.

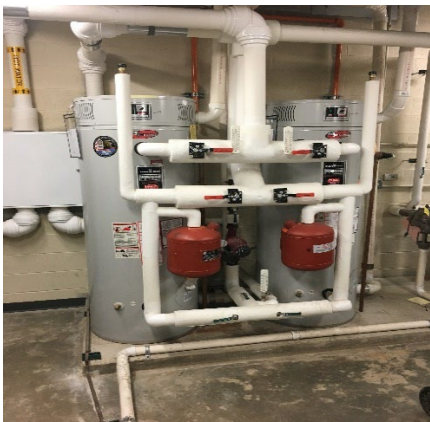
Hot Water Heaters

The two 100-gallon Bradford White water heaters are nearing the end of their life cycle.

Replacement will be needed within the next two to five years.

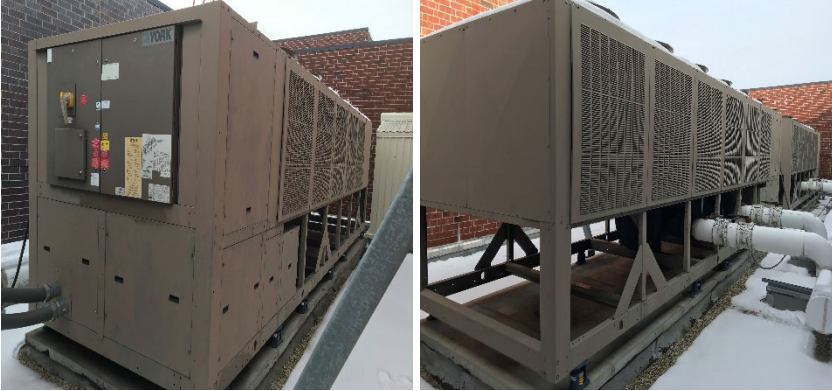
Hot Water Heaters

The two 100-gallon A.O. Smith water heaters are nearing the end of their life cycle.

Replacement will be needed within the next two to five years.

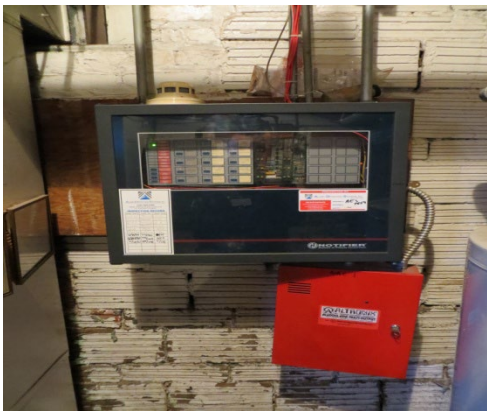
Fire Alarm System

Notifier 5000 fire alarm panel will need to be updated to meet current NFPA code requirements.

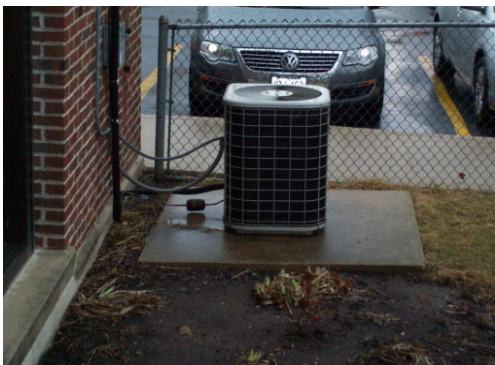
Fan Coil and Condensing Units

The entire building is cooled with fan coil units.

Several are beginning to fail and most will need to be replaced in the next two years.

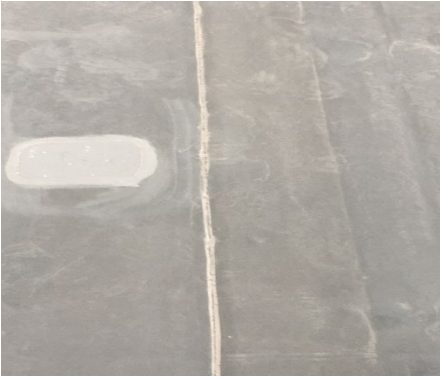
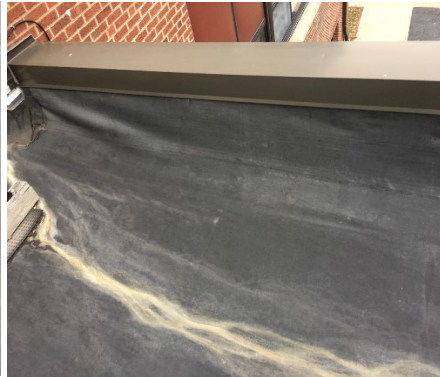
The roof is 21 years old and many sections are in poor condition.

Roof replacement/restoration will be needed in the next two years.

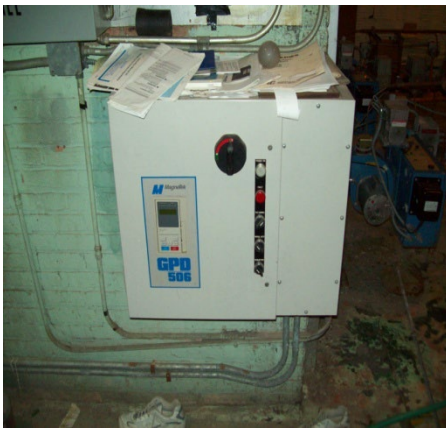
Variable Frequency Drive

VFD has failed and needs to be replaced.

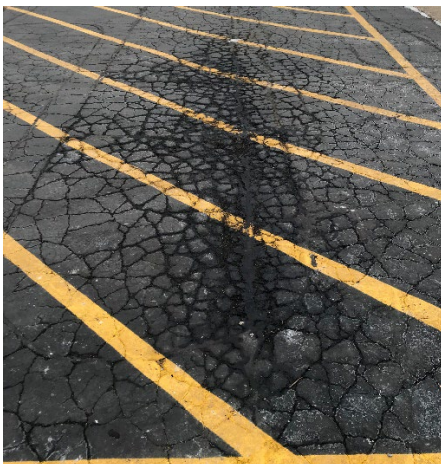
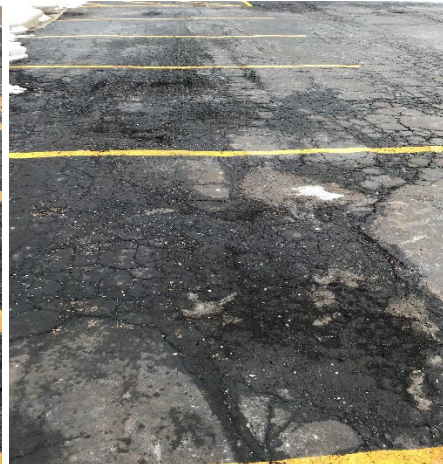
Parking Lot

Several areas with extreme cracking.

Resurfacing will be needed.

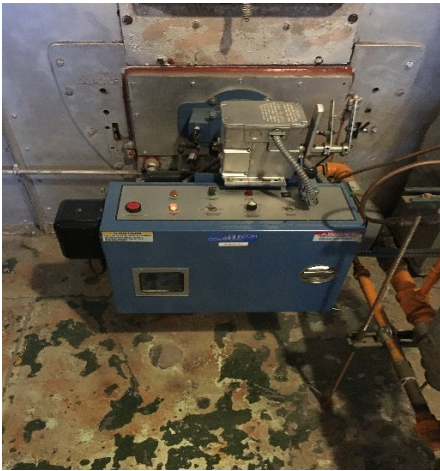
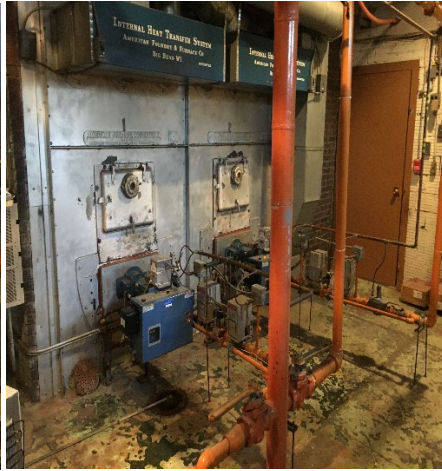
Forced Air Furnace Burners

Burners are 23 years old.

Nearing the end of their estimated service life as per ASHRAE.

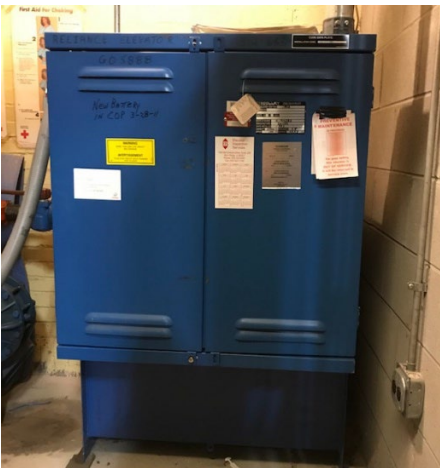
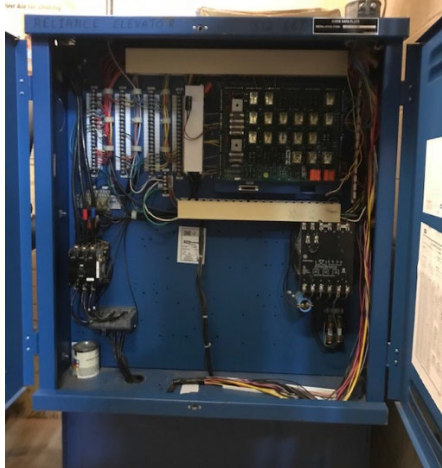
Elevator Control System Upgrade

The current elevator control system parts are becoming obsolete and no longer available for repairs.

Control upgrades will be needed in the next two years.

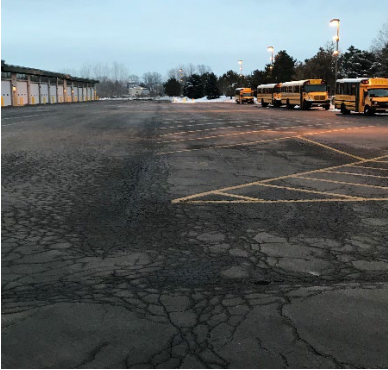
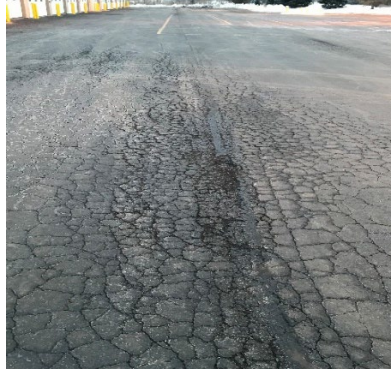
Parking Lot

Pavement starting to crack and breakdown.

Resurfacing and drainage improvements will be needed in the next two years.

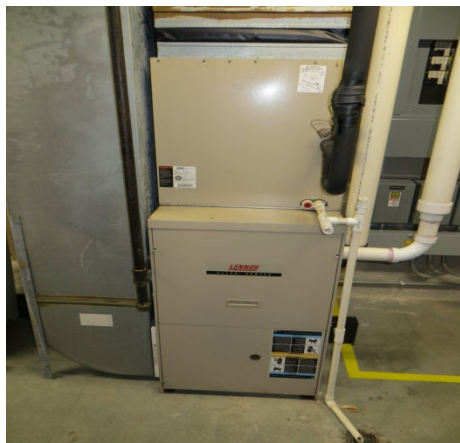
HVAC Split System

The 3 Lennox split systems are nearing their ASHRAE recommended service life.

Replacement will be needed within the next two years.

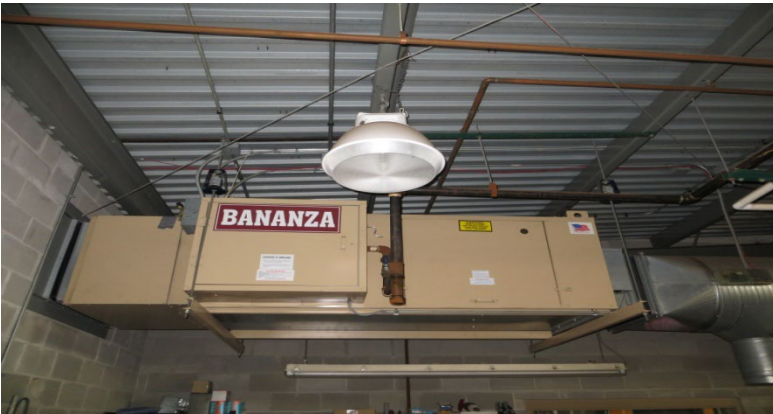
Air Handling Unit

The three Bananza make-up air units are nearing their ASHRAE recommended service life.

Replacement will be needed within the next two years.

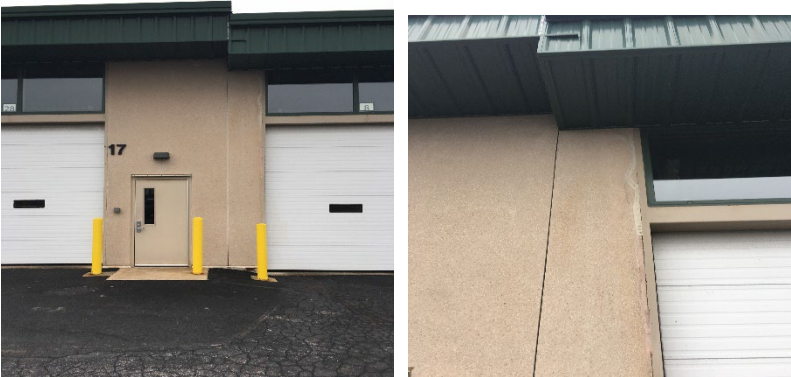
Architectural Precast Wall Panel

The exterior architectural **precast wall panel** has cracked and will need to be replaced. Resurfacing and drainage improvements to the current **parking lot** will be needed within the next two years. Also, a **parking lot expansion** into the new property will be needed for additional staff parking and bus storage. The **heating ventilation and air conditioning (HVAC)** equipment is original to the building and nearing the end of its estimated service life according to ASHRAE. This includes the three Lennox split systems that serves the offices and conference area, along with three Bananza make-up air units that serve the three service bays. The **lighting** will need to be upgraded to replace the inefficient metal halide and fluorescent fixtures with energy efficient LED fixtures and lighting controls throughout the entire building for energy savings. The **parking lot** will need to be crack filled and sealcoated in the next five to seven years to extend the life of the new pavement.

The exterior architectural precast wall panel has cracked and will need to be replaced.

Replacement will be needed this year.
