PEAK Drainage Assessment

June 19, 2023

Scott Archer - PE LEED AP, BD+C

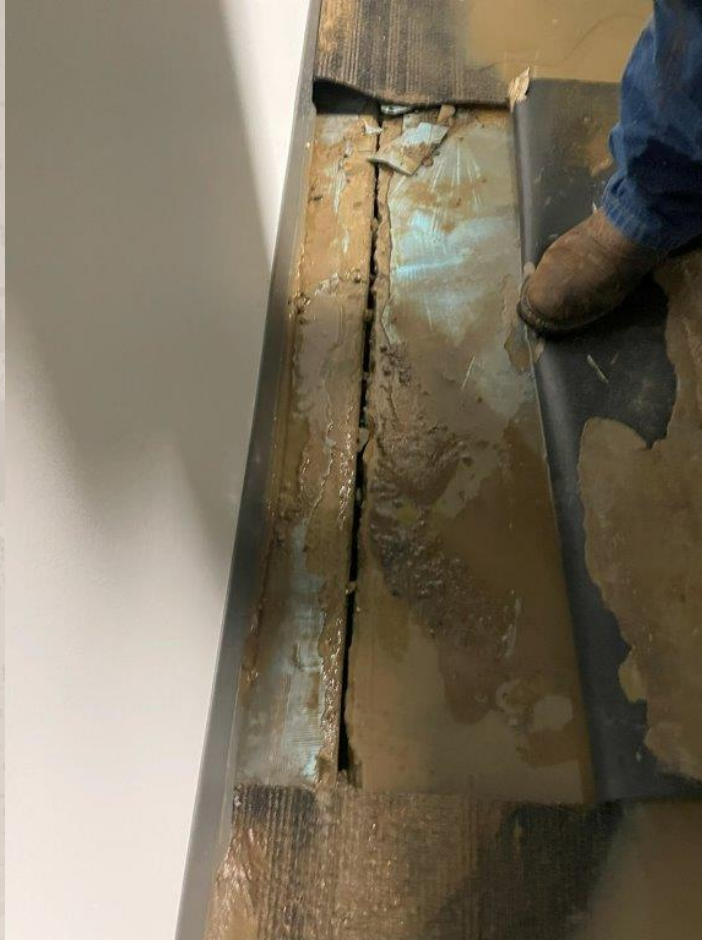
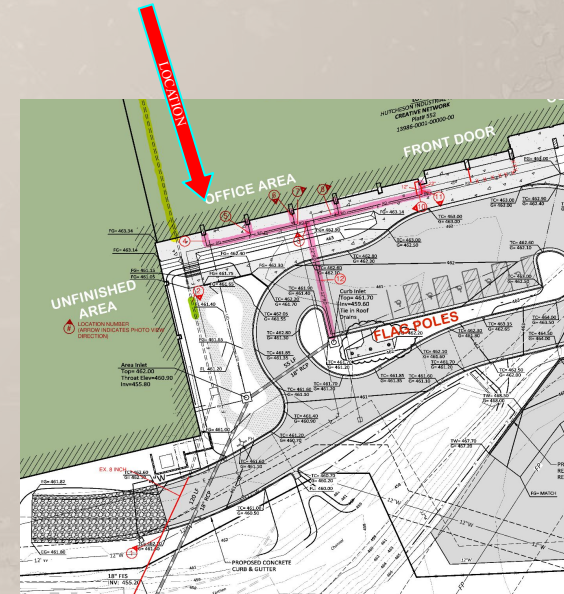
Photo 1 - Infiltration along grade beam and slab

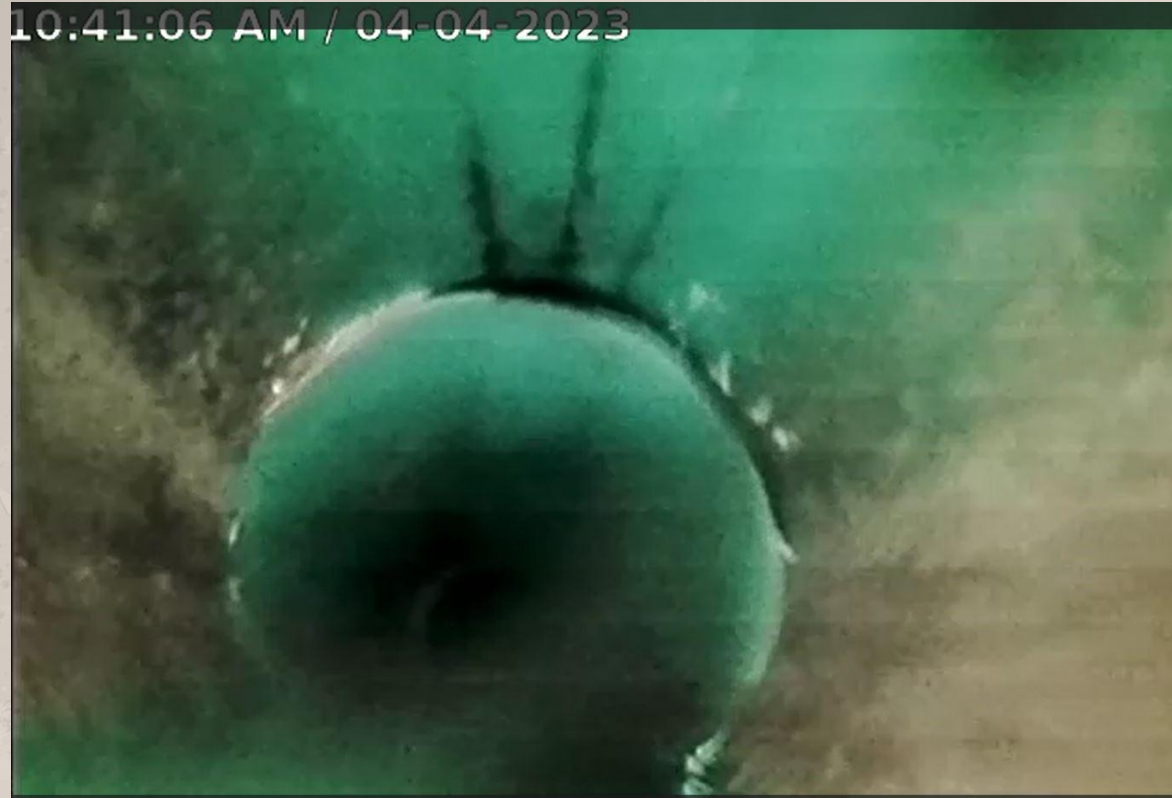
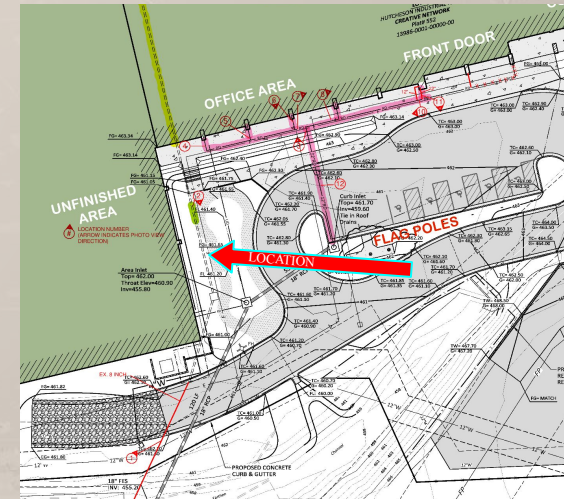
Photo 2 - Drainage Interface at location 2

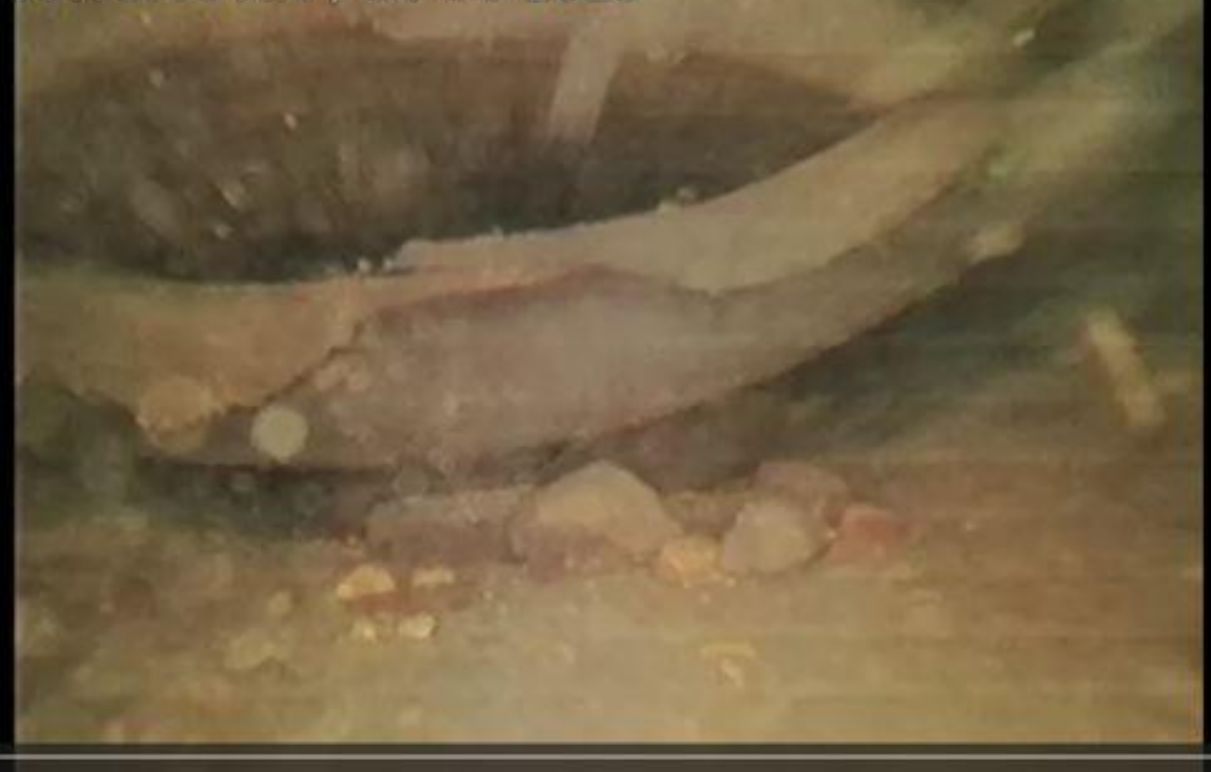
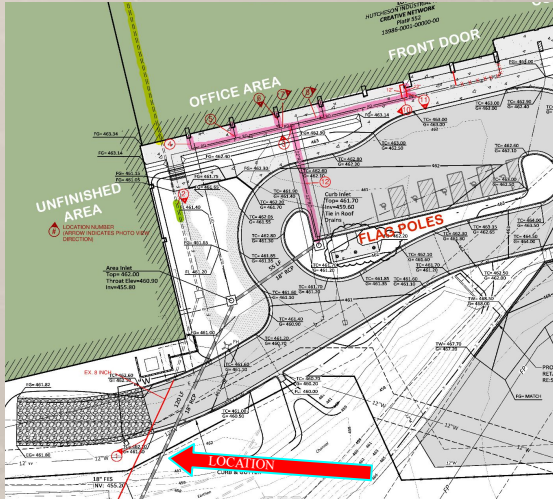
Photo 3 - Piping connection at location 1

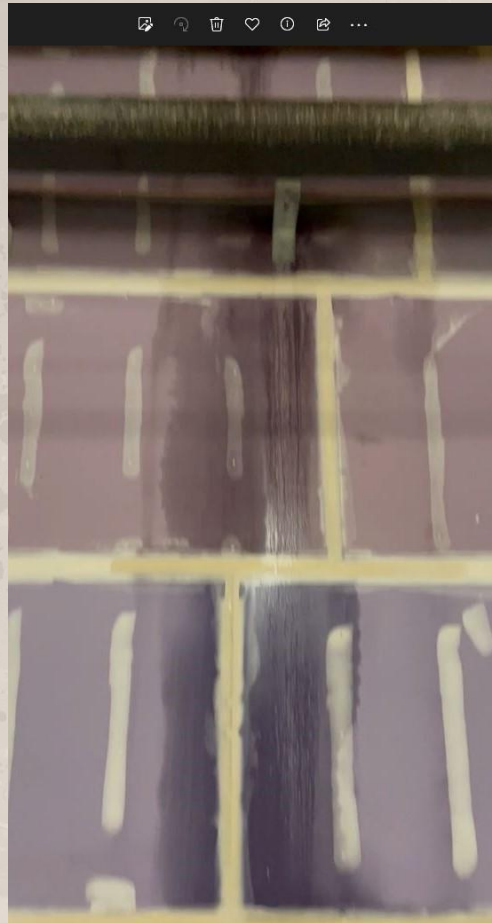
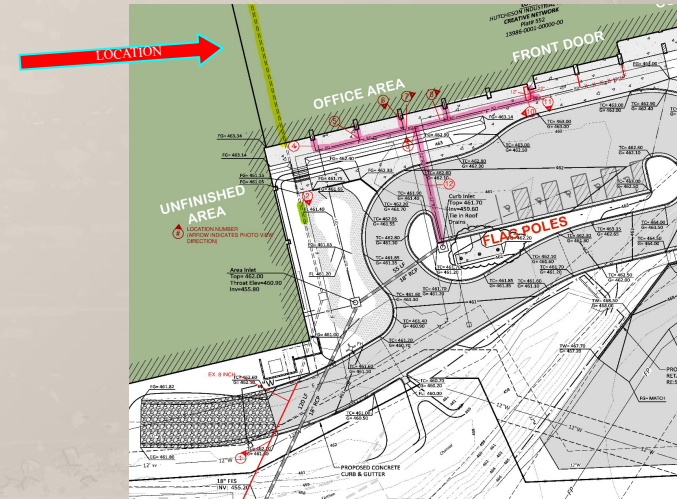
Photo 4 - Sheet flow on wall

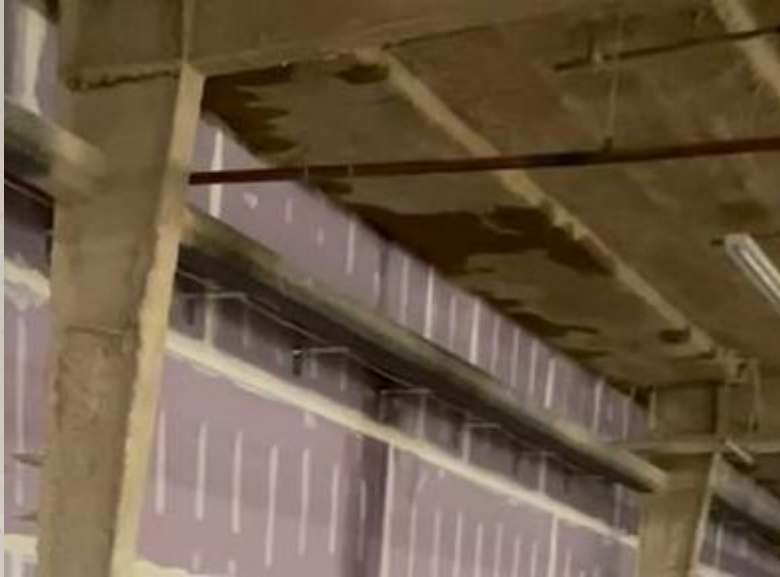
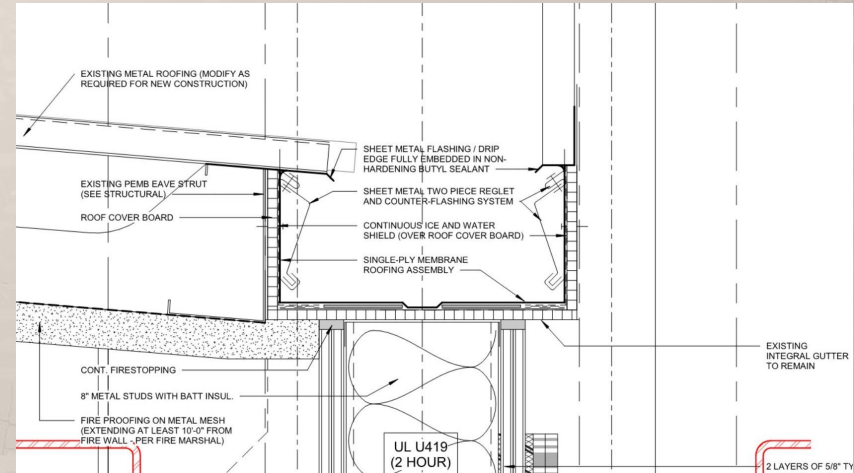
Photo 5 - Water on wall between east & west wing

- **Recommend to abandon existing below slab drainpipe. Reroute roof drains between east and west buildings to exposed drainage at ceiling and take south to ditch**
- **Rework the below grade roof drain piping on the south side of the east wing to allow adequate relief of the drainage**

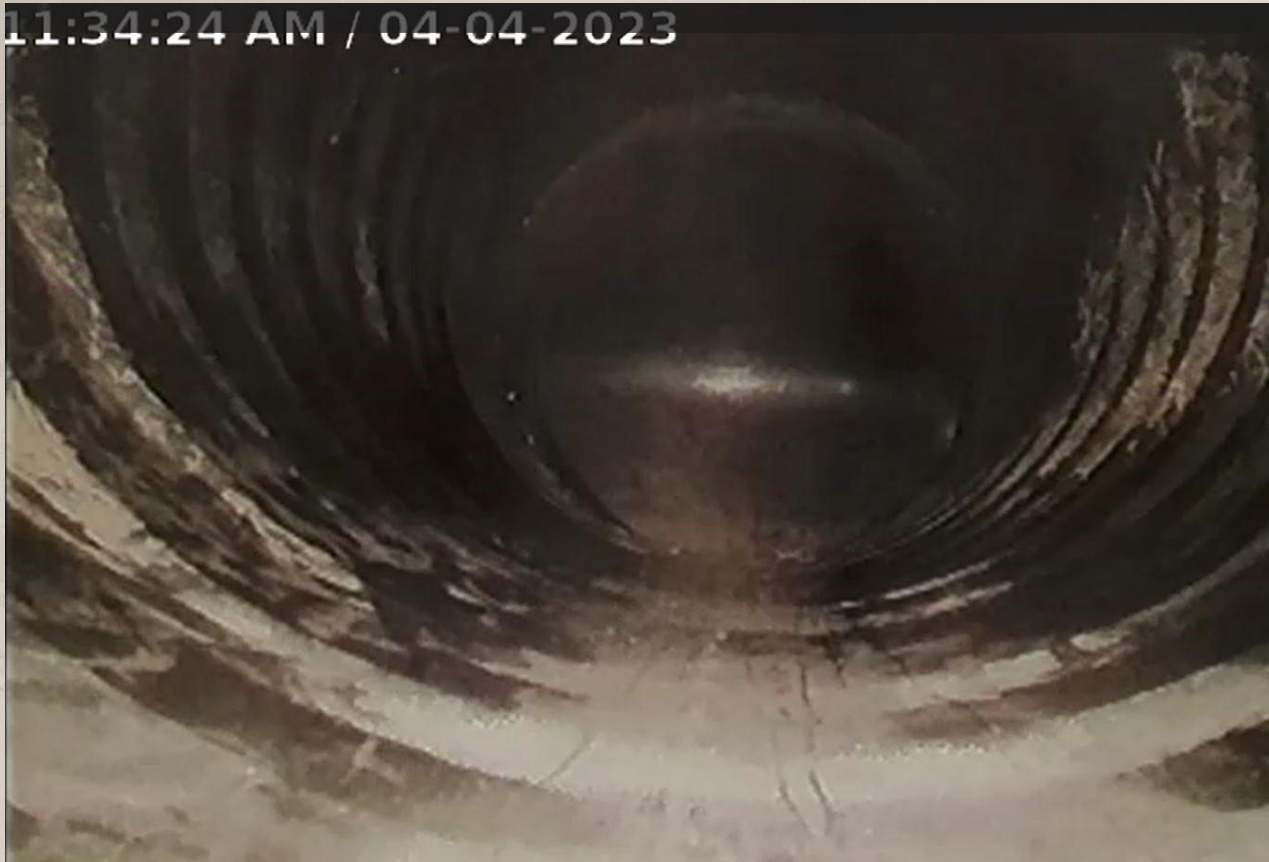
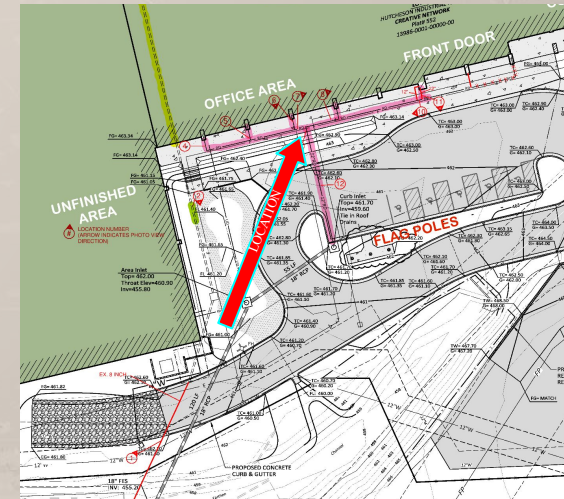
Photo 6 - Bull head tee at location 3

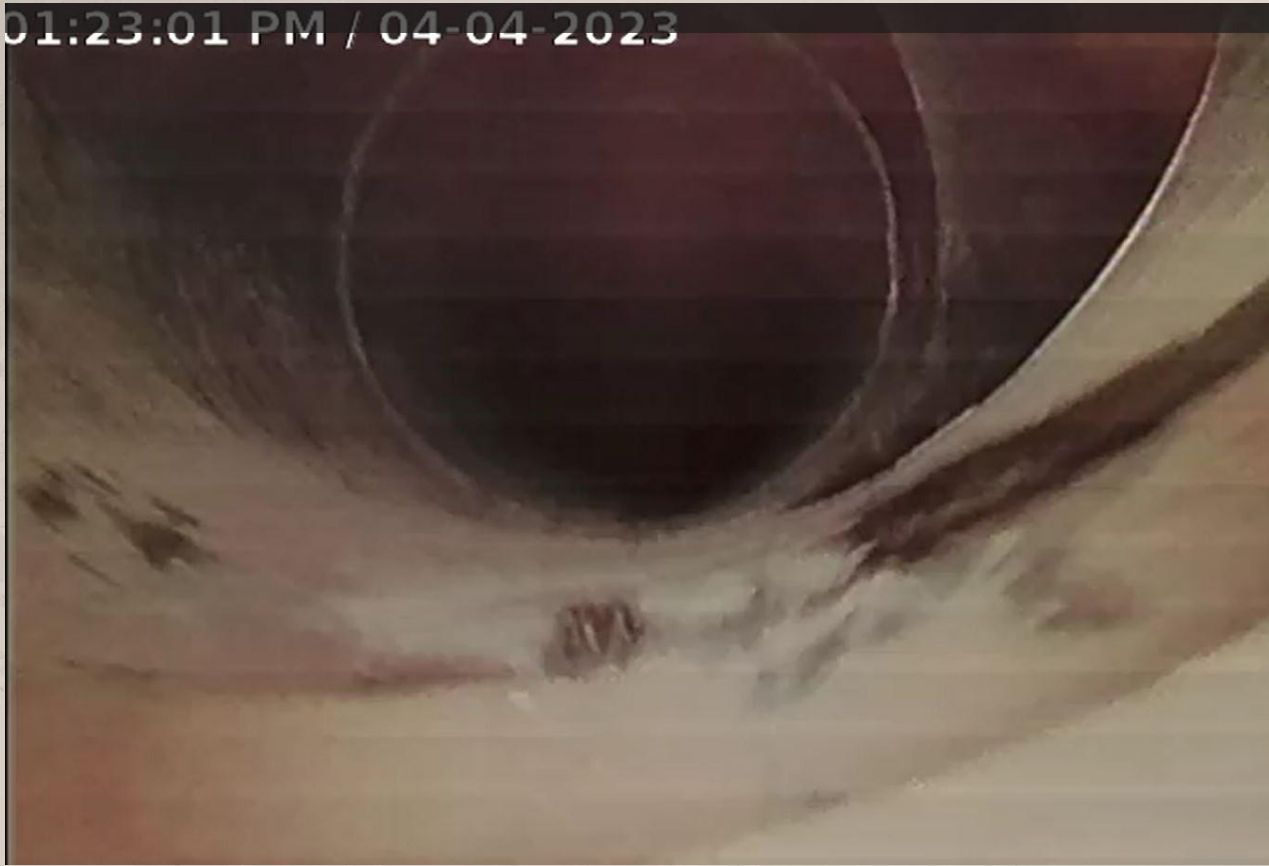
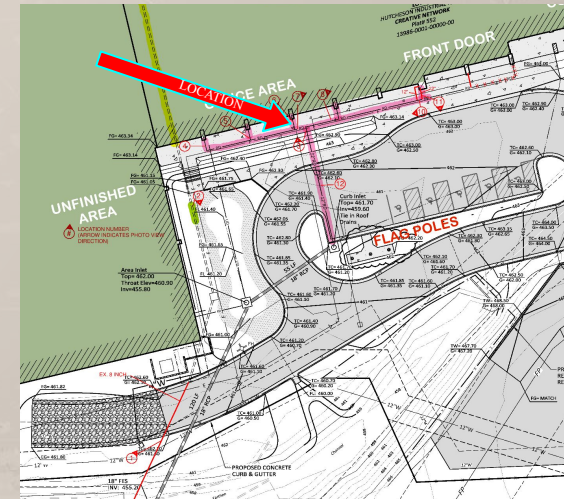
Photo 7 - Bull head tee at location 7

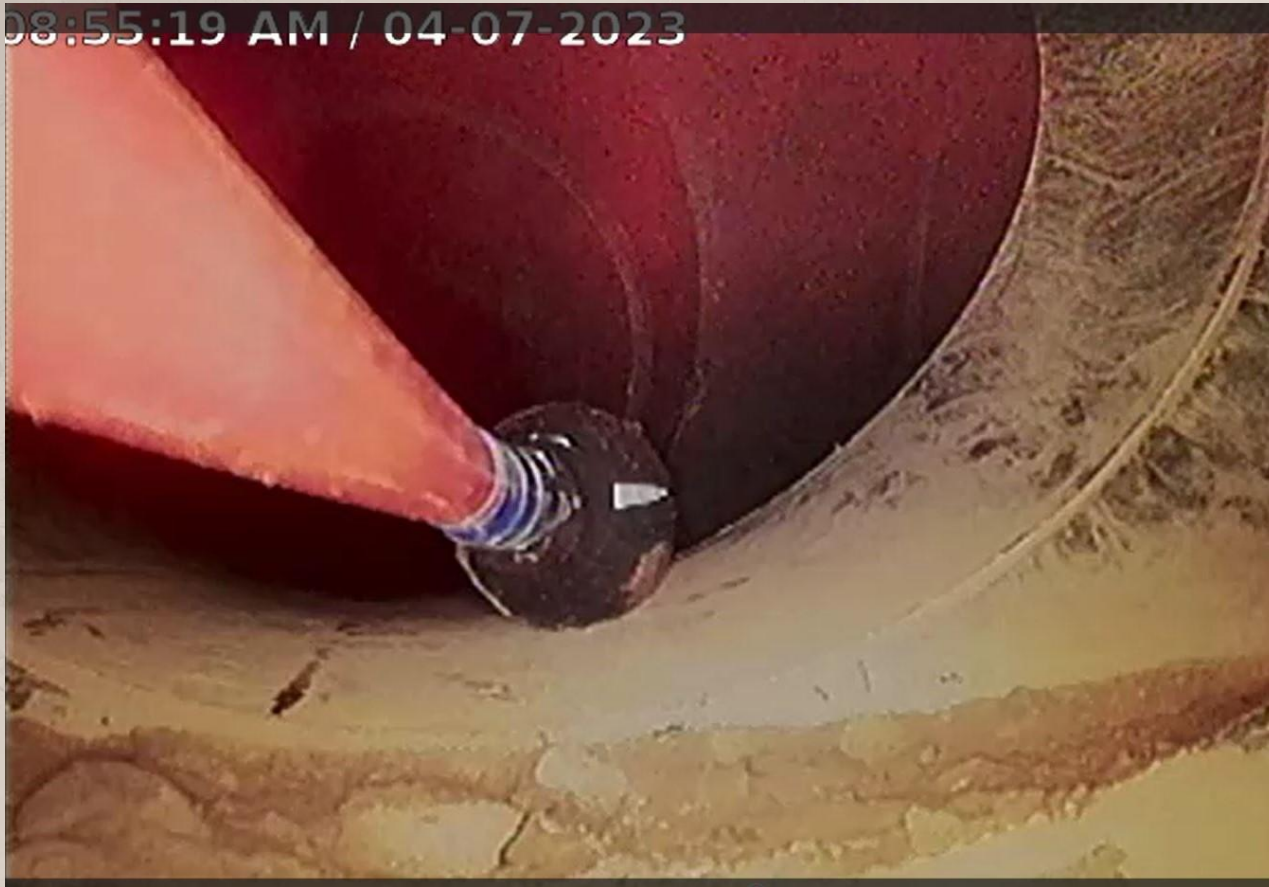
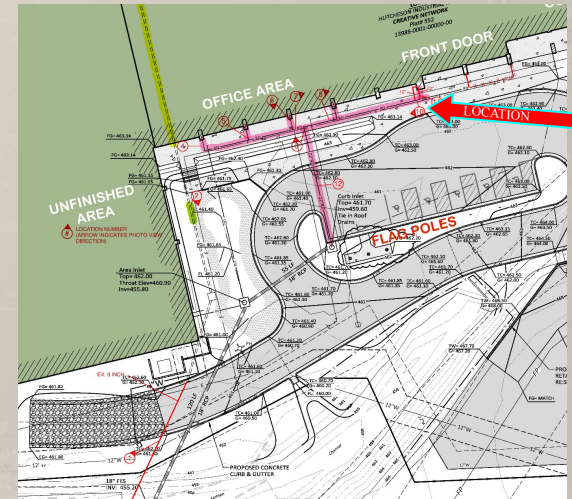
Photo 8 - Bull head tee at location 10

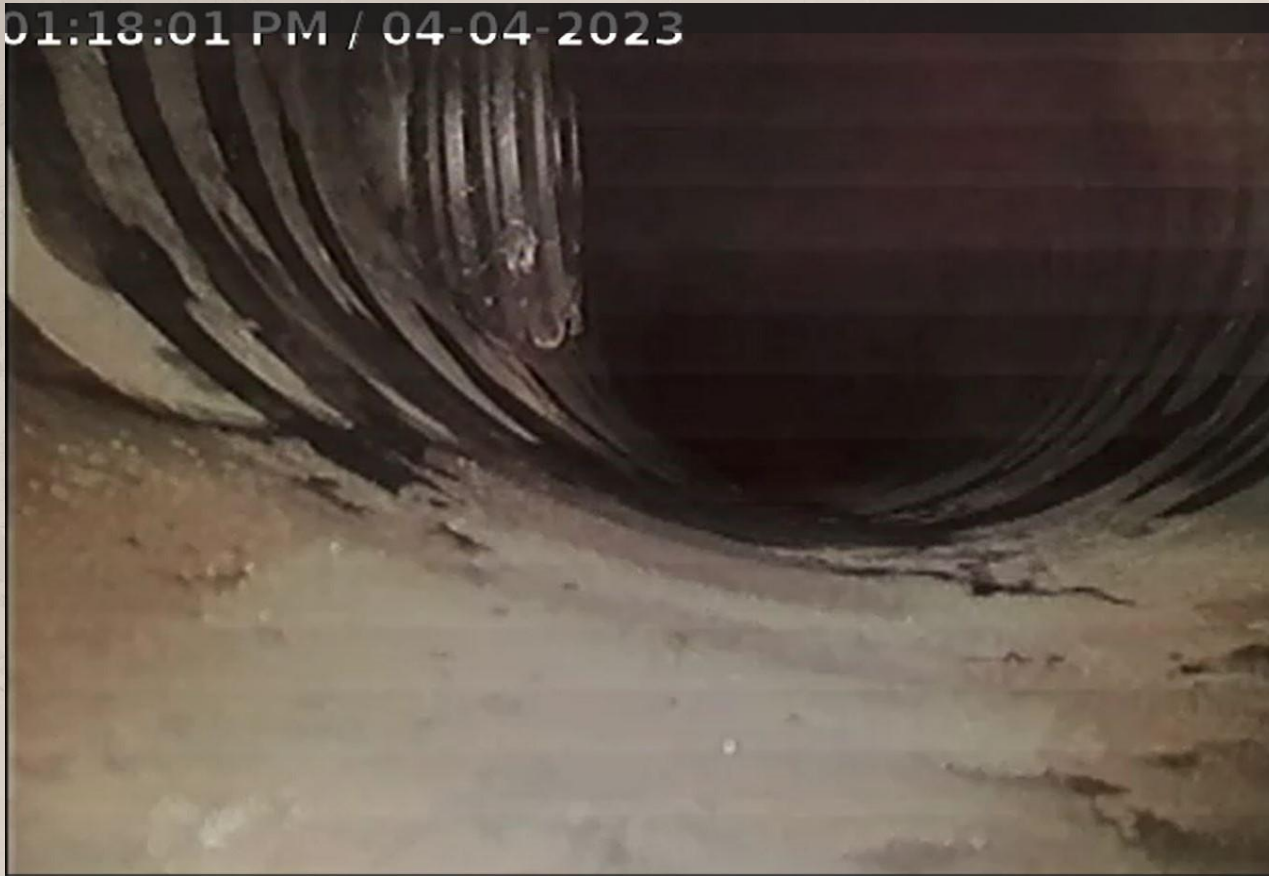
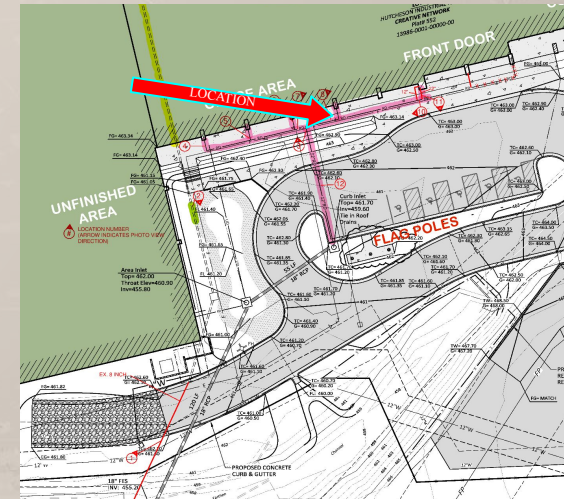
Photo 9 - 4" corrugated penetrating 12" corrugated at location 8

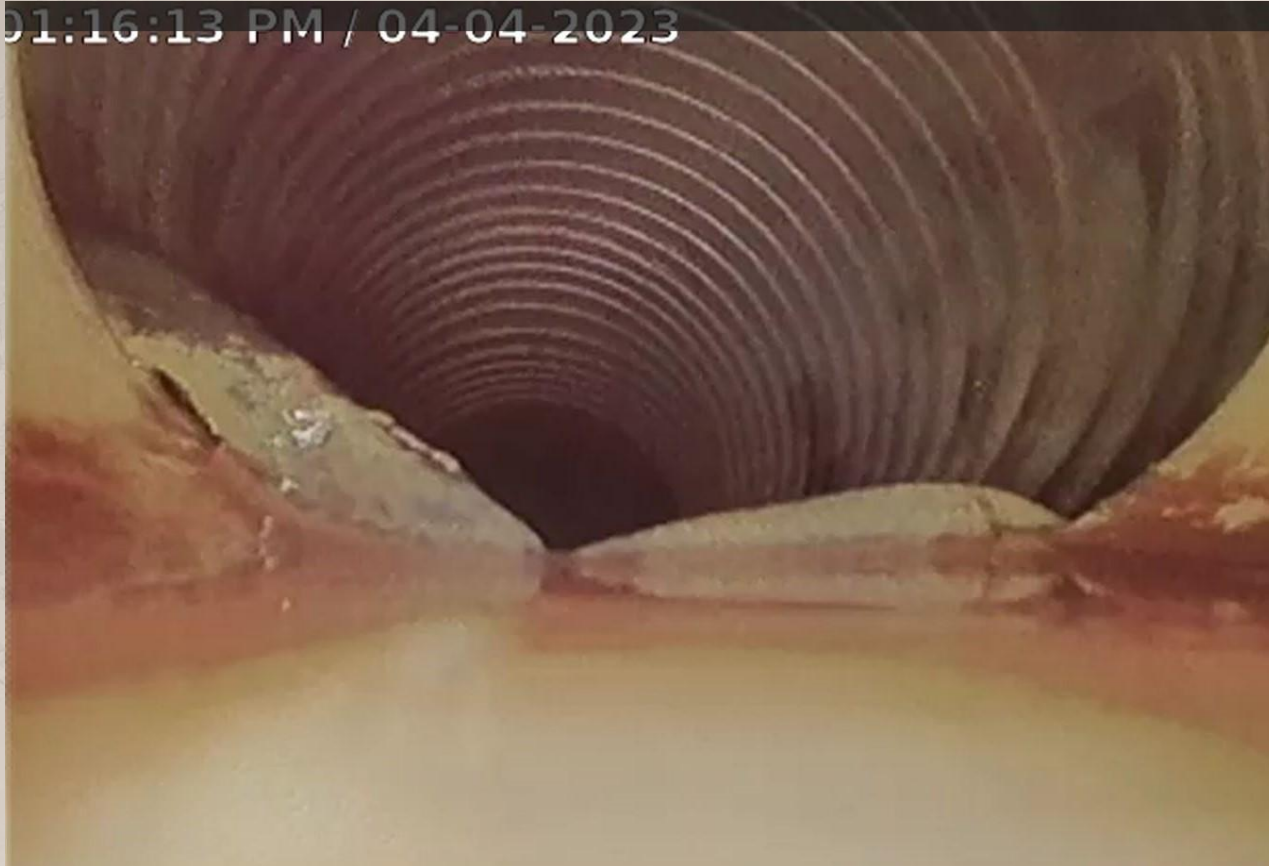
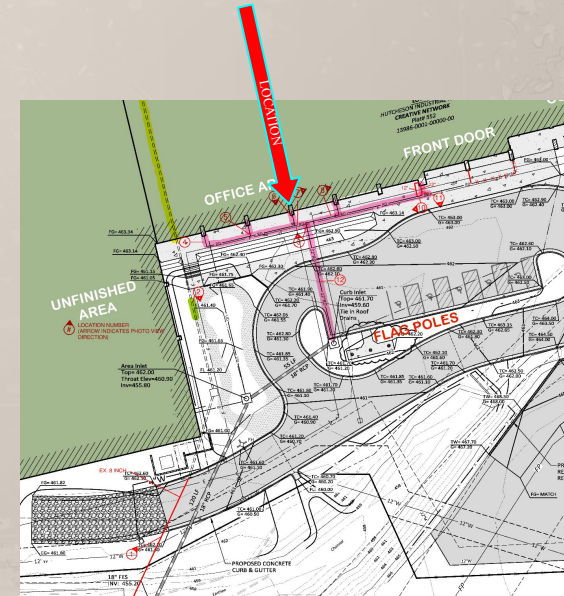
Photo 10 - Poor connection 4" pvc to 4" corrugated at location 6

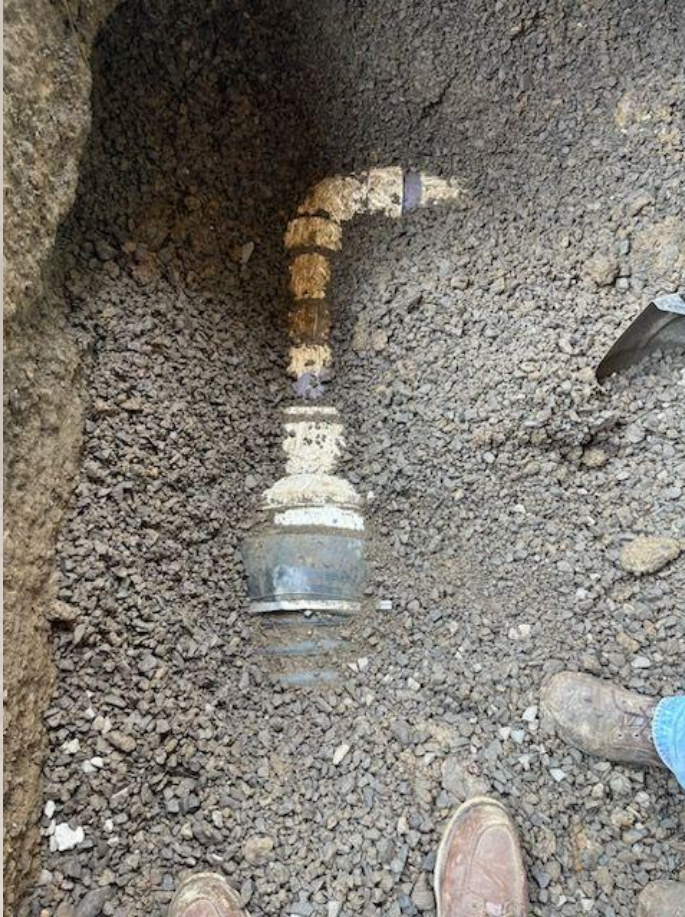
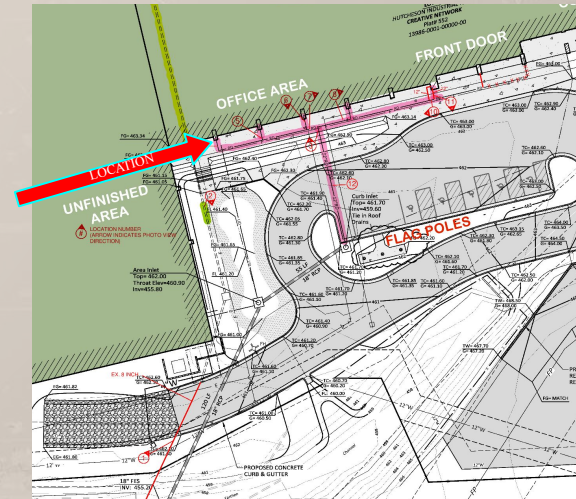
4" Downspout Connection - Post report investigation

- Connection from 4" downspout to the 12" trunk line

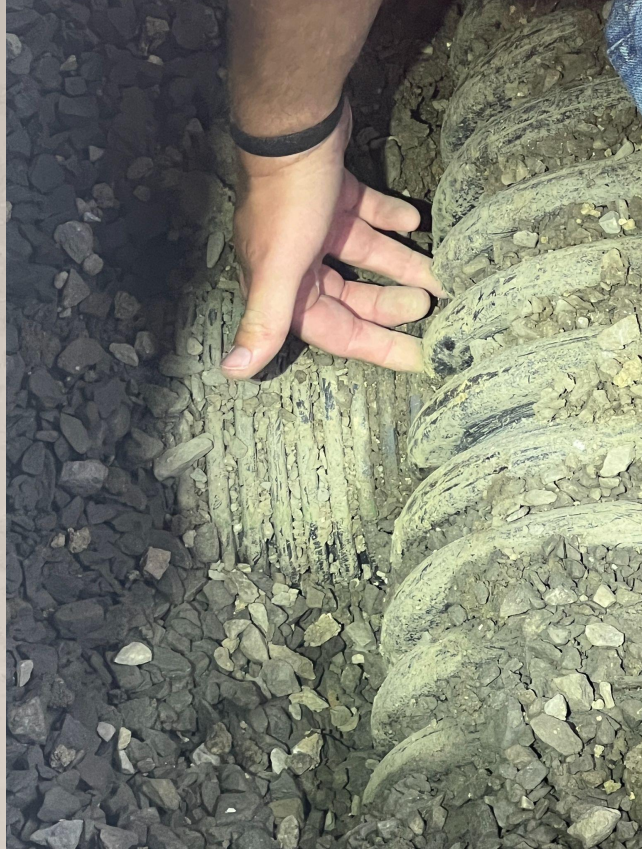
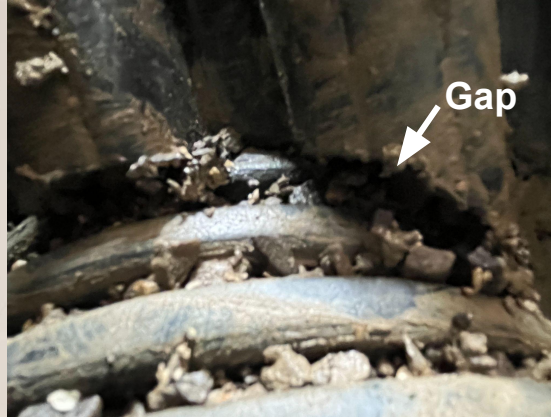
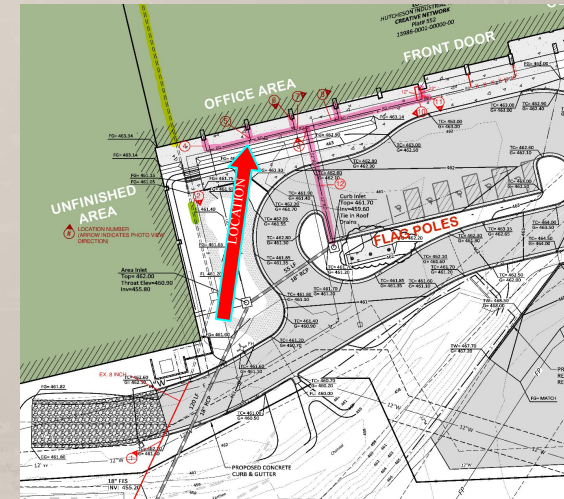
4" Downspout Connection - Post report investigation

- Not a water tight connection
- 4" has negative slope towards building.

- **There are holes in the existing drainage system right next to the building**
- **The existing drainage system was downsized from a 10 inch to an 8 inch**
- **Note that the connections from 4 inch to 12 inch are not standard or properly sealed**

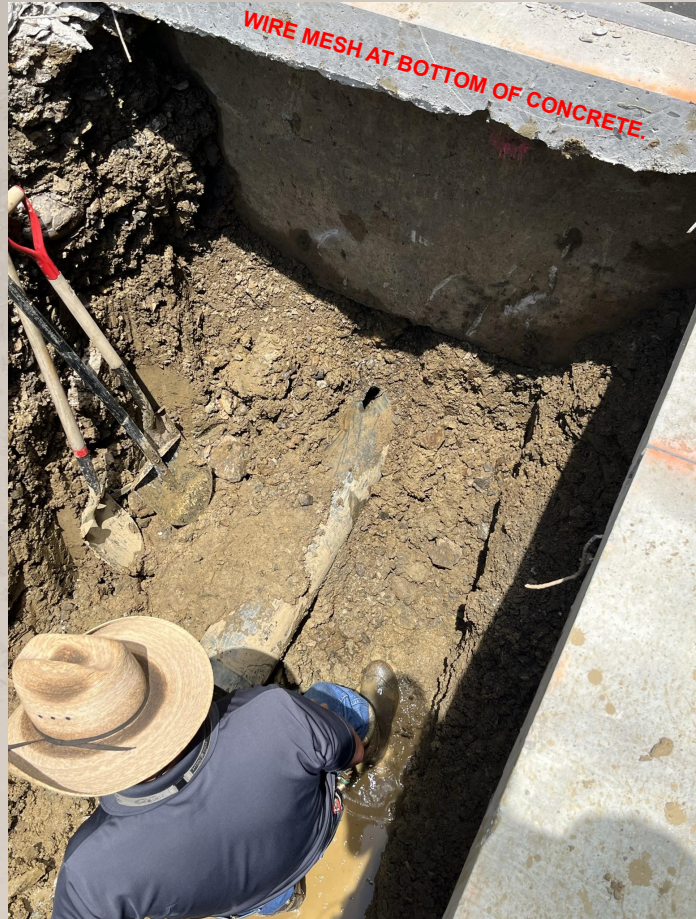
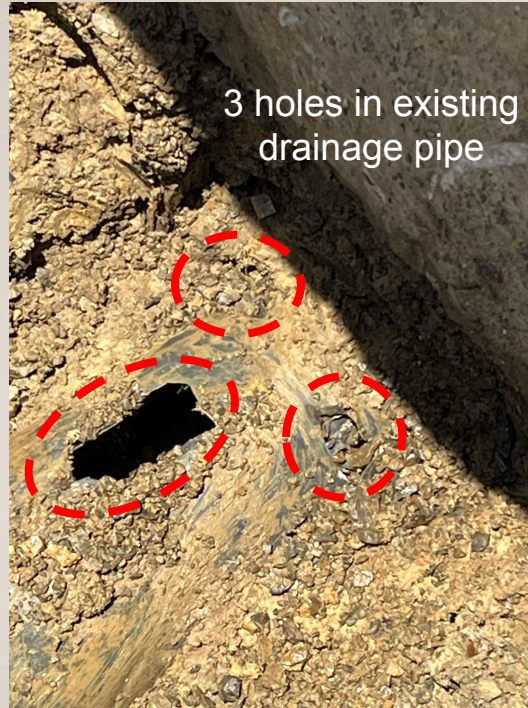
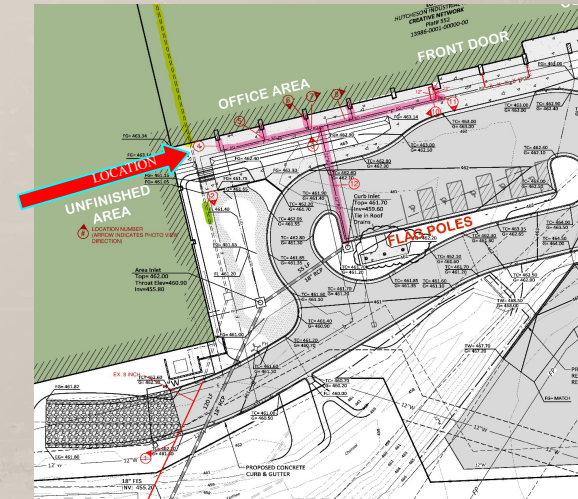
Existing 10" Roof Drainage Pipe - Post report investigation

- Damage to existing 10" roof drainage pipe
- Reinforcement wire under the concrete and not embedded within the concrete

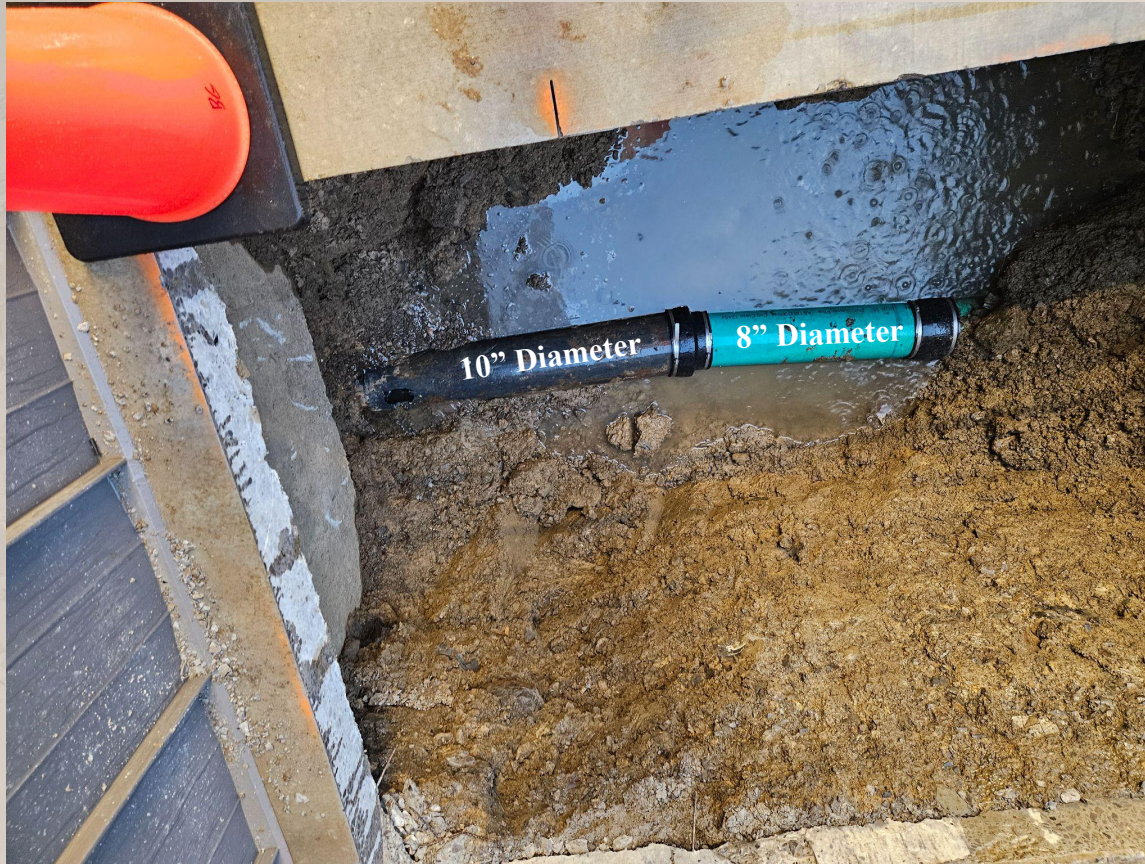
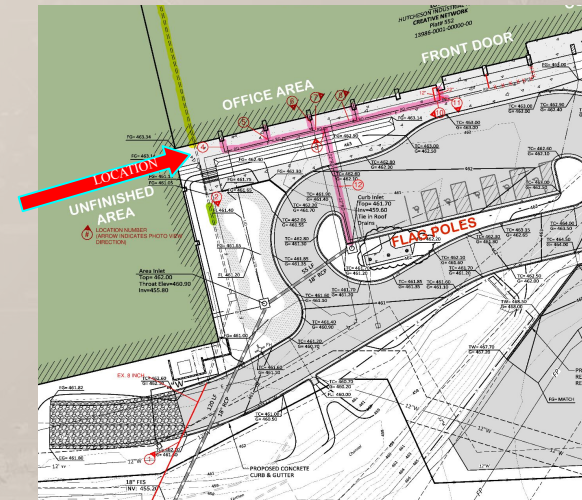
Existing 10" Roof Drainage Pipe - Post report investigation

- Existing pipe transitions from 10" to 8"
- Downsizing the pipe restricts water flow from facility/roof
- There is piping under the slab that has only been investigated by a camera (interior)
