# MASONRY RESTORATION ASSESSMENT TODD HALL SCHOOL

3925 W Lunt Ave, Lincolnwood, IL 60712

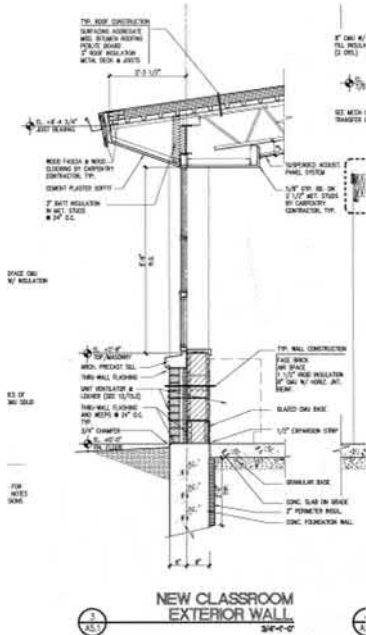
(Typical 1993 wall construction)

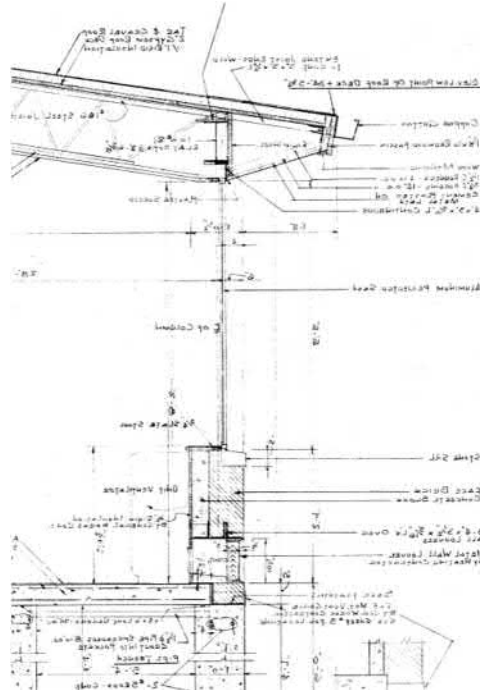
(Typical 1955 wall construction)

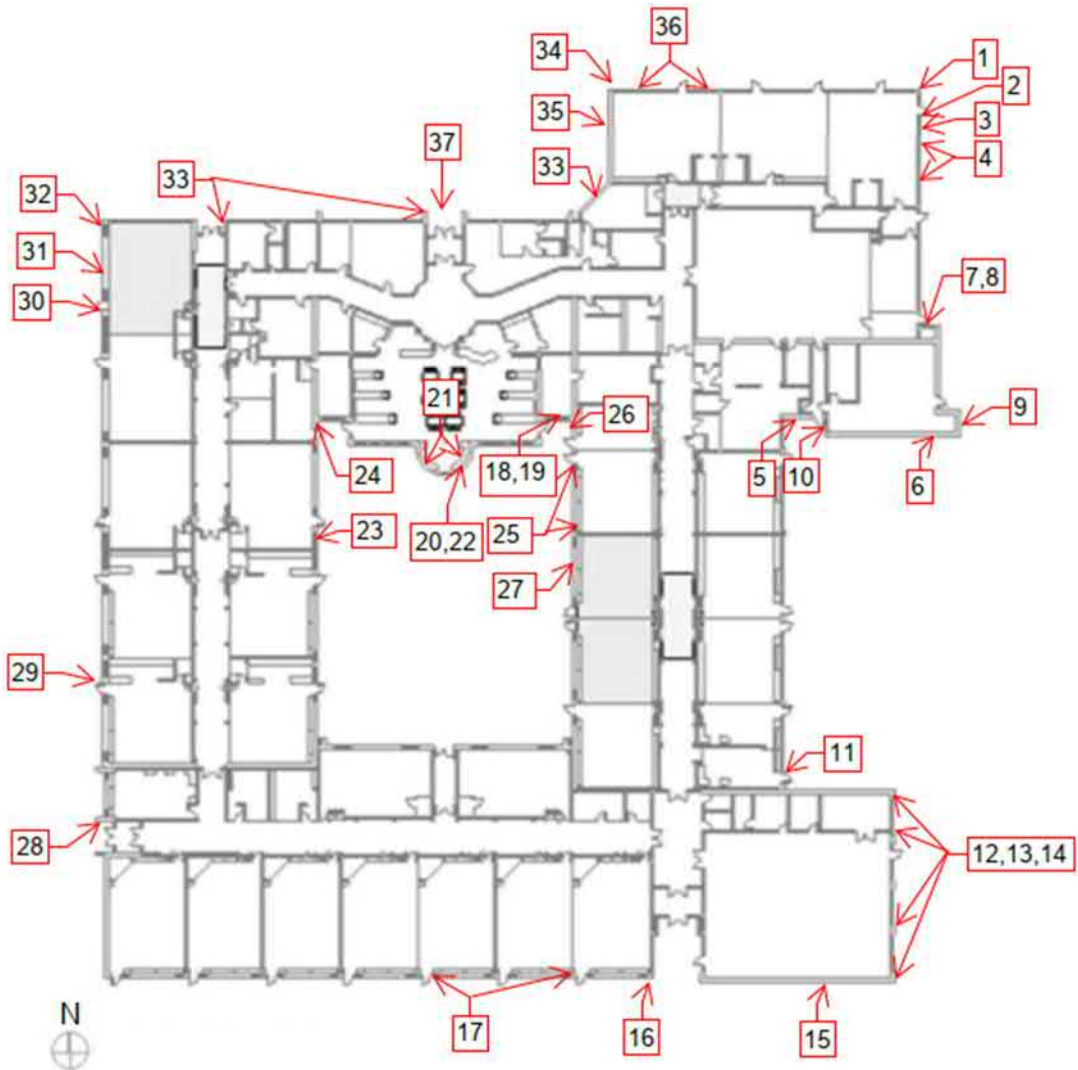
PHOTO LOCATION KEY PLAN:

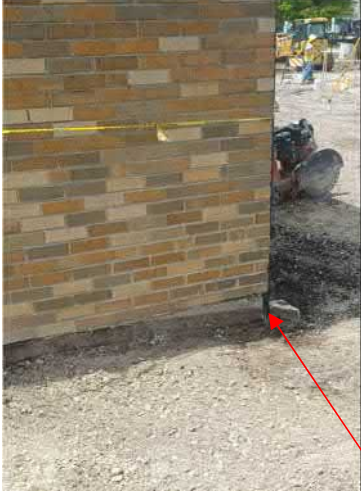
*Figure 1: Area of damaged foundation and cracked mortar joints @ Southwest corner in need of repair and tuckpointing.*

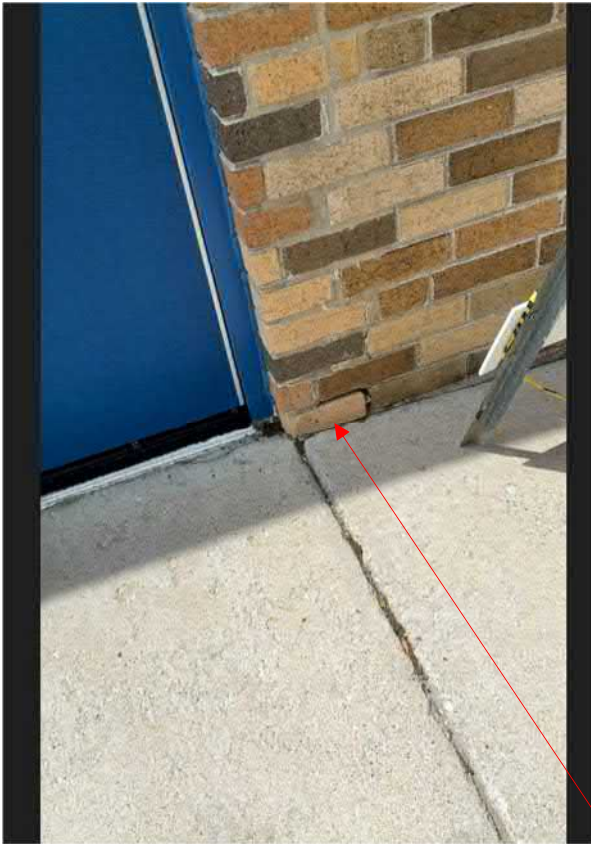
*Figure 2: Mortar damage @ Door #28, general area in need of repair and tuckpointing.*

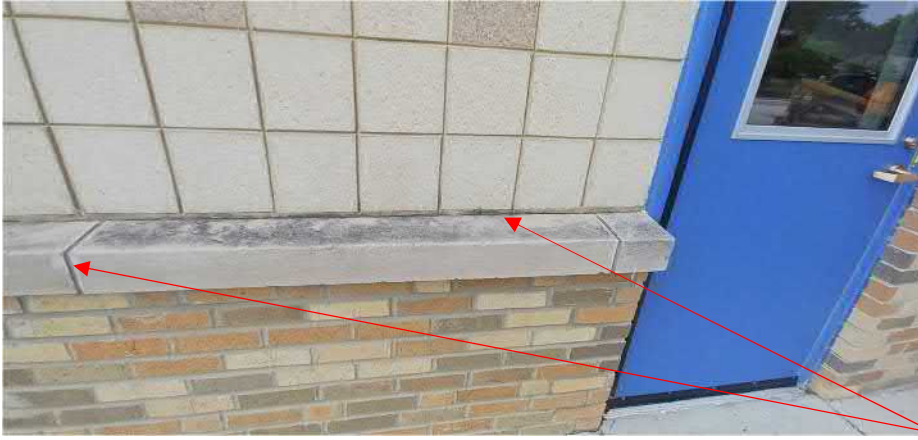
*Figure 3: Existing Cast Stone Sills, in need of cleaning, sealing, grinding out of joints and re-sealed with elastomeric sealant, per current construction methods.*

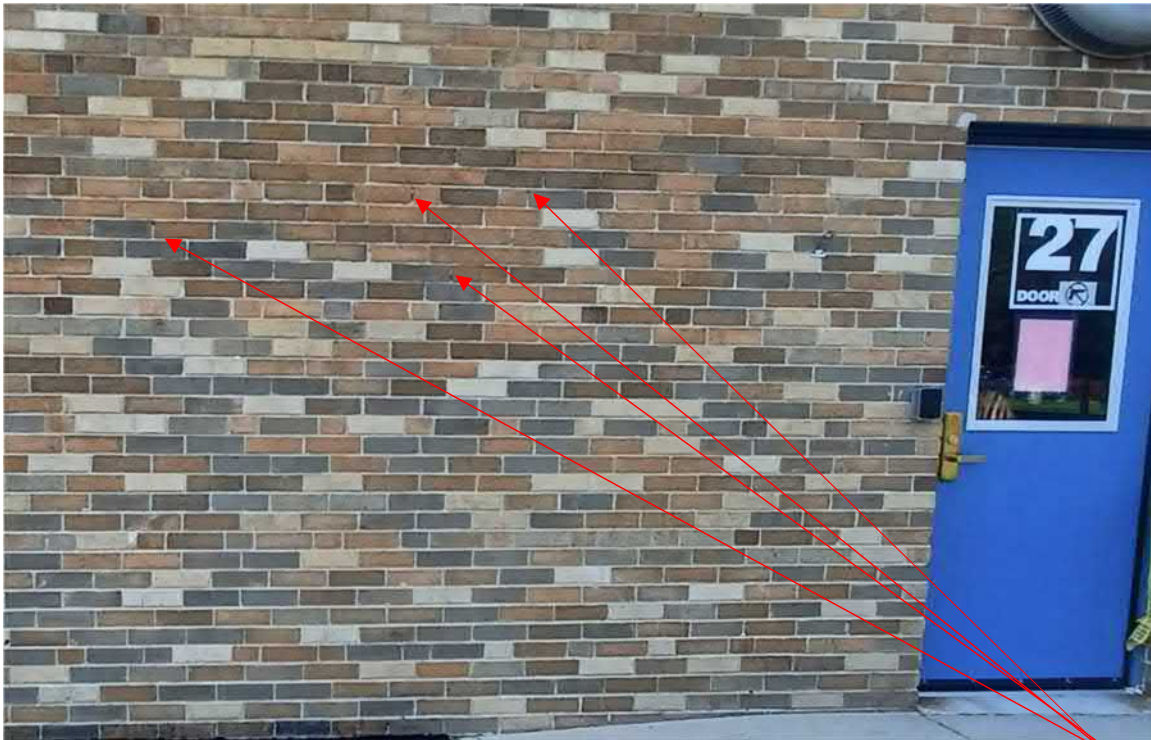
*Figure 4: General Areas of cracked mortar in need of repair and tuckpointing of broken and open joints.*

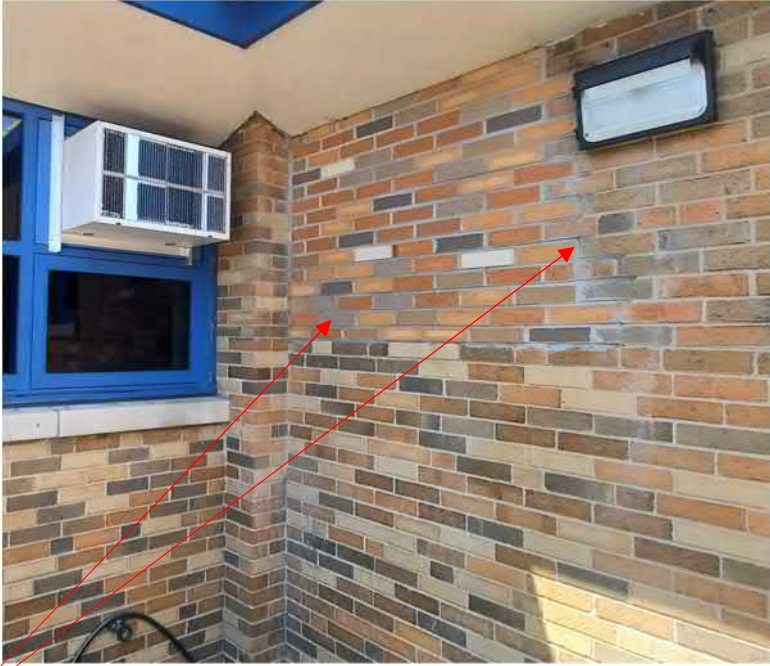
Figure 5: Previously tuckpointed area that could be improved, re-pointed to match existing joints.

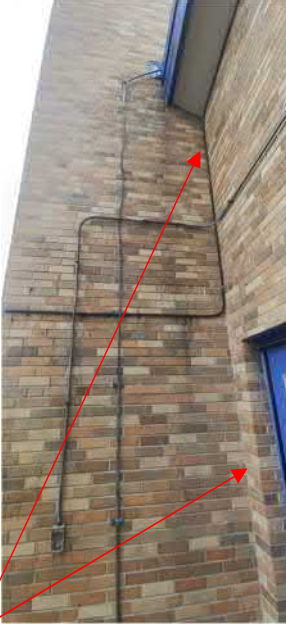
Figure 7: General area in need of tuckpointing and a few broken / cracked bricks..

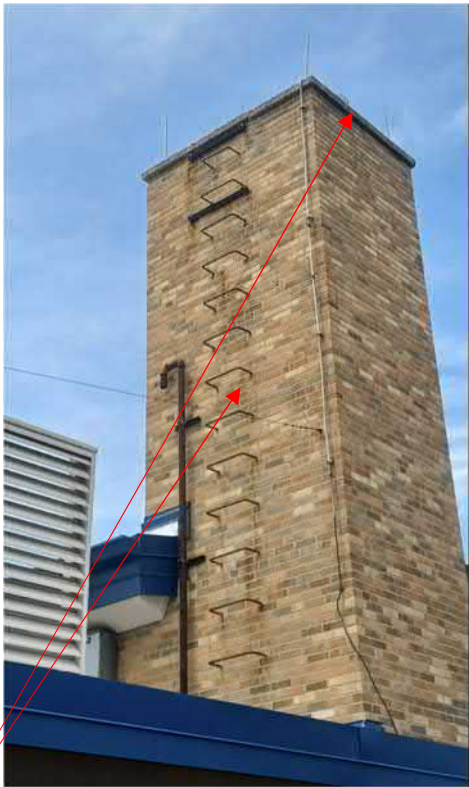
Figure 8: Crumbling cast stone chimney cap in need of replacement. Rust stains on brick in need of cleaning/power-washing.

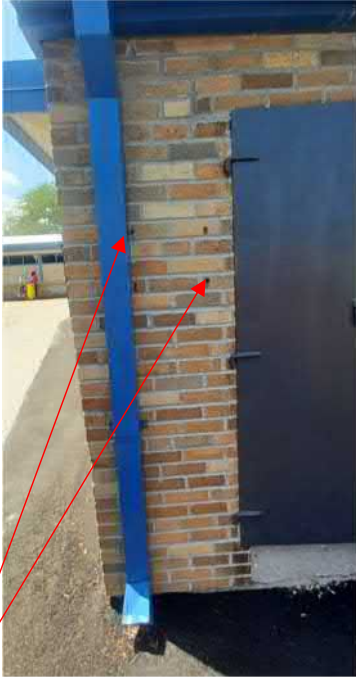
Figure 9: Remove / drill out fasteners and seal. (Option: Replace bricks with new.)

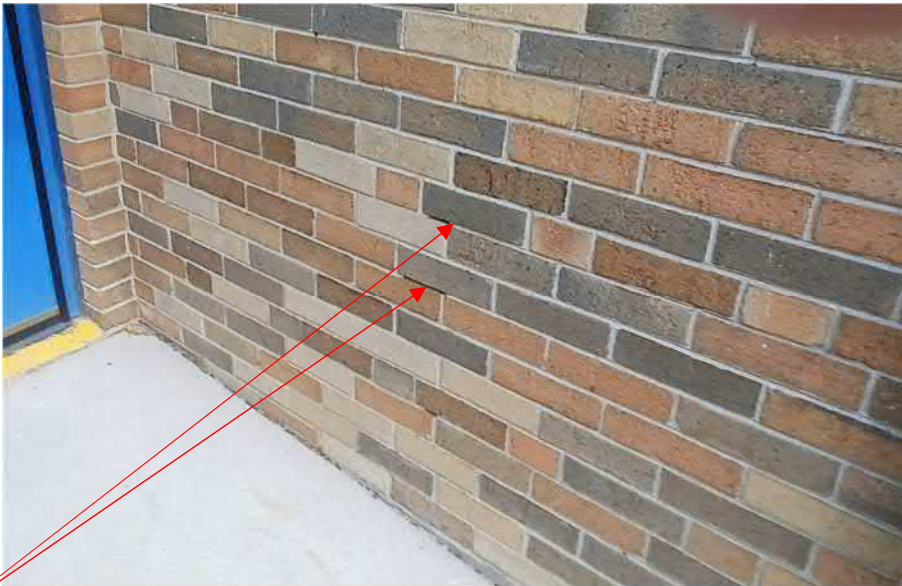
Figure 10: Cracked and open joints by door 24 in need of repair and tuckpointing..

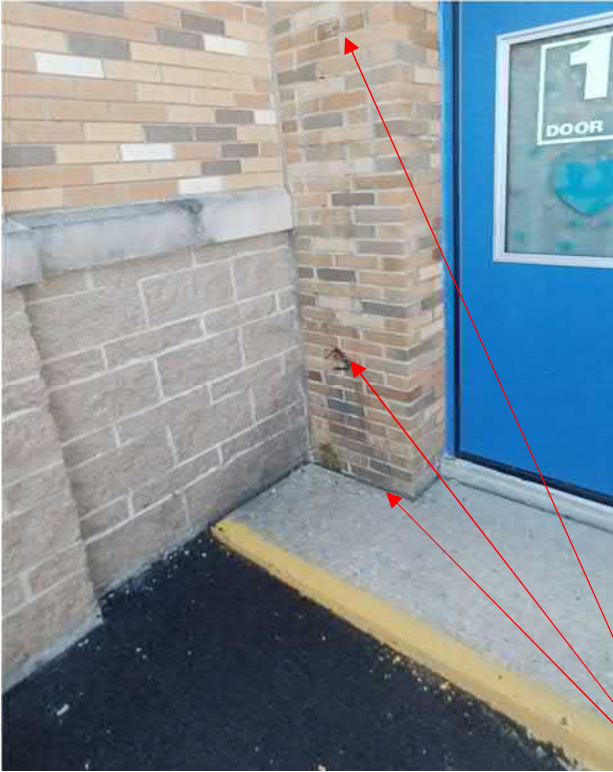
*Figure 11: Stoop coming away from bldg. should have compressible filler installed and then sealed. Brackets could be removed, brick pier in need of repair and tuckpointing*

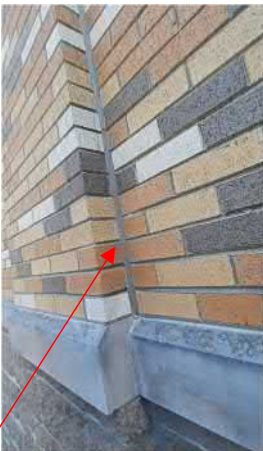
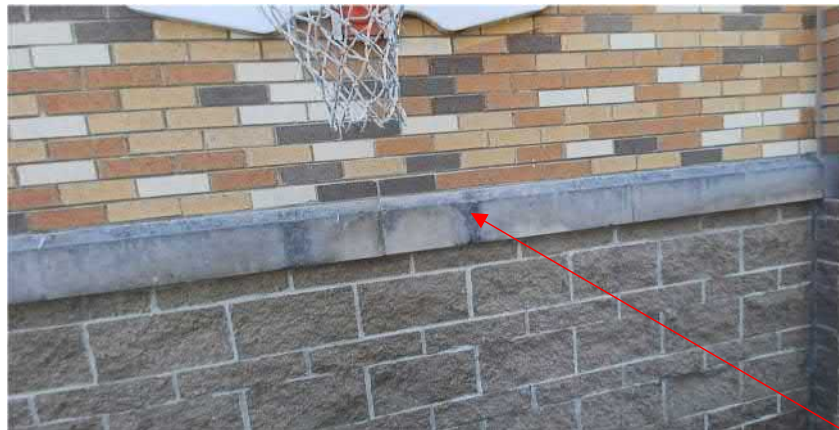
*Figure 12: Vertical control/expansion joints at 1993 construction gymnasium, to be removed and re-sealed with new sealant, outside and inside. Cast stone sills are in need of repair and cleaning. Joints in need of being ground out re-pointed and re-seal*

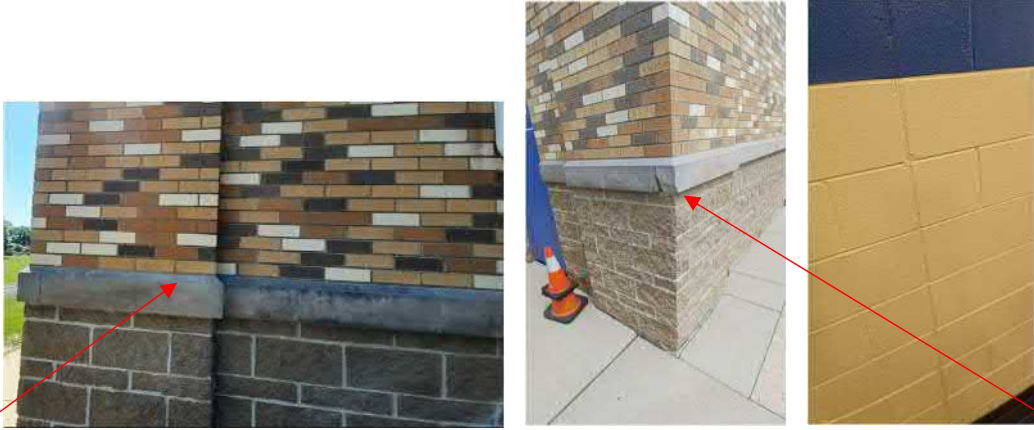
*Figure 13: Vertical control/expansion joints at 1993 construction gymnasium, to be removed and re-sealed with new sealant, outside and inside. Cast stone sills are in need of repair and cleaning. Joints in need of being ground out re-pointed and re-sealed.*

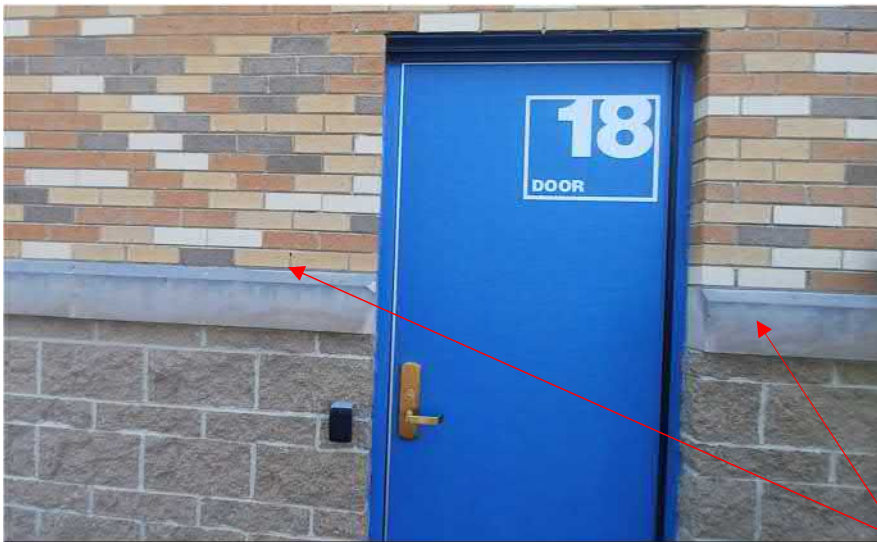
*Figure 14: General Areas of cracked mortar in need of repair. Tuckpoint and seal open joints. Clean Sills.*

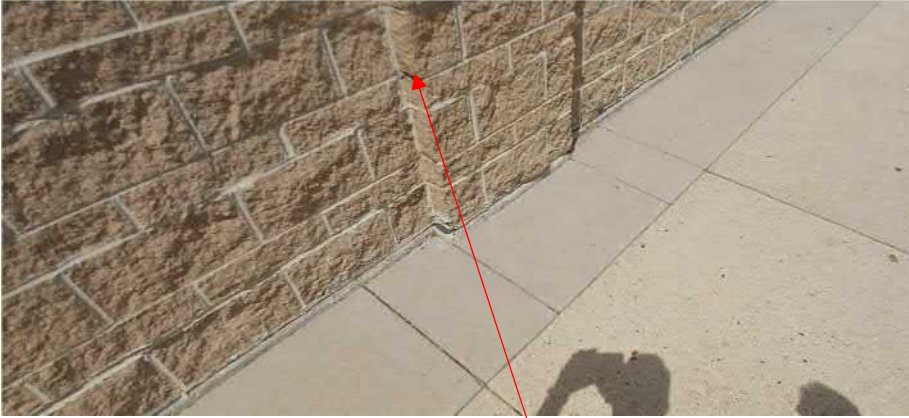
Figure 15: Area of mortar in need of tuckpointing.

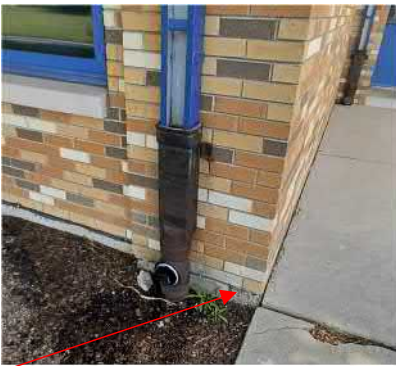
Figure 16: Foundation wall in need of repair.

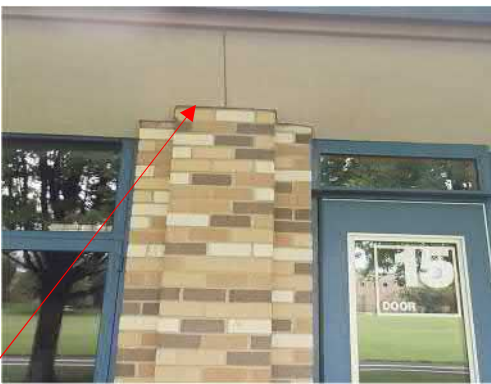
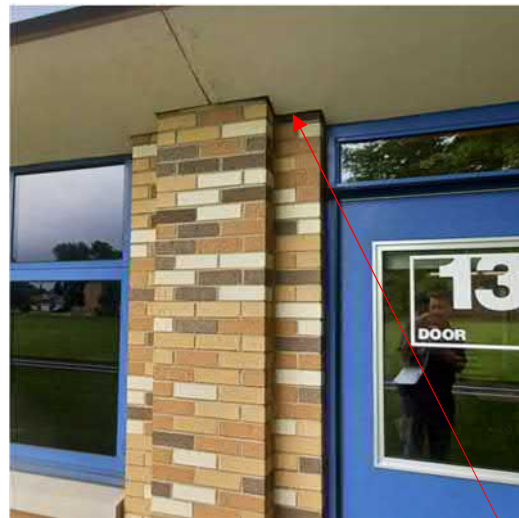
Figure 17: Tops of brick piers into the soffit in need of sealing/re-sealing. typical at several locations.

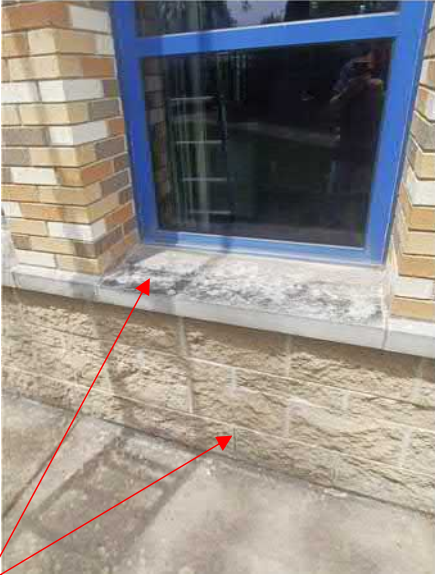
*Figure 18: Stained stone sills in need of power-washing and grinding out of joints and re-sealing. Areas of split face CMU in need of repair and tuckpointing.*

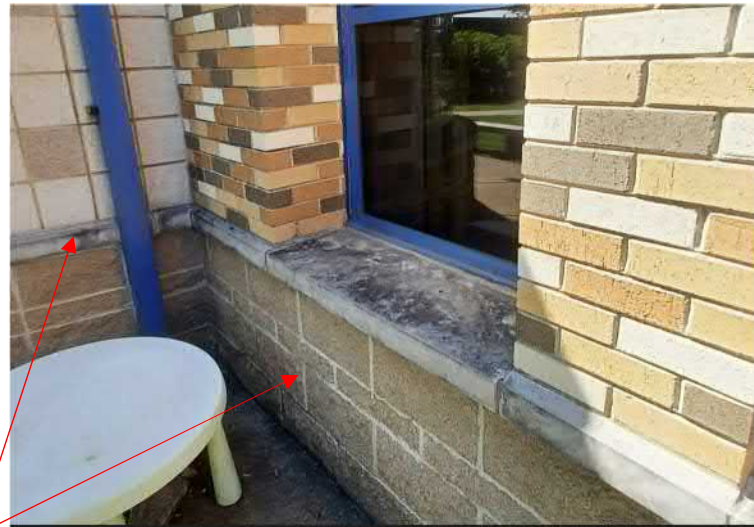
*Figure 19: Stained stone sills. Stained stone sills in need of power-washing and grinding out of joints and re-sealing. Areas of split face CMU in need of repair and tuckpointing..*

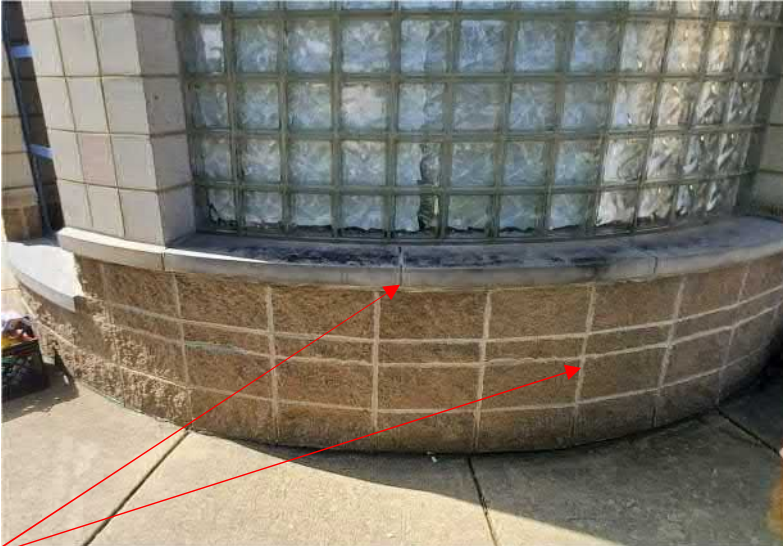
Figure 20: Stone sills in need of grinding out and sealing of joints. Cracked mortar joints in split face CMU in need of tuckpointing.

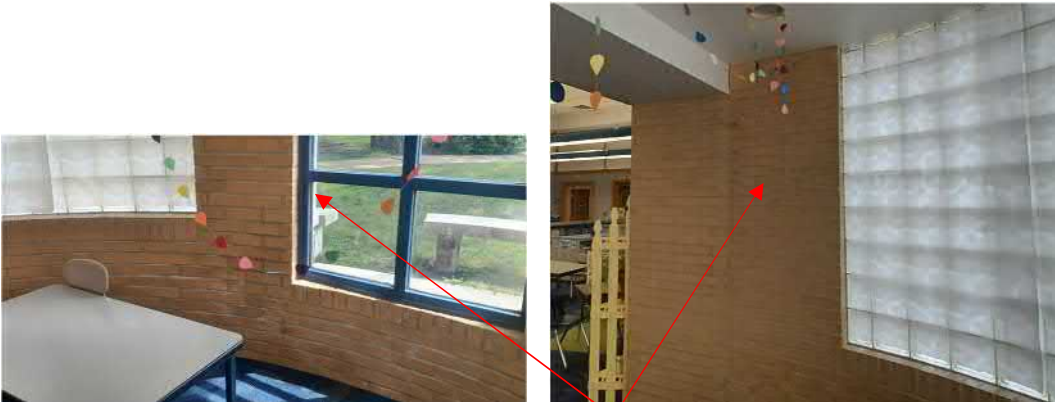
Figure 21: Evidence of water infiltration / efflorescence.

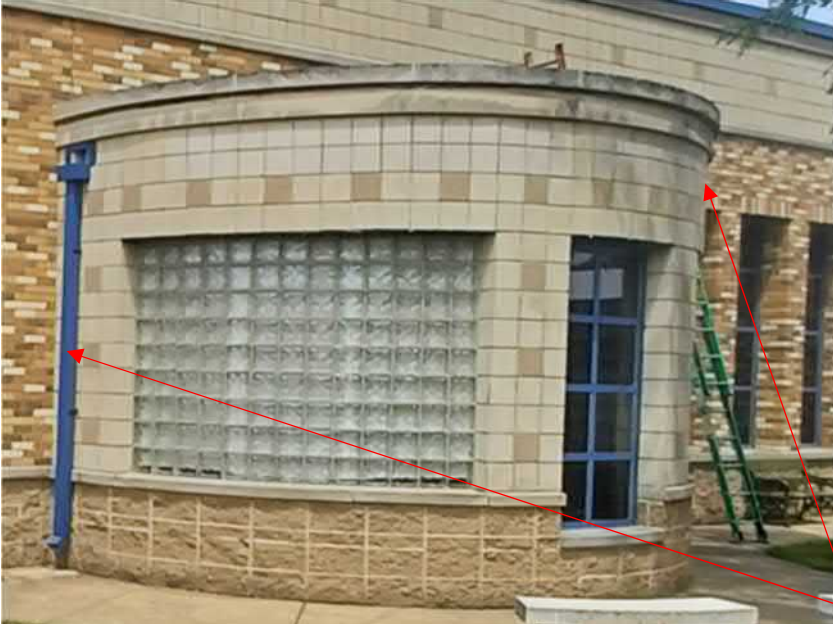
Figure 22: 'Rotunda' area Stone sills in need of grinding out and sealing of joints. Cracked mortar joints in split face and smooth face CMU in need of tuckpointing.

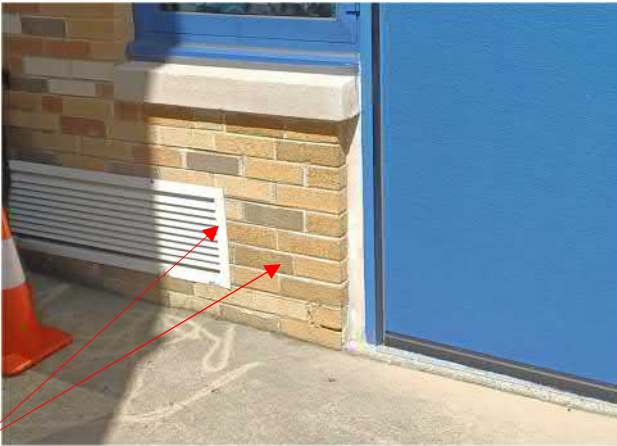
Figure 23: Areas requiring brick replacement, tuckpointing and cleaning.

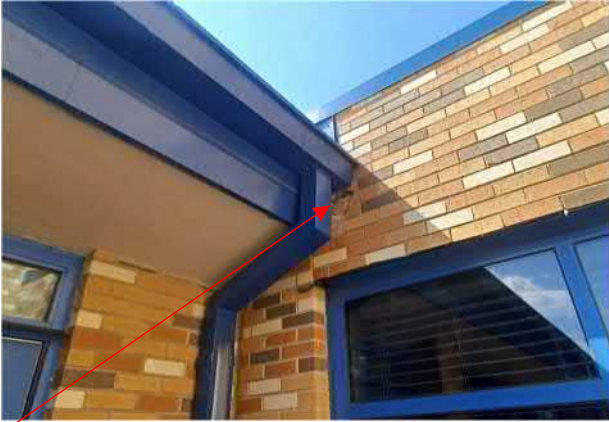
Figure 24: Broken brick in need of repair.

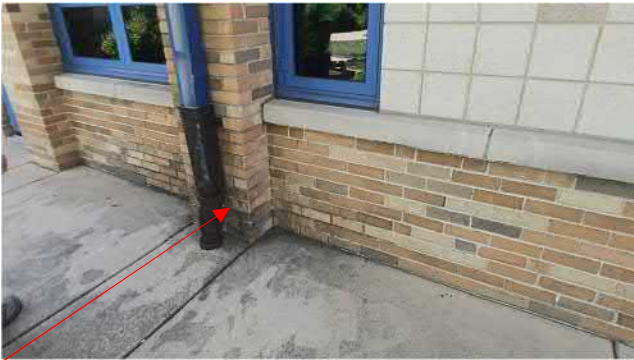
Figure 25: Brick pier in need of cleaning and tuckpointing.

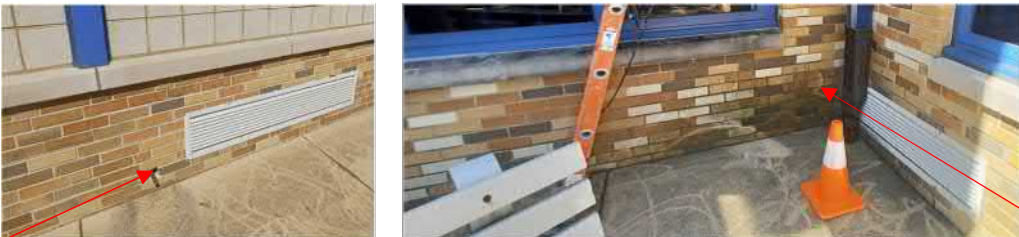
Figure 26: Areas requiring brick replacement, tuckpointing and cleaning. Existing, drying and cracking sealant at sills in need of re-sealing with new elastomeric sealant.

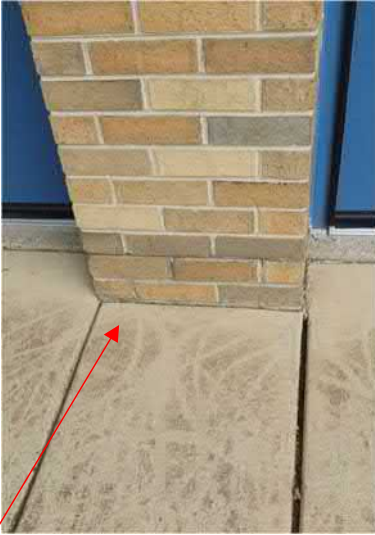
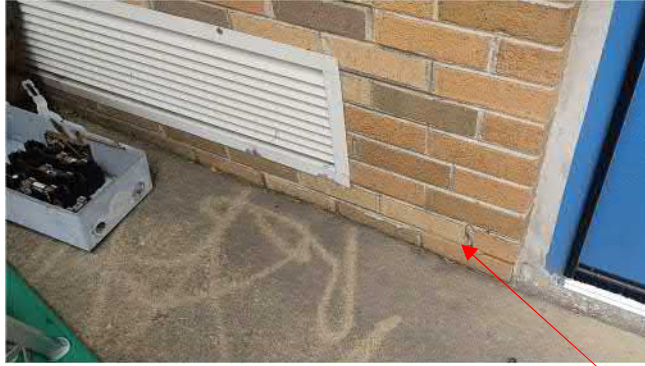
Figure 27: Bottom 2 or 3 courses of brick in need of tuck pointing. Typical at several areas on the east elevation (west side) of the courtyard.

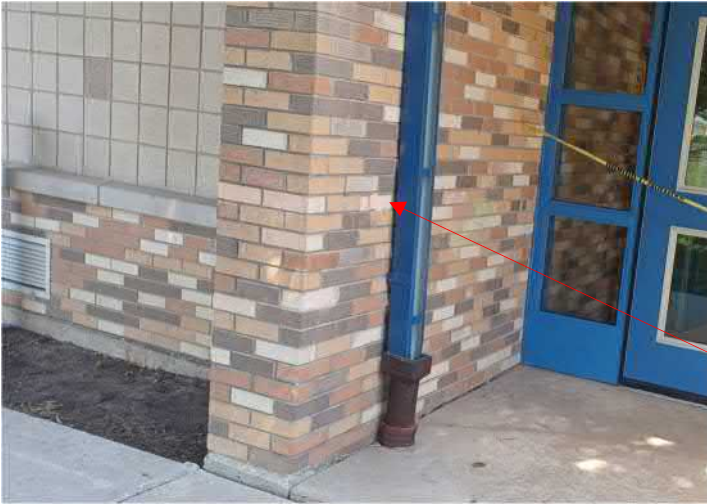
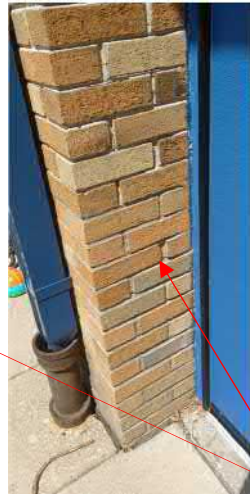
Figure 28: Piers by doors 7 and 8 spalling / popping bricks in need of replacing and tuckpointing.

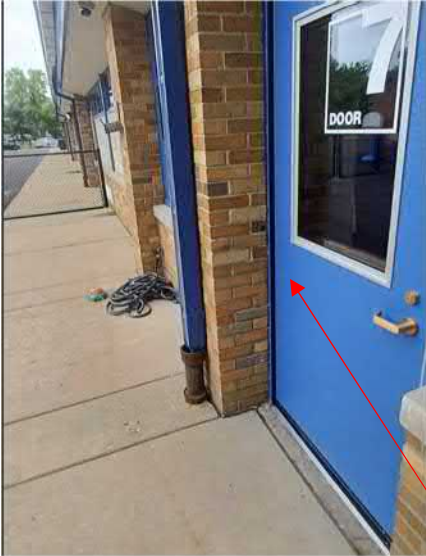
Figure 29: Area of mortar in need of tuckpointing.

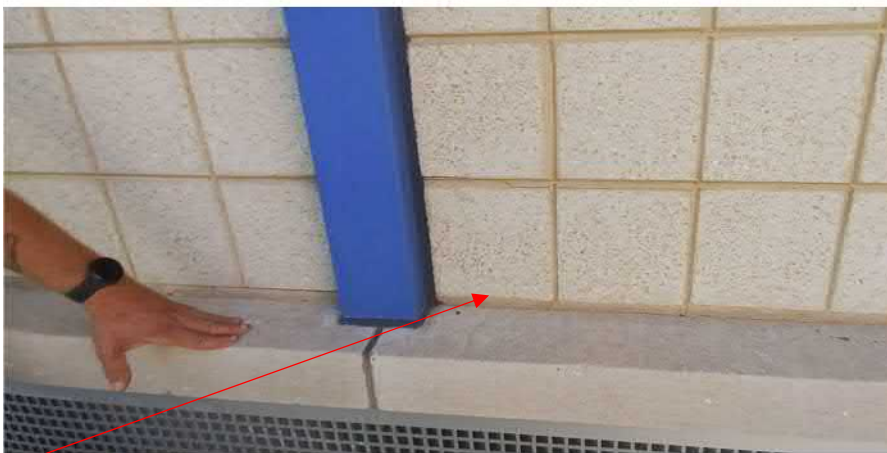
Figure 31: The cast stone sills appear to be 'drooping' at the center of the larger unit ventilator grilles, which is cracking the mortar between the wall and Smooth face CMU window infill. The 1955 and 1993 details show steel lintels for the smaller grilles, but none were found for the larger grilles. Further investigation is required.

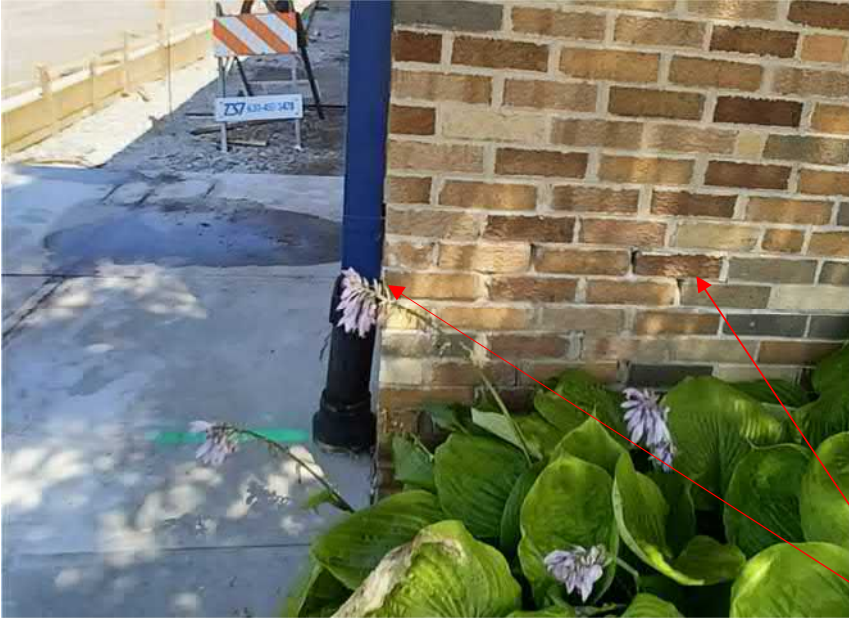
Figure 32: General areas of cracked, broken brick in need of replacing and tuckpointing.

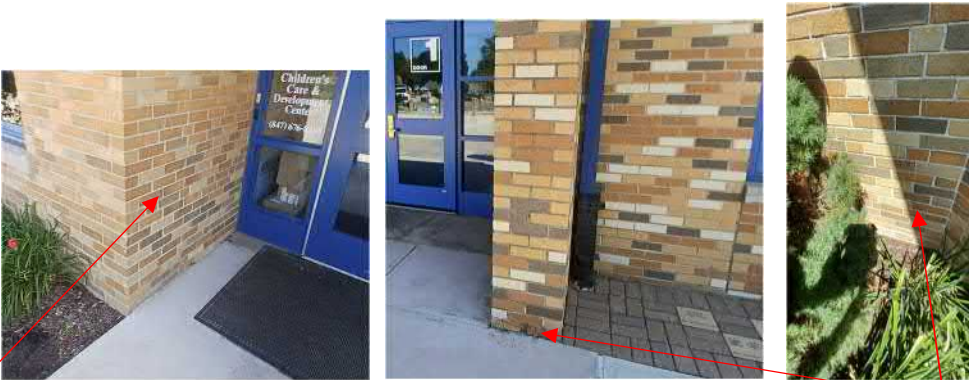
Figure 33: General areas of cracked, broken brick in need of replacing and tuckpointing.

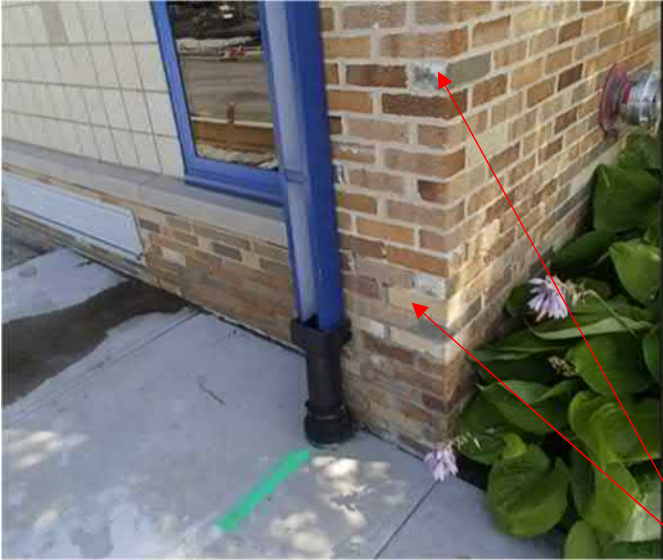
Figure 34: Several bottom courses of brick in need of tuckpointing

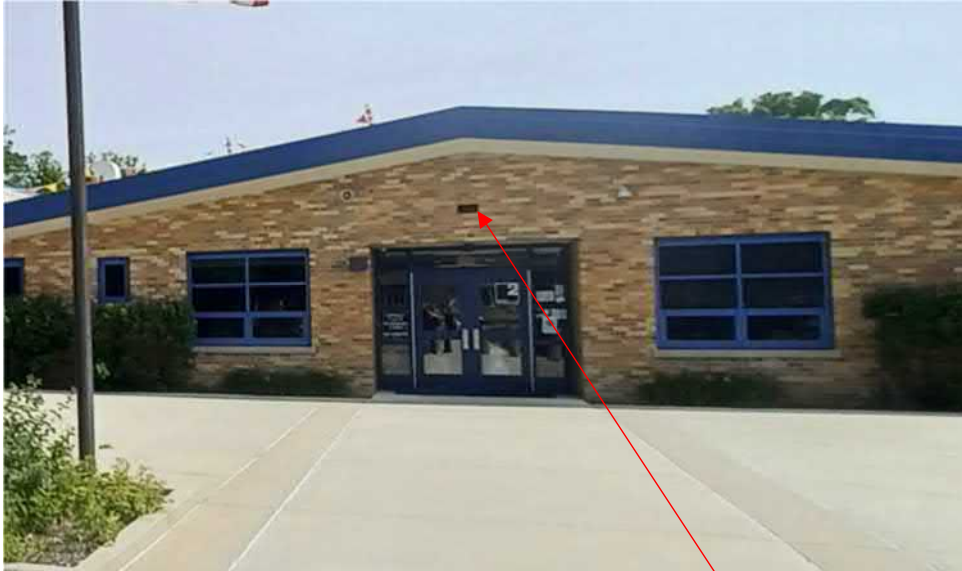
Figure 37: New bricks needed to replace missing bricks above door #2.

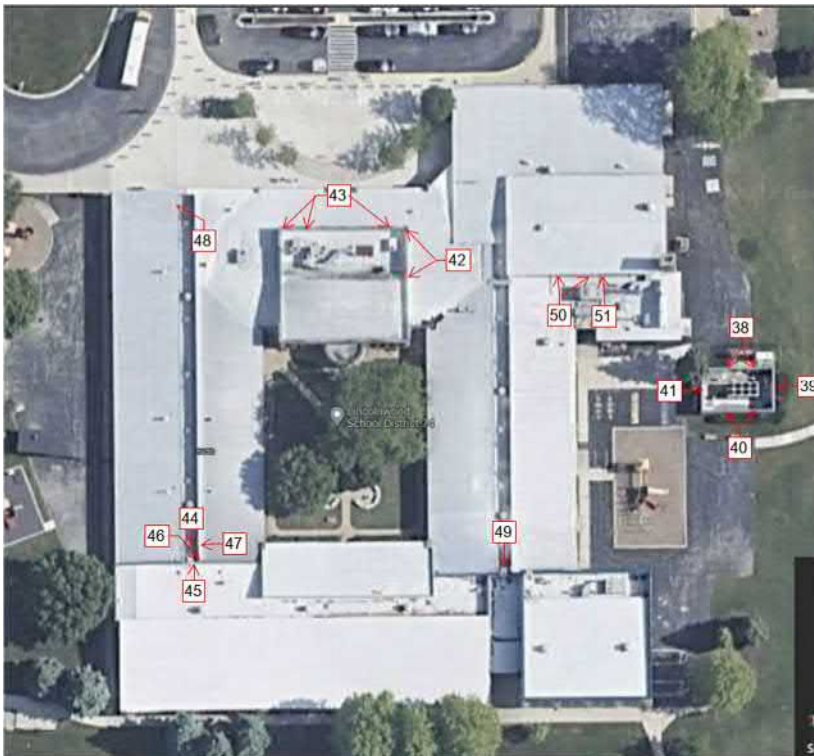
## Condenser Screen:

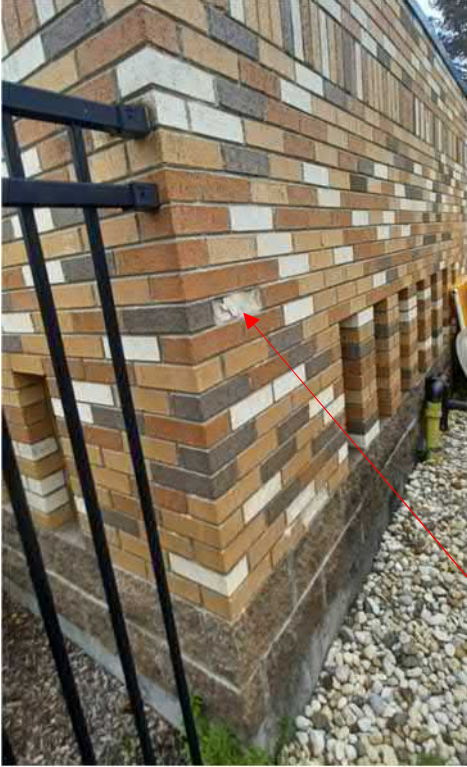
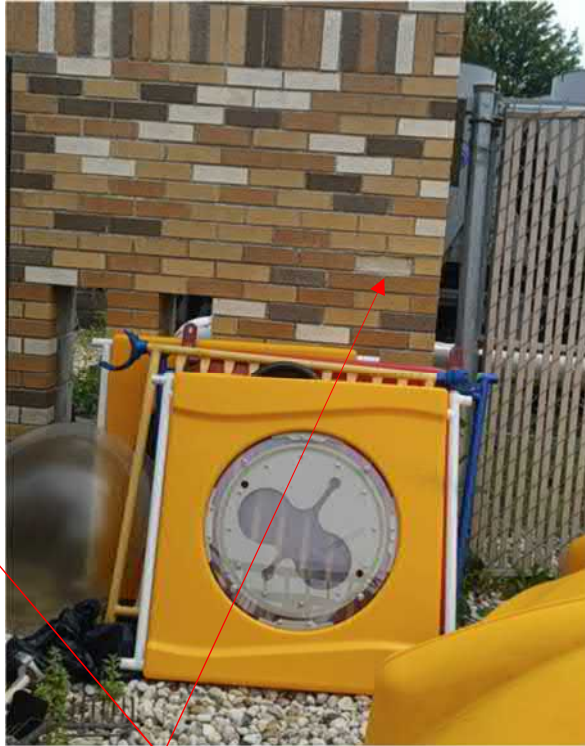
Figure 38: Spalling / popping Brick, in need of replacement.

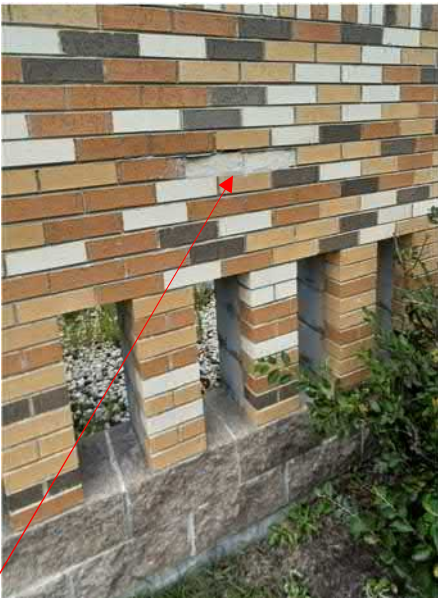
Figure 39: Spalling / popping Brick, in need of replacement

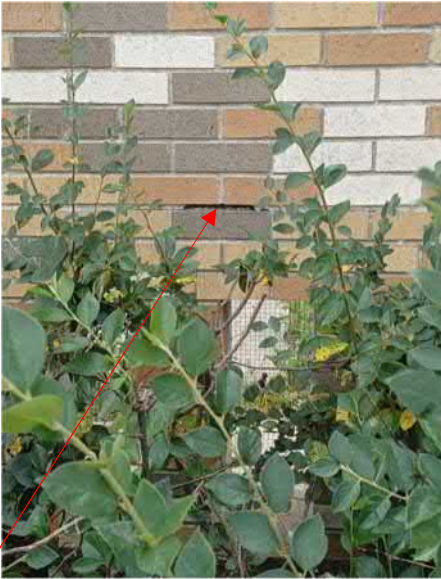
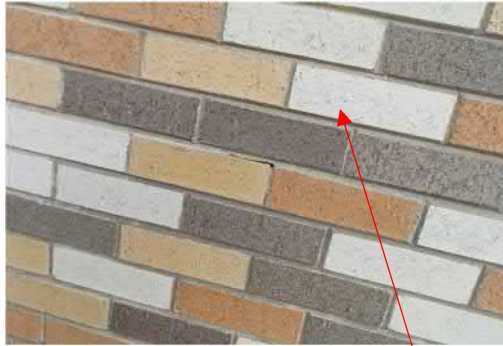
*Figure 40: Cracked and open mortar joints in need of tuckpointing in various areas.*

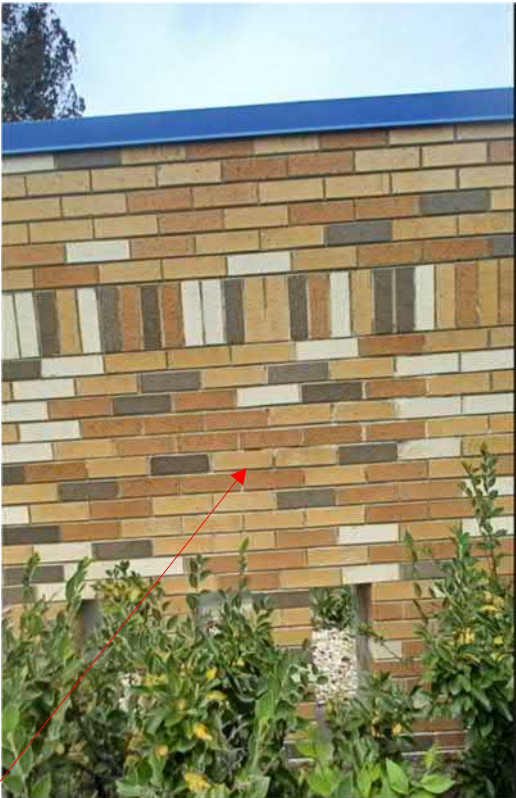
*Figure 41: Cracked and open mortar joints in need of tuckpointing in various areas.*

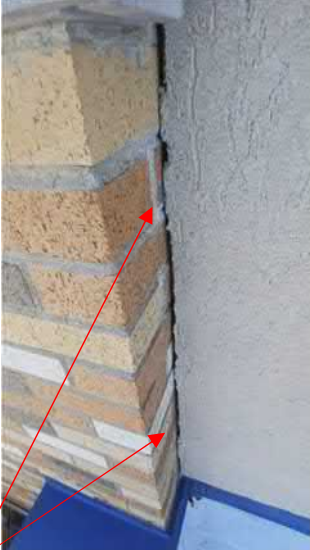
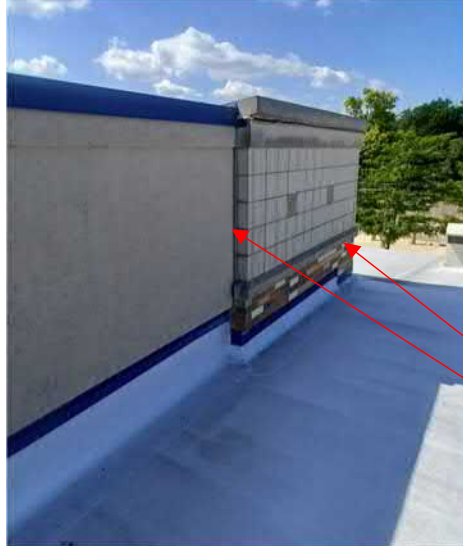
*Figure 42: Vertical brick to EIFS joints in need of resealing. Stone sills and smooth face CMU in need of power washing.*

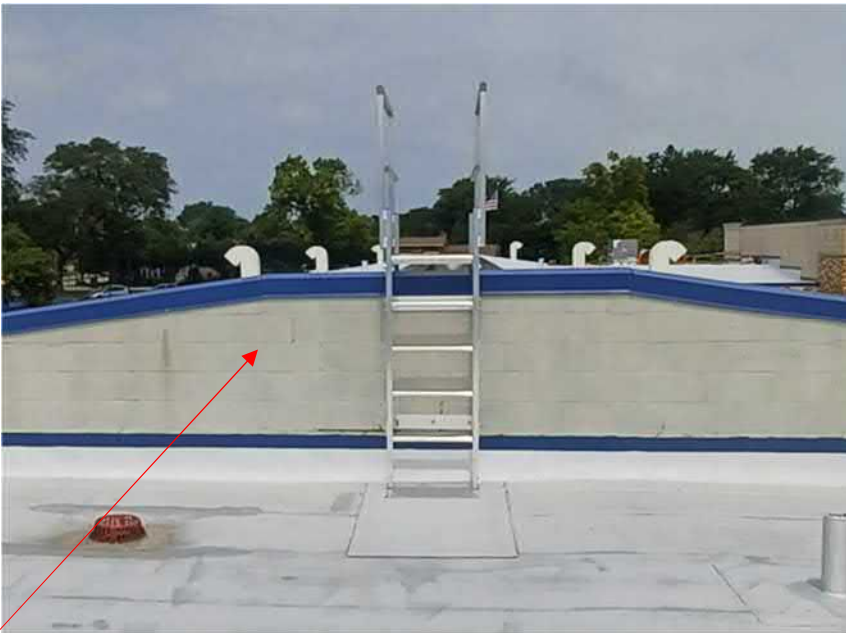
*Figure 45: other various areas of painted CUM walls, in fair condition. Future tuckpointing and painting (or covering with metal panel.) should be considered.*

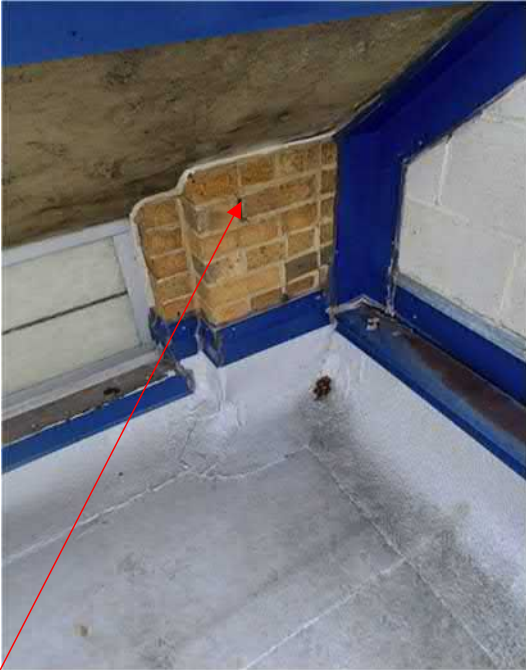
Figure 46: Various brick 'piers' with areas of broken and open mortar joints in need of repair and tuckpointing.

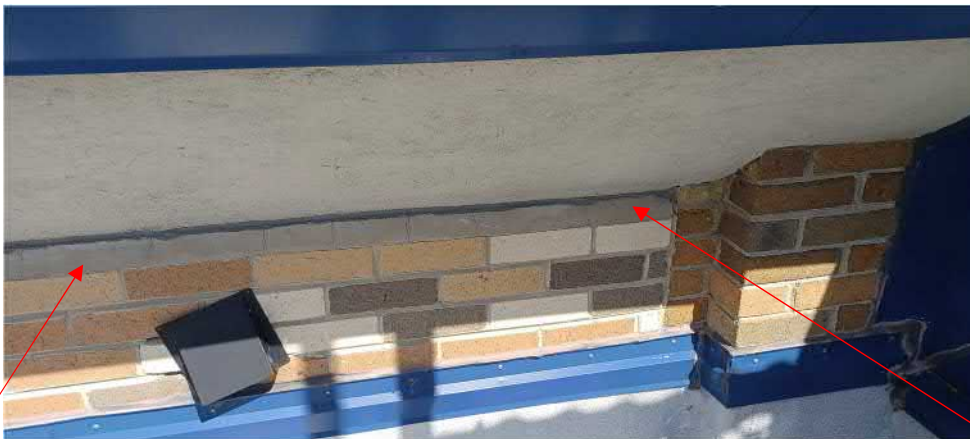
Figure 47: Cracked mortar requiring repair and or replacement. Tuckpoint all broken and open joints.

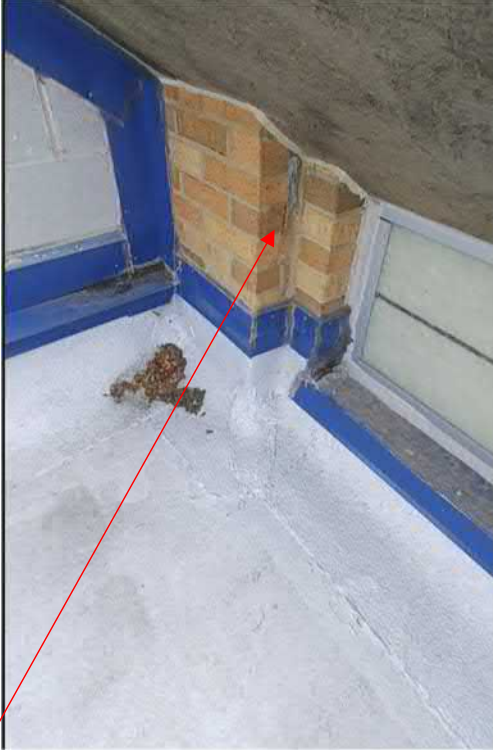
Figure 48: Cracked mortar requiring repair and or replacement.

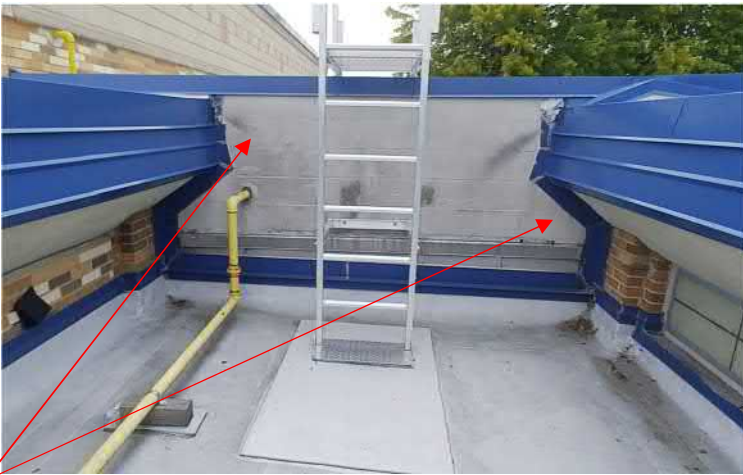
Figure 49: CMU in need of repair, tuckpointing and painting.

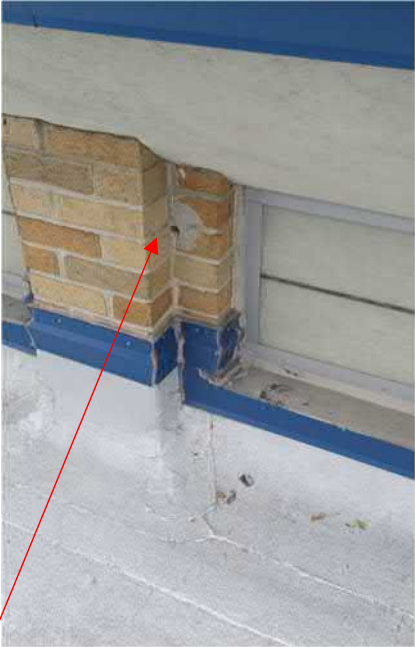
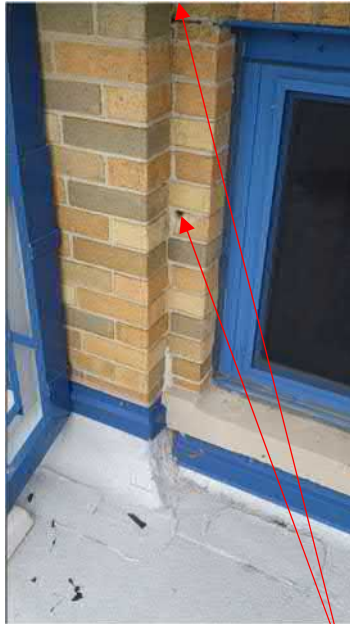
Figure 50: Cracked mortar, open joints requiring repair and or replacement.

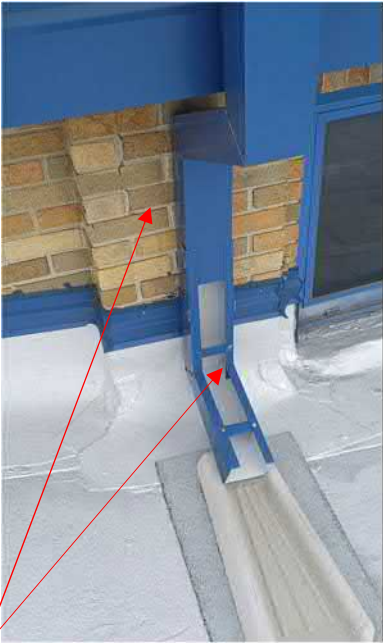
Figure 51: Broken brick and mortar in need of repair.
