**Soderstrom Architects**

Facilities Assessment Report  
Parkrose School District  
Multnomah County, Oregon

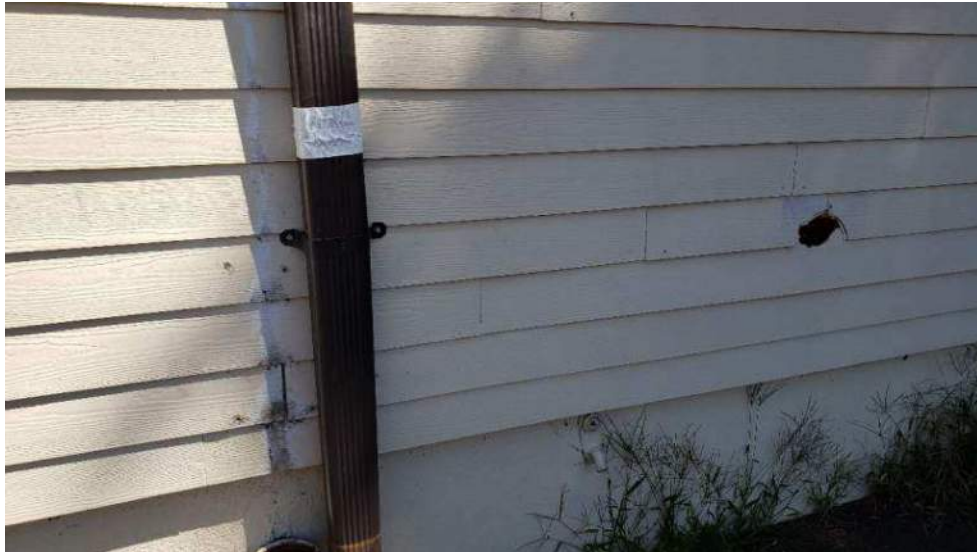
crawlspace. The roof structure is framed with trusses in the multipurpose room and conventional 2x wood framing in the remaining areas. Portions of the building has glass block, which lacks structural integrity and is considered a seismic falling hazard. The north side of the classroom wing consists of fiber cement siding, which has a large amount of damage. Although this damage is primarily cosmetic, it is possible that the compromised siding can cause structural damage in the form of rotting framing members, mold and rodent damage if left unmitigated.

**Figure 1: Damage to siding and downspout**

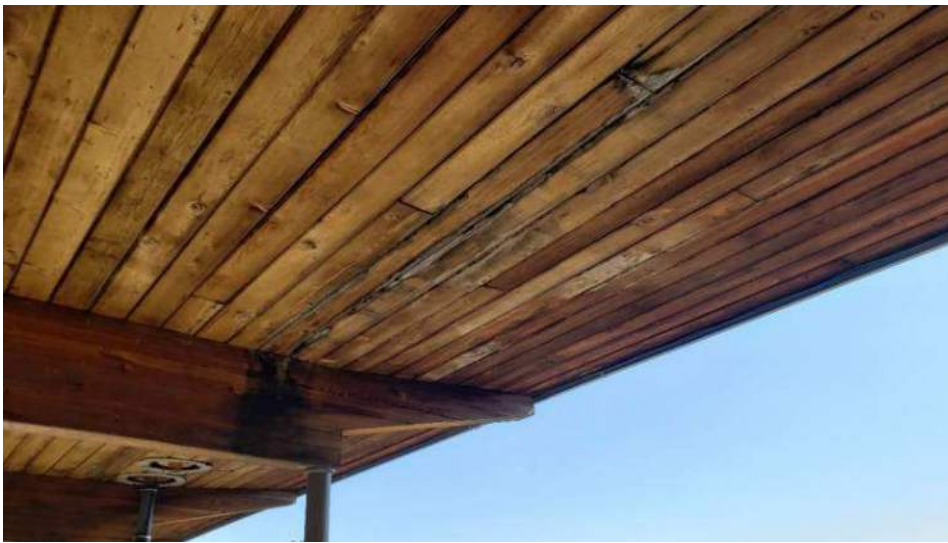
Russell Academy is located at 2700 NE 127<sup>th</sup> Ave. in Portland, Oregon and was constructed in 1963 with an approximate footprint of 47,000 square feet. The building is a single-story structure consisting of wood framed interior and exterior walls. The floor consists of concrete slab on grade, and the roof structure is framed with glulam beams and straight decking. Moisture damage to the exterior glulam beams and decking was observed at the exterior covered areas. Further investigation into the condition of these members and suggested treatment is recommended.

**Figure 2: Damage at covered walkway areas**

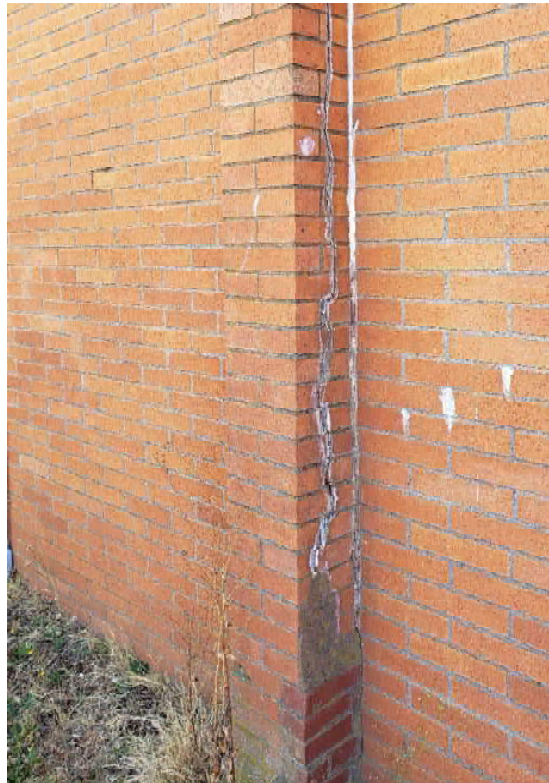
Damage and cracking is also apparent in brick veneer pilasters, which was reconstructed as part of the 1996 seismic upgrades. It is our recommendation to remove and reinstall the veneer at these locations.

**Figure 3: Damaged brick veneer**

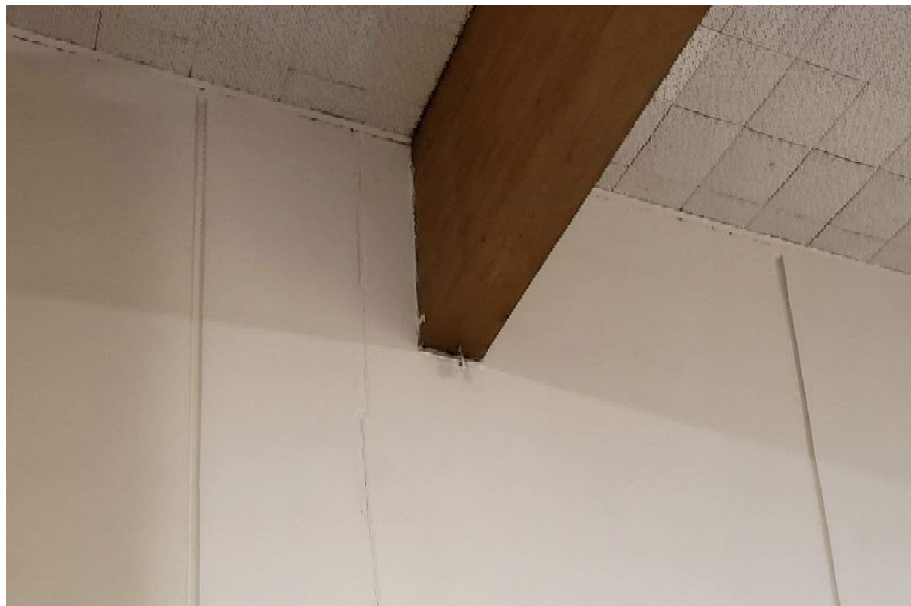
Sumner Elementary School is located at 8678 NE Sumner St. in Portland, Oregon. The original school building was constructed in 1954 with an approximate footprint of 42,900 square feet. The building is a single-story structure consisting of cast-in-place concrete exterior walls. The interior bearing walls consist of wood framed stud walls. The floor consists of concrete slab on grade, the roof framing consists of diagonal 1x sheathing supported by 2x wood framing. The multipurpose room has glulam roof beams supporting 2x rafters and 1x diagonal sheathing. Portions of the building has glass block, which lacks structural integrity and is considered a seismic falling hazard. The multipurpose roof has a large crack in the exterior concrete wall, which appears to have been repaired multiple times. The cause of this crack is not clear, but does not appear to pose significant risk to the building.

**Figure 4: Crack in exterior concrete wall**

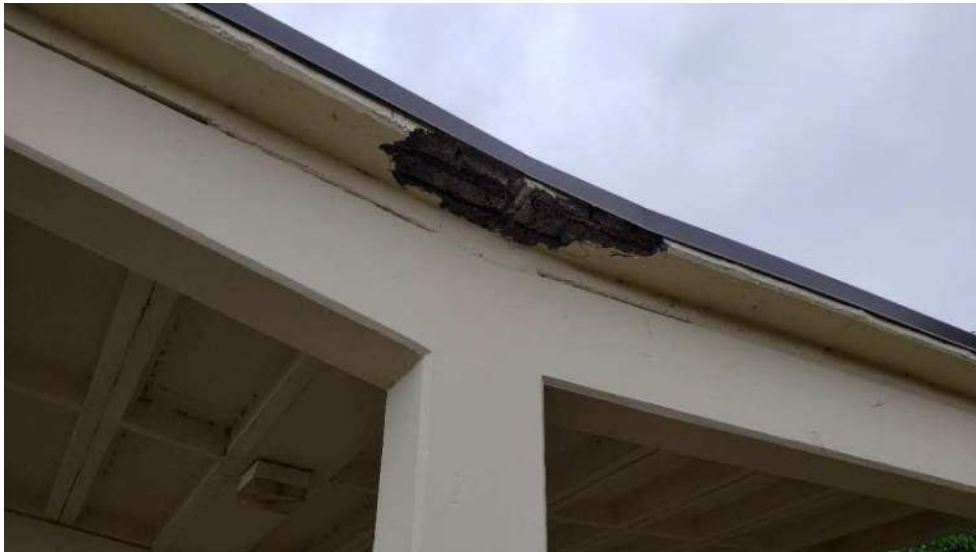
**Figure 5: Deteriorated concrete at front entry canopy**

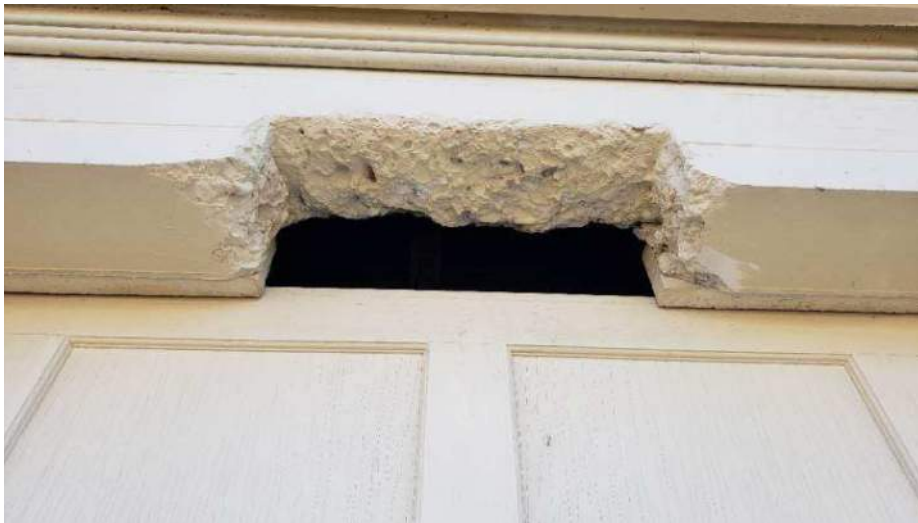
The 7,600 square foot maintenance facility buildings were constructed in 1955 and consist of cast-in-place concrete walls with wood rafted trusses and straight decking. Several garage door openings are located on the north side of the building, with sections of the concrete headers removed. It appears that existing rebar in the headers was cut to accommodate these notches in the headers. It is not clear that these headers are adequate to support the roof structure in their current state. Further investigation of these headers and possible strengthening is recommended.

**Figure 6: Damage to concrete headers**

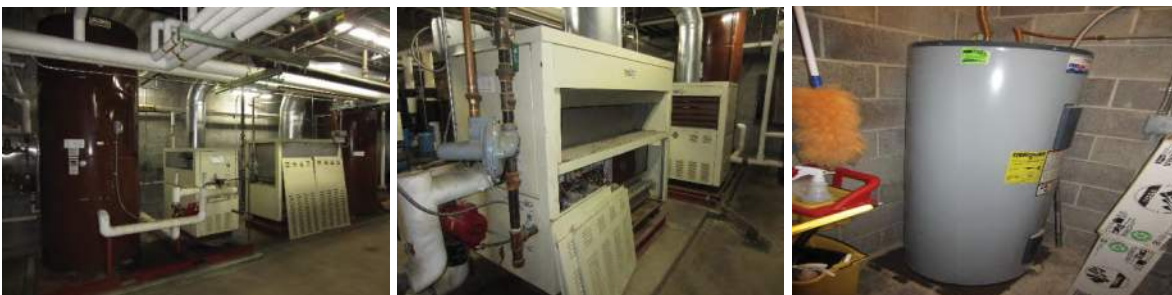
The stand-alone fine arts building has one 80-gallon tank type electric heater with 3.38 kW of heating capacity installed in 1998. It is recommended that unit be replaced.

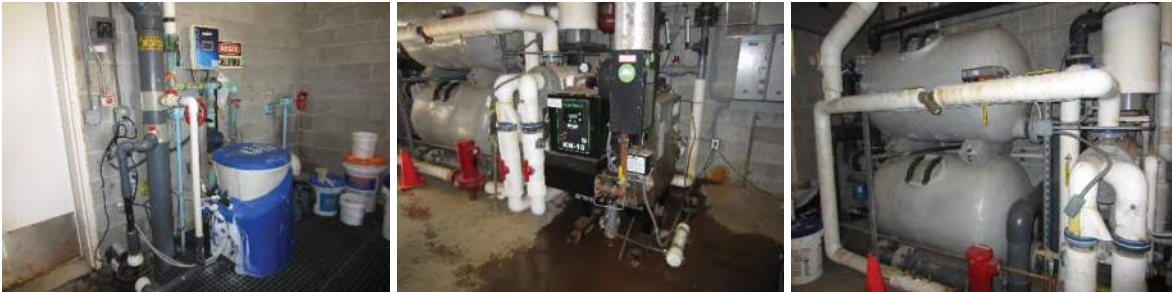
There is an indoor swimming pool that uses one HydroTherm gas-fired condensing boiler to heat pool water with an input heating capacity of 1.0 MMBTU. It was installed in the early 2010s. The school is looking at replacing this boiler with a new one due to corrosion of the heat exchanger.
