Geneva Community Unit School District #304  
Operations and Maintenance  
7 Year Capital Improvement Plan

January 11, 2016

## Introduction

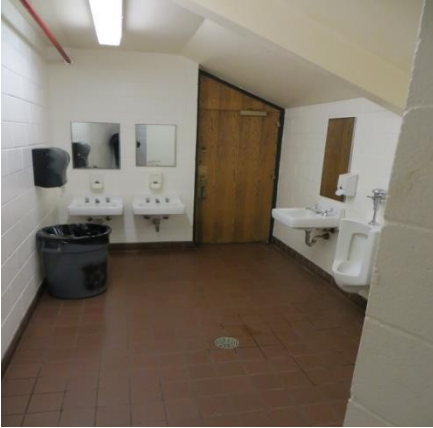
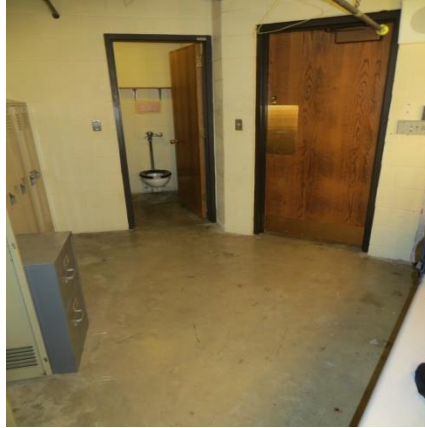
## Cafeteria and Stage Craft Bathrooms

Bathrooms are 41 years old.

Showing significant wear.

Need to update.

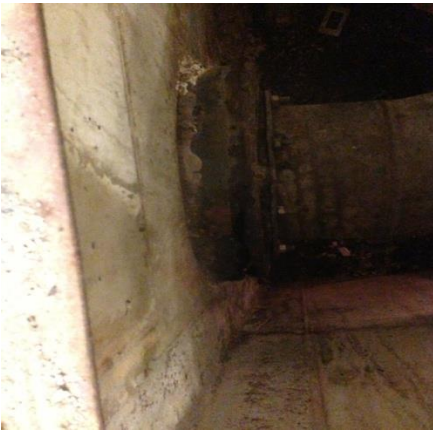
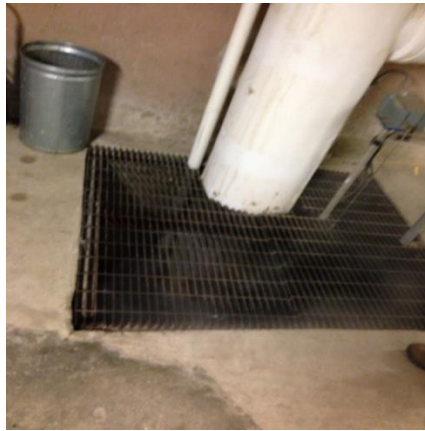
## Steam Pipe Replacement

Insulated jacket failing around steam pipe.

Will continue to deteriorate.

Significant safety hazard.

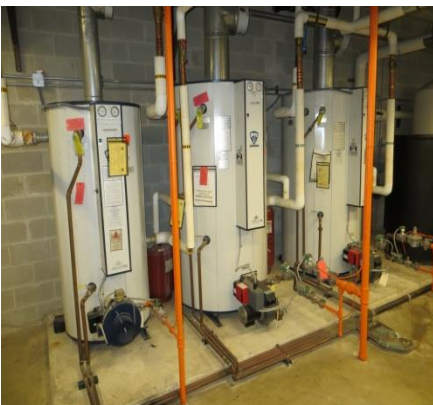
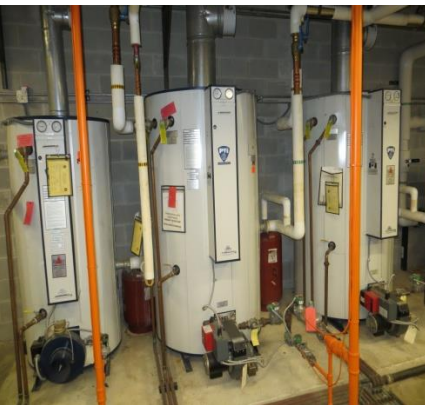
## Hot Water Heaters

The three 600 gallon PVI water heaters are nearing the end of their life cycle.

Replacement will be needed within the next seven years.

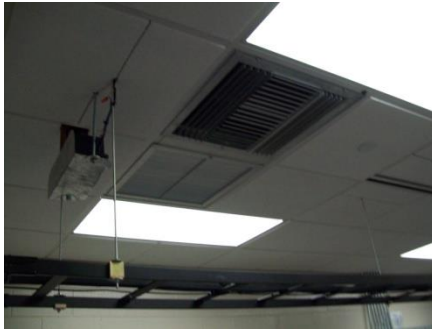
## LMC

AHU is undersized for space.

Only 2 VAV boxes serving the space.

Recommend increasing the capacity of the AHU and adding 4-6 VAV boxes with controls to increase comfort and control humidity.

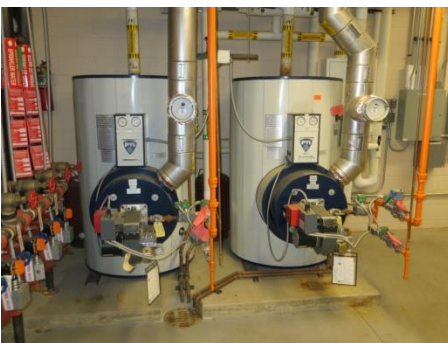
## Hot Water Heaters

The two 300 gallon PVI water heaters are nearing the end of their life cycle.

Replacement will be needed within the next seven years.

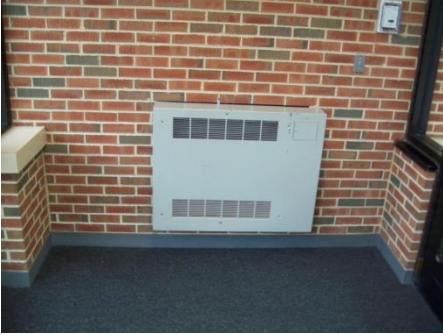
## **Cabinet Unit Heaters**

15 units are over 35 years old.

Replace with energy efficient units.

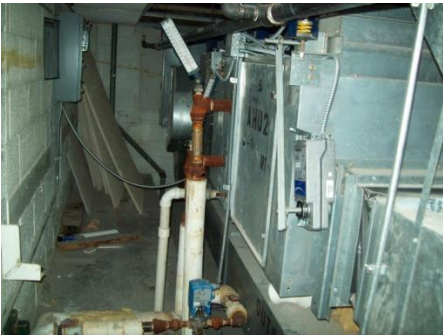
## **Air Handling Unit**

Needs rebuilding or possible replacement.

New motor, shaft, bearings and controls needed.

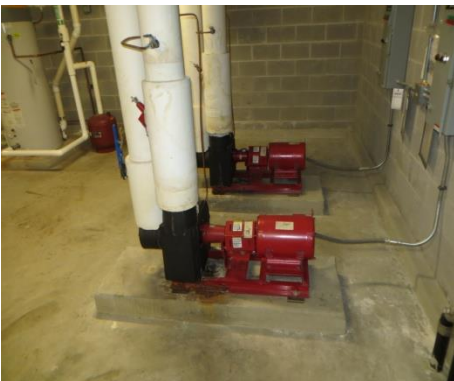
## **Boiler Pumps**

Pumps nearing end of life cycle.

Need to replace with energy efficient design and variable frequency drives for increased energy efficiency.

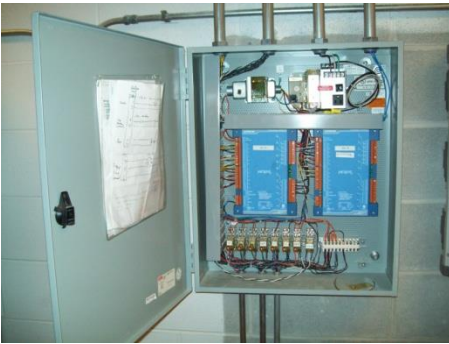
## Lon Controller

Lon controls throughout the building.

Outdated and costly to repair.

Replace Lon to Bacnet.

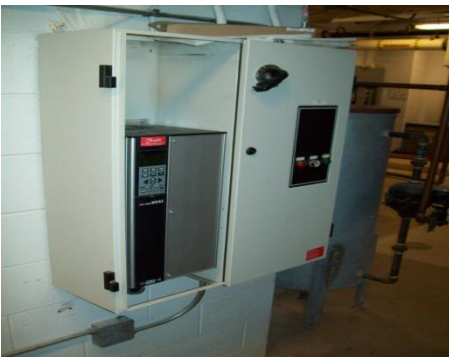
## Variable Frequency Drive (VFD)

VFDs have started failing this year.

All units need replacing.

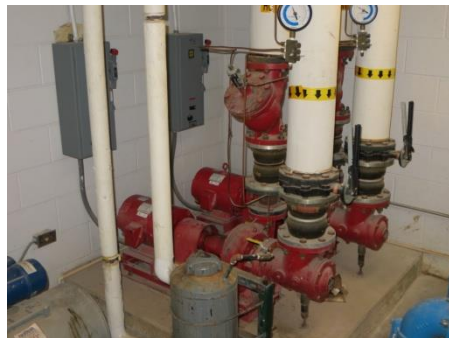
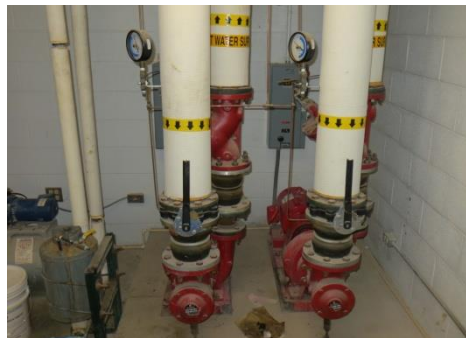
## Primary and Secondary Boiler Pumps

Original to the building.

Need replacing with energy efficient design and variable frequency drives for increased energy efficiency.

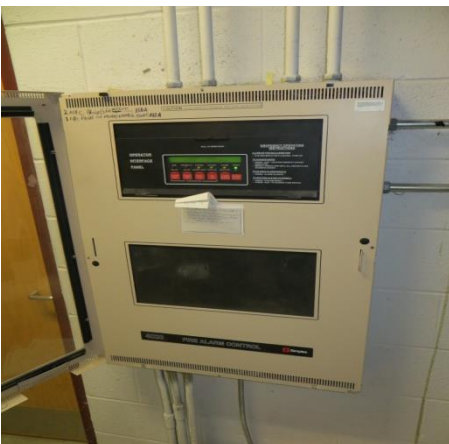
## Fire Alarm System

Simplex fire alarm system needs to be updated.

Escalating repair costs and consistent breakdowns.

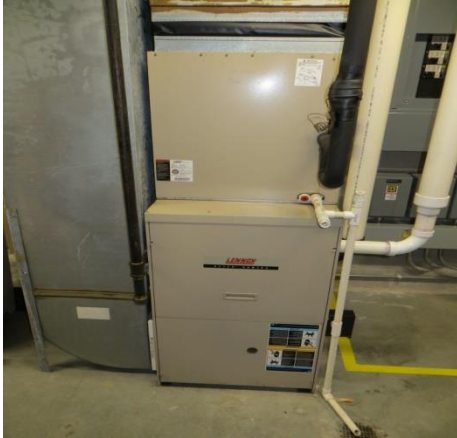
## HVAC Split System

The 3 Lennox split systems are nearing their ASHRAE recommended service life.

Replacement will be needed within the next seven years.

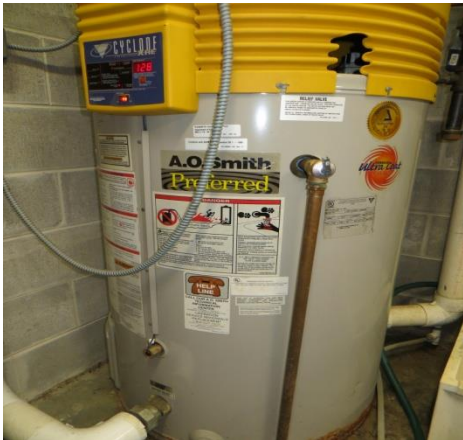
## Hot Water Heater

The 60 gallon A.O Smith water heater is nearing the end of its life cycle.

Replacement will be needed within the next two to five years.
