Re: Bleacher Inspection for Pana CUSD #8
BLDD Project No.: 151EF27.200

BLDD Architects, Inc. conducted an inspection of the Pana High School and Junior High School indoor and outdoor bleachers. The following information is based on the conditions at the time of the inspection and is subject to change. This Bleacher Inspection includes the inspection of all indoor and outdoor bleachers, the operation of the indoor telescoping bleachers (from stored to fully extended), checking the condition of the substructure (angle iron, fasteners and attachments, rollers and operators), the condition of the seat boards, foot boards, supports, connections, handrails and steps. The result of the inspection is as follows:

Pana High School Football Field Bleachers

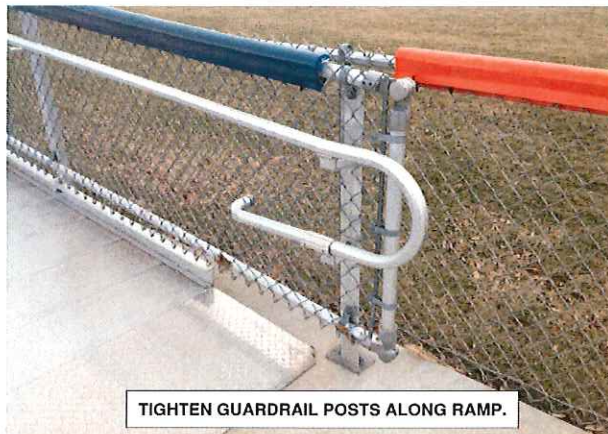
IMAGE A-5
DATE: 02/04/16
Football Field - Home Bleacher

- a. The west railing at the bottom of the ramp is loose. Tighten railing to prevent movement (Image A-5).
 - b. The gap between the top of the ramp and the walkway is excessive. It is recommended that the ramp be adjusted to fit tight against the bleacher or a metal closure strip be installed to eliminate the gap (Image A-6).

TIGHTEN GUARDRAIL POSTS ALONG RAMP.

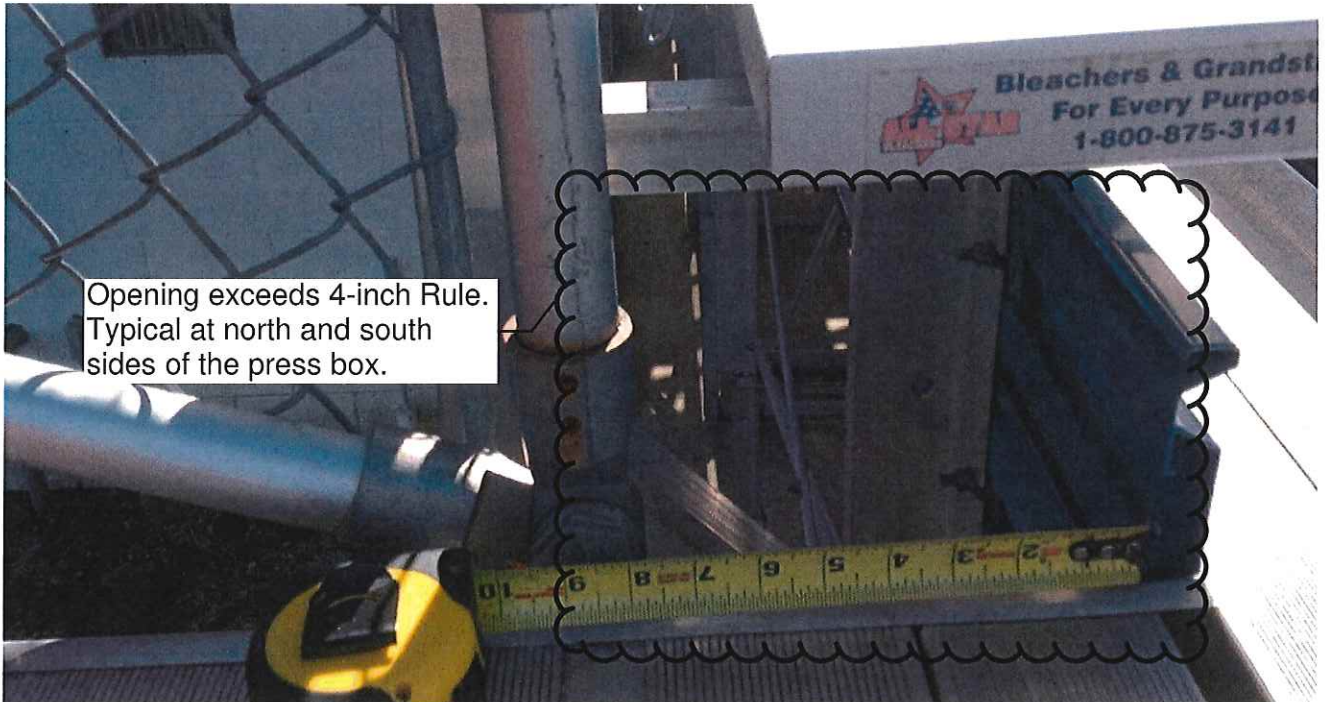
IMAGE A-7
DATE: 02/04/16
Football Field - Home Bleacher

- c. There is a loose walkway foot-board in the main walkway in front of the north wheel chair seating area.
 - d. There are two openings, one near the north end of the press box and the other near the south end of the press box that exceed the 4" Rule " *any opening that is located more than 30" above grade, shall be provided with intermediate construction such that a 4-inch diameter sphere cannot pass*" (See Images A-7- A-9).

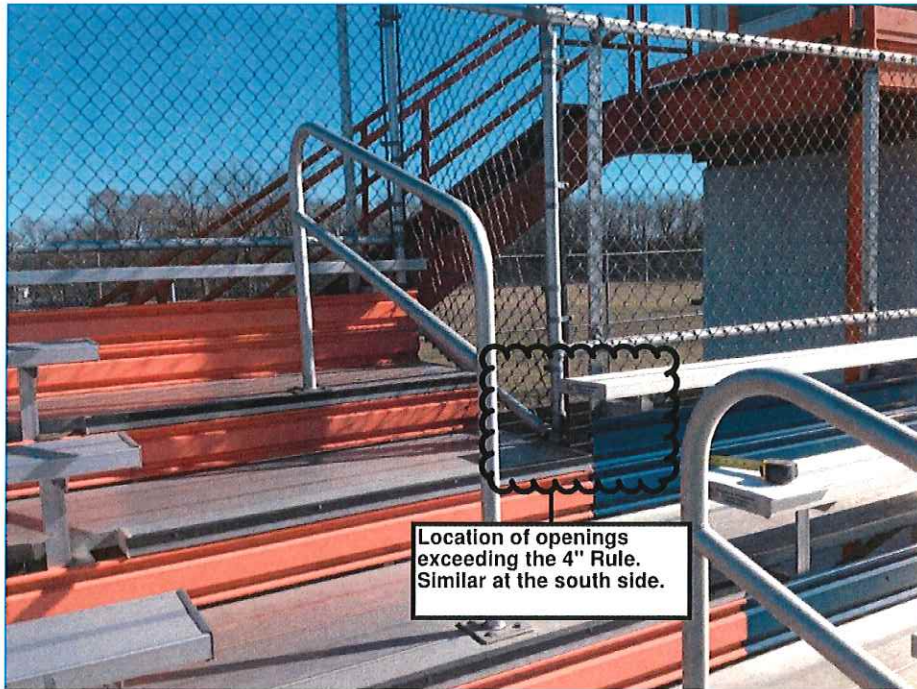
IMAGE A-9
DATE: 02/04/16
Football Field - Home Bleacher

Location of openings
exceeding the 4" Rule.
Similar at the south side.

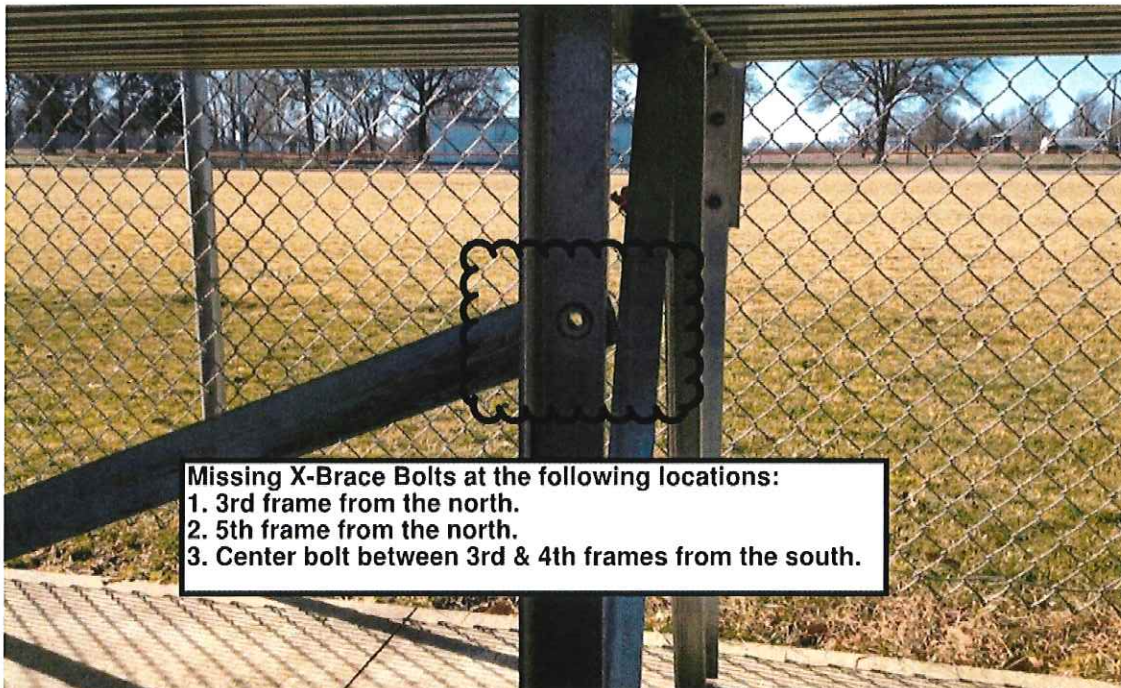
IMAGE A-10
DATE: 02/04/16
Football Field - Home Bleacher

Missing X-Brace Bolts at the following locations:
1. 3rd frame from the north.
2. 5th frame from the north.
3. Center bolt between 3rd & 4th frames from the south.

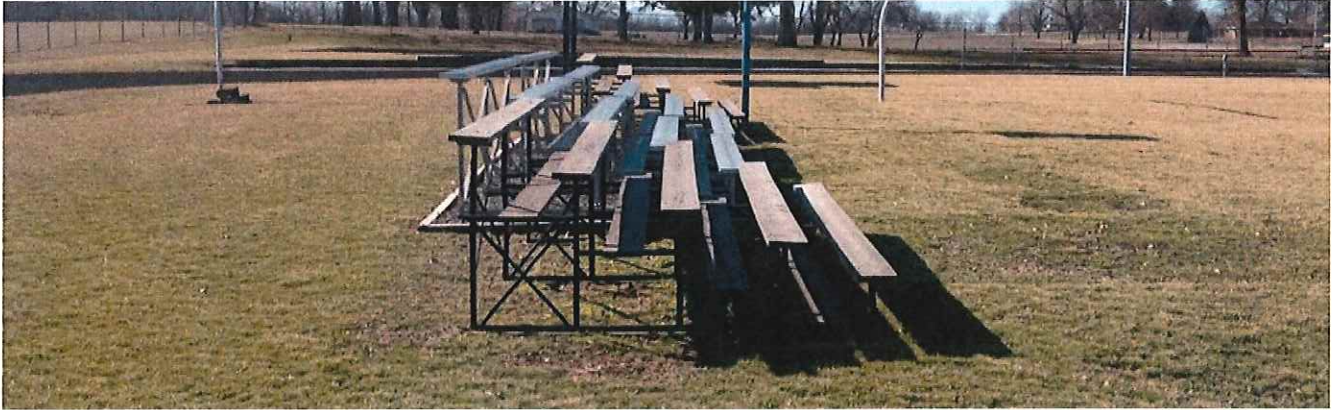
IMAGE A-28
DATE: 02/04/16
Football Field - South Bleacher

- a. Addition of intermediate supports to the wood seats and foot boards is recommended.
 - b. The two sets of aluminum bleachers are sitting tight together, but are not level or even with each other resulting in a potential trip hazard transitioning from one set to the other. (Image A28).

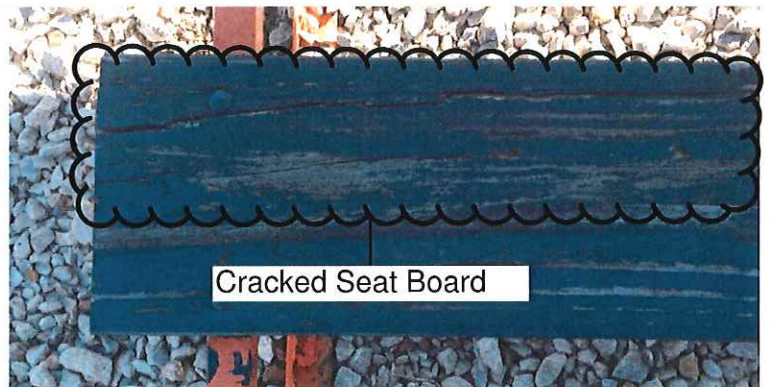
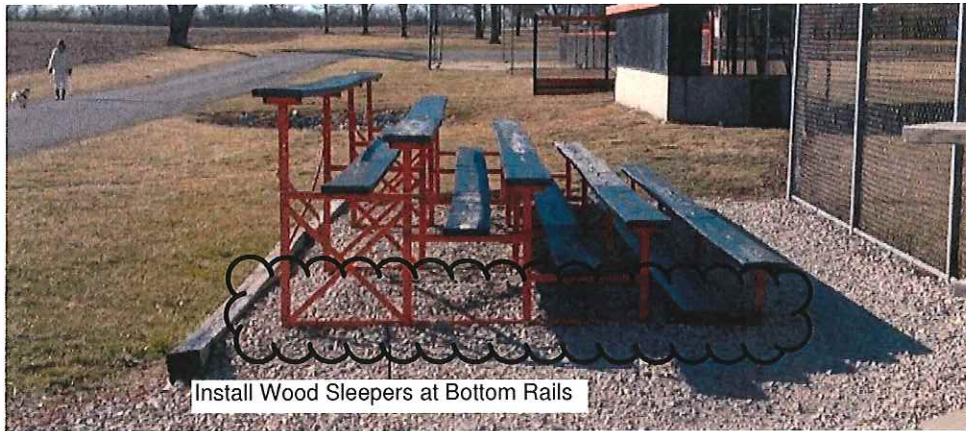
IMAGE A-34

1. The baseball field bleachers consist of Three (3) fixed, 5-row steel frame bleachers, with wood seats and wood foot boards. (Images A30- A36).
 - a. The first base line bleachers are out of level. Re-set bleachers to level.
 - b. Replace any cracked or damaged wood seats or foot boards.
 - c. The addition of intermediate supports to the wood seats and foot boards is recommended.
 - d. The third base line bleachers are sitting directly on grade with no wood sleepers, and the bottom rails have become partially submerged. Install wood sleepers.

Install Wood Sleepers at Bottom Rails

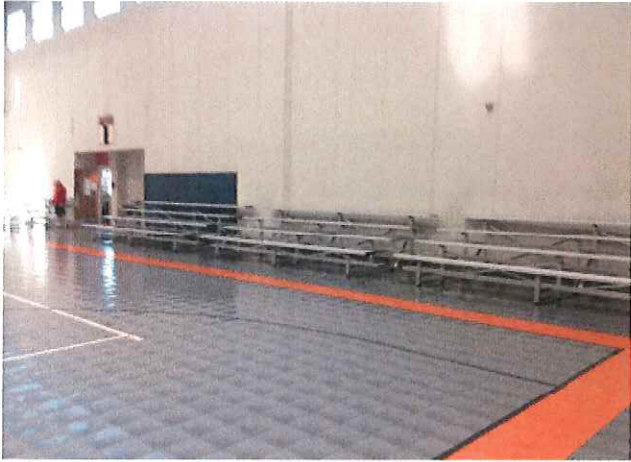
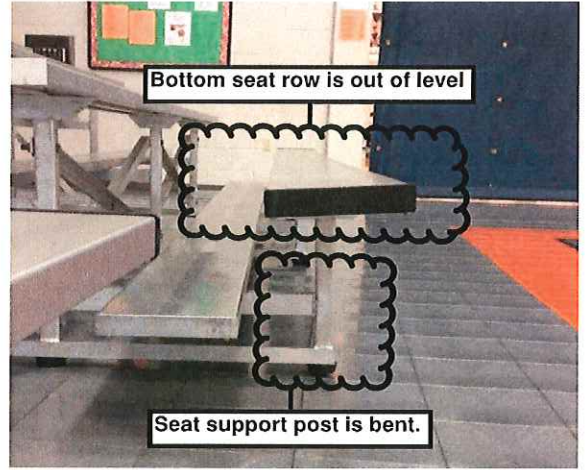
IMAGE A-40
DATE: 02/04/16

1. The High School practice Gym has five (5) fixed bleachers. They consist of one (1) section, four (4) rows high. (Images 39-41).
 - a. Two of the portable bleachers have bent posts at the bottom seat row, resulting in un-level seats at the bottom row. (Image-40)
 - b. Replace all bent / damaged seat board end caps. (Image-41).

Bottom seat row is out of level

Seat support post is bent.

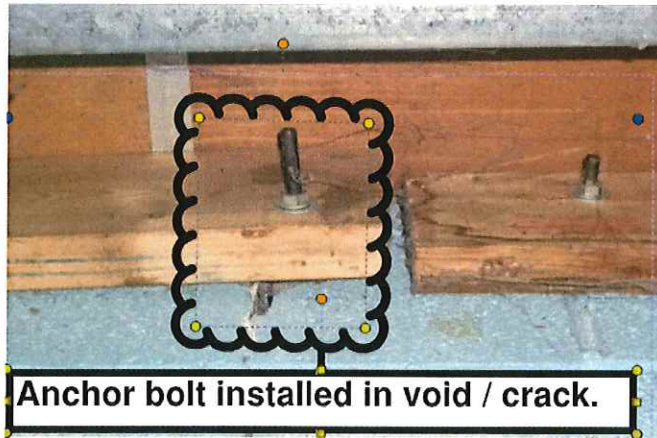
IMAGE A-44
DATE: 02/04/16

- a. One Anchor bolt at the upper support / attachment to the masonry wall is installed in a void / crack in the block wall. The anchor should be relocated to provide positive anchorage and support of the bleacher structure. (Image A-44)
- b. Tighten loose guardrail bolt at south end 3rd guardrail section up from the bottom.
