## Amphi High 500 Wing Structural Crack

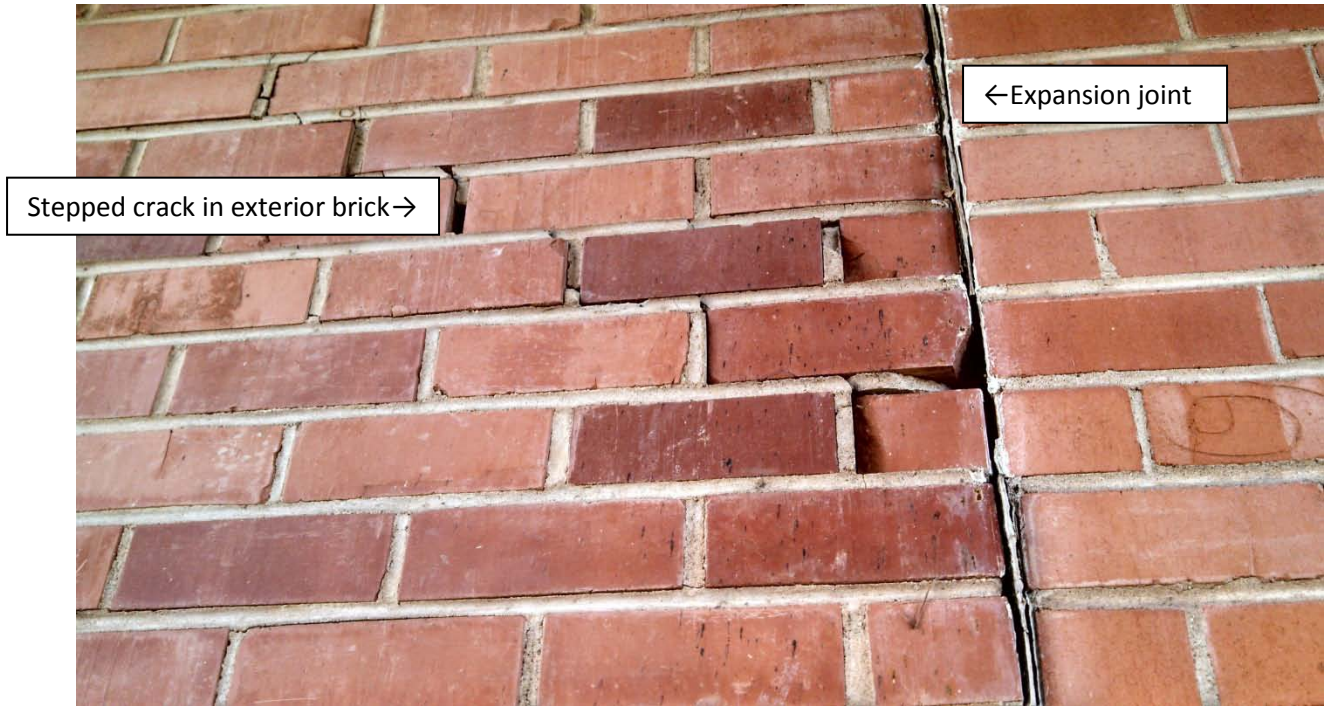
Exterior view (facing south) of the north wall approximately 10' above finish grade. Vertical expansion joint is where an older building (left) was joined to a newer building (right).

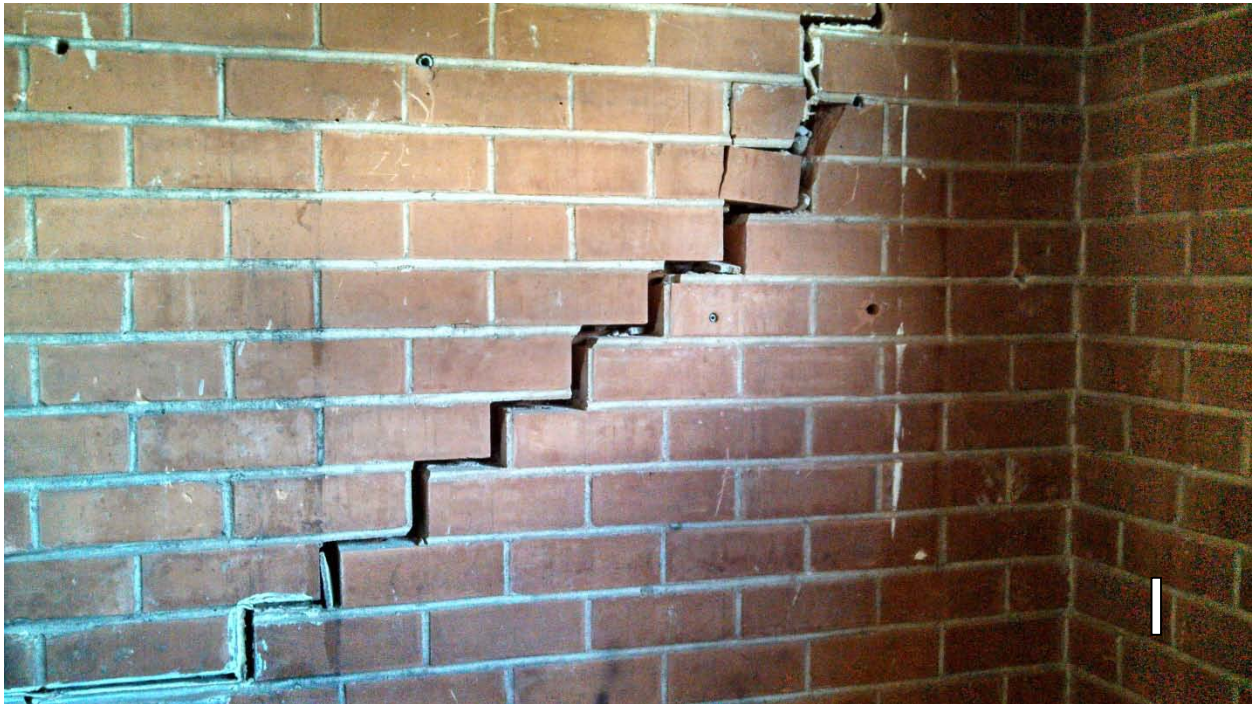
Interior view of the east wall

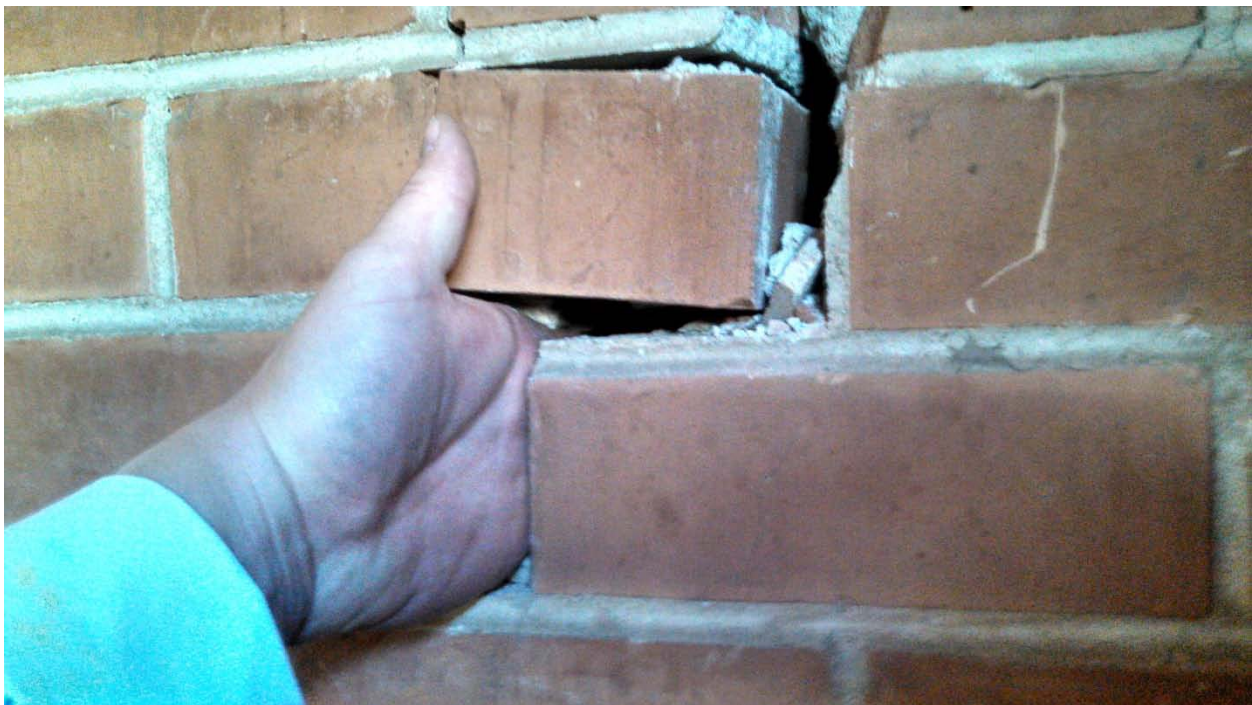
Interior view of the east wall. The brick is not removable by hand. Put hand in crack to show the width of the crack.

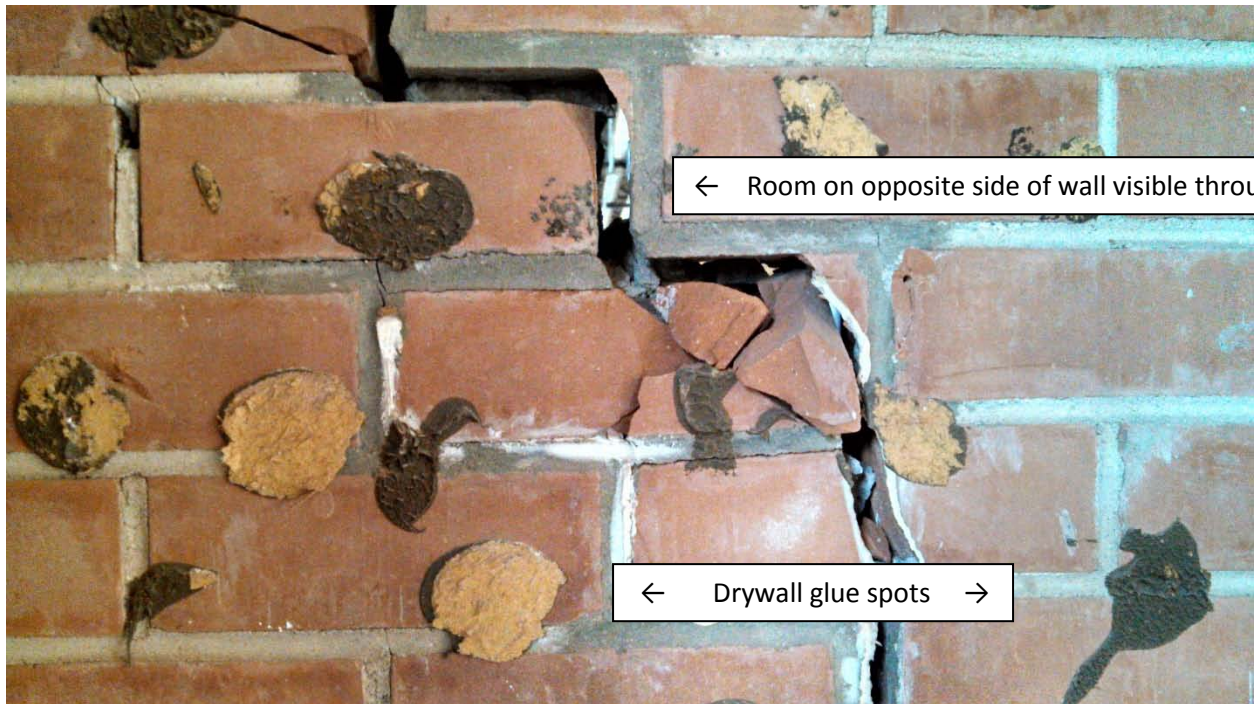
Interior view of the west wall. Black and tan colored spots are glue from drywall that used to be on the wall concealing the crack. The room on the opposite side of the wall is visible through the crack.

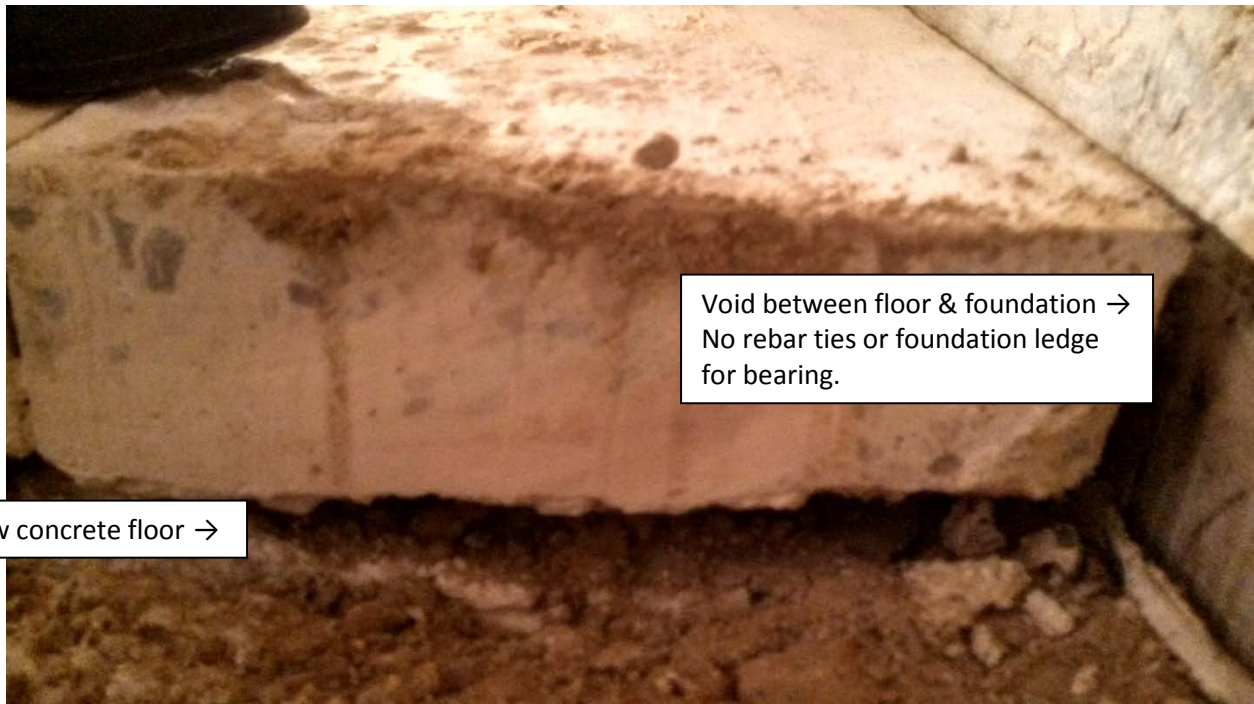
Cross section of the concrete floor (floor was cut and removed to show this view). Picture reveals a 1" void below the floor and between the floor and the foundation.
