**Geneva Community Unit School District #304  
Operations and Maintenance  
7 Year Capital Improvement Plan**

## **Board of Education Meeting**

**January 25, 2016**

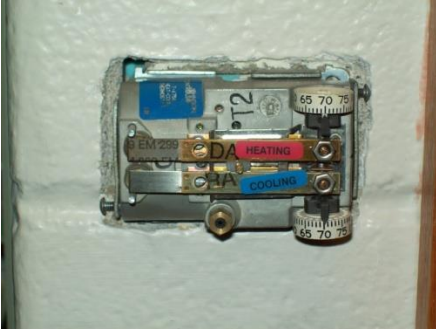
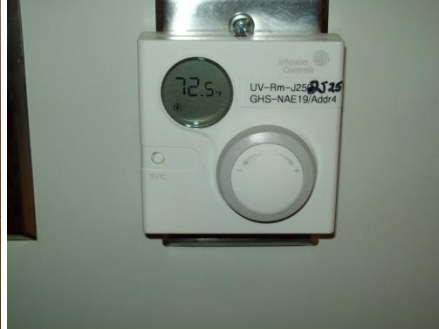
## Controls

Pneumatic to Digital conversion allowing for tighter control of temperature, setback and alarming features.

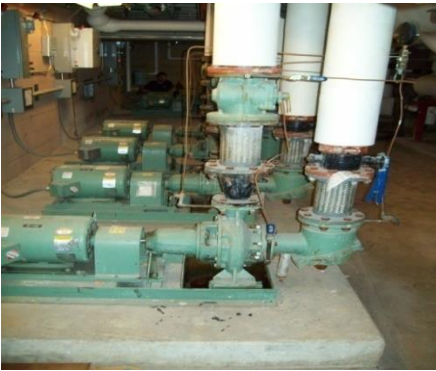
## Secondary Pumps (6)

Replace pumps that are nearing the end of their life cycle.

Variable Frequency Drives will greatly increase energy efficiency and lengthen the life of the pumps.

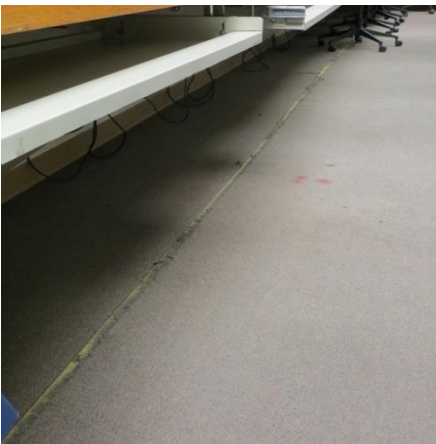
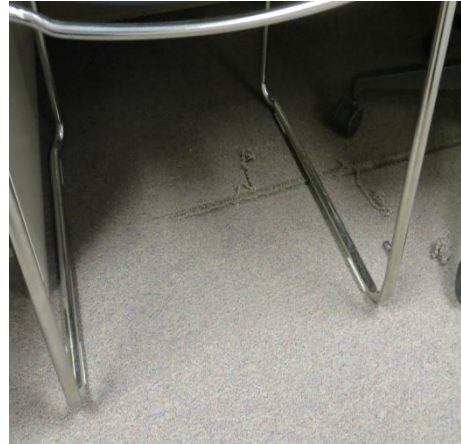
## Carpet

The carpet is starting to fray and cause trip hazards.

Carpet will need to be replaced.

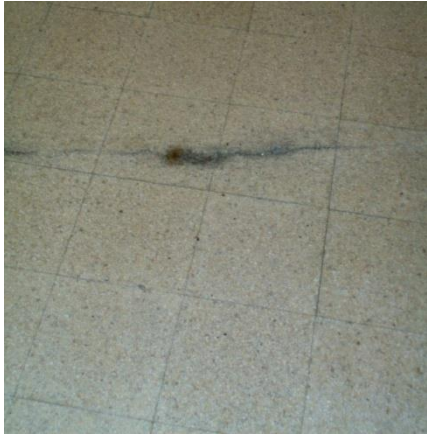
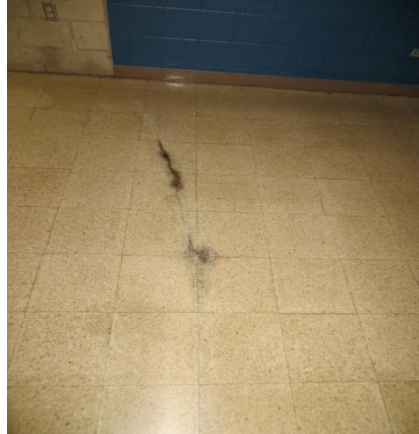
## Flooring

Existing quartz tile is cracking and has faded.

Replace tile in phases.

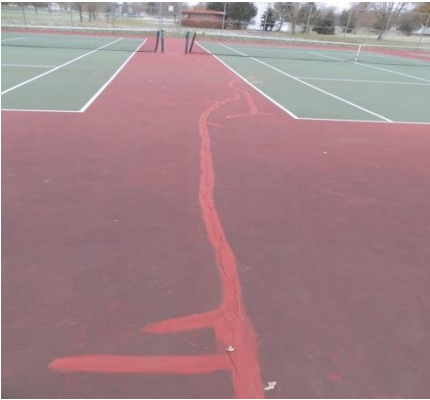
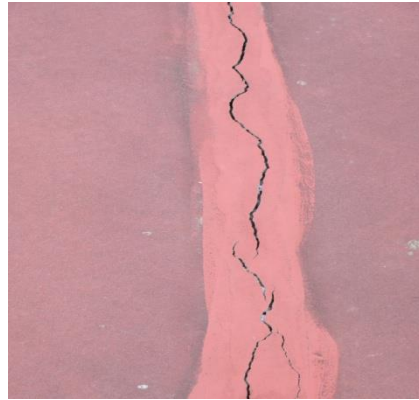
## Tennis Court Resurface

Cracks and patches throughout courts.

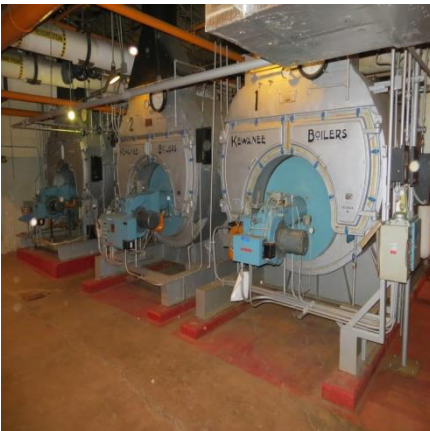
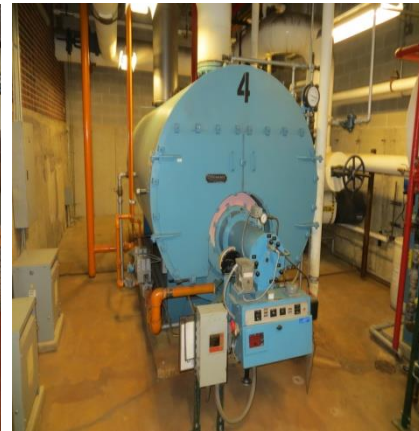
## Boiler Replacement

Breakdowns and repairs are becoming more frequent and costly.

Replace steam boilers with hot water boilers for energy efficiency.

Locate new boilers from boiler house to high school.

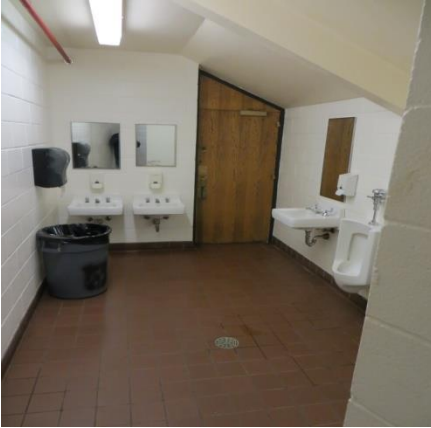
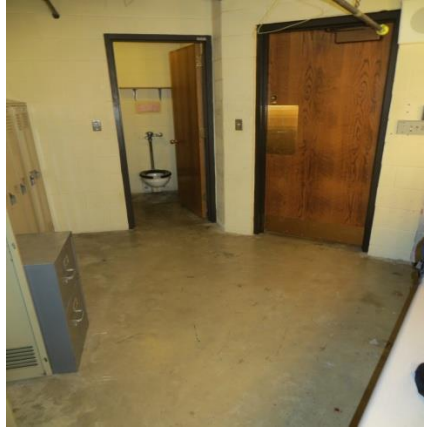
## Cafeteria and Stage Craft Bathrooms

Bathrooms are 41 years old.

Showing significant wear.

Need to update.

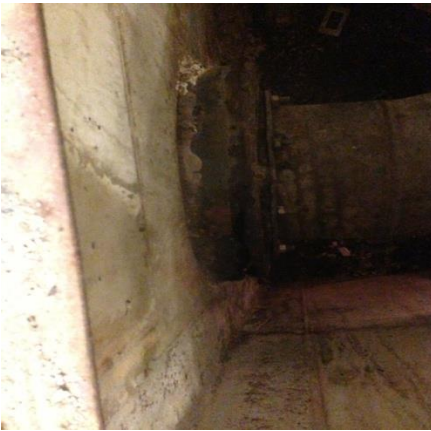
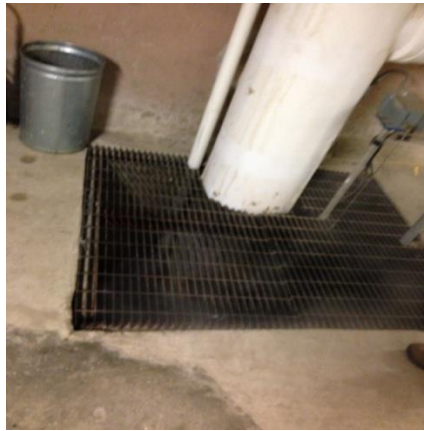
## Steam Pipe Replacement

Insulated jacket failing around steam pipe.

Will continue to deteriorate.

Significant safety hazard.

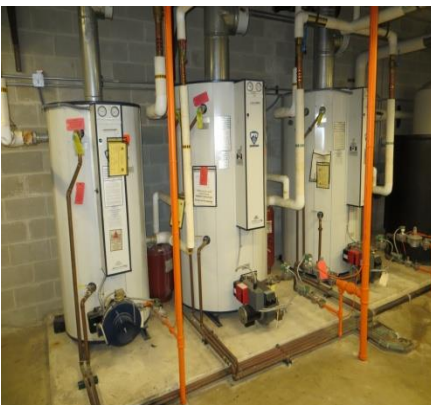
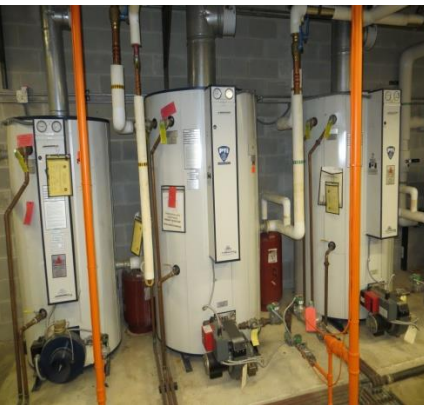
## Hot Water Heaters

The three 600 gallon PVI water heaters are nearing the end of their life cycle.

Replacement will be needed within the next seven years.

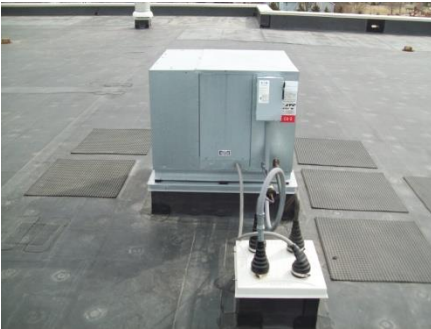
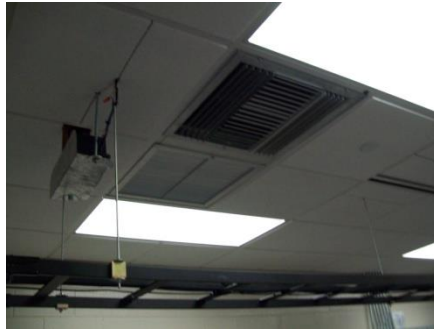
## IT Server A/C

Oversized for heat load of space.

Cycles on and off continually causing condensation issues and premature equipment failure.

Replace with properly sized unit.

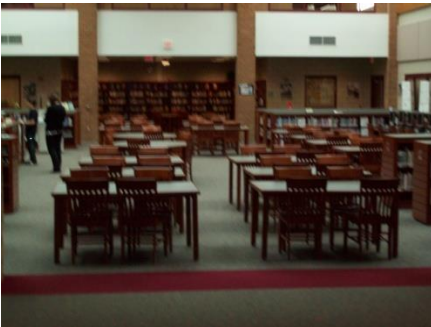
## LMC

AHU is undersized for space.

Only 2 VAV boxes serving the space.

Recommend increasing the capacity of the AHU and adding 4-6 VAV boxes with controls to increase comfort and control humidity.

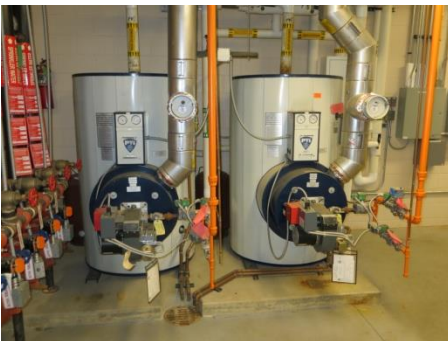
## Hot Water Heaters

The two 300 gallon PVI water heaters are nearing the end of their life cycle.

Replacement will be needed within the next seven years.

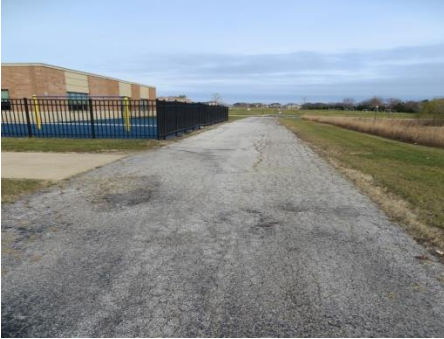
### **Fire Lane**

Pavement starting to show excessive cracking and breakdown.

Will need to be resurfaced.

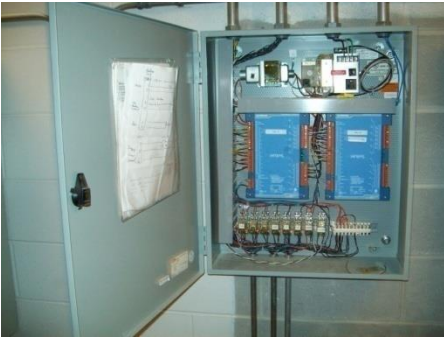
### **Lon Controller**

Lon controls throughout the building.

Outdated and costly to repair.

Replace Lon to Bacnet.

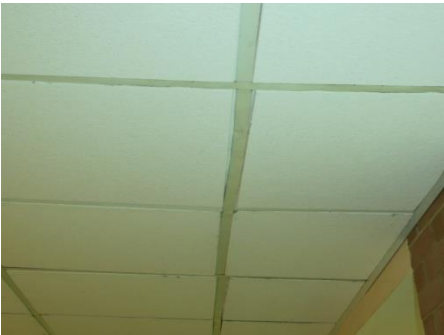
### **Ceiling Tile**

Ceiling grid and tile are starting to show excessive discoloration and wear.

Replace ceiling grid and tile.

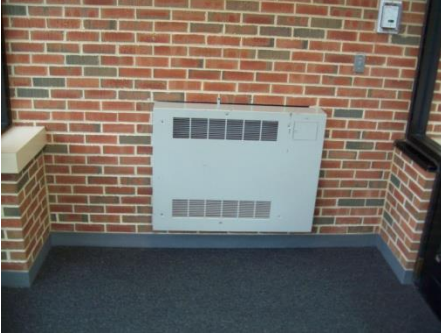
## **Cabinet Unit Heaters**

15 units are over 35 years old.

Replace with energy efficient units.

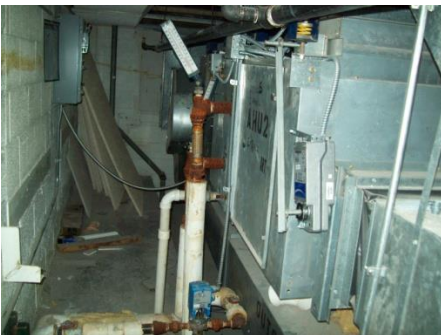
## **Air Handling Unit**

Needs rebuilding or possible replacement.

New motor, shaft, bearings and controls needed.

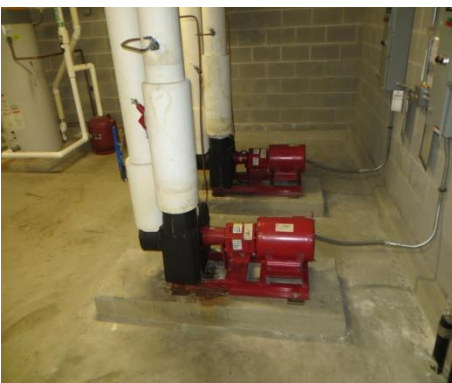
## **Boiler Pumps**

Pumps nearing end of life cycle.

Need to replace with energy efficient design and variable frequency drives for increased energy efficiency.

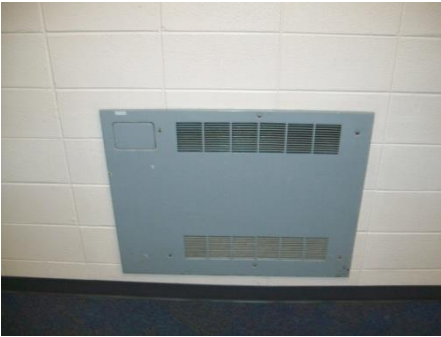
## Cabinet Unit Heaters

9 units are over 20 years old.

Replace with energy efficient units.

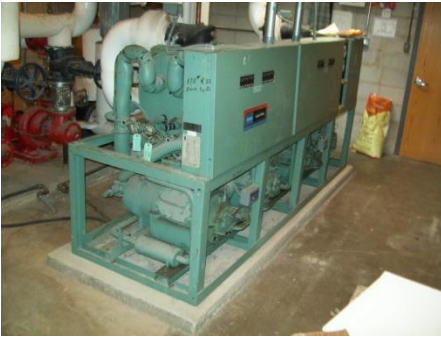
## Chiller

27 year old chiller is inefficient and repairs are becoming more frequent.

Replace with new efficient chiller.

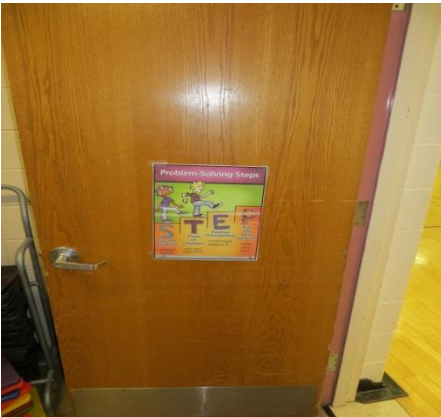
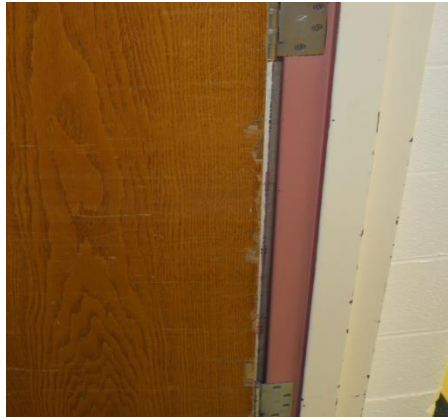
## Interior Doors

Several doors in the building are damaged and in need of replacement.

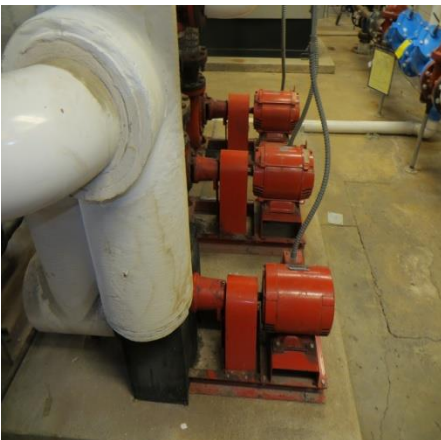
## Chilled Water and Boiler Secondary Pumps

Pumps nearing end of life cycle.

Need to replace with energy efficient design and variable frequency drives for increased energy efficiency.

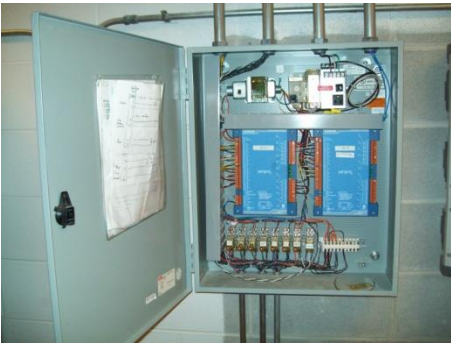
## **Lon Controller**

Lon controls throughout the building.

Outdated and costly to repair.

Replace Lon to Bacnet.

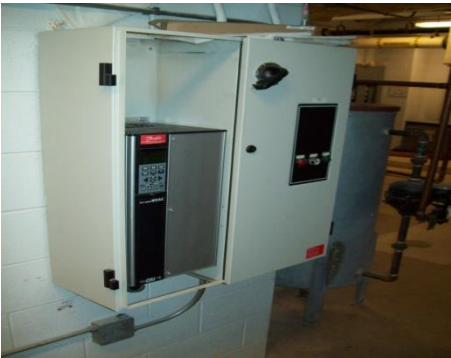
## **Variable Frequency Drive (VFD)**

VFDs have started failing this year.

All units need replacing.

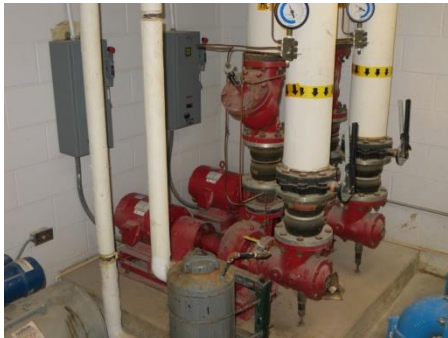
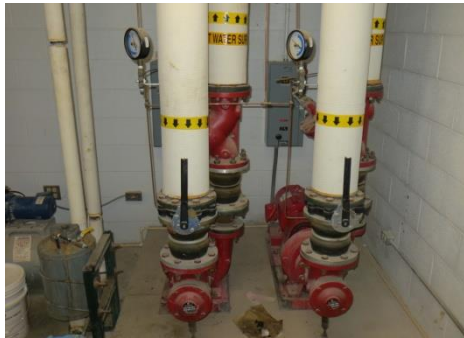
## **Primary and Secondary Boiler Pumps**

Original to the building.

Need replacing with energy efficient design and variable frequency drives for increased energy efficiency.

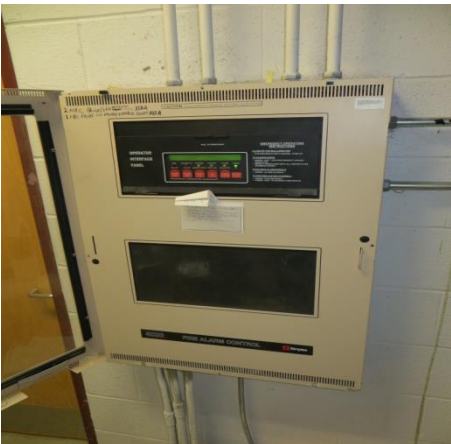
## **Fire Alarm System**

Simplex fire alarm system needs to be updated.

Escalating repair costs and consistent breakdowns.

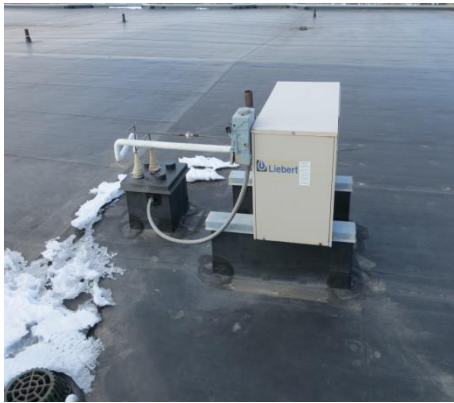
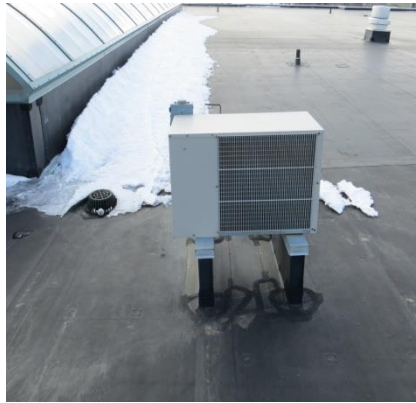
## **Air Handling Unit**

Air handling unit is nearing the end of its life cycle.

Will need to be replaced in the next two to four years.

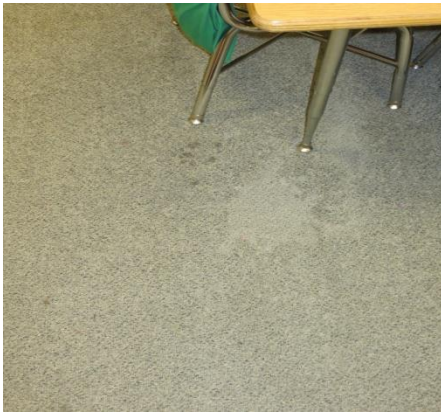
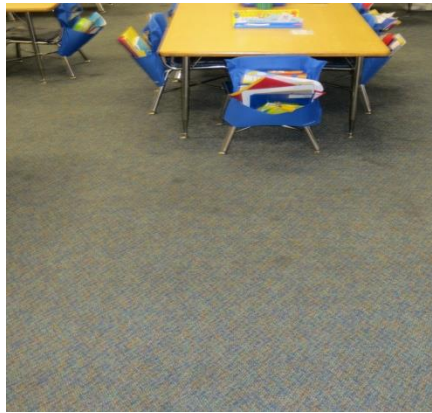
## **Carpet Replacement**

Carpet is starting to show wear and staining that we are unable to remove.

Life cycle of carpet is 12-20 years.

Carpet will need to be replaced.

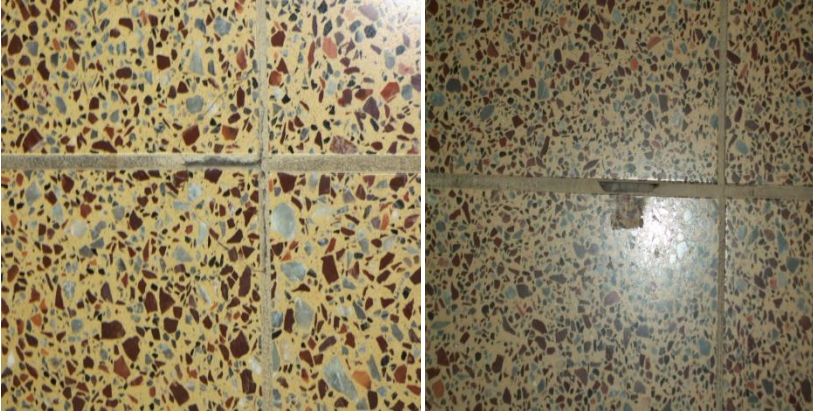
### Floor Tile

Terrazzo tile repair/replacement.

Tile did not properly bond to the floor and is cracking.

Final phase of replacing all ground floor tile will begin the summer of 2016.

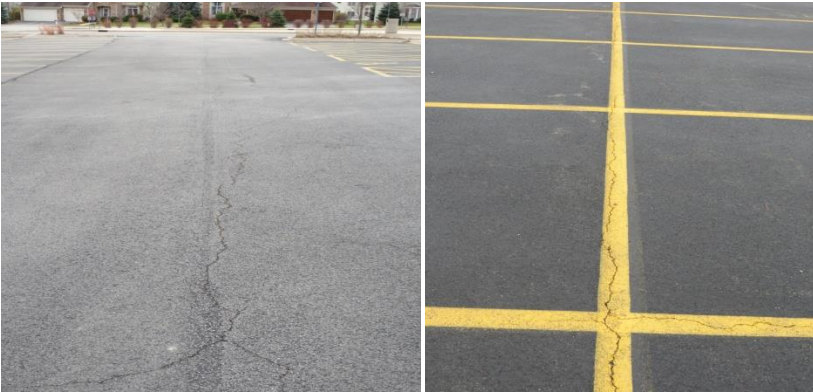
### Parking Lot

Several areas are starting to show cracking.

Crack filling and seal coating will be needed in the next two to three years to extend the life of the pavement.

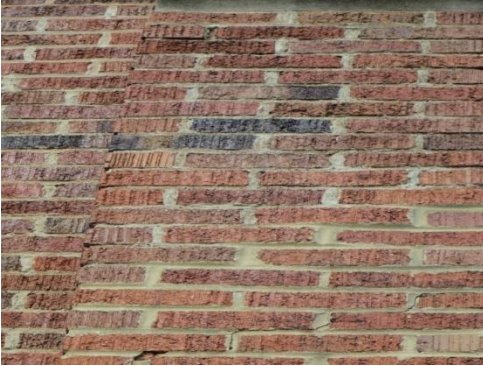
## **Tuck-pointing**

Mortar joints are cracking and will need to be repaired.

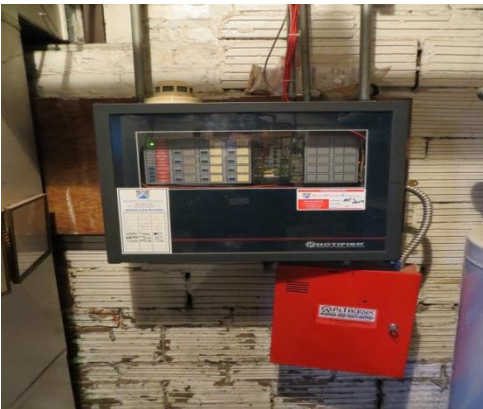
## **Fire Alarm System**

Notifier 5000 fire alarm panel will need to be updated to meet current NFPA code requirements.

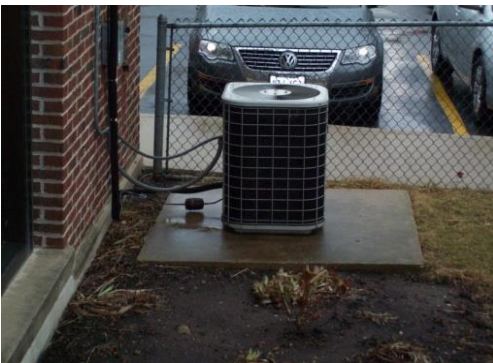
## **Fan Coil Condensing Unit**

The entire building is cooled with fan coil units.

Several are beginning to fail and most will need to be replaced in the next two to seven years.

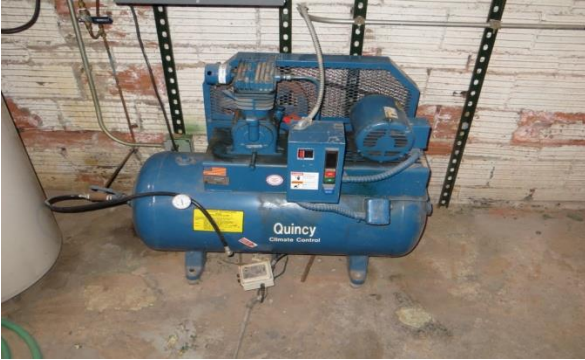
### Air Compressor

Twenty years old and needs to be replaced.

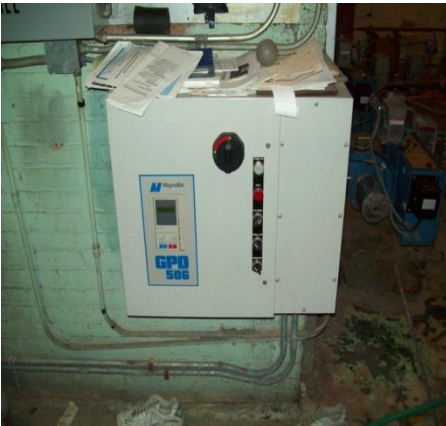
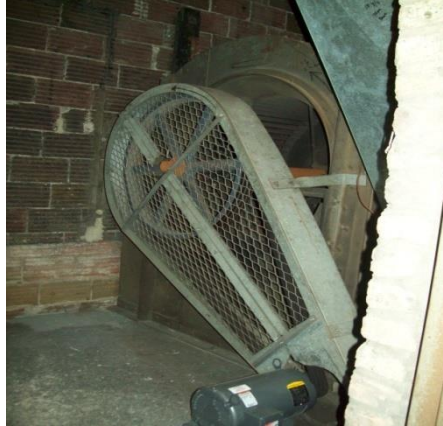
### VFD and Fan for the Furnace

VFD doesn't work and the fan for the furnace is at least 37 years old.

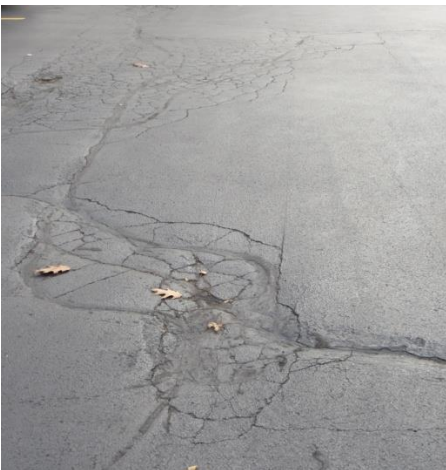
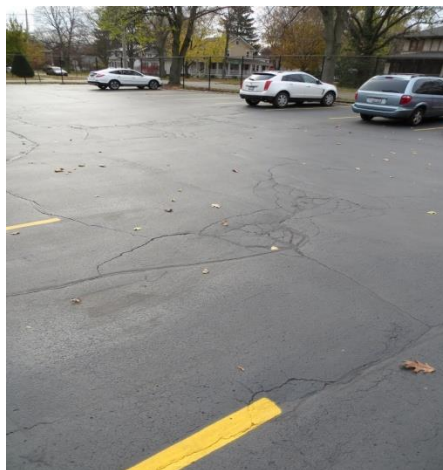
### Parking lot

Several areas with extreme cracking.  
Resurfacing will be needed.

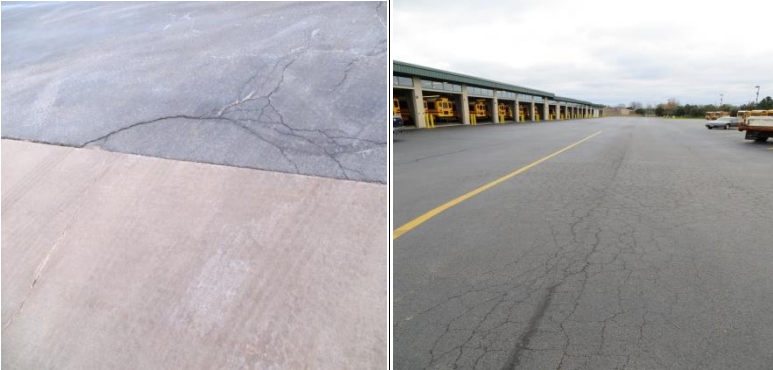
## Parking Lot

Pavement starting to crack and breakdown.

Resurfacing will be needed in the next two to three years.

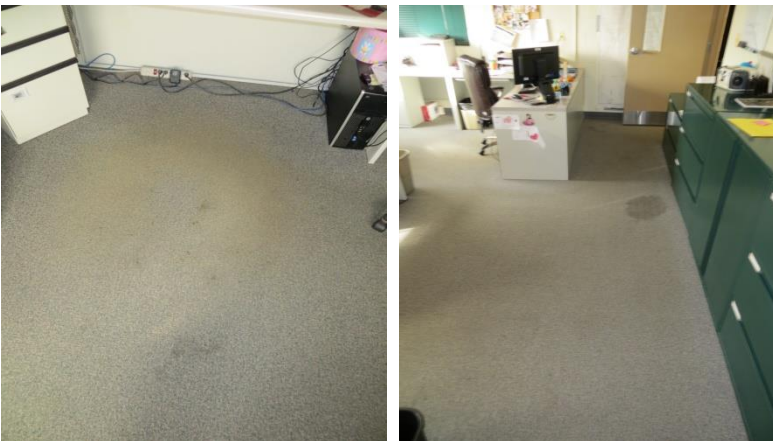
## Carpet Replacement

The carpet is starting to show wear and we are unable to remove stains.

Carpet will need to be replaced.

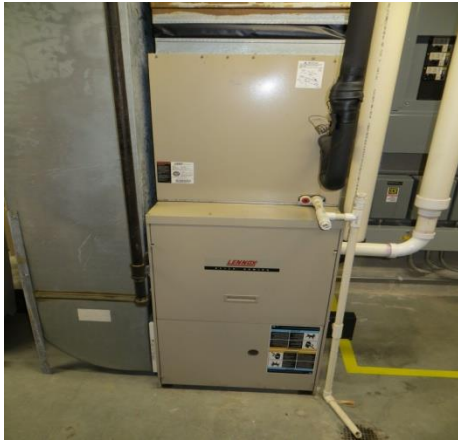
## HVAC Split System

The 3 Lennox split systems are nearing their ASHRAE recommended service life.

Replacement will be needed within the next seven years.

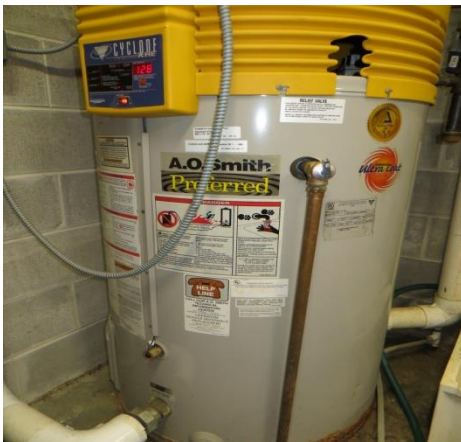
## Hot Water Heater

The 60 gallon A.O Smith water heater is nearing the end of its life cycle.

Replacement will be needed within the next two to five years.

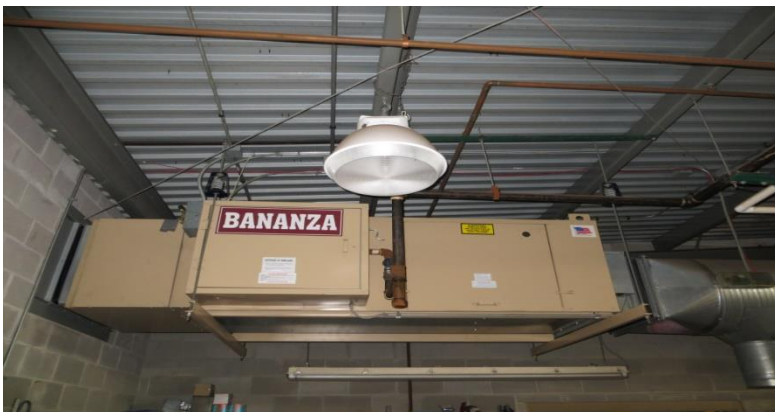
## Air Handling Unit

The three Bananza make-up air units are nearing their ASHRAE recommended service life.

Replacement will be needed within the next seven years.
