# EROSION & SEDIMENTATION MITIGATION

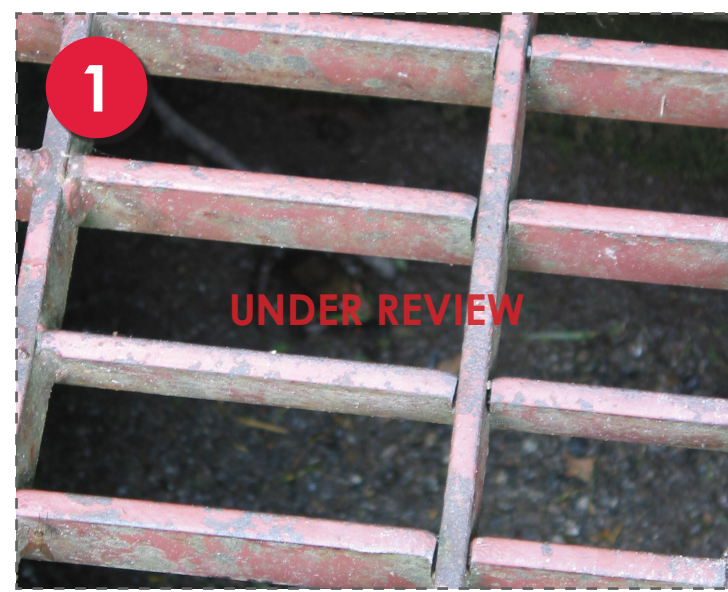
**Catch Basin Cleaning  
Energy Dissipater Outfalls**  
All Drainage Areas

**Priority: High**

Status of each catch basin structure was not verified during 9/25/2023 visit. Some observed grated inlets need to be cleared of leaves/sticks/debris. Riprap energy dissipaters were not verified during 9/25/2023 visit.

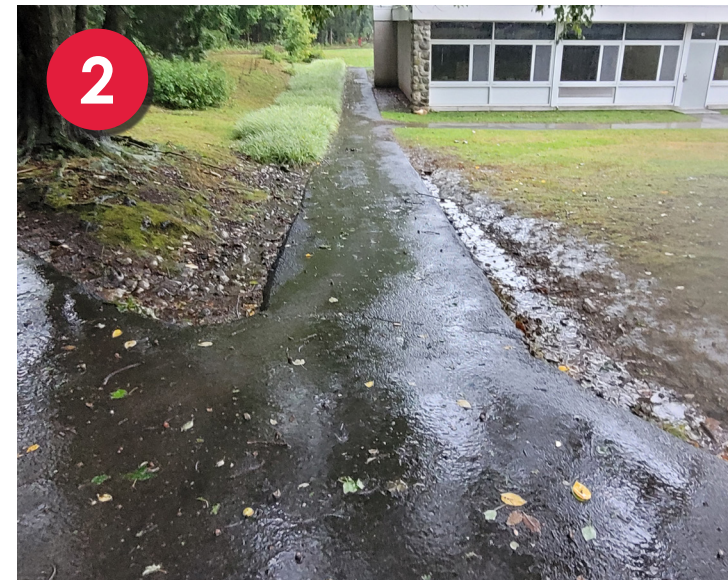
**Biofiltration Swale**  
Drainage Area 1

**Priority: Med/High**

Biofiltration swale was not installed at this location. The walk at this location has been repaved since 2011

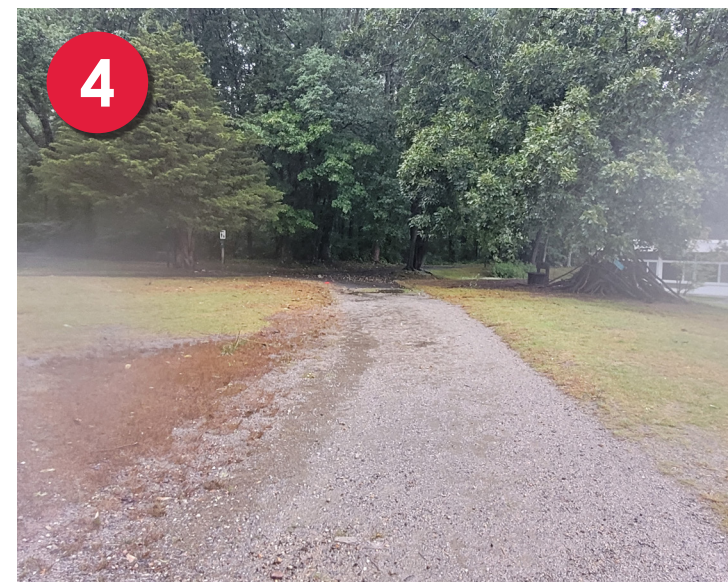
**Biofiltration Swale**  
Drainage Area 1

**Priority: Med/High**

Biofiltration swale has not been installed at this location.

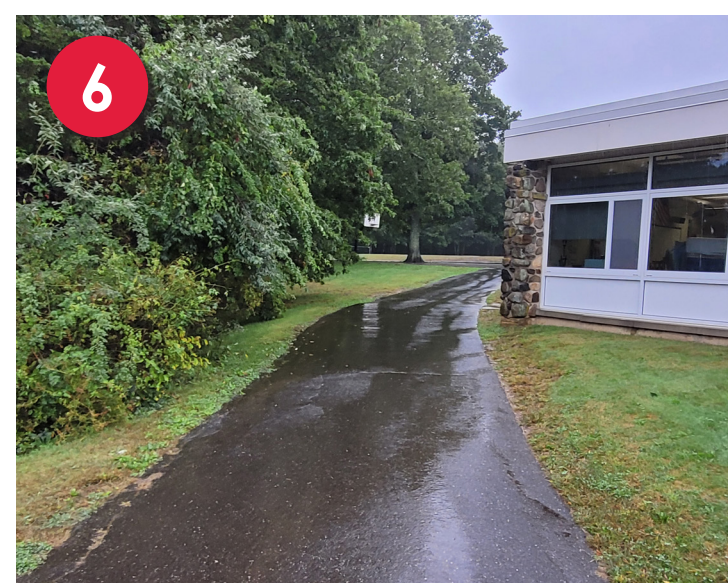
**Formalize Walk  
Revegetate Slope**  
Drainage Area 1

**Priority: Med**

New walk has been installed at this location since 2011 condition. Eroded areas here have been revegetated with grass, not the ornamental shrubs as indicated in 2011 recommendation.

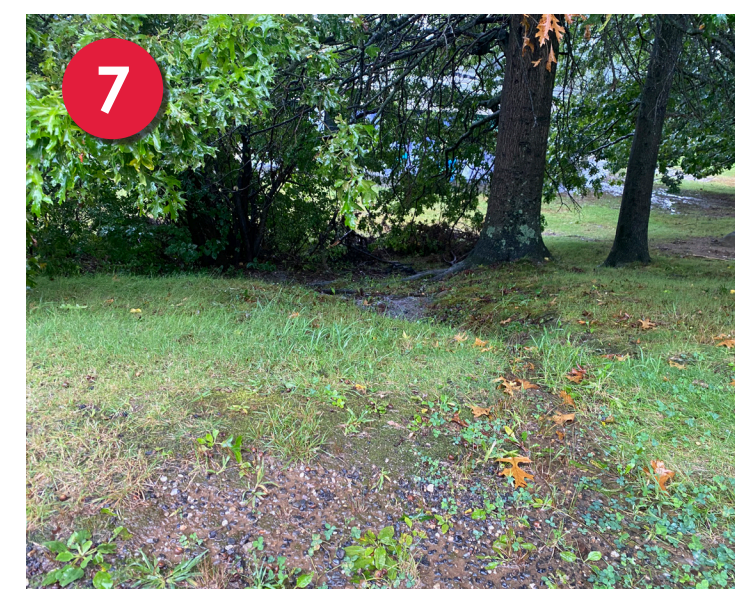
**Revegetate Slope**  
Drainage Area 1

**Priority: High**

Portions of slopes remain unvegetated at this location. Shrubs have not been installed. Stormwater runoff was observed streaming down the slope during the 9/25/2023 visit.

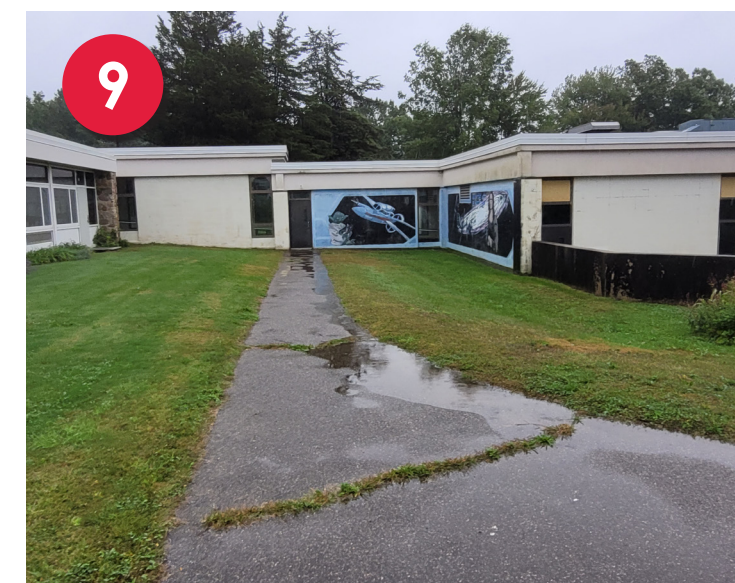
**Rain Garden**  
Drainage Area 1

**Priority: High**

Rain garden / biofiltration swale have not been installed. Grades appear unmodified from 2011 condition. Ponding was observed at this location per 9/25/2023 visit.

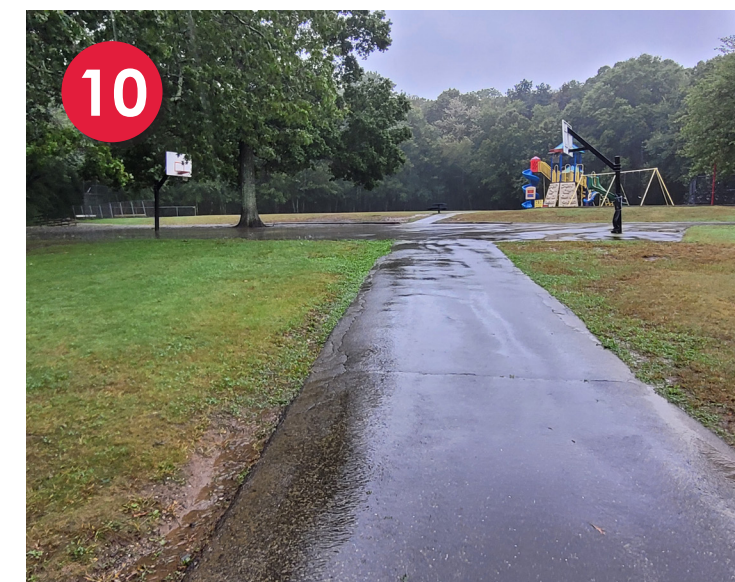
**Formalize Walk  
Revegetate Slope  
Biofiltration Swales**  
Drainage Area 1

**Priority: Med/High**

A formalized walk to the playground has been installed at this location. Ornamental shrubs and bioswale have not been installed per 2011 recommendation. Bare spots remain at this location

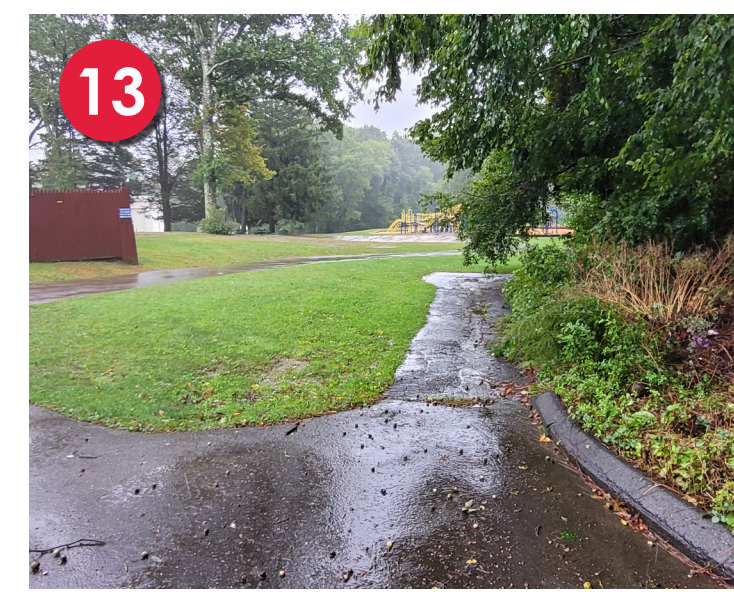
**Remove Pavement  
Biofiltration Swale**  
Drainage Area 1

**Priority: Med/Low**

Pavement swale at this location has not been removed. Biofiltration swale has not been installed.

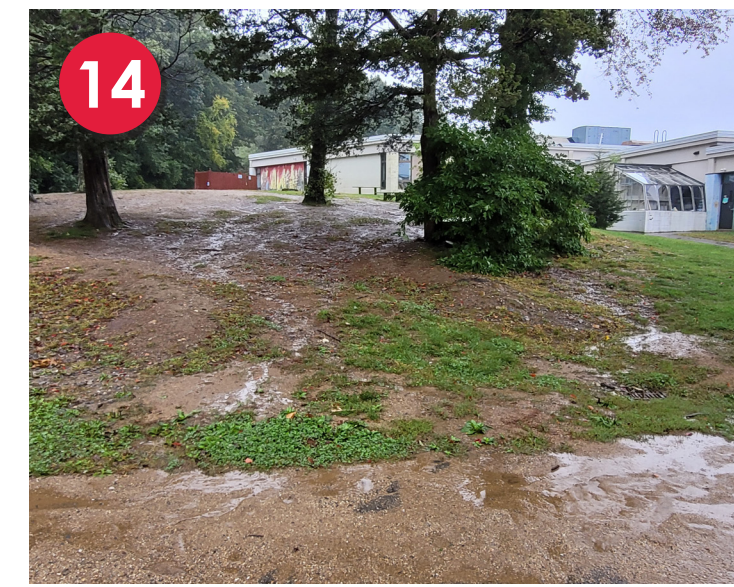
**Establish Gravel  
Gathering Area  
Revegetate Slopes**  
Drainage Area 1

**Priority: High**

A formalized gathering / volleyball area has not been established. Evergreen groundcover and native shrubs have not been installed. Portions of this area remain bare and erodible.

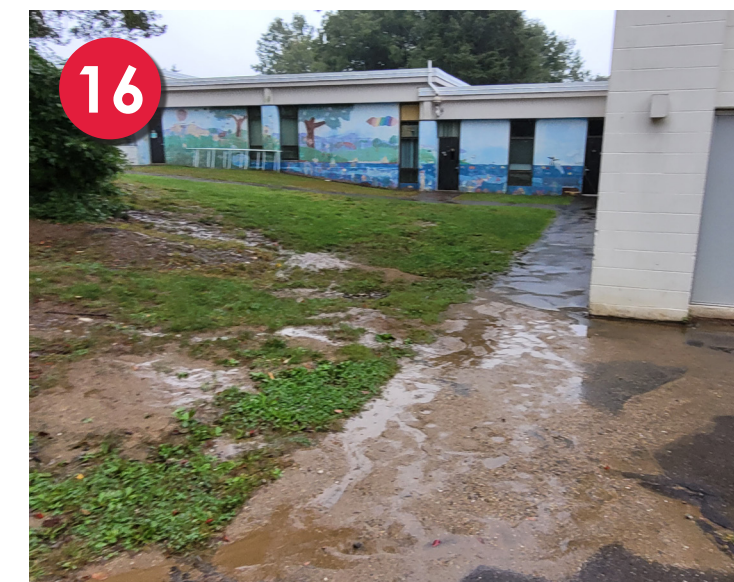
**Rain Garden**  
Drainage Area 1

**Priority: High**

Rain garden has not been installed at this location. Catch basin invert appears unchanged with no dome top frame. Major sedimentation and ponding was observed at this location during 9/25/2023 visit.

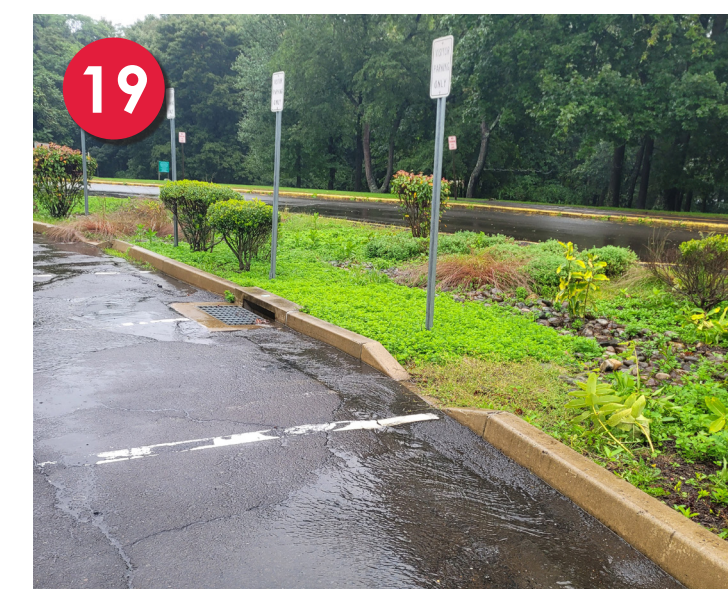
**Remove Pavement  
New Pervious Pavement**  
Drainage Area 2

**Priority: Low**

Pavement appeared relatively new. The permeable property of the pavement was not verified. Minor ponding was observed along gutterline during 9/25/2023 visit. Conveyance to leakoffs could be improved.

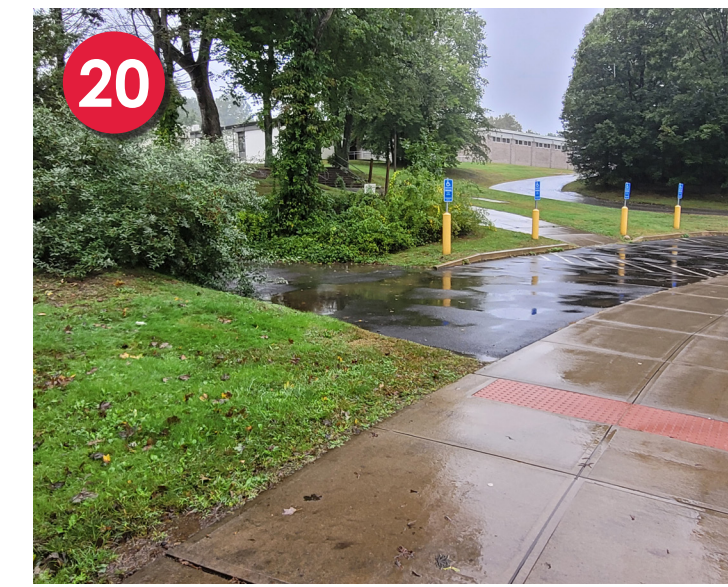
**Revegetate Slope**  
Drainage Area 4

**Priority: Low**

Evergreen groundcover and native shrubs have not been installed at this location.

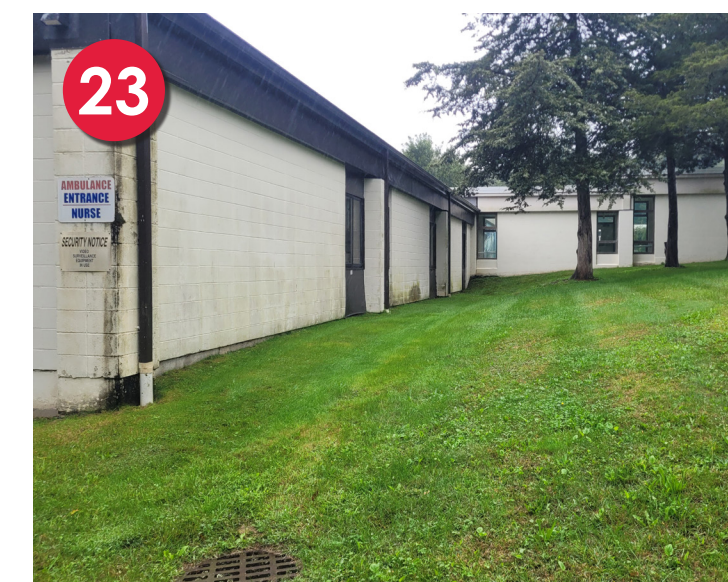
**Rain Garden**  
Drainage Area 5

**Priority: Med**

Grades appear similar to 2011 condition at this location. No rain garden has been installed here.

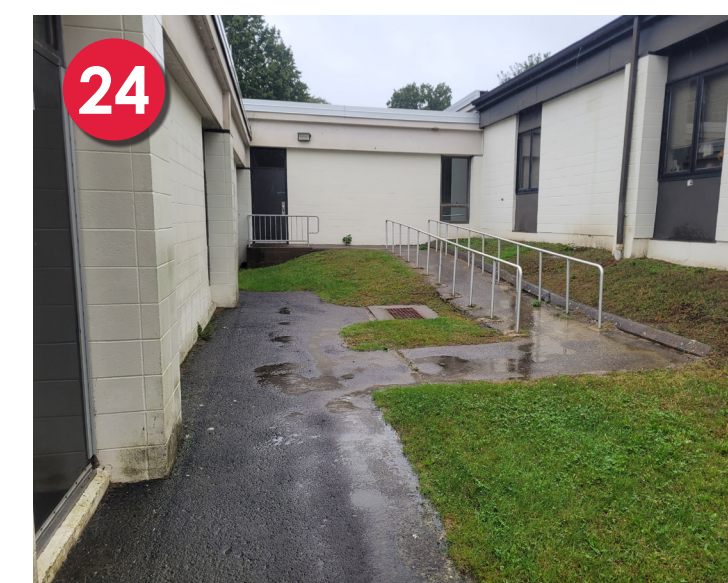
**Revegetate Slopes  
Rain Garden**  
Drainage Area 5

**Priority: Med**

Evergreen groundcover, native shrubs, and rain garden have not been installed at this location.

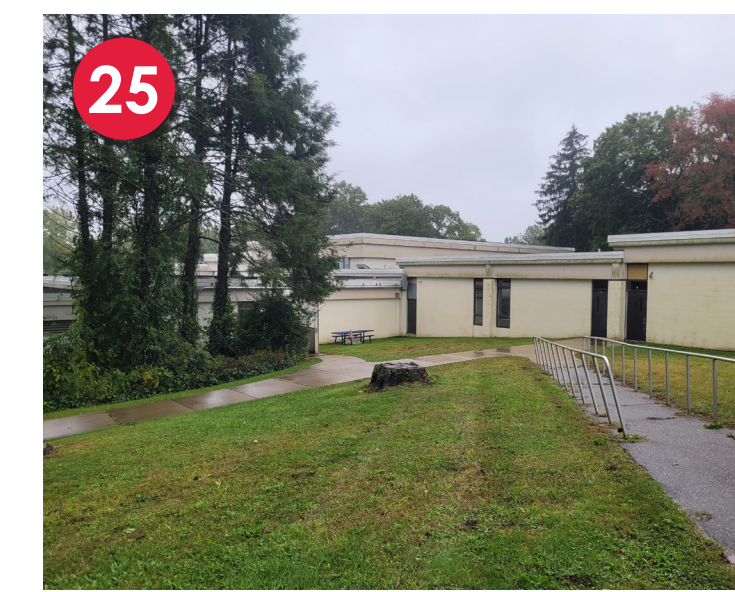
**Biofiltration Swale  
Revegetate Slope**  
Drainage Area 5

**Priority: Low/Med**

Biofiltration swale and ornamental shrubs have not been installed along walk. Ramp railings are no longer plumb with ground.

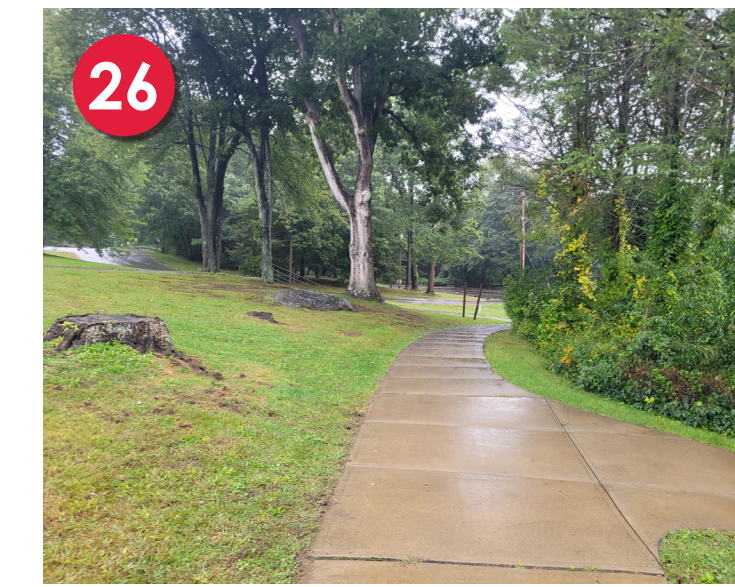
**Biofiltration Swales**  
Drainage Area 5

**Priority: Med/High**

New concrete walk has been installed at this location since 2011. Biofiltration swales have not been installed along new walkway.

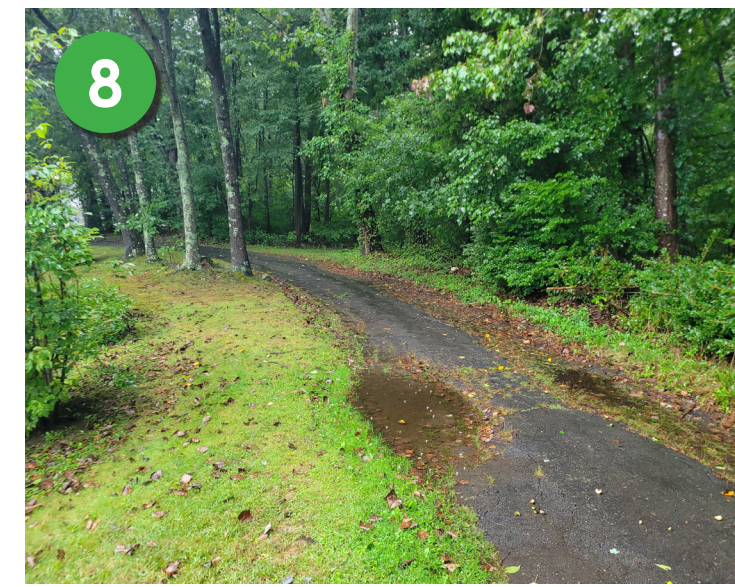
**8**  
Woodland Buffer Remove Invasives  
Drainage Area 2

**Priority: Low**  
Conditions appear similar to 2011. Ponding was observed along pathway during 9/25/23 visit. Invasive removal was not verified.

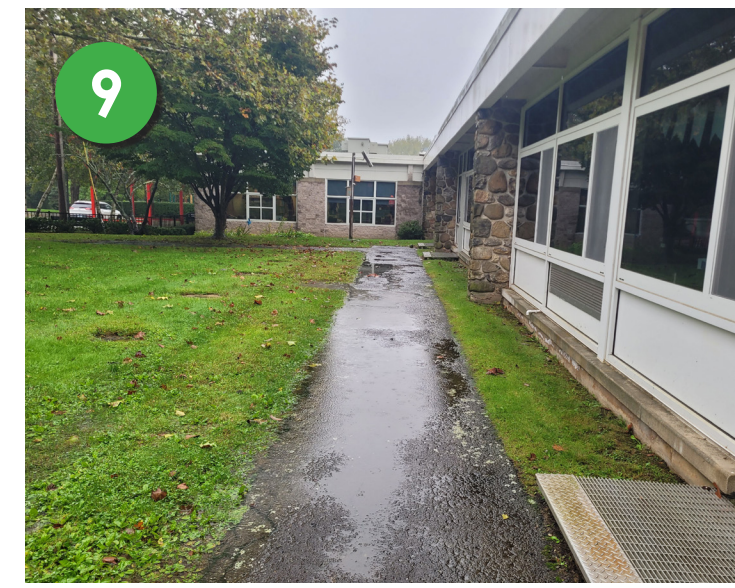
**9**  
Butterfly/Rain Gardens  
Drainage Area 2

**Priority: Med**  
Butterfly / rain gardens have not been installed at this location.

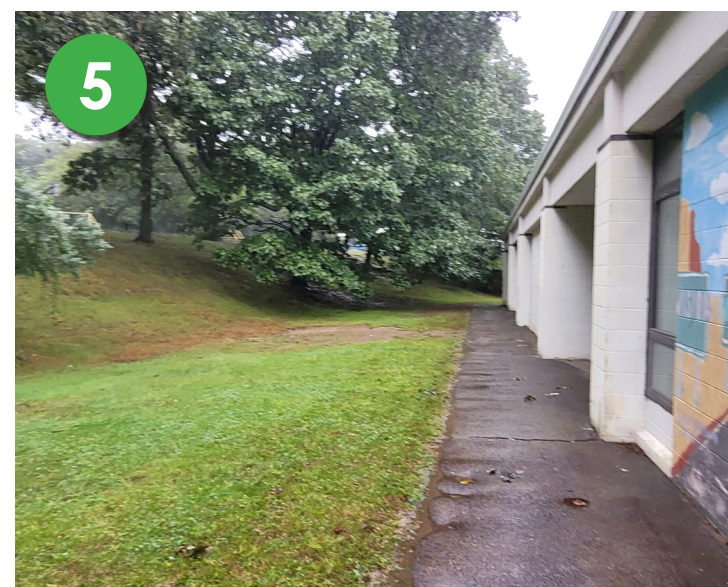
**5**  
Woodland Buffer Remove Invasives  
Drainage Area 1

**Priority: Low/Med**  
Woodland buffer appears unchanged from 2011 condition. Invasive removal was not verified during 9/25/23 visit.

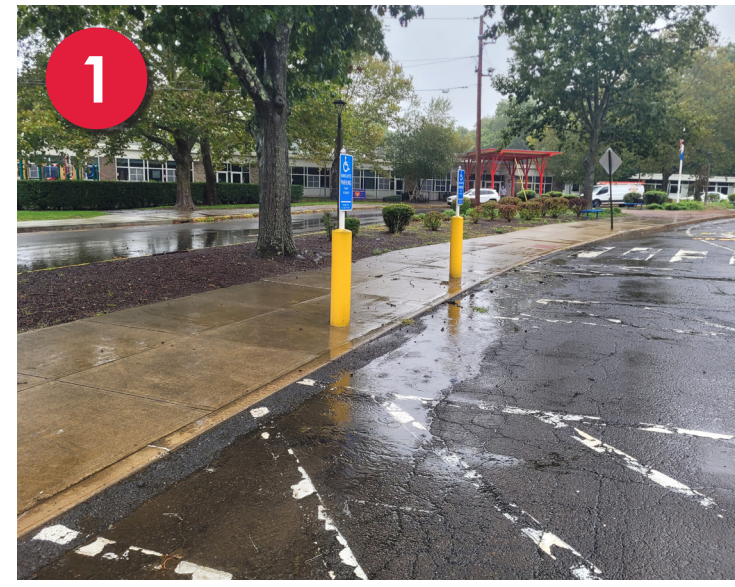
## Pavement Modifications Drainage Improvements

Priority: Med/High

Repave/regrade pavement to achieve positive drainage. Install additional drains. Pervious pavement is recommended.

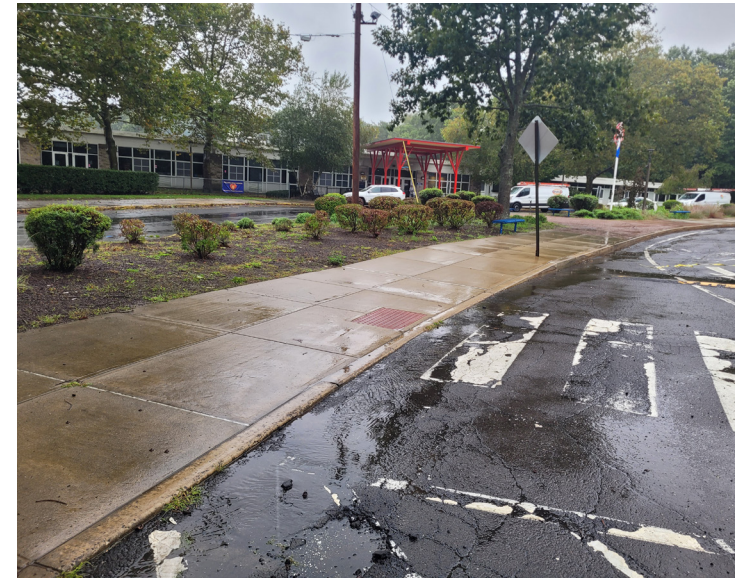
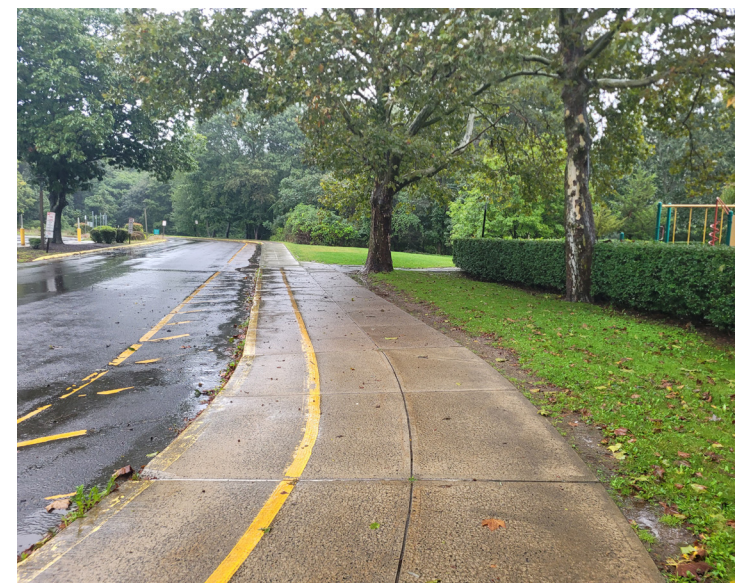
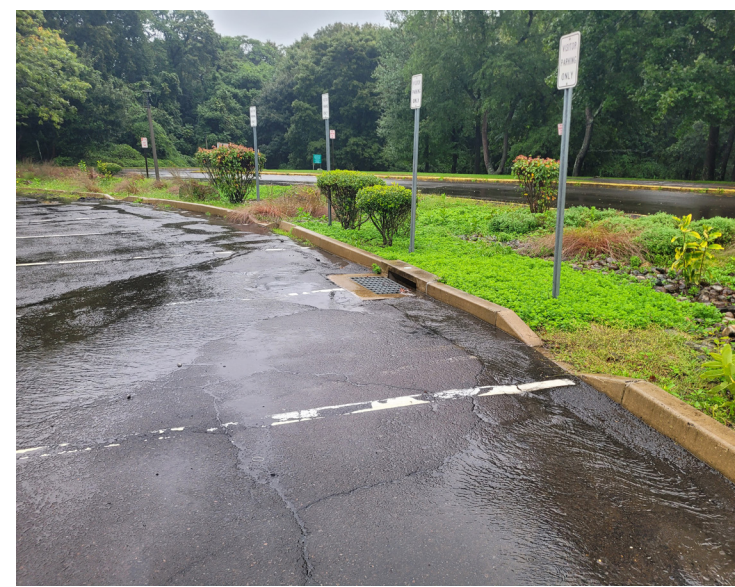
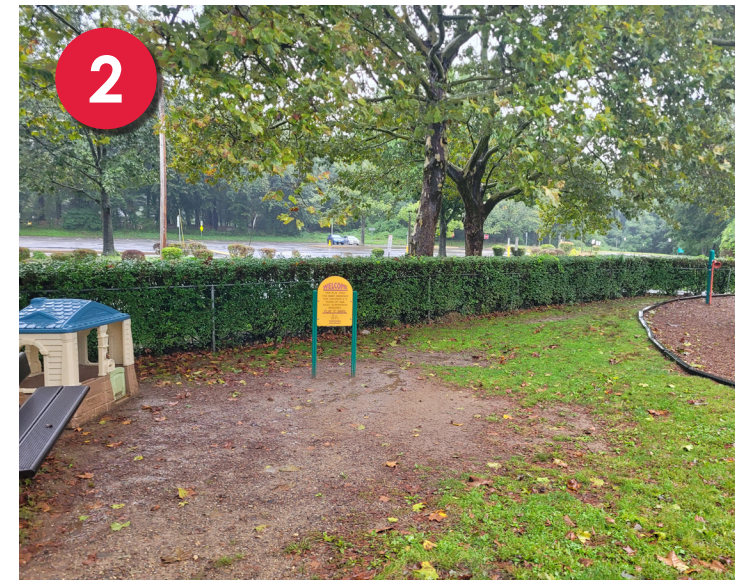
## Pavement Modifications Drainage Improvements

Priority: High

Grade and protect corner of playground experiencing runoff. Install additional drains. Regrade to ensure positive drainage.

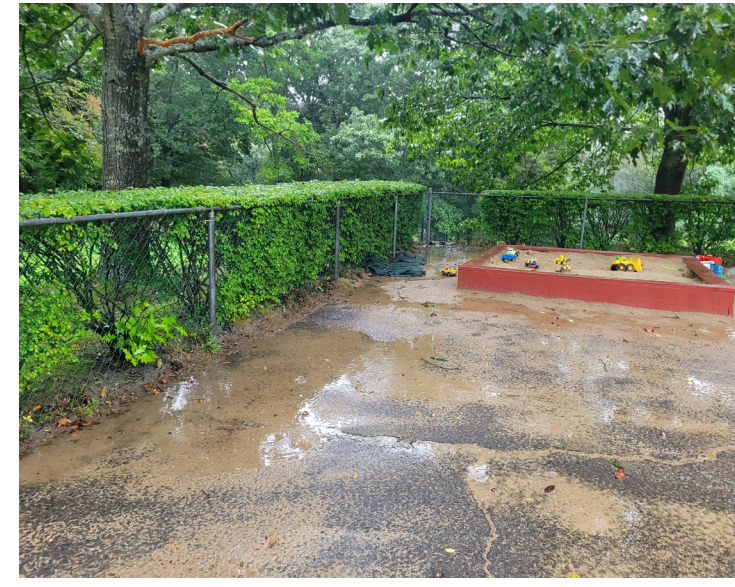
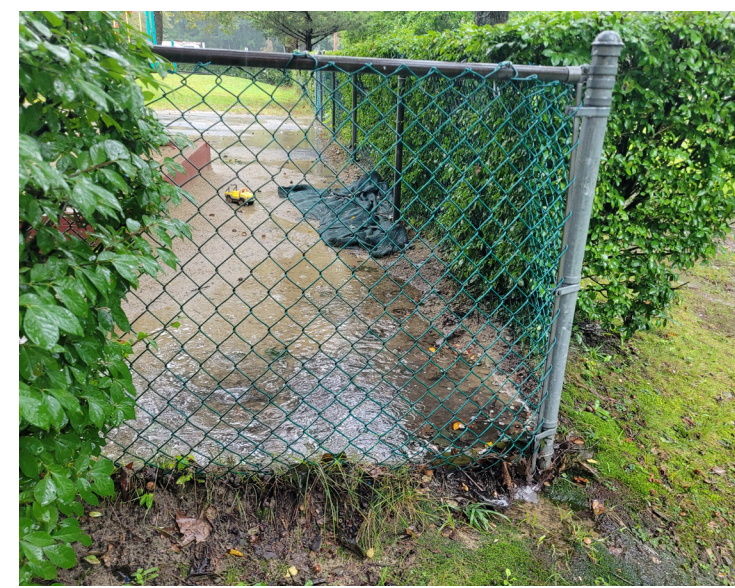
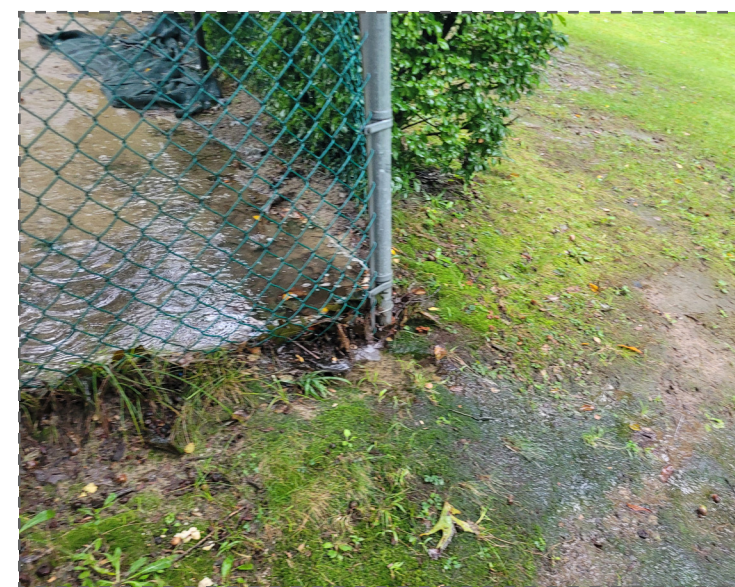
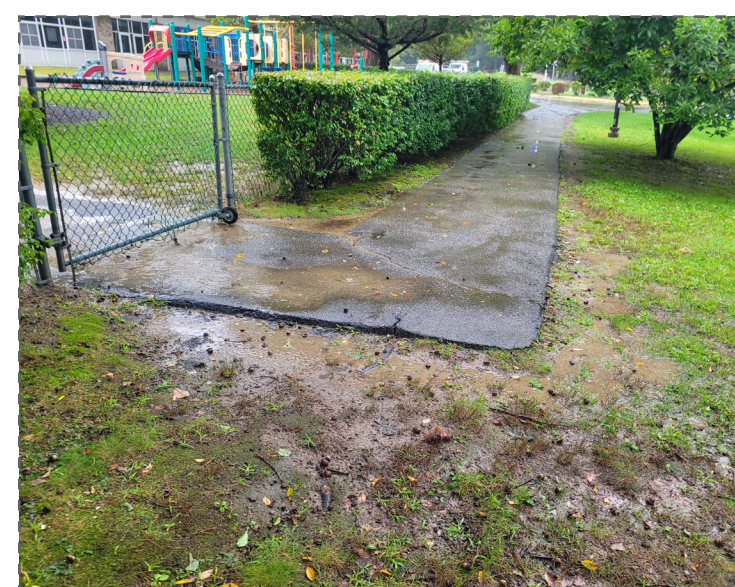
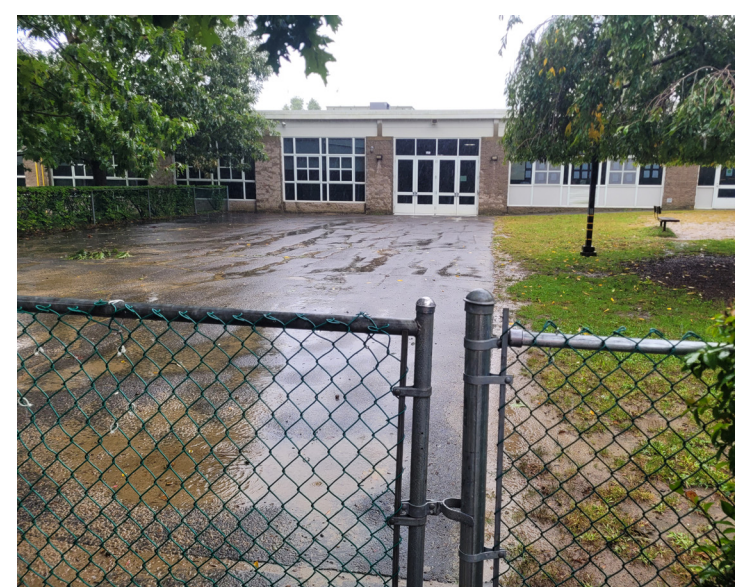
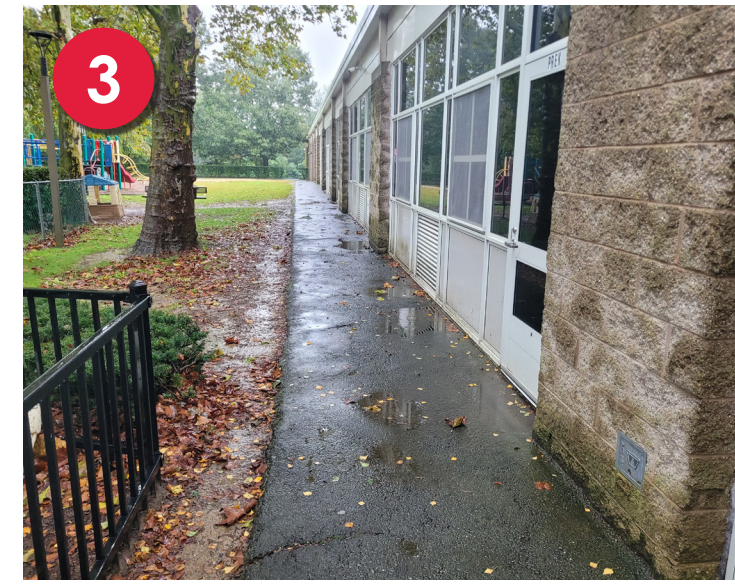
## Pavement Modifications Drainage Improvements

Priority: High

Repave walk to slope away from building. Remove low spots from pavement settling.

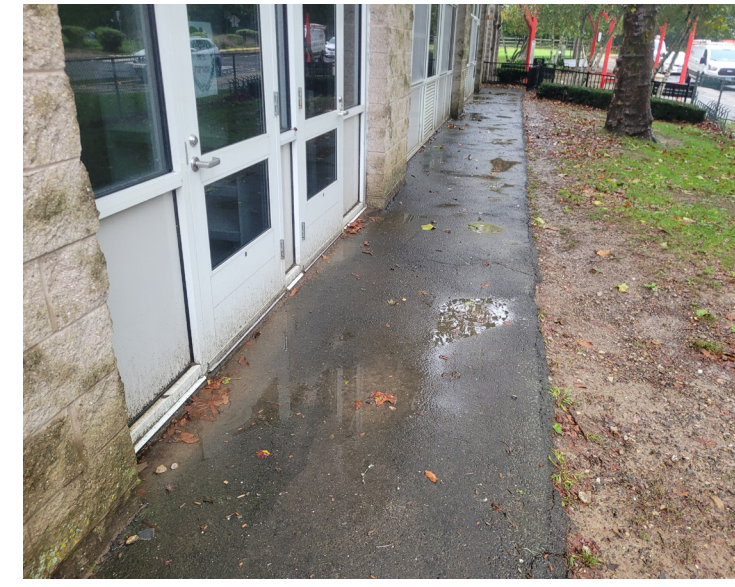
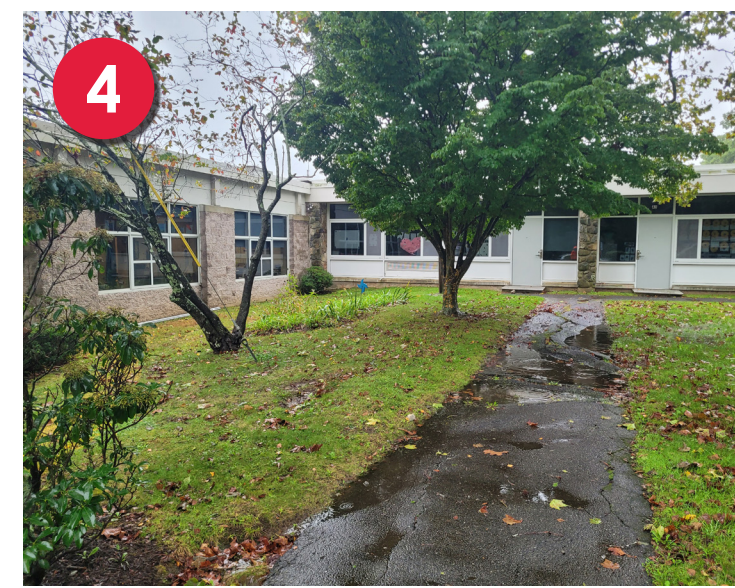
## Pavement Repair Drainage Improvements

Priority: High

Walk was observed to be heaving and ponding was present. Repave and ensure positive drainage. Install additional drain.

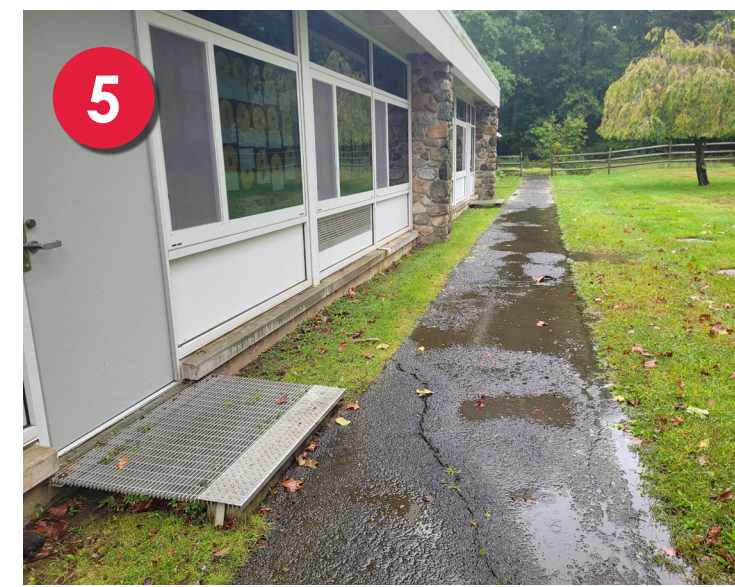
## Pavement Repair Drainage Improvements

Priority: High

Drainage is impeded by surrounding lawn at several walks along the building. Grade lawn or excavate and provide stone shoulder at edge of walk. Repave as required.

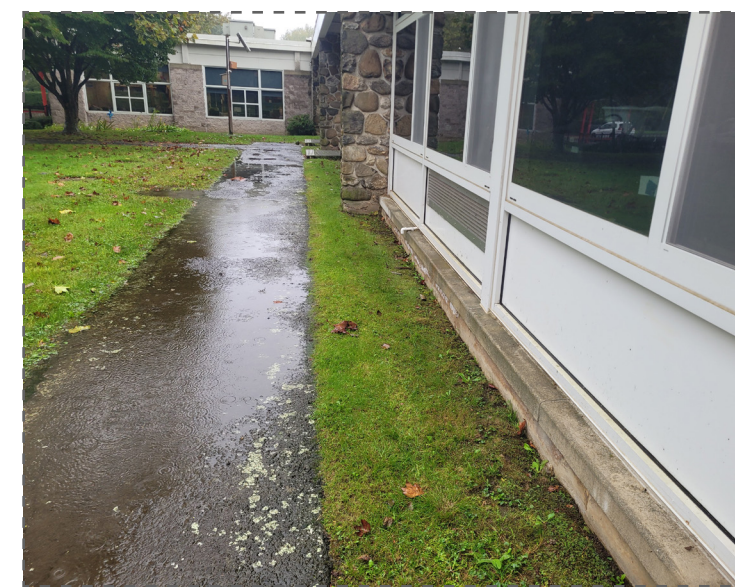
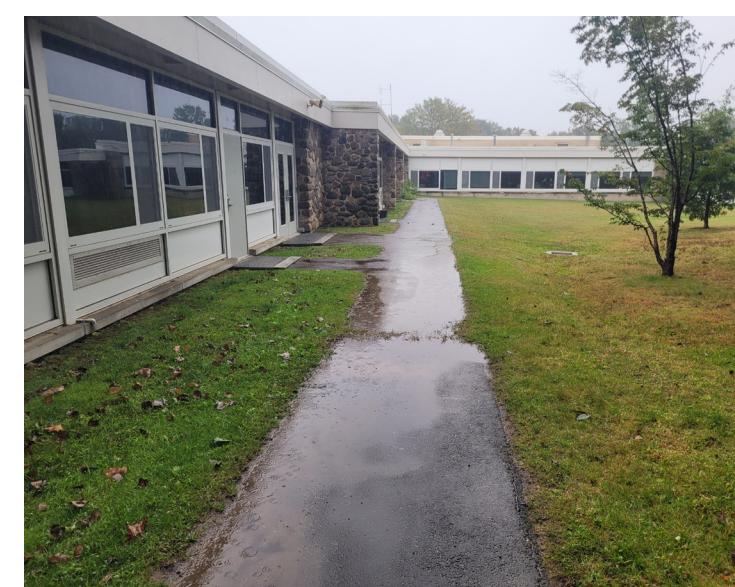
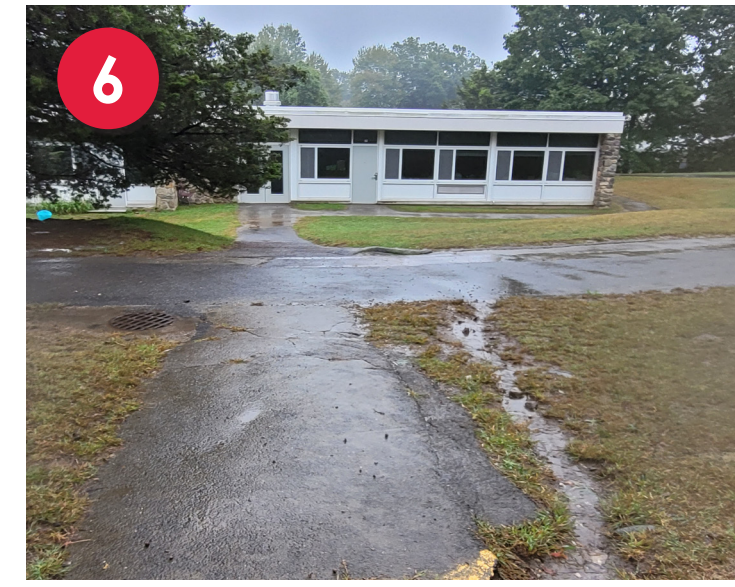
## Pavement Repair Drainage Improvements Erosion Protection

Priority: High

Portion of walk requires repair and runoff was observed eroding adjacent lawn. Repave walk and provide swale to guide water to nearby drain. Provide stone shoulder.

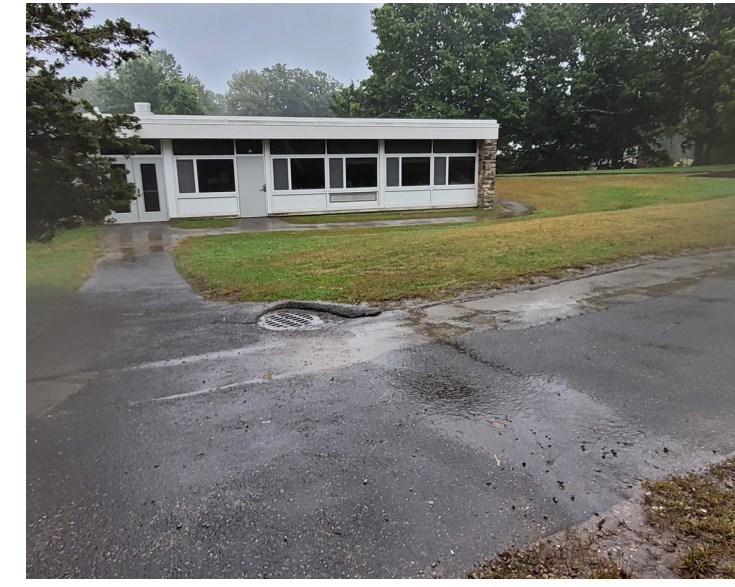
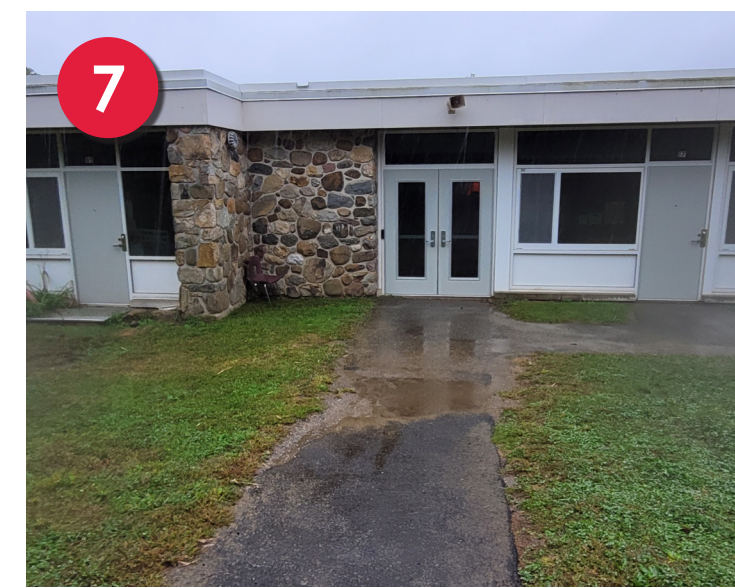
## Pavement Repair Drainage Improvements Erosion Protection

Priority: Med/High

Ponding and sedimentation were observed at this portion of walk. Repave walk and provide swale to nearby drain.

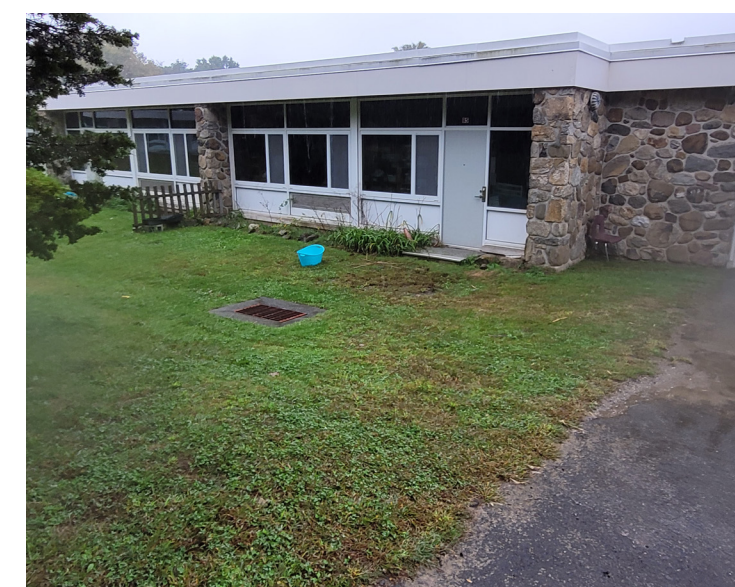
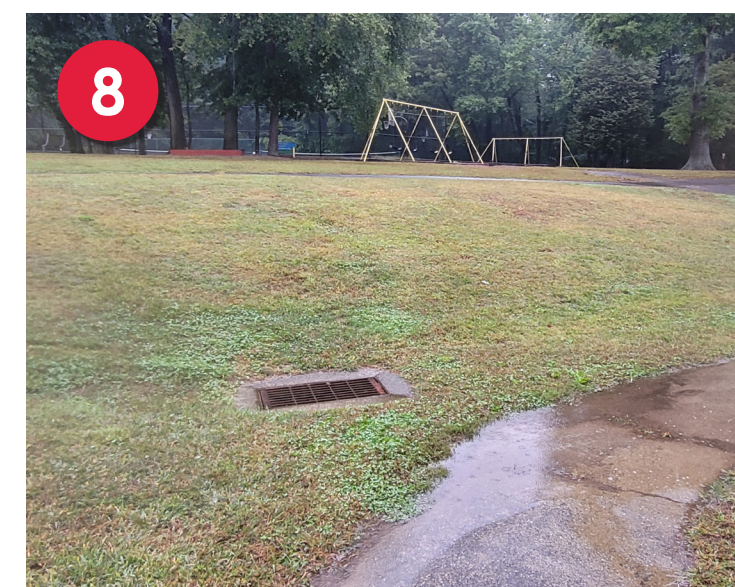
## Pavement Repair Drainage Improvements

Priority: Med

Ponding was observed at this portion of walk. Provide swale to nearby drain. Reset and lower basin. Repave as required.

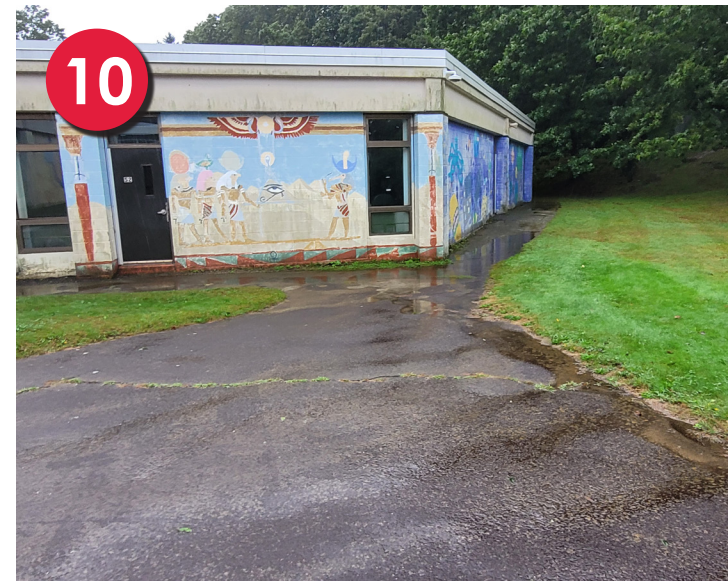
## Pavement Repair Drainage Improvements

Priority: High

Significant ponding was observed near doorway. Regrade lawn to ensure positive drainage. Install additional drains. Repave as required.

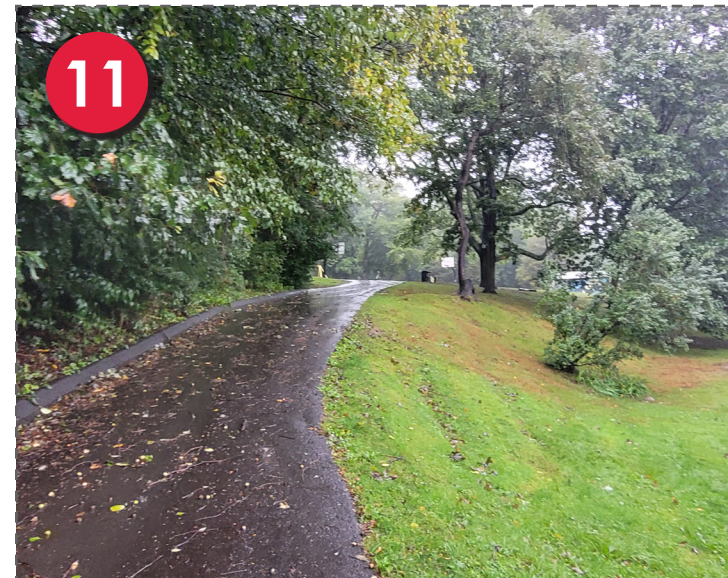
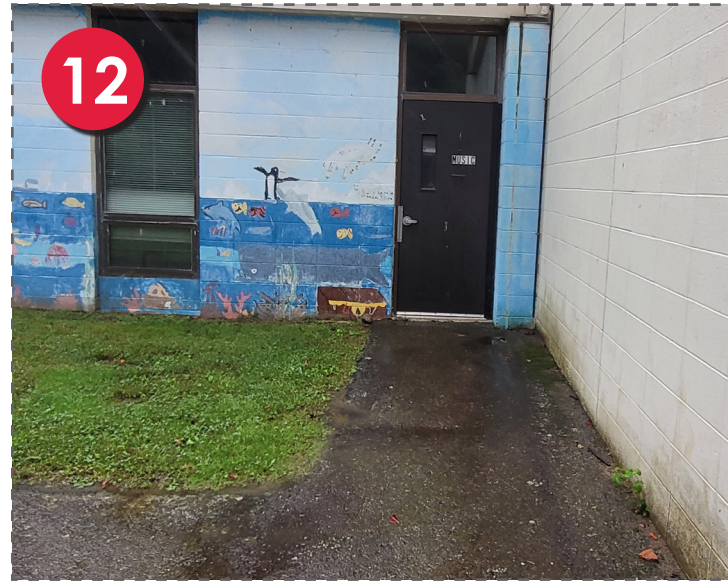
## Pavement Repair Drainage Improvements Erosion Protection

Priority: High

Walk was observed to be heaving and ponding was present. Erosion and sedimentation observed at downspout. Repave walk, install outlet protection and install additional drains.

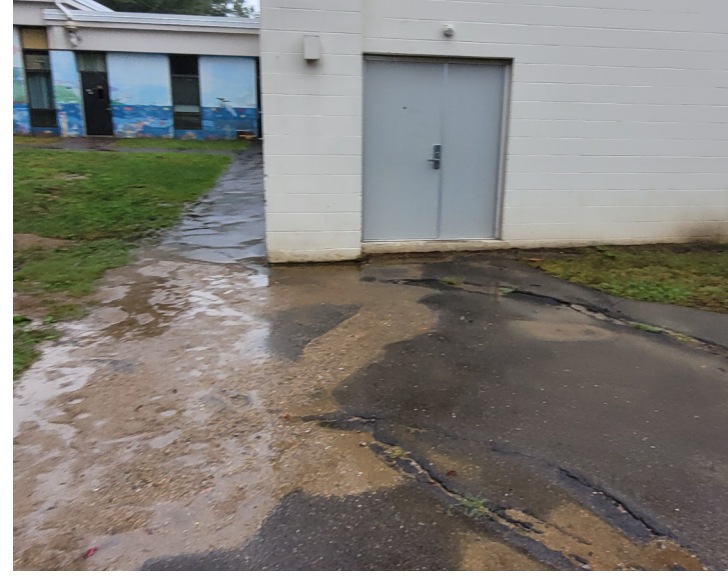
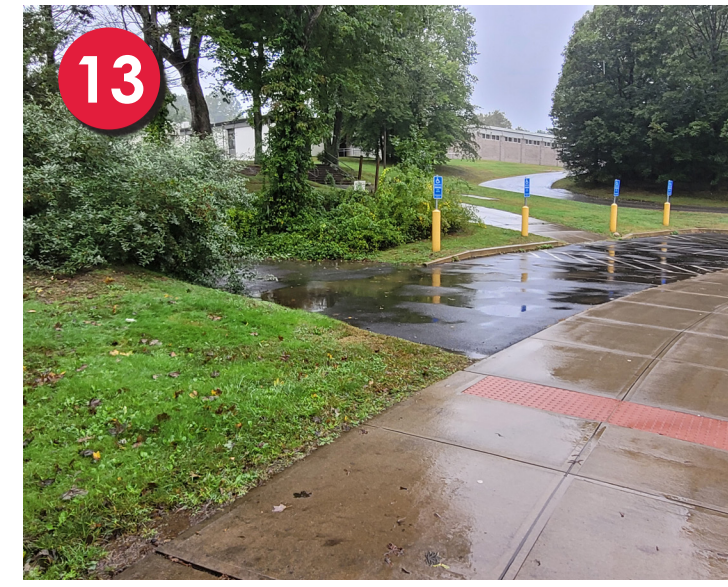
## Pavement Modification Drainage Improvements

Priority: Low/Med

Ponding was present in observed parking area. Additional drains should be installed. Pervious pavement is recommended.

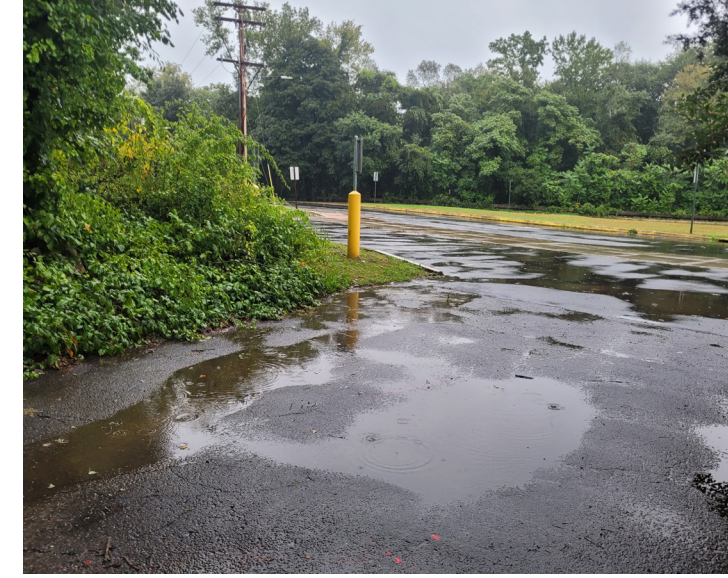
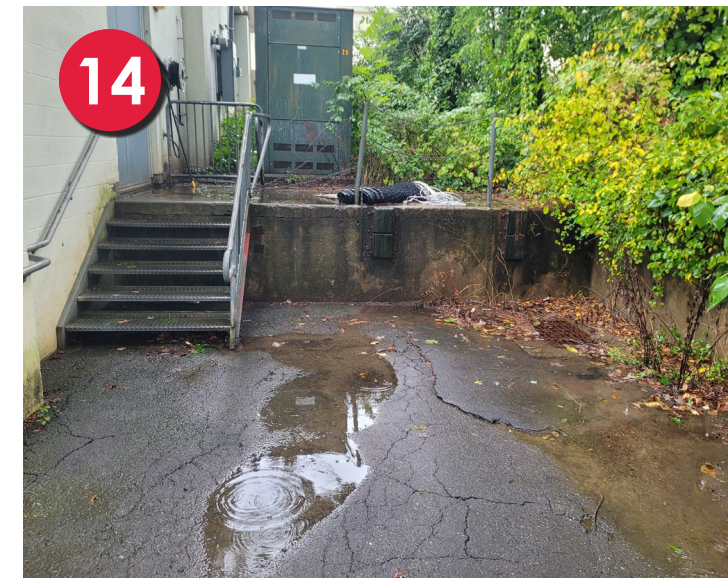
## Pavement Repair Drainage Improvements

Priority: Med

Pavement was observed to be heaving and ponding was present at loading dock. Repave to ensure positive drainage.

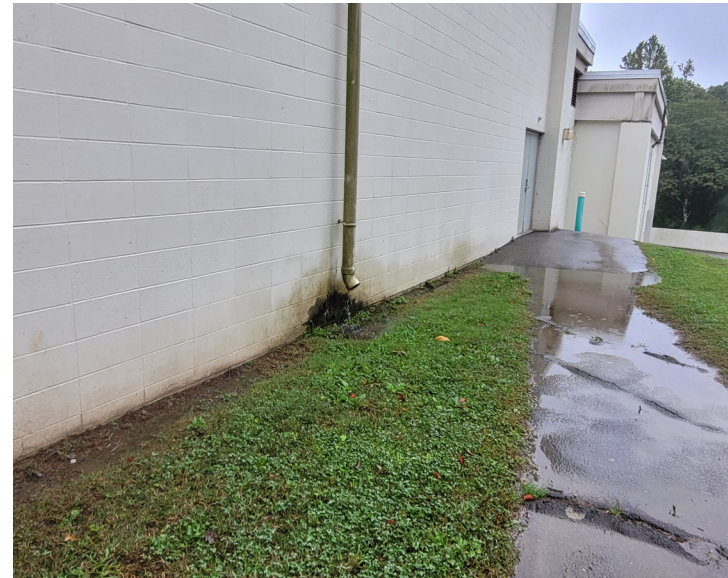
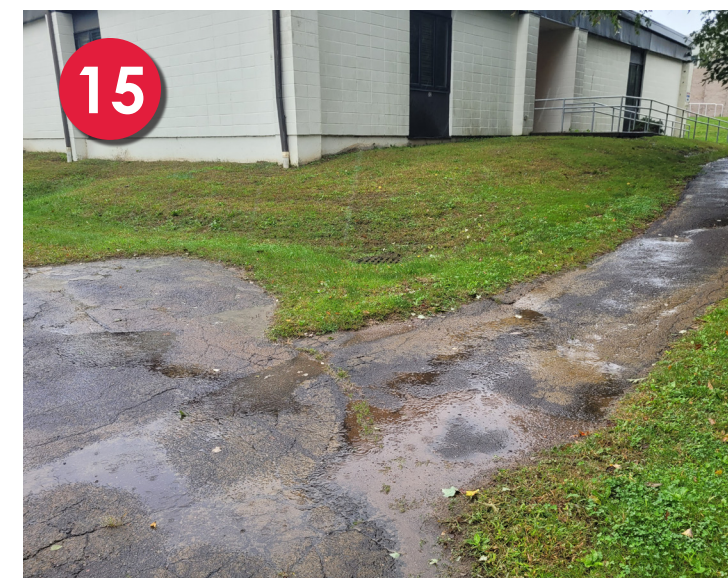
## Pavement Repair Drainage Improvements Erosion Protection

Priority: High

Pavement was observed to be broken. Ponding and sediments were present. Repave to ensure positive drainage to nearby drain structure.
