NUIQSUT TRAPPER

**NUIQSUT
AREAWIDE MECHANICAL AND ELECTRICAL
BUILDING ASSESSMENT AND INVENTORY SURVEY REPORT**

August 19, 2024

MECHANICAL AND ELECTRICAL CONSULTING ENGINEERS
670 W Fireweed Lane Suite 200, Anchorage, AK 99503 / 907-276-0521

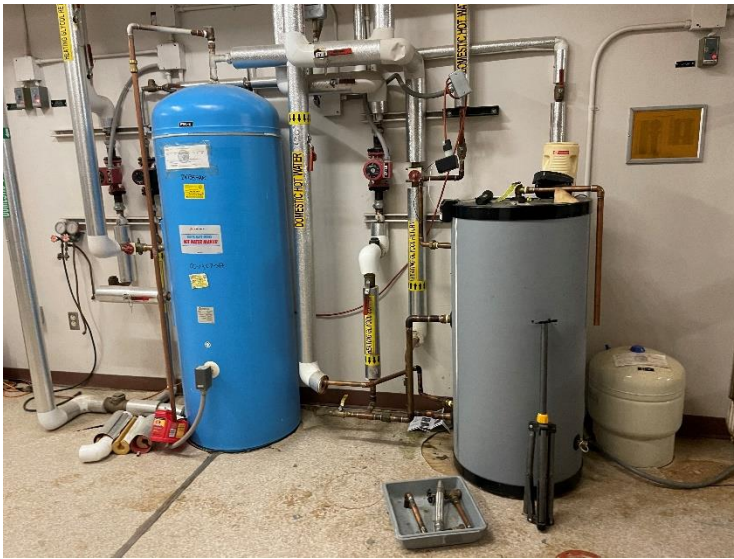
Domestic hot water is provided by two hot water generators that are in fair condition. They were installed in the year 2000. The hot water generators should be scheduled for replacement because they are approaching the end of their life expectancy.

Photo M1 – School Hot Water Generators

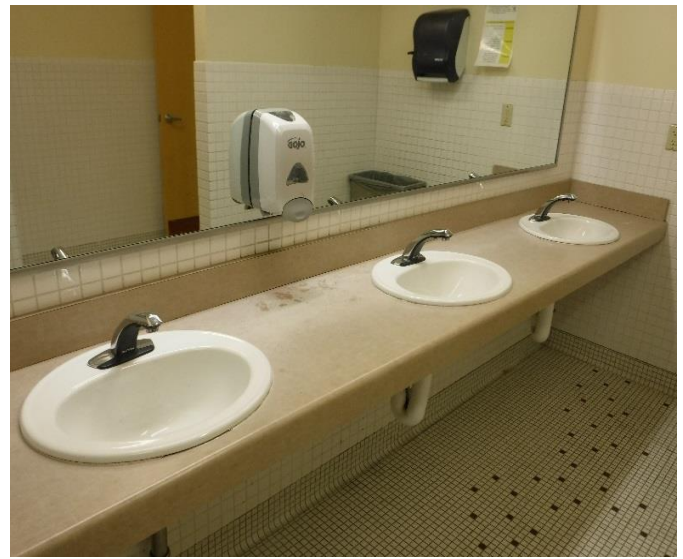
The condition of the domestic plumbing piping is fair. The plumbing fixtures vary in condition from fair to good. The piping under the lavatories does not have anti-scald valves. None of the lavatories appeared to be ADA compliant. Some of the toilets and urinals have automatic flush valves and others have manual valves. It is recommended that all the toilets and urinals be converted to automatic flush valves. The lavatories and countertops are in poor condition and should be replaced.

Photo M2 - Typical Condition of Restroom Sinks

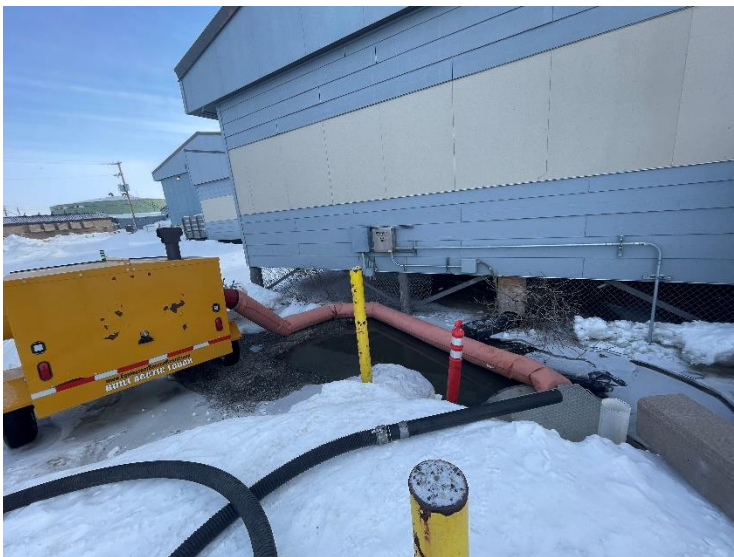
The sanitary sewer system was demolished and re-built in 2022 however its condition is unknown. The utilidor is compromised and some of the water and waste piping has suffered freeze damage. Currently the vacuum service barrel is being heated with a large portable diesel heater. The vacuum service barrel is also being pumped out via a pumper truck.

Photo M3 – Service Barrel Heating

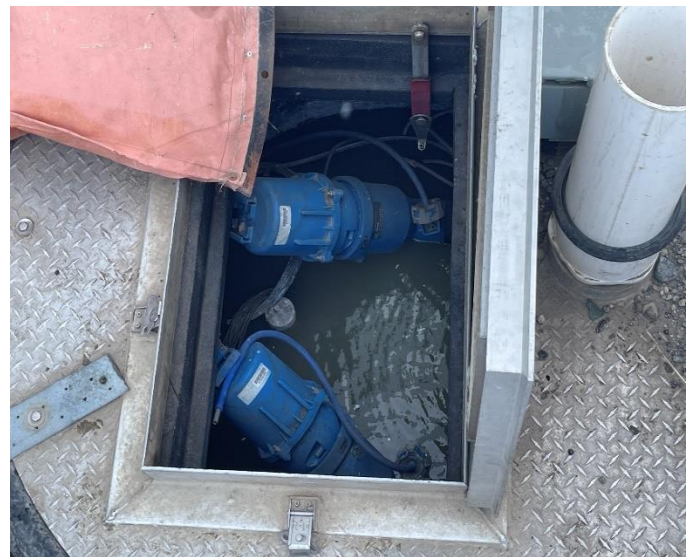
The boilers are failing and need to be replaced ASAP. In 2022 the waste piping was demolition and replaced; the existing lift stations were reused. The lift stations are in fair condition. The condition of the waste piping is unknown due to restrictions on utilidor access but appears to be damaged. Water and waste are leaking into the vacuum sewer service barrel and is being vacuumed out via a pumper truck.

Photo M4 – Service Barrel Flooding

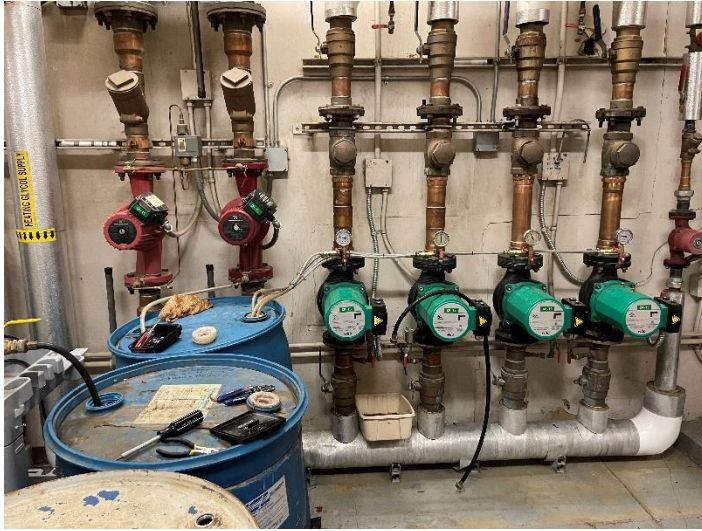
Photo M3 – Primary Heating Pumps

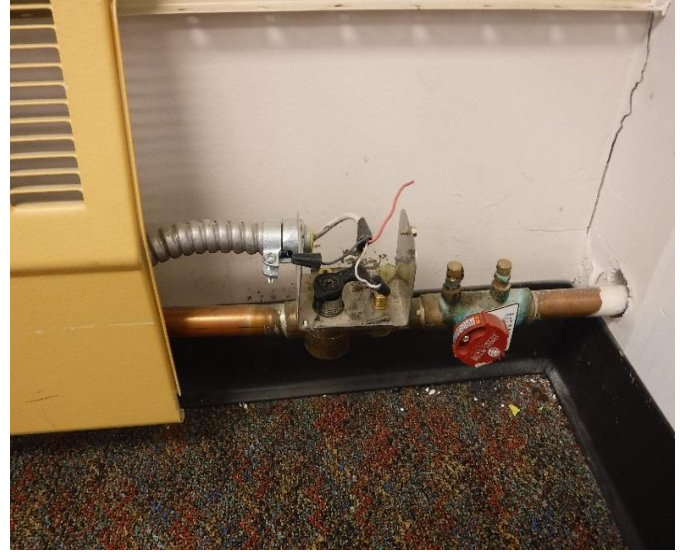
Terminal heating equipment in the building includes finned tube in the classrooms and offices, unit heaters in the storage and mechanical rooms and cabinet unit heaters in the entry areas. Several of the heaters have failed controls and cause over heating in the rooms. The teachers open the windows to cool the rooms. The finned tube enclosures and elements are in fair condition. The control valves, circuit setters and isolation valves should all be replaced when the control system is upgraded.

Photo M4 - Failed Finned Tube Valve

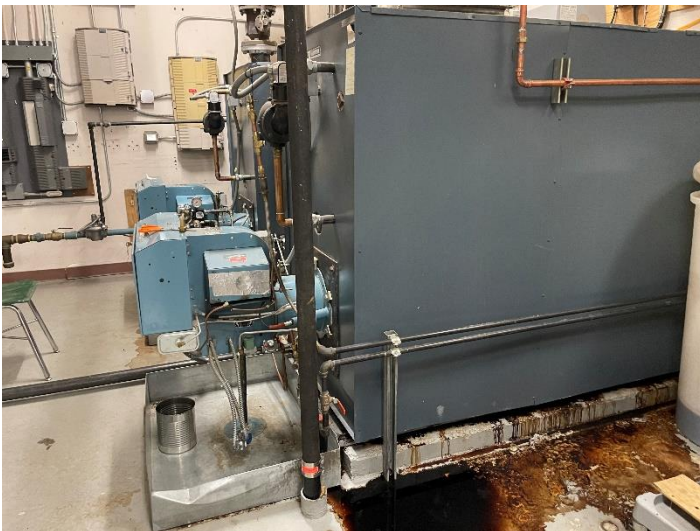
The boilers are failing and need to be replaced ASAP. Boiler B-1 was running during our visit; however, both are leaking glycol and are on the verge of failure. The glycol is also in poor condition and needs to be replaced along with the boilers.

Photo M5 – Leaking Boilers

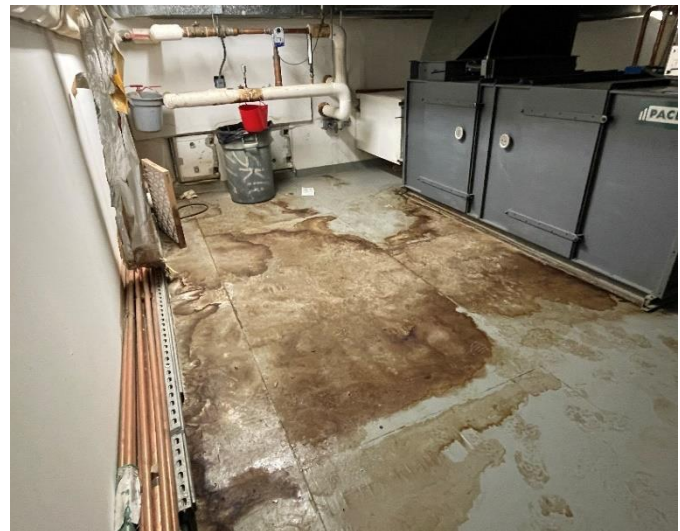
There is evidence of a substantial glycol leak in the fan room.

Photo M6 – Leak at Fan Room

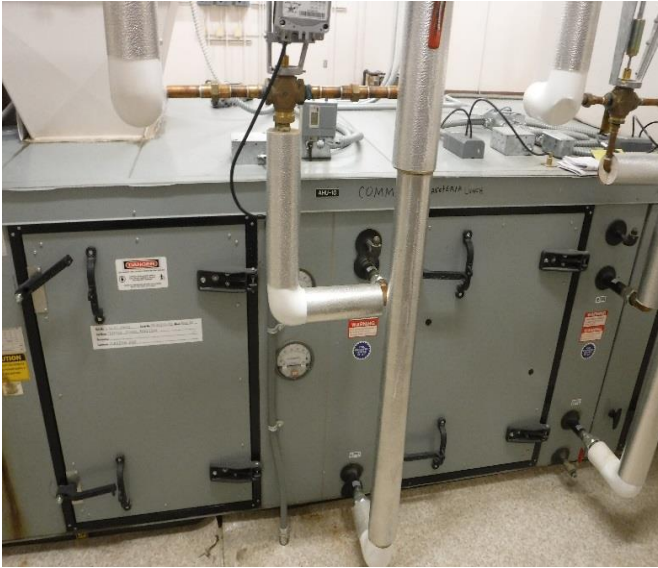
Photo M7 – Good Condition Air Handler

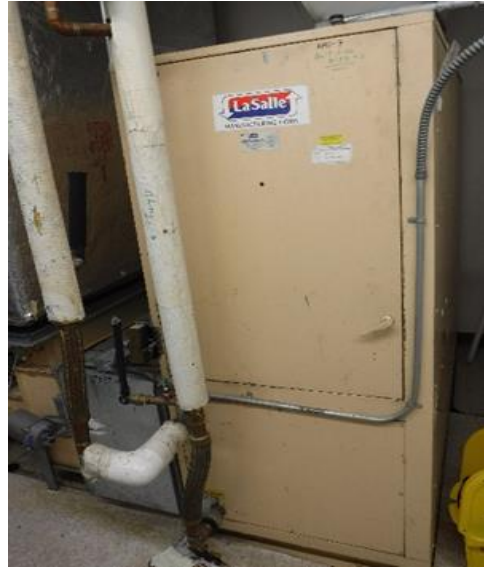
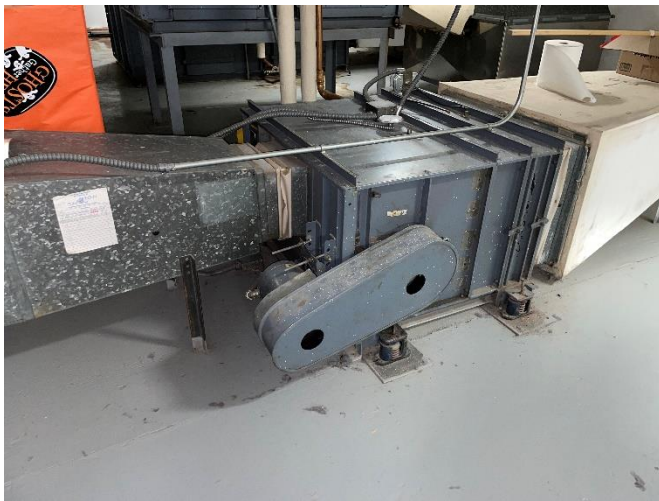
Ventilation for the school is provided by twelve air handlers distributed throughout the building. The air handlers vary in age and condition from good to poor. AHU-1 through AHU-7 is in poor condition and need to be replaced. The other air handlers are in good shape and only need new controls. The air handlers have hydronic heating coils and mixing dampers for economizer cooling and ventilation. It is likely that the air handlers are not providing current ASHRAE ventilation requirements due to failed controls.

Photo M8 – Poor Condition AHU

Photo M9 – Poor Condition AHU

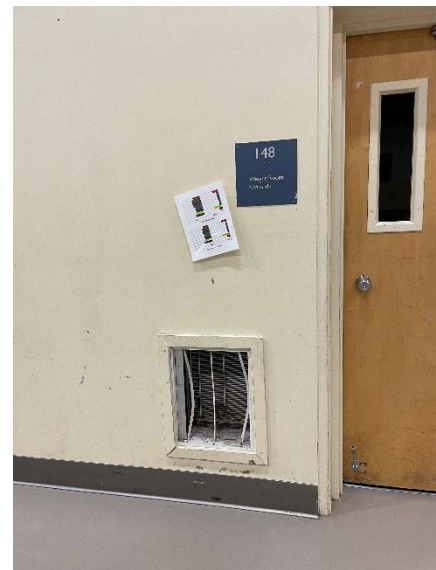
The low grilles in the gym are damaged and need to be replaced with heavy duty grilles.

Photo M10 – Grille in Gym

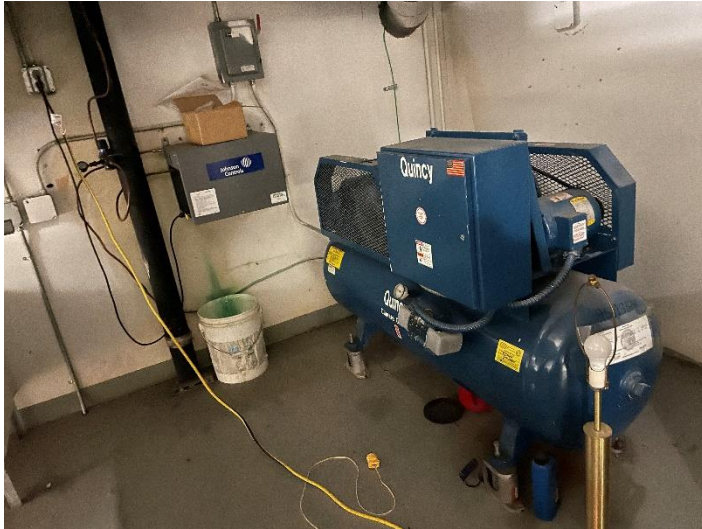
The control system utilized throughout the original building is primarily the originally installed pneumatic system. The 1998 addition has an electric DDC that is outdated. Many if not most of the pneumatic controllers are non-functional. Both the original school and 1998 addition HVAC control system needs to be replaced with a modern BACnet based DDC system for proper temperature control and energy management.

Photo M9 – Pneumatic Air Compressor

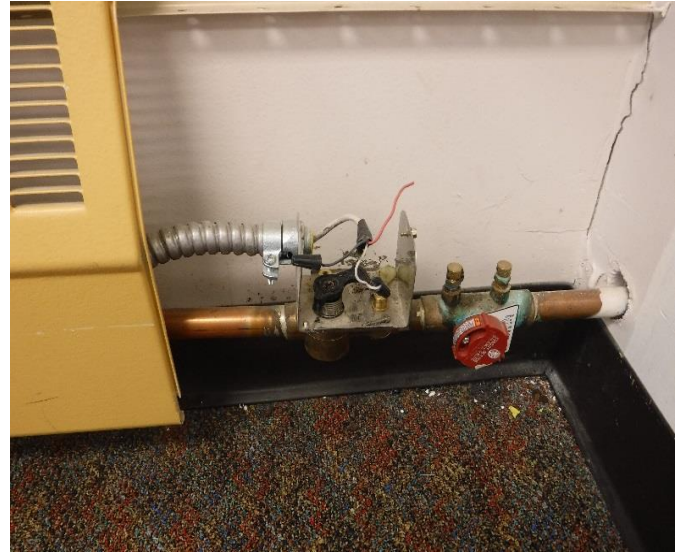
Photo M10 - Failed Finned Tube Valve

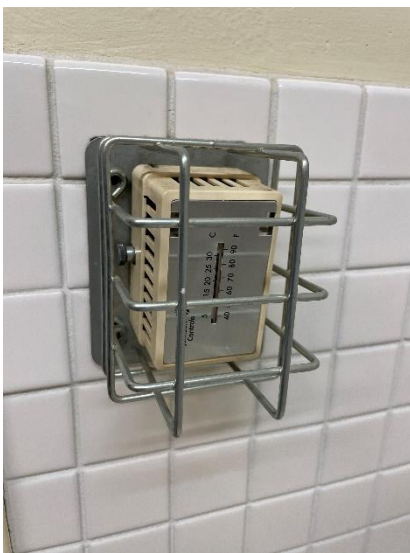
Photo M11 – Pneumatic Thermostat

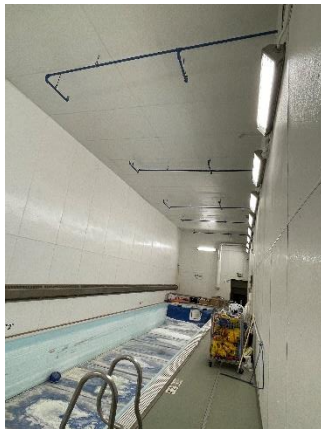
The natatorium is out of service. The deck drains do not comply with code, the liner is at the end of its life expectancy, the chemical system and associated controls are not operable, and the mechanical code does not meet code required ventilation. The natatorium equipment, drains, chemical feed system and ventilation system need to be upgraded.

Photo M13 – Out of Commission Swimming Pool

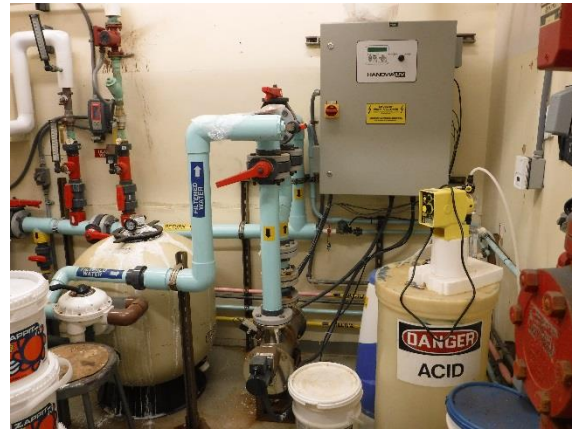
Photo M14 – Pool Equipment Room

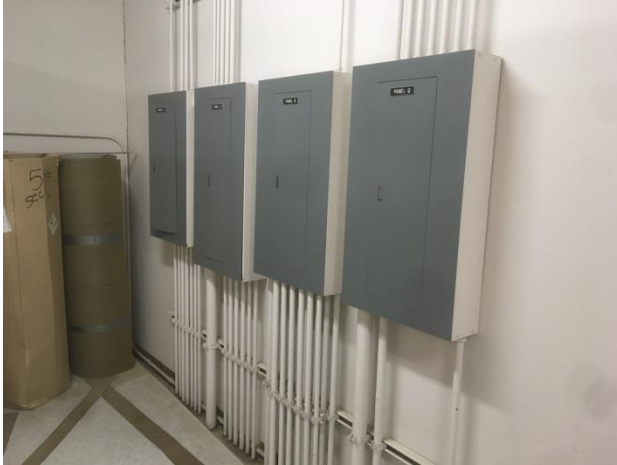
The typical branch wiring system in the facility consists of ½" electrical metallic conduit with copper building wire and a separate insulated green equipment grounding conductor. A few circuits left from the original construction used the conduit as a ground. (Photo E5)

Photo E5 – Typical Panelboards (1997 remodel)

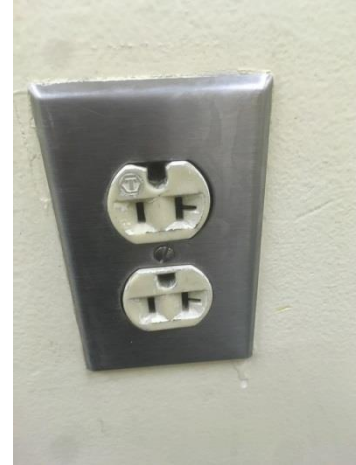
The wiring devices in the facility consist of ivory NEMA 5-20R receptacles and 20A,120V light switches with stainless steel wallplates. Many in high use areas are heavily worn and in need of replacement. (Photo E6)

Photo E6– Typical receptacle

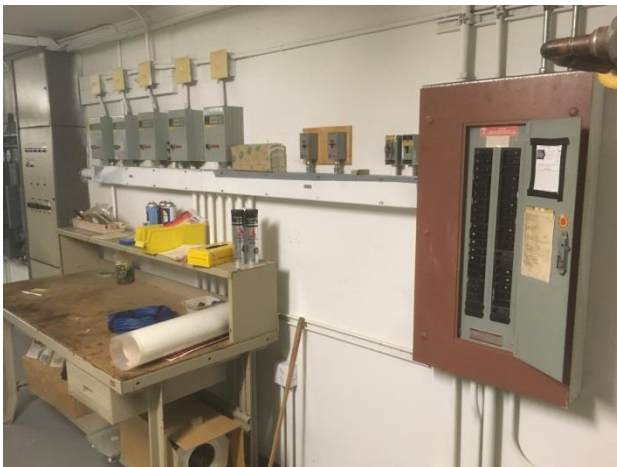
Motor starters in the original part of the building are past their useful life. (Photo E7)

Photo E7– Older Panel and Motor Starters

It is reported that any time there is a power outage they have a pump burn out. Recommend using a Surge Protective Device (SPD). There is an older SPD device on the MDP which needs maintaining and probably replacement of sacrificial parts. Alternately a new SPD device could be installed on the branch circuit panels or part of the motor starter when those are replaced.

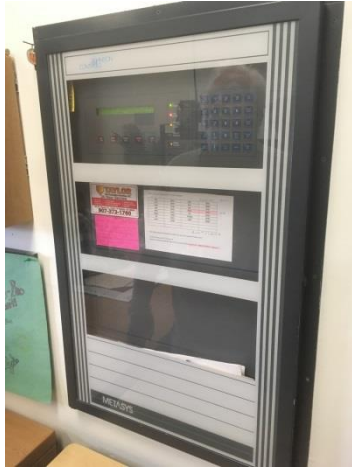
The fire alarm system consists of a zoned Class ‘B’ fire alarm System. The Fire Alarm Control Panel ‘FACP’ is located in the principal’s office and is a Johnson Controls Metasys Fire Alarm control panel which was installed in 1997. *(Photo E18)* There is an annunciator map in the main vestibule and a remote digital annunciator in the Maintenance Office. *(Photo E19)* The fire alarm initiating devices include pull stations at the exits, smoke detectors throughout the building, heat detectors in the mechanical and kitchen areas, duct smoke detectors on the air handlers, kitchen hood suppression system, and sprinkler flow/tamper switches. The signaling devices consist of fire alarm horn/strobes in the corridors, classrooms, and public spaces as well as an alarm dialer. The system is past its useful life and was in alarm at the time of inspection. The maintenance staff reported difficulty finding parts.

Arctic Fire and Security has recently updated the FACP with a new Notifier system along with annunciation devices. Original smoke detectors remain which are compatible with the new system controller. The new FACP is ready to be upgraded to the new code required voice evacuation system.

Photo E18– Main FACP

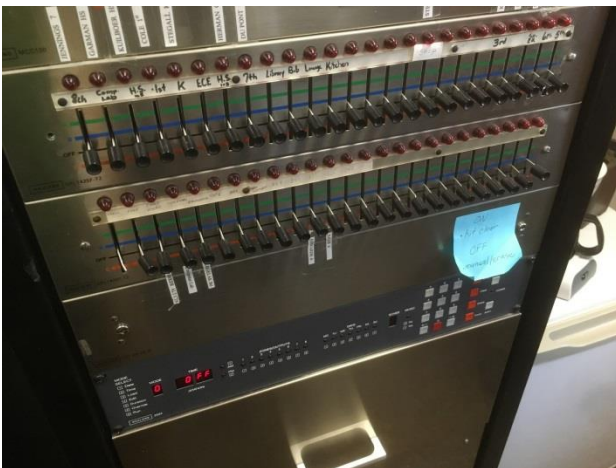
The school has a rack-mounted intercom/bell system that is located in the principal’s office. It is a Rauland #MCX300 intercom system and is past its useful life. It was original to the building in 1978. (Photo E20)

Photo E20– Intercom Headend

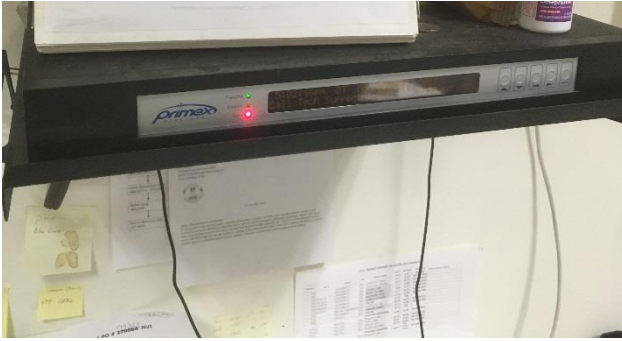
The wireless clock system is no longer in use and has largely been abandoned in place.

Photo 22– Wireless Clock Headend

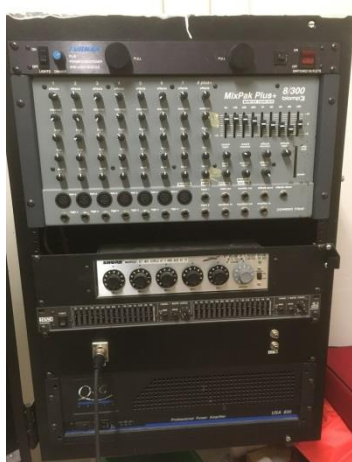
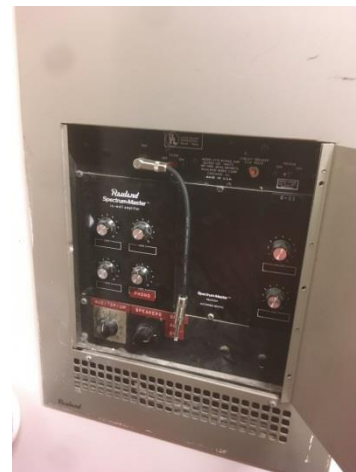
All of the sound system components are discontinued with either no support or limited support from the manufacturers.

Photo E23– Gym Sound System Rack

Photo E24– Gym Sound System In-Wall Amp

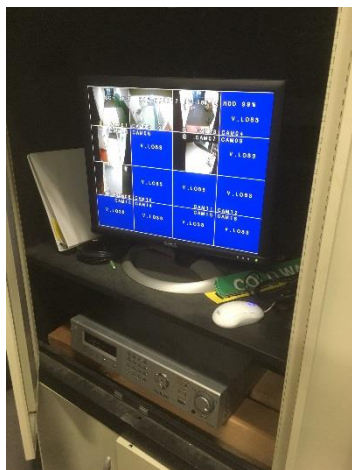
There is a security camera system distributed throughout the school, however only 6 of the cameras were operational. The headend equipment is located in maintenance office and consists of a Lillin #PDR-6160A 16-channel DVR multiplexer. (Photo E25) The equipment is still serviceable, but the inoperable cameras need to be repaired/replaced. There is also a PC with monitor in the Maintenance3 Office corner that also appeared to be connected to the security camera system. (Photo E26).

Photo E25– CCTV Camera Headend
