Wausau School District

Facility Assessment

February 2025

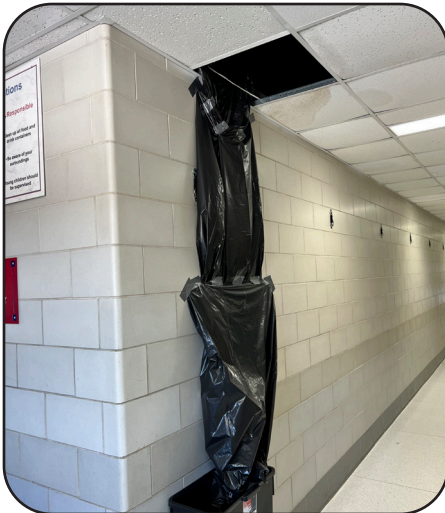
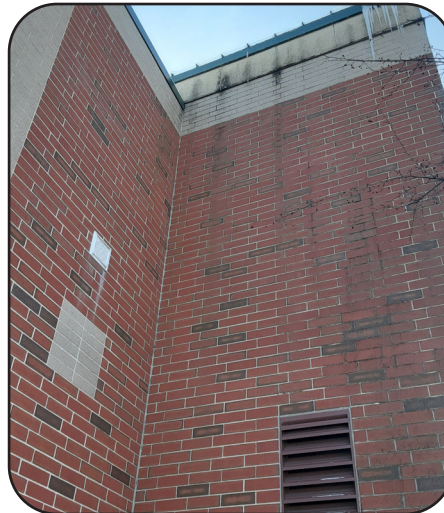
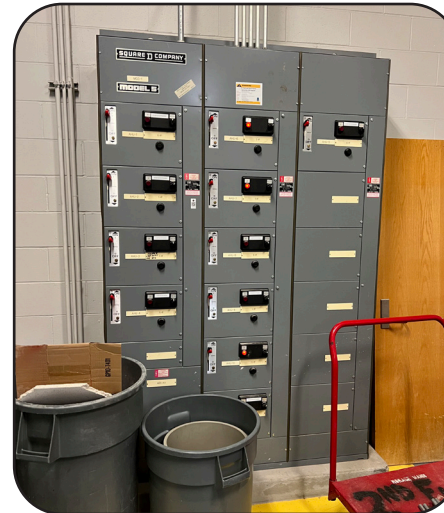
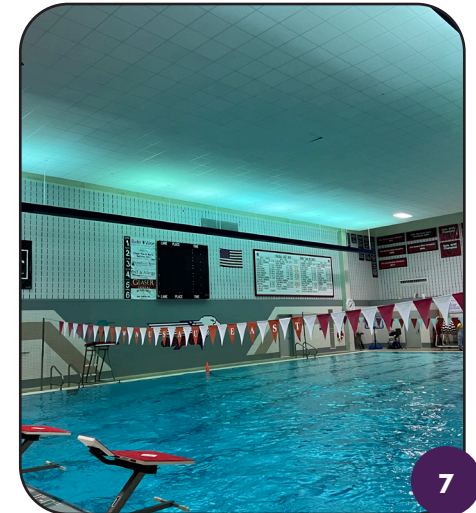
Building System	General Description	Recommendation	Cost Estimate
Exterior Building - Roofing	Roof sections A-G and I, totaling 66,500 sq. ft., are all roughly 22 years old and out of warranty. All of the M section roofs, covering former standing seam metal roof, are also 22 years old and out of warranty. Inspect these M roofs thoroughly in attempt to extend life given a strong underlying roof. Roof sections H, J, & K come out of warranty in 2025, however should have roughly 5-10 years of life remaining. From Google Earth historical imagery, it did not appear that all M roofs are of the same vintage, as roofing reports state.	Replace sections A-G and I in 3-5 years, expect to replace sections H, J, K, and the M roofs in 5-10 years.	\$1,900,000
Exterior Building - EIFS	The school is experiencing ongoing problematic leaking in the gym roof/EIFS wall area. Concrete panels by pool entrance doorways leaking. These issues have been difficult to solve and has been bringing water into the building for years.	Complete upper EIFS demo/reflash/reconstruction. Extend or modify scupper to prevent staining. Professionally clean face brick.	\$250,000

Electrical - Breakers	The large Square D Model 5 motor control center in the second floor mechanical room is obsolete. Parts may be difficult to obtain on the used market.	Replace the obsolete breaker panel with modern equipment in the next 5-10 years.	\$75,000
Electrical - Pool Lighting	Pool lighting position above pool edge restricts ease of access. Ongoing issue per staff interviews.	Relocate and update lighting to provide safer accessibility.	\$28,000

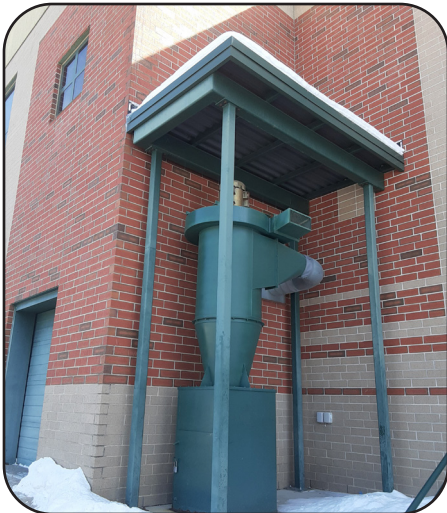
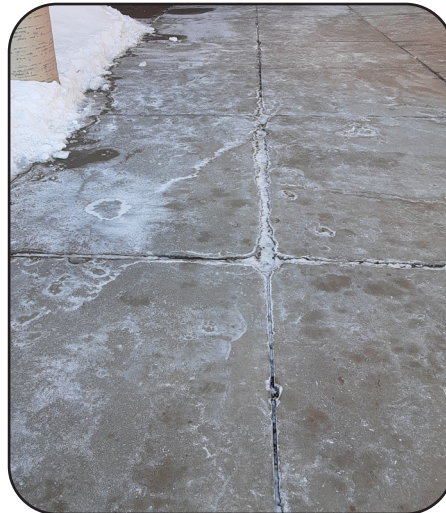
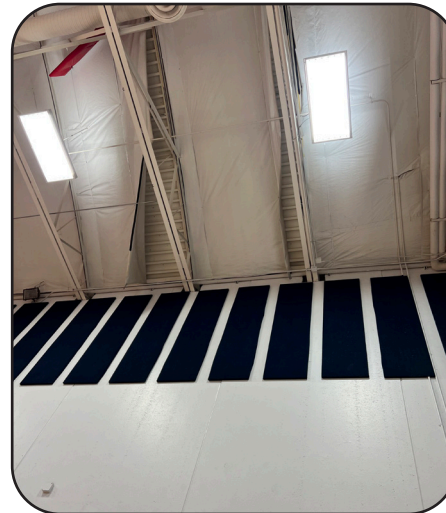
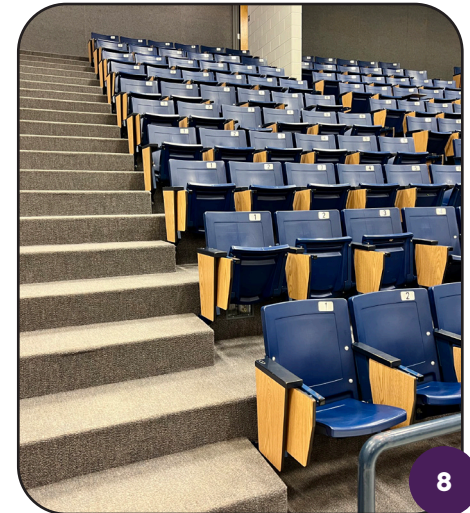
Building System	General Description	Recommendation	Cost Estimate
Mechanical - Shop Dust Collection	The Tech-Ed dust collection system is functional but original, making it 32 years old, past its expected life. A new system will be more reliable and energy efficient.	Replace and upgrade the dust collection system in the next 1-5 years.	\$125,000
Site & Landscape	Multiple concrete walk slabs with transitional and divided cracks.	Replace cracked concrete walk slabs.	\$40,000
Interior -Gym Ceiling	Acoustical ceiling pads in the gym are coming down in some areas likely due to area water infiltration.	Although the condition of the ceiling blankets could not be determined from the ground. It is likely that these just need to be retaped/resecured after the water leaks are addressed.	\$10,000
Interior - Large Group	The large group room seating and flooring is showing its age. Carpet is wearing, showing through to backing in some areas. Seating is worn and uncomfortable.	In order to replace the carpeting, the seating must be removed. Seating is worn but functional. Determine if the district would like to refurbish and reinstall or purchase new seating. A band-aid fix would be to replace the worn stair sections with a rubber tread material. Pricing given for full replacement of flooring and seating.	\$150,000

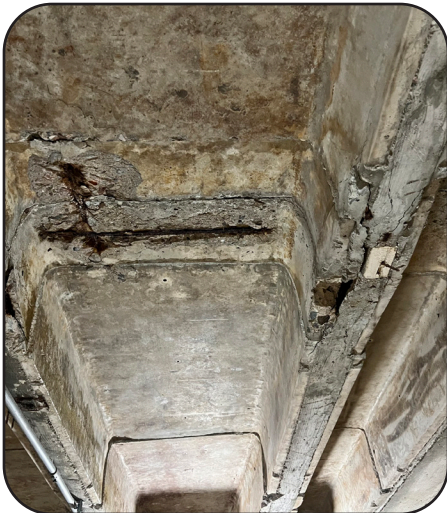
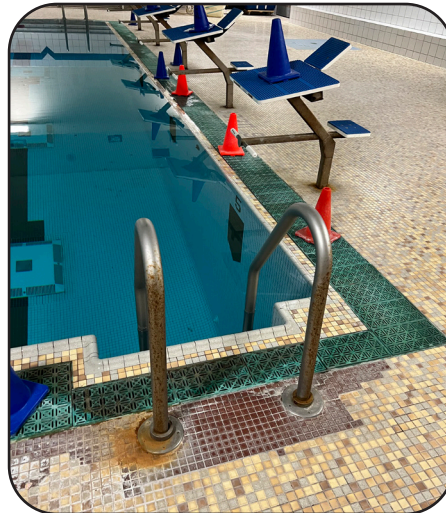
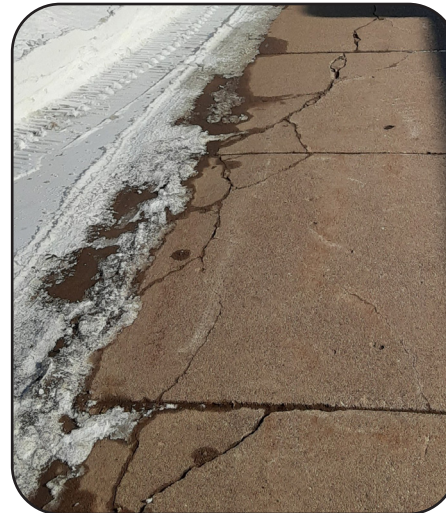
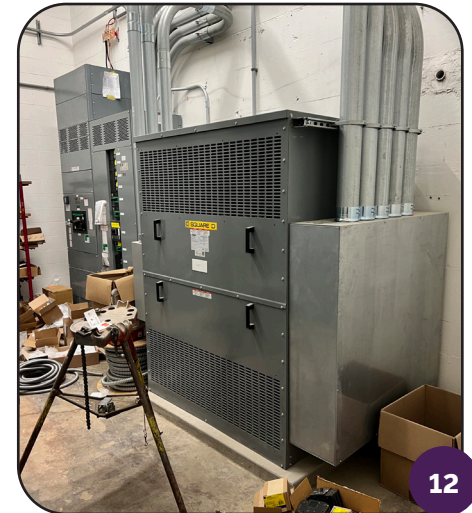
Building System	General Description	Recommendation	Cost Estimate
Interior - Pool Deck Structural	The underdeck tunnel area surrounding the pool is degrading. In certain areas, concrete reinforcement is severely rusting and has popped concrete out of the structure.	Work with a structural engineer to identify if there is any immediate risk and put forth a repair plan. This will likely include chipping away loose concrete, grinding, painting rebar, and reapplying new concrete. The longer this repair is deferred, the worse the situation will get.	\$50,000
Interior - Pool Deck and Equipment	The pool deck tile has locations of past spot replacement and some tile grout is missing. Stainless steel rails, pool start stations, and judge station are rusting.	The pool deck will likely need attention in the next 3-7 years. At this time determine if the district would like to redeck the entire pool area or continue with spot replacement. Replace or refurbish pool equipment in conjunction with a deck project.	\$175,000

Site & Landscape	Site concrete sidewalks in poor condition.	Replace surrounding concrete sidewalk as needed.	\$50,000
Electrical - Surge Protection	Loss of phase and power surges have become an issue in John Muir.	The district is currently working with an electrical engineering company to rectify these issues across the district. Our recommendation is to prioritize the individual issues at the various sites and compare project costs from multiple vendors.	\$35,000

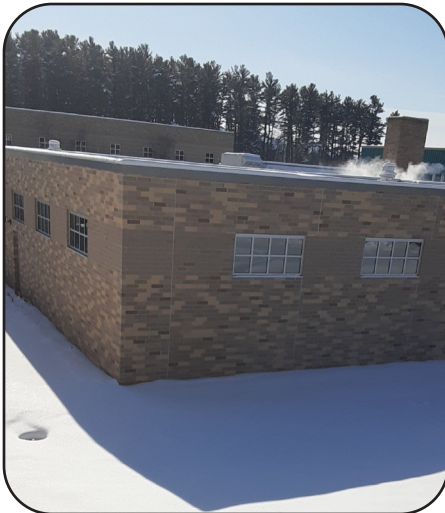
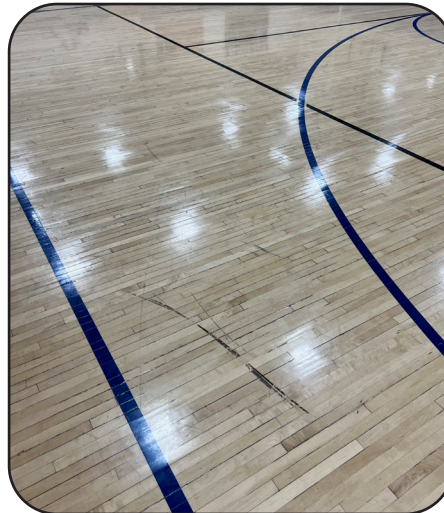
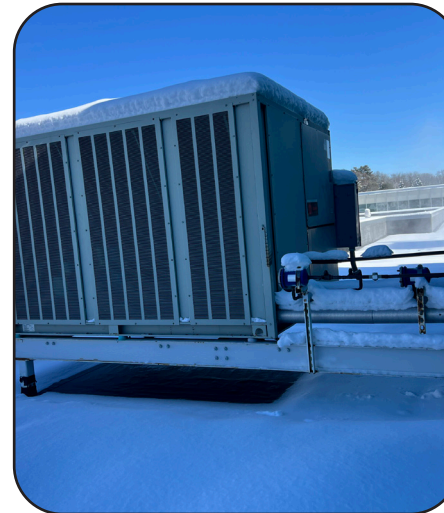
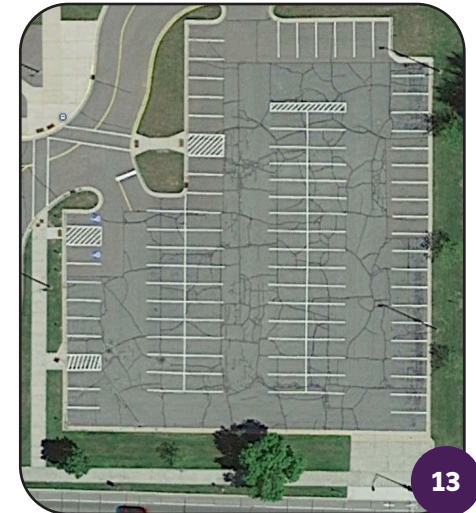
Building System	General Description	Recommendation	Cost Estimate
Exterior Building Roofing	Roof sections X-Y are 21-23 years old and out of warranty. These roofs should be replaced in the next 2-5 years. Various other sections (A-F) begin to come out of warranty in 2025-2027, however should have life left until roughly 2030-35.	Replace roof sections X and Y in the next 3-5 years. Expect to start seeing issues in roof sections A-F in 7-10 years.	\$825,000
Interior - Gym Flooring	The main gym floor is scuffed, scratched, and overdue for refinishing.	Sand, paint, and refinish gym floor in next 1-2 years. Maintain a wood floor refinishing cycle, recommended every 5-10 years dependent on use and condition.	\$35,000
Mechanical - Air Handling	E1 AHU/DX system has frequently been problematic. Additionally, ongoing mechanical maintenance due to system complexity.	Replace the E1 AHU/DX unit in the next 3-5 years. Air handling mechanical equipment in this school is in fair condition overall. Several units have had sections mothballed due to past failures. Given the age of the equipment, it is recommended to continue to maintain due to the high cost of replacement. Mechanical maintenance costs at Muir will be higher compared to average schools.	\$675,000

Site & Landscape	Southeast parking lot is in failing condition.	Hire a civil firm to design a rework and resurface the lot. Ensure stormwater utilities are properly in place.	\$350,000

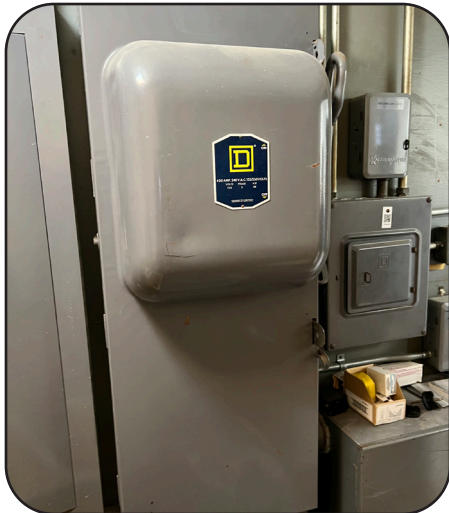
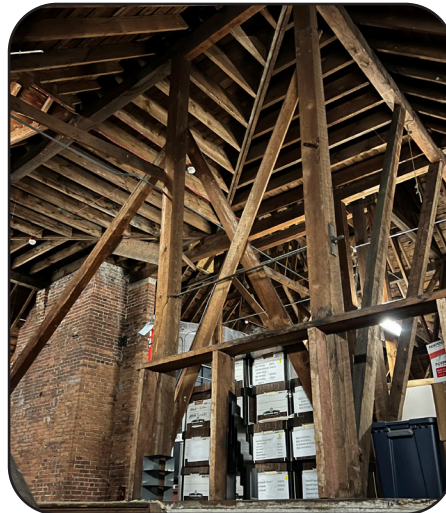
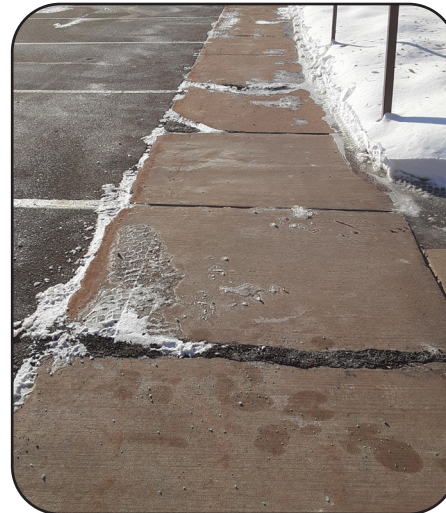
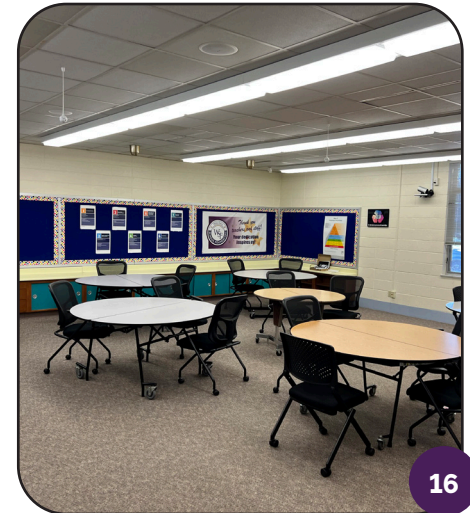
Building System	General Description	Recommendation	Cost Estimate
Electrical - Annex Main	The main electrical equipment feeding the annex is original 1963 and well beyond it's expected life. The equipment is obsolete and parts will be very difficult to find if needed. The electrical room is being used as janitorial storage.	Replace all the annex electrical main gear. Keep code clearance in front of electrical panels.	\$75,000
Interior - Fire Hazard	The original 1894 structure is composed of an open truss, wood-framed attic. The space is used for paper and materials storage, and HVAC. It is not sprinkled but does have smoke detection.	Install a dry sprinkler system into the attic space.	\$80,000
Site & Landscape	Front walk in poor condition. Concrete is in need of maintenance.	Replace cracked concrete walk slabs. Grind or level uneven slabs.	\$45,000
Electrical - Whole Building Lighting Upgrade	The facility is in need of a whole building lighting upgrade from fluorescent to LED. Interior lighting projects typically provide a 6 year simple payback, along with giving building occupants the ability to adjust light levels to their liking. Additionally, the systems have a 20+ year lifespan, drastically reducing maintenance required to change lamps and ballasts.	Perform a whole building lighting conversion to LED fixtures including occupancy sensors in appropriate spaces, and dimming control. Before moving forward, ensure it is the district's intention to stay in this facility for 5+ years to break even on the investment.	\$60,000

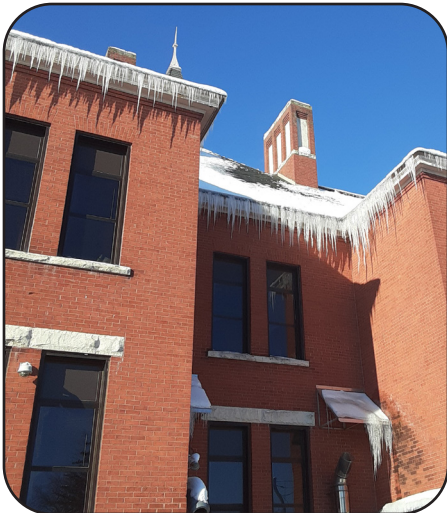
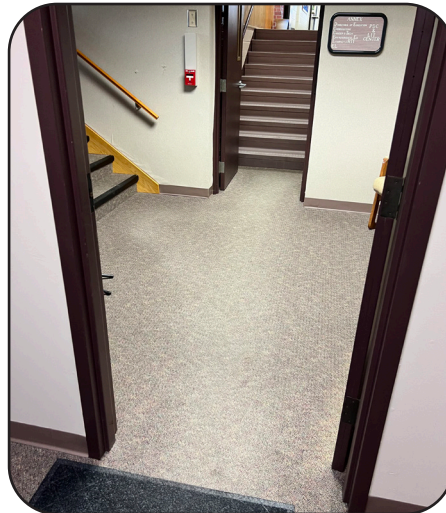
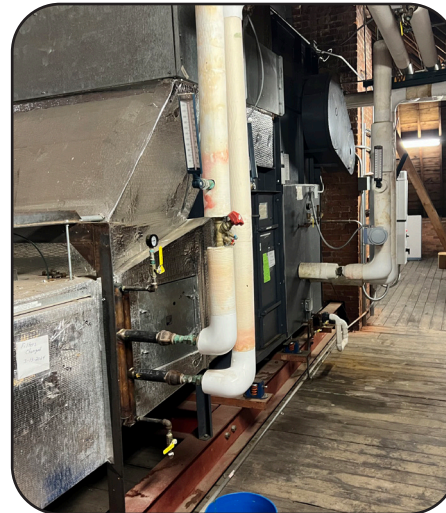
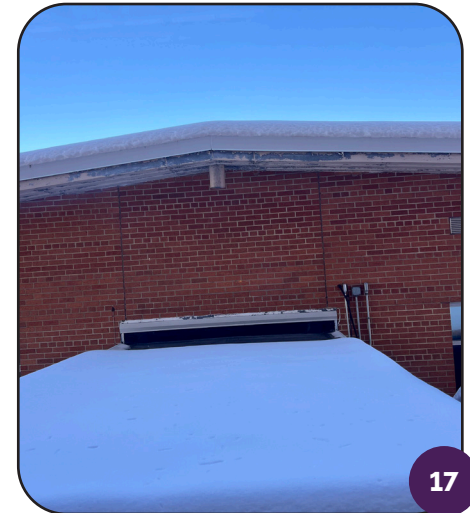
Building System	General Description	Recommendation	Cost Estimate
Exterior - Soffit/ Facia	Large icicles around roof edges of the original and 1990 additions causing ice dams and heavy ice edge build up. Anticipate moisture infiltration during warmer seasons.	Air seal around perimeter of attic areas. Add underlayment ice and water shields to lower roof sections as part of roof replacement. Consider installing ice melt system if problems persists.	\$65,000
Interior - ADA	ADA access does not transition between the Annex and original building. Wheelchair access is not provided between the two buildings.	Install an accessibility lift between the two facilities.	\$75,000
Mechanical - HVAC Renovation	The Longfellow facility has multiple HVAC issues, some spelled out individually. This FIM identifies a full mechanical renovation at the facility replacing air handlers and piping. The facility uses a single-pipe system, heating and cooling water is run within the same pipe, making temperature control impossible at times in spring/fall. The air handler of the annex is plugged and no longer operating, not allowing code minimum fresh air to the space. All AHU's have been modified and are past their expected useful life.	Perform a full air & water piping HVAC renovation to the facility, installing both hot and chilled water piping. This FIM does not include boiler and chiller replacement identified elsewhere. If this entire project is not performed, replacing AHU-1 in the annex is high priority. (est. \$125,000) Perform this FIM at the same time as boiler/chiller replacement.	\$950,000

Exterior - Soffit/ Facia	Painted metal soffit and fascia around 1963 addition chipped and peeling.	Prepare and paint soffits and fascia. Consider cladding in aluminum to improve appearance and extend durability.	\$35,000

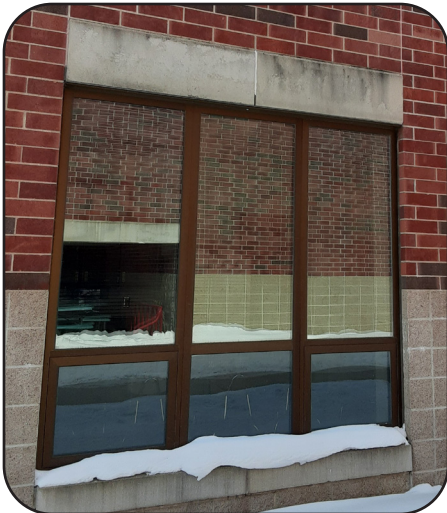
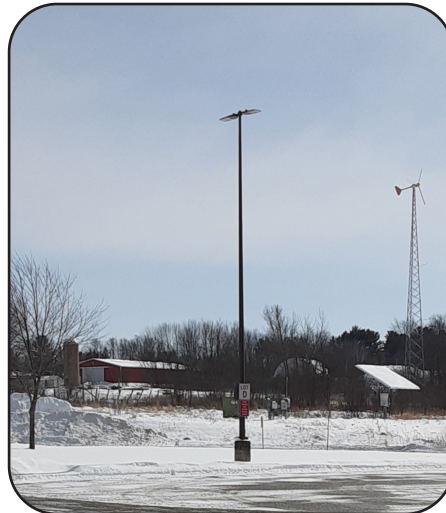
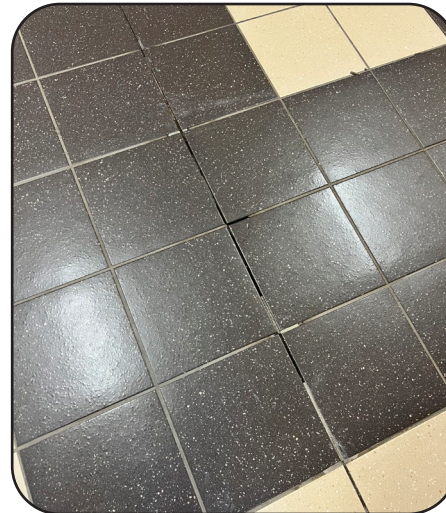
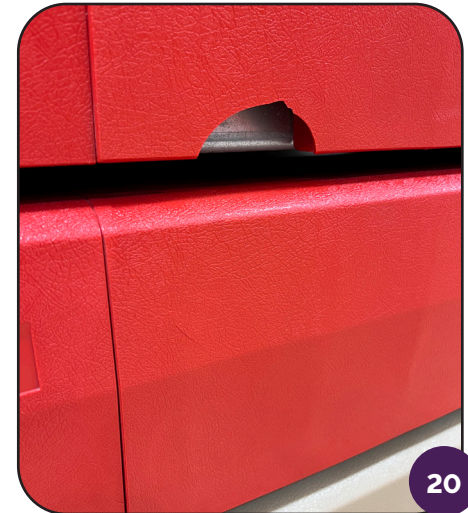
Building System	General Description	Recommendation	Cost Estimate
Exterior Building	Light colored EIFS above exterior door entrances and large storefront windows are darkly stained.	Clean above areas. Seal and caulk openings. Prepare and paint to remove and cover stains.	\$21,000
Electrical - Exterior Pole Base Lighting	Due to freeze/thaw and drainage issues in the main parking lot (addressed in separate FIM), the parking lot lights are heaving and wiring breaks are occurring.	Replace damaged pedestals and rewire during parking lot project. Include electrical in parking lot design.	\$400,000
Interior - Ceramic Flooring	Areas of the school are seeing extensive failure of grout lines between ceramic tile.	RegROUT entire sections of areas with widespread failed grout.	\$65,000
Interior - Bleachers	East's bleachers are constructed of a plastic material easily damaged by balls. Also, frequent issues occur when pulling out the bleachers with electric motors not pulling in unison, binding the bleachers on their way out.	Install protective bleacher netting. Have the manufacturer go through the motor and pulley system to extend the life of the bleachers. Budget to replace damaged plastic bleacher rows.	\$45,000

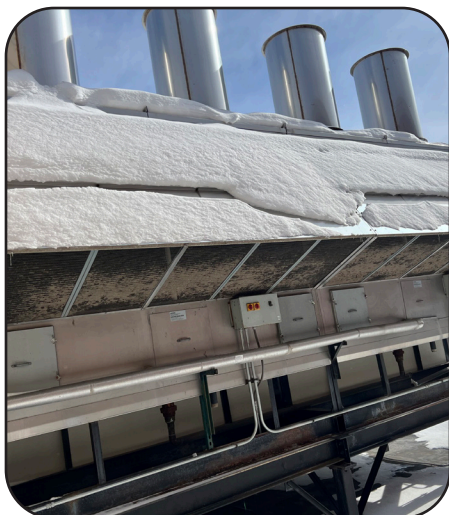
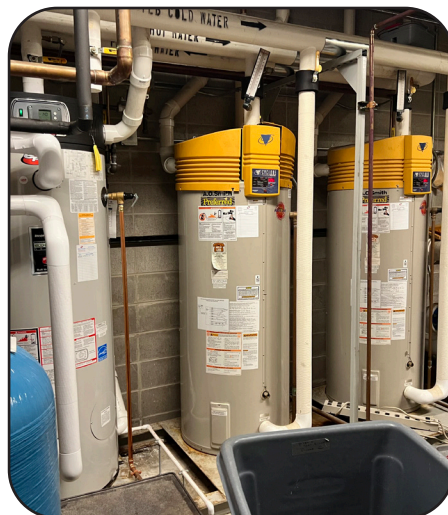
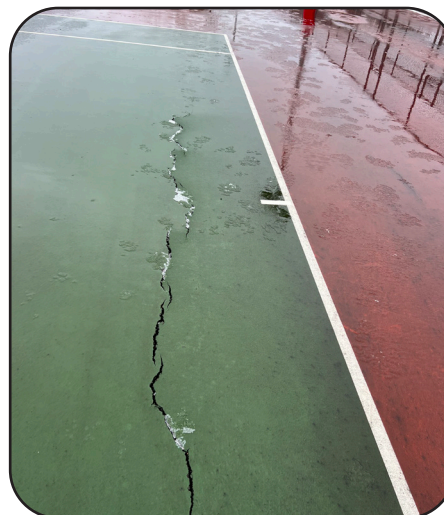
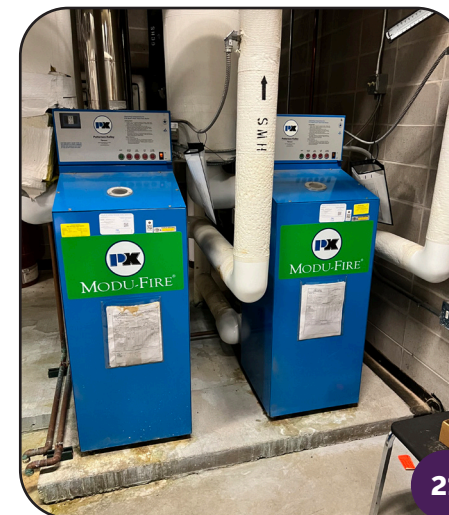
Building System	General Description	Recommendation	Cost Estimate
Mechanical - Air Handling	Ongoing mechanical maintenance due to system complexity.	Air handling mechanical equipment in this school is in fair condition overall. Several units have had sections mothballed due to past failures. Given the age of the equipment, it is recommended to continue to maintain due to the high cost of replacement. Recent cooling issues demand frequent follow up until resolved. Mechanical maintenance costs at East will be higher compared to average schools.	\$300,000
Mechanical - Domestic Hot Water	Of the five units reviewed during the audit, two were recently installed, one is 12 years old, and the remaining two are 23 years old - well past their expected life.	Expect to replace two water heaters within the next 1-2 years, and one within 3-5 years.	\$22,500
Site & Landscape	The tennis court area is failing. Cracked surfaces due to poor subbase drainage is occurring.	Hire a civil engineer to design a new court surface system with proper subbase drainage. Excavate and replace the courts entirely.	\$600,000

Mechanical-Boilers	Aside from the 2016 addition boiler, all 8 remaining boilers in the facility are 21 years old and approaching their end of life.	Expect to replace all eight original boilers in 5-10 years.	\$700,000

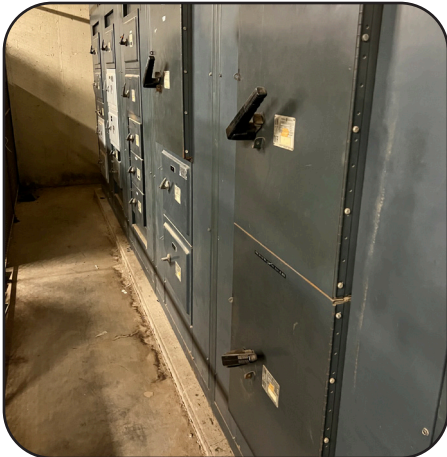
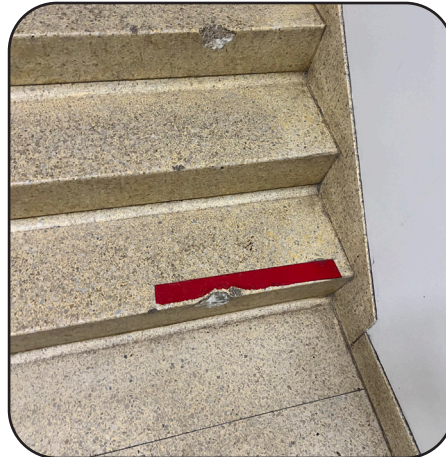
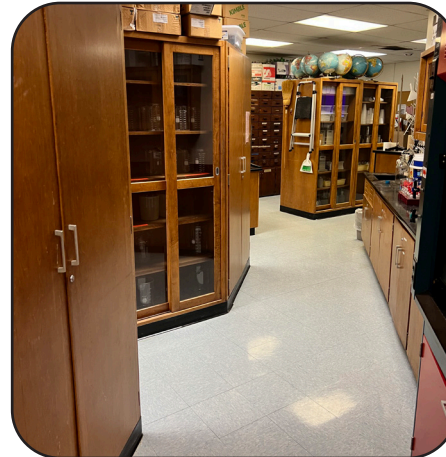
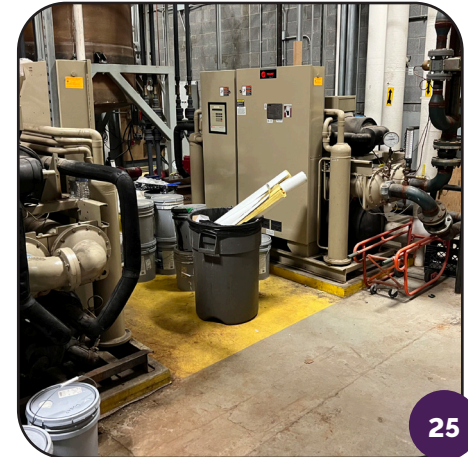
Building System	General Description	Recommendation	Cost Estimate
Electrical - Main Service	One of the main 3000A electrical services is of 1960's vintage, well beyond it's expected life, and obsolete for manufacturer support. Replacement parts will be difficult to find and expensive on the used market.	Replace the old 3000A main and its entire network of same vintage large breakers.	\$200,000
Interior - Stairwell Flooring	Terrazzo stairwells throughout the facility are in poor condition with many having major failures.	Prep the surfaces and install rubber tread. Address handrail issues.	\$240,000
Interior - Science Life Safety	Second floor science consists of a conglomerate of pods with the interior large science storage area being landlocked with no corridor space. This space appeared to have no emergency lighting and be under served with fire protection equipment.	Install 24-hour egress lighting in science storage and the surrounding four vestibules. Review smoke detection and alarm/strobes with a fire protection specialist. Be aggressive with monitoring and alarm given the space usage.	\$12,500

Mechanical - HVAC & Chilled Water	One of the two main water cooled chilling plants has a failed condenser bundle - a costly repair. The chilled water plant is water cooled. This cooling tower is also in need of repair and a high maintenance item. Several complex large AHU's (namely 1, 2, & 15) have been frequently problematic with portions of their components shutdown and frequently plugging air streams.	Hire a mechanical design firm to create a long term HVAC plan for the school. Evaluate the pros/cons of abandoning water cooled chilled water with ice storage vs. air cooled chilled water. Consider replacements of AHU's 1, 2, & 15 to conventional dual-coiled VAV w/reheat units. Complete an in depth mechanical strategic plan prior to replacements to ensure conformity to long term plan. Pricing given for systematic replacement of higher priority issues. Budgeting provided assumes: chiller maintenance years 1-2, chiller plant and AHU15 replacement years 3-5, AHU's 1 & 2 area full mechanical replacement in years 5-10. Large scale AHU's 1&2 replacement should coincide with needed renovations to second floor science interior.	\$4,150,000

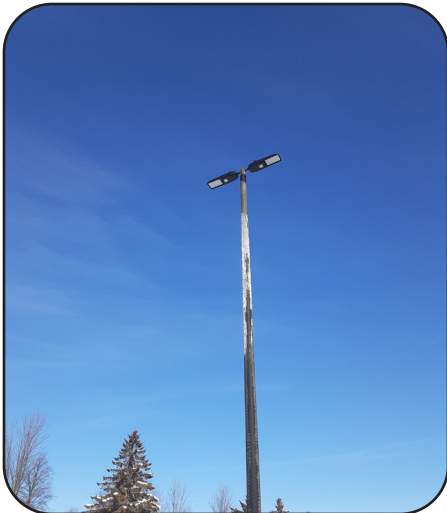
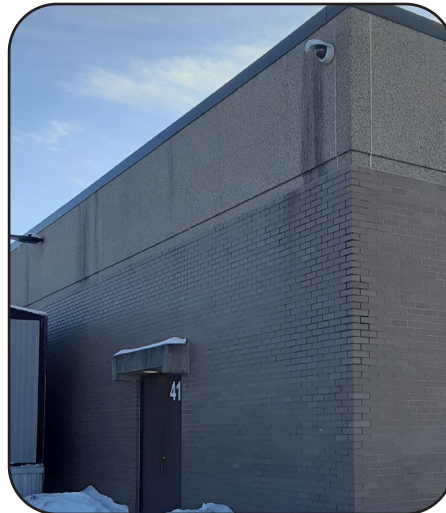
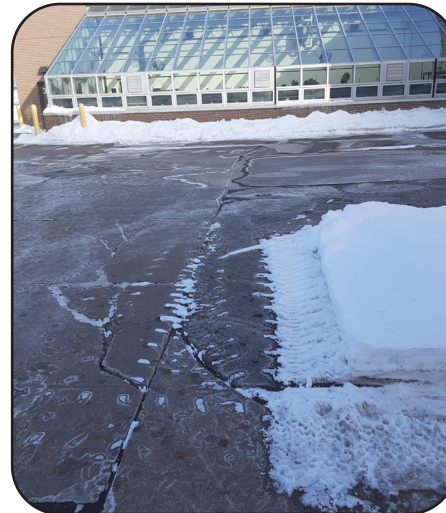
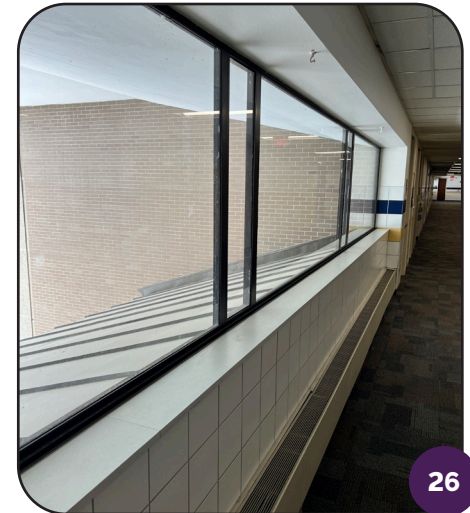
Building System	General Description	Recommendation	Cost Estimate
Electrical - Exterior Lighting	Exterior fiberglass light poles degrading and issues with control operation. School district owns the poles and WPS owns the light fixtures.	Replace district owned poles and repair or upgrade controls. Request WPS replace and upgrade fixtures as part of the pole replacement.	\$80,000
Exterior - Tuckpointing	Tuck pointing and masonry repairs needed. Stained face brick with open, missing, and deteriorating mortar.	Re-tuck walls, replace missing and damaged masonry, and professionally clean stone and bricks.	\$45,000
Site & Landscape	Set routine asphalt maintenance schedule with area rotation.	Continue to crack clean and crack fill as needed. Every 3-5 years seal, and repaint asphalt.	\$5,500
Exterior - Windows	Three large corridor windows on second floor are single-pane non-tempered windows. These windows are both inefficient and dangerous.	Replace the large single pane sections with double-pane thermally-broken tempered glass aluminum windows.	\$50,000
