Owner Assistance / HVAC Evaluations

**Beecher Road Elementary School
40 Beecher Road - South
Woodbridge, CT 06525**

van Zelm Heywood & Shadford, Inc.
10 Talcott Notch Road
Farmington, CT 06032

December 18, 2018

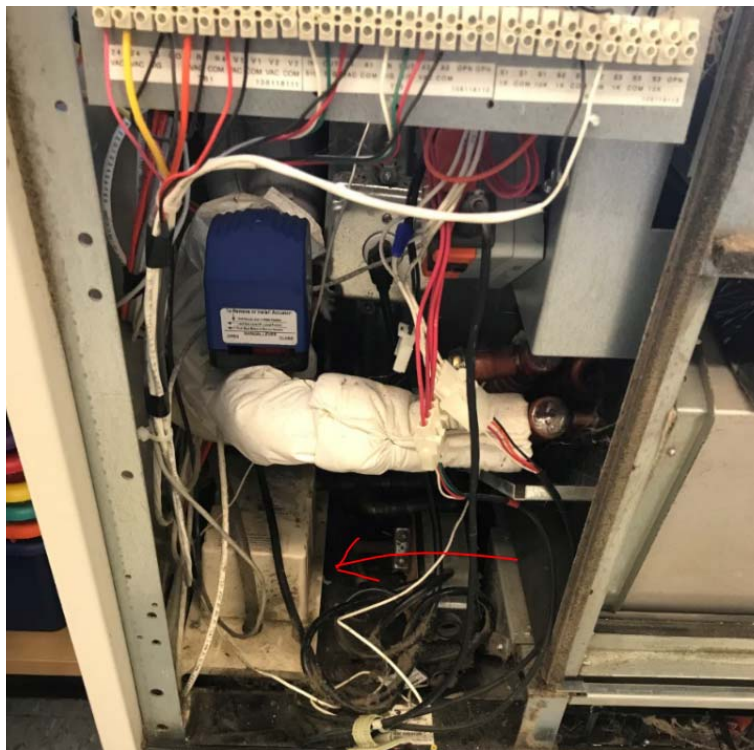
- c. The coils on the UV and FCU in the sample rooms were verified to be piped correctly (counter-flow fashion).
- d. Some of the condensate pumps in the UV's were found to be unplugged.

Figure 2- Location of condensate pumps on UV's

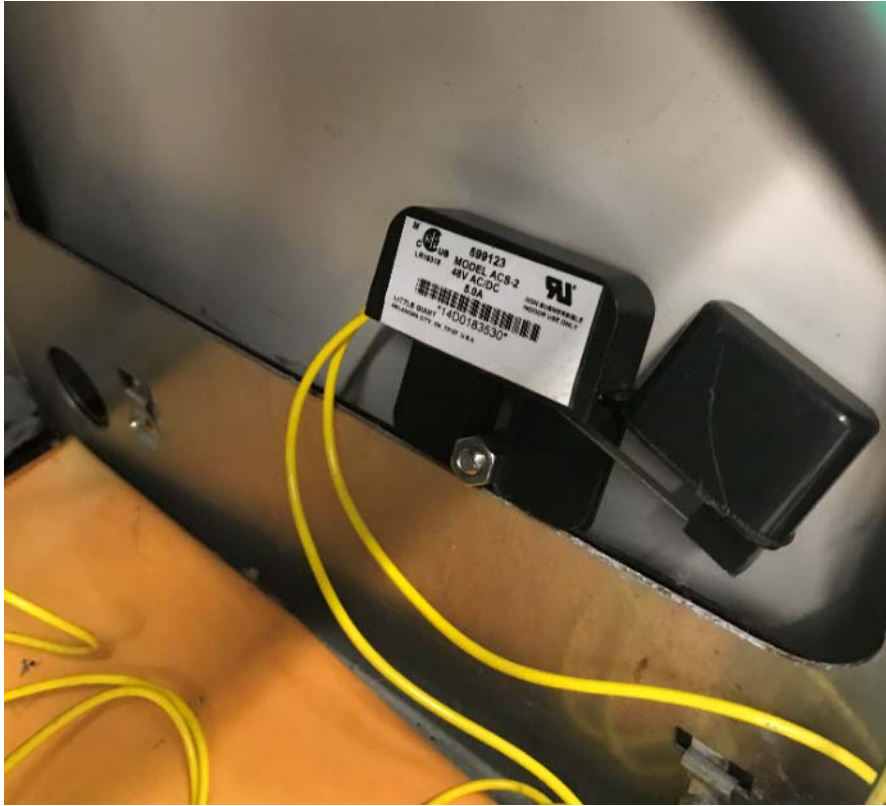
Figure 3- Typical UV float switch

3. Permanently mount the float switch to the unit in an area that will sense a drain pan overflow condition.

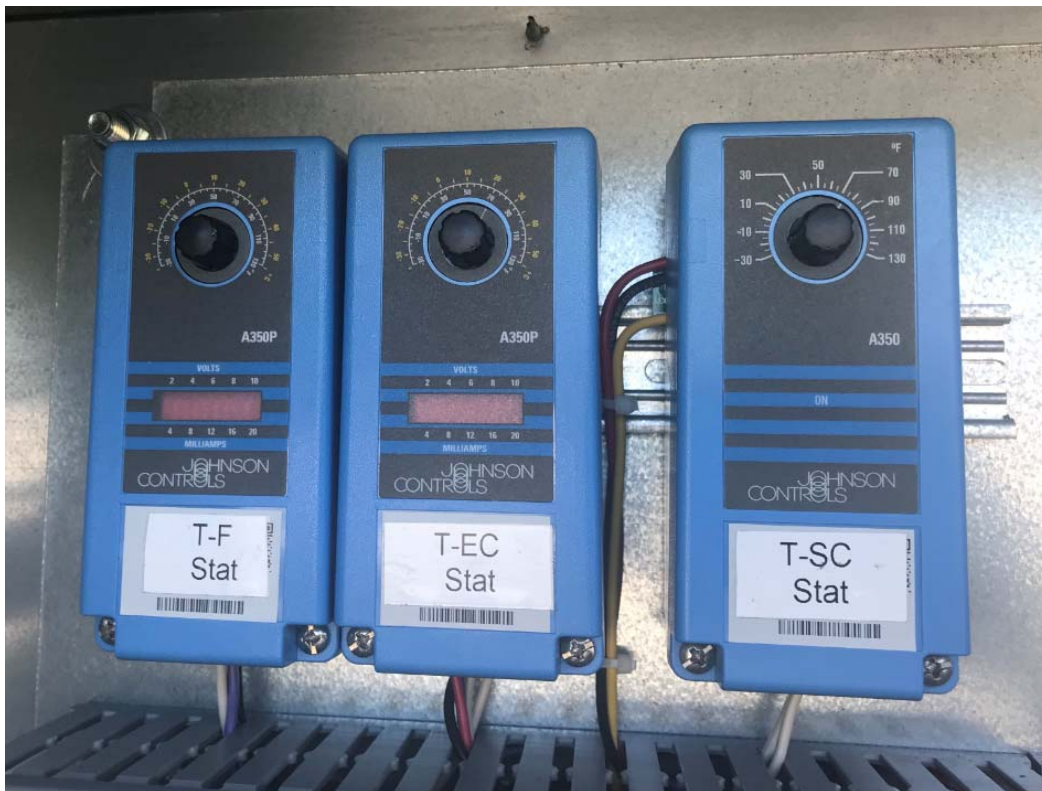
- a. We discovered that the local controls on the ERV's were not setup properly. The local sensors are meant to control frost mode, economizer mode, and summer recovery. The manufacturer supplied controls for the heat exchanger bypass damper control had been adjusted to prevent the unit from entering "summer recovery" mode. With this as-found condition, the heat exchanger would be bypassed in the summer months, thereby delivering completely untreated, hot and humid air into the building.

Figure 8- ERU local controls

Currently the ERU's have localized controls to operate frost control, economizer and summer switchover modes. Since these are functions happening within the unit, they are not able to be seen or trended by the BAS. We highly recommend that these control functions be brought on to the BAS system to allow for better control and monitoring of the ERU's in both the heating and cooling seasons.

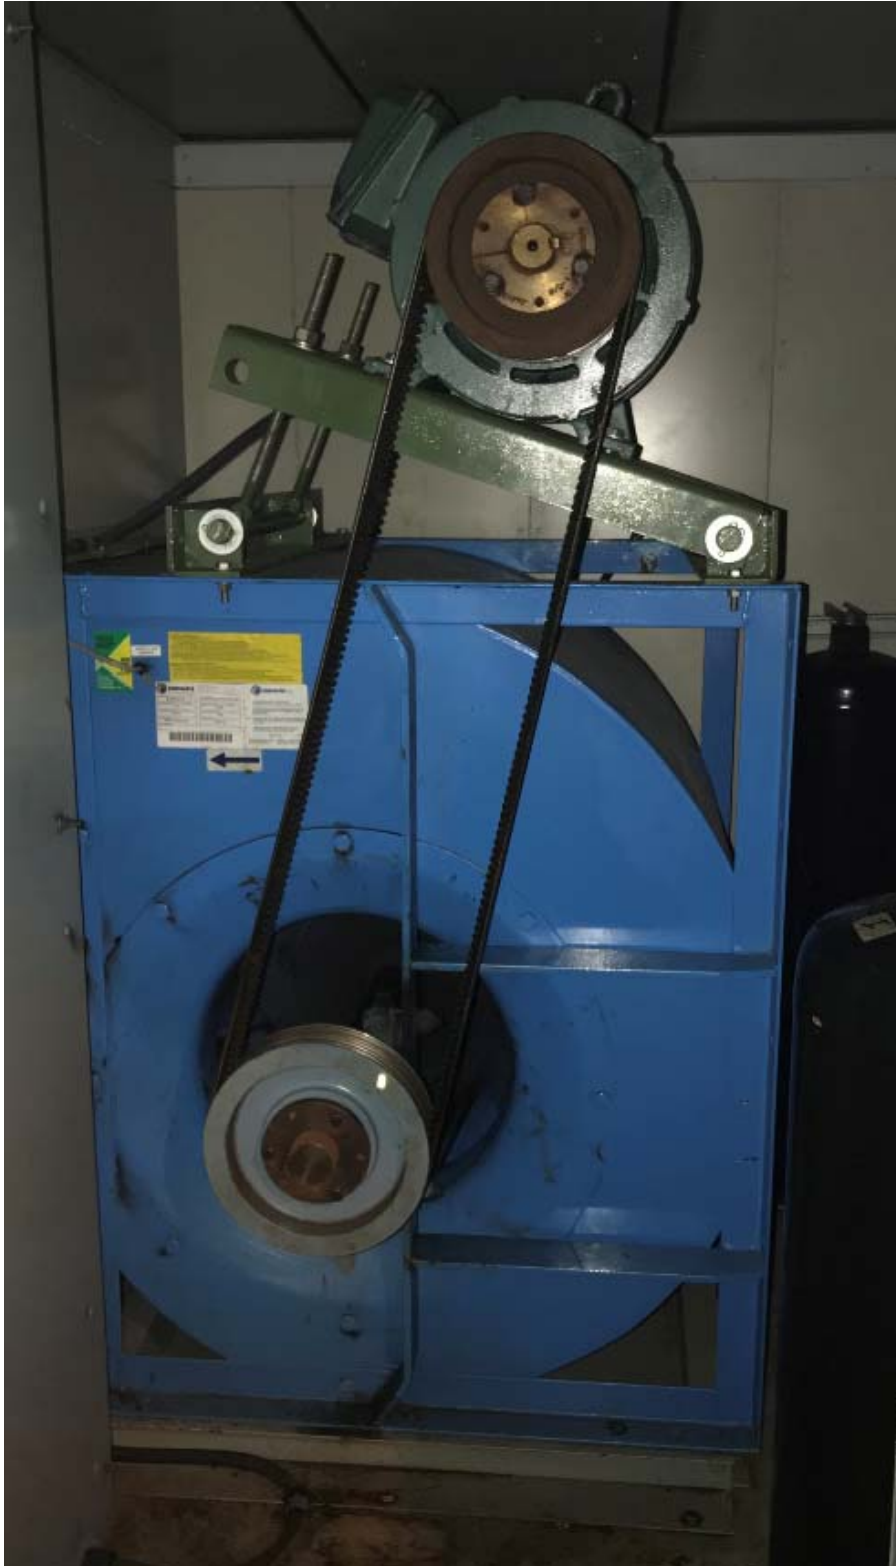
- a. When we first arrived at the School on October 25, 2018, we observed that the Dectron unit was off. When it was turned on, a very loud noise was observed coming from the supply fan motor bearings. We contacted the Manufacturer Rep (Aercon Corporation) to make them aware of the ongoing issues that we are having with the current bearing failure, along with past bearing failures that occurred. As part of the discussions, we had asked them to advise on a company that we could use to test the existing bearings and existing supply fan motor to determine how much damage may have been done to the unit. They recommended Integrated Diagnostic Services, Inc (John Tecchio). The School then hired IDS to perform vibration testing on the Unit.

- b. We met with IDS onsite on October 5, 2018 to conduct the first test on the Unit. It was observed that the pulleys were misaligned and both inner and outer bearings were bad and needed to be replaced. IDS test reports have been included in Appendix C.

Figure 12-Dectron Unit-Supply Fan section

Now that the greasing schedule has been determined, we recommend that EMCOR perform the maintenance and update the O&M manual with this new information. Also, we would highly recommend that IDS return in six months (May of 2019) to recheck the fan bearings. Subsequent vibration testing intervals should be determined after the six-month evaluation.

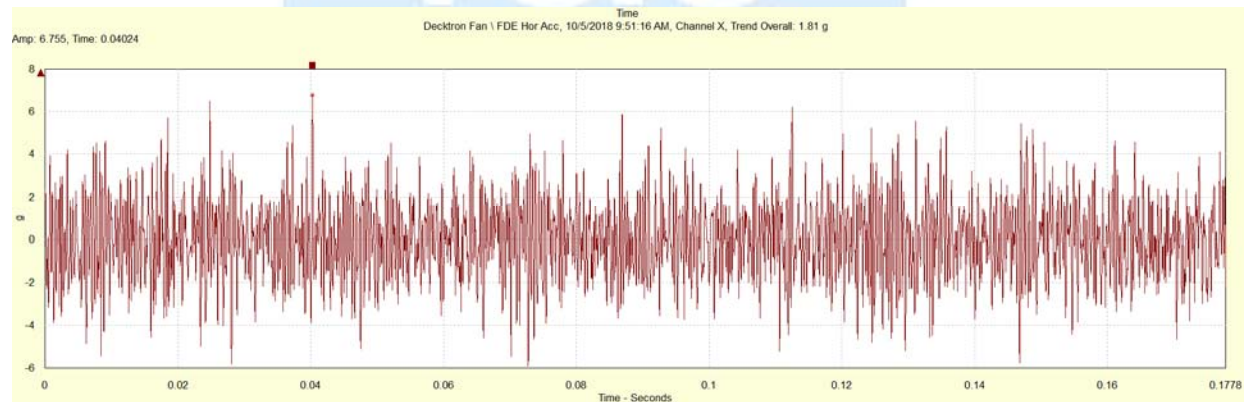
The drive side fan bearing shows an acceleration reading of 1.81g. This is well above a normal alarm threshold of 1.00g. There are multiple mid-to-high level impacts visible in the Time Waveform. This bearing should be considered in fault and can fail at any time.

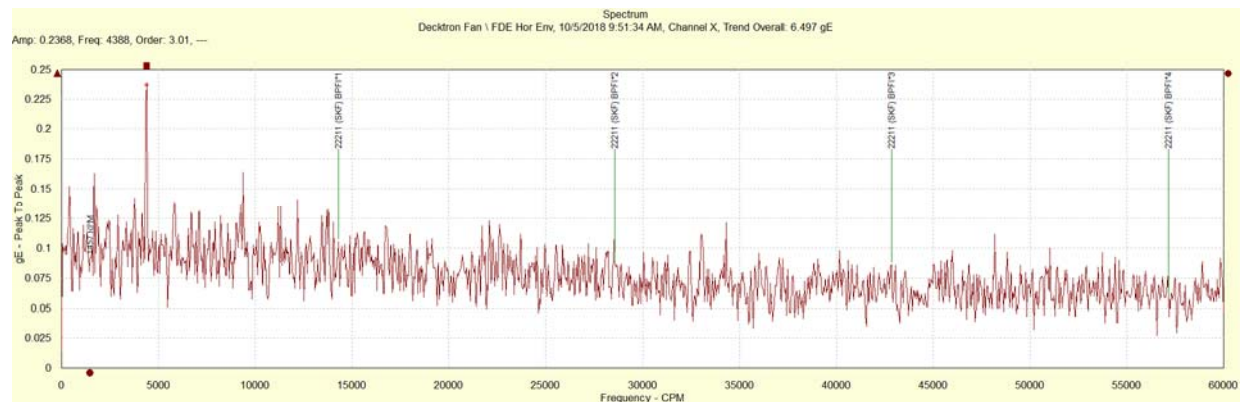
The Envelope Spectrum confirms the above impacts. There are multiple defect frequencies at the Inner Race.

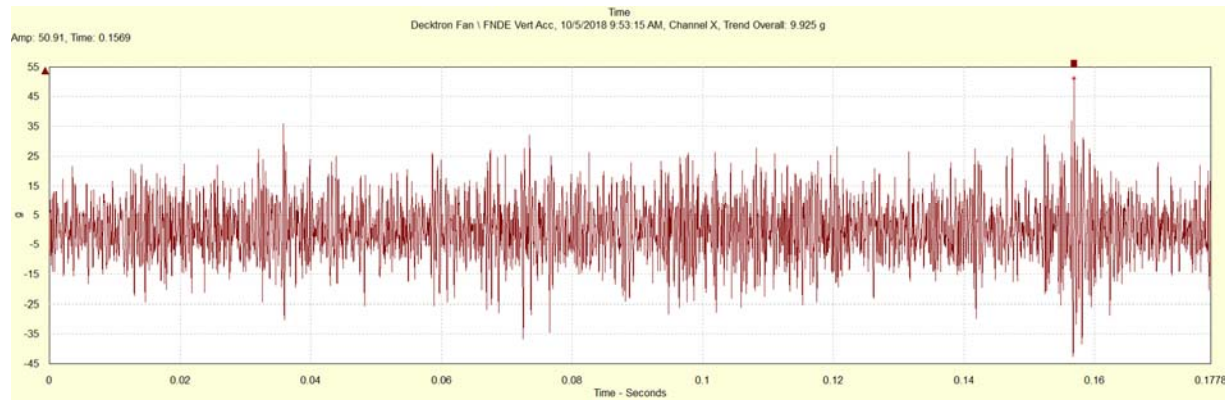
The non-drive side fan bearing shows an acceleration reading of 9.925g. This bearing should be considered at a Stage 4 fault and can fail at any time.

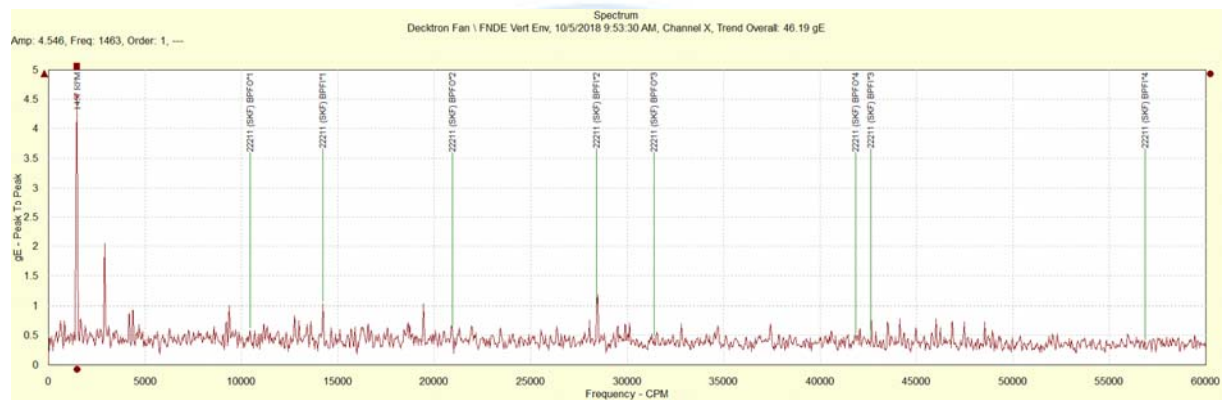
The Envelope Spectrum shows multiple bearing defect frequencies at both the Inner and Outer Race.

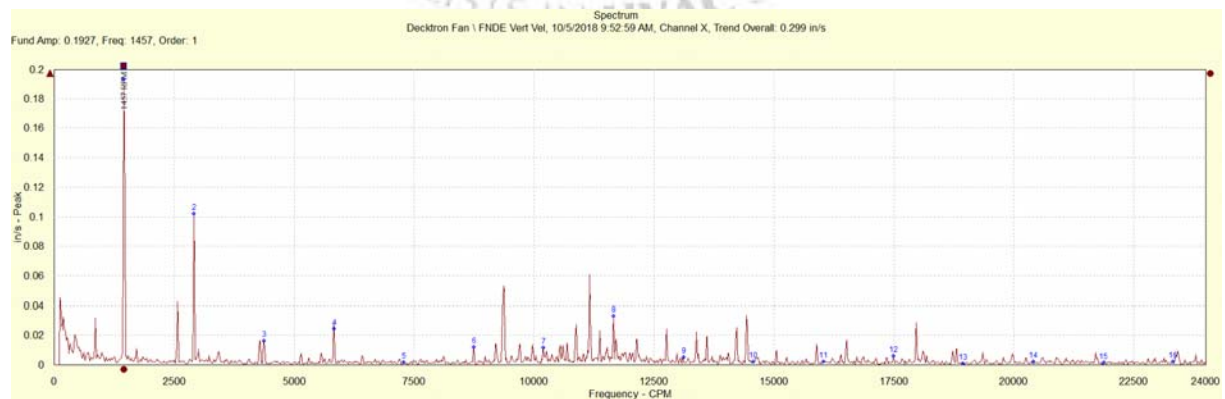
The Velocity Spectrum shows multiple harmonics of the running speed. This would indicate a Mechanical Looseness. Either the bearing is getting loose on the shaft (shaft may be scored) or the bearing is loose in the housing. Though there is a high amplitude at the running speed, it does not indicate a fan unbalance at this time. This does not mean that the fan is not out of balance, it means that a correct diagnosis cannot be done while the bearing is in fault.

Another thing to think about is: these bearing usually come with a fixed or an expandable spacer. If both bearings are of the fixed variety; they will cause a premature bearing failure. Make sure to order the correct bearings so this does not happen.

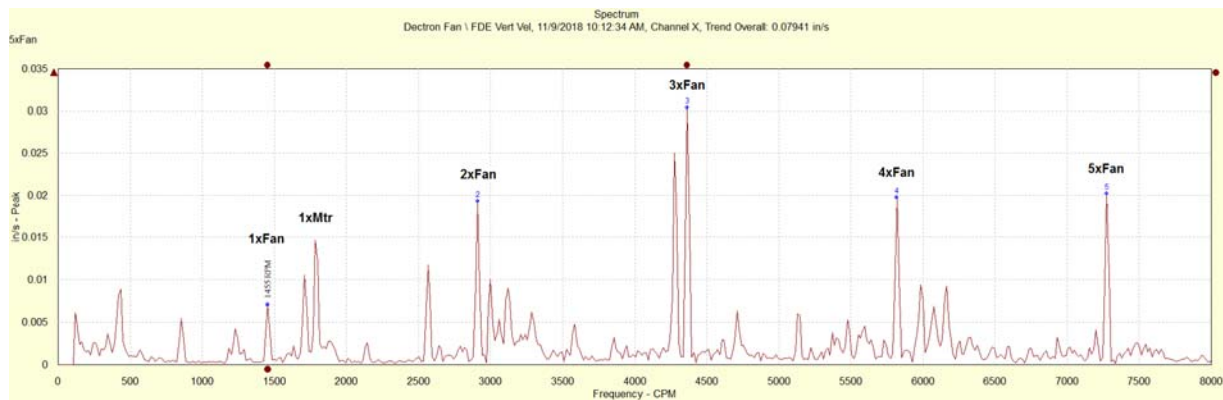
The Fan Drive End Bearing Velocity reading taken in the Vertical Position shows multiple harmonics of the fan running speed. This is an indication of a Type C Mechanical Looseness.

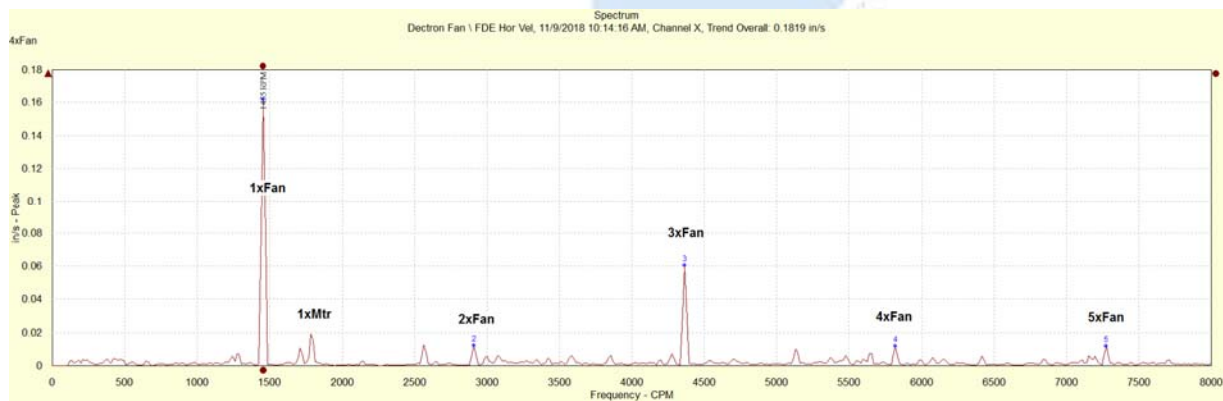
The Fan Drive End Bearing Velocity reading taken in the Horizontal Position shows the same harmonics of running speed with a higher Fundamental amplitude.

A Type C Mechanical Looseness can be caused by a bearing loose in its housing, an improper fit between components, and a loose impeller on its shaft. **All bolts should be checked for proper torque on the fan and bearing assemblies. The sheaves should be checked to see if they need to be replaced (they do look bad) and the belts should be checked for proper tension.**

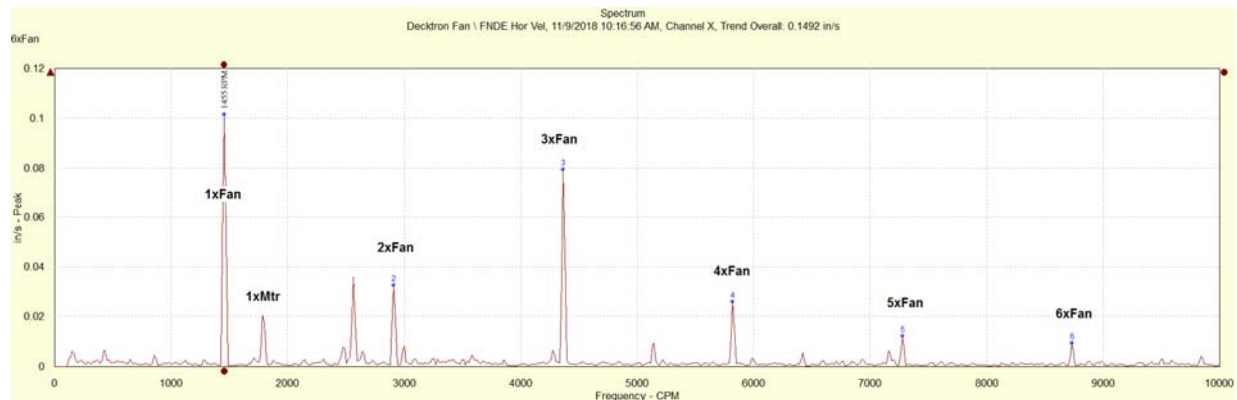
The Fan Non-Drive end Bearing Velocity reading in the Horizontal Position shows the same indications of a Mechanical Looseness.

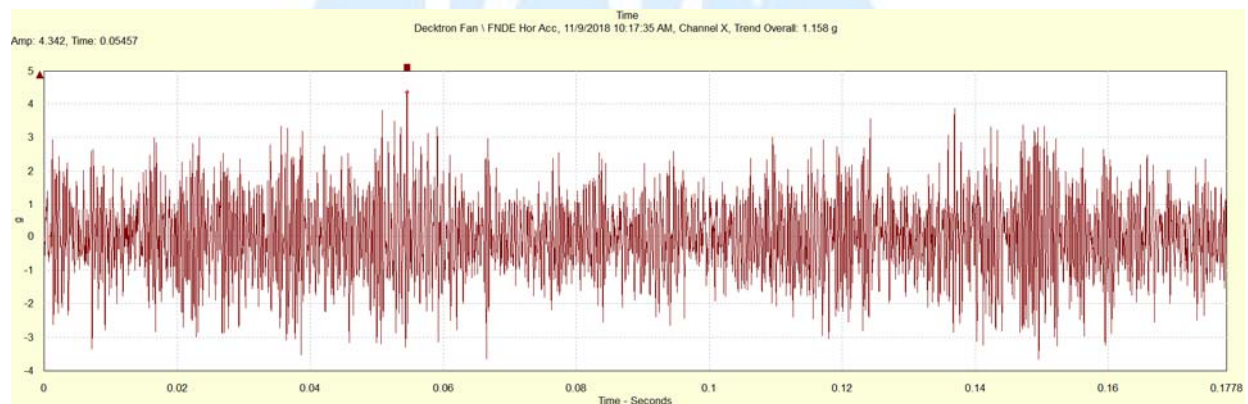
The Fan Non-Drive End Bearing Acceleration reading in the Horizontal Position shows an elevated Overall value. A good reading would be below 1.0g and a reading above 1.0g would show signs of a possible bearing issue.

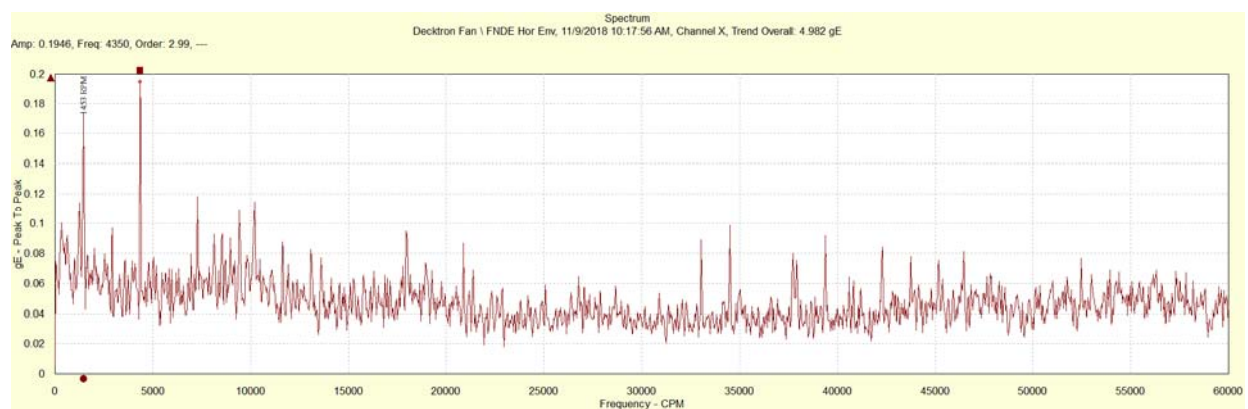
The Fan Non-Drive End Bearing Envelope reading in the Horizontal Position shows an elevated Overall value. A good reading would be below 4.0gE. A reading between 4.0gE and 7.0gE would show the possibility of a bearing fault.

I have seen these readings on new bearings many times in the past. Usually they can be reduced or eliminated by properly greasing the bearing. Manufacturers will tell you that the bearing comes pre-lubricated, but it is up to the field technician to determine if the bearing is properly lubricated.

I would highly recommend checking all the above points as well as adding the proper amount and proper lubricant to the bearings to see if the readings become acceptable.

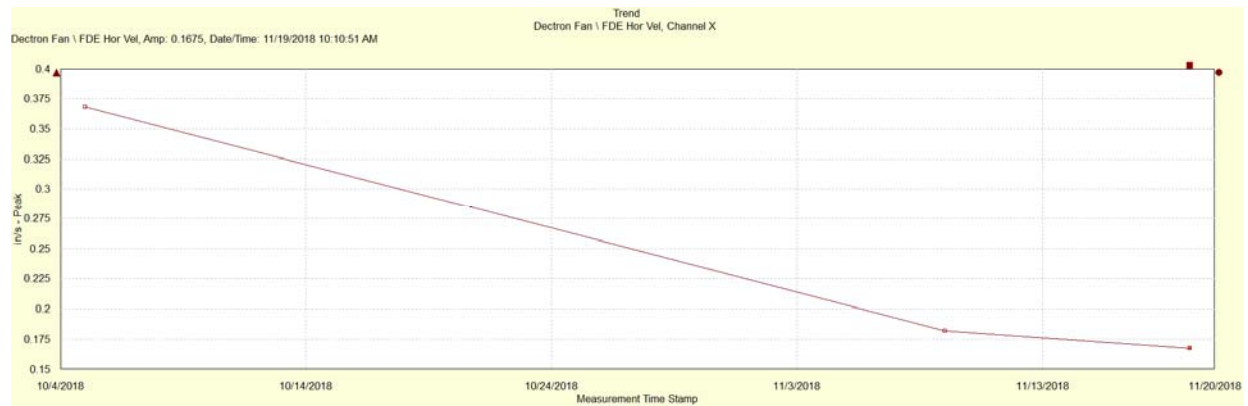
The vibration trend shows a 55% reduction in the velocity readings since the first trip to the site.

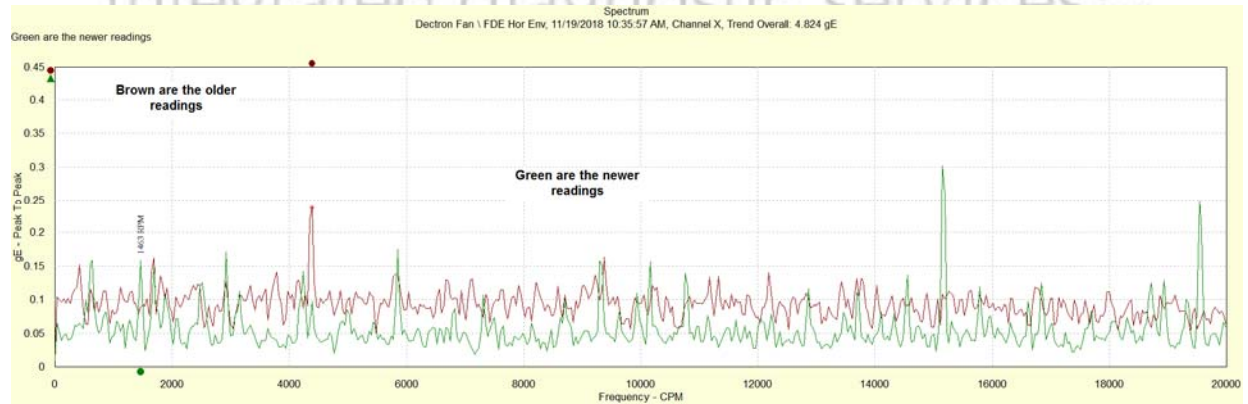
While there is still bearing noise showing up in the Envelope, there has been a 50% reduction since the first visit. The Overall reading is still showing the beginning stage of a fault.

The recommendation would be to check these readings in 6 months to see if there is any increase in the readings.
