To/Attention	Alicia Clark	Date	December 12, 2014
From	Dan Hess	Project	Russell MP Room
cc	Gordon Odette, Scott Wood	Project No.	12004
Subject	Warranty List

WARRANTY INSPECTION

PROJECT:	PARKROSE SCHOOL DISTRICT / SHAVER ELEMENTARY SCHOOL ROOF REPLACEMENT PROJECT - Q.C. INSPECTIONS	PROJECT #: R2817.08
-----------------	--	----------------------------

PROJECT:	PARKROSE SD / SACRAMENTO ELEMENTARY SCHOOL ROOF REPLACEMENT PROJECT - Q. C. INSPECTIONS	PROJECT #: R2817.07
-----------------	--	----------------------------

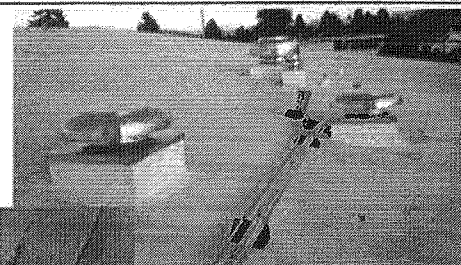
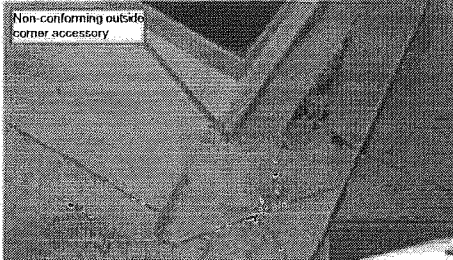
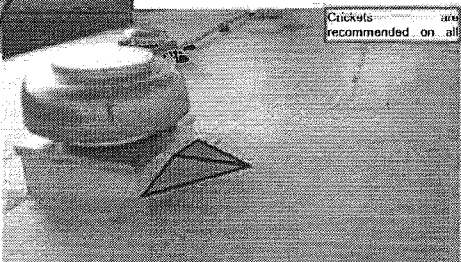
- 1.01 Three new exhaust fans have been installed through the new Sarnafil roof system on the South slope of Roof Area A. The three curbs have been installed with crickets to promote positive drainage. The outside corners of these units have been flashed with field fabricated flashing in lieu of the pre-molded accessories as was specified in the 2013 Roof Replacement project Contract Documents. It is of additional concern that these tenant improvement may not have been performed by the same installing contractor of 2013. This inconsistency of roofing contractors could have disrupted the installing contractor's warranty, as now a second contractor has performed work on the warranted roof. As well, if the roofing manufacturer's was not contacted prior to the installation of these tenant improvements, the manufacturer's warranty may also be disrupted.

Non-conforming outside corner accessory

Recommendation: Review the 2014 Contract Documents to confirm compliance to the Roofing Specification regarding the membrane installation at each new curb. Notify the roofing manufacturer in writing of the tenant improvements, their location on the roof plan and information regarding the installing contractor, in effort to maintain the existing warranty. It should be verified that the installing contractor of these tenant improvements is an authorized Sarnafil installer, if not the curb should be re-flashed by an authorized Sarnafil installer and preferably by the original installing contractor of the roof system.

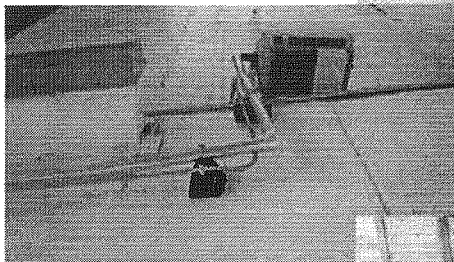
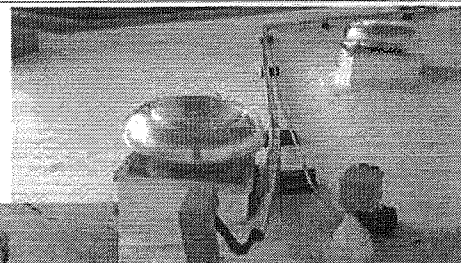
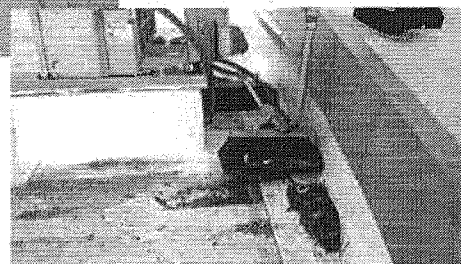
- 1.02 Due to the location of one of the newly installed curbs, the condensate line, which traverses the roof, is askew from its original straight line. This has resulted in the pipe being stressed at the corner of the curb to make the turn into the flashing hood. Additionally, the other end of this line was pushed up slope to help account for the new angle, which in turn, has lifted the support block off the roof surface of Roof Area B. By lifting the support block off the roof surface, the block is now in contact with the base flashing membrane, which could result in friction wear of the base flashing and ultimately water intrusion into the structure.

Recommendation: This line should be refabricated to account for all changes in direction and length to avoid stress in the line and to place the pipe support back to the roof surface.

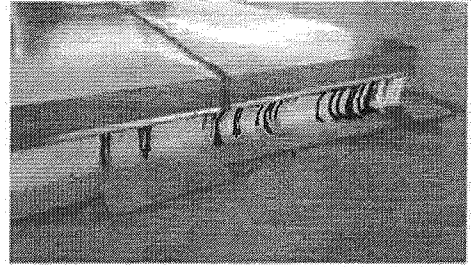
- 1.03 On Roof Area A, at the location of the removed chimney, the installed underlayment below the metal cap has been heated beyond its melting point and has drained down the curb onto the PVC membrane. The underlayment is manufactured with asphalt which is considered a contaminant to the PVC roofing membrane. This contaminant will result in early deterioration of the membrane and will not be covered under the manufacturer's warranty.

Recommendation: Remove the metal cap and the installed underlayment, remove all contaminated PVC membrane, install new PVC membrane to re-flash the base flashing of this curb, and install a new high temperature underlayment with a minimum temperature resistance of 240° F. (E.G. Grace Ice and Water Shield HT, Carlisle WIP 300 HT). As per Sarnafil Technical, no self-adhered membrane is to be in direct contact with the PVC roofing membrane. The use of Sarnafil's silver tape could be used at the top edge of the termination bar to separate the two membranes.

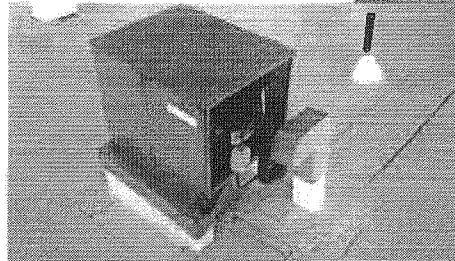
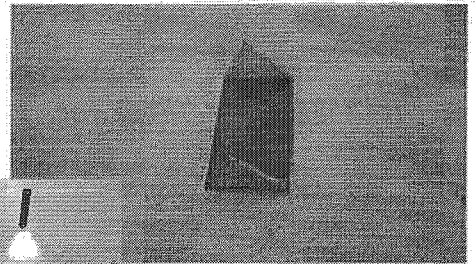
- 1.04 The hood to a refrigerant unit has become dislodged and was found on the membrane. Sharp edges of the hood could have resulted in damage to the membrane, though none was observed during this inspection.

Recommendation: Reattach the hood to the unit with securement fasteners or if no longer necessary, remove the hood from the roof level.

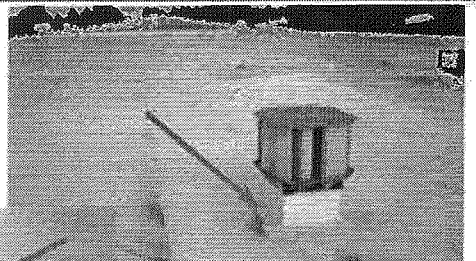
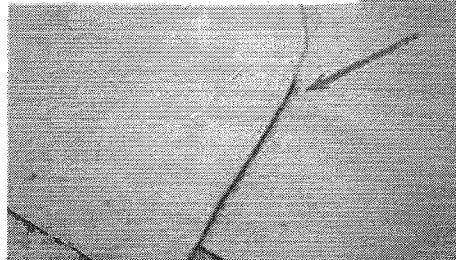
- 1.05 On the unit depicted to the right, one outside corner was installed with a minor void in the weld at the transition, which over time could continue to open resulting in a moisture intrusion.

Recommendation: Install a fully welded patch of unsupported membrane over the damage in accordance with the manufacturer's written repair procedures.

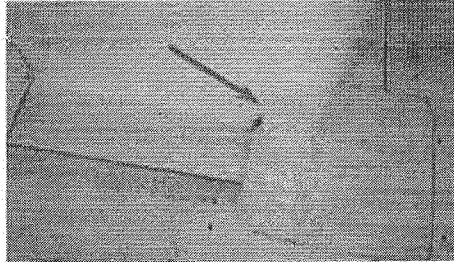
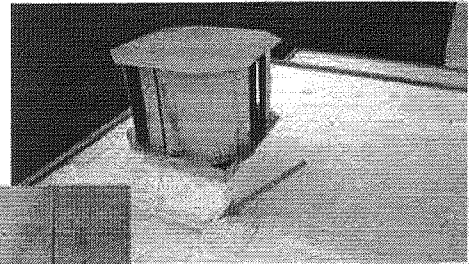
- 1.06 On the unit depicted to the right, one outside corner was installed with a minor void in the weld at the transition, which over time could continue to open resulting in a moisture intrusion.

Recommendation: Install a fully welded patch of unsupported membrane over the damage in accordance with the manufacturer's written repair procedures

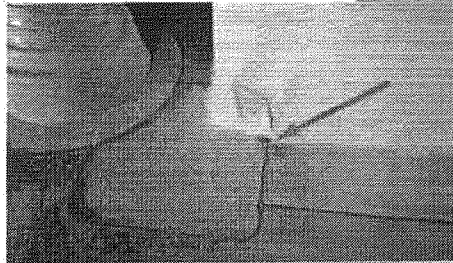
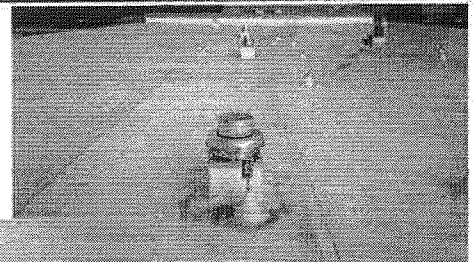
- 1.07 On the unit depicted to the right, one outside corner was installed and pressed in with a tool at the transition which has resulted in damage to the unsupported membrane. Though this damage may not yet be a source of moisture intrusion, these conditions have history of becoming leak sources.

Recommendation: Install a fully welded patch of unsupported membrane over the damage in accordance with the manufacturer's written repair procedures.

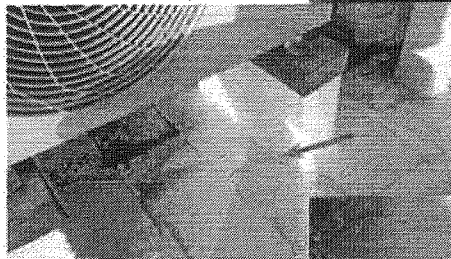
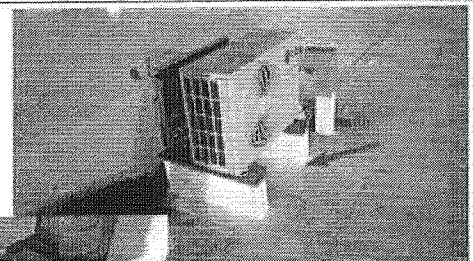
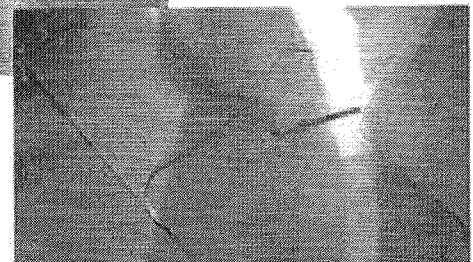
- 1.08 On Roof Area C, at the location of the elevated Condenser unit, one outside corner flashing was installed with a hole in the membrane. This is often the result of an over stretched membrane and could result in moisture intrusion into the roof system and ultimately the structure as a leak.

Recommendation: Install a fully welded membrane patch of unsupported PVC over the damaged location in accordance with the manufacturer's written repair

procedures.

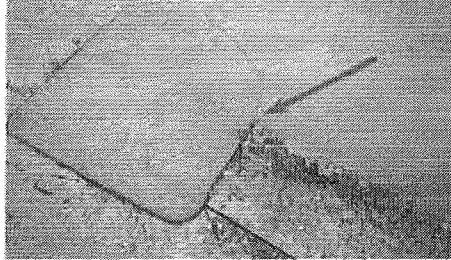
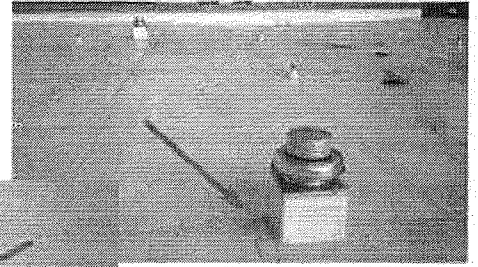
- 1.09 On the unit depicted to the right, one outside corner was installed with a minor void in the weld at the transition, which over time could continue to open resulting in a moisture intrusion.

Recommendation: Install a fully welded patch of unsupported membrane over the damage in accordance with the manufacturer's written repair procedures.

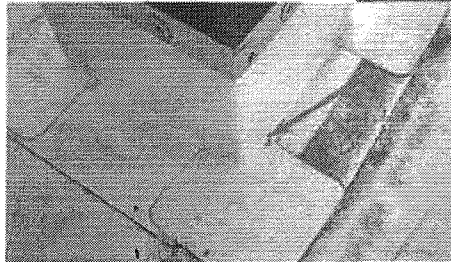
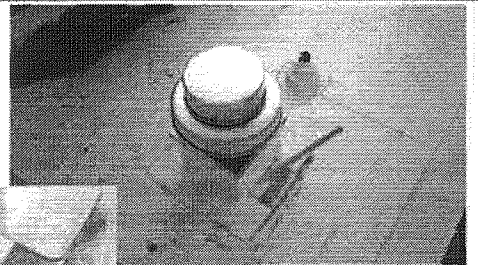
- 1.10 On the unit depicted to the right, one outside corner was installed with damage of the outside corner at the transition, which over time could result in a moisture intrusion.

Recommendation: Install a fully welded patch of unsupported membrane over the damaged area in accordance with the manufacturer's written repair procedures

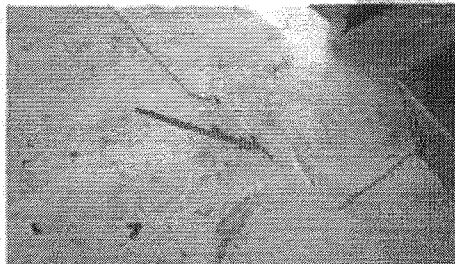
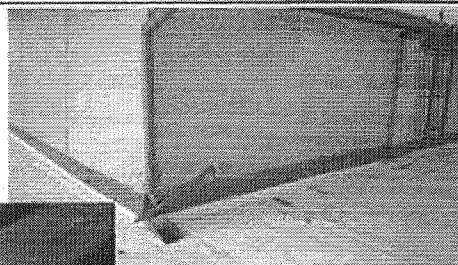
- 1.02 The outside corner patch at the base flashing on Roof Area B, adjacent to the corner down spout was installed with a cold weld, which is allowing moisture to infiltrate between the membranes, which will result in leaks if not addressed.

Recommendation: Install a fully welded patch of unsupported membrane over the damage in accordance with the manufacturer's written repair procedures.

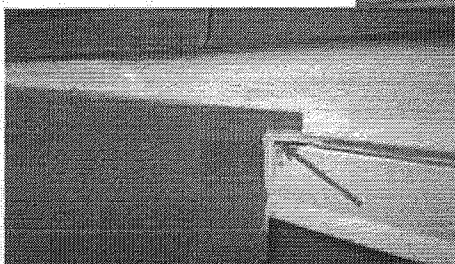
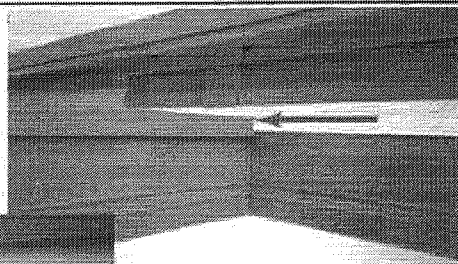
- 1.03 At the inside corner of the clad metal flashing, an unsupported membrane corner patch has become disbonded from the clad metal and could result in moisture intrusion.

Recommendation: Install a fully welded patch of unsupported membrane over the damage in accordance with the manufacturer's written repair procedures.

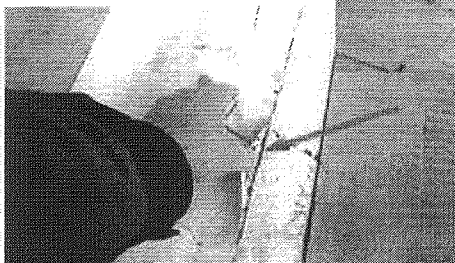
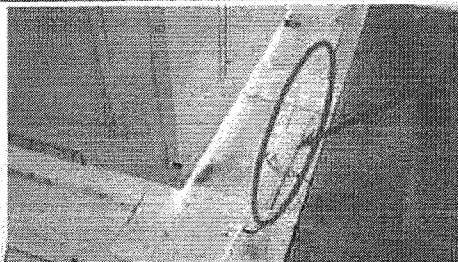
- 1.04 On the south side of the HVAC unit, the base flashing membrane has become disbonded and is open to moisture intrusion. This location was previously marked for repair by the manufacturer's technical representative.

Recommendation: Install a fully welded patch of Sarnafil's G410 membrane over the damage in accordance with the manufacturer's written repair procedures.

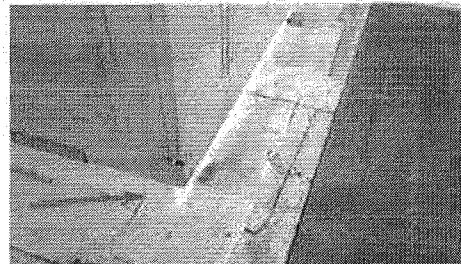
- 1.05 The outside corner patch located on the southwest corner of the HVAC unit was installed with a void at the transition location.

Recommendation: Install a fully welded patch of unsupported membrane over the open void in accordance with the manufacturer's written repair procedures.
