Badger School District ISD #676

Facilities
Assessment

June 2021

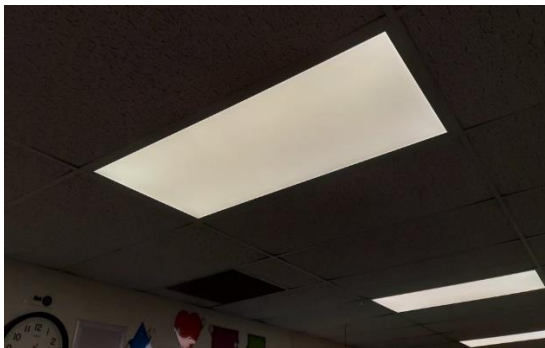
2: Facility Lighting

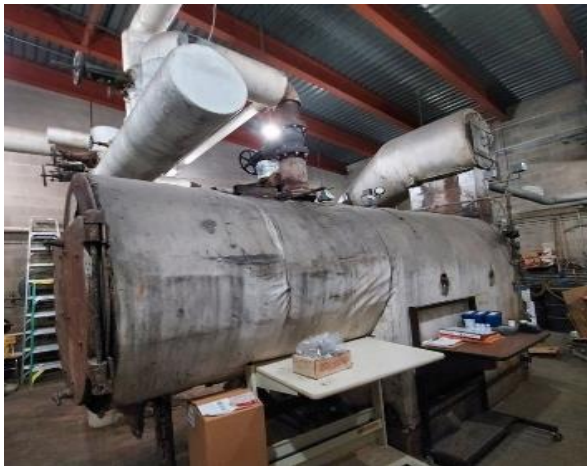
4: Steam boiler past its useful life

The school uses a combination of fuel oil/propane steam and hot water boilers to meet the heating loads of the facility. The hot water boiler was re-tubed 6 years ago but is nearing the end of its lifecycle. The steam boiler is well past its useful lifespan and is too costly to repair. The school would benefit by installing newer condensing, high efficiency boilers.

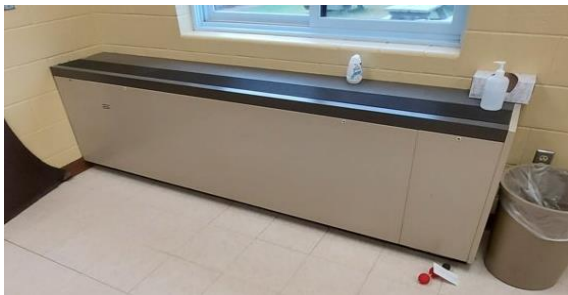
5: Unit ventilators are past their useful life

The school uses air handlers to heat and ventilate the 1988 section of the facility. The 1951 section uses a combination of unit ventilators and Fan Coil Units (FCU). Installation of an air handler would better serve the 1951 section. During the assessment tour, the school was very humid and it appears to be normal in the school, due to all the Acoustical Ceiling Tile (ACT) sagging. The classrooms have operable windows, which the teachers open to help cool and ventilate their rooms. This makes it difficult to regulate Indoor Air Quality (IAQ). Also, many of these windows were left open throughout the night, which presents a security concern.

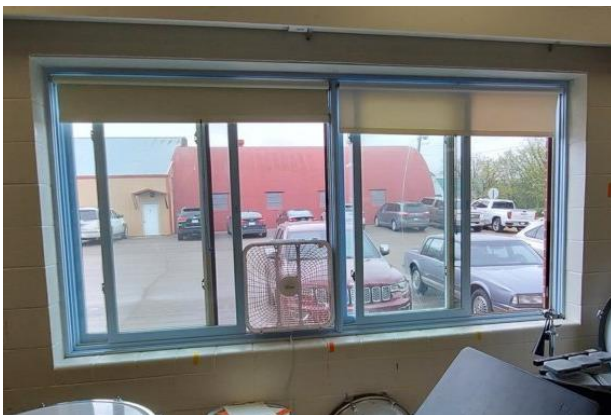
6: Sliding windows are open often to help ventilate rooms

With security becoming a bigger concern over the last few years, the district should look to update several areas of weakness. The sliding windows, which provide enough area for someone to gain access, tend to be left open often and sometimes overnight. Exterior doors are damaged and the frames are rusting/rotting out. Only 7 of the 16 (5 interior & 2 exterior) security cameras are working. Update this outdated system, install new interior cameras and additional exterior cameras around the school.

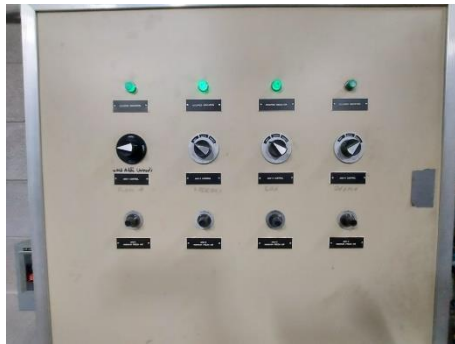
7: Outdated pneumatic controls

Currently, all temperature controls are pneumatic or manual. These are outdated temperature controls, which should be updated to direct digital controls (DDC).

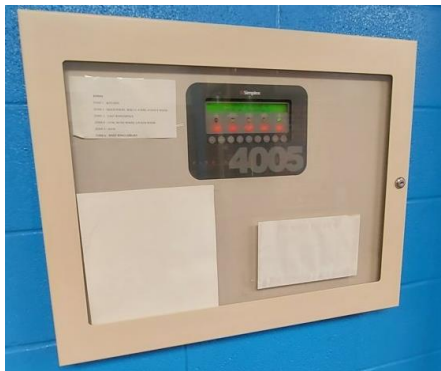
8: Problematic fire alarm control panel

Maintenance staff has been having a lot of issues with the Fire Alarm Control Panel (FACP). It is an outdated zone panel that needs to be updated to a fully addressable system. With the FACP update, the fire alarm devices will need to be upgraded as well.

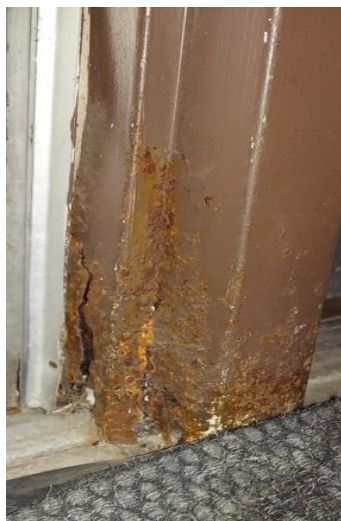
9: Heavily damaged door frames that are rusted through

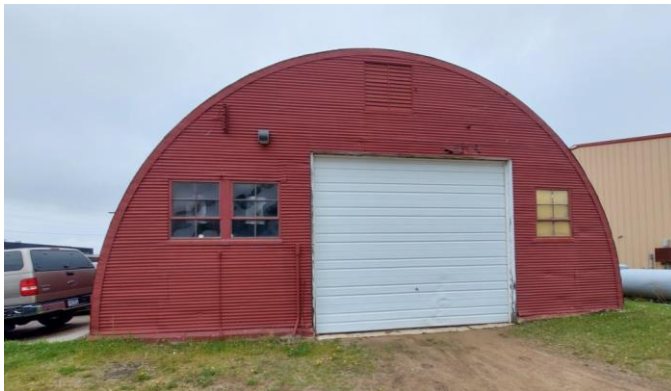
11: Large, manual opening garage door

The bus garage building doesn't have many large needs, as it's in good condition overall. However, there are a few items that should be addressed. The garage door on the Quonset hut is quite large and is opened manually. Currently, the Quonset hut houses another bus that is used often, so installing a garage door opener would be beneficial. Also, the site slopes into the north side of the west side garages. This has led to water infiltration into the office. Maintenance has used foundation tar to seal this up. There is a sloped trough area in front of the bus garage stalls that diverts water to the north. Sloped paving could be added to the north side of the west side garages to redirect the water to the sloped trough to carry water away from this corner.

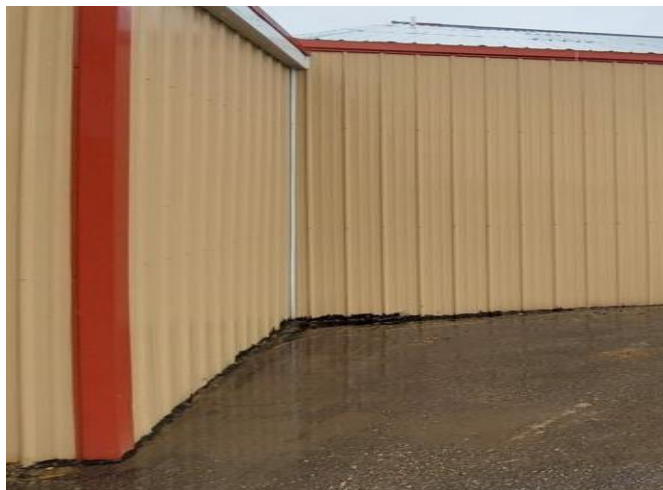
12: Pavement slopes towards the building causing water infiltration

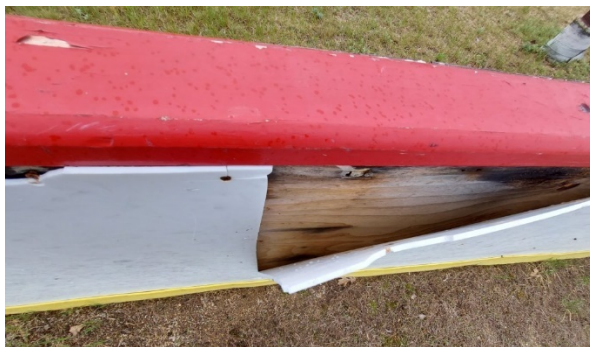
15: Damaged rink dasher boards

The arena is so new that there are very few items that need to be repaired or replaced. The biggest area of concern here is the need to repair the rink's dasher boards. Several of the attached high-density polyethylene (HDPE) boards are cracked, broken and missing pieces. The arena building and rink will need general maintenance items done throughout the 10-year plan.
