REPORT OF FINDINGS

FORT SMITH PUBLIC SCHOOLS

PEAK INNOVATION CENTER
Envista Matter No: MAT-160449-G7V3
REPORT DATE: March 14, 2024

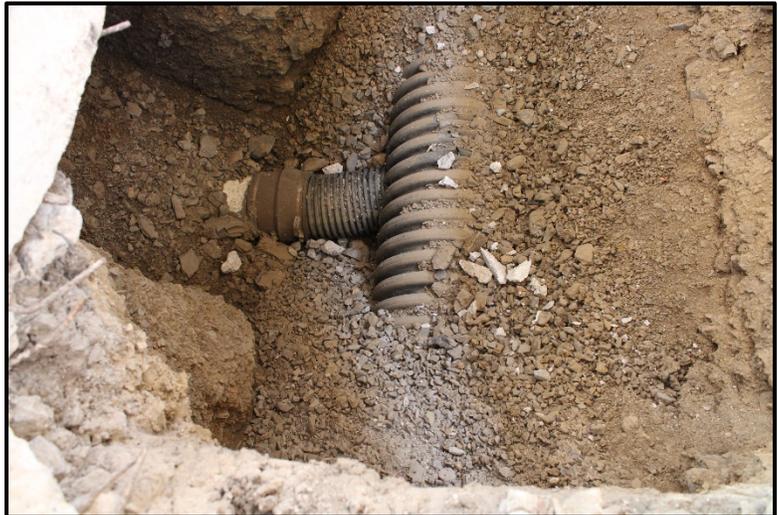
The four excavated areas occurred where the canopy roof's 4-inch PVC roof drain pipes were connected to the main piping. The fittings consisted of a flexible rubber transition connector from the 4-inch PVC pipe to a 4-inch single wall plastic corrugated pipe. The 4-inch corrugated pipe was inserted through a hole cut into the side of the 12-inch main piping leaving open gaps around the cut-in-place hole for water to escape. The invert elevation of the 4-inch corrugated pipe at the main piping connection appeared to be higher than the invert elevation of the 4-inch PVC roof drain pipe. A fitting was not used at the connection to the main piping, which caused open gaps around the connection. (Figure 4)

Figure 4: Example of a PVC roof drain connection at the underground main roof drain piping (occurs in four places).

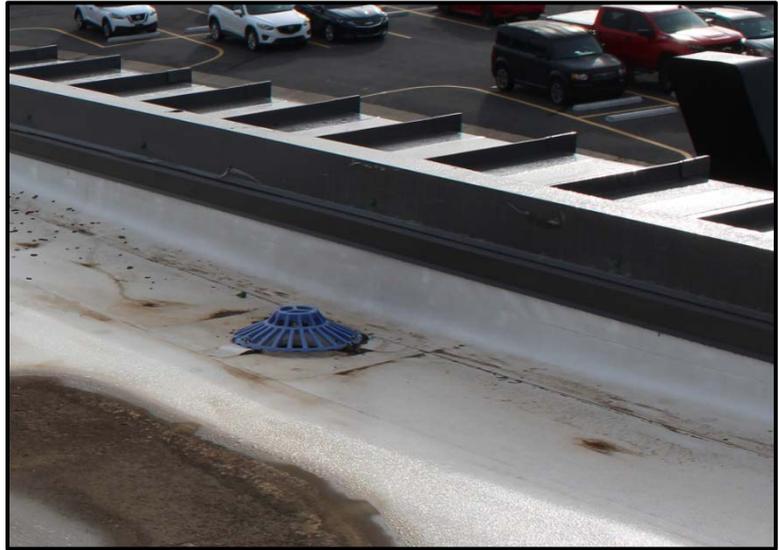
potentially the membrane adhesive. Each roof drain had a strainer that was attached to the roofing membrane with three tabs of roofing membrane material heat-welded to the primary roof membrane. There was not a secondary roof drain system present, nor were there secondary scuppers in the parapet wall adjacent to the drains. There were areas of ponded water on the high side of the roof drains, which indicated a discontinuity of positive roof drainage to the roof drains. The edge of the ponded water was approximately 24-inches from the roof drain inlet at each location. (Figure 5)

Figure 5: Example of a roof drain at the south facet of the East Wing roof.

As noted in Envista's observations above, the roof membrane was turned in to the roof drains and there was an absence of visual evidence to verify a watertight connection was provided. Therefore, Envista concluded that *the roof drains' installation on the East Wing main roof did not comply with the IBC minimum requirements because the TPO membrane reduced the size of the roof drain inlet and was terminated without a watertight connection.*

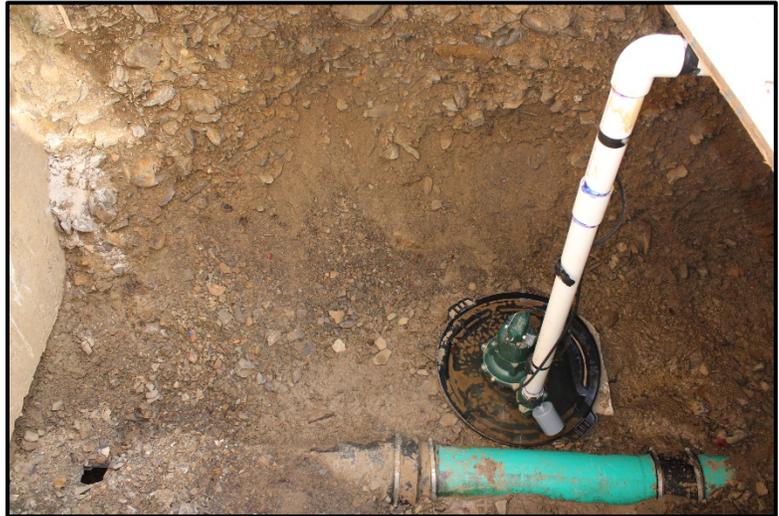
drains for the east side of the roof where the West Wing abutted the East Wing. There was an approximately 3- to 4-inch square hole in the top of the 12-inch roof drain that was reportedly found in the pipe during the excavation. Approximately 5-feet south of the East Wing foundation wall, the 12-inch roof drain outlet was connected to an 8-inch green PVC site roof drain pipe with a reducer fitting. The reducer fitting was fixed to each of the pipes with band clamps, which did not appear to be snug/tight against the fitting. The 8-inch site roof drain pipe reportedly was routed south to an Area Inlet near the southeast corner of the West Wing. A temporary sump pit was installed by the FSPS as an alternate drain due to the excavated area filling with rainwater from the hole in the roof drain pipe. (Figure 6)

Figure 6: Excavation where the West Wing roof drain pipe emerged from below the East Wing.

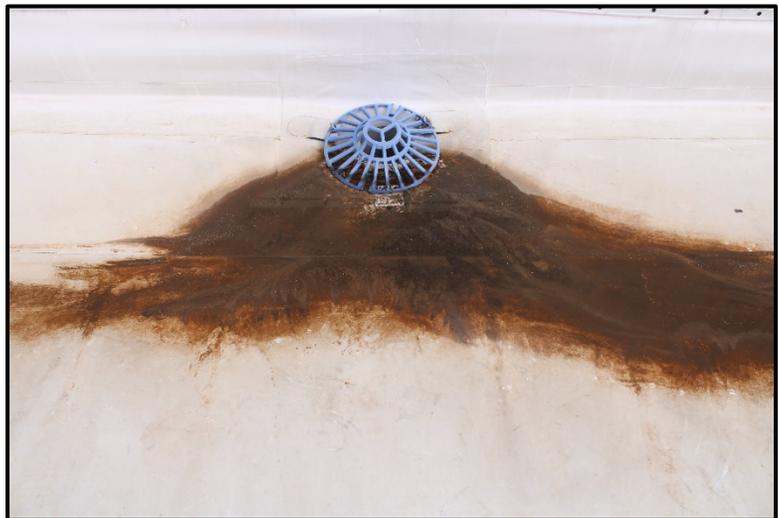
Envista observed the roofing for the West Wing, which revealed the roofing to likely be a fully adhered Thermoplastic Polyolefin (TPO) single-ply membrane. There were 10 roof drains for the east facet: the six drains previously noted and four additional roof drains where the West Wing projected south beyond the East Wing spaced at 55-foot centers and 26-foot centers respectively. Each roof drain appeared to be a 6-inch diameter outlet and the roofing membrane was turned down inside the pipe. There was not an apparent connection between the membrane and the roof drain except for potentially the membrane adhesive. Each roof drain had a strainer that was attached to the roofing membrane with three tabs of roofing membrane material heat-welded to the primary roof membrane. There was not a secondary roof drain present, nor were there secondary scuppers in the parapet wall adjacent to the drains. There were areas of environmental deposits on the high side of the roof drains. (Figure 7)

Figure 7: Example of a roof drain on the east facet of the West Wing.

As noted in Envista's observations above, the roof membrane was turned into roof drains and there was an absence of visual evidence to verify a watertight connection was provided. Therefore, Envista concluded that *the roof drains' installation on the West Wing, east facet roof did not comply with the IBC minimum requirements because the TPO membrane reduced the size of the roof drain inlet and was terminated without a watertight connection.*

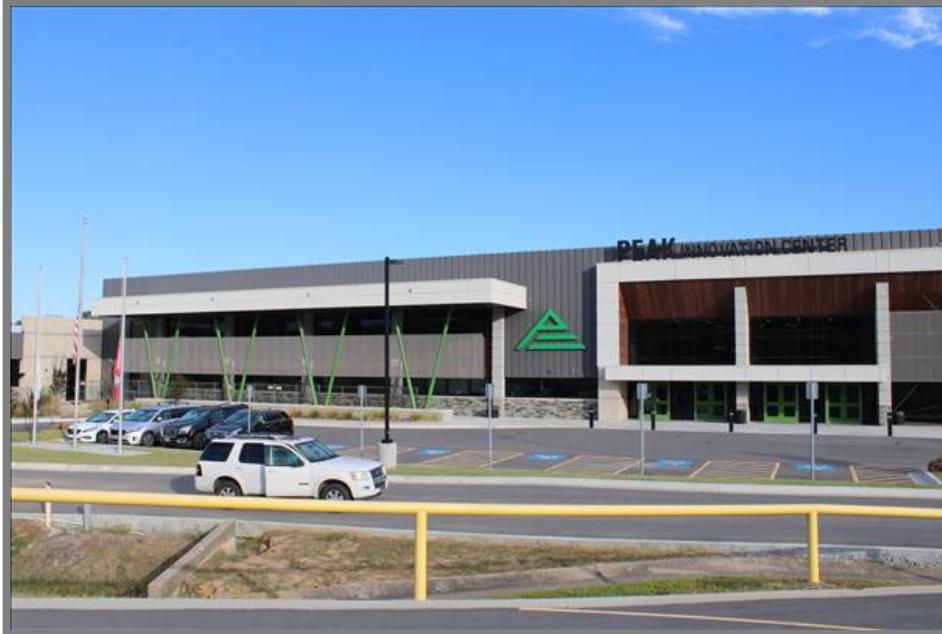
Photograph #1

Overview of the south side of the East Wing, west portion.

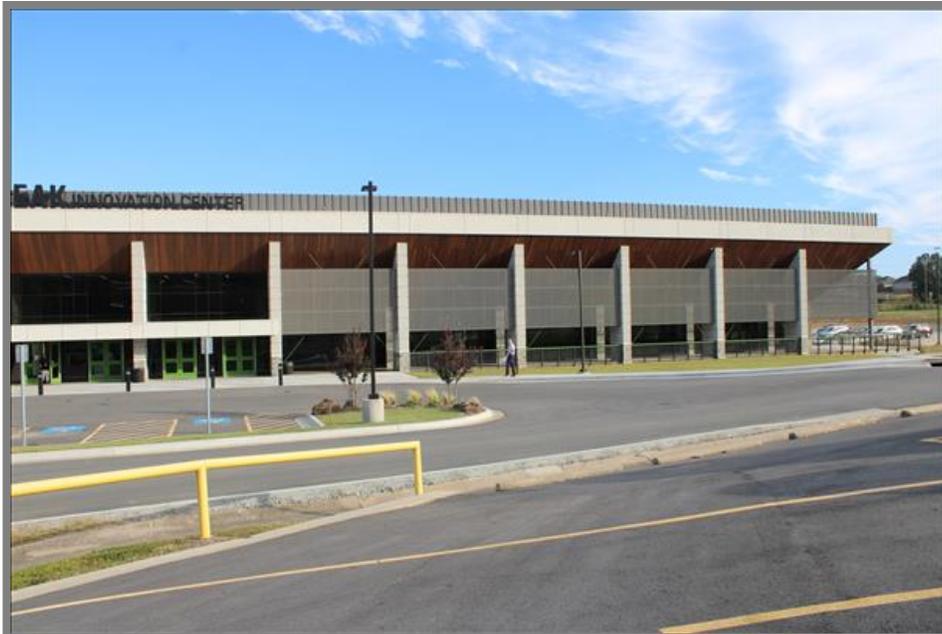
Photograph #2

Overview of the south side of the East Wing, east portion.

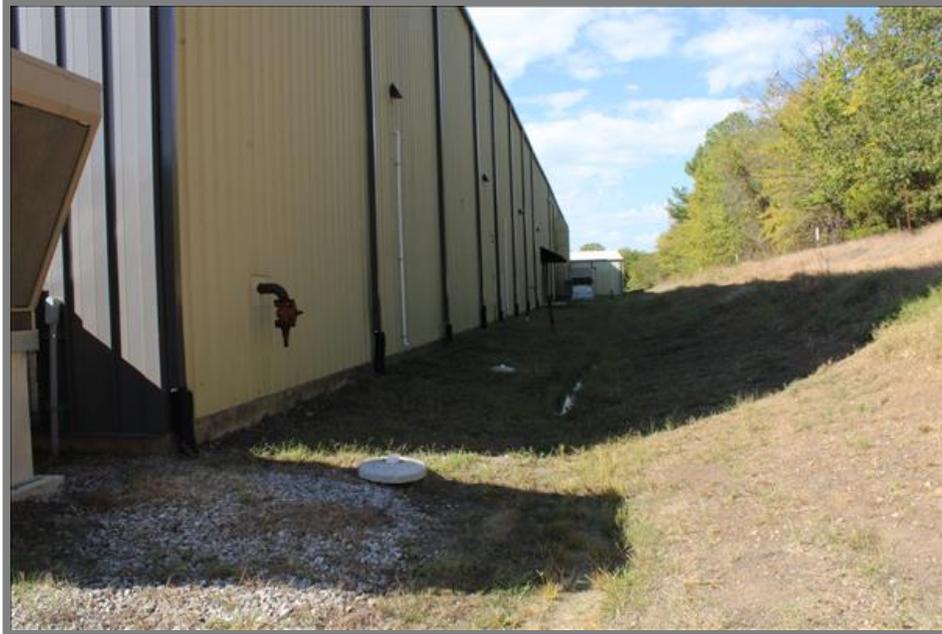
Photograph #3

Overview of the north side of the East Wing, east portion.

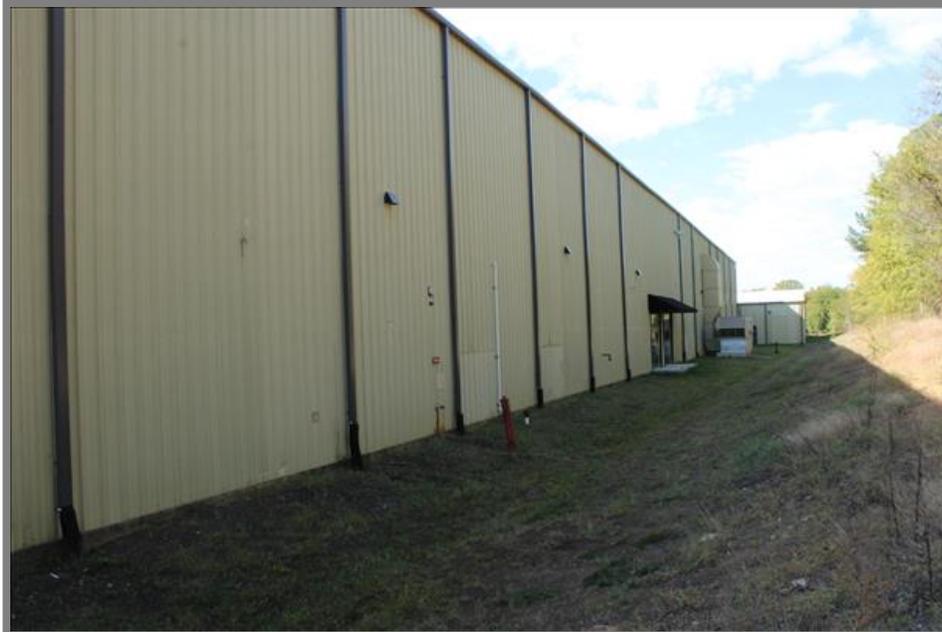
Photograph #4

Continued view of the north side of the East Wing, central portion.

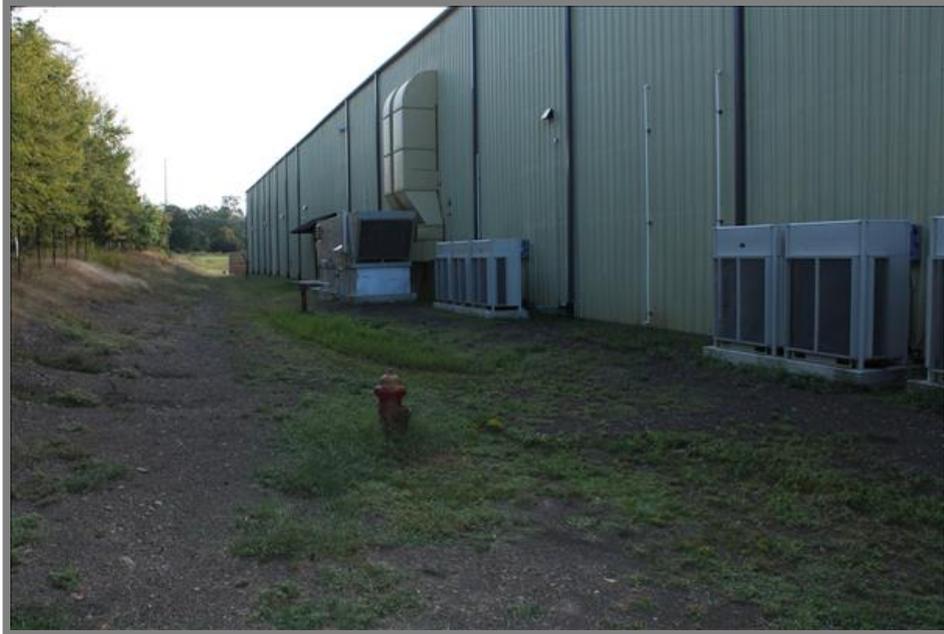
Photograph #5

Overview of the north side of the East Wing, west portion looking east.

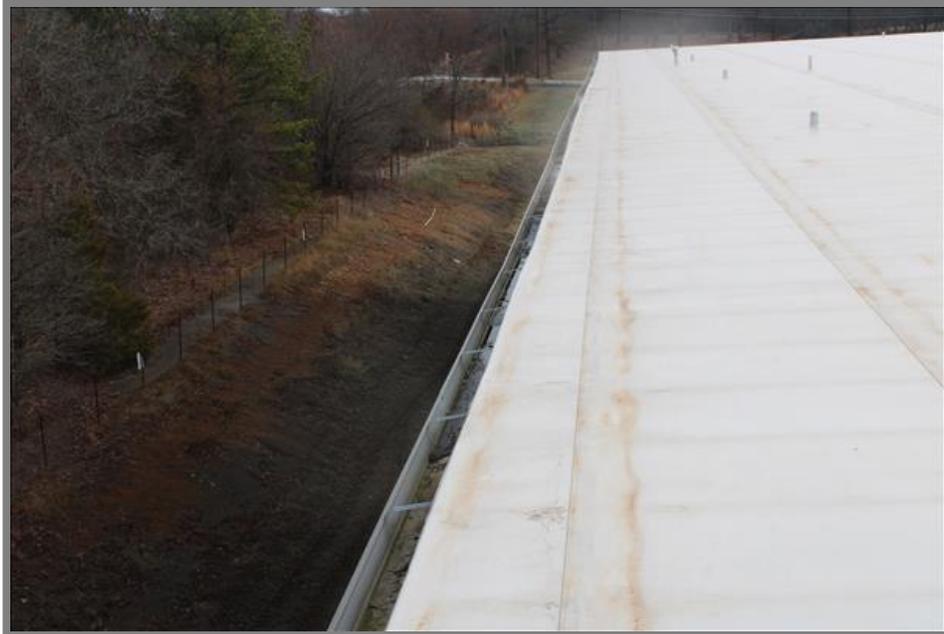
Photograph #6

- f. The gutter did not have expansion joints as required by SMACNA, which caused thermal expansion/contraction stresses to deform the gutter system and potentially compromise the gutter anchor system.

Overview of the East Wing gutter on the north side looking east. Note the curved/wavy appearance of the gutter and roof edge.

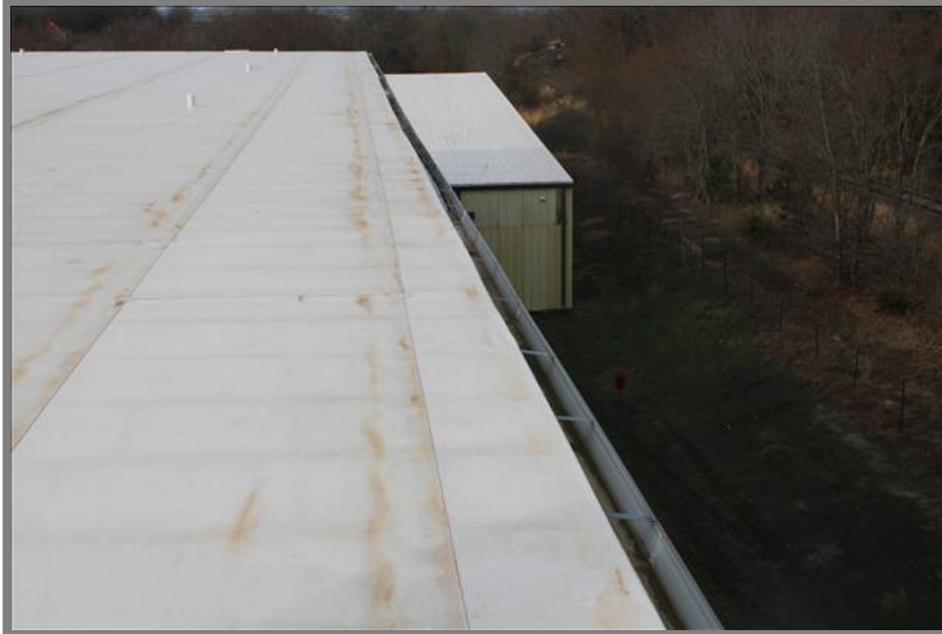
Photograph #7

Overview of the East Wing gutter on the north side looking west. Note the curved/wavy appearance of the gutter and roof edge.

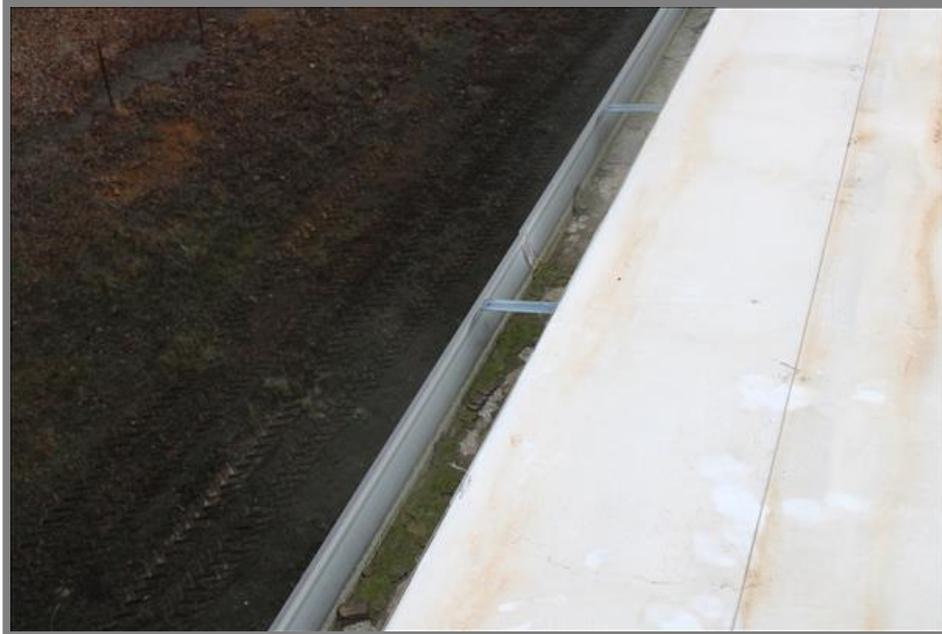
Photograph #8

There were 15, 5-inch by 4-inch sheet metal downspouts connected to an approximately 336-foot-long by 7-inch-wide by 5-inch-deep sheet metal gutter for the north side of the East Wing. The downspouts terminated above-grade at a plastic transition fitting that was connected to a 6" single-wall plastic corrugated drainage pipe that was routed below grade. The spacing of the downspouts along the length of the gutter varied from approximately 20-feet to 57-feet. The gutter along the roof eave consisted of approximately 10-foot sections with lapped joints, and there was an absence of expansion joints over the full length of the gutter. The existing gutter exhibited a curved, wavy-type appearance over its length and the gutter lap joints' sealant exhibited gaps and cracks.

Example of a gutter lap joint on the north side of the East Wing. Note the open gap in the lap sealant.

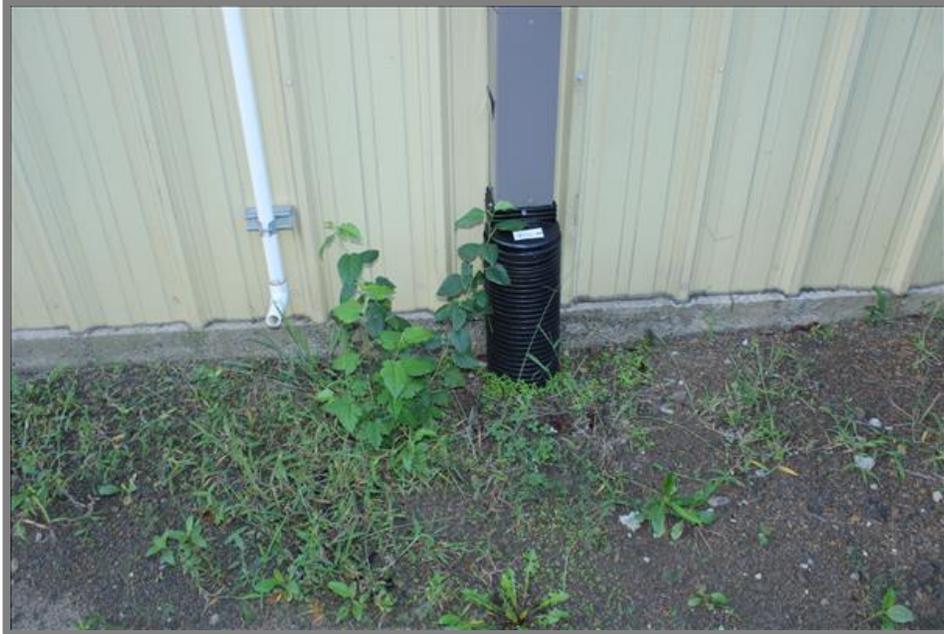
Photograph #9

Example of a gutter to corrugated plastic pipe transition on the north side of the East Wing.

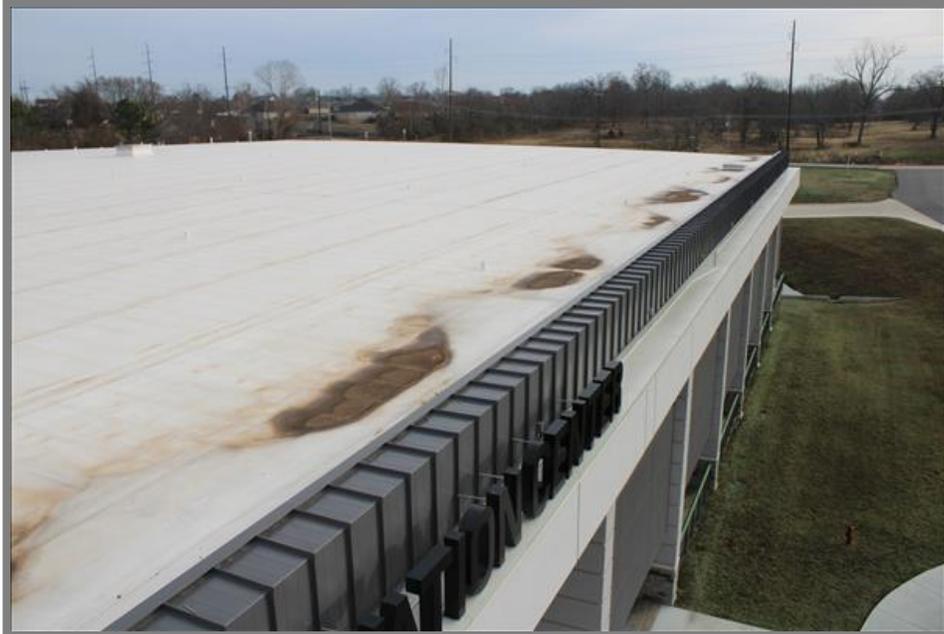
Photograph #10

Overview of the roof drains on the south side of the East Wing looking east.

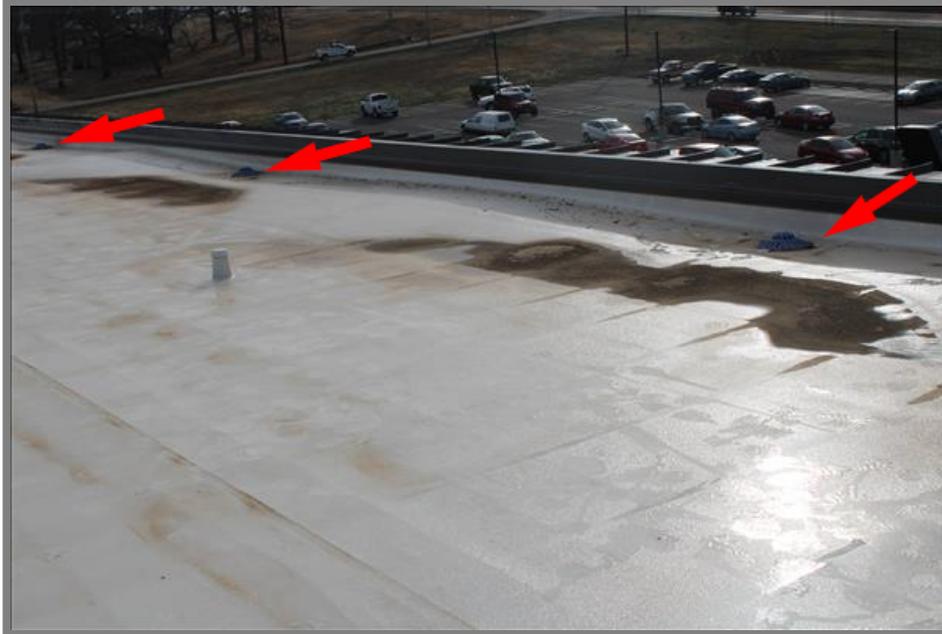
Photograph #11

View of the roof drains on the south side of the East Wing. Note the gap between the pooled water and the roof drains.

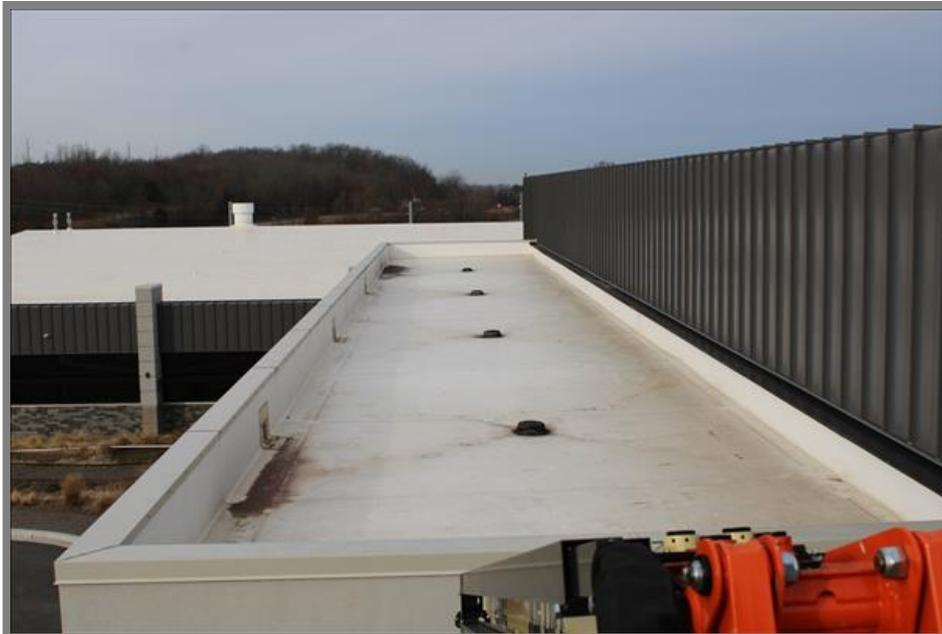
Photograph #12

Overview of the canopy roof at the East Wing with the roof drains and the adjacent scuppers.

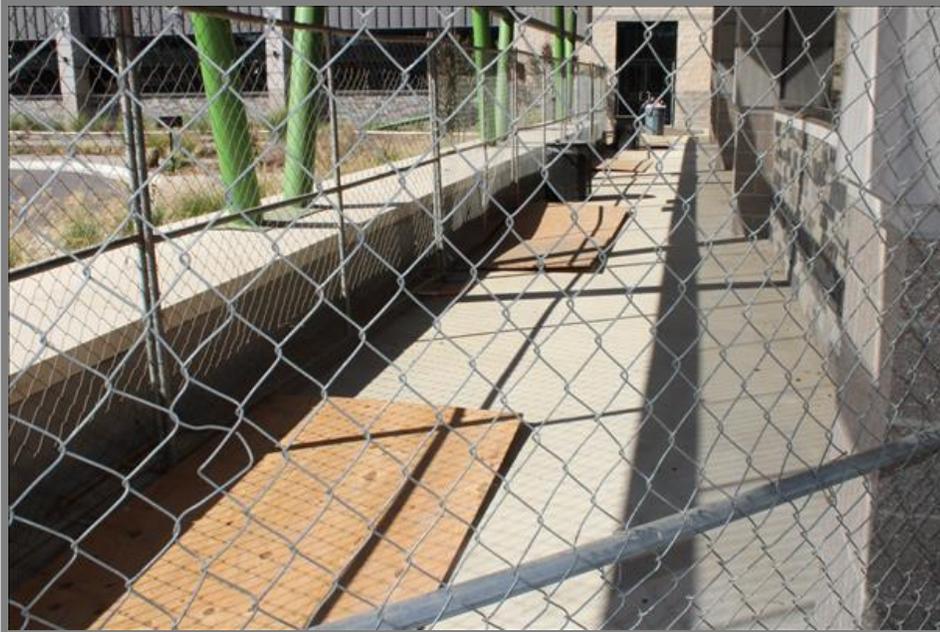
Photograph #13

View of excavations at the connection of the building roof drain lines and the site utility roof drain lines covered by plywood.

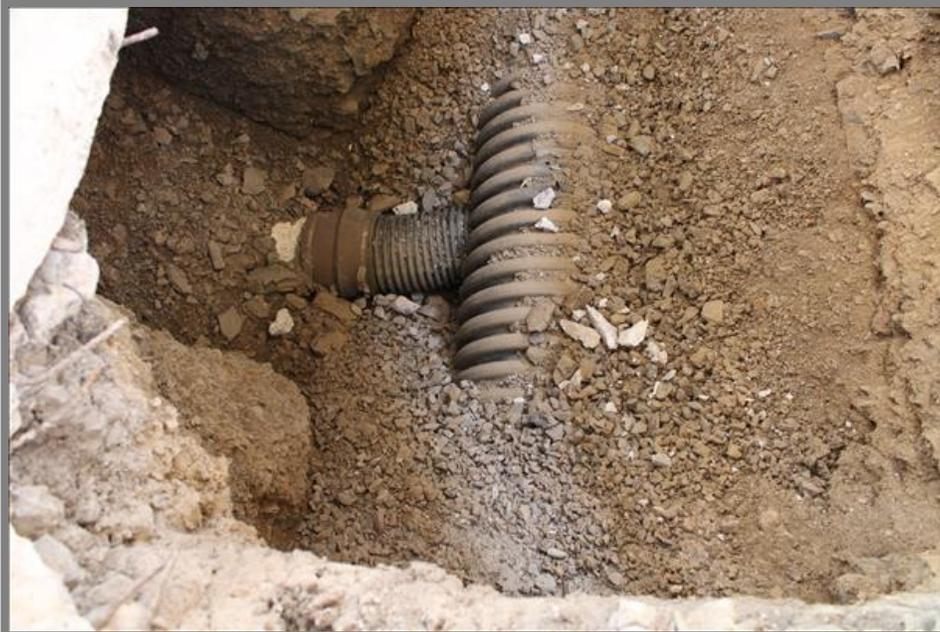
Photograph #14

- f. The East Wing, south side underground roof drain piping installed at the four canopy roof drains was noncompliant with the IPC because the plastic corrugated piping did not have drainage-type fittings. Furthermore, the absence of drainage-type fittings created an unsealed drainage system at these locations, which increased the potential for erosion of the underlying soil and also water intrusion into the building.

View of a connection between a canopy roof drain and site roof drain.
Note a fitting was not used at the raised pipe invert.

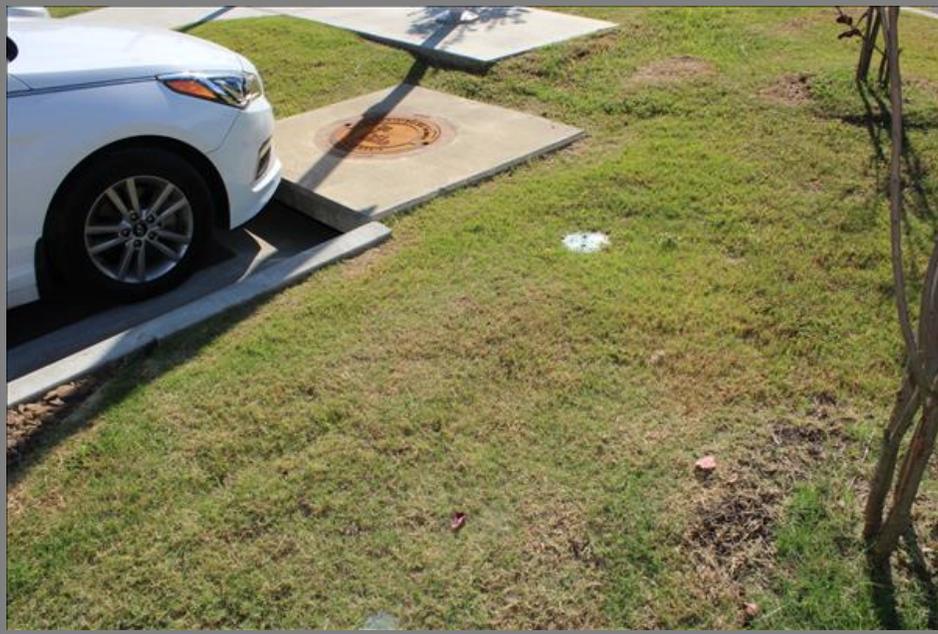
Photograph #15

View of the Curb Inlet in the parking lot at the site roof drain line tie-in location.

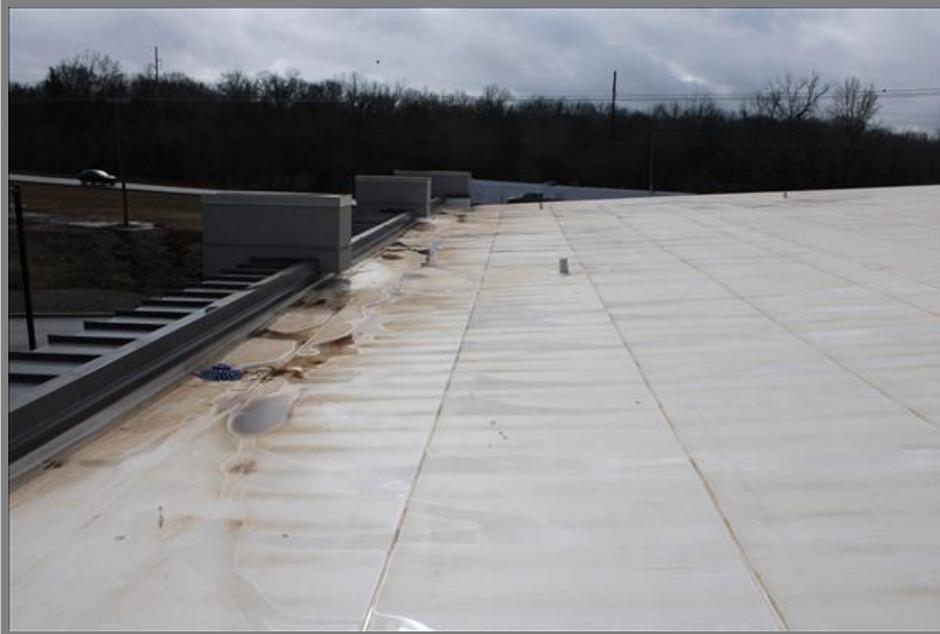
Photograph #16

Overview of the east roof facet of the West Wing looking south.

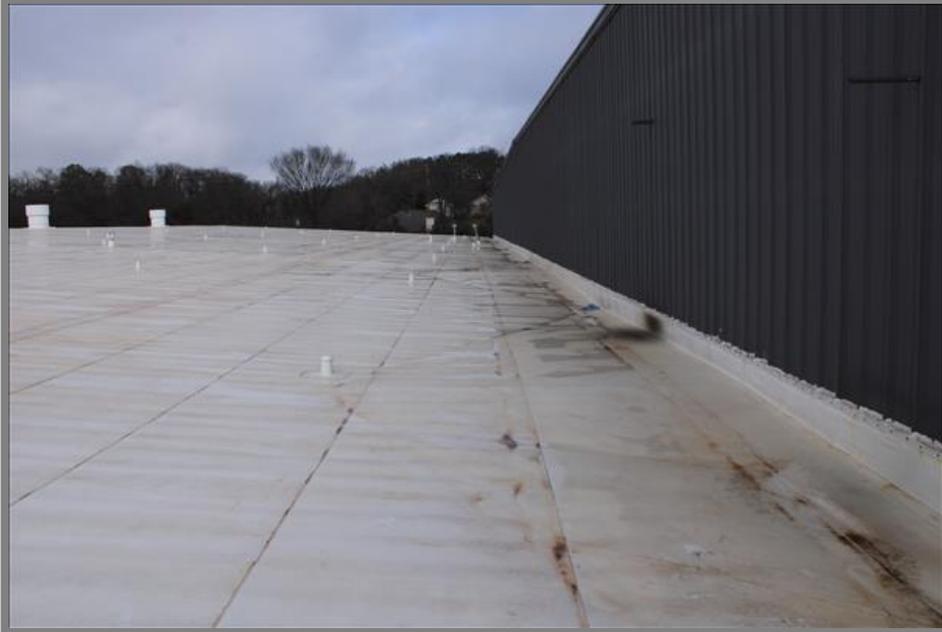
Photograph #17

Overview of the east roof facet of the West Wing looking north.

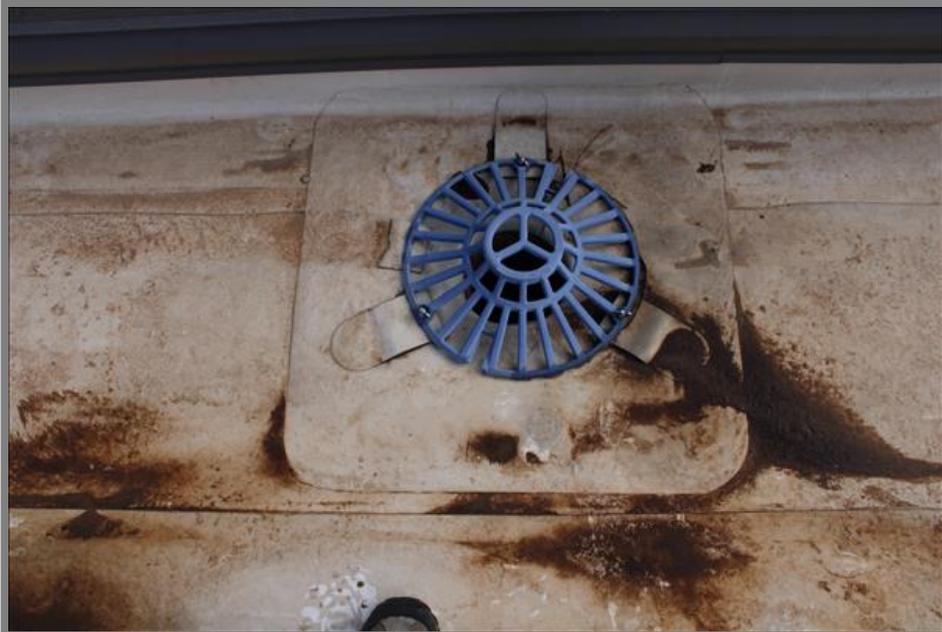
Photograph #18

View of a roof drain at the east facet of the West Wing adjacent to the East Wing exterior wall.

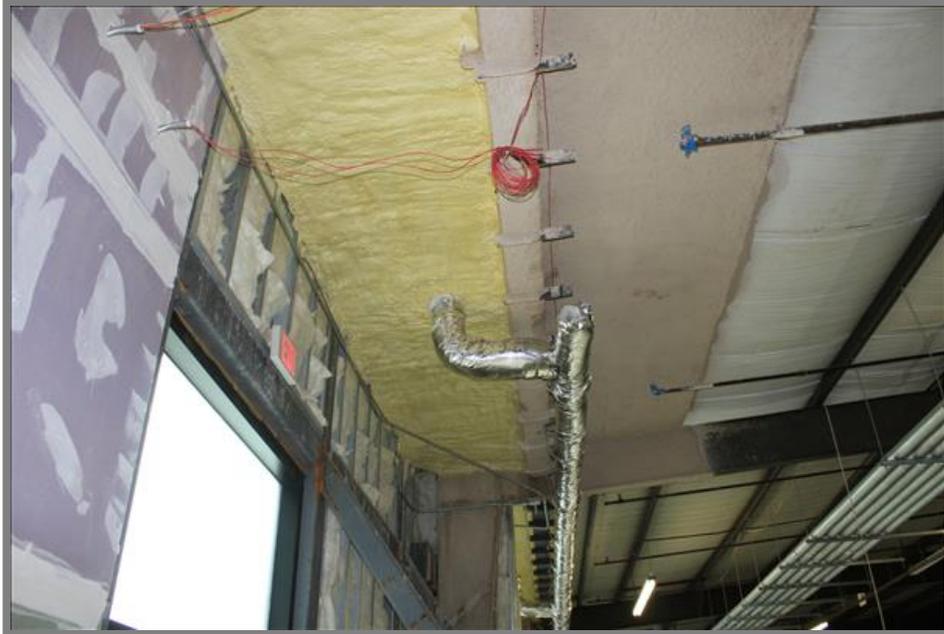
Photograph #19

View of the interior roof drain piping at the south end of the West Wing.

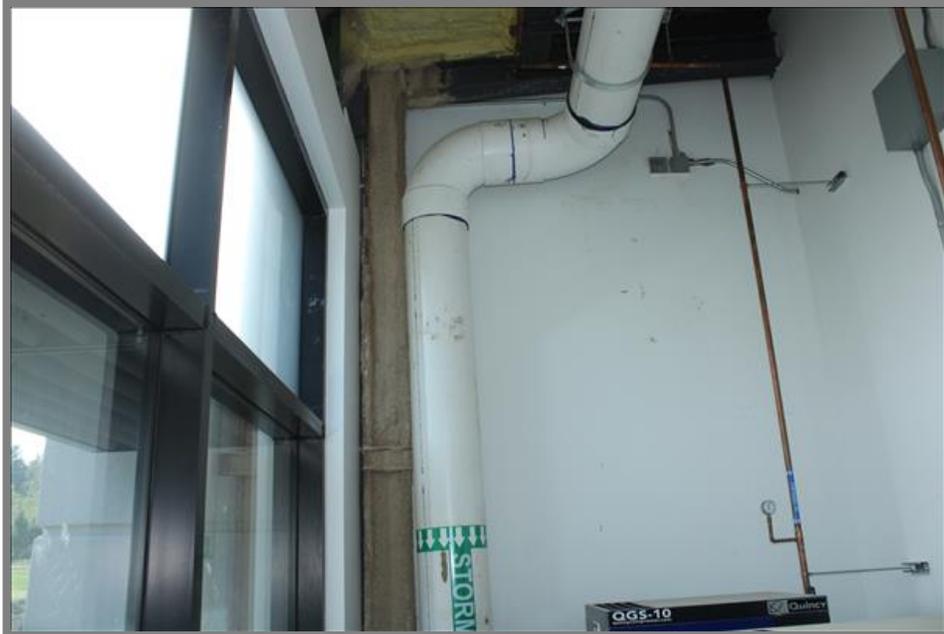
Photograph #20

View of the interior 12-inch roof drain piping where it turned down prior to exiting the building to the site drainage.

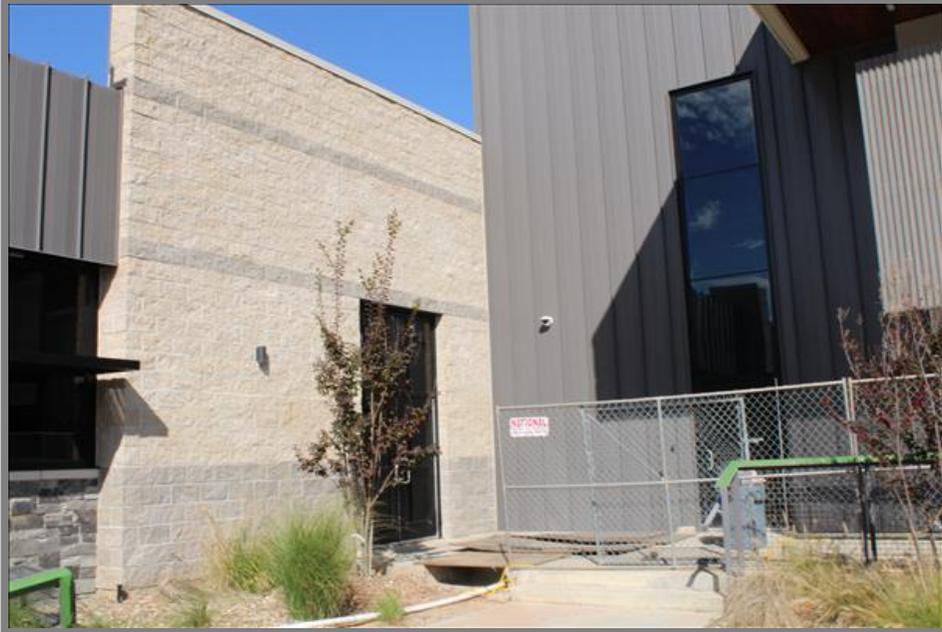
Photograph #21

Overview of the junction between the East Wing and the West Wing.

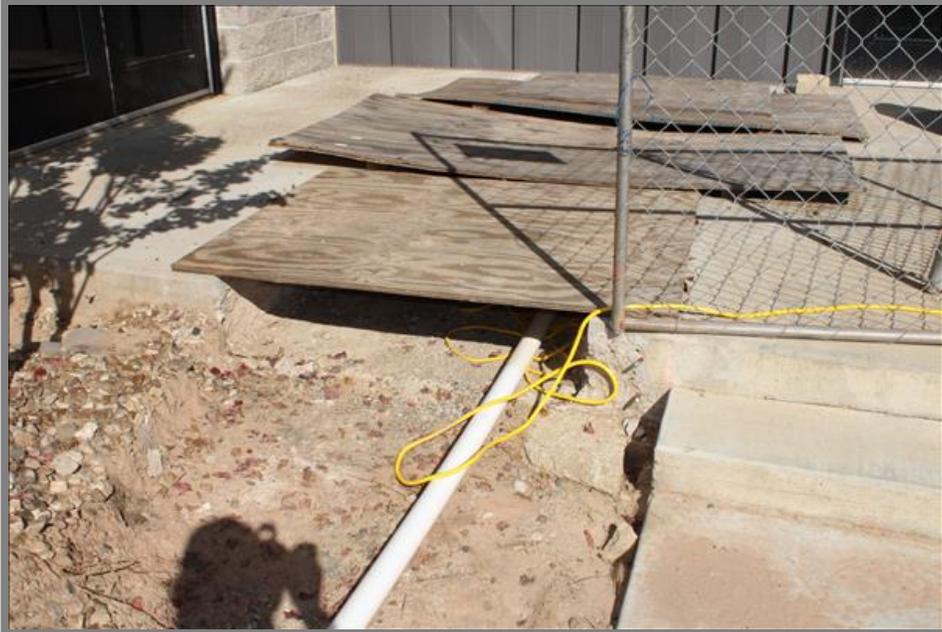
Photograph #22

View of the excavation at the West Wing roof drain outlet from below the East Wing.

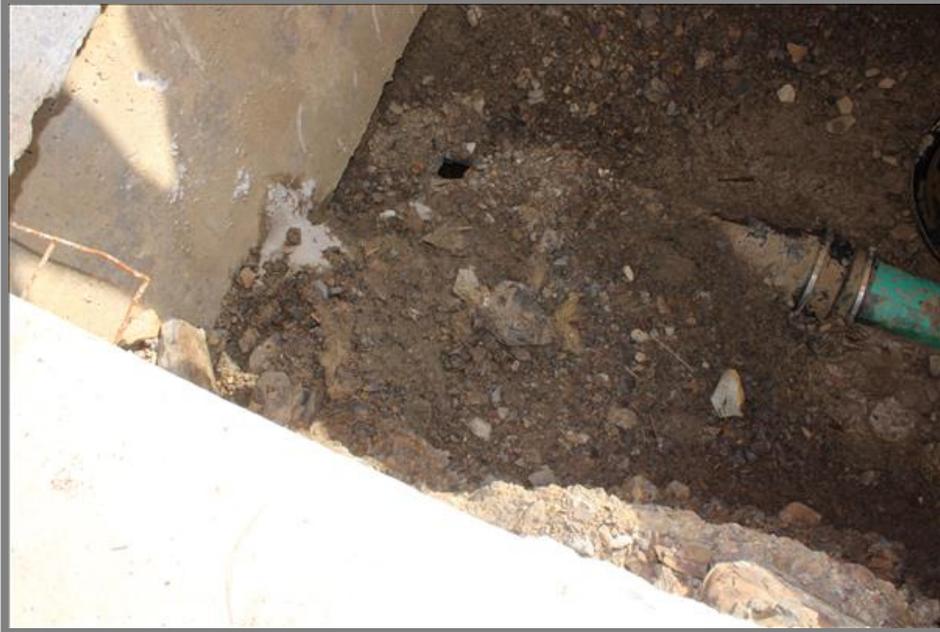
Photograph #23

- When excavating the West Wing underground roof drain line, it was discovered that the 12-inch PVC roof drain pipe exiting the building was connected to an 8-inch site roof drain pipe.
- Additionally, excavations at the underground roof drains for the canopy connected to a site roof drain line did not have connector fittings causing open gaps in the drain line.
- During moderate and heavier rainfall, the north side gutter system overflows the gutter in the center portion of the gutter, and water emerging from the downspout-to-underground roof drain transition fittings at all 15 downspouts was observed.
- FSPS does not have confirmatory information regarding the underground roof drain pipes on the north side of the building.

View of the West Wing roof drain transition to site roof drain. Note the breach in the roof drain and downstream reducer fitting.

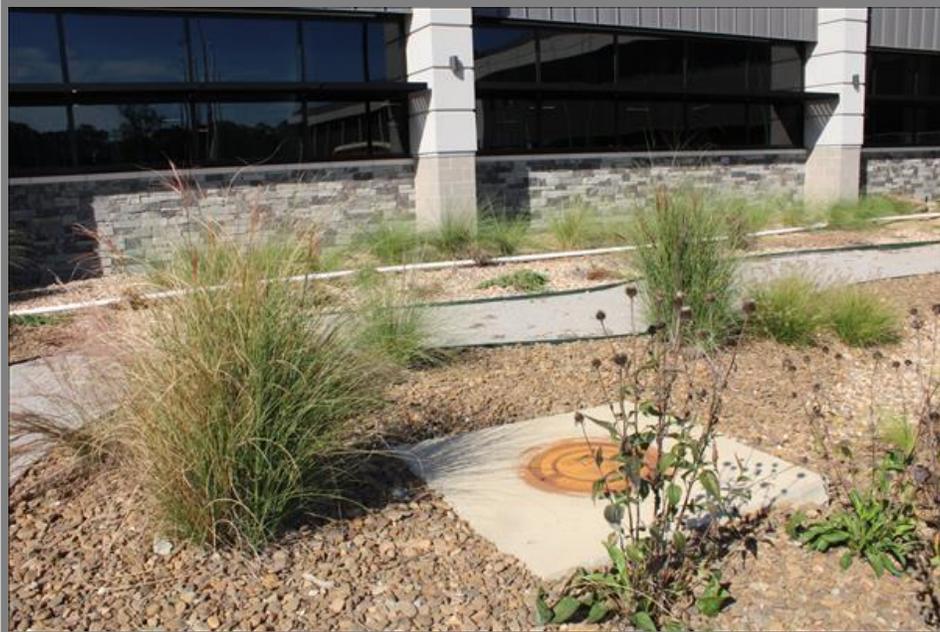
Photograph #24

View of the site Area Inlet near the southeast corner of the West Wing.

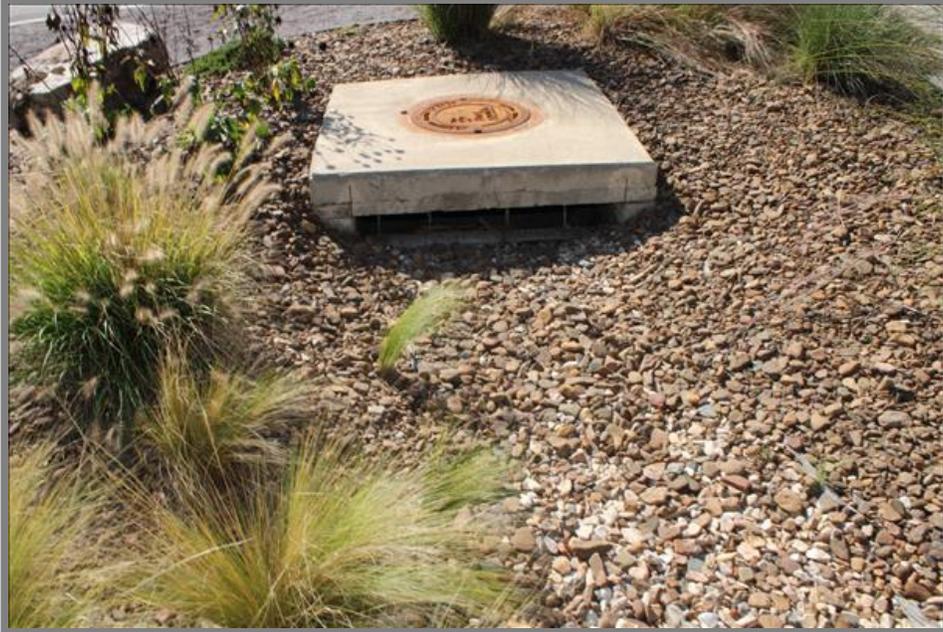
Photograph #25

View of the Area Inlet shown in the previous photograph looking south.

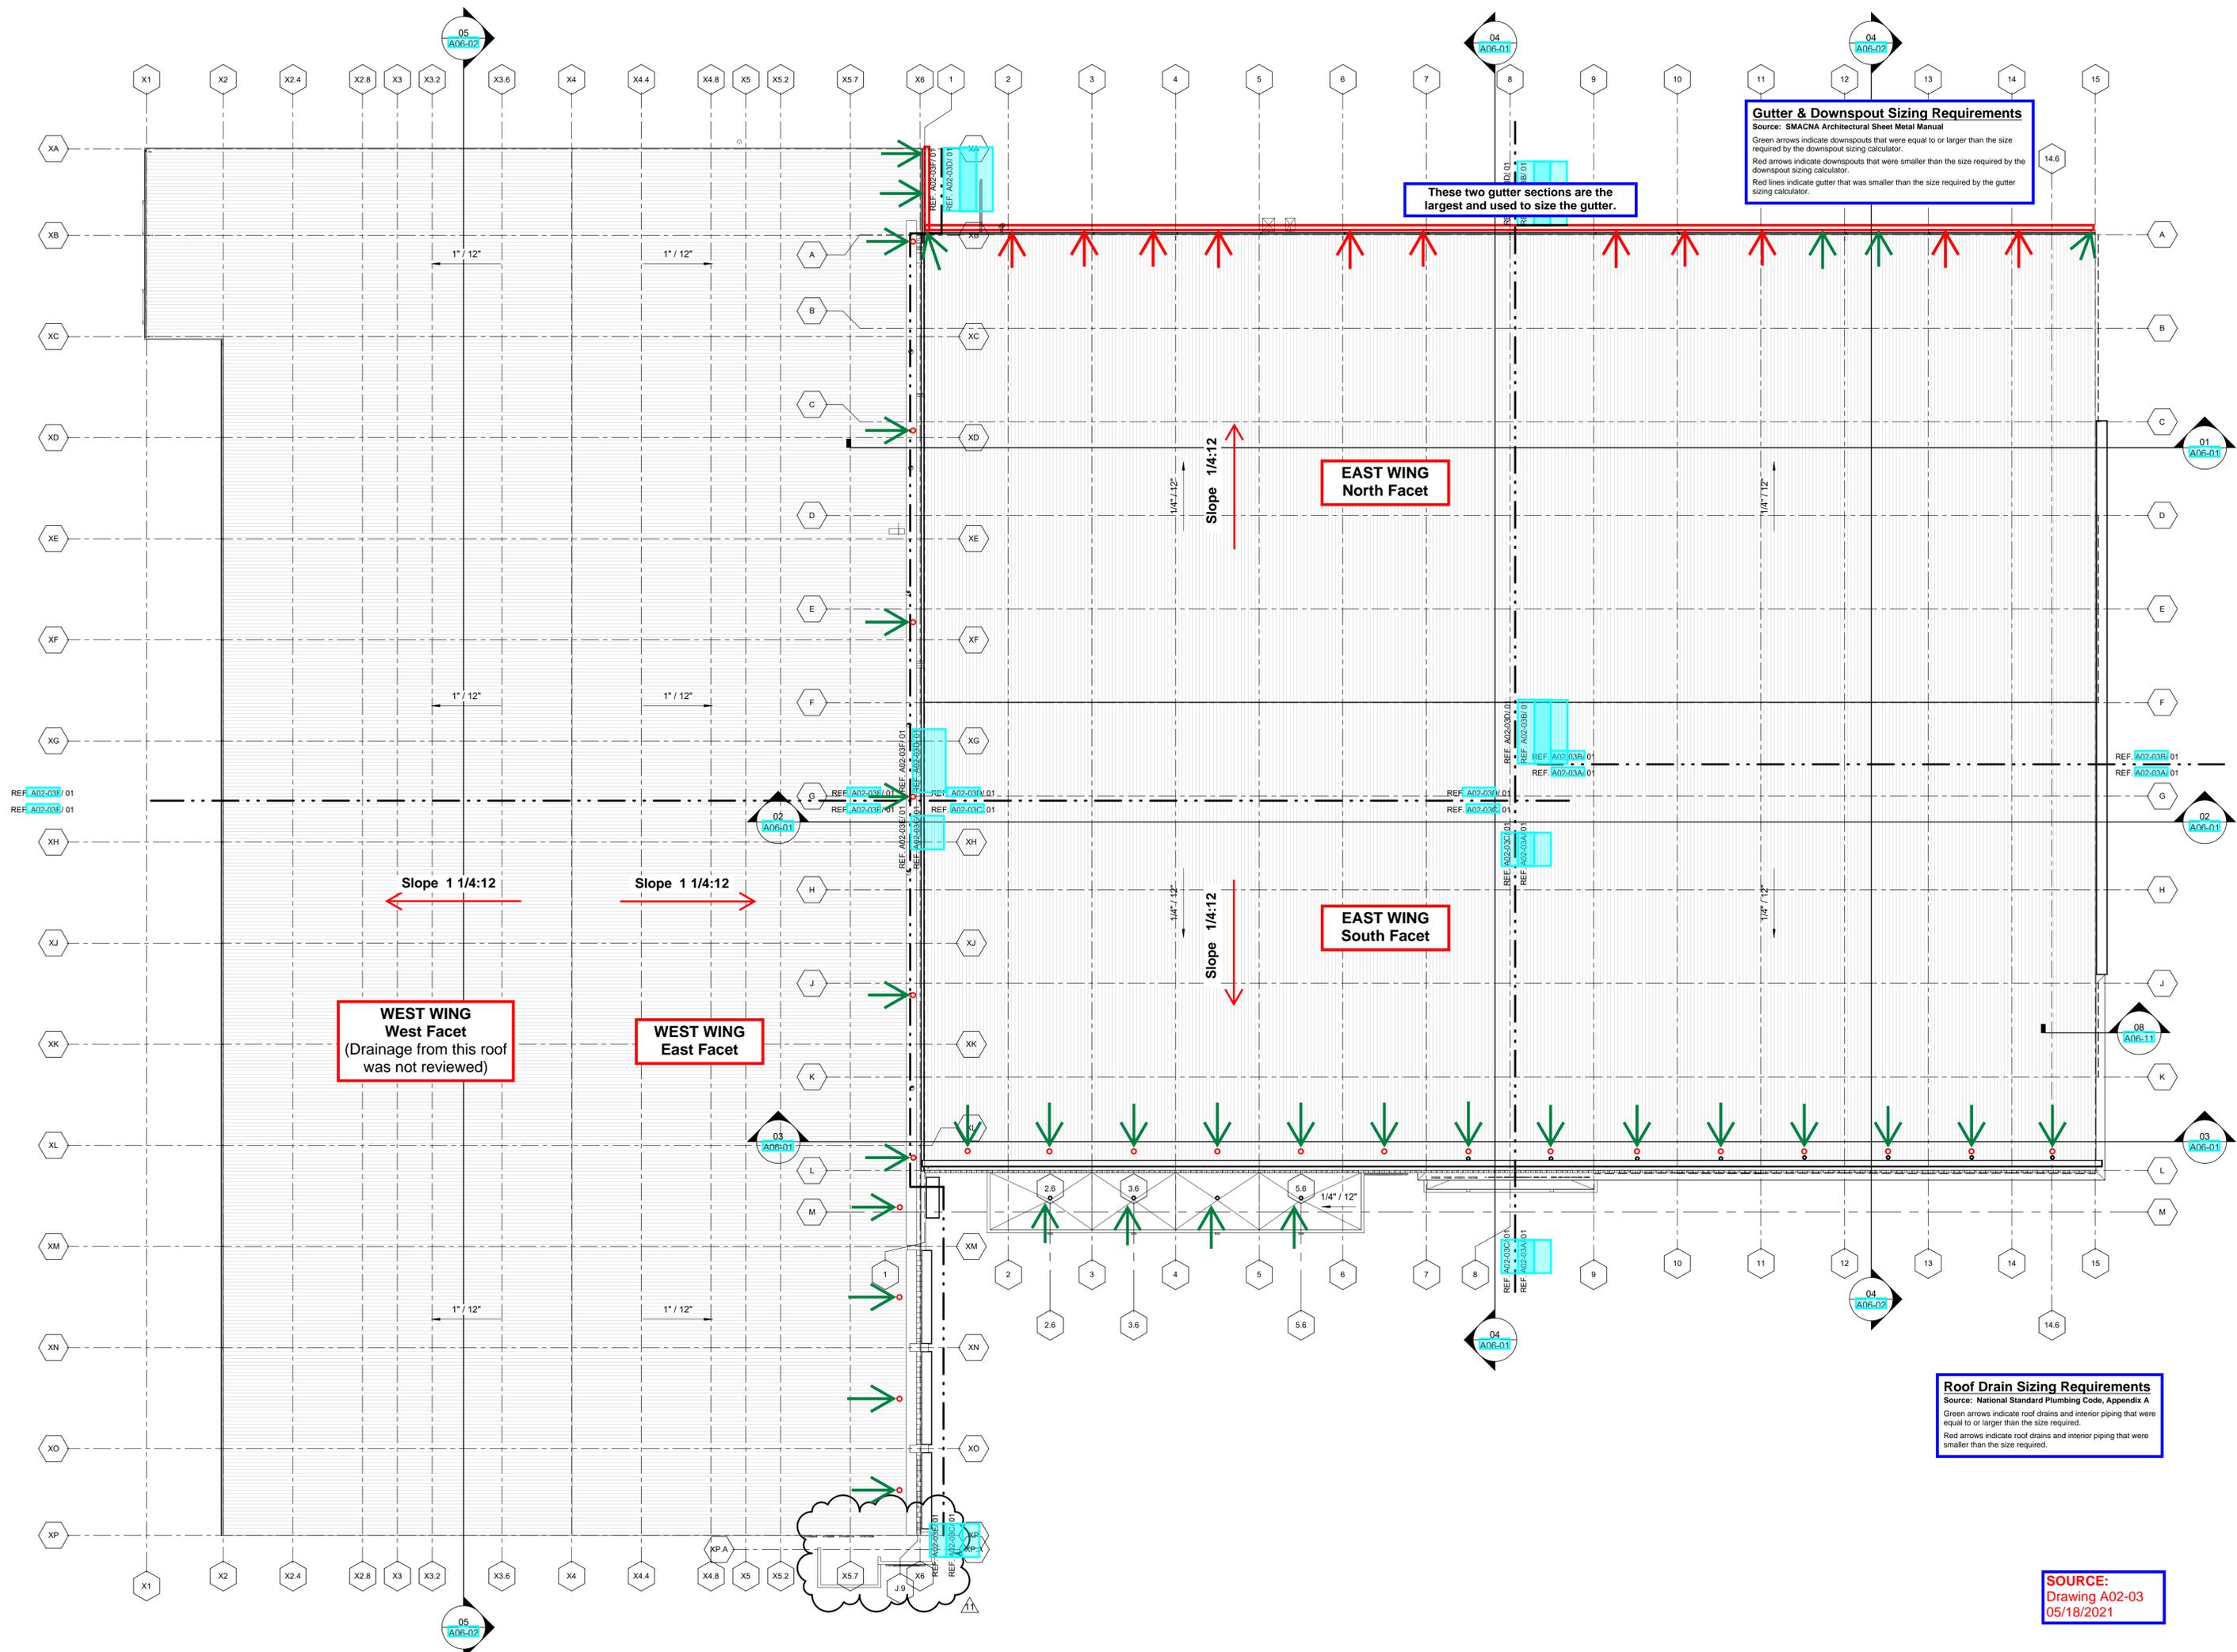
SOURCE:
Drawing A02-03
05/18/2021

Source: National Standard Plumbing Code, Appendix A
Green arrows indicate roof drains and interior piping that were equal to or larger than the size required.
Red arrows indicate roof drains and interior piping that were smaller than the size required.
