Geneva CUSD 304 5-Year Capital Improvement Plan 2013

Geneva Community Unit School District #304

March 11, 2013

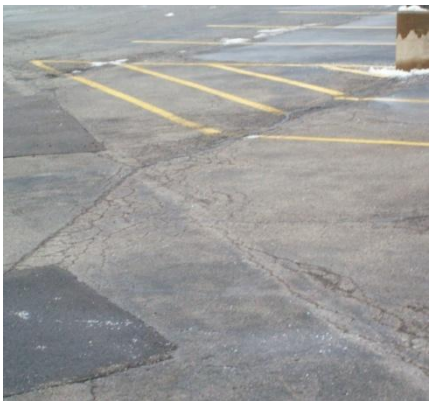
Burgess Parking Lot

Cracks and patches throughout.

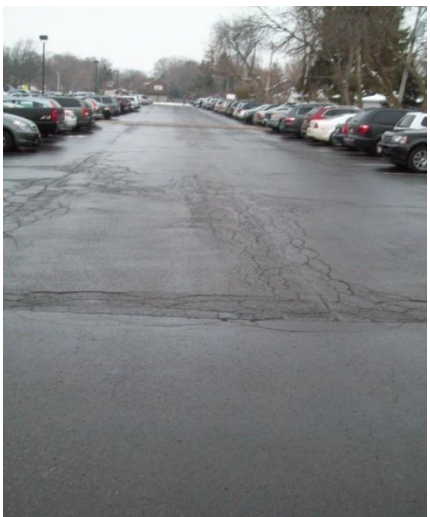
McKinley Parking Lot

Deep cracks throughout.

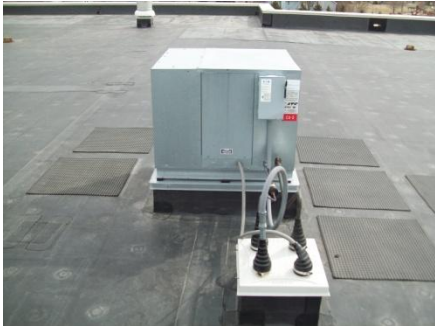
IT Server A/C

Oversized for heat load of space. Cycles on and off continually causing condensation issues and premature equipment failure.

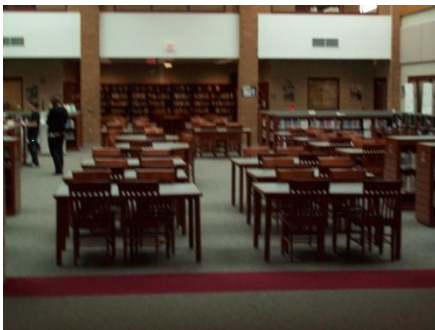
LMC

AHU is undersized for space. Only 2 VAV boxes serving the space.

Recommend increasing the capacity of the AHU and adding 4-6 VAV boxes with controls to increase comfort and control humidity.

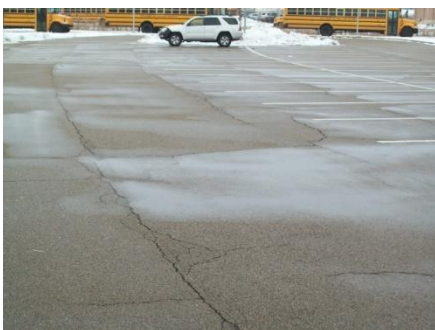
Parking Lot

Multiple deep cracks. Seal coating and crack filling was done last summer to extend life of parking lot. Resurfacing may be required within 5 years.

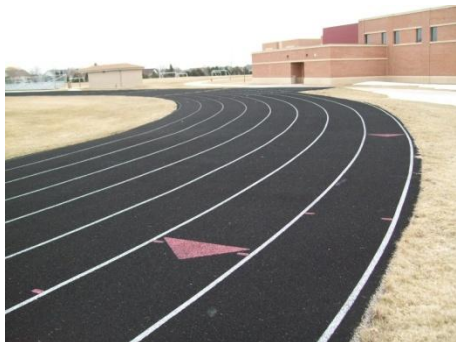
Track – installed in 2005

Track resurfacing is normally required every 8-10 years. Excessive wear spots are apparent.

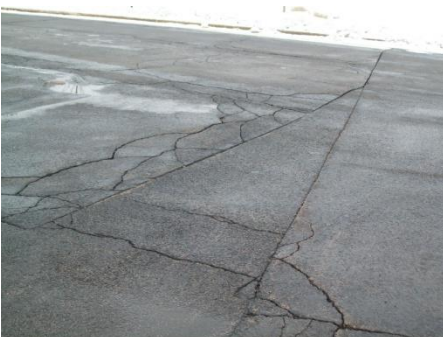
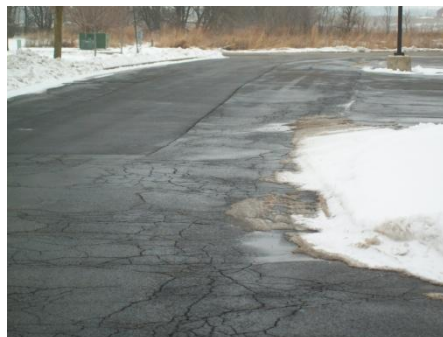
Parking Lot

Cracks filled and lot seal coated three years ago.

Partial patching seen on right picture.

Resurfacing needed this year.

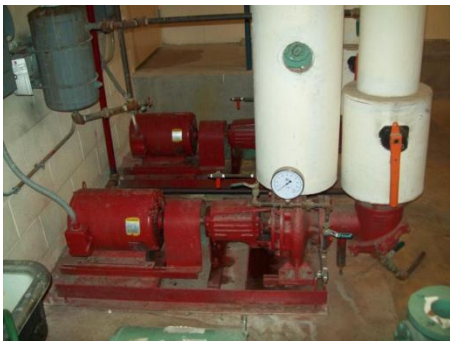
Primary and Secondary Boiler Pumps

Original to the building. Need replacing with energy efficient design and variable frequency drives for increased energy efficiency.

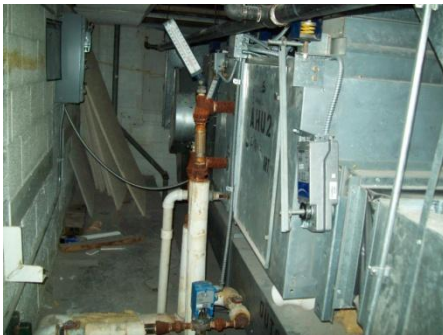
Air Handling Unit

Typical of three. Needs rebuilding or possible replacement.

New motor, shaft, bearings and controls needed

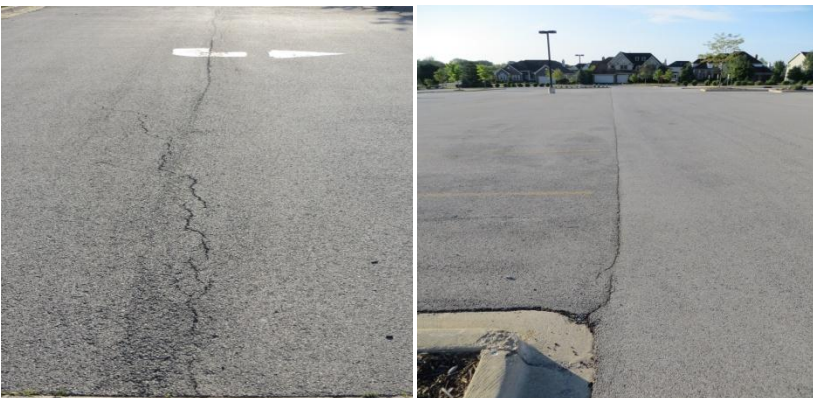
Parking Lot

Several areas starting to show cracking. Crack filling and seal coating will be needed within the next five years.

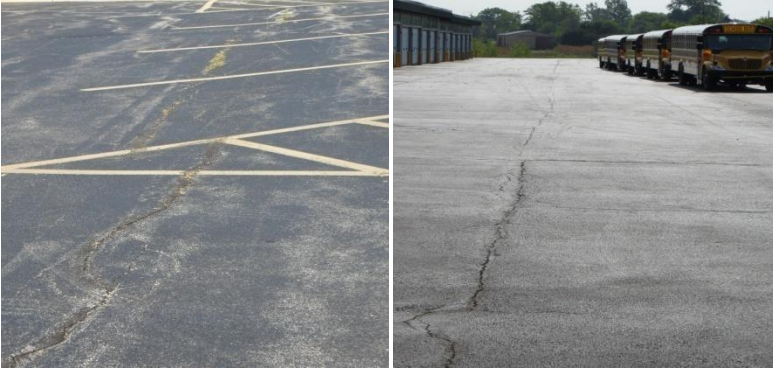
Parking Lot

Several areas starting to show cracking. Crack filled and seal coated two years ago. Crack filling and seal coating within the next five years.
