NORTHWEST ARCTIC BOROUGH SCHOOL DISTRICT

Property Services

February 2026

Preventive Maintenance Site Visit Report

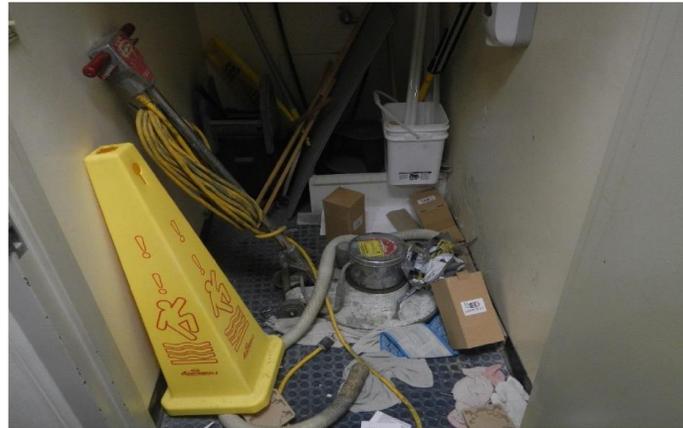
Areas needing improvement were also identified. Mechanical rooms and custodial closets were cluttered and disorganized, and preventive maintenance did not appear to be consistently completed. At the Kisimigiutq School in Kivalina, which has been open for just over two years, several required preventive maintenance tasks are clearly not being performed. Examples include emergency eyewash stations without water supply, wastewater treatment plant screens and filters not being cleaned or replaced, and one boiler that has not operated since the school opened.

Figure 10 Cluttered custodial closet

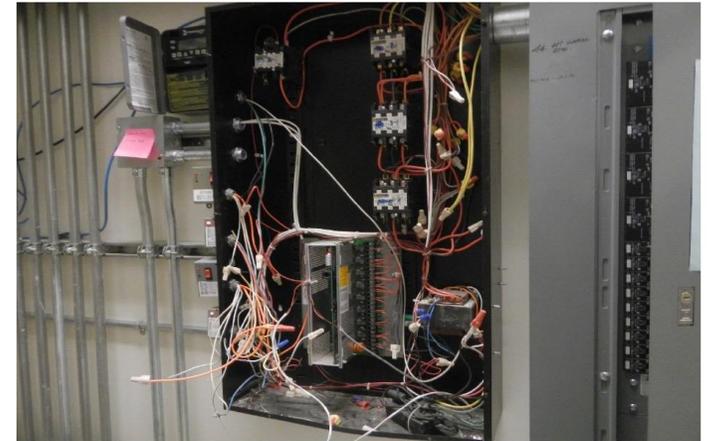
Figure 24 All covers should be on electrical boxes

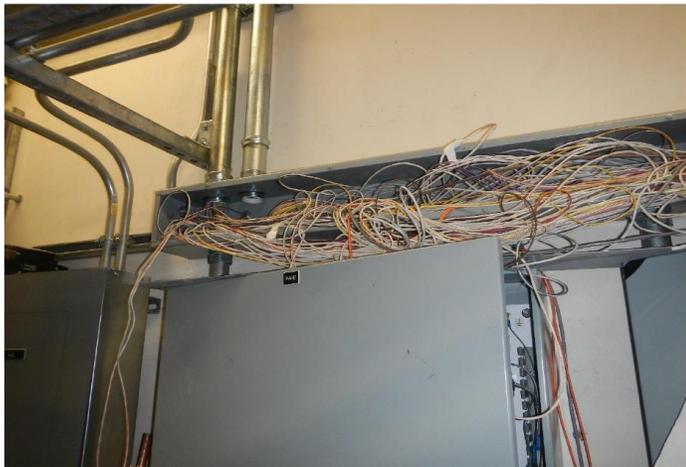
Figure 21 Poor wire management, needs fire caulking

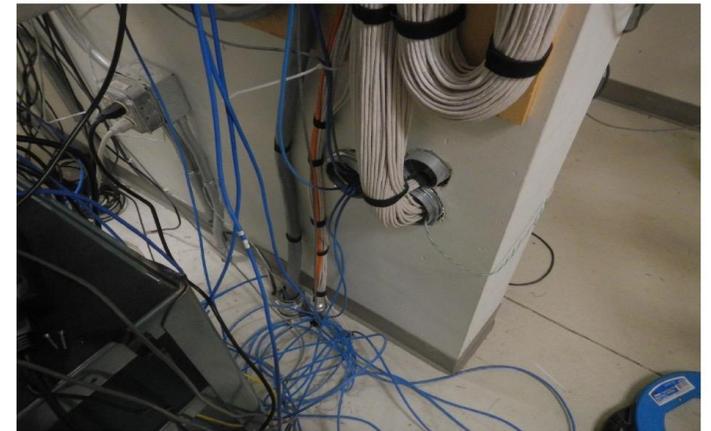
Figure 25 Poor wire management, fire stops missing

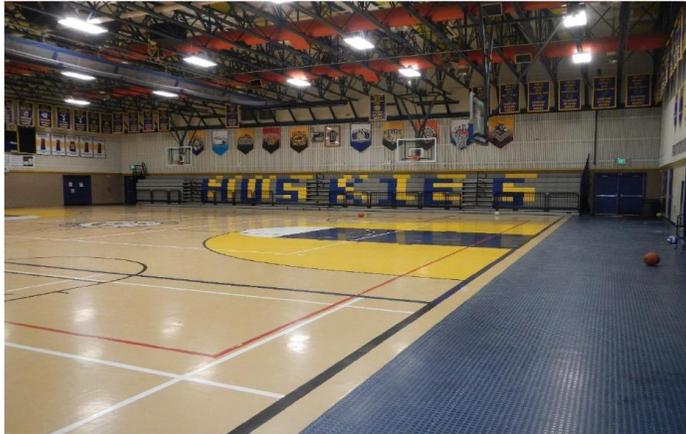
Figure 26 The gym floor sustained some damage from cots when housing displaced residents during the typhoon

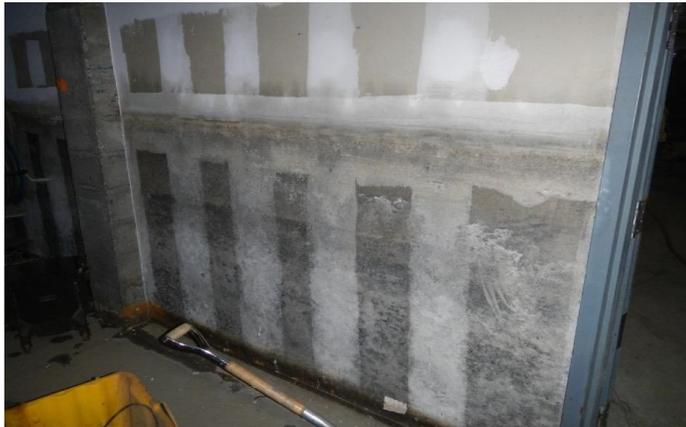
Figure 27 Water damage from typhoon flooding

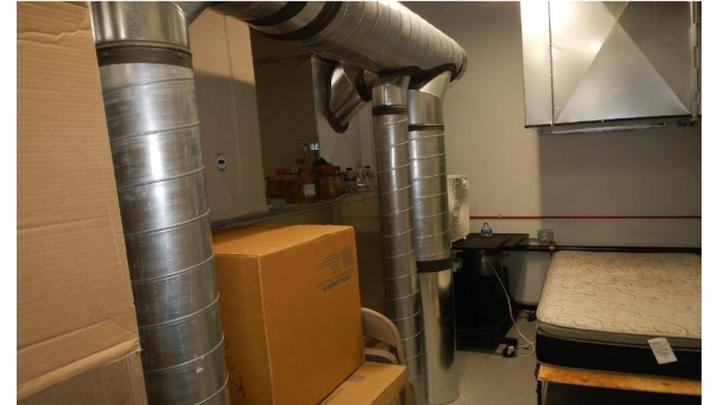
Figure 36 Clutter must be removed

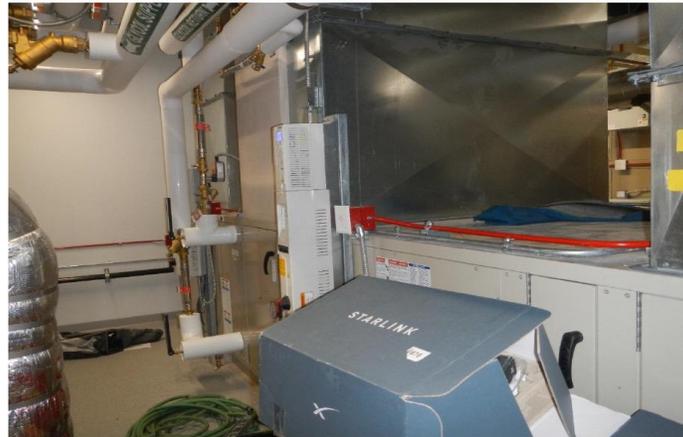
Figure 35 Clutter needs to be removed from all mechanical rooms

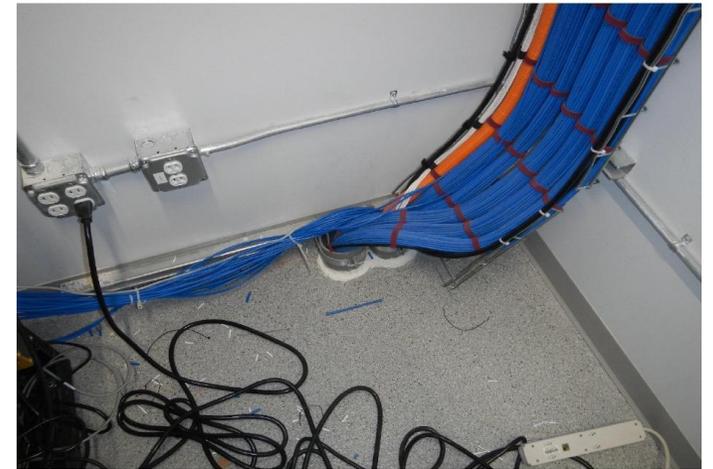
Figure 37 Trip hazards in network room

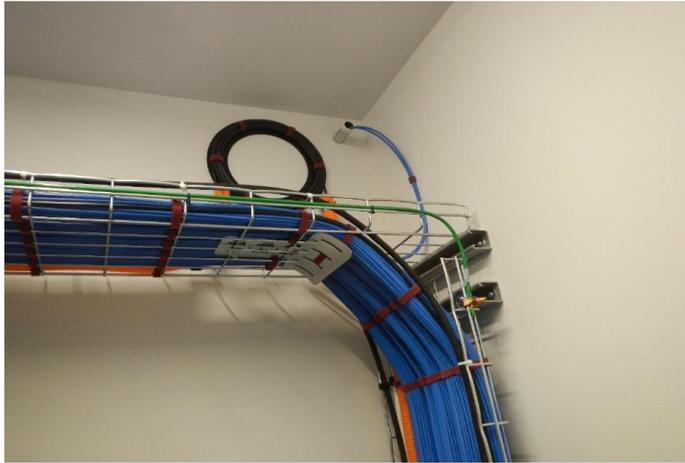
Figure 38 Firewall penetrations must be sealed

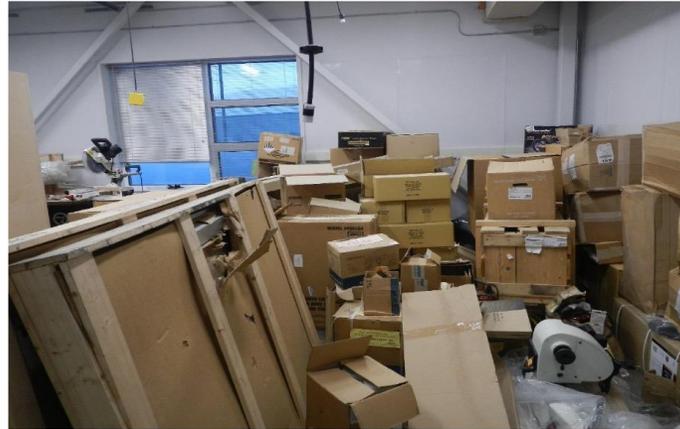
Figure 40 Maintenance space must be clutter free

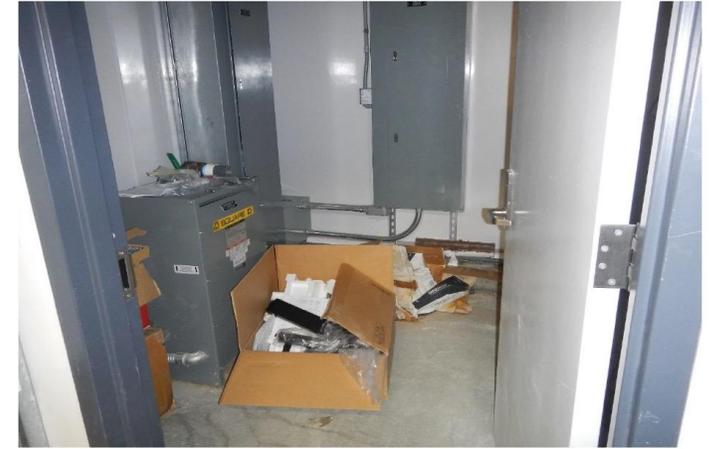
Figure 42 Nothing can be blocking the electrical panels. Electrical rooms must be clutter free

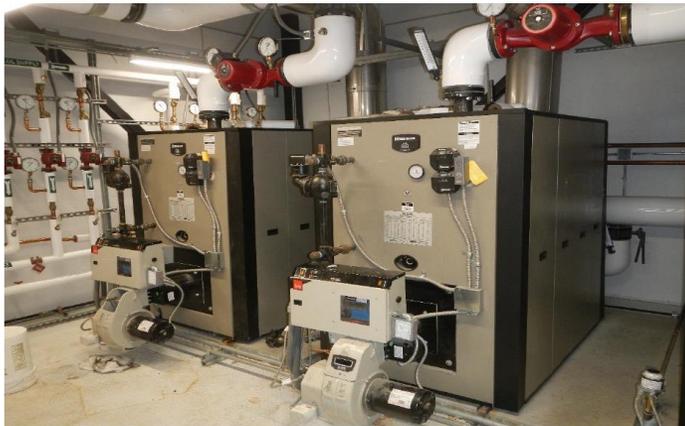
Figure 39 One of the boilers has not worked since the opening of the school 2 years ago

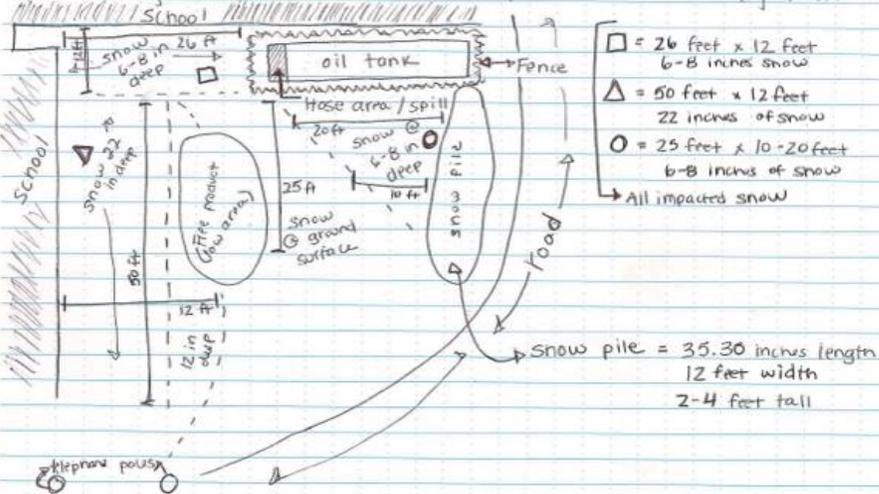
1130 Arrive in Noorvik. Heading to school to see spill site.
 1100 Spill into 2 Tank connected to fill hose. Check valves were left open for unknown amount of time before they realized it was spilling. Free product filled up inside the hose containment area, there is still free product in there. They used a shop vac to pump out free product from tank and from ground surface. stopped using it due to sparking. Have been using 5-gallon buckets to pump & get fuel off of ground since.

1120 measuring depth of snow. Some snow was piled off to the side w/ city dozer.

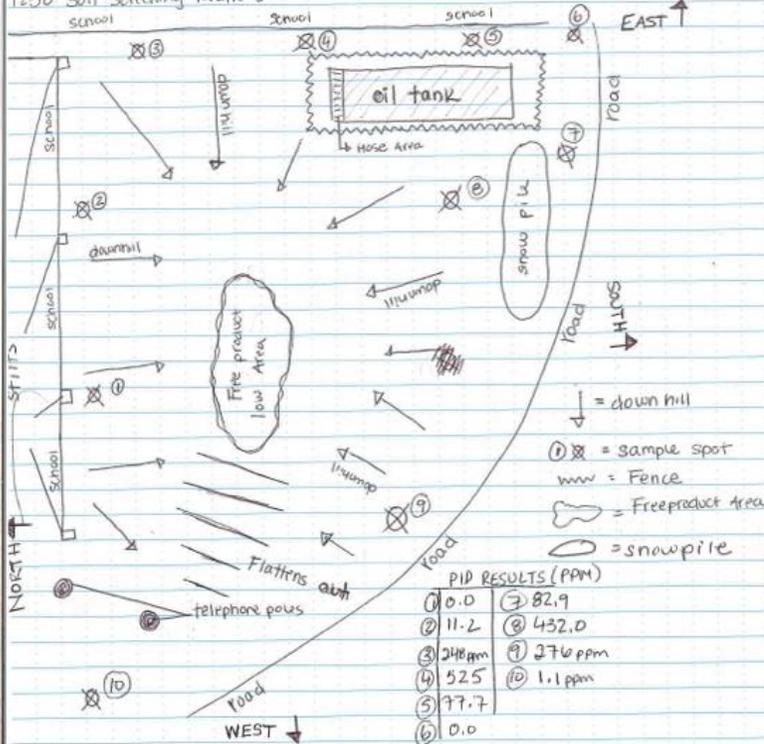
1230 Soil screening locations:

PID RESULTS (PPM)

① 0.0	⑦ 82.9
② 11.2	⑧ 432.0
③ 248 ppm	⑨ 276 ppm
④ 52.5	⑩ 1.1 ppm
⑤ 77.7	
⑥ 0.0
