FACILITY CONDITION ASSESSMENT

FACILITY CONDITION ASSESSMENT REPORT OF CI JOHNSON ELEMENTARY SCHOOL 1934 Liberty Street Aurora, Illinois 60505

EMG Project #: 112945.15R-009.017
Date of Report: April 25, 2015
On site Date: April 7, 2015

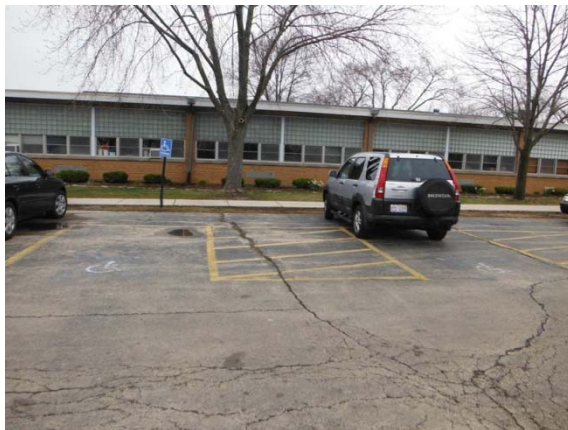
Two handicap accessible parking stalls are provided; however, no van accessible stalls are provided and one of the car spaces is missing a vertical sign. Installing a full van accessible stall, adding a vertical car sign and installing one more full car accessible stall will be required. The van space should be the stall closest to the main entrance door.

Photo #11:	Accessible parking stalls –no van stalls and one vertical sign missing
------------	--

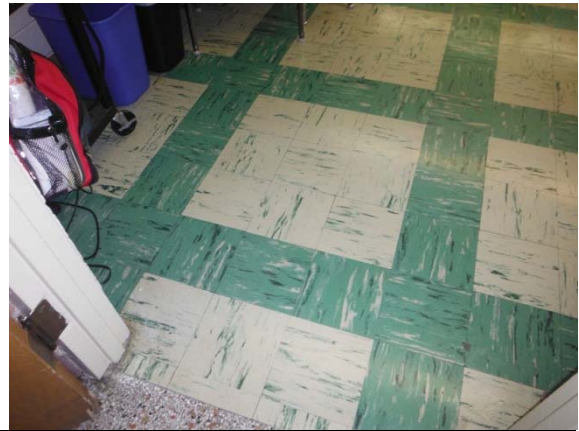
9X9 suspect ACM vinyl tile is located in the original sections of building (200 and 300 classroom wings). Proper removal and replacement of all 9X9 suspect ACM vinyl will require further study and testing by a licensed contractor. The cost for a follow-up study is included in the cost table.

Photo #62: 9X9 suspect ACM vinyl tile in classroom of original building section

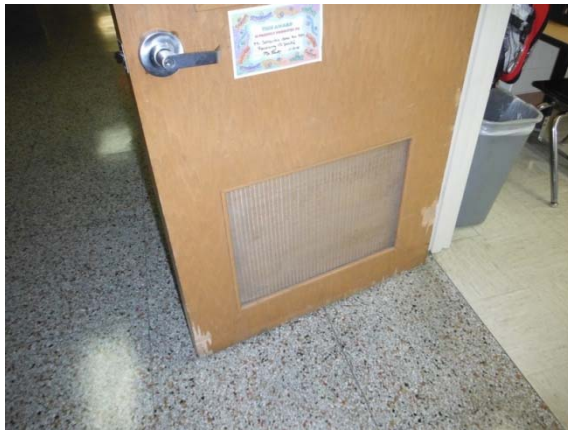
Wood doors in the original section of building have some that are worn and delaminating (200 and 300 classroom wings, as noted in the common doors leading into the 300 wing, cafeteria and classroom 301. Replacement of the older doors is recommended early in the reserve term.

Photo #63: Condition of older classroom door

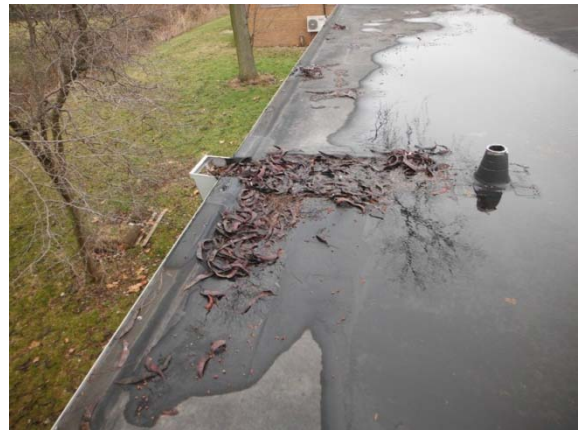
Roof drainage appears to be inadequate. Significant areas of ponding are evident on the sides of the roof at both the 200 and 300 wings and a clogged scupper noted on east side of the 300 wing roof at the ponding area. The low spots in the roof must be reframed to promote adequate drainage to existing drainage devices during the next roof replacement. In addition, clearing and minor repair of drain system components should be performed regularly as part of the property management's routine maintenance program.

Photo #64: Clogged scupper and ponding on east side of 300 wing roof

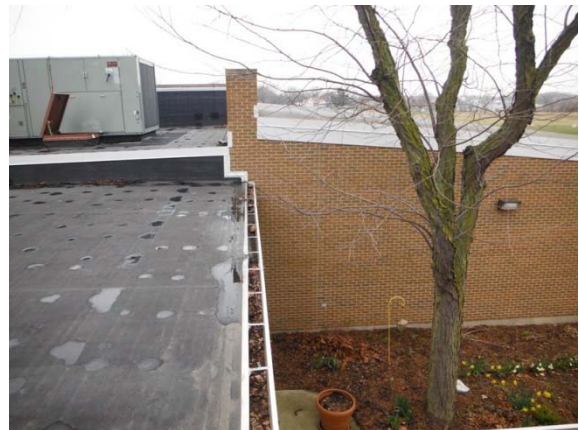
Some trees noted growing close to or branches overhanging the roof surfaces on the south, north and east side of the building. It is recommended that all trees are trimmed back away from building in to prevent clogging of scuppers and gutters. This work can be performed as part of the property management's routine maintenance program.

Photo #66: Clogged gutter on north side of building

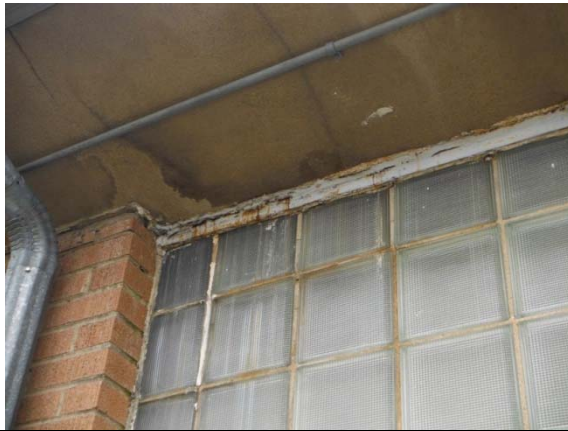
The original section of the building (200 and 300 classroom wings) have older single-paned metal hopper and fixed window units in poor condition, exhibiting rusting and deterioration, as well as some cracked glass blocks located above these windows. Early replacement of these older windows, including the glass blocks, is recommended due to their age and condition, the estimated Remaining Useful Life (RUL) and for energy savings.

Photo #67: Rusting window framing at original section of building

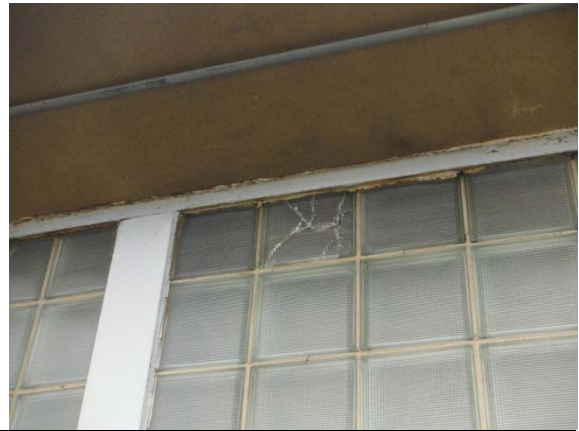
Photo #68: Cracked glass block at original section of building

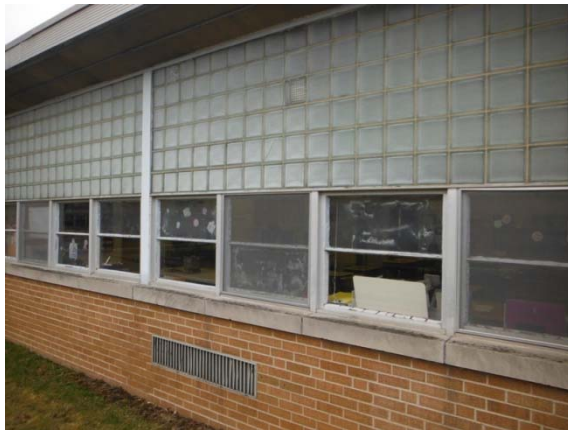
Photo #69: Original (200 & 300 wings) sections of building have original single-pane windows

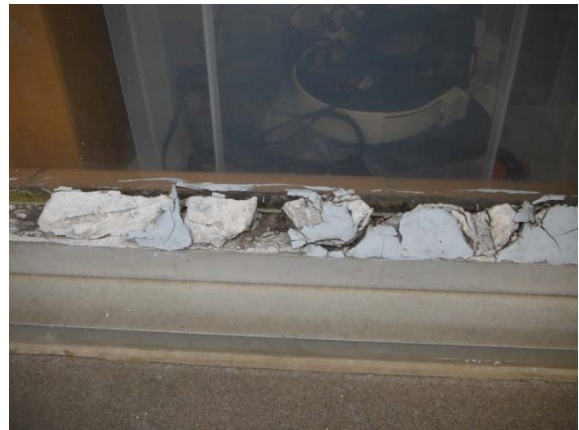
Photo #70: Close up of condition of single-pane windows

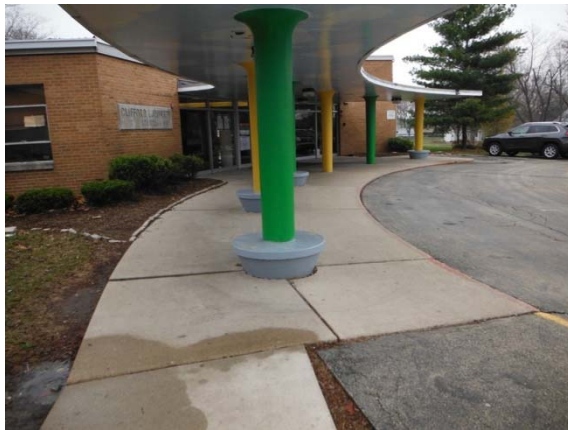
The concrete sidewalks along the front of the school, adjacent to the main building entrance, were observed to have minor areas of settlement, with separation areas leaving large gaps between the sections of sidewalk and isolated areas of spalled concrete occurs. As such, sectional replacement of the concrete sidewalk will be required early during the evaluation period.

Photo #71: Minor settlement of concrete sidewalk at front walk

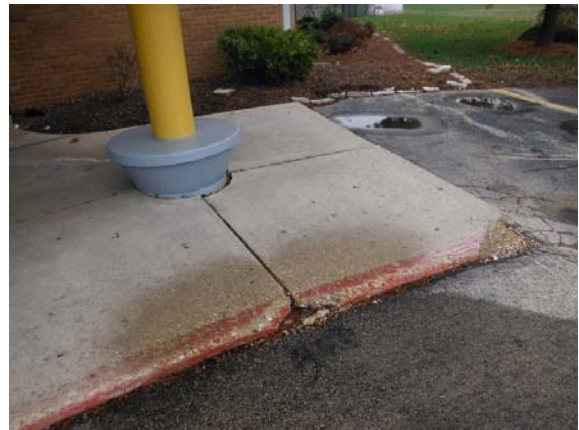
Photo #72: Spalling concrete sidewalk at front walk

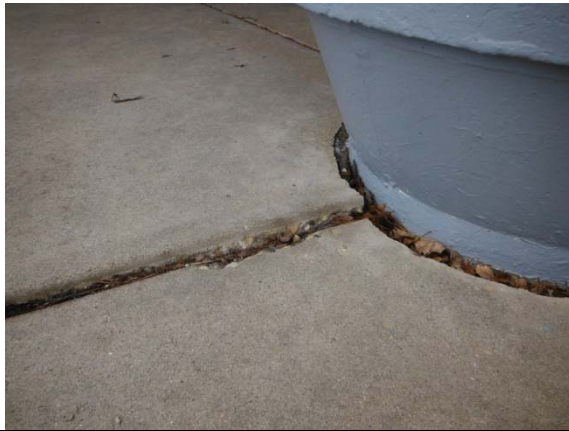
Photo #73:	Concrete sidewalk settlement and open gaps at front walk
------------	--

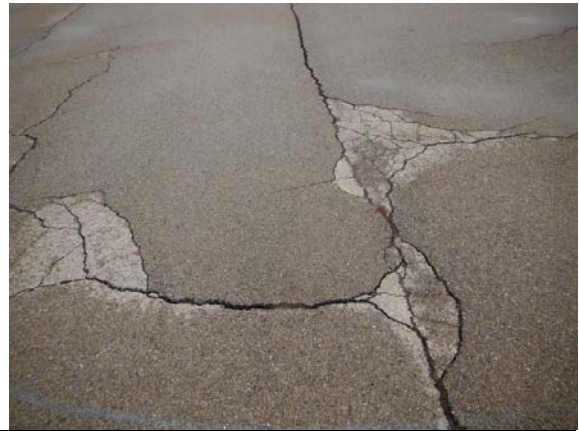
The basketball court asphaltic pavement is worn and cracking at various locations throughout. Crack sealing and seal coating of the basketball court surface will be required early during the evaluation period.

Photo #74:	Condition of asphalt basketball court on northwest side of building
------------	---

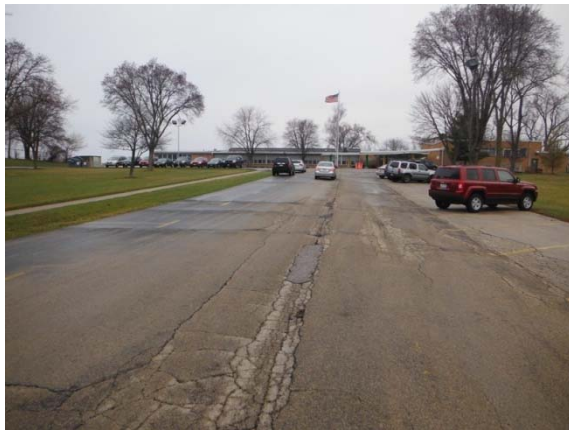
The asphalt pavement is in fair to poor condition, with overall heavy surface wear, worn striping, widespread alligator cracking, and a moderate number of depressions and potholes. The area immediately entering and exiting the property main drives are generally in the worst condition. The most severely deteriorated areas must be cut and patched during the early portion of the evaluation period, and all of the areas are recommended for replacement as soon as the budget allows, as well as seal coating and re-striping.

Photo #75:	Condition of asphalt pavement at entry drive
------------	--

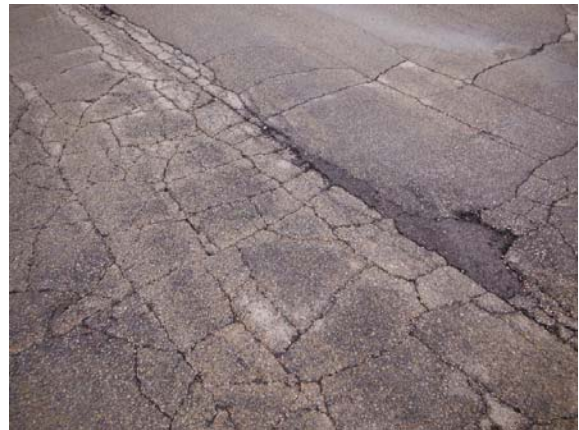
Photo #76:	Asphalt deterioration at entry drive
------------	--------------------------------------

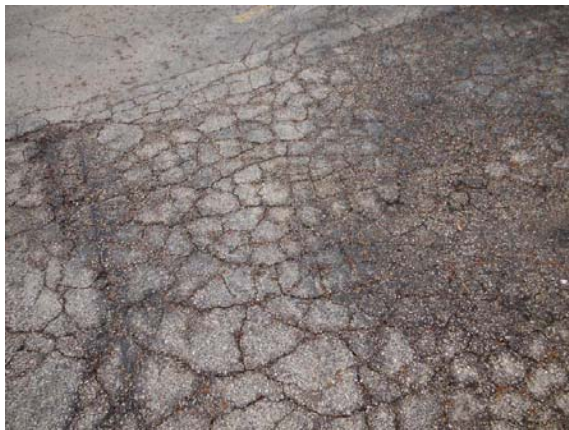
Photo #77:	Asphalt deterioration at top of entry drive
------------	---

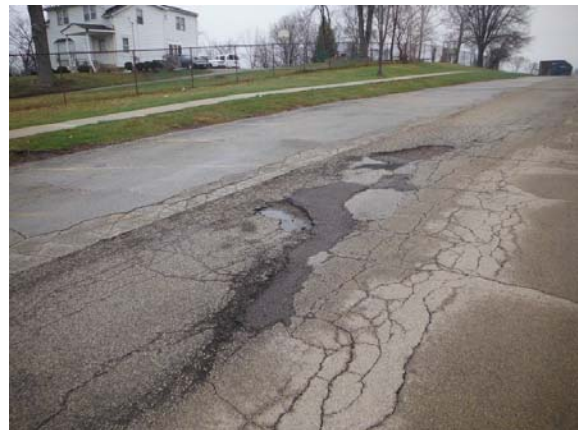
Photo #78:	Asphalt deterioration at exit drive
------------	-------------------------------------

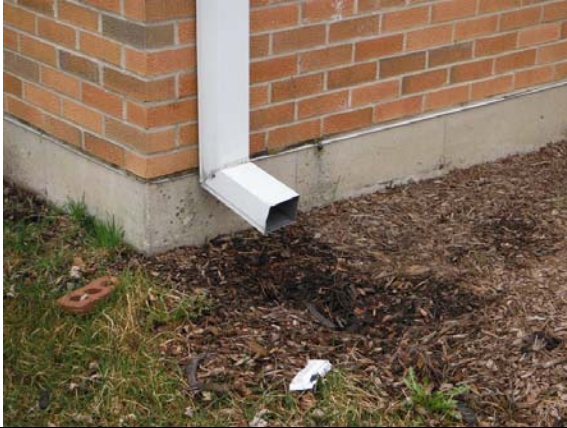
Some of the existing downspouts spill onto the soil, causing soil erosion, due to missing splashblocks. Concrete splashblocks must be installed at the base of the downspouts to prevent erosion. This work can be performed as part of the property management's routine maintenance program.

Photo #79:	Missing splashblock at base of downspout at north side of building
------------	--

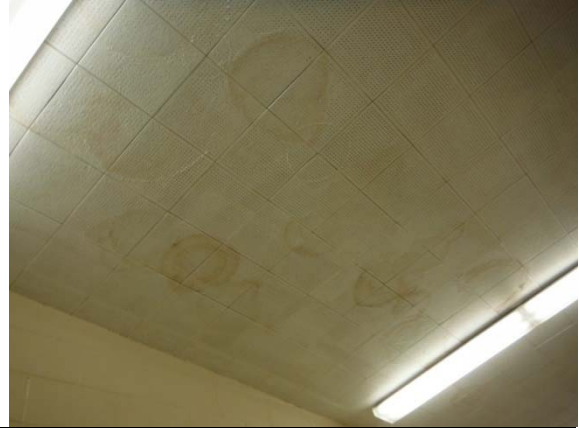
Water stained acoustical ceiling tiles noted at the cafeteria, lobby corridor, and few classrooms. According to the Building Fireman, these stains are from prior roof leaks that have since been repaired. Replacement of the older ceiling tiles are recommended early in the reserve term.

Photo #80:	Water stained ceiling tiles at classroom 301
------------	--
