Geneva Community Unit School District #304  
Operations and Maintenance  
7 Year Capital Improvement Plan

**Board of Education Meeting**  
**December 8<sup>th</sup>, 2014**

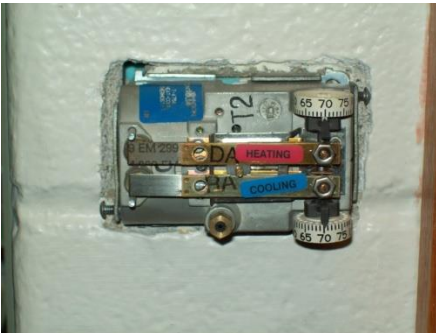
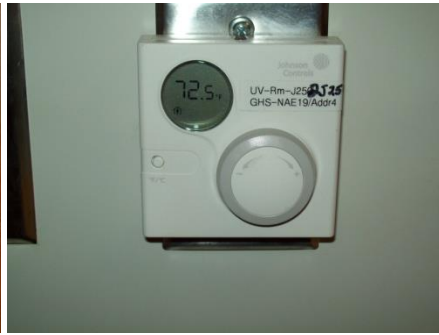
## Controls

Pneumatic to Digital conversion allowing for tighter control of temperature, setback features, alarming feature and will be computer based.

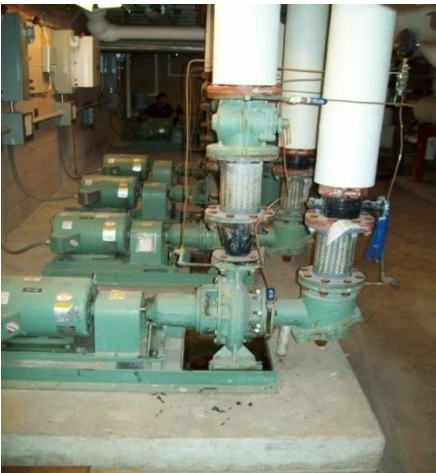
## Secondary Pumps (8)

Replace pumps that are nearing the end of their life cycle

Variable Frequency Drives will greatly increase energy efficiency and lengthen the life of the pumps.

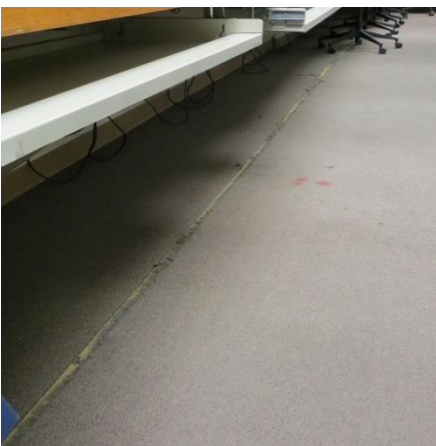
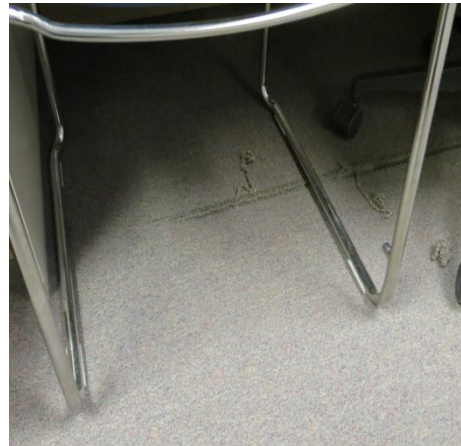
## Carpet

The carpet is starting to fray and cause trip hazards.

Carpet will need to be replaced.

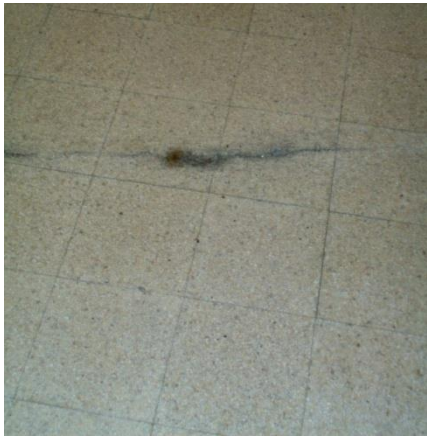
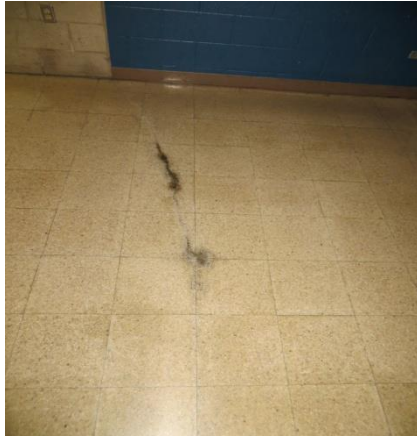
## Flooring

Existing quartz tile is cracking and has faded.

Replace tile in phases.

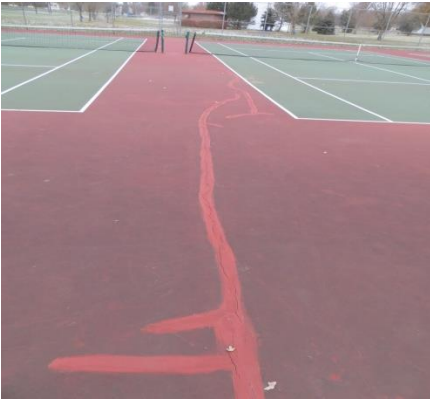
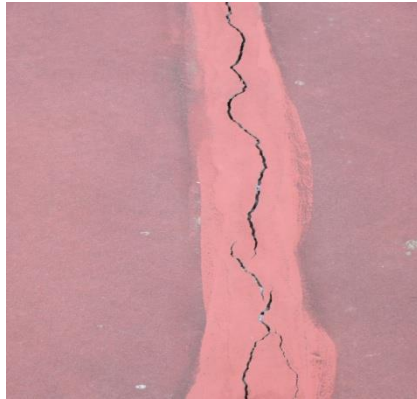
## Tennis Court Resurface

Cracks and patches throughout courts.

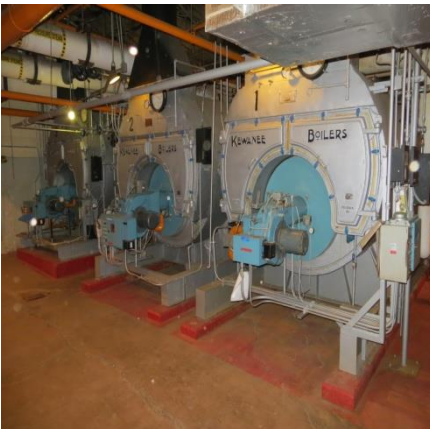
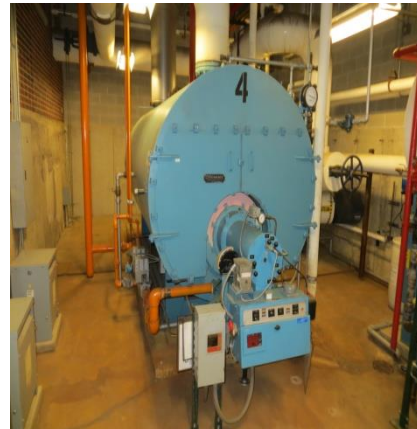
## Boiler Replacement

Breakdowns and repairs are becoming more frequent and costly.

Replace steam boilers with hot water boilers for energy efficiency

Locate new boilers from boiler house to high school.

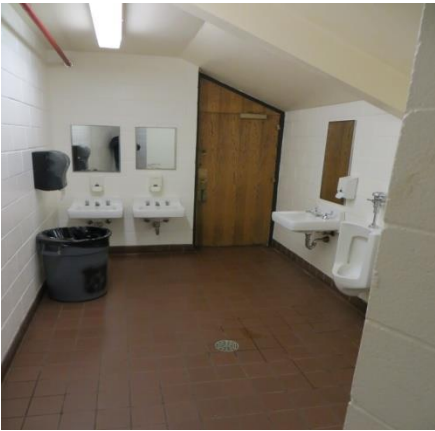
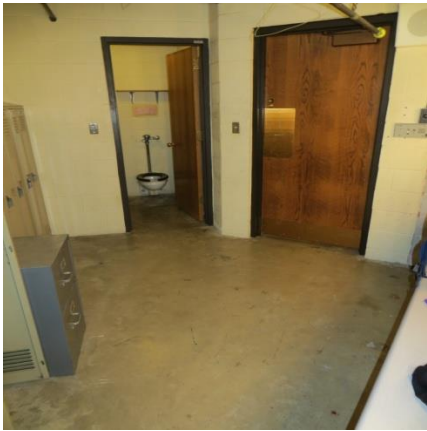
## Cafeteria and Stage Craft Bathrooms

Bathrooms are 40 years old.  
Showing significant wear.  
Need to update.

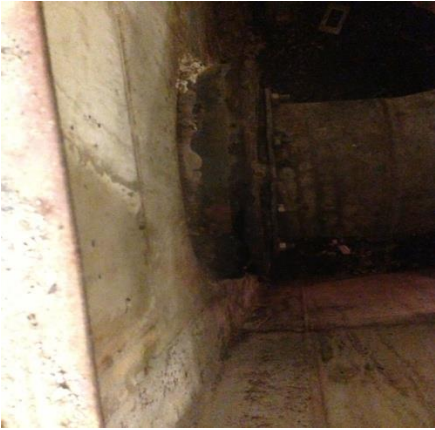
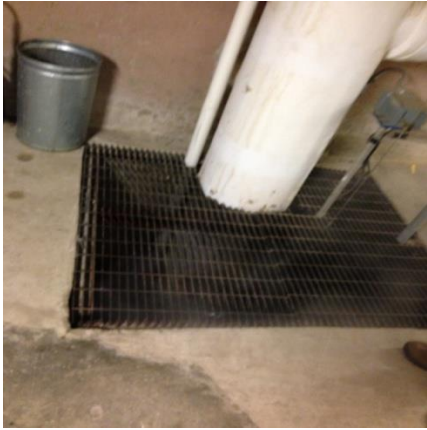
## Steam Pipe Replacement

Insulated jacket failing around steam pipe.  
Will continue to deteriorate.  
Significant safety hazard.

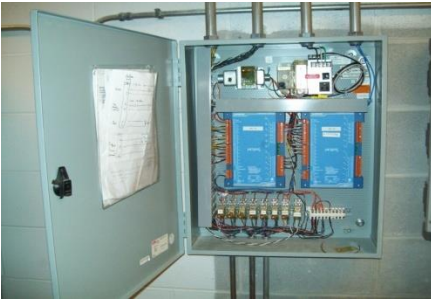
## Lon Controller

Lon controls throughout the building.

Outdated and costly to repair.

Replace Lon to Bacnet.

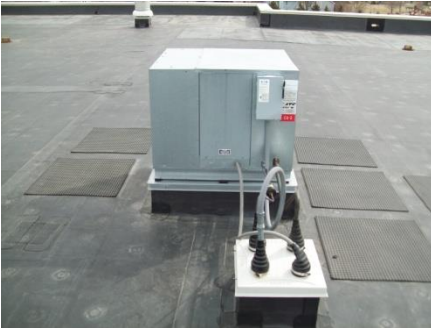
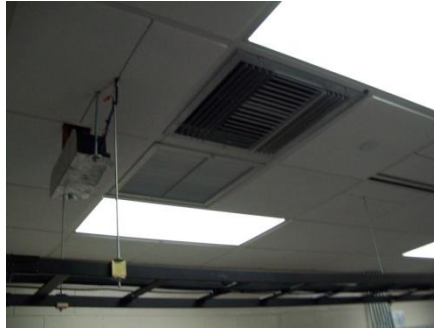
## IT Server A/C

Oversized for heat load of space.

Cycles on and off continually causing condensation issues and premature equipment failure.

Replace with properly sized unit.

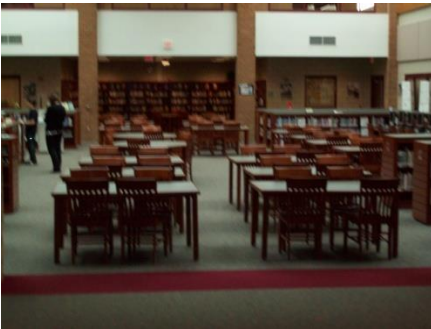
## LMC

AHU is undersized for space.

Only 2 VAV boxes serving the space.

Recommend increasing the capacity of the AHU and adding 4-6 VAV boxes with controls to increase comfort and control humidity.

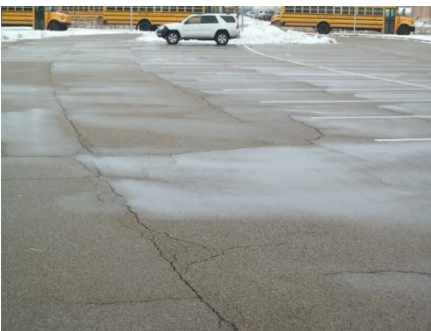
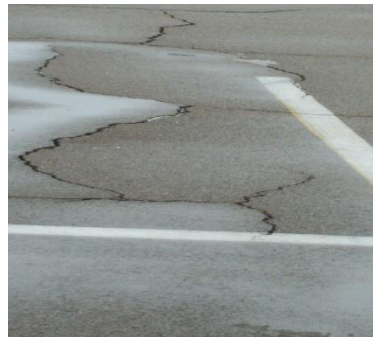
## Parking Lot

Multiple deep cracks.

Crack filling and seal coating will extend the life of the parking lot.

Resurfacing may be required within the next four to five years.

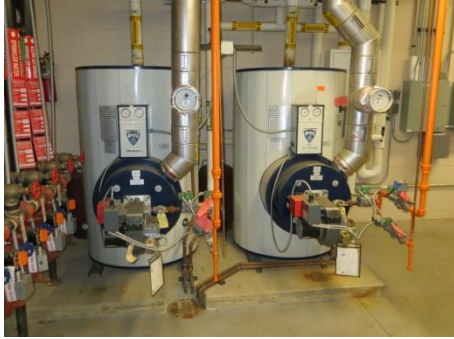
## Hot Water Heaters

The two 300 gallon PVI water heaters are nearing the end of their life cycle.

Replacement will be needed within the next seven years.

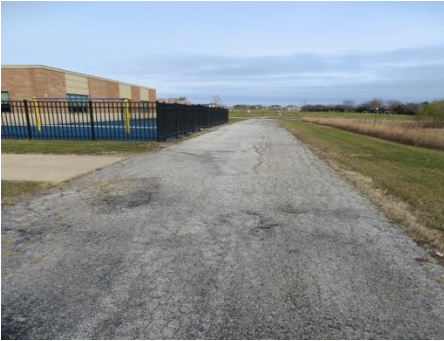
## **Fire Lane**

Pavement starting to show excessive cracking and breakdown.

Will need to be resurfaced.

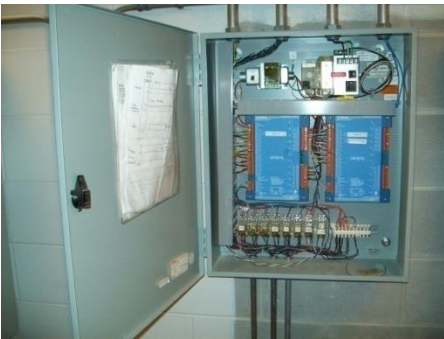
## **Lon Controller**

Lon controls throughout the building.

Outdated and costly to repair.

Replace Lon to Bacnet.

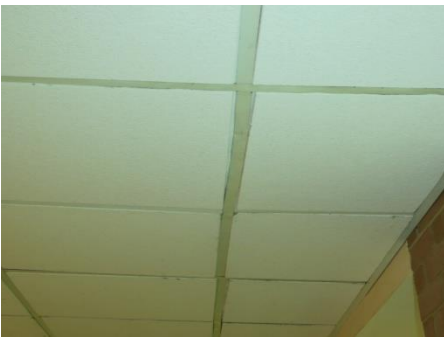
## **Ceiling Tile**

Ceiling grid and tile are starting to show excessive discoloration and wear.

Replace ceiling grid and tile.

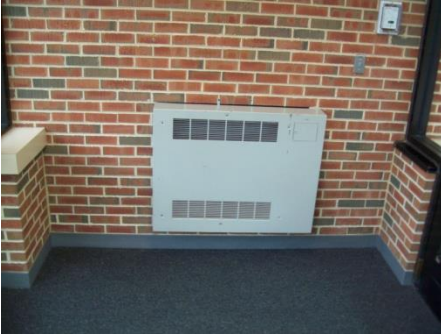
### **Cabinet Unit Heaters**

15 units are over 35 years old.

Replace with energy efficient units.

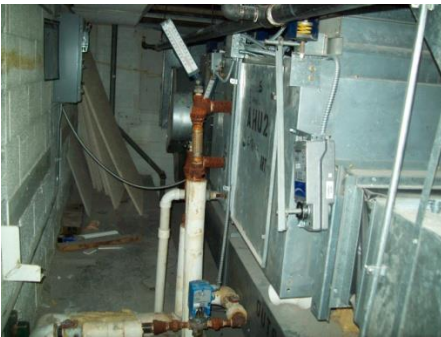
### **Air Handling Unit**

Needs rebuilding or possible replacement.

New motor, shaft, bearings and controls needed.

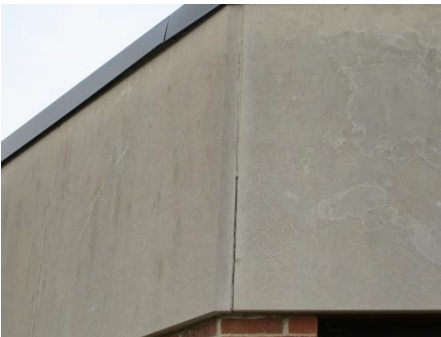
### **Tuck-pointing**

Cracks and missing mortar joints will need to be repaired.

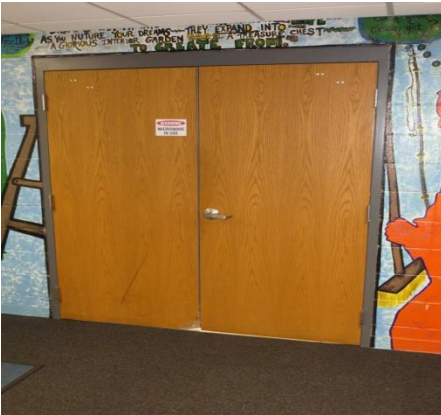
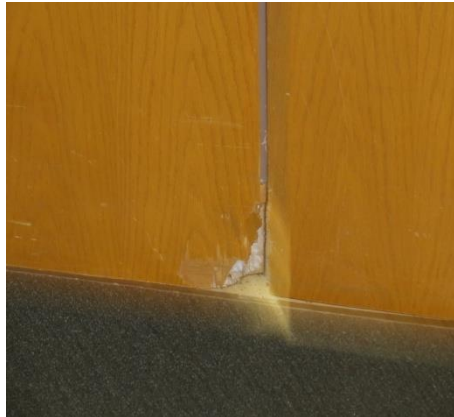
## Interior Doors

Several doors in the building are damaged and in need of replacement.

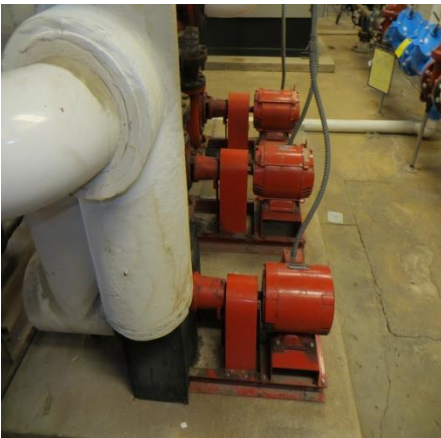
## Chilled Water and Boiler Secondary Pumps

Pumps nearing end of life cycle.

Need to replace with energy efficient design and variable frequency drives for increased energy efficiency.

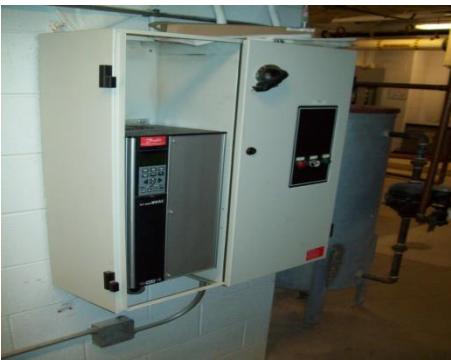
## Variable Frequency Drive (VFD)

VFDs have started failing this year.

All units need replacing.

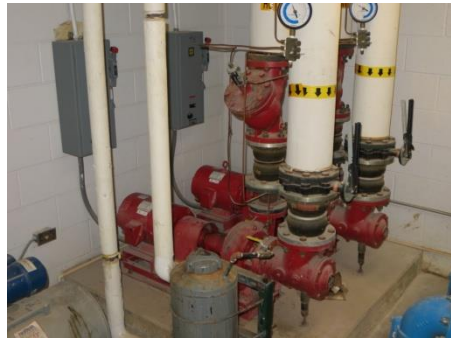
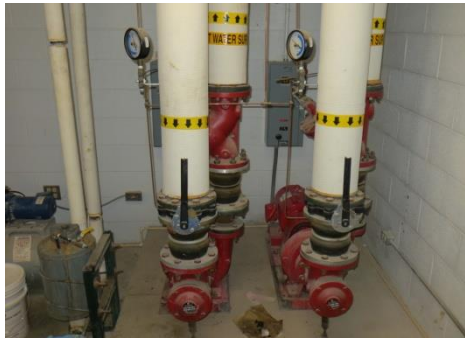
## Primary and Secondary Boiler Pumps

Original to the building.

Need replacing with energy efficient design and variable frequency drives for increased energy efficiency.

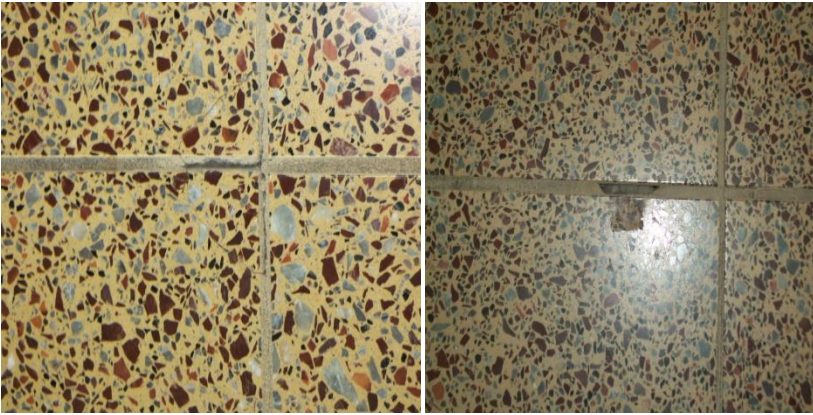
## Floor Tile

Terrazzo tile repair/replacement.

Tile did not properly bond to the floor and is cracking.

Final phase of replacing all ground floor tile will begin the summer of 2015.

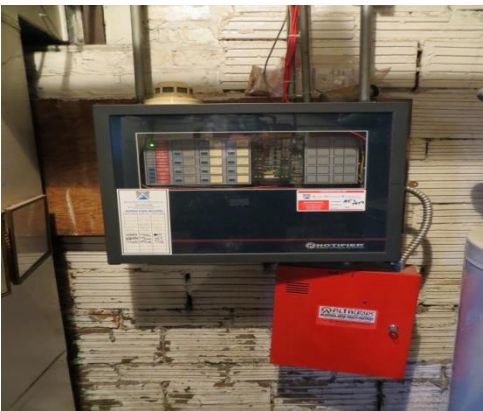
## **Fire Alarm System**

Notifier 5000 fire alarm panel will need to be updated to meet current NFPA code requirements .

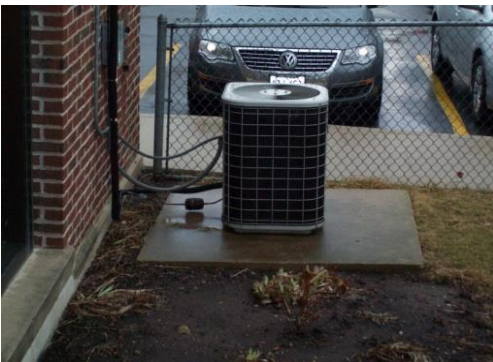
## **Fan Coil Condensing Unit**

The entire building is cooled with fan coil units.

Several are beginning to fail and most will need to be replaced in the next 5 years.

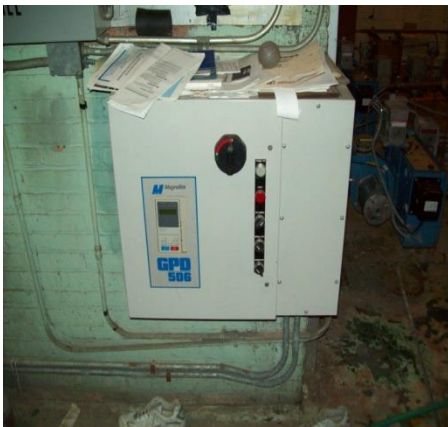
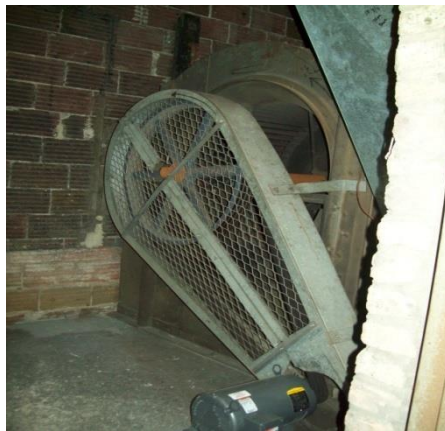
### VFD and Fan for the Furnace

VFD doesn't work and the fan for the furnace is at least 36 years old.

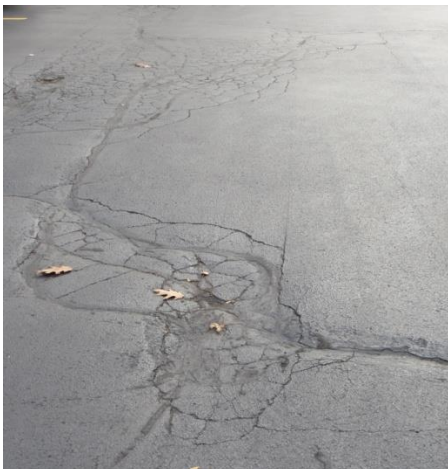
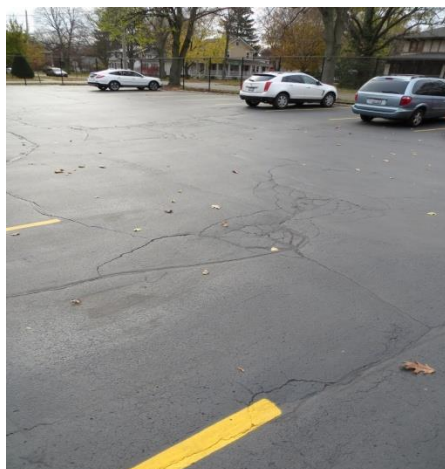
### Parking lot

Several areas with extreme cracking.  
Resurfacing will be needed.

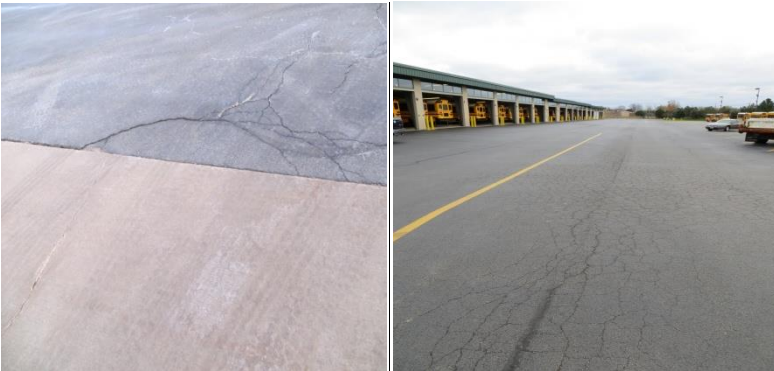
## Parking Lot

Pavement starting to crack and breakdown.

Crack filling and seal coating will extend the life of the parking lot.

Resurfacing will be needed in the next three to five years.

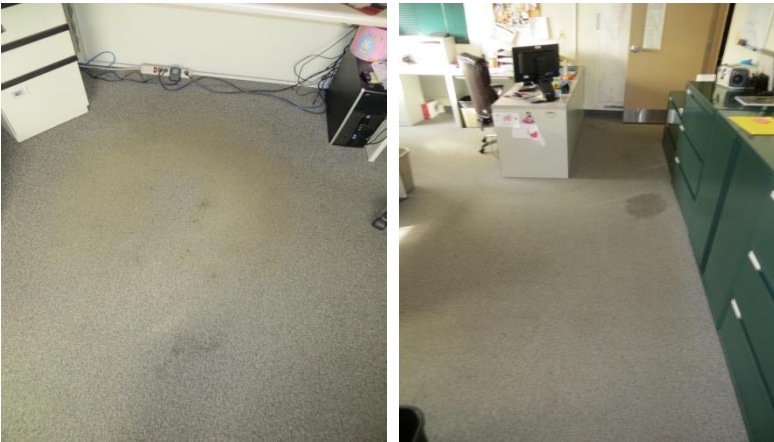
## Carpet Replacement

The carpet is starting to show wear and we are unable to remove stains.

Carpet will need to be replaced.
