## NORCOAST MARINE SURVEYORS, INC.

**SURVEY / APPRAISAL #** 1194680  
**DATE OF INSPECTION:** 9/5/2019  
**DATE OF REPORT:** 9/10/2019

**SUBJECT PROPERTY:** Southeast Islands School District residential float house  
(Formerly the Southeast Islands School District Administration Building and the J. R. Gildersleeve Floating School)

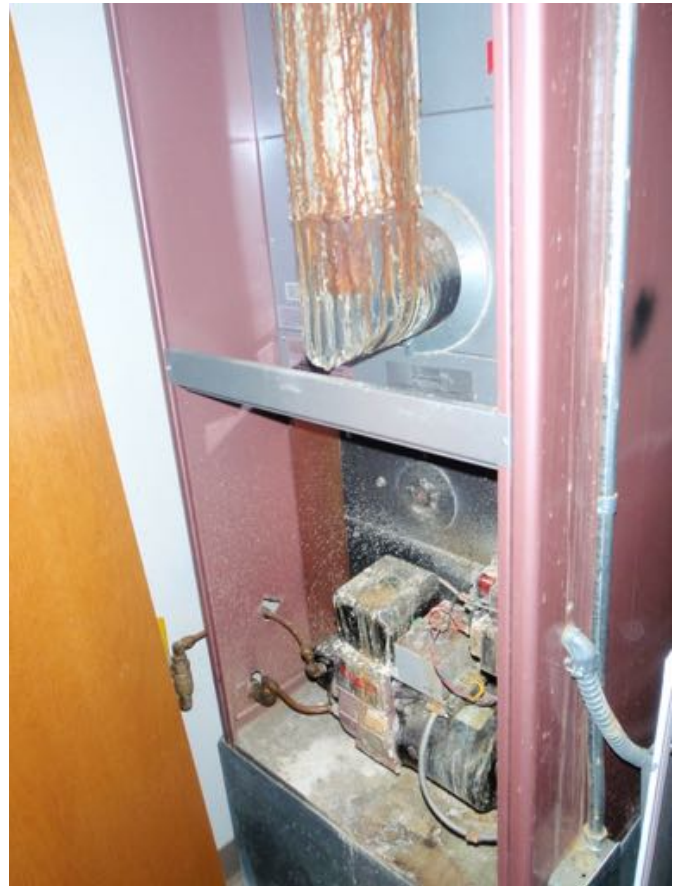
Furnace room

OVERALL CONDITION Exterior of fair to good appearance, last painted 2013. Some deterioration of siding noted on upper south wall, and minor spalling of concrete cells in area of handicap entry, East side. Metal roof in good condition as viewed from deck level. Interior in good overall condition, to include wall and ceiling finish, and built-in cabinetry, with minor touchup required. Carpet with some soiling / staining. Furniture is excluded from this appraisal. Some windows have been replaced. Cracked inner glass noted on Southeast kitchen, upper apartment living room and upper apartment dining area windows. Heating, lighting, fresh water and electrical systems reported to be fully operational, though upper apartment furnace is suffering from leakage at the roof jack.

4. Repair rainwater leak observed at exhaust stack, second floor furnace room and renew corroded exhaust stack.
5. Service auxiliary generator alarm system, where a fault indicator is showing.

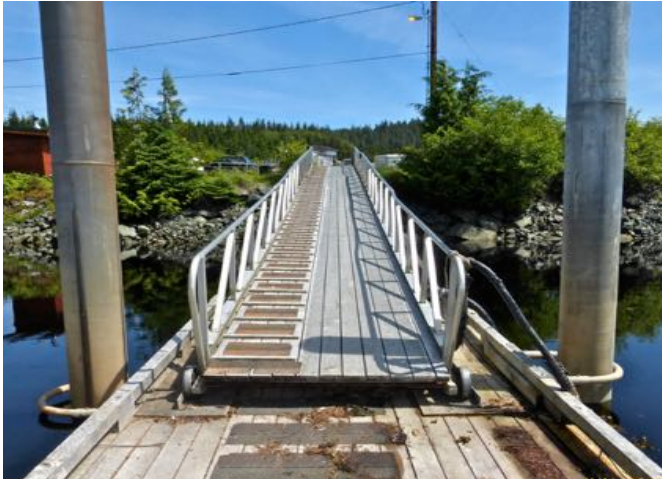
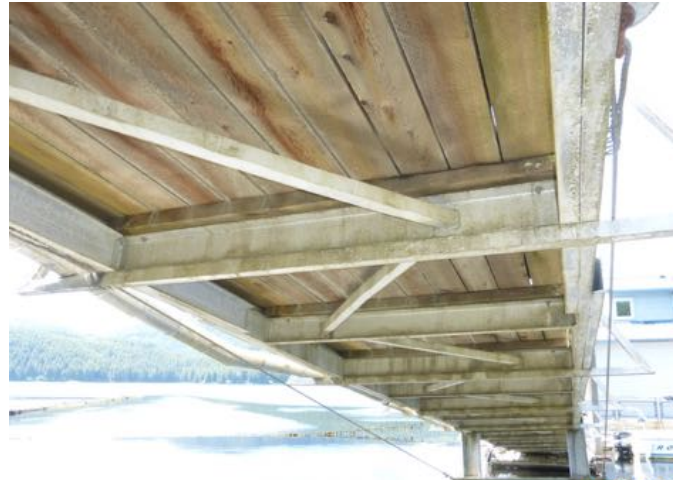
**BOARDING GANGWAY** Welded aluminum, 69' length X 6' width, with 36' hand railings. Built with one 1/4 X 4 X 8" I-beam underlaid with one 1/4 X 2 X 6" channel main stringer each side and same transverse framing 4' on center with diagonal cross bracing. Bottom truss each side of 1/2" galvanized cable over 1/4 X 2 X 8" channel center chord. Deck is untreated wood with wire screen and asphalt shingle traction. Handrails are 2" square tube with 1 1/2" i.d. top pipe, repairs evident. This ramp is of light residential grade construction, sagging at center and possibly in need of additional structural reinforcement.

Access ramp (gangway) top side viewed from float and underside viewed from shore

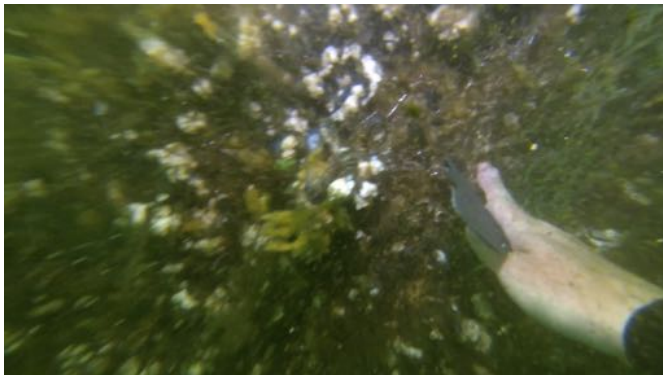
North corner

The North Shoreward corner was the first sample scrape. Growth on hanging lines was visible. Kelp on the edges was minimal due to being on the shade side of the structure. The area had a smooth uneven surface after scraping, which appeared to be calcified marine life not pitting.

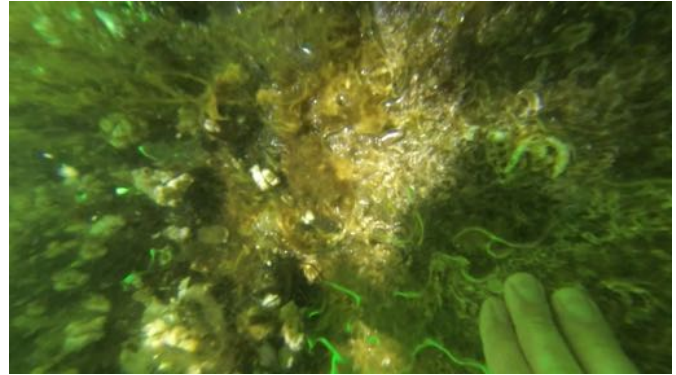
South corner

The South Shoreward corner was very similar, but with larger kelp growth due to more sunlight. The scrape sight was consistent with the previous.

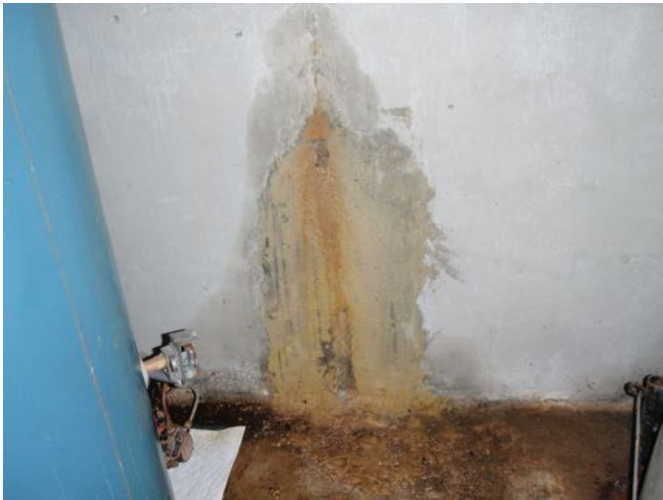
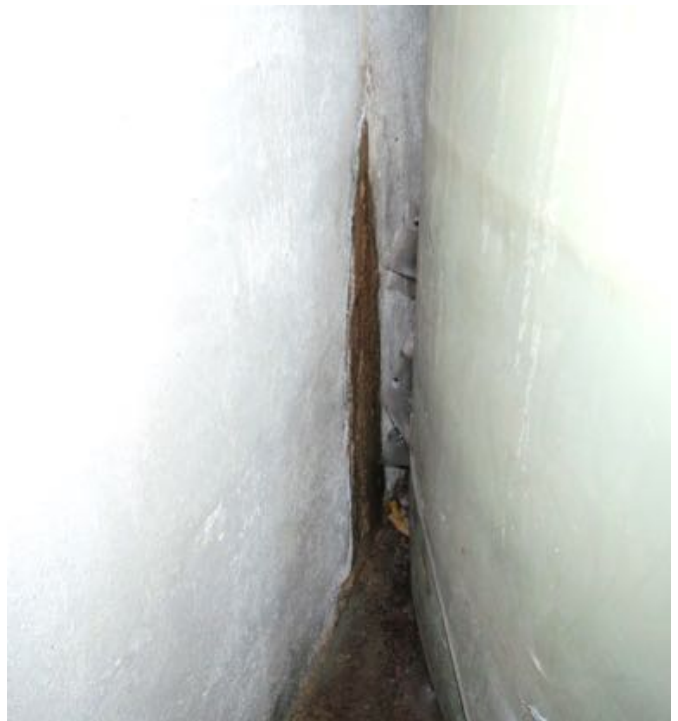
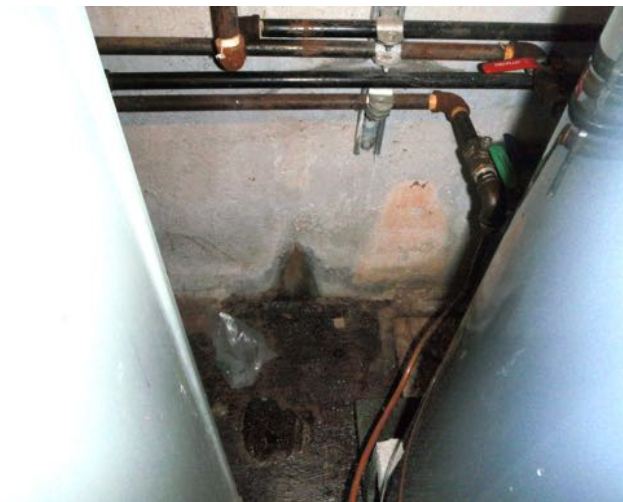
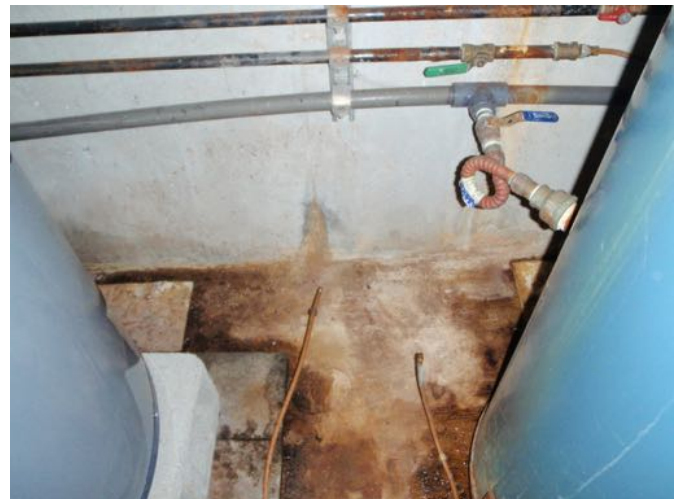
A deficiency in the form of weeping and alkaline deposit noted on the concrete interior wall to the North and west walls of the lower mechanical compartment. The north wall is a cell wall abutting the "moon pool" that is open to the sea, and where effluent is discharged. The most obvious weeping emanates approximately 48" above the floor of the compartment, near the water heaters, with a secondary area adjacent the #2 potable water reservoir. These deficiencies have not increased in scope significantly and do not appear to be of a serious nature at present. The severity of the weeping is slightly more apparent than as viewed during the previous inspections conducted in 2008 and 2014.

Photos of weeping areas in utility room

2. Leakage continues in the wall of the utility room. Repair with epoxy or other suitable material.
3. Hull potential reading at lower panel indicates a system fault. Repair as found necessary, and verify correct operation of the hull protection monitoring system.
