Carmel Clay Public Library

Building Condition Study

January 2013

**Carmel Clay Public Library
55 4th Avenue SE, Carmel, Indiana
Facility Study**

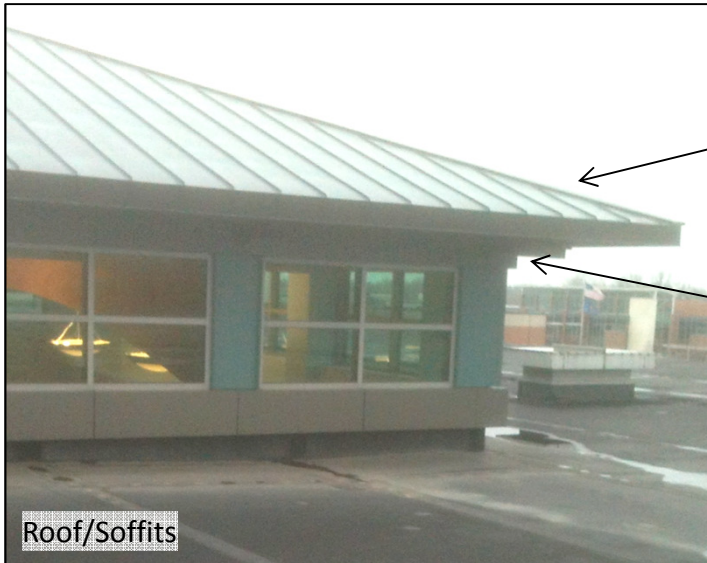
Standing seam metal roof

Redwood soffit and trim

Clerestory with standing seam metal roof, redwood soffits, and metal panel exterior cladding

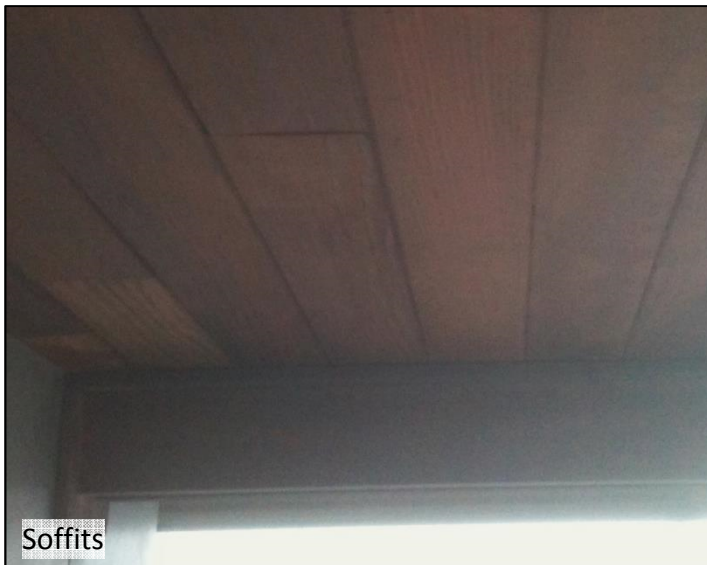
Redwood soffits at upper clerestories are generally in good condition.

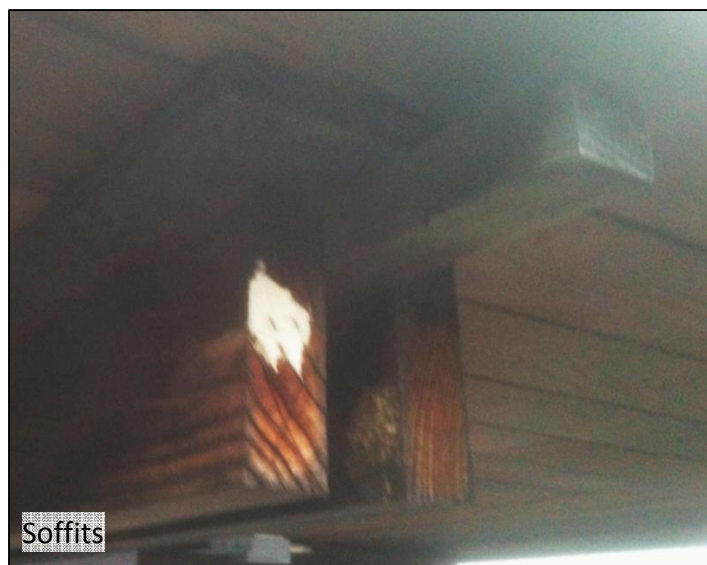
Dimensional redwood details at soffits are starting to show some checking and drying out. No attention is required at this time but condition should be monitored

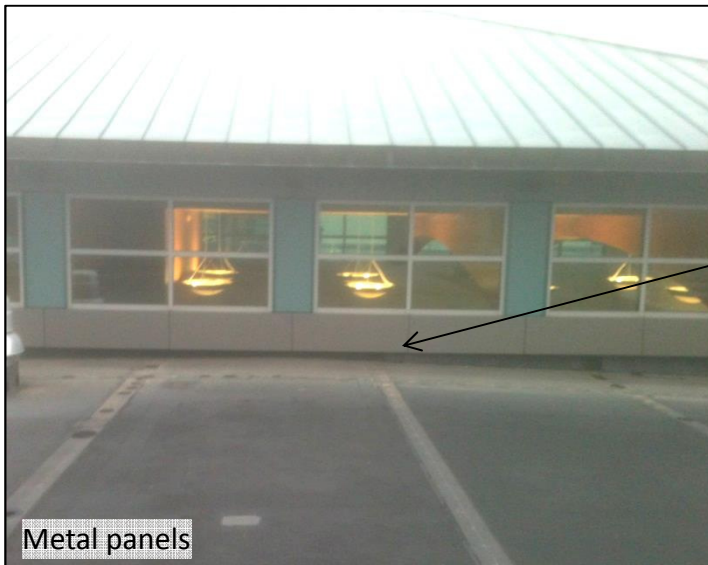
Metal panels

Roof slope to drain creates a condition where roof tapers up to metal panels.

Metal Panels are set close to the roof membrane.

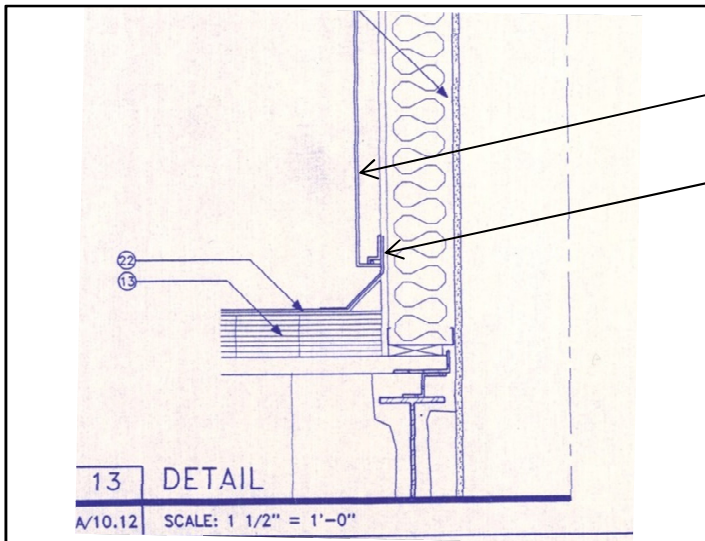
Detail from original Contract Documents

It should be noted that the detailing of the metal panels relative to the roof membrane may cause challenges at the time the roof does need to be repaired or replaced. Refer to the detail from the original contract documents included in the graphic portion this report. The detailer left little room between the top of the roof membrane and bottom of the panel and does not appear to have taken into account the slope of the roof. There are many locations where the metal wall panels are either nearly touching the roof membrane, or have even had to be modified to hold them above the roof. It may be necessary to remove the metal panels to allow the roof membrane to be turned up behind them when the roof membrane is replaced.

Roof membrane turns up a short distance behind the metal panel system as shown in contract documents. Minimal space is available for any type of termination when a new roof membrane is installed.

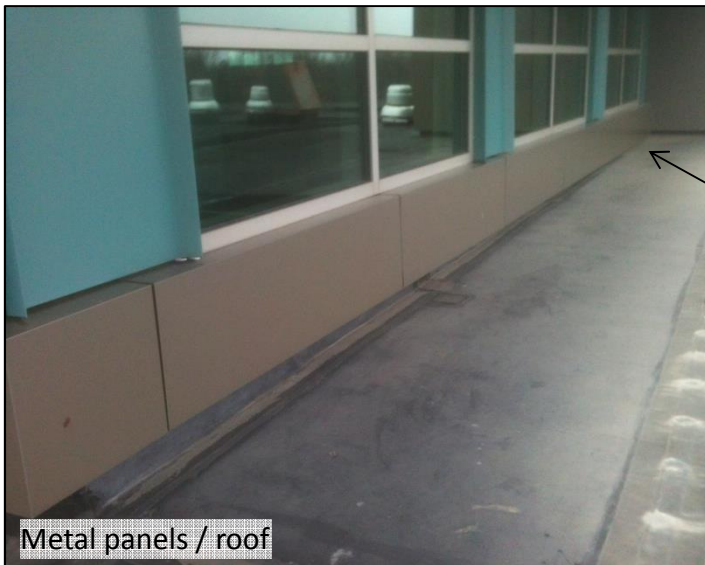
Roof slopes to base of metal panel

Metal Panels are set close to the roof membrane.

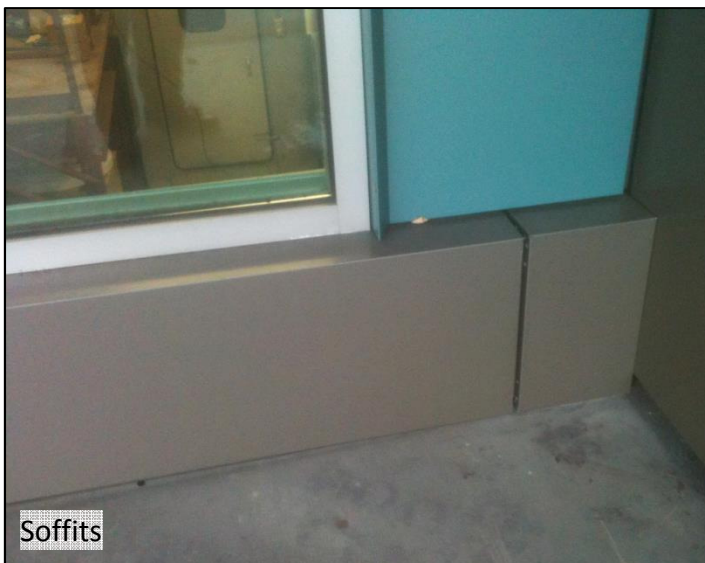
When the time comes to replace the roof membrane, it may be necessary to remove the metal panels in order to turn the new roof membrane up and behind the panels. There is not adequate room below the panels to provide a termination bar to seal the top of a new membrane. The roof will not require replacement for several years.

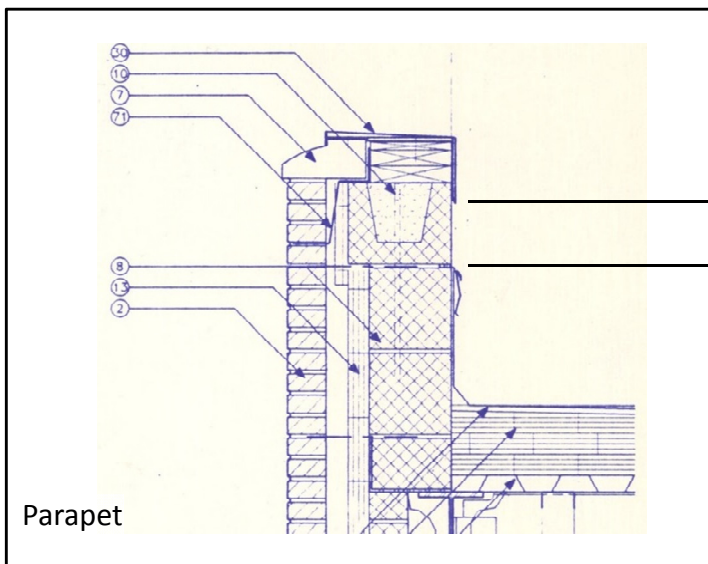
Detail from original Contract Documents

The junction between the membrane roofs and the wall parapets was detailed with a gap between the roof counter flashing and the top of the parapet as shown in the original contract detail included in the graphic portion of this report. Fortunately it appears that in each case this condition was not constructed as detailed, and the membrane was wrapped up under the coping which is a much better solution. The detail at the building walls was, however, constructed with the membrane turned up only a short distance from the deck. This can allow water to enter the building skin either through brick weeps or directly through the masonry particularly when snow is banked up against these walls. Water infiltration has occurred in one location, and has been repaired by extending the membrane up the wall with a termination bar. This solution works in this location because there are windows above and no brick weeps in the walls. Caution should be used if this solution is used in any other locations to assure that no brick weeps are covered, as this will channel water directly below the roof membrane and into the building. Please see the photographs included for further illustration of this condition.

The way the roof and flashings are detailed leave an opportunity for water infiltration at both the parapets and building walls. If this detail is addressed, care must be taken at building walls to make sure that wall weeps are not covered.

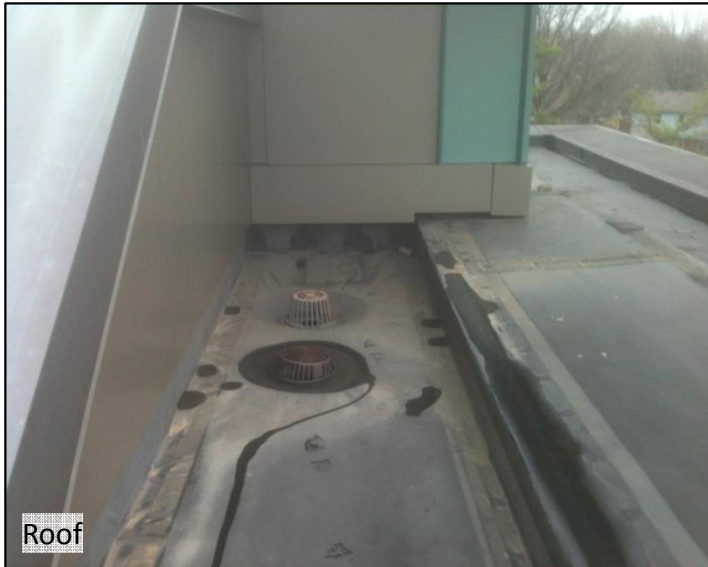
The membrane roof is in good condition and will not require replacement for several years. This is another location where replacement of the roof will be challenging.

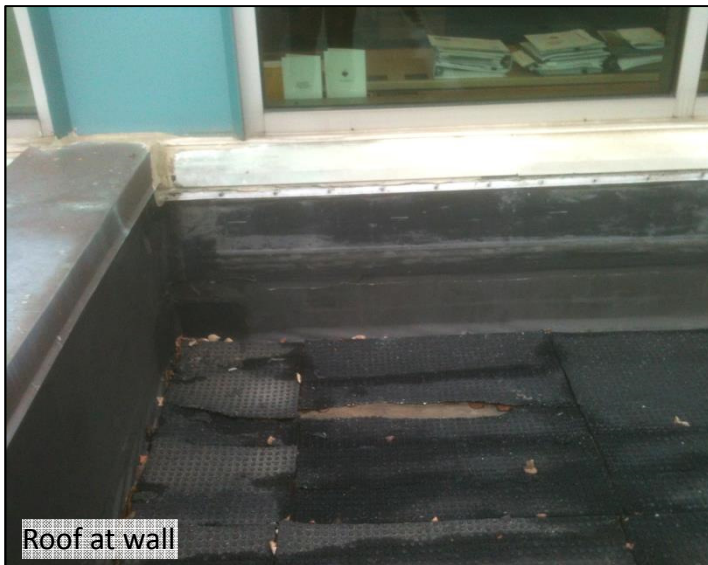
Roof detail.

The masonry wall in this location, over the main entry, was allowing water infiltration. The repair consisted of turning additional roof membrane up and over the masonry with a termination bar to keep water from entering through the brick.

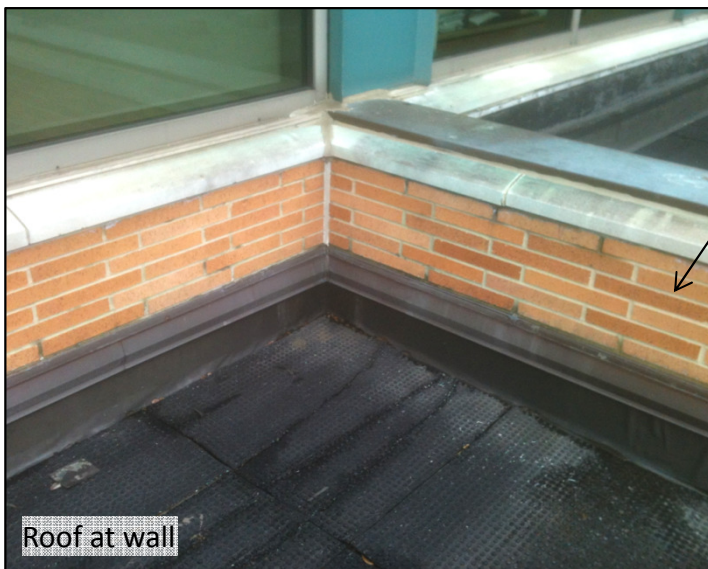
The brick in this location has not shown sign of leaking, however the detail is identical to the area which did leak. This condition should be monitored for potential issues. See Construction Document detail previous page.

Existing flashing and counter flashing.

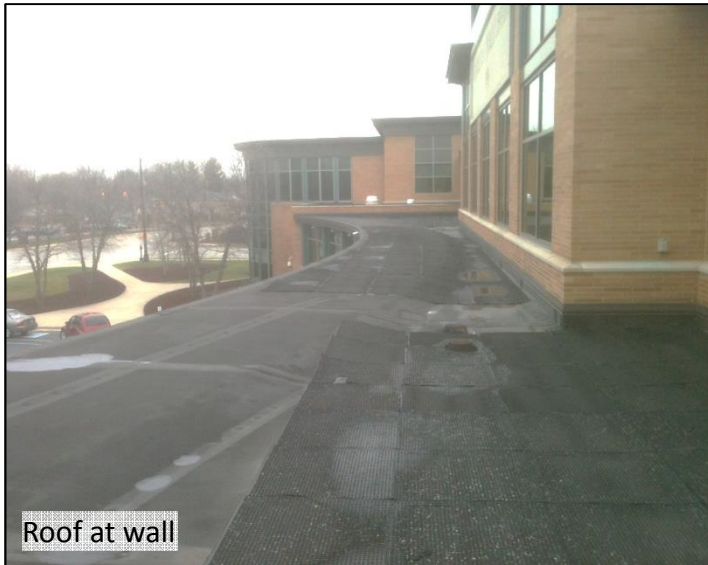
The reason the wall has not leaked at this location is likely because the flashing and counter flashing is higher than the exterior edge condition.

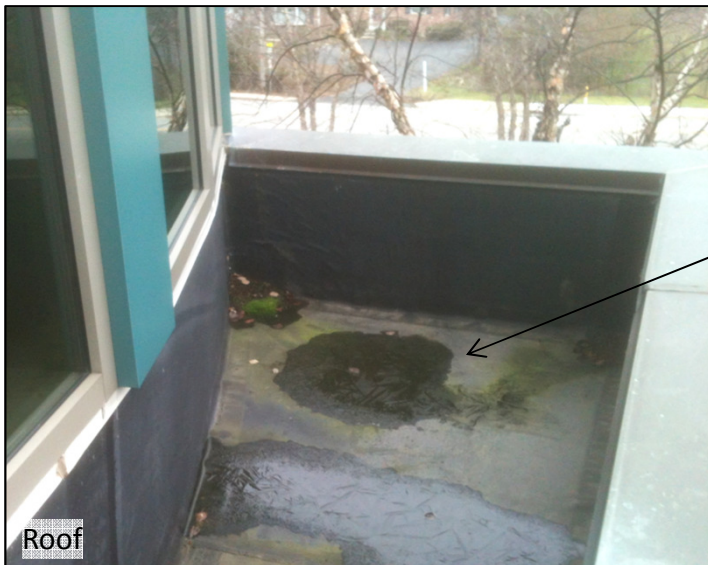
Debris and plant growth.

Roof maintenance should be done where water or debris become trapped.

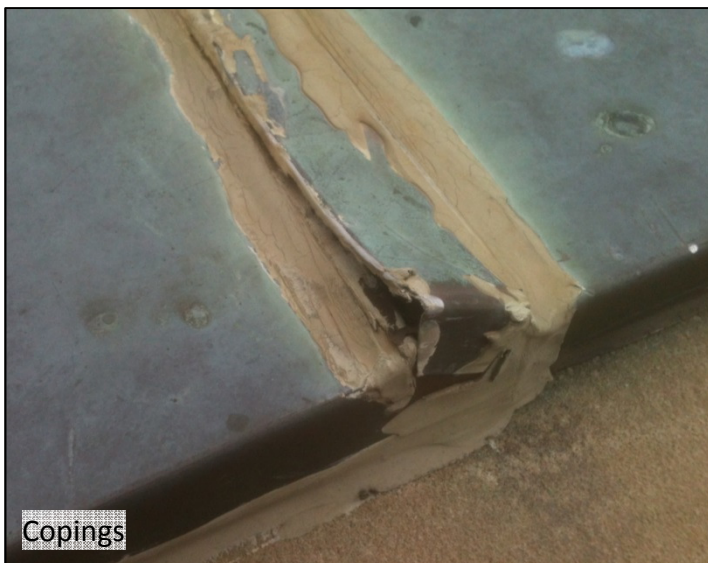
Coping are generally in serviceable condition. IF the membrane has been turned up and under the copings they are primarily cosmetic. As long as there is no sign of water infiltration, maintenance can be done as convenient.

Maintenance should be done at roof copings. This is primarily cosmetic IF the flashing has been done per the original documents.

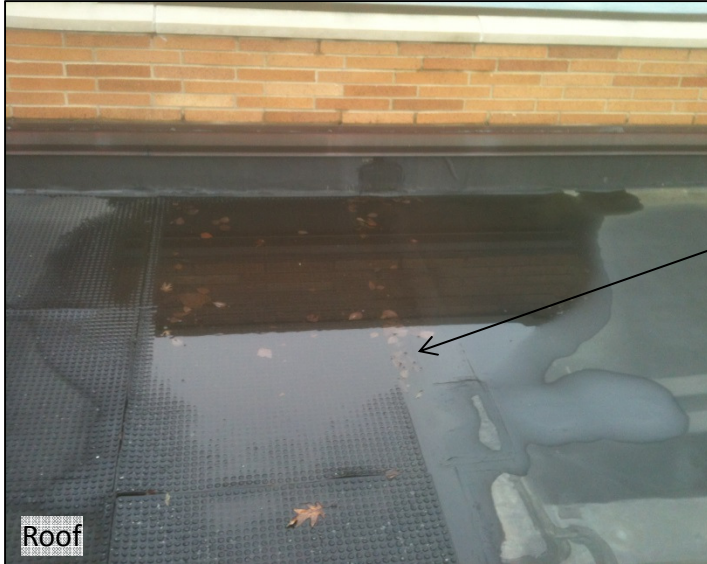
Ponding Water.

Ponding water to this extent should not be a problem as long as the EPDM is sound, however these conditions should be corrected when the membrane is replaced.

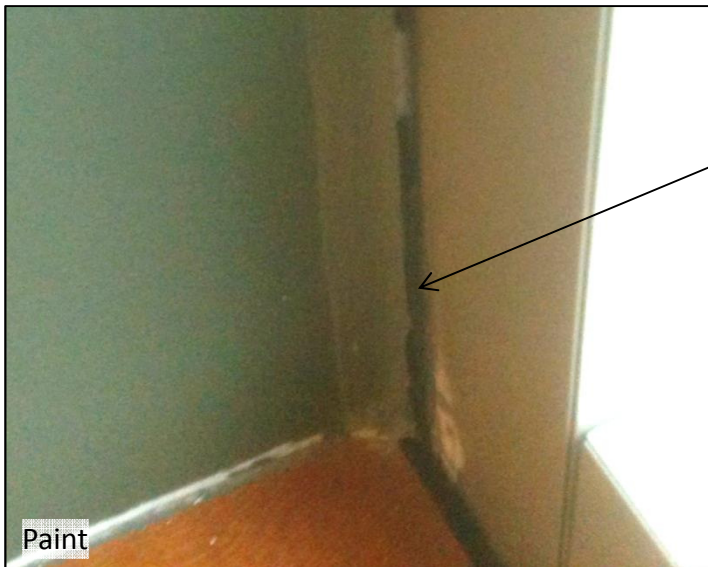
Sealant at exterior windows.

The exterior window frames and the door frames in the public areas are aluminum, and should require no maintenance or painting. The only comment we would make is that the caulking of the exterior windows was done on the surface as opposed to in a caulk space between the window and adjacent finish. This will inherently peel off. If possible the caulk should be removed whenever these walls are painted and properly be tucked into the space between the window and finish, IF such a space exists.

Sealant has pulled away from window frame.

When the walls are painted at the exterior windows, the sealant between the walls and frames should be addressed. If possible the sealant should be installed in the space between the frame and wall rather than over the top.

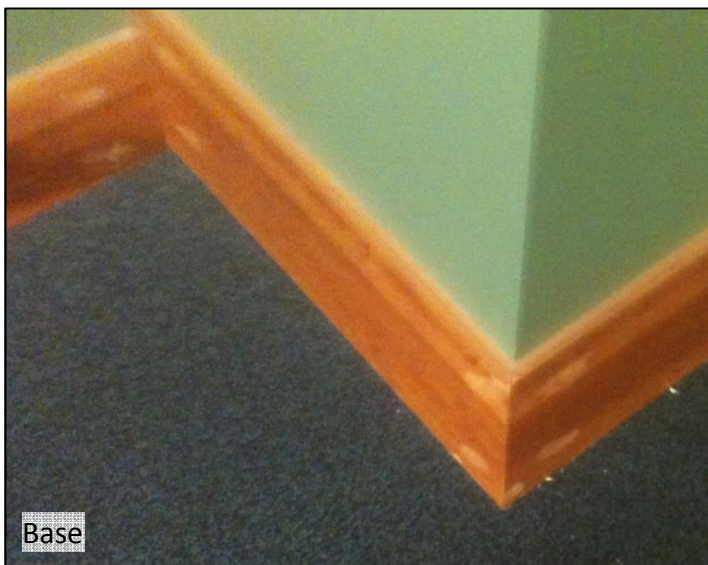
Wood base.

Several locations were noted where the wood base was installed with the wood putty smeared onto the surface of the wood. While this is purely cosmetic, the wood could be sanded down and refinished.

The public spaces have wood base which typically would not need attention for a long time. There are several locations where the nail putty was smeared on the surface of the wood. Consider sanding out and re-finishing when the walls are due for new paint.

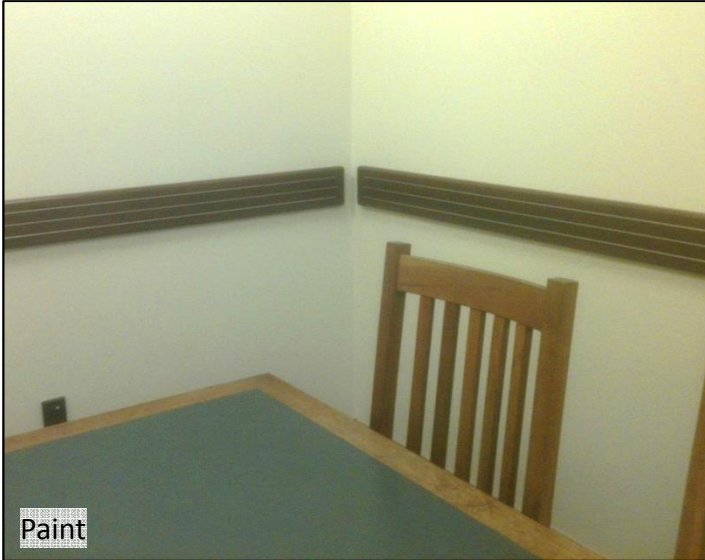
Wall at study room

Walls are in good condition, few need repair of the gypsum board.

Consider putting walls on schedule for painting to allow a yearly budget to be set.

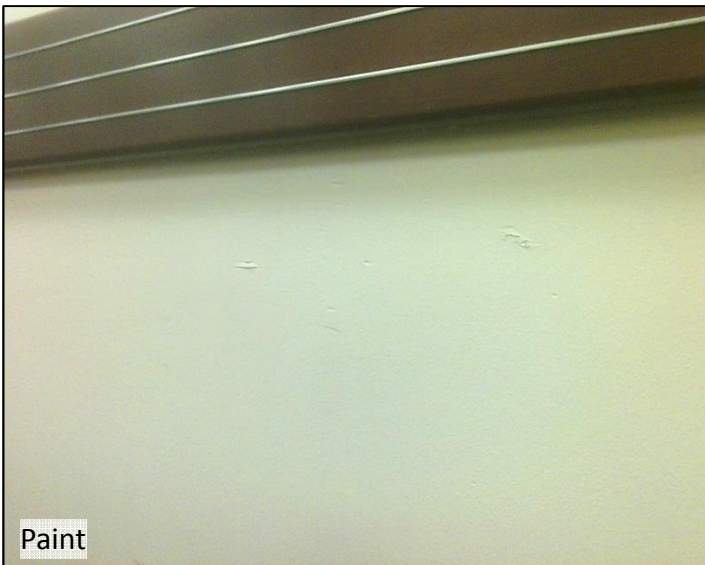
Wall below chair rail.

Chair rails reduce the amount of wall damage, however be aware that some repair will be needed on occasion.

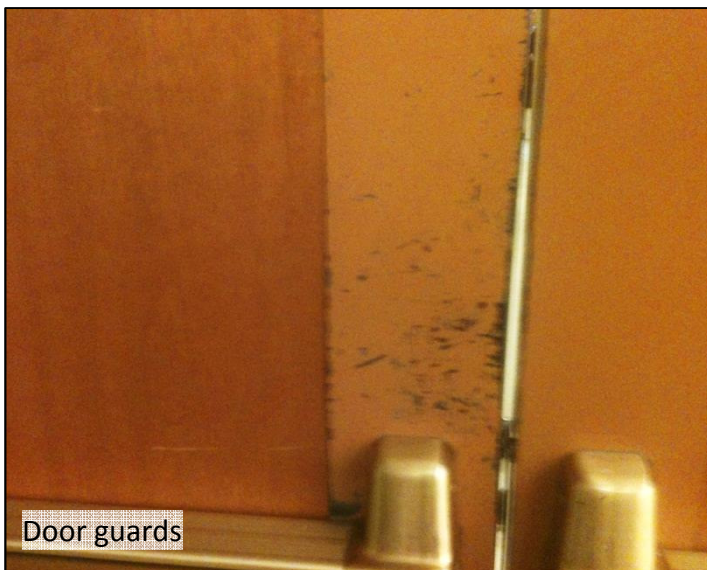
Door guards

The metal edges of the doors between public and non-public areas take a lot of abuse. Regular re-finishing will be required to keep them looking good.

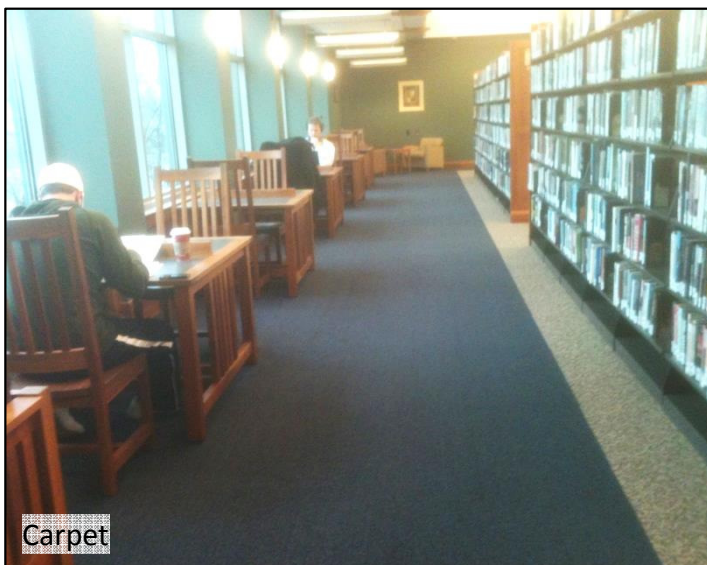
Carpet at stacks.

Carpet is in reasonably good condition. Carpet squares allow replacement of individual sections of carpet. Consider developing a regular schedule for carpet replacement.

Regular cleaning, including extraction, can greatly extend the life of carpet.

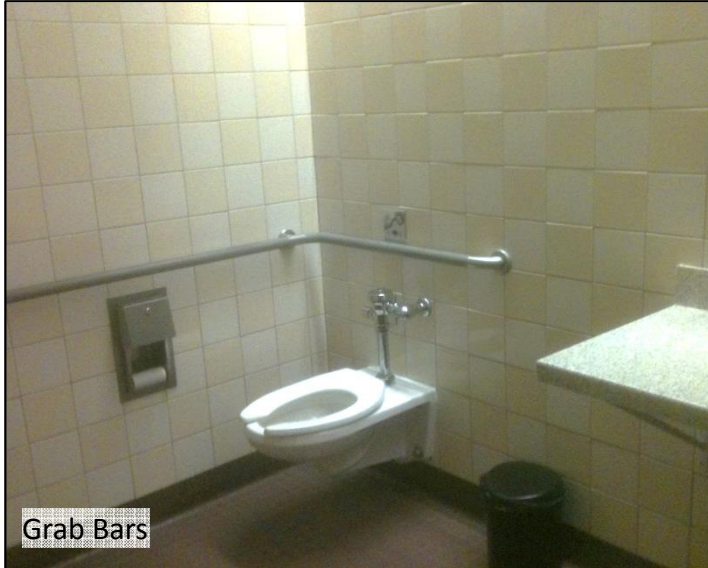
The facility was constructed under accessibility guidelines which are very similar to those in force today. The only difference observed is that there is a new requirement for a vertical grab bar at the water closets. Installation of this grab bar may require opening up the wall to provide new blocking.

The revised accessibility code requires an additional vertical grab bar. Consider adding this at all water closets.

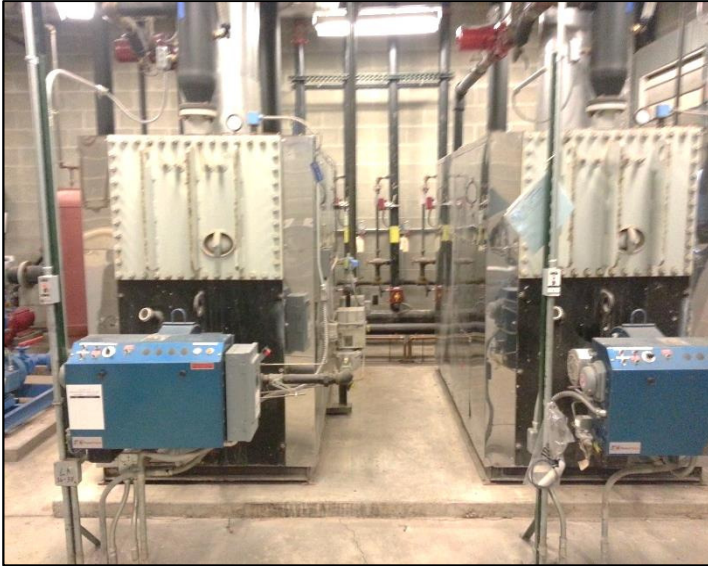
Boilers

Building heating originates at two 3 million btu/hr Ajax gas fired, water tube, hot water boilers. These boilers appear to be in good condition and with good water treatment, proper control and maintenance should last many more years. During our visit the boilers seemed to be cycling excessively with one boiler operating, shutting down, and then the second boiler starting soon after. We may want to review the current control sequence to minimize this. Heating hot water is pumped to coils and terminal units throughout the building. These pumps have variable flow to help in energy use, but they were running fairly constant at the time of the visit. A review of their control sequence may also be helpful.

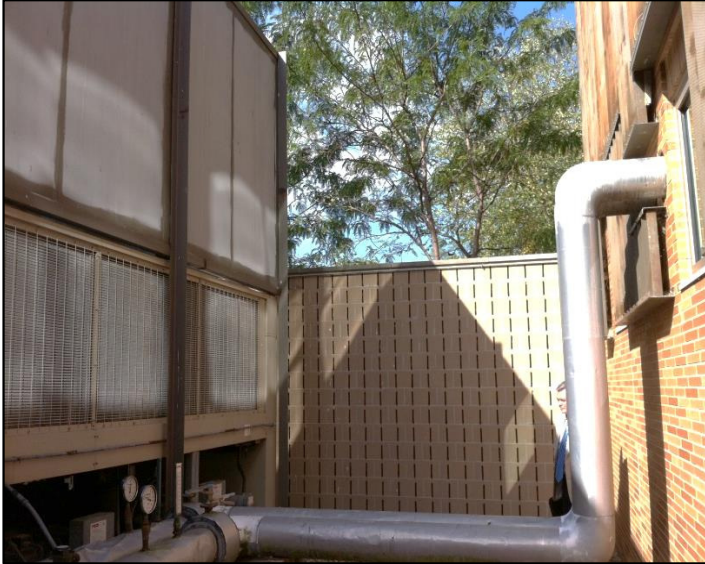
The McQuay air-cooled chiller located in an exterior enclosure has a problematic history. Objectionable noise levels led to acoustic additions at the enclosure which may have affected performance and compressor life. Compressors have been replaced over the years at a higher than average rate. The median life for this class of equipment is about 20 years and the longevity may have been compromised by the acoustic modifications. Replacement should be anticipated in the next 4 to 8 years.

Air Cooled chiller with plenum on top.

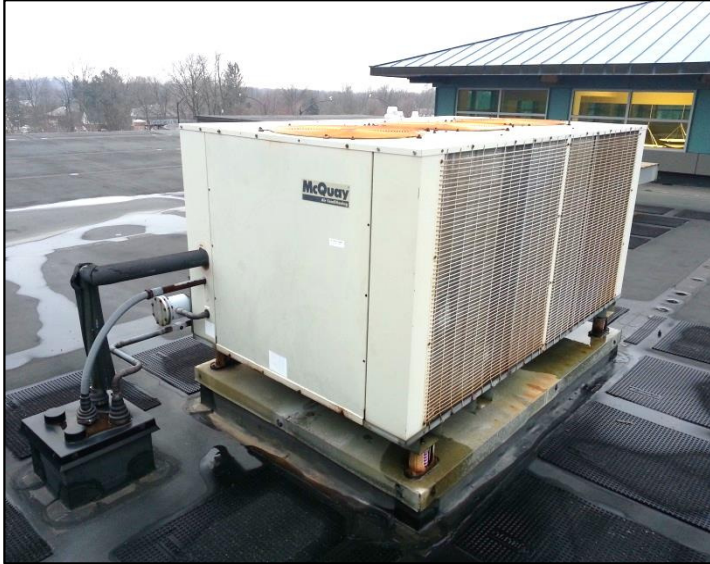
A third air handling unit is located on the northwest mezzanine and serves only the Program Room. This air handler is also in good condition. It is not served by the building chiller but has its own air cooled condensing unit on the roof. This equipment appears to be in fair condition but is near the end of a predicted 15-20 year median life.

Program Room Air Cooled Condensing Unit

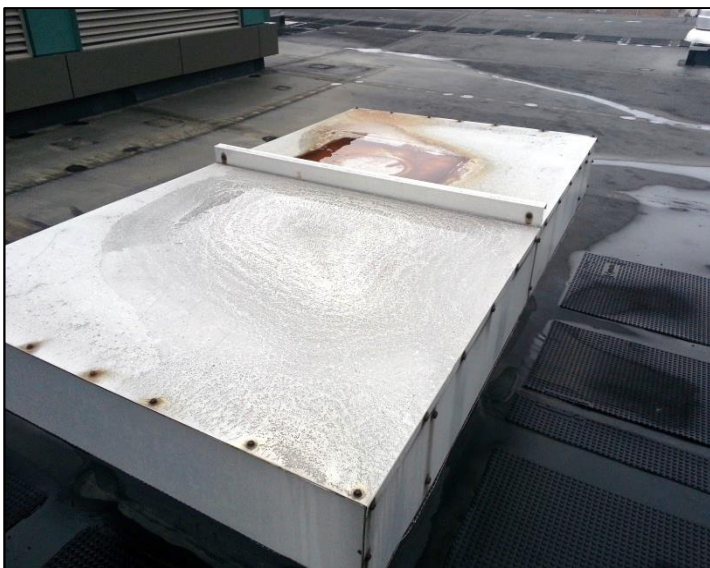
Rooftop exhaust fans are in good condition. Rooftop relief hoods are showing rust where water pools but are otherwise in good condition.

Roof mounted relief hood, showing some rust.
