August 15, 2025

Subject: HIC Testing Report for **Alsea School District**

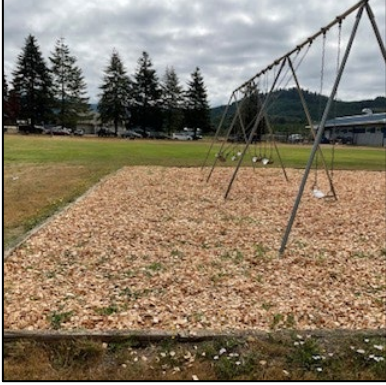
<p>Location Description: SWING USE ZONE</p> <div data-bbox="43 216 427 598">

</div> <div data-bbox="451 216 613 254">PG: N/A</div> <div data-bbox="630 216 792 254">HIC: N/A</div> <div data-bbox="506 325 721 520">

</div> <p>Recommendations: The use zone for a belt swing should extend to the front and rear of a single-axis swing a minimum distance of twice the vertical distance from the pivot point and the top of the protective surface beneath it. Consider extending use zone.</p>	<p>Location Description: LOOP LADDER</p> <div data-bbox="816 216 1198 598">

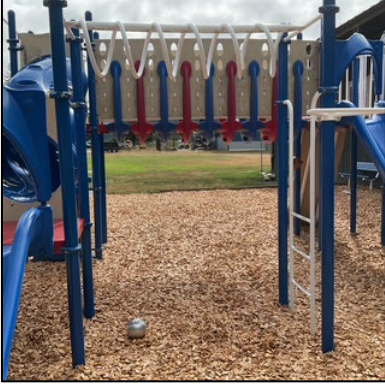
</div> <div data-bbox="1230 216 1393 254">PG: 172</div> <div data-bbox="1409 216 1572 254">HIC: 1032</div> <div data-bbox="1279 325 1494 520">

</div> <p>Recommendations: Fall-surface in this area should be maintained on a regular basis. Loose-fill surfacing should be added to the use zone. Surface should have a consistent 9"-12" of absorbing material.</p>

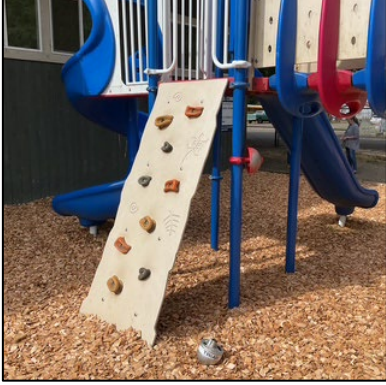
<p>Location Description: CLIMBING WALL</p> <div data-bbox="43 791 427 1173">

</div> <div data-bbox="451 791 613 829">PG: 261</div> <div data-bbox="630 791 792 829">HIC: 2107</div> <div data-bbox="506 900 721 1096">

</div> <p>Recommendations: Fall-surface in this area should be maintained on a regular basis. Loose-fill surfacing should be added to the use zone. Surface should have a consistent 9"-12" of absorbing material.</p>	<p>Location Description: SLIDE</p> <div data-bbox="816 791 1198 1173">

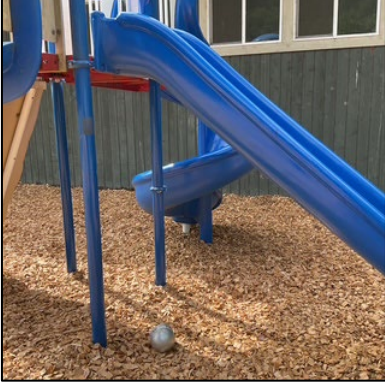
</div> <div data-bbox="1230 791 1393 829">PG: 250</div> <div data-bbox="1409 791 1572 829">HIC: 2001</div> <div data-bbox="1279 900 1494 1096">

</div> <p>Recommendations: Fall-surface in this area should be maintained on a regular basis. Loose-fill surfacing should be added to the use zone. Surface should have a consistent 9"-12" of absorbing material.</p>
<p>Location Description: LADDER</p> <div data-bbox="43 1367 427 1749">

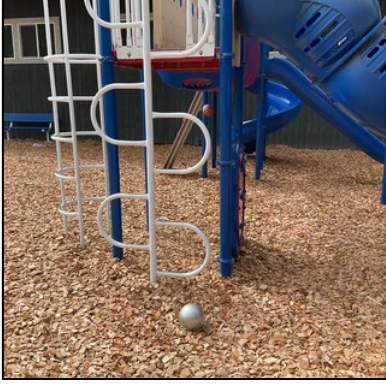
</div> <div data-bbox="451 1367 613 1404">PG: 141</div> <div data-bbox="630 1367 792 1404">HIC: 920</div> <div data-bbox="506 1476 721 1671">

</div> <p>Recommendations: Fall-surface in this area should be maintained on a regular basis. Loose-fill surfacing should be added to the use zone. Surface should have a consistent 9"-12" of absorbing material.</p>	<p>Location Description: BAR CLIMBER</p> <div data-bbox="816 1367 1198 1749">

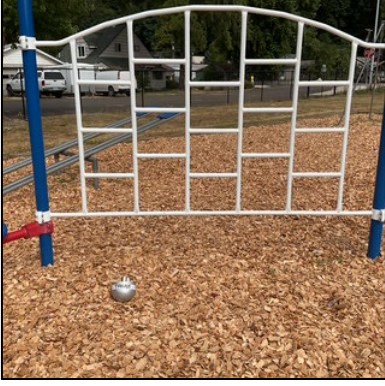
</div> <div data-bbox="1230 1367 1393 1404">PG: 117</div> <div data-bbox="1409 1367 1572 1404">HIC: 576</div> <div data-bbox="1279 1476 1494 1671">

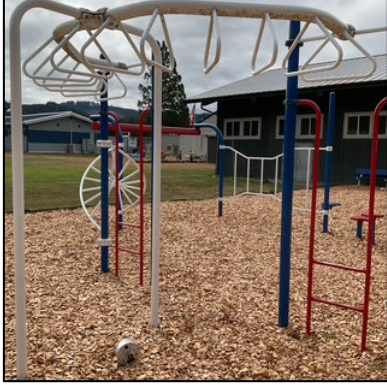
<p>Location Description: LOOP LADDER</p>

<p>PG: 133 HIC: 664</p>

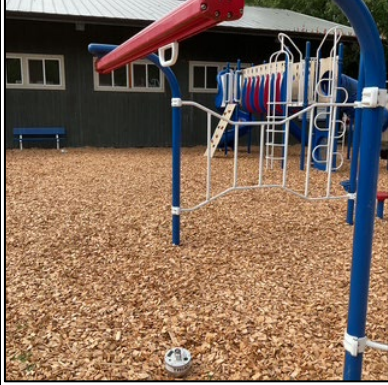
<p>PG: 224 HIC: 1140</p>

<p>Recommendations: Fall-surface in this area should be maintained on a regular basis. Loose-fill surfacing should be added to the use zone. Surface should have a consistent 9”-12” of absorbing material.</p>
<p>Location Description: SWINGS</p>

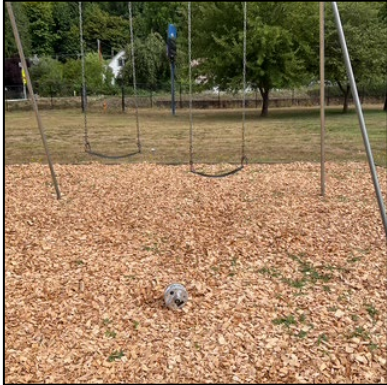
<p>PG: 99 HIC: 380</p>

<p>Recommendations: Loose-fill surfacing should be added to the swings use zones. Surface should have a consistent 9”-12” of absorbing material. Consider adding attenuation mats beneath each swing.</p>	<p>Location Description: SWINGS</p>

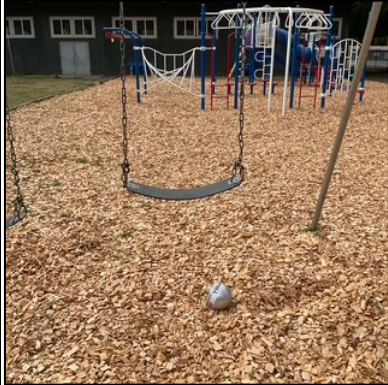
<p>PG: 117 HIC: 535</p>

<p>Recommendations: Loose-fill surfacing should be added to the swings use zones. Surface should have a consistent 9”-12” of absorbing material. Consider adding attenuation mats beneath each swing.</p>

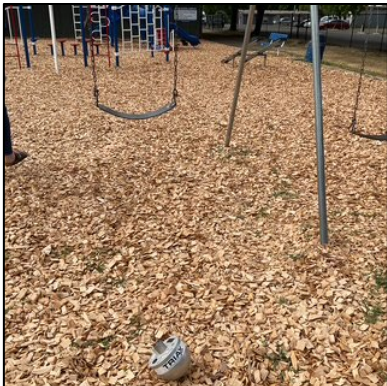
<p>PG: 166 HIC: 865</p>

<p>Recommendations: Loose-fill surfacing should be added to the swings use zones. Surface should have a consistent 9”-12” of absorbing material. Consider adding attenuation mats beneath each swing.</p>	<p>Location Description: SWINGS</p>

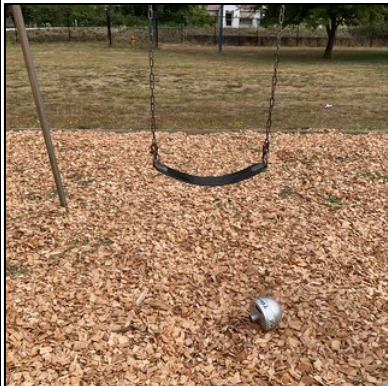
<p>PG: 155 HIC: 761</p>

<p>Recommendations: Loose-fill surfacing should be added to the swings use zones. Surface should have a consistent 9”-12” of absorbing material. Consider adding attenuation mats beneath each swing.</p>

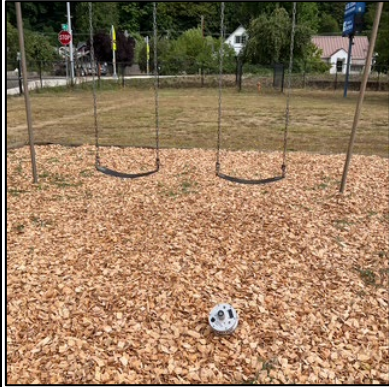
<table border="1" data-bbox="451 212 794 254"><tr><td>PG: 147</td><td>HIC: 677</td></tr></table>

<p>Recommendations: Loose-fill surfacing should be added to the swings use zones. Surface should have a consistent 9"-12" of absorbing material. Consider adding attenuation mats beneath each swing.</p>	PG: 147	HIC: 677	<p>Location Description: SWINGS</p>

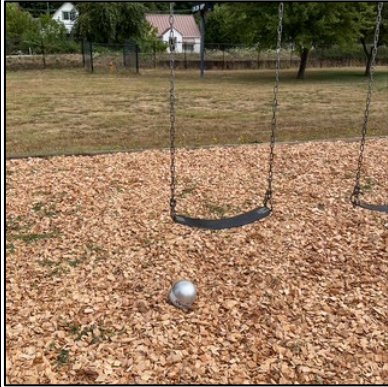
<table border="1" data-bbox="1222 212 1565 254"><tr><td>PG: 142</td><td>HIC: 720</td></tr></table>

<p>Recommendations: Loose-fill surfacing should be added to the swings use zones. Surface should have a consistent 9"-12" of absorbing material. Consider adding attenuation mats beneath each swing.</p>	PG: 142	HIC: 720
PG: 147	HIC: 677				
PG: 142	HIC: 720				
<p>Location Description: SWINGS</p>

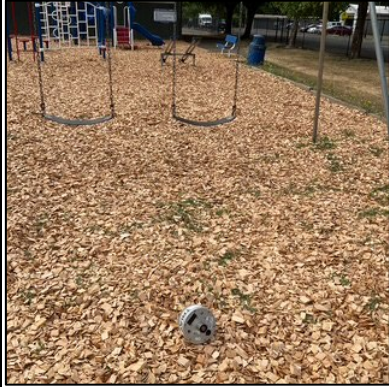
<table border="1" data-bbox="451 787 794 829"><tr><td>PG: 140</td><td>HIC: 638</td></tr></table>

<p>Recommendations: Loose-fill surfacing should be added to the swings use zones. Surface should have a consistent 9"-12" of absorbing material. Consider adding attenuation mats beneath each swing.</p>	PG: 140	HIC: 638	<p>Location Description: Click or tap here to enter text.</p> <table border="1" data-bbox="1222 787 1565 829"><tr><td>PG: Click</td><td>HIC: Click</td></tr></table>
