BLOOMINGDALE SCHOOL  
DISTRICT 13

FACILITIES MASTER PLAN

UPDATED – JANUARY 15, 2019

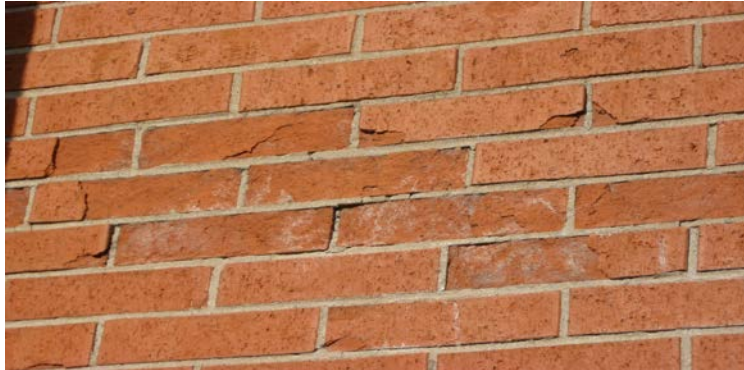
The building is composed of brick walls. The brick on the new addition is in good condition. The brick on the original building is in fair condition with some spalling (flaking) in certain areas. Remedy of this condition requires replacement of the brick and correctly installing new brick. Brick with the same style, color, and texture of the damaged brick is no longer available. Matching of the existing brick will be near impossible. In 2004 columns were installed along the perimeter of the old gymnasium. This project was done to solidify the structure after it was discovered that a lack of control joints and poor construction was creating a possible hazard. Since the installation of the columns, no cracks have reappeared in the interior walls in the gym. Life expectancy of this solution is estimated to be 15 to 20 years.

**Spalling brick.**

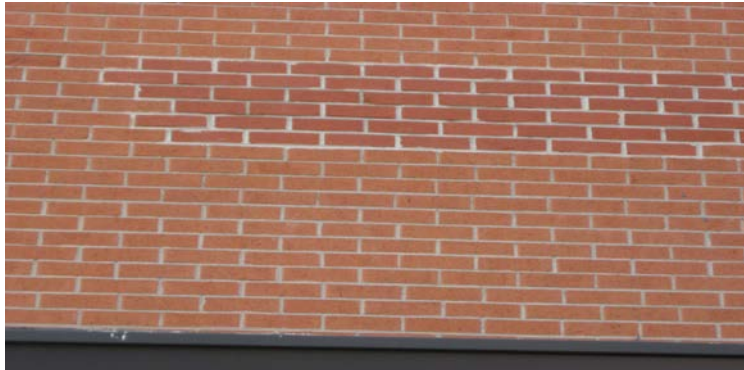
**Replacement brick difficult to match.**

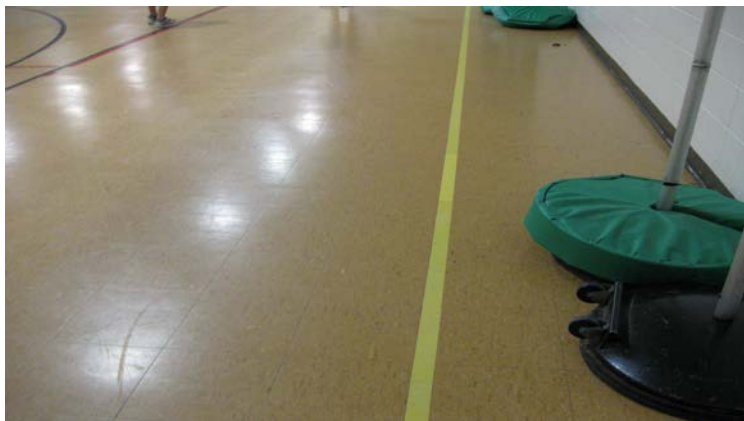
Flooring in the building consists mainly of carpet and vinyl composition tile (VCT) with the exception of the new gym that has a rubber floor. Removal and replacement of asbestos containing VCT in the south end of the building (the Commons) was begun in 2008. It is anticipated that this process will continue throughout the building until all asbestos containing flooring is removed. Carpeting in the north end (the IMC and surrounding classrooms) of the building was replaced in 2009 and 2011 and is in excellent condition. Carpeting in the new addition is in fair condition but will need replacing in the next few years. Replacement of the hallway carpeting in this area has already been completed.

**Asbestos floor tile in gymnasium.**

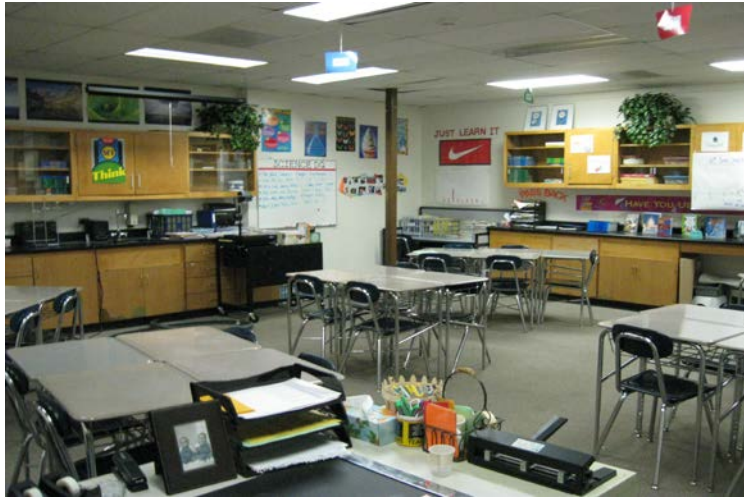
The interior walls are generally in good condition. Ongoing routine maintenance will extend the life of the walls. In the north end of the original building, walls were constructed to create multiple, individual classrooms. While these classrooms are functional, many of the classrooms are considered small in comparison to the square footage of the average classroom.

**Small classroom bordering the IMC.**

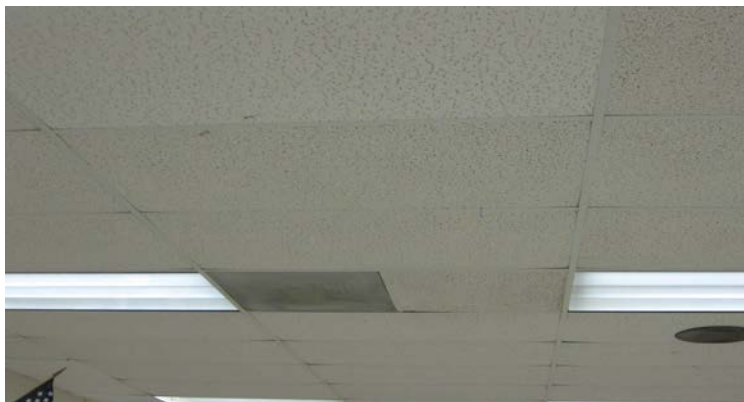
Ceiling tiles in the original building are beginning to sag and show age in some areas. To improve appearance and prevent future sagging, ceiling tiles should be replaced using 2' x 2' tiles instead of 2' x 4' tiles. This process was begun when the IMC was remodeled and should continue in the classrooms whenever possible.

**Sagging, old ceiling tiles.**

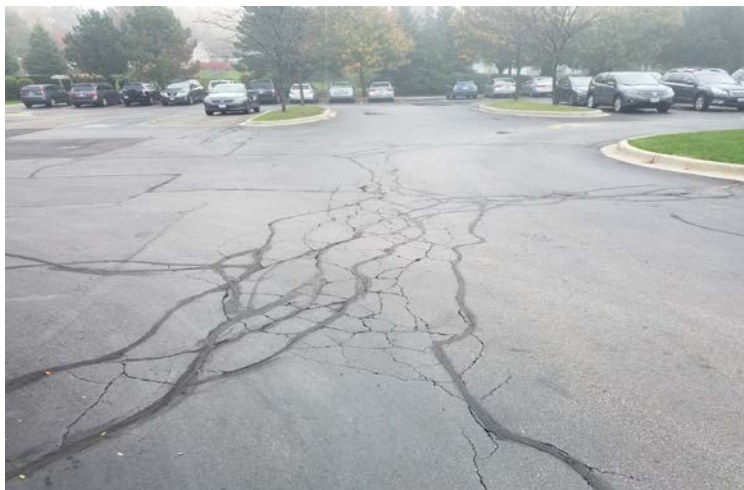
Private residences border Westfield Middle School to the east and a sufficient flood retention area borders the building on the north side. Parking lots and sidewalks are on the south and west sides of the building. The parking lots and sidewalks were installed in 2001 along with the new addition. These components are in fair condition; continuous repairs and maintenance are needed.

**Parking lot patching needed.**

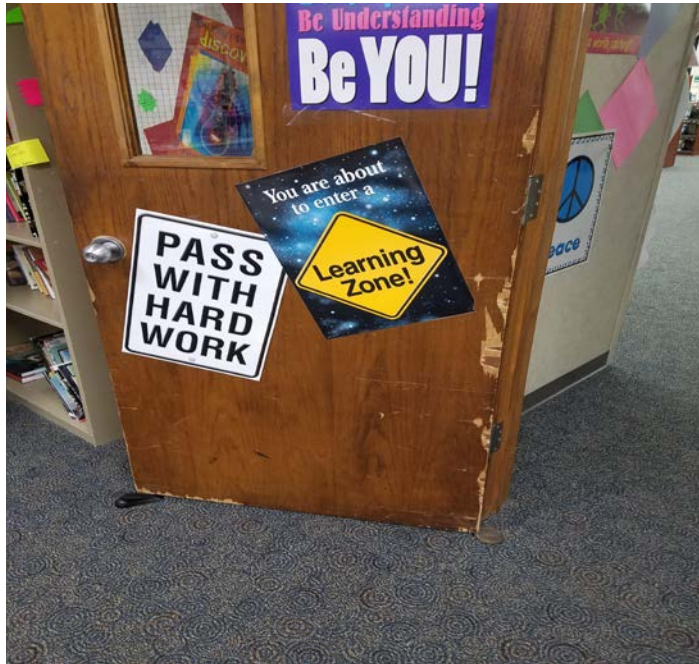
Generally, the interior doors are in fair condition. Doors will need replacing as they age. Some door closers need adjusting or replacing. Doors in the original part of the building should be fitted with new hardware to meet ADA guidelines and improve security.

**Interior door needs replacing and doorknob not meeting ADA requirements.**

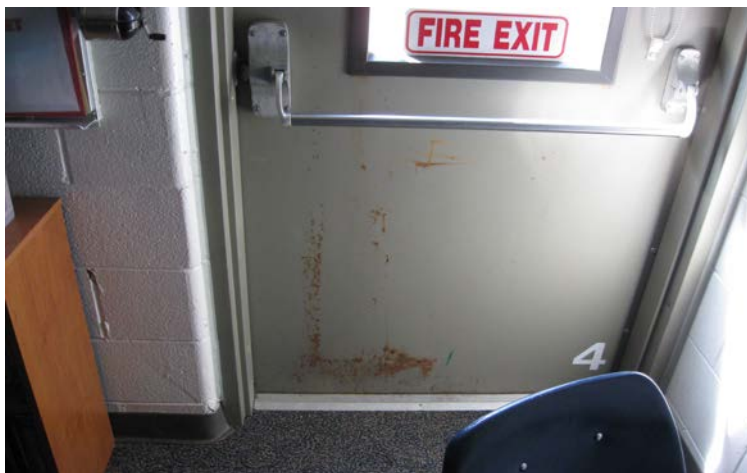
Most exterior doors are in good condition but will need to be replaced as needed due to weathering. It is recommended to replace the failing steel doors, and frames, with fiberglass doors and glass.

**Exterior door needs replacing.**

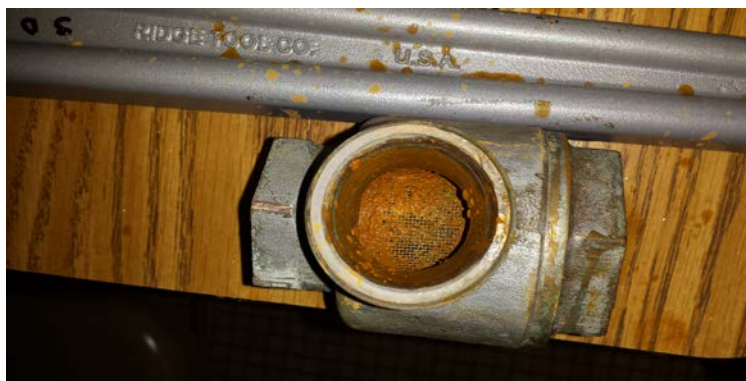
Domestic hot water is provided via two hot water boilers. The original building is supplied domestic hot water via a small capacity boiler located in the receiving area. The 2001 addition is supplied domestic hot water via one medium capacity boiler located in the mechanical room. The boiler for the 2001 addition was replaced in 2017. Water is distributed via galvanized piping. Several hundred feet of pipe was replaced in 2016 due to multiple leaks that had occurred. Continued pipe replacement is recommended.

**Rusty pipe fitting.**

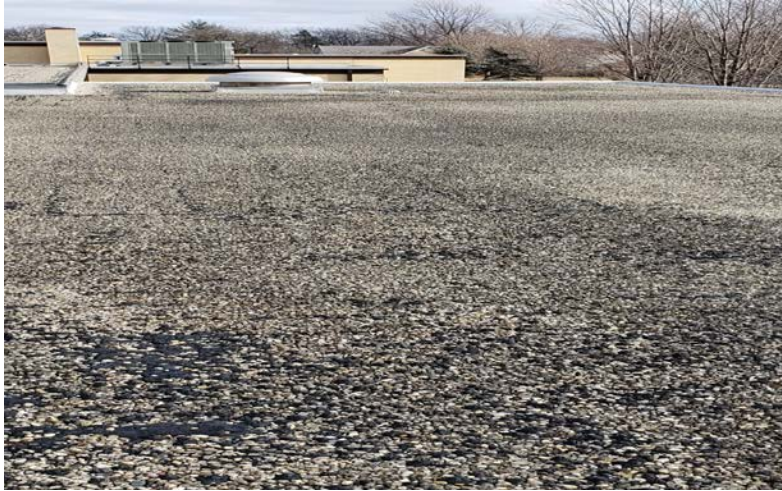
The school roof was replaced in 1998 and is in fair to poor condition. Trees too close to the building were removed and trimmed back in 2008. The proximity of the trees to the building constantly created clogged roof drains and puddling. These conditions may have resulted in premature roof failure. Continued maintenance of the school roof should help it last at least 2 to 3 years. The roof over the 1995 addition is now over 24 years old and should be replaced at the same time as the school roof.

**Roof needs replacing**

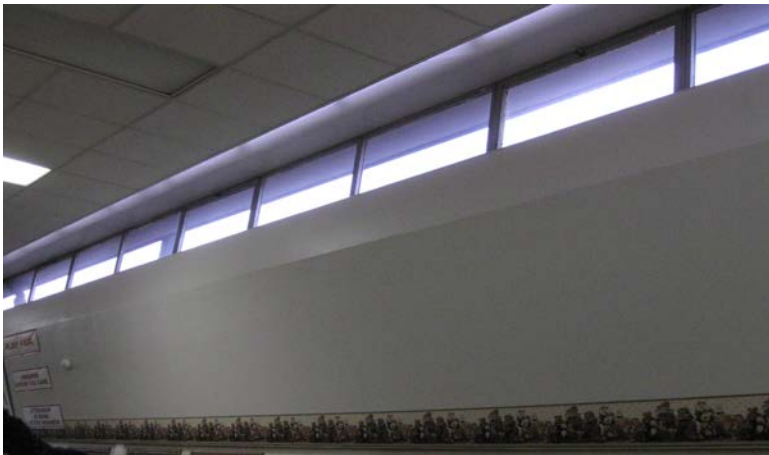
The building's exterior is composed of brick walls. The brick is in fair to good condition. Classroom windows on the 1964 and 1971 areas of the building were replaced in 2007 with energy efficient, insulated windows. The upper windows around the IMC are original and should be replaced. However, they contain asbestos caulk which would have to be abated first. The exterior classroom doors were replaced in 2017 and are in good condition. The new doors are aluminum with insulated glass. The soffits around the building are beginning to show age. A phased replacement should be continued as needed.

**IMC windows need replacing.**

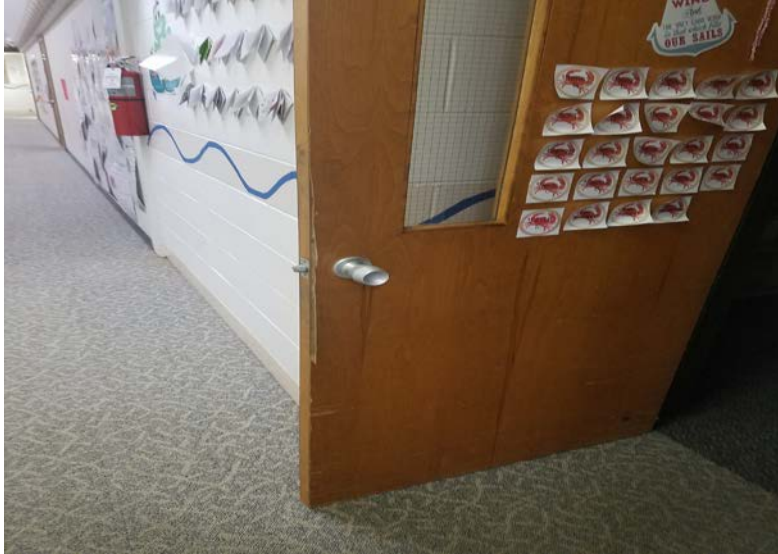
Generally, the interior doors around the IMC are in poor condition. The hallway doors leading to the IMC were replaced in 2008. Classroom doors in the 1964 addition were replaced in 2014 while doors in the 1971 part of the building need replacing and new hardware to meet ADA guidelines.

**Classroom doors needing replacing.**

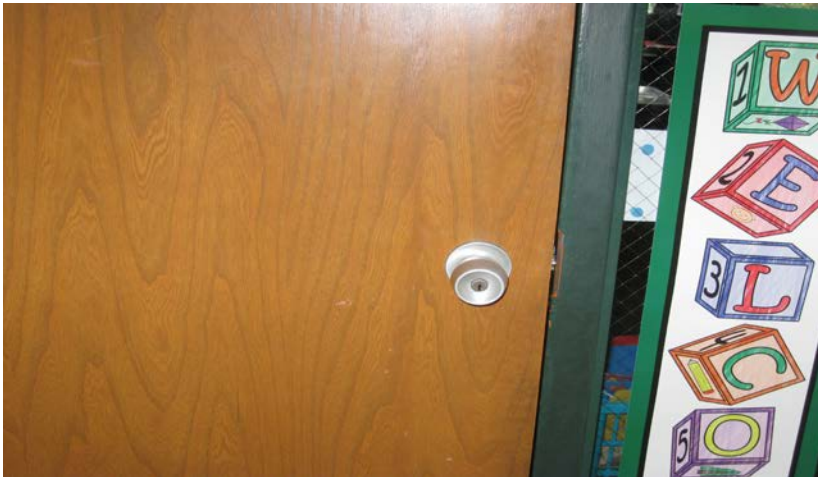
**Door hardware not to ADA guidelines.**

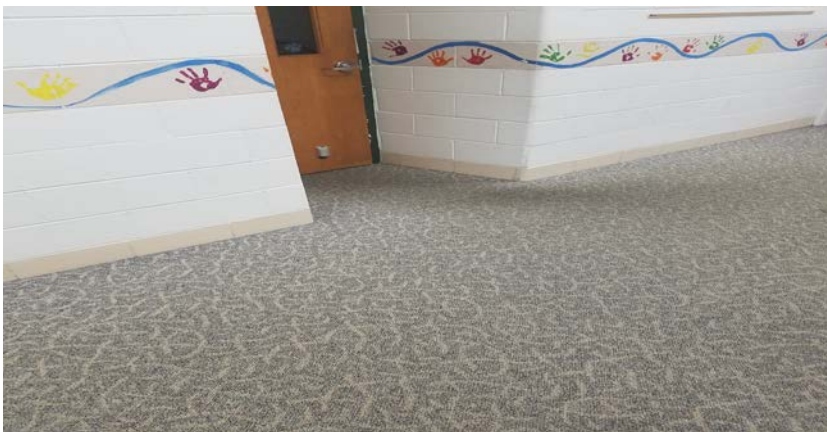
The carpet in the IMC was replaced in 2003 and is beginning to show wear patterns while the carpeting in the surrounding rooms was replaced in 2009 and is in good condition. Carpeting in the 1995 addition was replaced in 2008 and is in excellent condition.

**Wear patterns in carpeting.**

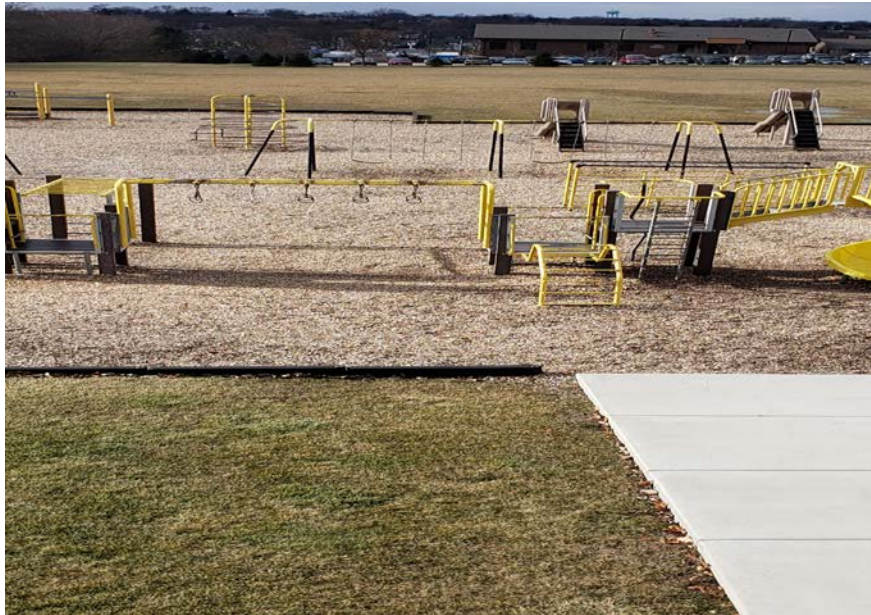
**Aging playground equipment.**

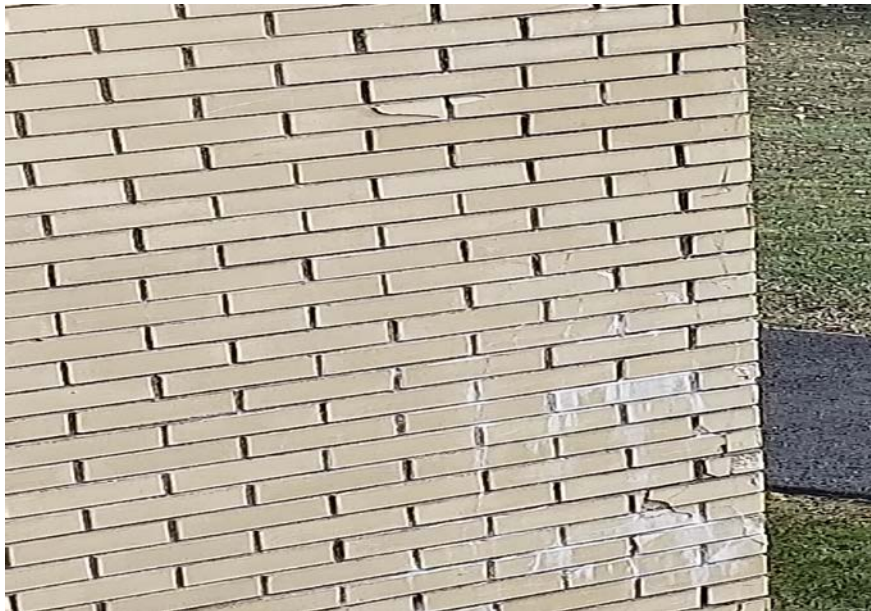
**Tuck pointing needed.**

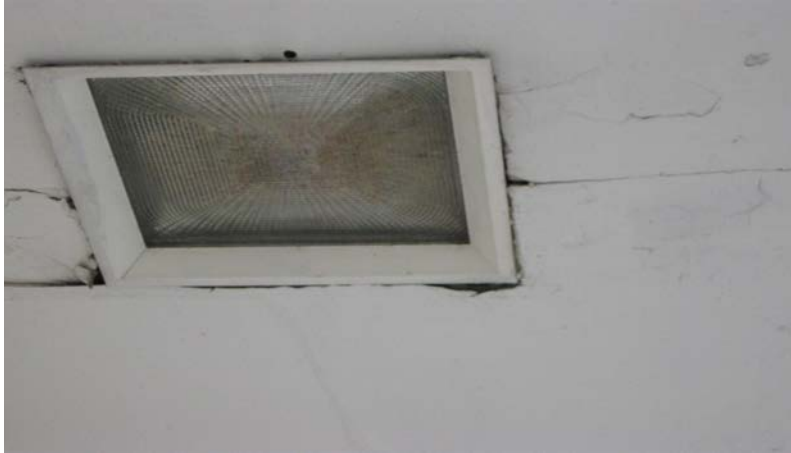
Interior lighting is achieved primarily by fluorescent fixtures. Lighting in 95% of the building was upgraded and retrofitted in 2006 with more energy efficient ballasts and T-8, fluorescent bulbs. In 2011, the fixtures on the parking lot light poles were converted to LED lighting. In 2013-2016, much of the soffit lighting was upgraded to LED light fixtures. Replacement of older, less efficient exterior light fixtures will continue.

**Replace exterior lighting.**

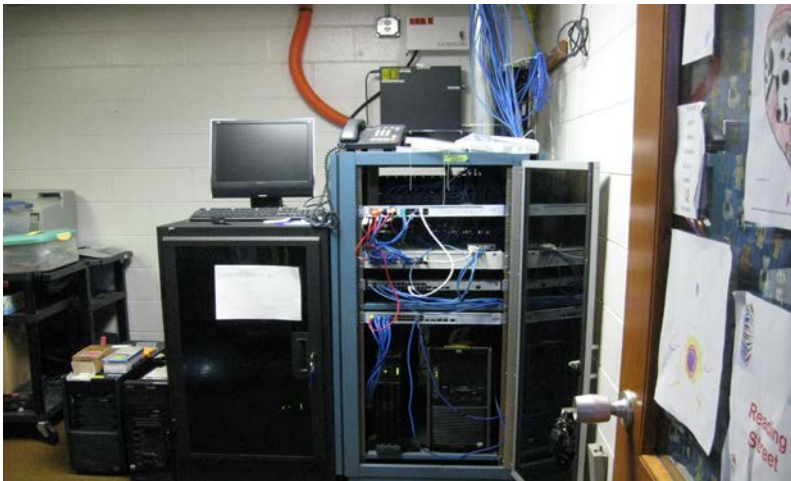
The server room at DuJardin is sufficiently functional but could use a facelift. Technology equipment at DuJardin is stored in a room that is also the office for the IMC director and has minimal cooling capacity. A dedicated room with year round air conditioning should be considered. As our network and technology demands have grown, equipment has been added as needed wherever it can fit in the server room. A modernization of the room would benefit the technology staff with better network and equipment management.

**Crowded server room/equipment.**

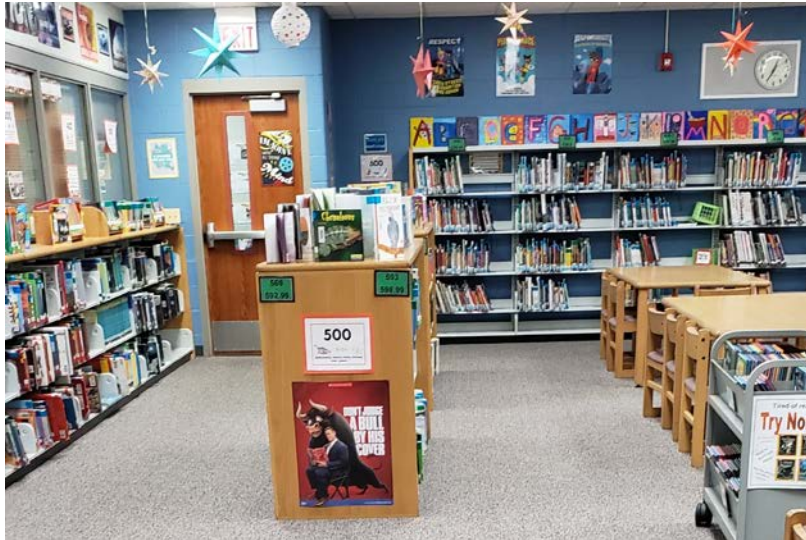
Flooring in the building consists of carpet, vinyl composition tile (VCT), ceramic tile, and vinyl sheet flooring. In 2007, a phased process of replacing carpeting was begun. As of 2016 only the IMC has original carpeting remaining. It is still in good condition.

**Replace worn carpeting in IMC.**

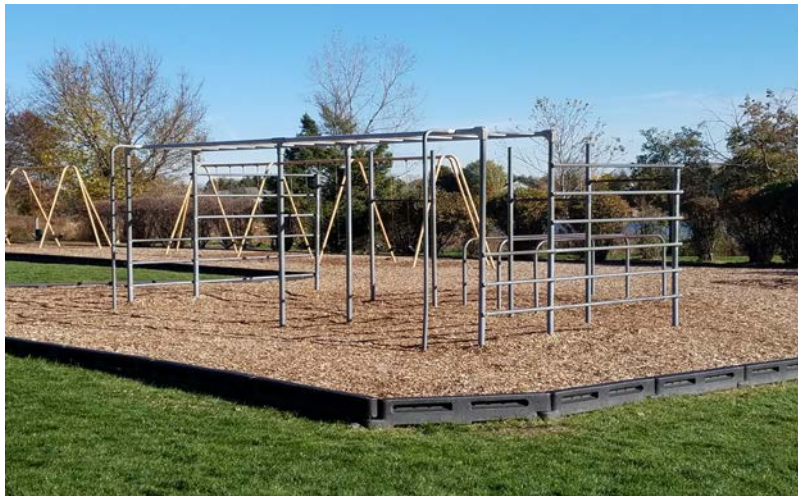
In 2014, we began a phased renovation of the surfacing material around the playground equipment at Erickson. Some pieces of equipment are aging and should be replaced as needed in the near future.

**Replace older playground equipment.**

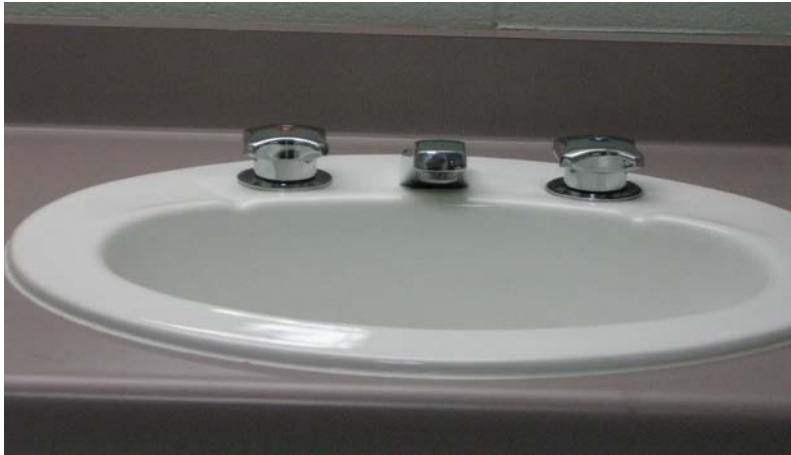
Domestic hot water is provided via one hot water heater located in the boiler room. The heater was installed with the new boilers in 2013 and is in excellent condition. The bathrooms in the building are in very good condition. Touchless towel dispensers have been installed in an effort to create a more sanitary environment. It is recommended that automatic faucets and flush valves be installed as well.

**Replace fixtures with touchless fixtures.**

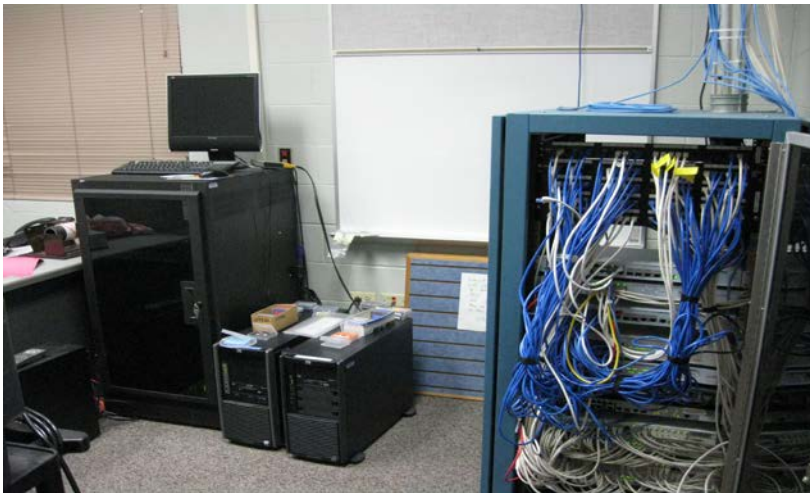
The server room at Erickson is sufficiently functional but could use a facelift. Technology equipment at Erickson is stored in a room that is also the IMC office and has minimal cooling capacity during the winter months. A dedicated room with year round air conditioning should be considered. As our network and technology demands have grown, equipment has been added as needed wherever it can fit in the server room. A modernization of the room would benefit the technology staff with network and equipment management.

**Crowded server room/equipment.**

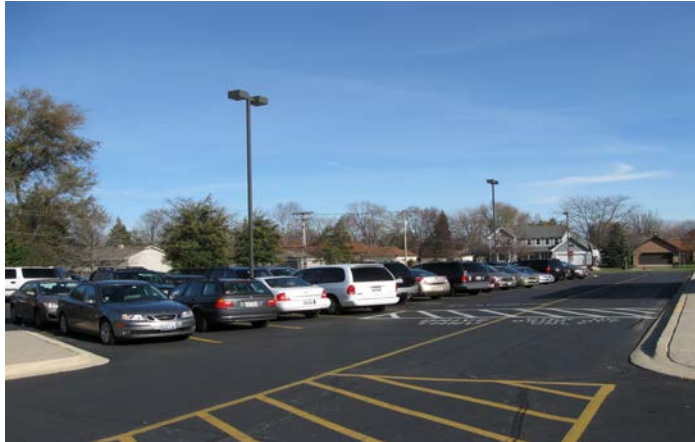
**Limited overflow parking on crowded days.**

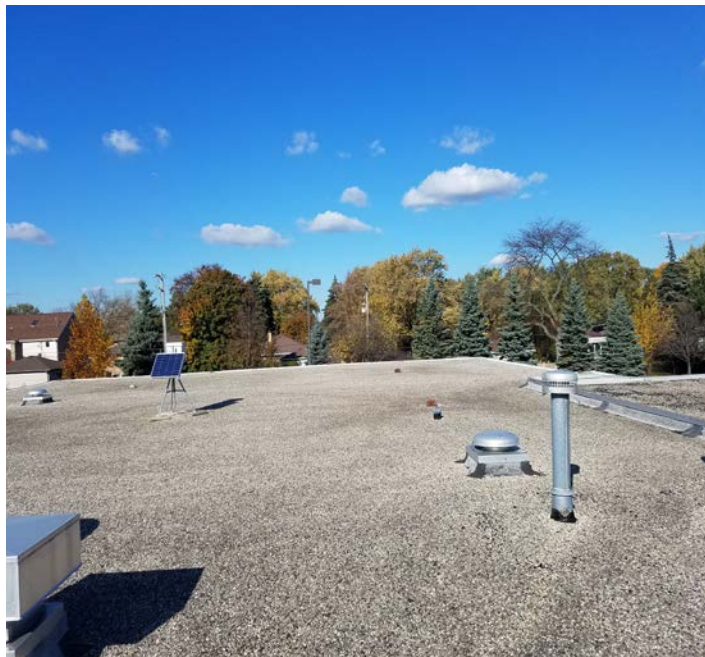
The roof is original and in fair condition. Continued maintenance of the roof should help it last approximately 2 to 5 years.

**Roof is aging.**
