General Knowledge Environmental Health and Safety (EHS) Inspection

School District of Turtle Lake / 24 Apr
2025 / Luke Krumenauer

School District of Turtle Lake

Custodial Supply and Wrestling

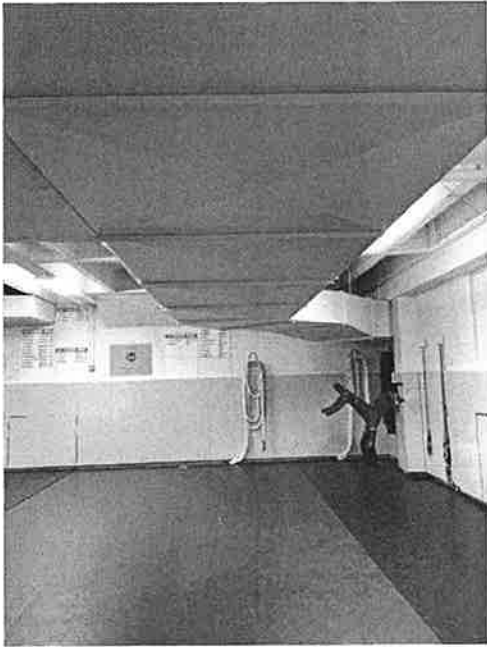
Photo 9

Determine ceiling load limit for lighting and other ceiling mounted improvements.

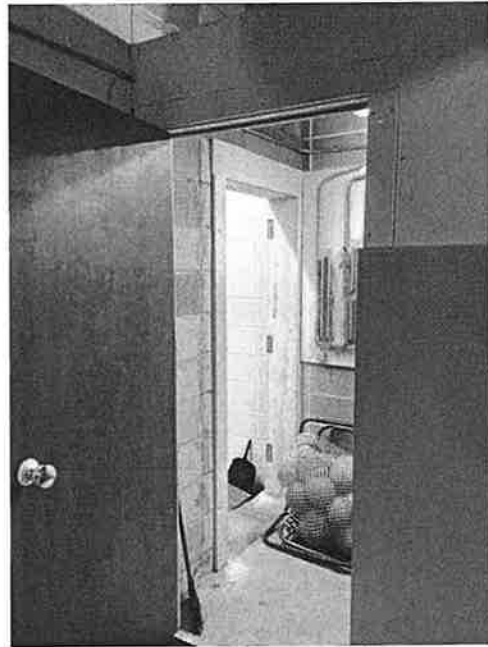
Photo 10

Determine if lead based paint is present.

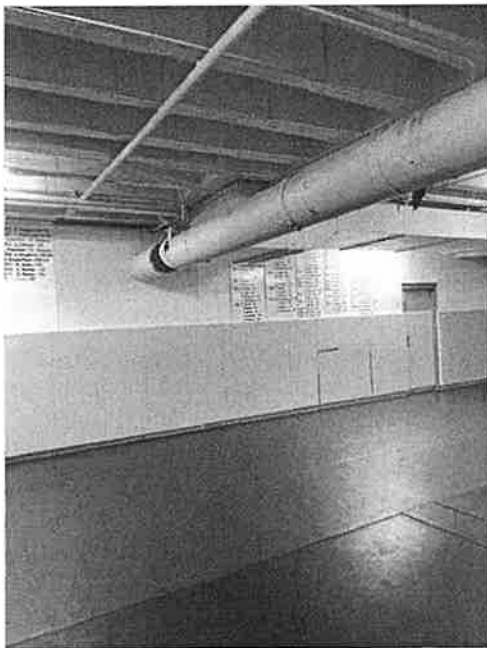
Photo 11

Determine asbestos content for materials to be renovated based off existing plans.

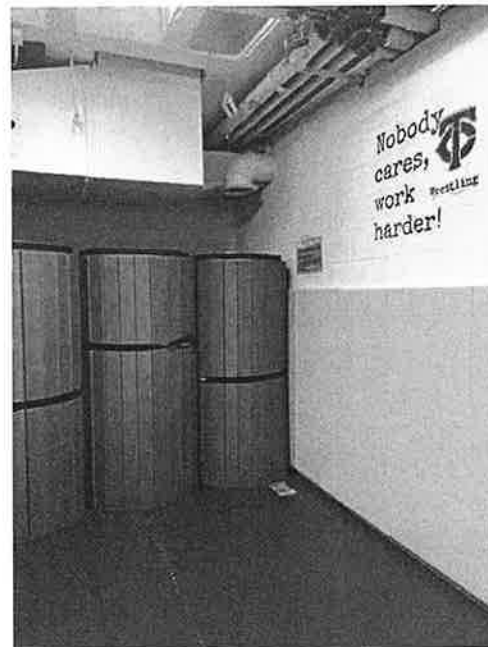
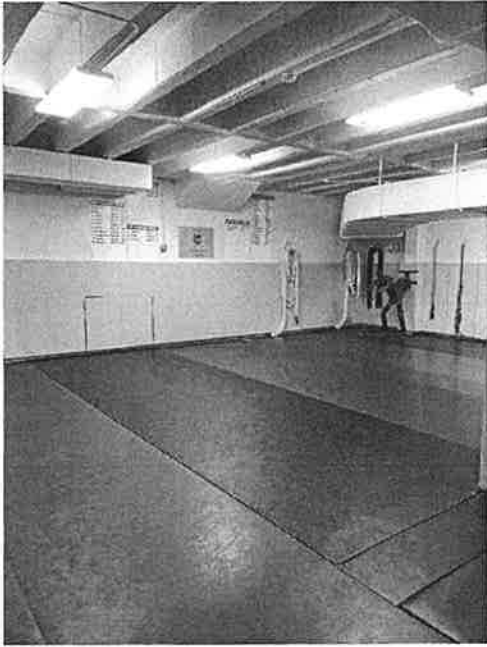
Determine if HVAC occupancy for room has been calculated.

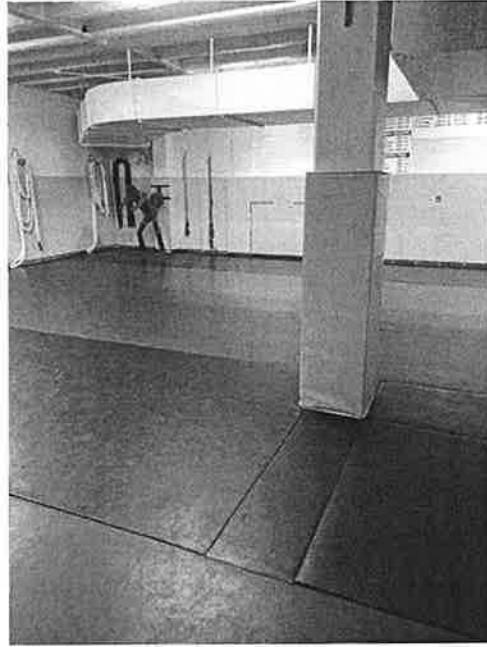
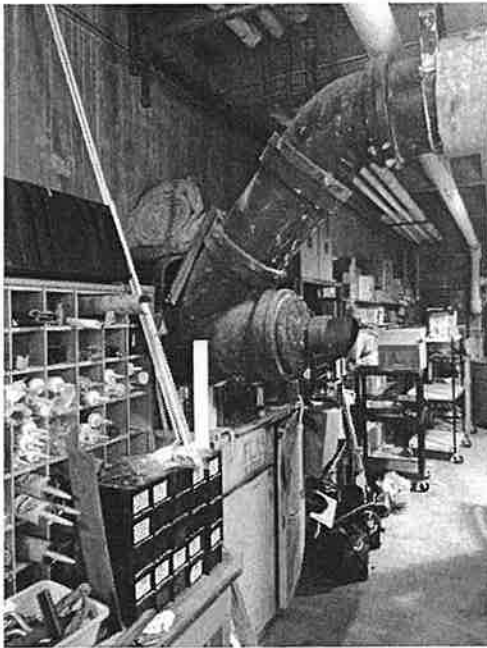
Determine risks associated with low ceiling heights for piping and valves.

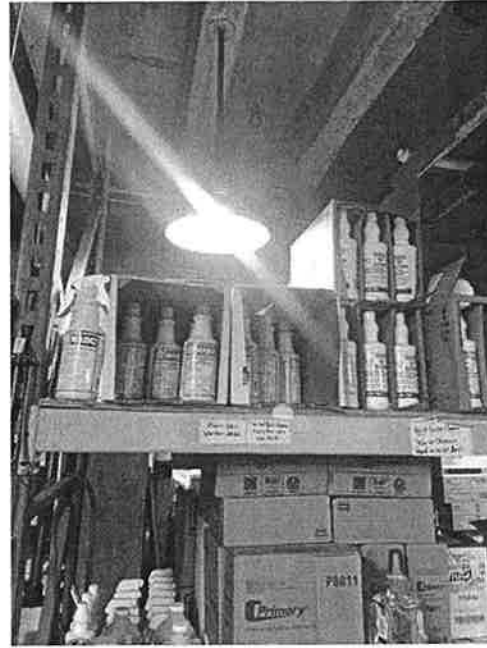
Photo 16

Ensure lighting is guarded

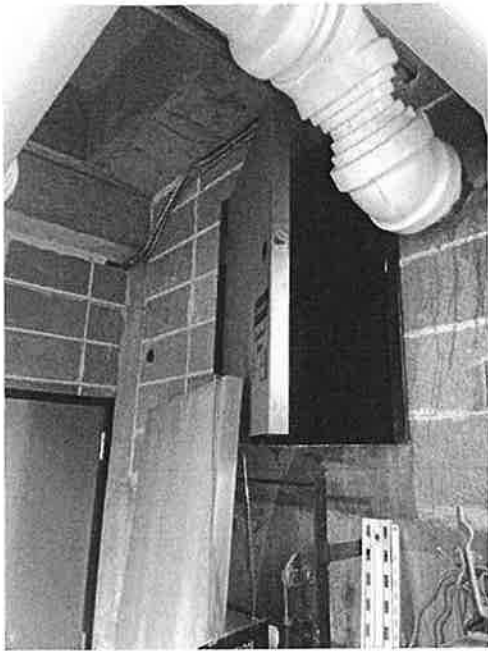
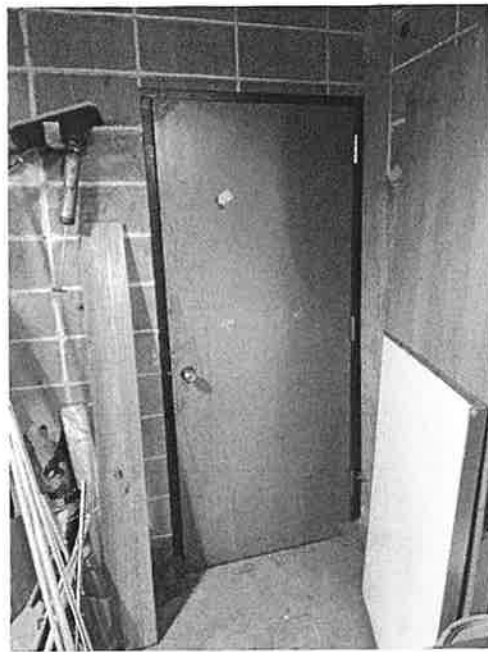
Ensure tunnel and HVAC room entrances are restricted entry through/after renovation.
