**WAUNAKEE COMMUNITY MIDDLE SCHOOL  
TRACK PAVEMENT CONDITION REPORT**

John V. Kneer, President, PLA  
Rettler Corporation  
3317 Business Park Drive  
Stevens Point, WI 54482

Project Number 26.053

October 5, 2026

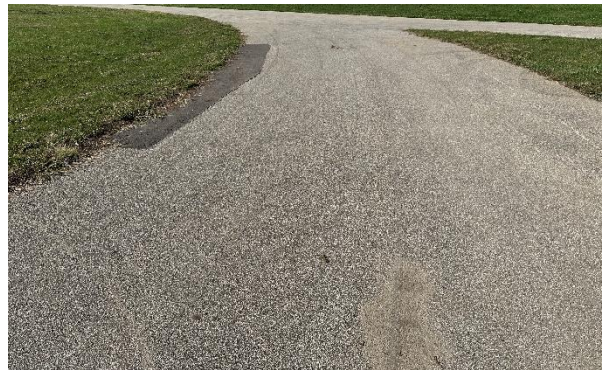
Photo 2: Surface Deformation – North Curve

Settlement of the track was observed most severely along the north curve. There is no apparent rutting however distortion of the surface was observed in these locations. Because the underlying subgrade soils are frost-susceptible, and no apparent sub-surface drainage is present, it is possible some heaving occurs in the freeze / thaw portions of the year.

Structural issues were observed such as subgrade settlement, or frost heaving, potentially caused by a lack of drainage on the north, south, and west sides of the track. Additional underdrain is recommended outside of the track, particularly on the west side where higher elevations.

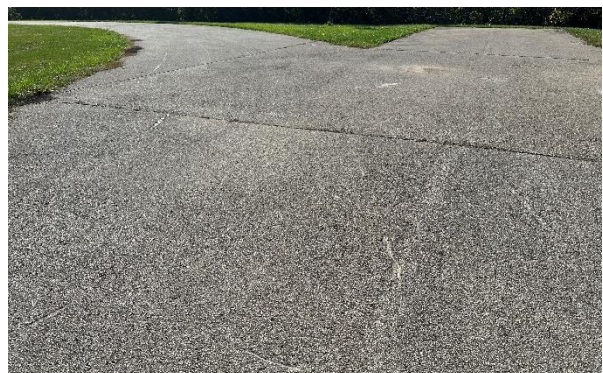
Photo 3: Longitudinal and Transverse Cracking

Some major traverse cracking was observed. Minor transverse and longitudinal cracking has also been documented. It appears no regular maintenance such as crack filling in the past and has proven successful.

No potholes were observed in the pavement however several patches were completed over time.

Typical weathering and aging have caused the track asphalt surfacing to become brittle and cracks present allow for infiltration of water. The presence of frost susceptible soils, subsurface moisture, and freeze / thaw cycles have caused minor surface distortion, major and minor cracking of the asphalt surface.
