June Facilities, Finance & Operations Committee Meeting  
Friday, June 12, 2026  
9:00 AM  
Zoom Webinar

**Subject:** 5 Year IAQ Report

The HVAC systems were inspected from 2/17 to 2/20 to evaluate operation with emphasis on ventilation. This report summarizes the systems and describes the ventilation operation as found and reviewed on site. Observations cover outdoor entry paths, filters, and control system review.

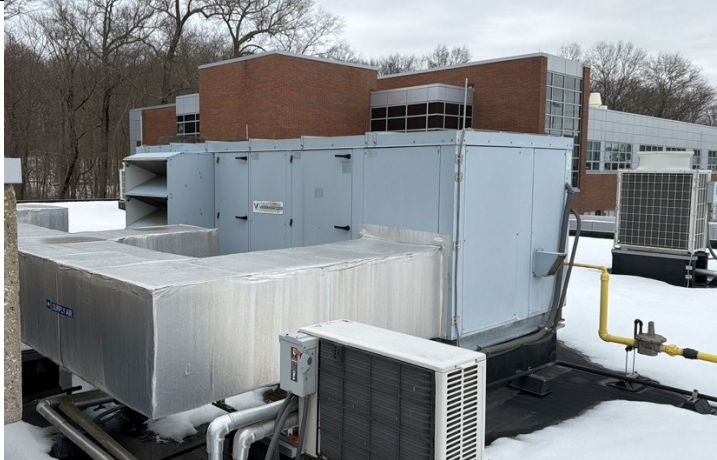
The DOAS unit is missing filters in both the outdoor air stream and the exhaust stream. It is supplying unfiltered outdoor air to the classrooms. The exhaust filters are meant to be installed upstream of the desiccant wheel heat exchanger to protect it from fouling and losing heat transfer effectiveness. The supply filters do the same with the added task of filtering the outdoor air supplied to the classroom. Without filters the wheel has some self-cleaning capability as supply air enters in one direction through half of the wheel as exhaust air passes through the other half of the wheel in the other direction.

Priority	Low
Tag	VRF DOAS
Location	E wing roof
Service	E wing classroom
Make	Venmar CES VHC50
Outdoor Air	100% OA
Filters	None installed on return or supply side of wheel.

Dedicated outdoor air energy recovery unit

Air flow velocity measurements at supply and exhaust registers in a sample of classrooms show an average of 147 cfm of outdoor air and 99 cfm of exhaust per classroom. This calculation assumes a 75% free area in the 5x12 inch grill and that the supply is the side with the highest air flow. Applying the average to 12 classrooms in the E-wing the total outdoor air should total at least 1,800 cfm. There are also supply grilles for the corridors. The DOAS unit is providing outdoor air to the E-wing and should be put into the regular maintenance schedule to install and replace filters.

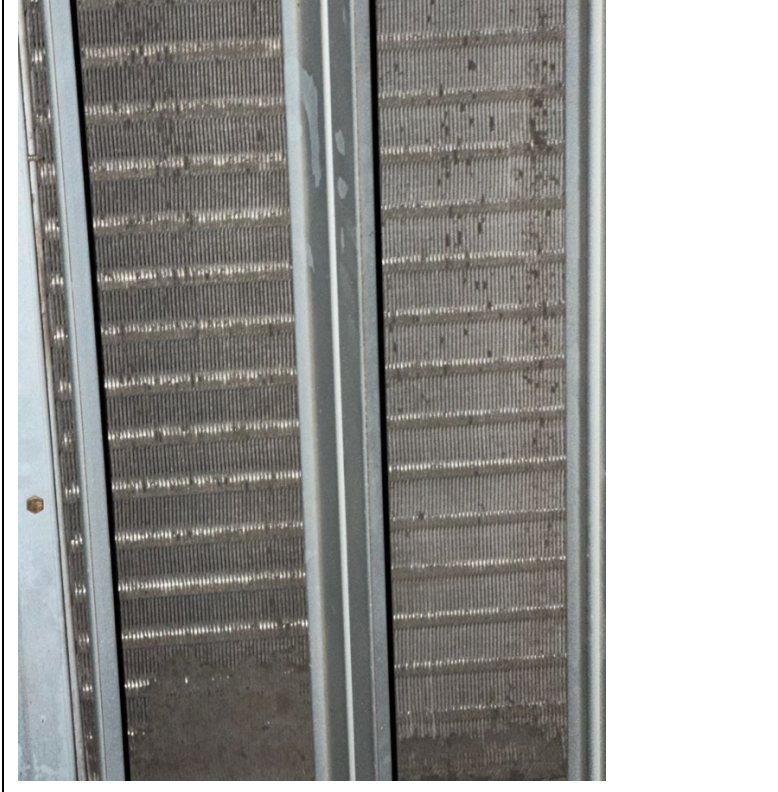
Dirty coil face inlet

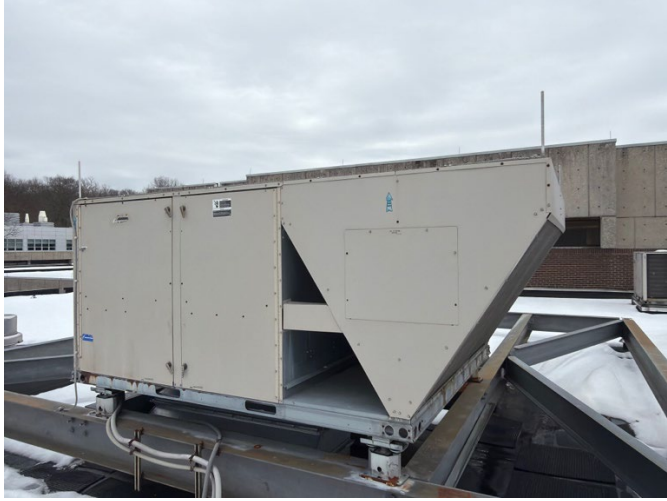
Priority	Medium
Tag	RTU-7
Location	Roof
Service	Admin Offices
Type	Multizone VAV
Outdoor Air	Packing material at OA inlet screen has blown out
Filters	2 inch MERV-8

Unit overview

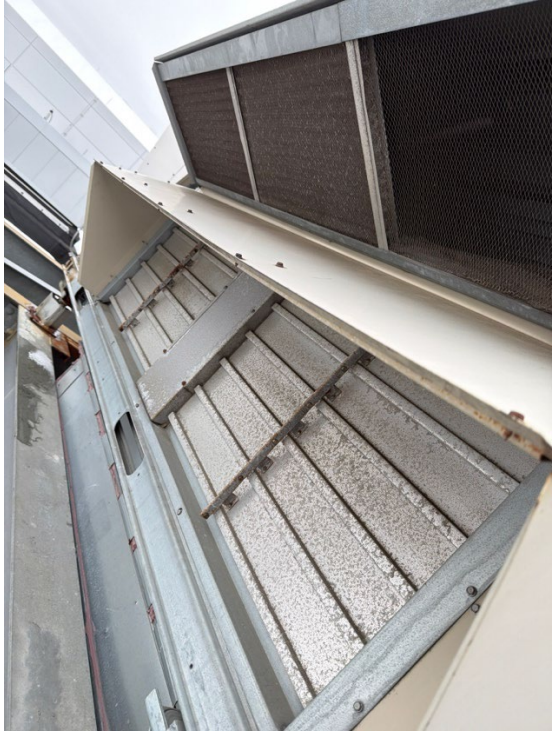
Inlet screen fill has broken loose – top Relief dampers – bottom (powered exhaust fan behind dampers)

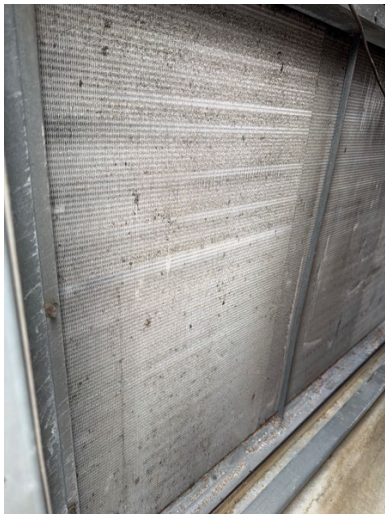
Found filter blown out of rack and dirty coil inlet face

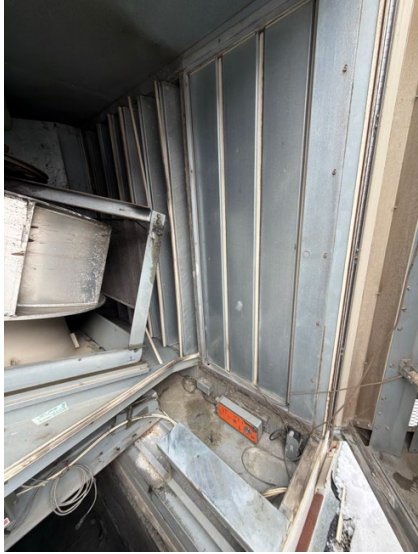
RTU-3	Mixed air temperature suggests 43% outdoor air when the damper is commanded to only 5% open. Airflow increases with more open damper. Is damper actually closing to 5%?
RTU-3	AFMS wiring is looped around OA damper blade.
RTU-3	Found filter blown out from rack and dirty coil inlet face.
RTU-6	The AFMS and mixed air temperature calculation suggest that the damper position has no effect on the outdoor air. Is damper actuating? Suspect damper is stuck about halfway open.
RTU-6	AFMS wiring is loose and sticks through OA damper opening.
RTU-6	Found filter blown out from rack and dirty coil inlet face.
RTU-8	No issues.
RTU-9	Data suggest that the outdoor dampers are mostly open when commanded closed.
RTU-9	Coil inlet face is dirty.
Auditorium	No design data. Mixed air temperature suggests 24% outdoor air with damper commanded 5% open.
HV-1	Mixed air temperature suggests 50% outdoor air with damper commanded 5% open.

OA damper right – wire wrapped around bottom of blade  
Return dampers left

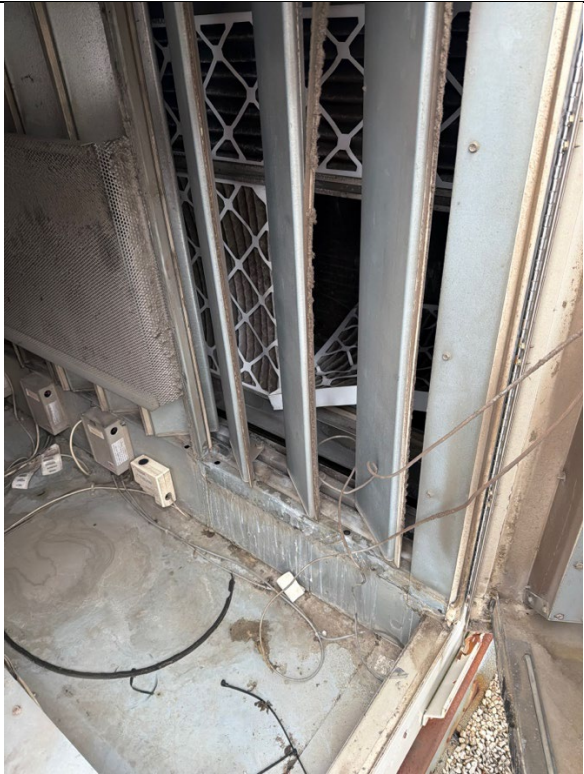
Outdoor air damper – filter blown out behind damper. Wiring is looped through damper blades.

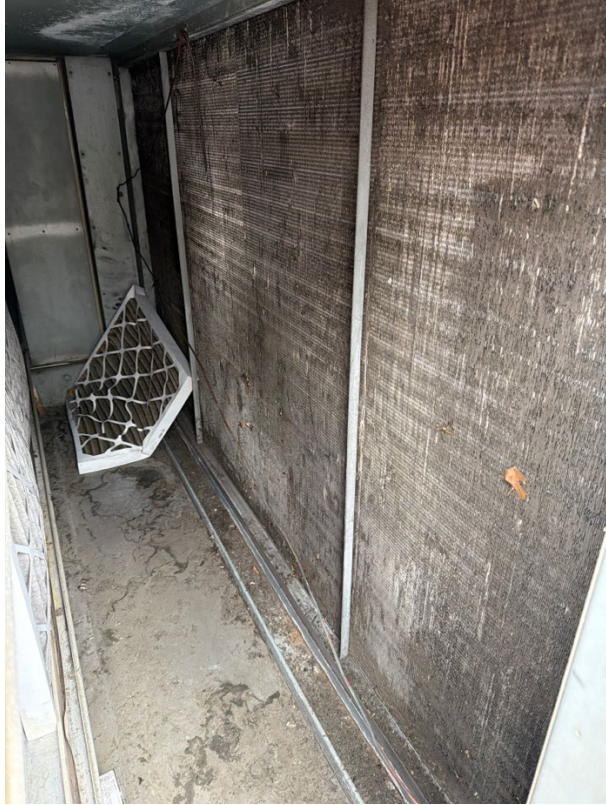
Dirty coil inlet face. Filter blown out.

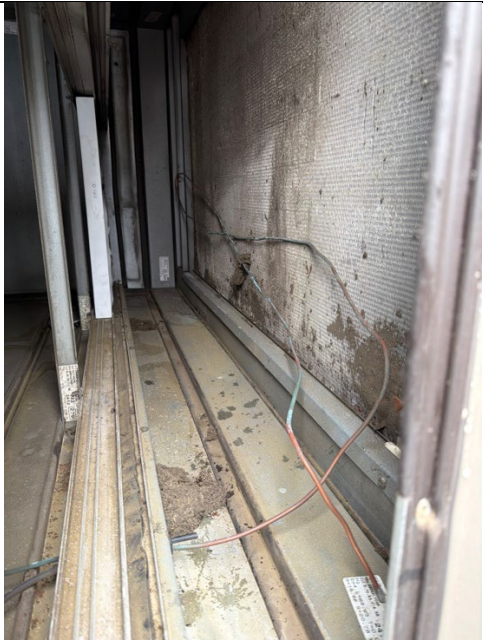
Dirty coil inlet face. Mixed air temperature across bottom of coil.

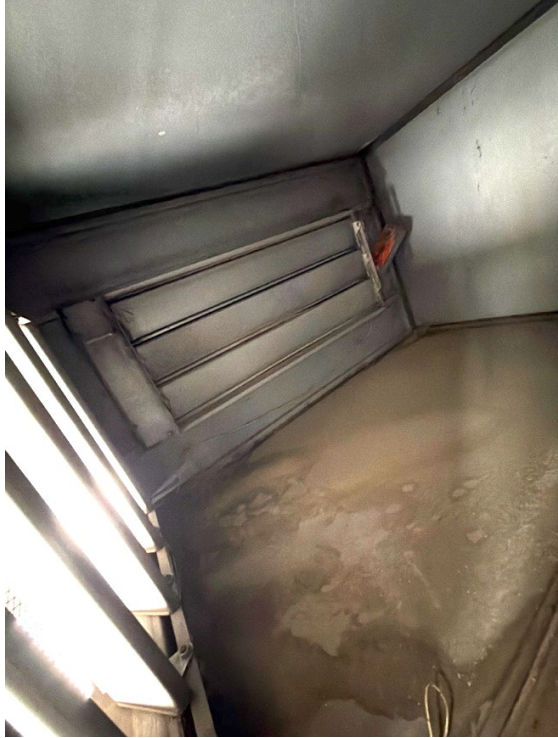
Damper is open when unit is off.  
Is actuator connected to closed damper? It is at an odd angle.

AFMS outside under shroud.  
Damper did not close when unit was off,

- RTU damper actuation should be verified. Observations noted some dampers open when the units are off or not closing completely. A relief damper that is erroneously open could contribute to the observed reduction in system air flow by exhausting excess return air.

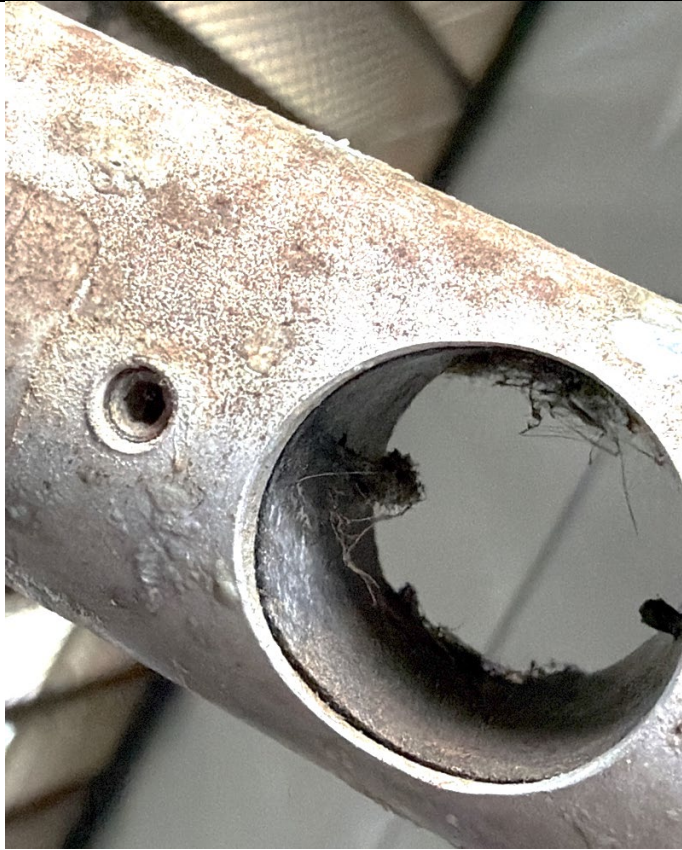
Significant debris on outdoor air flow sensor element.

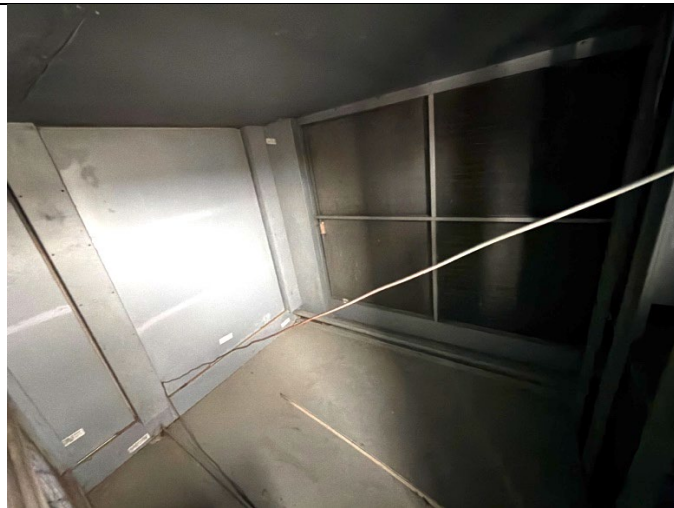
Lower center filter blown out

Mixed air temperature sensor and dirty coil inlet face

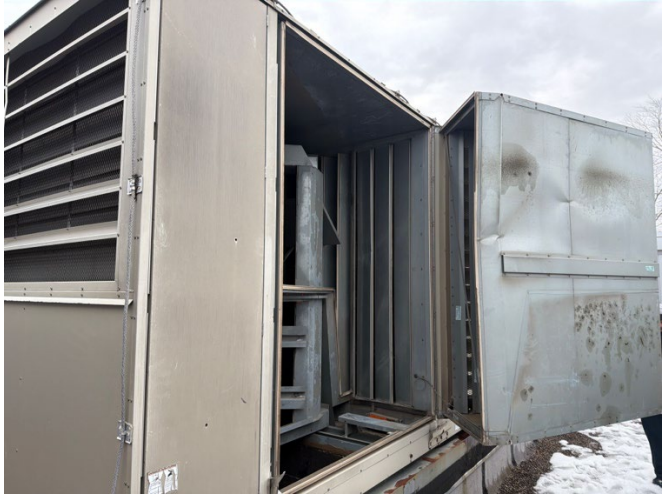
Return air section with outdoor air dampers – right AFMS in door with intake louver OA dampers do not close completely with unit off

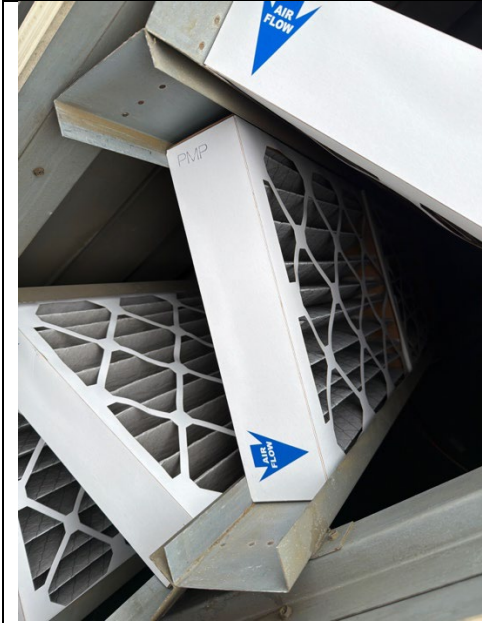
Filters lack blank off panels at end allowing dirty air to bypass filters

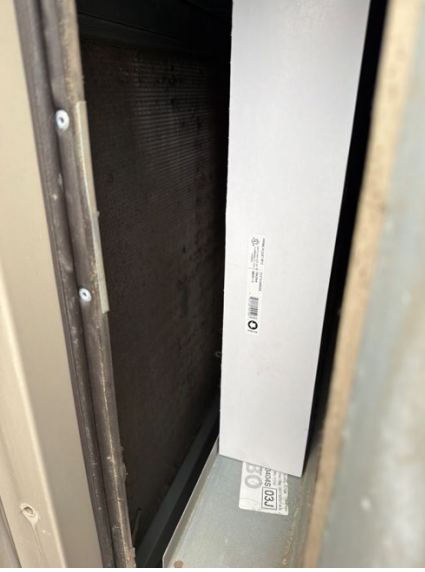
Filter racks are missing blank off plates at the end of the filter allowing air to bypass filter and clog coil

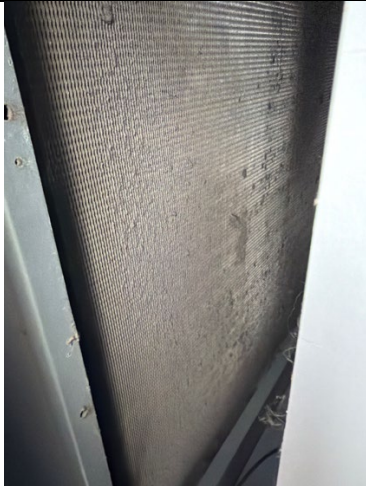
Dirty coil inlet face

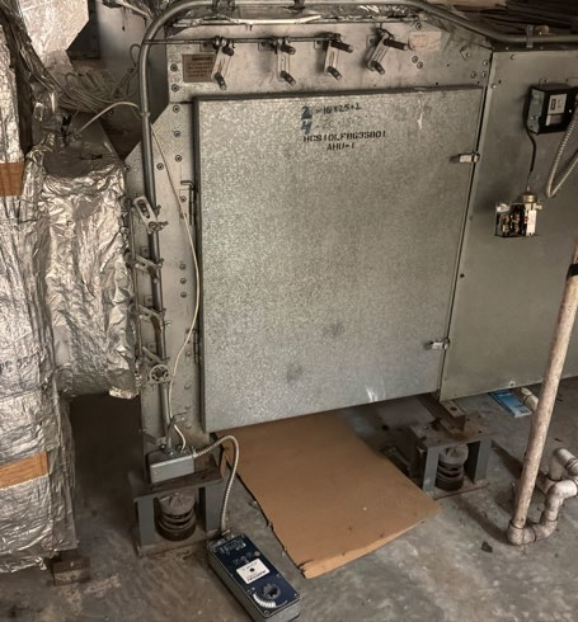
Damper control actuator is disconnected (on the floor) Damper blade linkage is disconnected

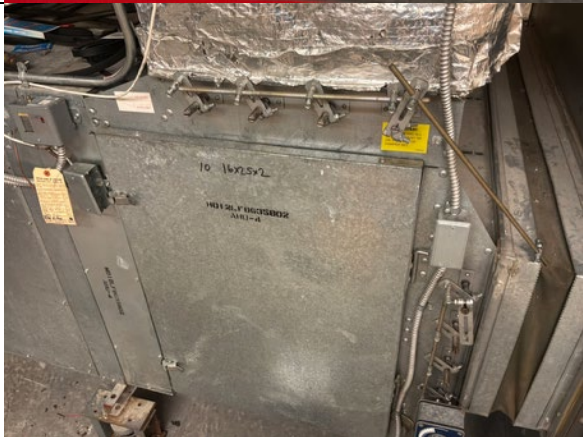
Return damper linkage connection to actuator is loose. Outdoor damper linkage is disconnected

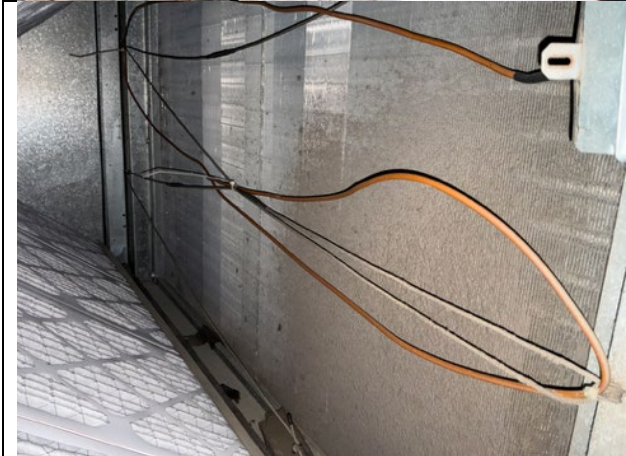
Coil face near the door is covered in dust. Air is bypassing filter in gap between filter and door.

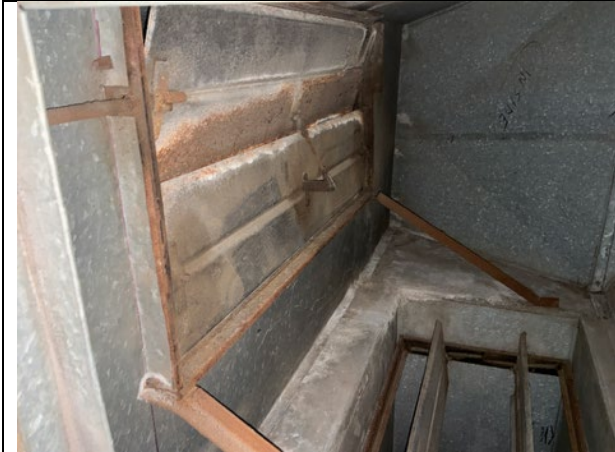
Outdoor air damper (left) is closed with one blade cracked open  
Return damper (bottom) is open

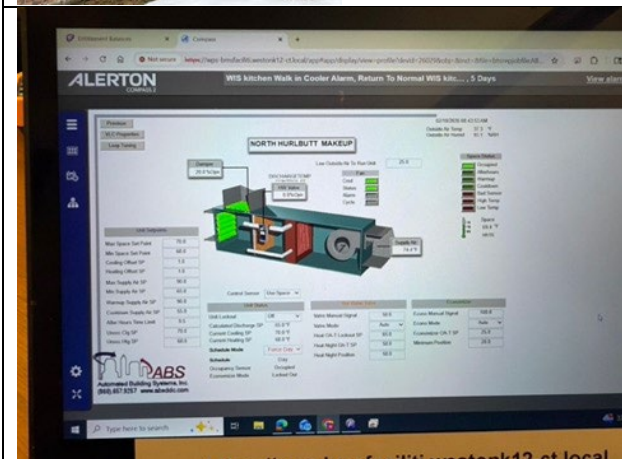
BAS graphics screen  
No return damper found

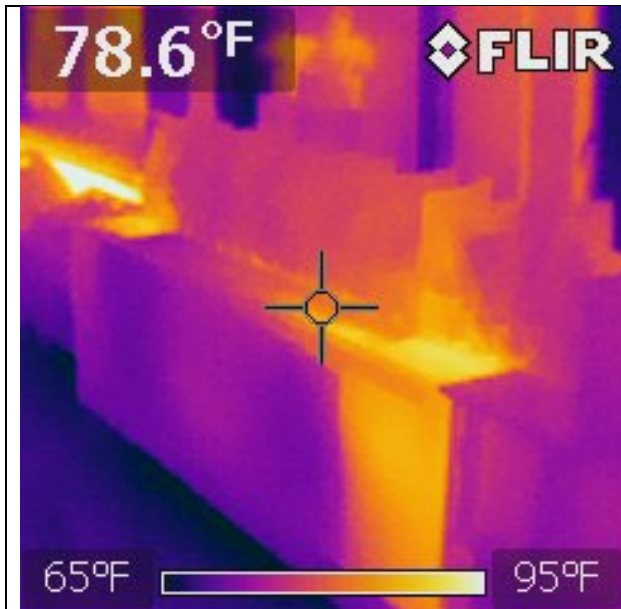
Room N17  
End of unit with heat control valve stays hot
