## Certificate of Substantial Completion

**PROJECT:** *(name and address)*  
2022-024.PRE - FRANKLIN CUB  
ACADEMY  
1049 Sloan Drive  
Franklin, IN 46131

# Site Visit Construction

VISIT NAME: Flooring Punch

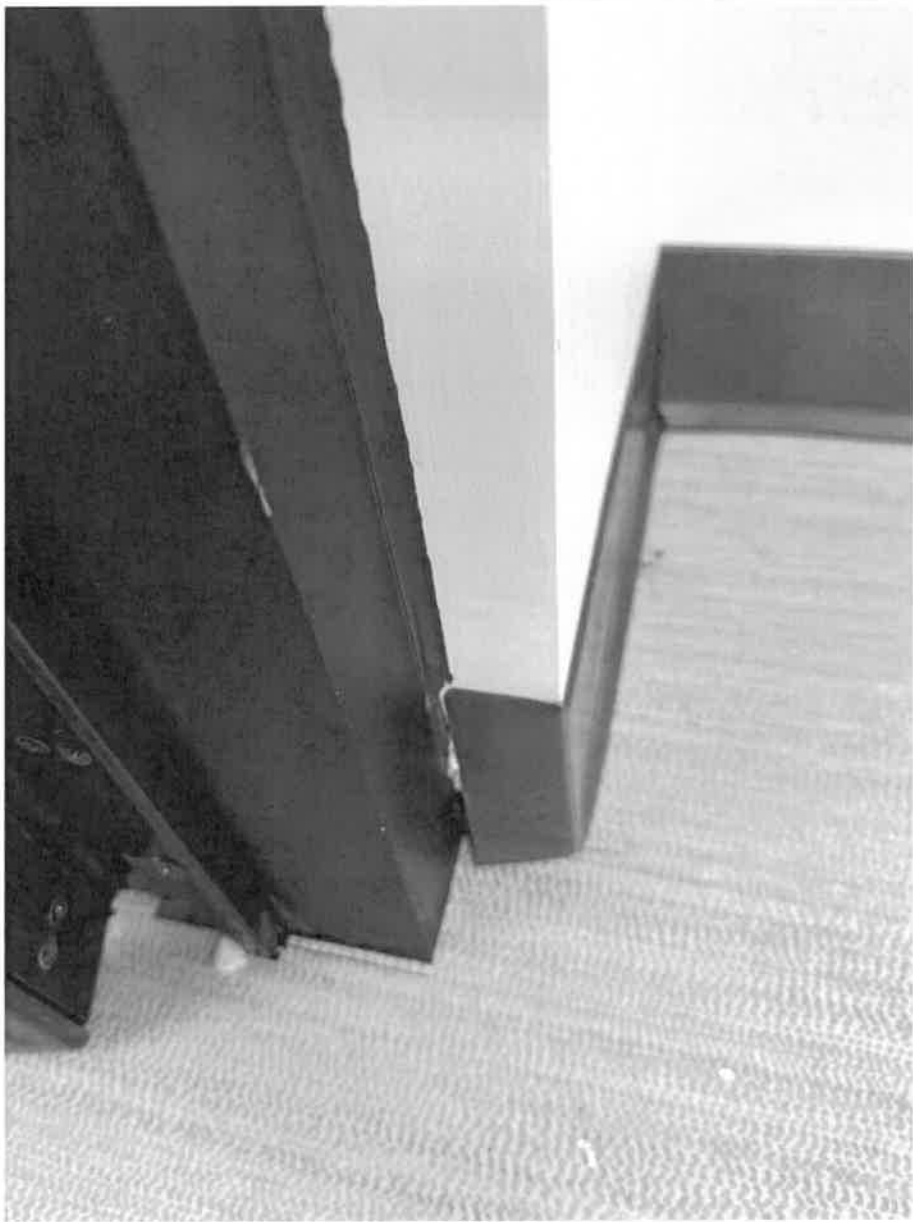
ITEM: 027-013

SUBJECT: Corridor H101  
REMARKS: Caulk base to frame  
CATEGORY: Quality

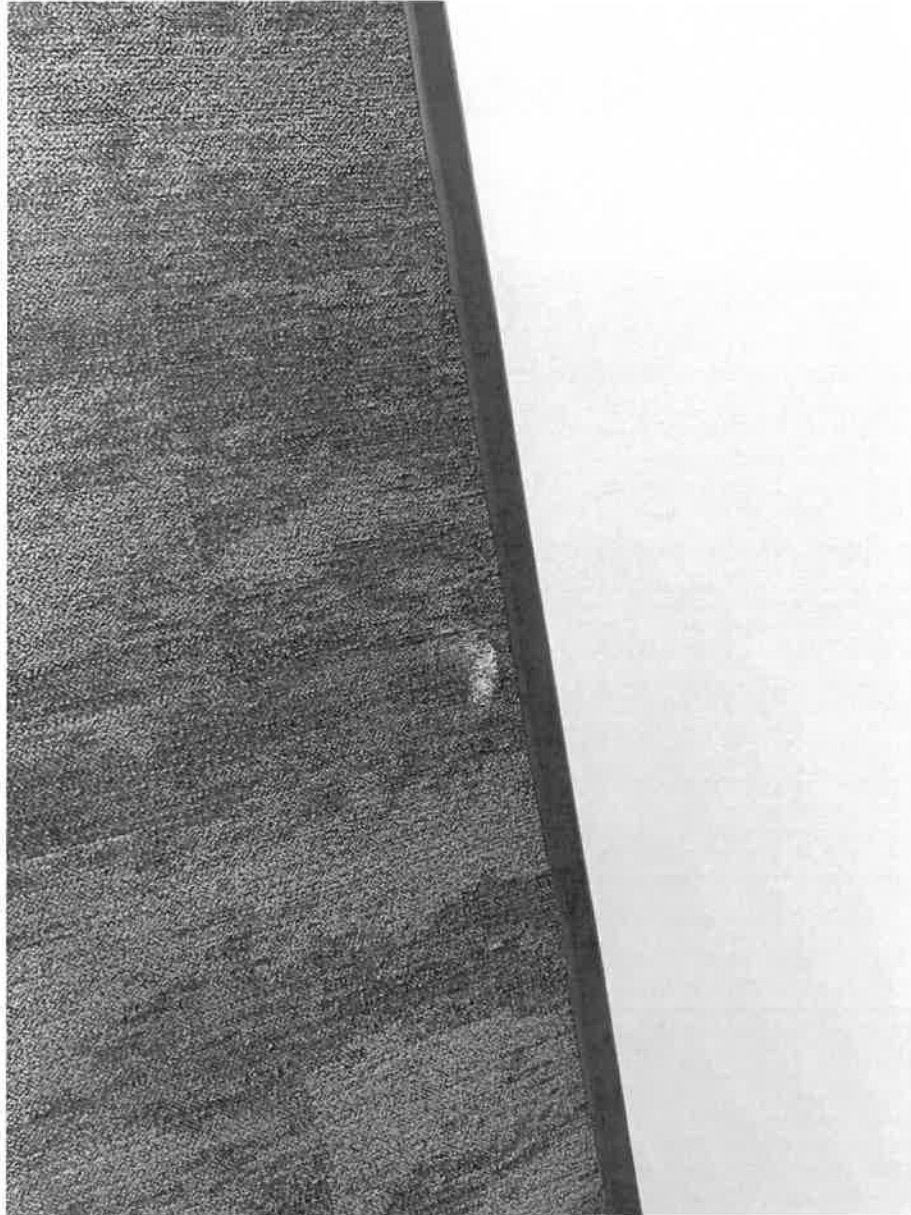
ITEM: 027-017

SUBJECT: A103  
REMARKS: Paint on carpet near window  
CATEGORY: Quality

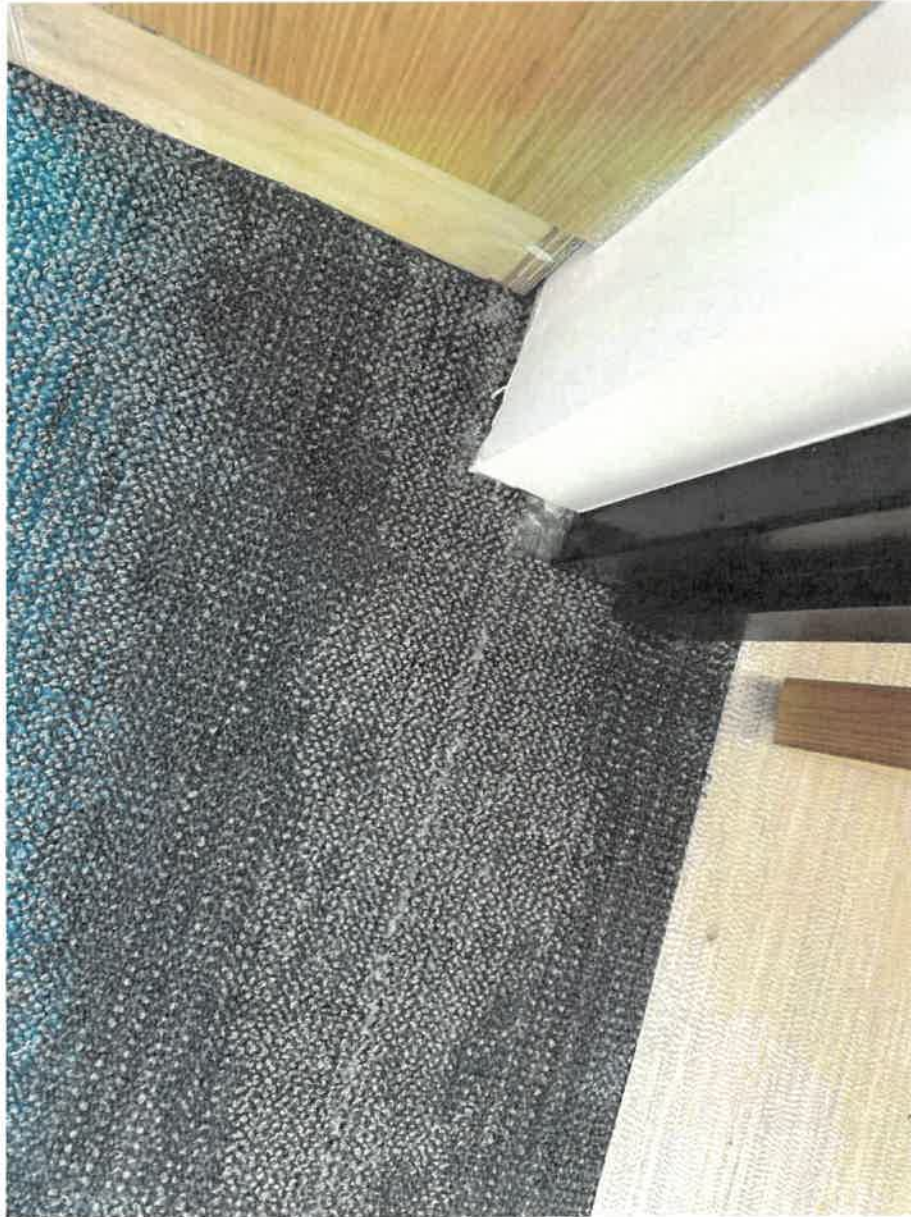
ITEM: 027-019

SUBJECT: D105a  
REMARKS: Missing carpet  
CATEGORY: Quality

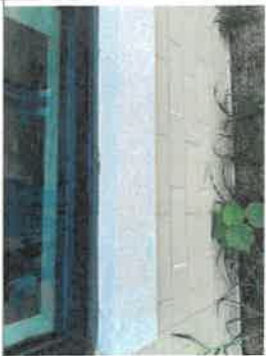
| SPACE NUMBER | SPACE NAME | ELEMENT | LOCATION | DESCRIPTION | STATUS LABEL | ID | SUPPORTING DOCS |
|---|---|---|---|---|---|---|---|
| | N/A | Exterior | | Remove Joint sealant on sills | Open | 0000<br>7 | |

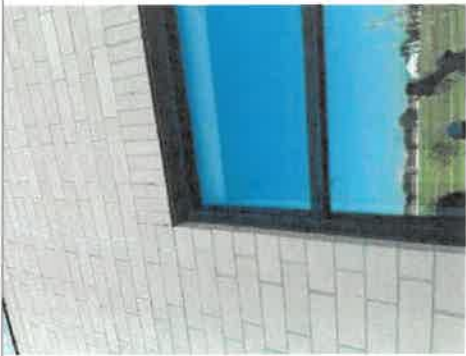
| SPACE NUMBER | SPACE NAME | ELEMENT | LOCATION | DESCRIPTION | STATUS LABEL | ID | SUPPORTING DOCS |
|---|---|---|---|---|---|---|---|
| | N/A | Exterior | | Mortar missing on west side of building | Open | 0000<br>8 | |

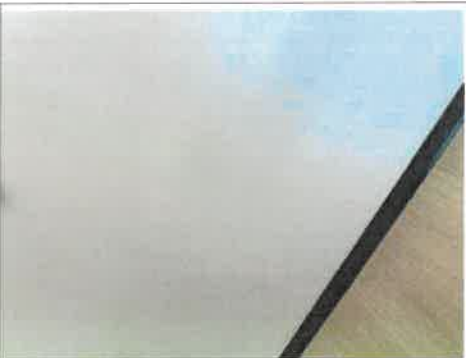
| SPACE NUMBER | SPACE NAME | ELEMENT | LOCATION | DESCRIPTION | STATUS LABEL | ID | SUPPORTING DOCS |
|---|---|---|---|---|---|---|---|
| | N/A | Workroom C112 | | Fix drywall | Open | 0003<br>0 | |

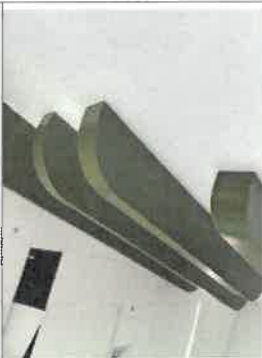
| SPACE NUMBER | SPACE NAME | ELEMENT | LOCATION | DESCRIPTION | STATUS LABEL | ID | SUPPORTING DOCS |
|---|---|---|---|---|---|---|---|
| | N/A | Great Room C108 | | Touch up bulkheads | Open | 0003<br>1 | |

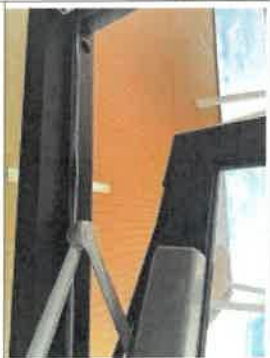
| SPACE NUMBER | SPACE NAME | ELEMENT | LOCATION | DESCRIPTION | STATUS LABEL | ID | SUPPORTING DOCS |
|---|---|---|---|---|---|---|---|
| | N/A | Opening C108.2 | | Seal needs replaced | Open | 0003<br>2 | |

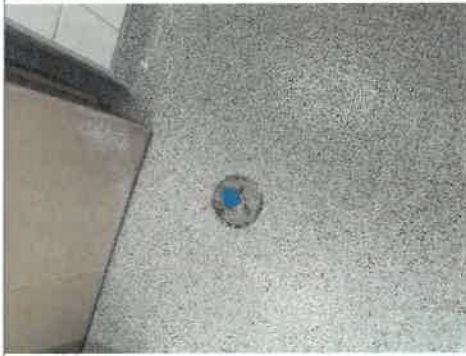
| SPACE NUMBER | SPACE NAME | ELEMENT | LOCATION | DESCRIPTION | STATUS LABEL | ID | SUPPORTING DOCS |
|---|---|---|---|---|---|---|---|
| | N/A | Handwashing C150 | | Replace clean out cover | Open | 0004<br>1 | |

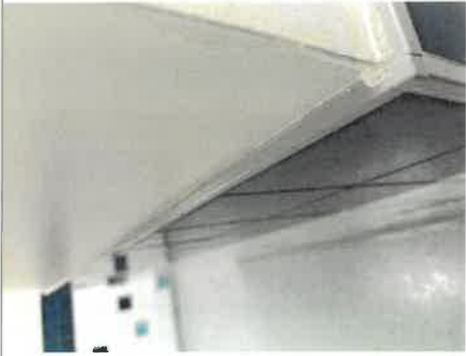
| SPACE NUMBER | SPACE NAME | ELEMENT | LOCATION | DESCRIPTION | STATUS LABEL | ID | SUPPORTING DOCS |
|---|---|---|---|---|---|---|---|
| | N/A | Girls C151 | | Caulk between wall and schluter strip | Open | 0004<br>2 | |

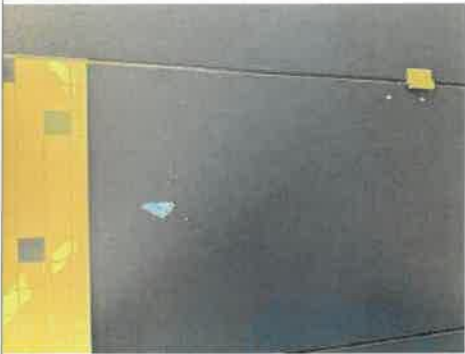
| SPACE NUMBER | SPACE NAME | ELEMENT | LOCATION | DESCRIPTION | STATUS LABEL | ID | SUPPORTING DOCS |
|---|---|---|---|---|---|---|---|
| | N/A | Boys C152 | | Repair scratches on partition | Open | 0004<br>6 | |

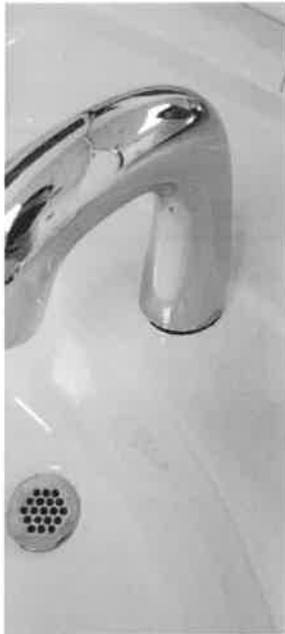
- i.
- e. All mop basins were observed to have been missing the stainless-steel wall guard as required by specifications.
- f. Multiple faucets were observed to be either loose or installed off center of penetration leaving and exposed gap on the fixture. Install fixtures as per manufacturers installation requirements to ensure sink faucets pivot without coming loos and lav faucets to conceal penetrations complete.

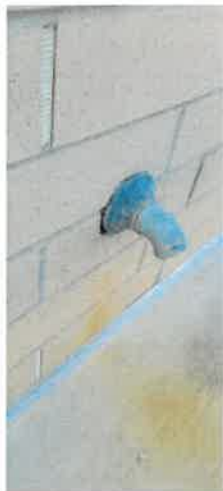
3. Test drain for sprinkler system installed near grease interceptor is not fully sealed around wall penetration.

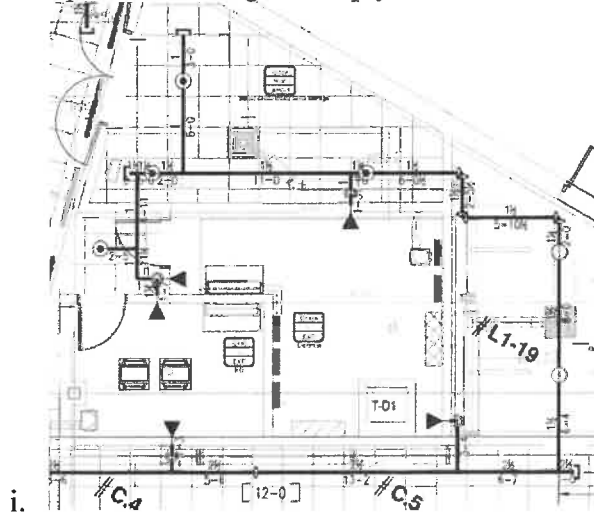
- a. Sprinkler piping in the vestibule shall be re-evaluated by the sprinkler contractor to determine if coverage is required above and below the ceiling clouds as per NFPA 13.
- b. At least one sprinkler head was observed to have the head taped up and covered. Ensure all sprinkler heads are compliant with NFPA 13 requirements for installation.
- c. Sprinkler piping was observed to be installed within electrical room when sidewall head sprinklers are required on drawings and shown on submitted plans. Update sprinkler routing to comply with contract documents.
