Bethel Board of Education Special Meeting - HVAC Feasibility

Bethel High School Mechanical Upgrades Study

June 3, 2022

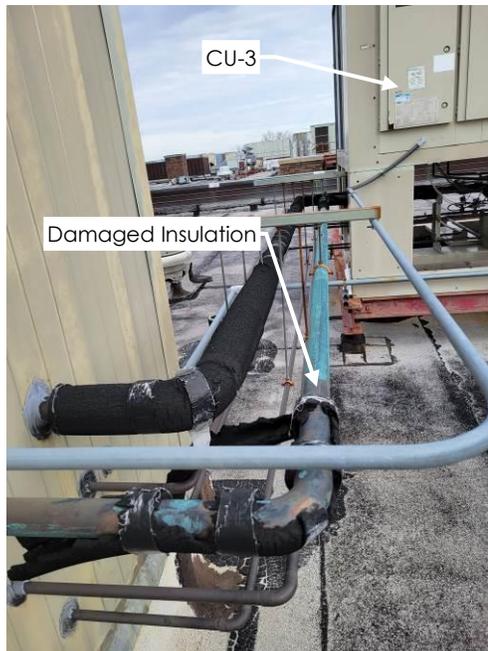
The rooftop condensing unit serving AHX-1, tagged as CU-3, is mounted on steel dunnage without external vibration isolation. The unit is comprised of 4 compressors which have damaged and missing refrigerant pipe insulation and mild corrosion at the pipe fittings. The condensing unit utilizes R-22 refrigerant which has been phased out. The unit was installed during the 2007 renovation and replaced an existing chilled water coil serving AHX-1.

Damaged CU-3 Insulation

Remove AHX-1 and its associated condensing unit entirely. Replace this unit in kind with a modular air handling unit sized for 10,800 CFM similar to a Trane Climate Changer matching the components of the existing AHX-1 including its remote condensing unit. Cooling capacity shall be increased to 45 tons. Existing steel dunnage supporting the condensing unit shall be cleaned, treated for corrosion, and painted. New ductwork shall connect to the existing duct risers at the floor of the penthouse.

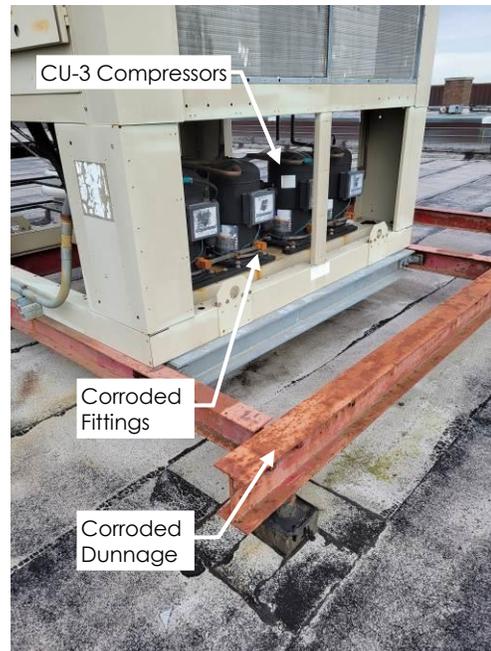
CU-3 on Dunnage

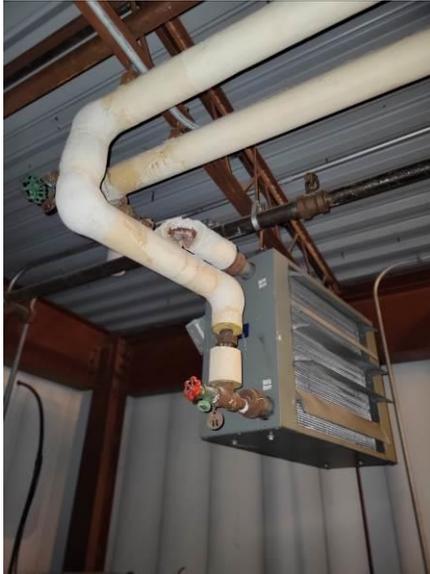
The rooftop penthouse containing the components for AHX-1 has internal dimensions of approximately 44'-6"L x 17'-6"W x 8'-9"H. The penthouse is heated via a hot water unit heater. At the time of survey, the unit heater fan was running continuously without any hot water flowing through it. A hot water control valve serving this unit heater was not found.

Penthouse Unit Heater

Provide a new DDC 2-way hot water control valve to serve the penthouse unit heater. Remove and replace the penthouse propeller exhaust fan with a new fan in kind sized for approximately 700 CFM. Remove and replace the penthouse make up air damper actuator with a new actuator.

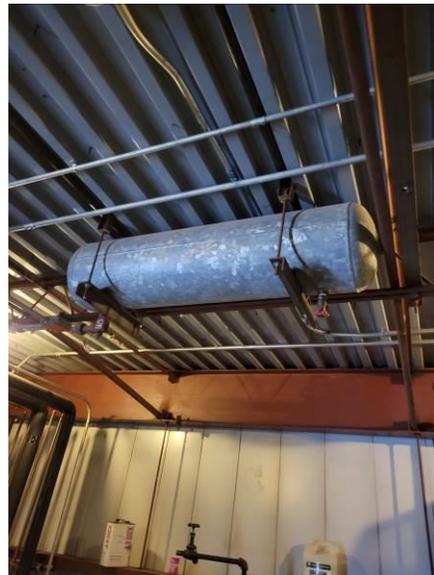
The penthouse is cooled via a sidewall propeller exhaust fan and intake air damper. The damper appeared to be in good condition, but it is controlled via an antiquated actuator. The exhaust fan is corroded, in poor condition and appears to be inoperable. An abandoned suspended expansion tank was found in the penthouse which appears to be left over from the 2007 renovation. This is typical of items that were specified to be removed and were not as part of the renovation project.

Abandoned Expansion Tank

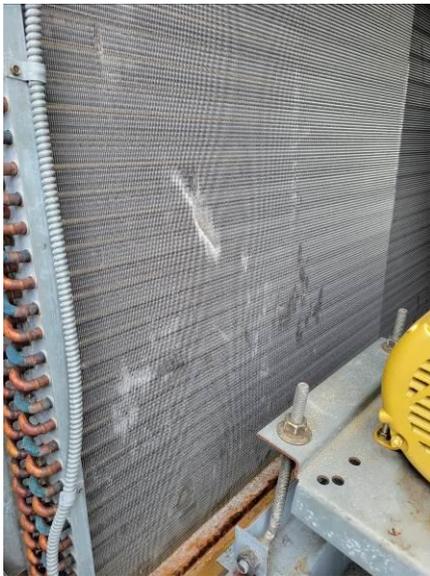
The unit was installed during the 2007 renovation and is in fair condition. Dirt and debris were seen inside the unit and on the cooling coil. Damaged cooling coil fins were observed as well as corrosion at the base of the coil. The unit contains 3 compressors which have damaged refrigerant insulation. Wiring splices were found in the supply fan section exposed to the airstream which should be contained in a junction box. AHU-2 does not have any reported issues with cooling, but it has been reported that AHU-2 spaces are subject to overheating. Since there are VAV boxes with reheat coils on this system, this can be avoided.

AHU-2 Cooling Coil Damage

Option 1 (Recommended): Remove and replace AHU-2 in kind with a new variable air volume gas fired / DX packaged rooftop unit similar to a Trane model IPAK sized to match the existing unit capacity. Provide a new adaptor curb and reconnect to the existing supply and return air main risers. All existing ductwork serving AHU-2 shall be cleaned, pressure tested and sealed as needed. All existing VAV boxes served by AHU-2 shall be inspected, cleaned, and reused. Two offices and one special education classroom on the second floor currently have no airflow and shall be furnished with new VAV boxes with hot water reheat coils fed from AHU-2.

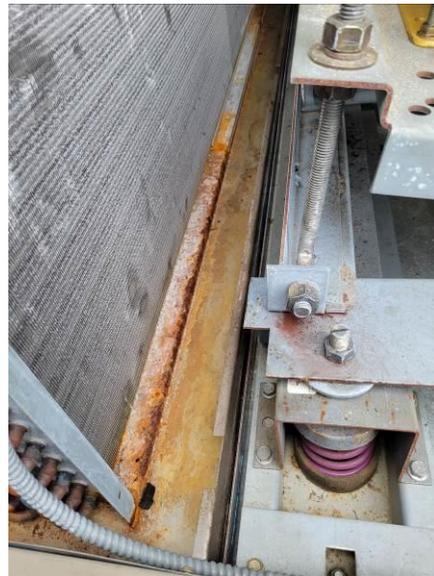
AHU-2 Cooling Coil Corrosion

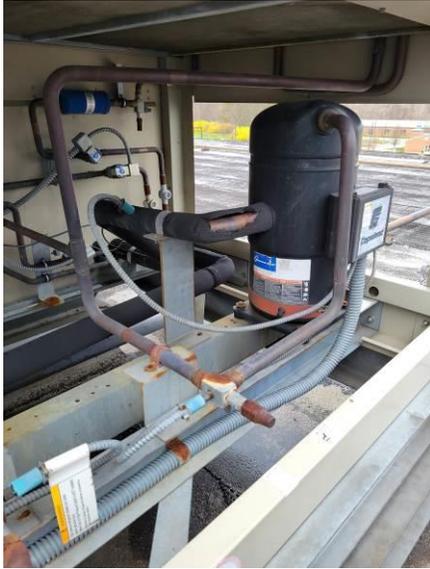
AHU-2 Damaged Refrigerant Insulation

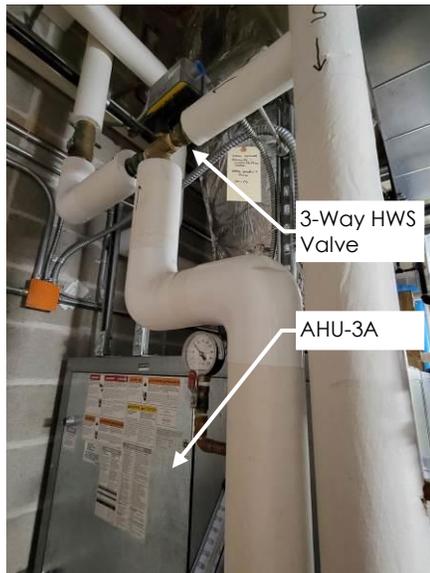
The units were installed during the 2007 renovation and are in good condition. Dirt and debris were seen inside the units and on the heating coils. The unit dampers, gaskets, fans, and components all appear to be in good working order. Hot water is controlled via a 3-way control valve and no deficiencies to the piping, components, or insulation were found. These units have a ducted outside air connection sized for airside economizer and no insulation was seen on the outside air ductwork. Insulation is required by the energy code. It was also cold to the touch at the time of survey. Although no condensation or water damage was found, this ductwork should be insulated to eliminate potential condensation issues and to comply with the energy code. Breakout noise from AHU-3A and 3B is audible within the locker rooms.

AHU-3A Heating Coil Piping

Although these units are in good operating condition, they do not cool nor dehumidify the locker rooms. Furthermore, they are not modular construction so adding a cooling coil to the existing units is not feasible. Both units shall be removed and replaced with new vertical modular air handling units similar to Trane Climate Changers, matching the current 4,000 CFM each. Each unit shall include a filter section, DX cooling coil, and vertical supply fan section. New duct mounted hot water reheat coils shall be installed in the supply air duct main above the ceiling of both locker rooms. All existing ductwork shall be cleaned and reused. The existing outside air ductwork shall be insulated with R-6 fiberglass duct wrap. The remote condensing units shall be mounted on the roof on 24" high equipment rails. The locker room inline exhaust fan (EF-1) shall be inspected and reused. The sidewall discharge louver associated with EF-1 shall be inspected and cleaned. The new air handlers and reheat coils shall be controlled by the BMS. Noise output of the new replacement units should be evaluated during the next phase of design. Duct silencers may be considered based on the new unit's published acoustical data.

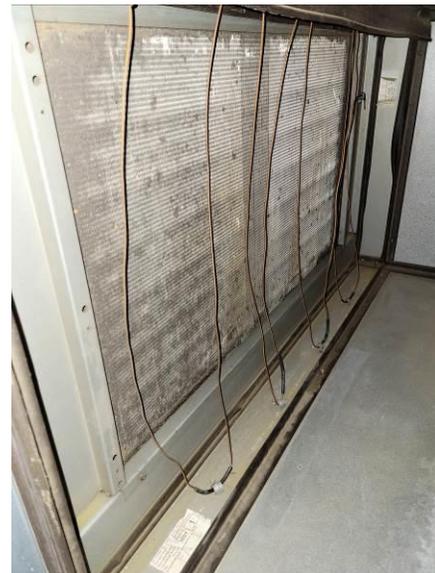
AHU-3A Dirty Heating Coil

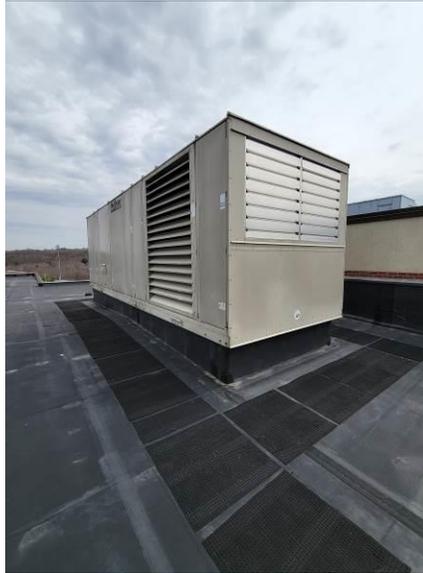
The unit was installed during the 2007 renovation and is in good condition. Dirt and debris were seen inside the unit and on the fan bearings. Light corrosion was observed on the heat exchanger condensate discharge. At the time of survey, the outside air damper and relief dampers were fully closed, and the unit was only recirculating air. The facilities staff noted this unit frequently shuts off on flameout. The gas pressure regulator is tagged with a 6 to 13 in. w.c. spring and the unit burner is tagged as requiring 8 in. w.c. minimum. Lastly, duct lining was not seen on the unit supply or return ductwork.

AHU-4 Casing and Shut Relief Damper

Remove and replace AHU-4 in kind with a new variable air volume gas fired / DX packaged rooftop unit similar to a Trane model IPAK sized to match the existing unit airflow and heating capacity. Provide a new adaptor curb and reconnect to the existing supply and return air main risers. The new unit shall be composed of a mixing box, filter section, DX cooling coil, hot gas reheat coil, integral condensing unit, indirect natural gas burner, belt driven supply fans, and belt driven return fans. The condensing unit section shall be sized for 70 tons of cooling. All existing ductwork serving AHU-4 shall be cleaned and sealed as needed. Internal lining should be added at least 15 feet downstream of the supply fan and 15 upstream of the return/relief air fan. New AHU-4 shall be controlled by the BMS.

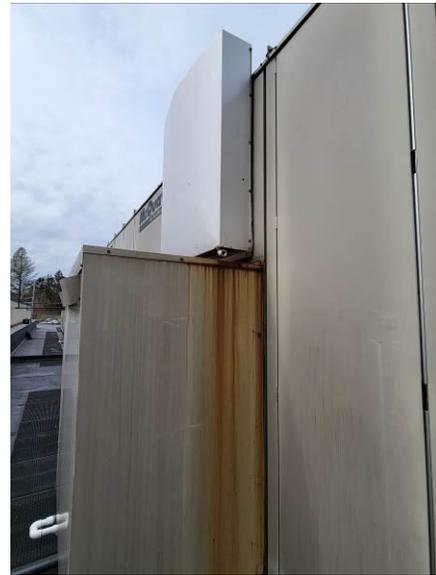
AHU-4 Corrosion on Condensate Discharge

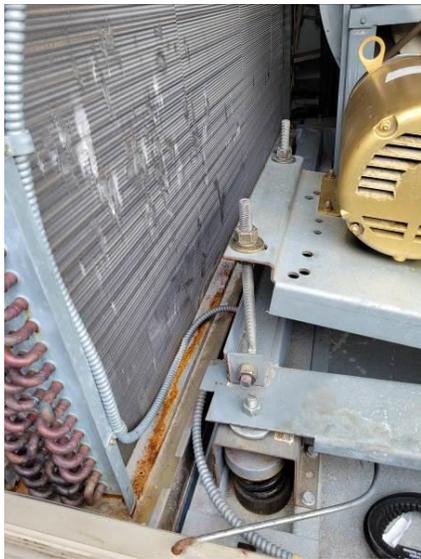
The unit was installed during the 2007 renovation and is in poor condition. Minor damage to the exterior duct insulation and refrigerant piping was observed. The cooling coil has damage to the fins and corrosion at the coil base. The return fan was out of balance with visible oscillation and excessive noise radiated from the supply fan possibly indicating a failing bearing. Excessive air leakage was observed at the unit module junctions. A plumbing vent was installed close to the outside air intake which does not comply with current code. The air balance report indicates this unit is providing less airflow than design. Lastly, the exterior ductwork was routed in such a way that it prevents access to the unit heating section.

AHU-5 Damaged and Corroded DX Coil

Remove and replace AHU-5 with a new variable air volume gas fired / DX packaged rooftop unit similar to a Trane model IPAK sized to match the existing unit airflow and capacity. New AHU-5 shall be relocated on the roof to avoid service conflict with the existing duct penetrations and to avoid existing plumbing vents. The unit shall be mounted on new steel dunnage at its new location.

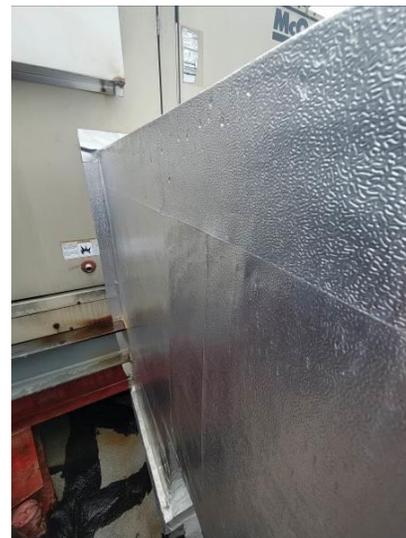
Exterior Ductwork Obstructing Access

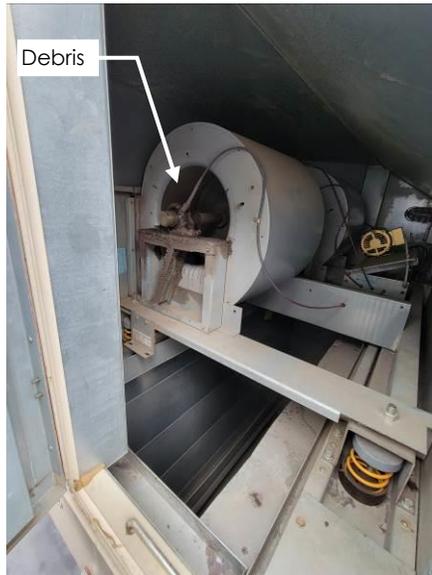
The unit was installed during the 2007 renovation and is in good condition. Heavy dirt and debris were observed on the return fan bearings. Mild corrosion was found on the unit casing as a result of the acidic burner condensate. The facilities staff noted this unit occasionally shuts off on flameout, although not as frequently as the neighboring AHU's.

Debris on AHU-6 Fan Bearing

Remove and replace AHU-6 in kind with a new variable air volume gas fired / DX packaged rooftop unit similar to a Trane model HAXX sized to match the existing unit airflow and 18 tons of cooling. Provide a new adaptor curb and reconnect to the existing supply and return air risers. If noise is a concern, consider installing duct mounted supply and return air silencers at this time. The new unit shall be composed of a mixing box, filter section, DX cooling coil, hot gas reheat coil, indirect natural gas burner, integral condensing unit, supply air fan, and exhaust air fan.

Until this unit is replaced it is recommended to remove and clean the gas regulator orifice, inspect the internal condition of the gas piping, and verify the regulator spring is adjusted properly to deliver the minimum gas pressure noted on the unit burner.

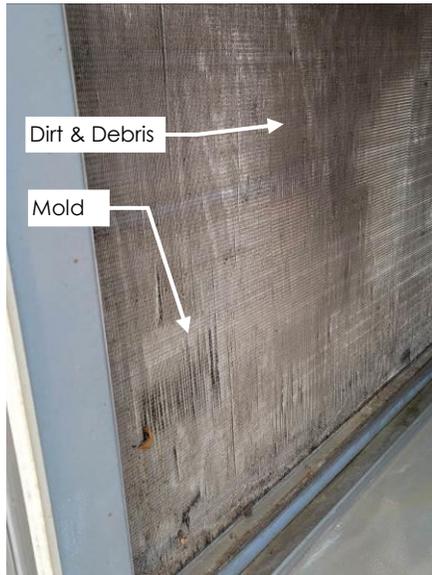
The unit was installed during the 2007 renovation and is in fair condition. Minor damage to the cooling coil fins was observed along with clogging debris, mold growth, and corrosion at the base of the coil. The unit outside air dampers were closed at the time of survey and the unit was operating under a heavy negative pressure. The condensate drain off the gas fired heat exchanger is causing acidic damage to the unit casing. Mild damage to the condenser coil fins and fan guard corrosion was discovered. The facilities staff noted this unit frequently shuts off on flameout when in heating mode. Lastly, no duct lining or silencers was found on the supply or return air ductwork leading to audible noise transmission in the lobby below. In addition, condensate was found on the supply air ductwork in the lobby which appears to be a result of the absence of duct lining along with air infiltrating the lobby from frequent use of the building entrances.

AHU-7 Cooling Coil

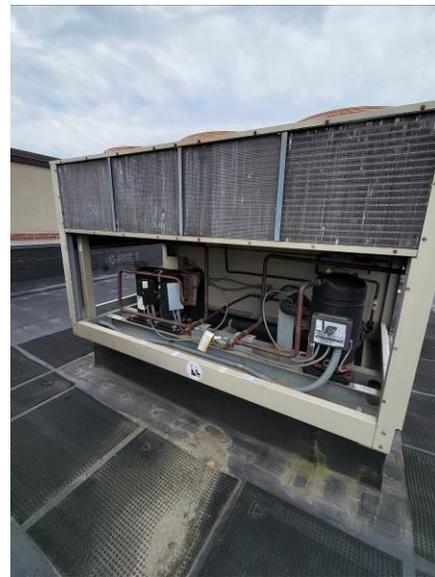
AHU-7 Condenser Section

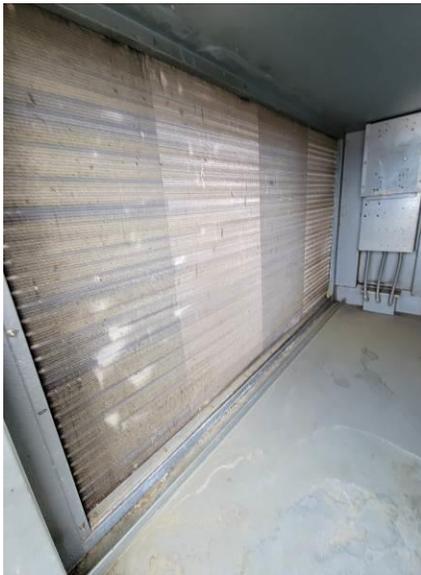
The unit was installed during the 2007 renovation and is in fair condition. Minor damage to the cooling coil fins was observed. The coil had considerable amount of dirt on the as did the inside of the unit in general. Additionally, the cooling coil was found to have significant corrosion along the base. The outside air and relief air dampers appear to be operating correctly at the time of survey. The facilities staff noted this unit frequently shuts off on flameout when in heating mode. Lastly, no duct lining or silencers was found on the supply or return air ductwork. This appears to be contributing to the audible noise observed in the lobby below.

AHU-8 Cooling Coil

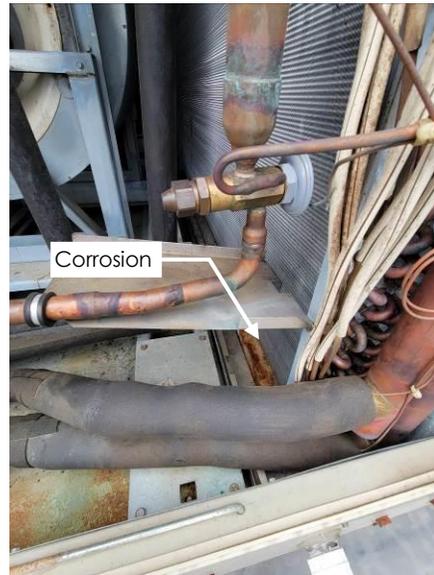
AHU-8 Cooling Coil Corrosion

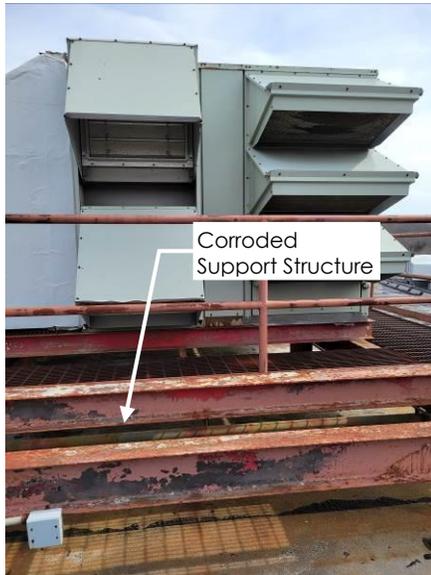
The unit was installed in 1995 and is in poor condition. The unit is scheduled for replacement during second and third quarter of 2022, therefore a detailed investigation was not performed. However, the unit support structure and existing exterior ductwork was examined. The dunnage and associated service platform is constructed of painted carbon steel structural beams. The paint has weathered over time and the structural dunnage is in poor condition. The exterior ductwork appears to have minor holes in the fiberglass insulation which led to sagging and degradation from rain.

AHU-9 Support Dunnage

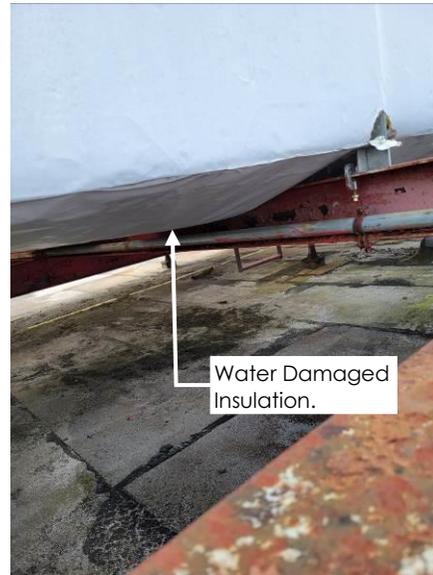
AHU-9 Duct Insulation

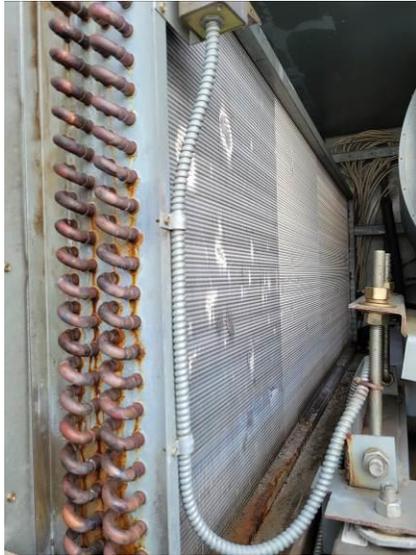
AHU-10 Damaged Cooling Coil

Remove and replace AHU-10 in kind with a new variable air volume gas fired / DX packaged rooftop unit similar to a Trane model IPAK sized to match the existing unit airflows and capacity. Provide a new adaptor curb and reconnect to the existing supply and return air mains on the roof. All existing rooftop ductwork shall be reinsulated with a closed cell product such as polyisocyanurate or flexible elastomeric insulation. Exterior insulation shall be protected with a self-adhesive aluminum jacketing. A new supply air main shall be routed to the (2) computer labs adjacent to the media center. Each computer lab shall be furnished with a new VAV box. The existing supply air main serving the media center shall be furnished with a slip in retrofit VAV box. New space mounted thermostats and CO2 sensors shall be installed to control temperature and ventilation. All existing ductwork serving AHU-10 shall be cleaned, pressure tested and sealed as needed. New AHU-10 and VAV boxes shall be controlled by the BMS.

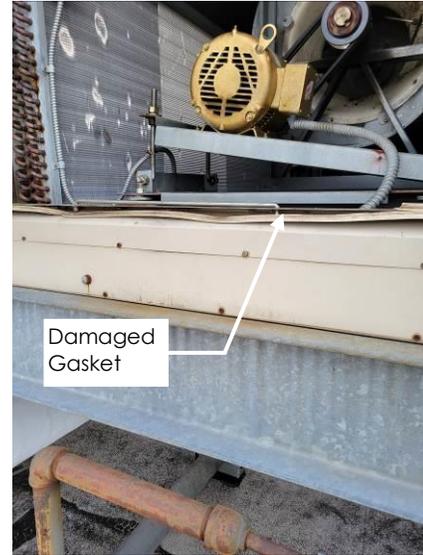
AHU-10 Damaged Door Gasket

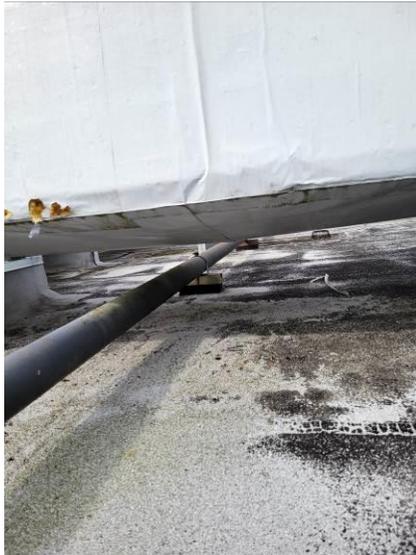
wrapped with fiberglass insulation which has holes and signs of water damage. Similarly, the refrigerant insulation is ripped, and corrosion was found at the compressor fittings.

AHU-10 Water Damaged Duct Insulation

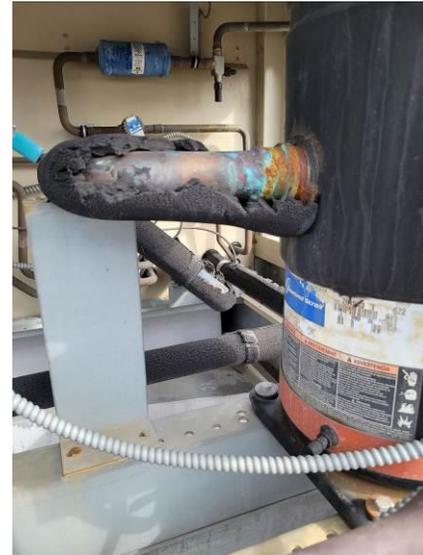
AHU-10 Damaged and Corroding Compressor

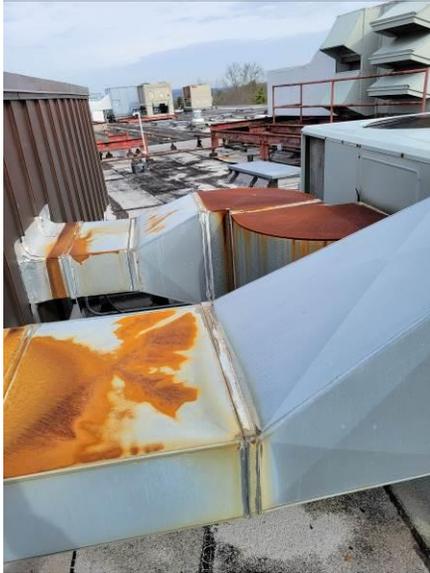
AHU-11 was installed around 2002 and is in inoperable condition. The facilities staff noted this unit has not operated in years. The exterior ductwork serving this unit is not protected and has an excessive amount of corrosion as a result. Rust was observed around the unit base along with damaged condenser fins.

AHU-11 Corroded Ductwork

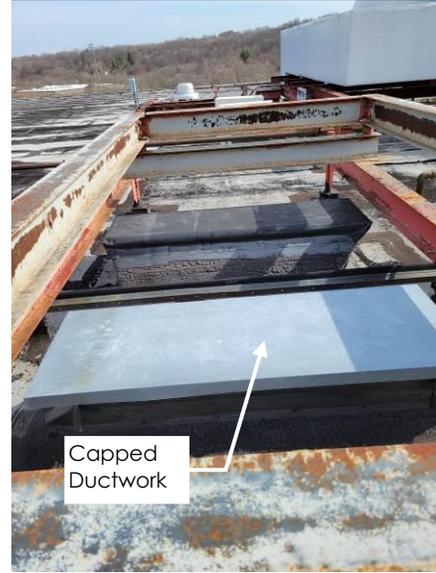
Abandoned AHU-12 Dunnage and Ductwork

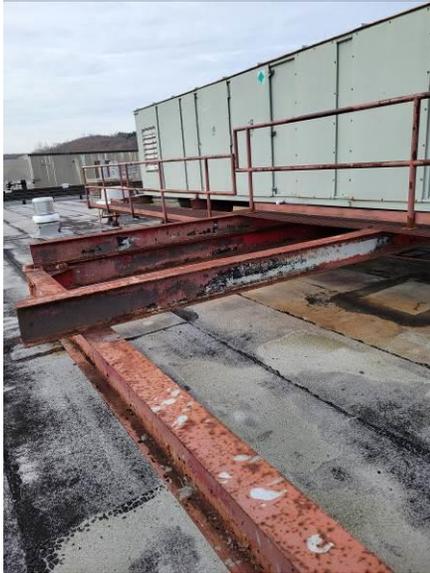
The unit was installed in 1995 and is in poor condition. The unit is scheduled for replacement during second and third quarter of 2022, therefore a detailed investigation was not performed. However, the unit support structure and existing exterior ductwork was examined. The base rail and associated service platform is constructed of painted carbon steel structural beams. The paint has weathered over time and the structural dunnage is rusting. Additional dunnage from previous units remains adjacent to AHU-13, abandoned in place. The exterior supply air ductwork serving AHU-13 is in poor condition and has excessive air leakage at all seams.

AHU-13 & Abandoned Dunnage

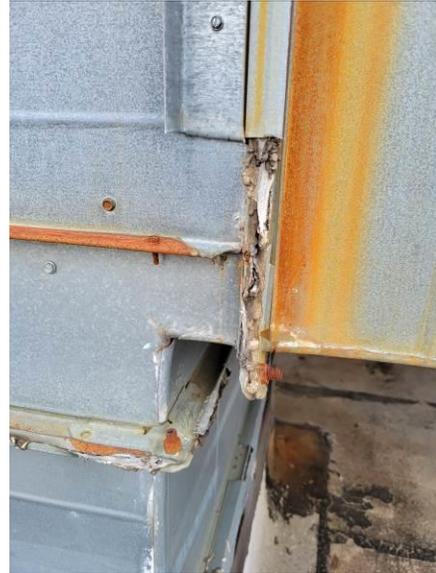
AHU-13 Example of Leaking Duct Seam

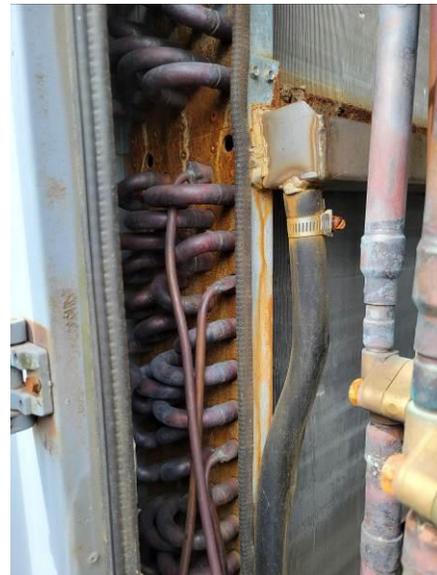
ERU-2 Cooling Coil Corrosion

It is recommended to remove and replace both ERU-1 and ERU-2 in kind with a new constant air volume hot water / DX packaged rooftop unit similar to a Semco model EPHC sized to match the existing unit airflows and capacity. Provide steel modifications based on unit size and reconnect to the existing supply and return air main risers for each unit. The new units shall be composed of a mixing box, filter section, DX cooling coil, hot gas reheat coil, hot water heating coil, supply air fans, and exhaust air fans. The cooling coil shall be connected to a new remote roof mounted condensing unit at the existing unit location. New supplemental steel dunnage shall be added to support the new condensing unit. All existing ductwork and reheat coils serving ERU-1 and ERU-2 shall be inspected, cleaned, pressure tested and sealed as needed. The cost to replace the failed energy wheel in ERU-2 is approximately \$80,000 compared to an estimated \$288,000 for full unit replacement. Repair of the wheel is not recommended.

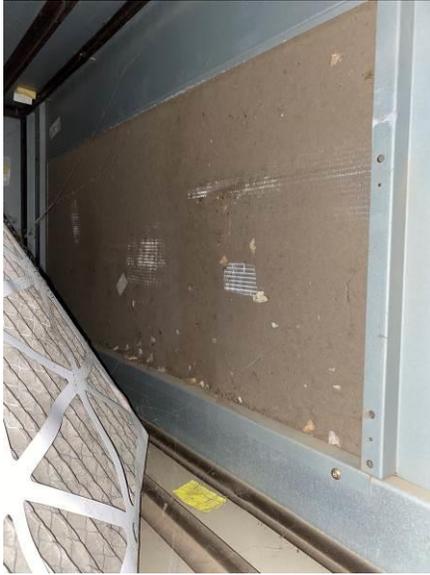
Access to repair or replace major components for MAU-1 is blocked by adjacent wall framing and the kitchen equipment below. Routine maintenance items such as filter and belt replacement is very difficult with the current unit location.

Clogged MAU-1 Heating Coil

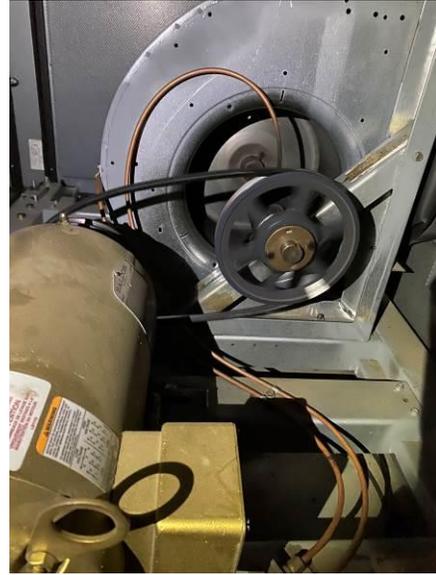
MAU-1 Supply Fan with Loose Belt

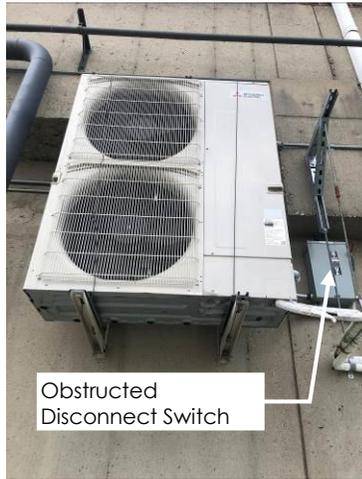
Obstructed Disconnect Switch

Mount all rooftop condensing units on 24" high equipment rails to avoid snow infiltration. Relocate the pipe hanger on the wall mounted unit to avoid the unit's disconnect switch.

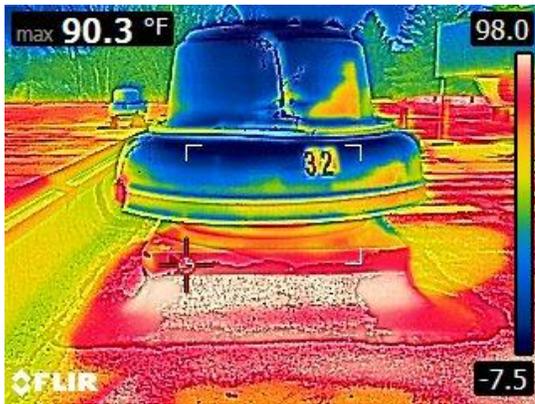
place for the exhaust fans inside the building. At a minimum the fans serving the toilets should be changed as this is an area of biggest complaint for odors. Fans that provide ventilation to unconditioned classrooms also need to be addressed.

EF-32 Thermal Image with Leakage

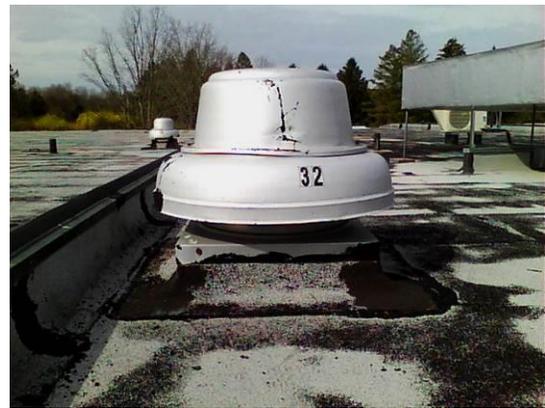
EF-32 Reference Image with Notable Damage
