**SCHOOL DISTRICT OF NEW GLARUS
BOARD OF EDUCATION
FACILITIES, TRANSPORTATION AND TECHNOLOGY COMMITTEE MEETING
MONDAY, FEBRUARY 25, 2019
HIGH SCHOOL CONFERENCE ROOM
6:45 PM**

ELEMENTARY & MIDDLE HIGH SCHOOL STUDY
NEW GLARUS SCHOOL DISTRICT

Analysis & Needs Assessment

February 11, 2019

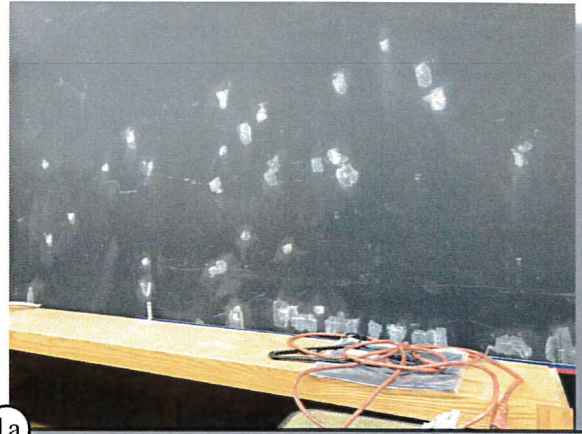
1a

- a. Interior walls are stained, cracked, dated or damaged.

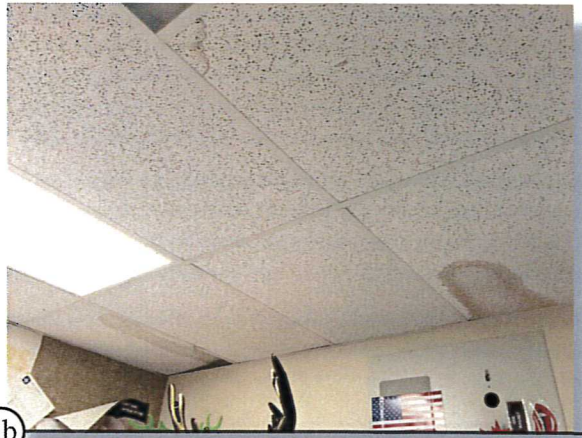
1b

- b. Indicated interior ceilings are damaged by water spots, broken /warped ceiling tile, missing tile.

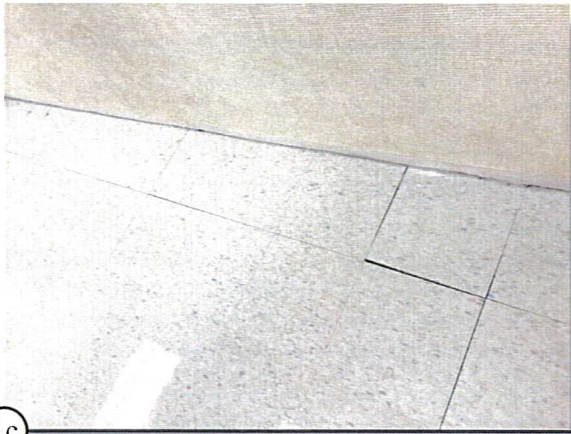
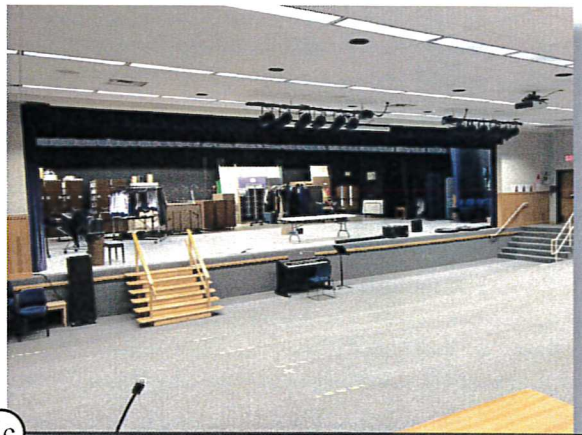
1c

- c. Interior Floors are dated, worn out carpet, chipped tile.

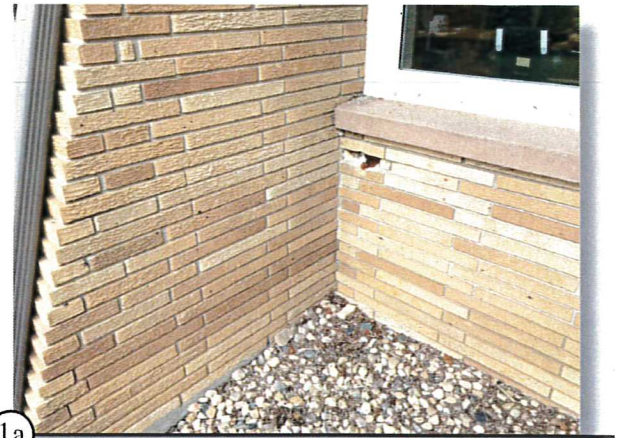
1a

- a. Exterior masonry walls are cracked, chipped, and damaged.
- b. Some exterior walls are stained with tar and rust.

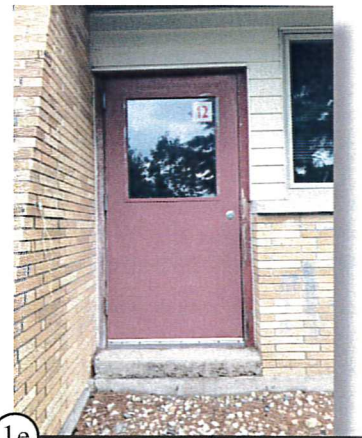
1e

- e. Some exterior doors are dated, worn, and rusted. Many are original to their respective existing building.

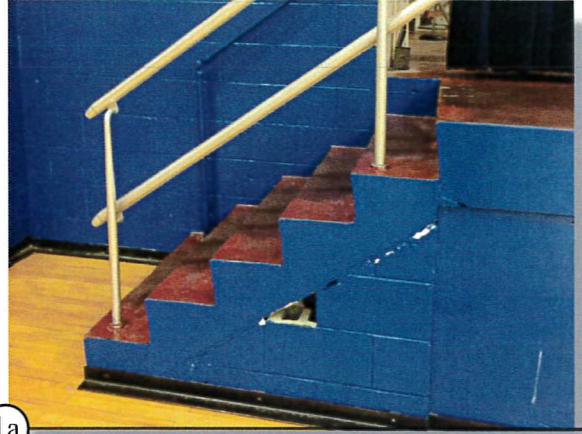
1a

- a. Interior walls are stained, cracked, dated or damaged.

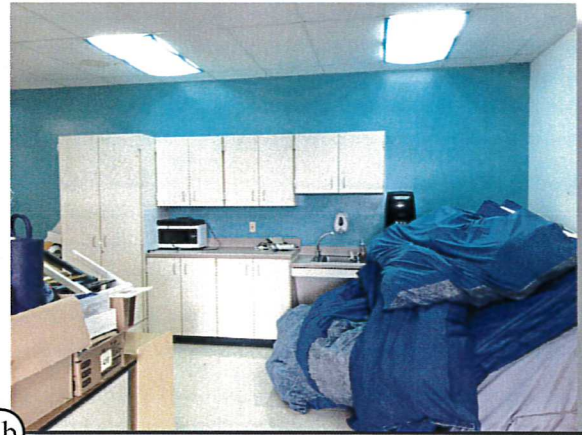
1b

- b. Indicated interior ceilings are damaged by water spots, broken /warped ceiling tile, missing tile.

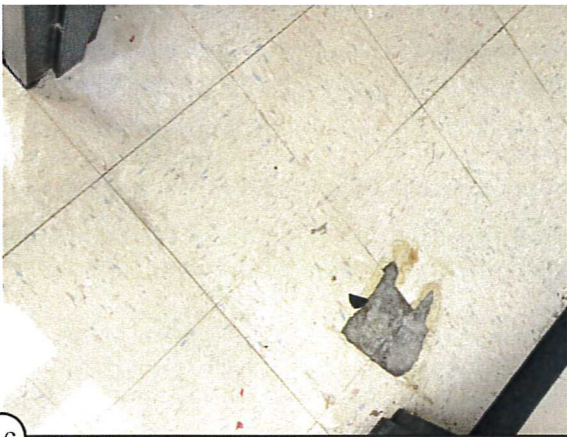
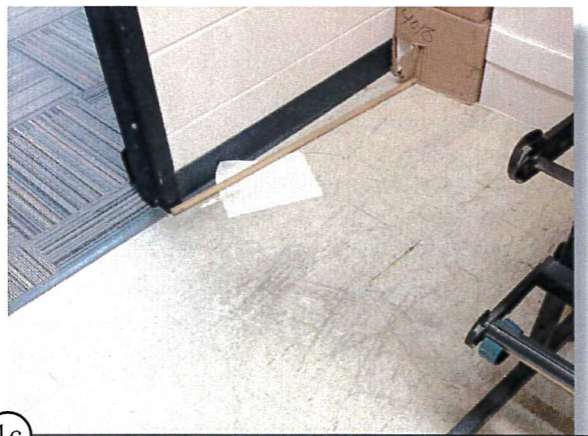
1c

- c. Interior Floors are dated, worn out carpet, chipped tile.

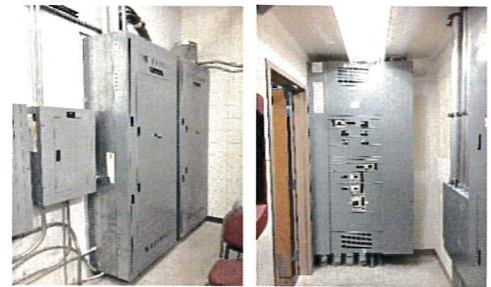
- F. The main service switchboard (MD) does have an integral surge protection device.
- G. The main distribution switchboards (MDP-1) and (MDP-2) do not have a surge protection device.

- A. The main switchboard (MD) is in good condition and can remain. If a large building addition or additional air conditioning is added, a new service upgrade may be required.
- B. The High School distribution switchboard (MDP-1) and Middle School distribution switchboard (MDP-2) are in good condition and can remain.

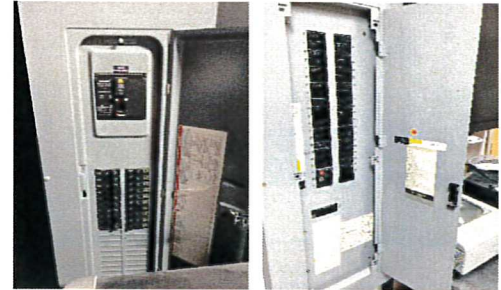
- A. We noted some newer but mostly original GE panelboards throughout the High School building. We also noted some newer Square D panelboards at the High School. The Middle School addition is primarily Eaton panelboards.
- B. The majority of the original GE panelboards are full and do not have space for additional circuit breakers.

- A. The GE and Square D panelboards at the original High School building are in good working order and can remain. The Eaton panelboards at the middle school addition are in good working order and can remain.
- B. Additional panelboards may need to be added where new circuits are required.

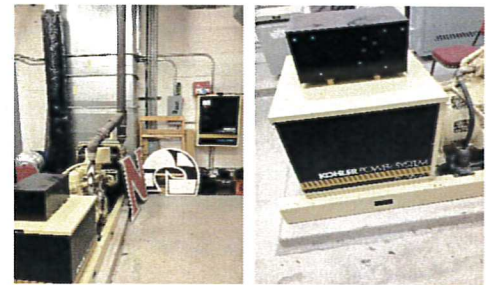
- A. There is an interior Kohler natural gas fueled generator located in upper mezzanine electrical room. There is only (1) Kohler automatic transfer switch. The emergency panels have egress lighting, exit lights, HVAC, server room power and fire alarm circuits only which is not code compliant. The staff indicated that the generator was installed in 2012.
- B. We noted battery powered egress lighting units in some locations. It is unclear how much of the of the facility lighting and exit lights are connected to the emergency panels.

- A. Due to the type of loads served by the generator and that there is only (1) transfer switch we would recommend replacement of the existing generator. The new generator unit would be located at the exterior of the building.
- B. We recommend (2) automatic transfer switches; (1) for life safety loads and (1) for non-life safety loads. Non-life safety loads could include circulating pumps and boilers for minimal heat, data rooms, AC for data rooms, sump pumps, kitchen coolers and freezers.

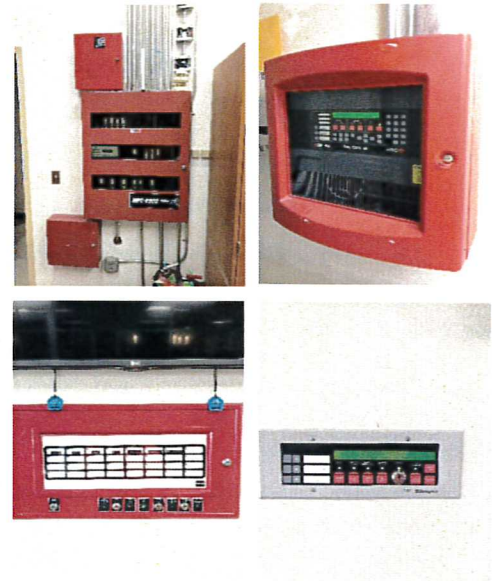
- A. Fire alarm system is a combination of an older Faraday zoned system at portions of the high school tied to a newer Simplex addressable system at the middle school addition.
- B. Pull stations are located at most exterior doors.
- C. Most corridors have adequate horn/strobe coverage.
- D. Most classrooms have notification devices.
- E. Magnetic hold open locations at fire walls have local smoke detection.
- F. There are some duct smoke detectors at air handling units.
- G. The school expressed concerns about the service provided by Simplex.

- A. The entire facility should be evaluated to ensure that the fire alarm system in all areas are code compliant with current standards.
- B. We recommend upgrading the entire facility to a new fully addressable system. A complete upgrade of the fire alarm system would require a voice annunciated system to meet current codes.

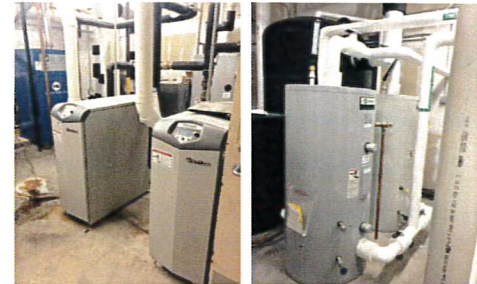
- A. The High School has two (2) Lochinvar AWN601PM hot water boilers providing domestic hot water to (2) A.O. Smith TJV 120A storage tanks. The hot water system is located in Mezzanine Mechanical Room by the Gym and provides hot water to the entire High School. The water heaters and storage tanks are in fair condition. There is a Taco hot water circulation pump which is in fair condition. The circulating pump is in good condition.

- A. The existing hot water systems are in good condition and can remain.
- B. The existing kitchen booster heater is in good condition and can remain.
- C. The existing water softening systems are in good condition and can remain.

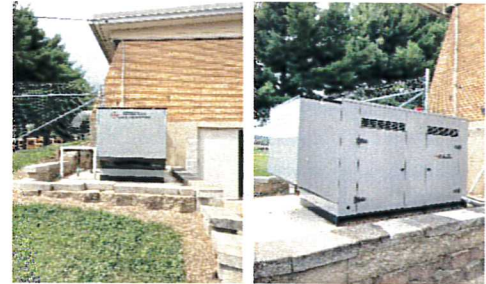
- A. There is an exterior Gillette natural gas fueled generator located outside the lower level storage entrance. There is only (1) automatic transfer switch. The staff indicated that the generator was installed in 2016 and is only used to serve the data/network equipment.
- B. We noted battery powered egress lighting units and exit lights throughout the facility that confirms the generator is not being used for life-safety loads.

- A. If a new generator is desired, we would recommend replacement of the existing generator. The new generator unit would also be located at the exterior of the building.
- B. If a new generator is desired, we recommend (2) automatic transfer switches; (1) for life safety loads and (1) for non-life safety loads. Non-life safety loads could include circulating pumps and boilers for minimal heat, data rooms, AC for data rooms, sump pumps, kitchen coolers and freezers.
