Guadalupe Appraisal District

The Guadalupe Appraisal District Board of Directors **(BOD)** has adopted Resolution 2025-03 proposing the acquisition and renovation of the historic Mary B. Erskine Building located at **216 East College Street, Seguin, Texas**, as the future headquarters of the Appraisal District.

As detailed in the attached **Mary Erskine Building Assessment Report** (dated May 6, 2025), the facility requires extensive renovation and modernization to be repurposed for government administration and public services. The **total Probable Project Cost is estimated at \$8,401,765**, which includes design, construction, project management, contingency, and all associated costs necessary to bring the facility into full operational use.

MAY 6, 2025

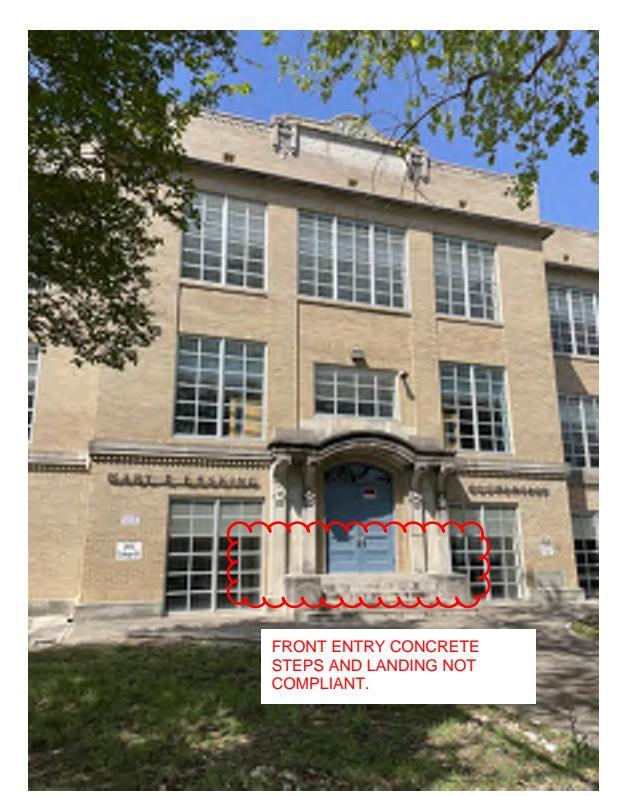
The front entry curb ramp and door landings exceed the maximum slopes for ADA Many areas of the concrete sidewalks to the building are cracked, spalled and uneven Rework concrete front entry steps for compliant entry

Figure 1: Entry sidewalk & curb ramp

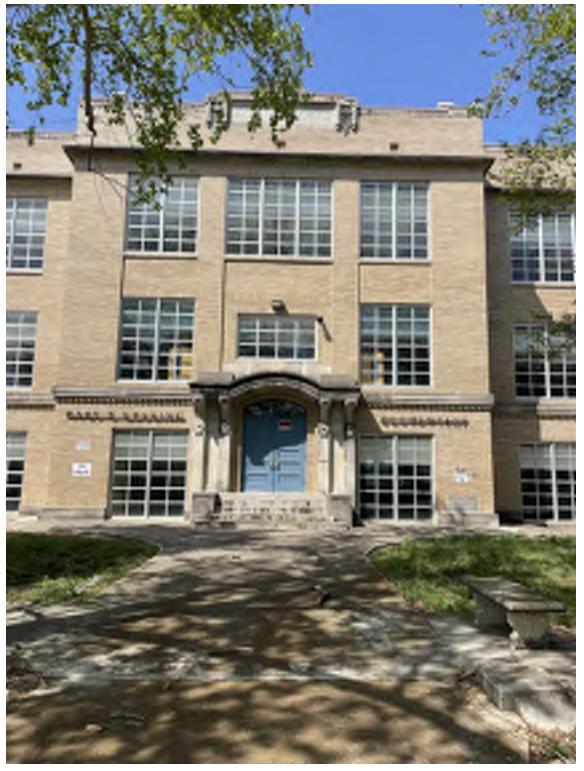
Some cracks were noted at the front entry stairs in the joint between the structural concrete stair framing and the infill wall below. These appear to be cracks caused by differential movement of different materials.

Figure 2: Front steps-landing

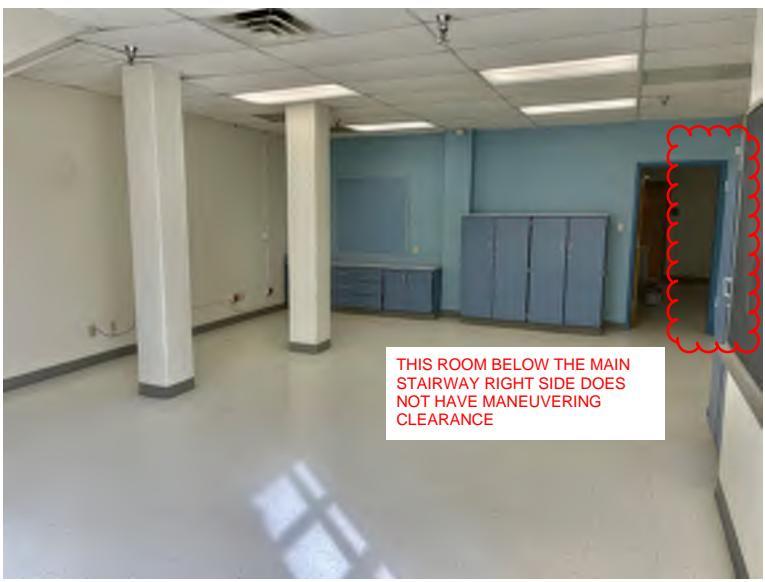
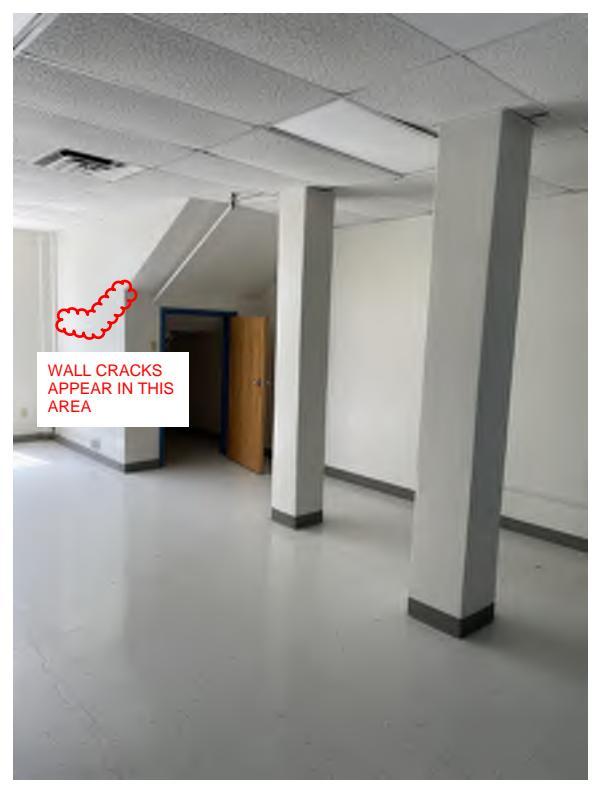
Many interior doors lack the required clearance of the push and pull side of the door All restrooms have various non-compliant issues, but the recommended scope is to completely renovate all restrooms and add restrooms at the Second Level.

Figure 11: First Floor Basement interior doors

Figure 12: First Floor Basement interior doors

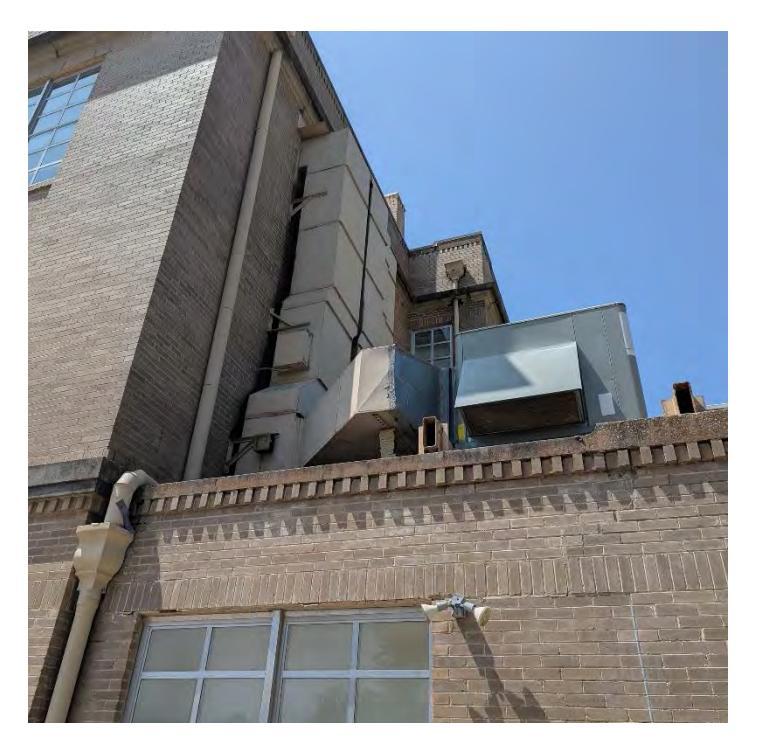
A total of four packaged Rooftop Units (RTUs) were installed on the roof of portions of the first floor, with two on the northeast corner and two on the northwest corner. Each RTU has gas piping routed to it for reheat. Supply and return duct come out horizontally from the unit, and run up along the side of the building into penetrations on the second and third floor. The duct does not appear to be insulated or protected from the elements. While not being able to be observed directly, it was noticed from observations that pieces were missing from the RTUs. The exterior cabinets looked weathered as well.

Figure 1. Packaged RTUs as seen from ground level

Outdoor packaged rooftop units would be replaced with new units with variable capacity compressors. The units would have higher efficiency and variable flow fans. New variable air volume terminal units with electric reheat would be installed to accommodate new zoning and occupancies.

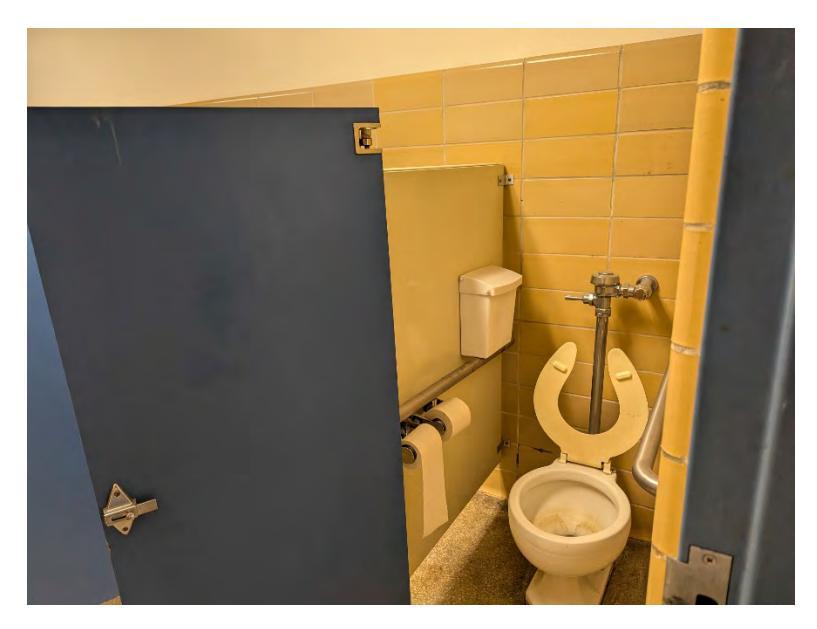
The water closets and urinals were in poor to fair condition. However, many were not sized for adults. The fixtures also were not ADA compliant.

Figure 3.Typical water closet

Based on observations of the site, it is recommended that the entire mechanical system be replaced with new equipment, ductwork, insulation, controls, and air devices. It is also recommended to replace all plumbing fixtures to full-sized ADA compliant fixtures and to add men's and women's gang restrooms to the second floor.

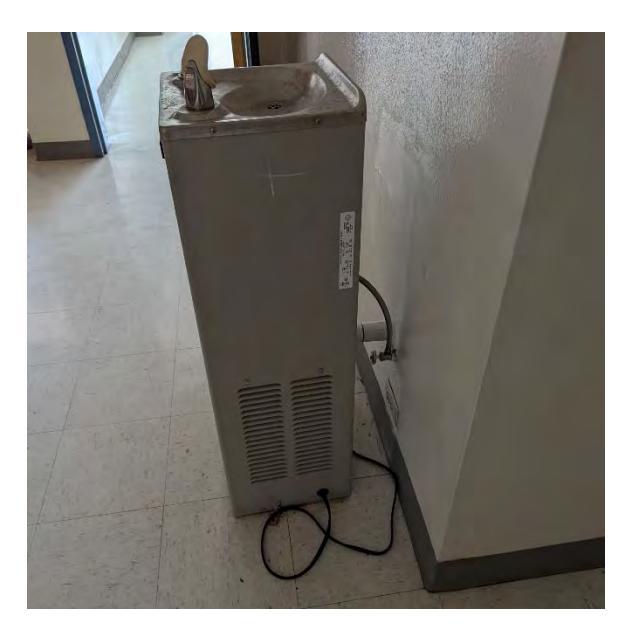
Drinking fountains were observed on each floor. These were in poor condition and were not ADA compliant. No split level fountains or bottle fillers were found.

Figure 5. Typical drinking fountain

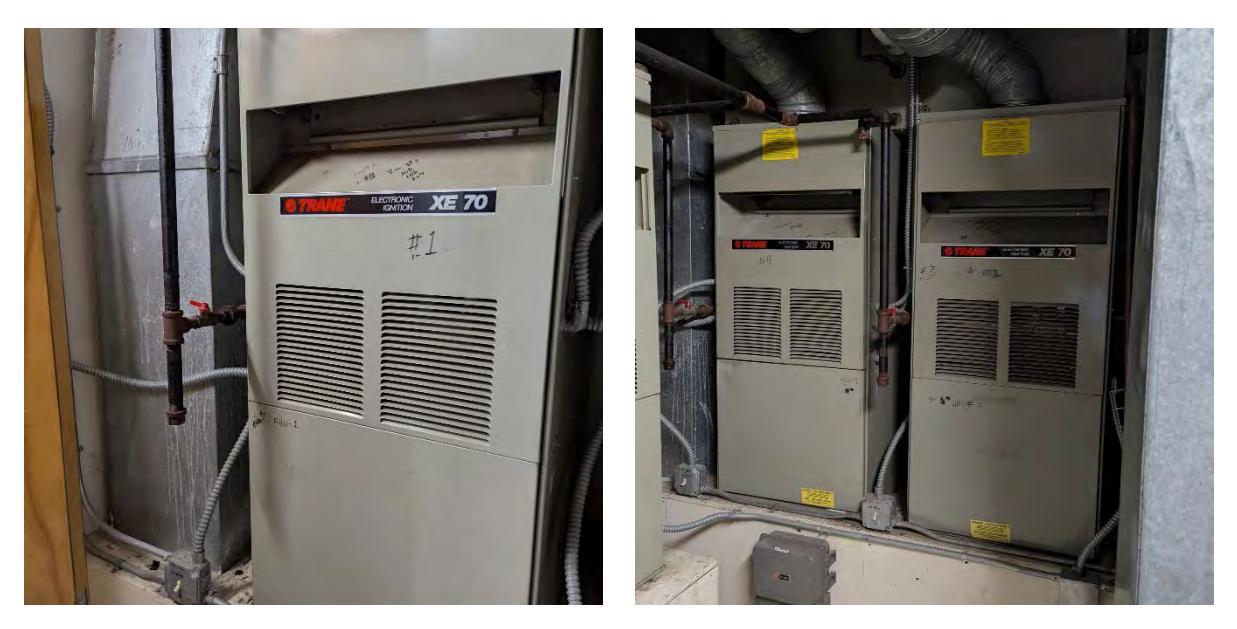
The five DX split systems serving the first floor are comprised of residential-grade indoor air handling units in vertical configuration with natural gas heat paired with an outdoor air conditioner. The nameplates of the air handlers were not accessible to read, however based on the outdoor air conditioner the units appear to be manufactured in 1991. The units are charged with refrigerant R-22, which is no longer permitted to sold in new equipment and is increasingly hard to service.

Figure 7. First floor vertical air handlers

This option would involve removing the existing mechanical equipment and replacing with new, similarly functioning equipment. The existing split systems would be replaced with new variable capacity heat pumps. The indoor vertical air handlers would be replaced with higher efficiency fan models.

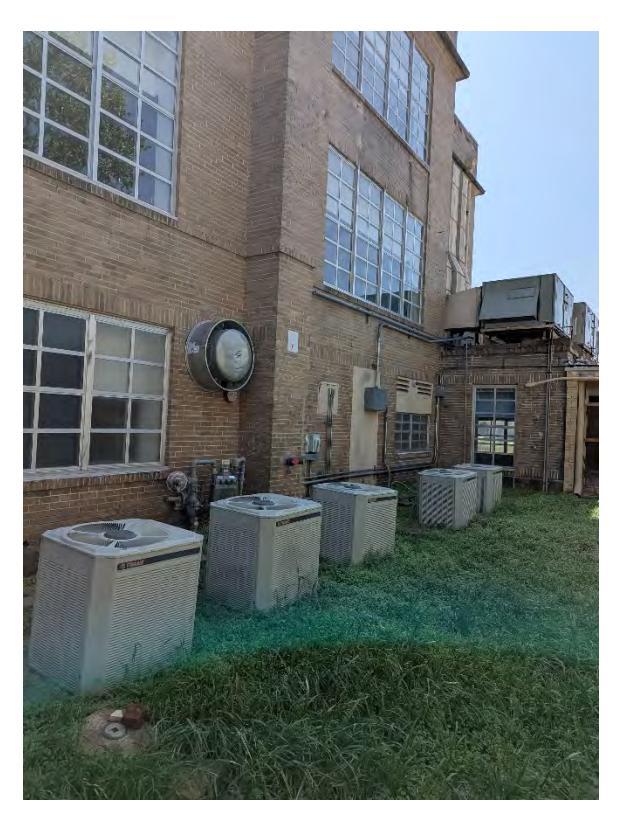
The outdoor air conditioners are mounted to concrete pads just outside of the building in between the main building and gym. The units were observed to be in poor condition and had components missing. The nameplates showed all were the same 5-ton model and manufactured in 1991.

Figure 10. First floor outdoor units in mechanical yard

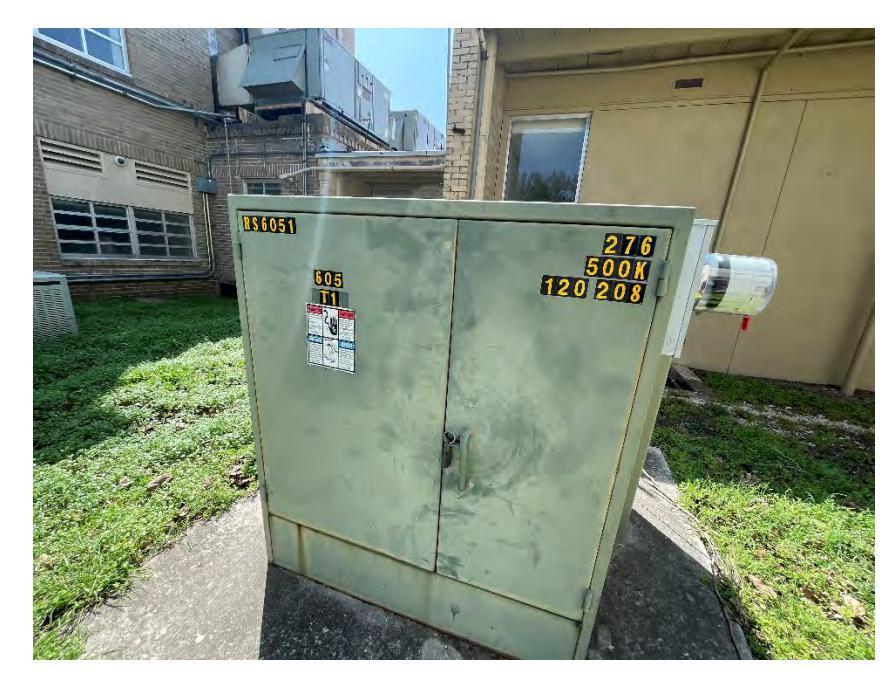
Electrically, the building is served by a 208Y/120V 500kVA utility transformer, which is likely to be sufficient for the renovation. The electrical distribution equipment appears to be dated from 1990 to 2000. The main switchboard was unable to be opened during the site visit. Based on the age of the equipment, it is recommended to replace the electrical distribution equipment and feeders. The new layout of the building and HVAC renovations will also likely require a reconfiguration of the distribution system. Additionally, this will allow for a more efficient electrical design that requires fewer pieces of equipment that can be consolidated to one area, instead of placed throughout the facility.

Figure 16. Utility transformer

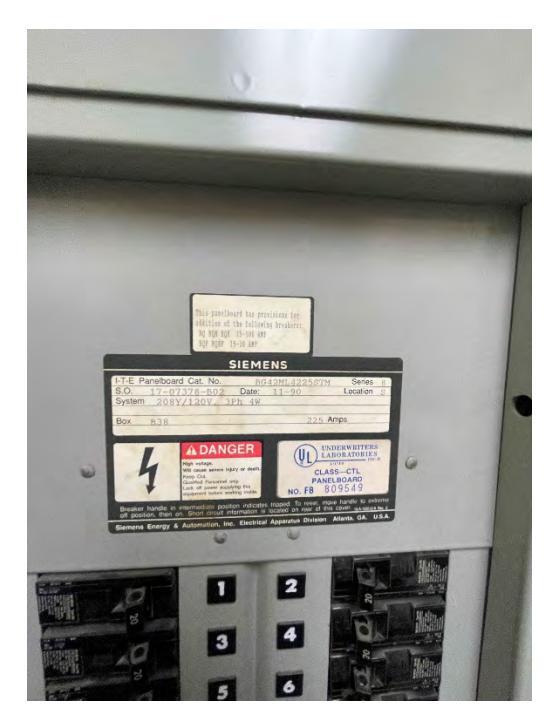
Figure 17. Panelboard nameplate showing a date of 1990

Based on observations of the site, it is recommended that the electrical distribution equipment and feeders be replaced. It is also recommended the at the lighting fixtures and controls be replaced. Additionally, the fire alarm system appears to be dated. Some work will be required to cover the new building layout. It is recommended to replace the fire alarm system to ensure full functionality. Electrical devices appear dated. They can remain, but device/wall plate replacement and raceway relocation is recommended to improve the aesthetics of the new spaces.

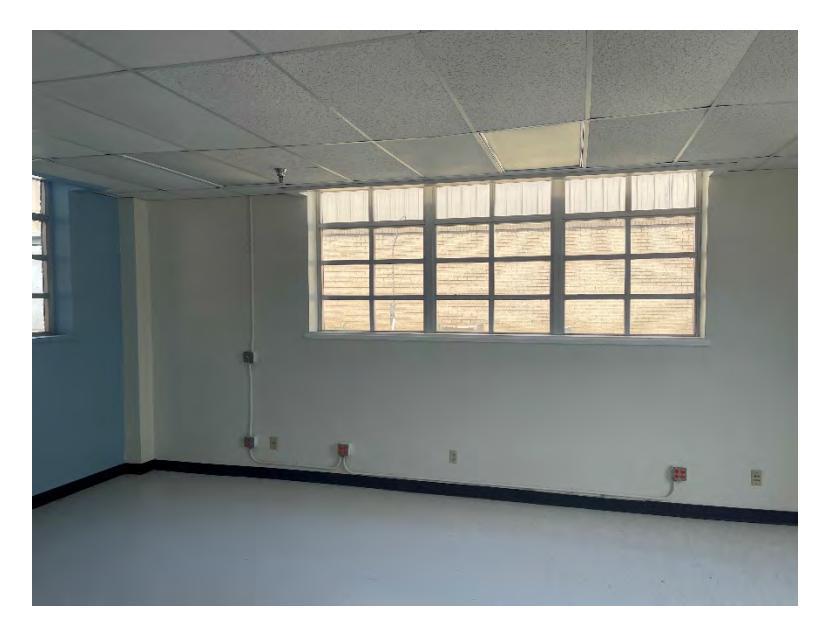
The devices appear dated. Some devices appear to have been added at a later date, and have surface mounted raceway providing power to the receptacles. There is an isolated grounding system in place for some of the receptacles. This can be left intact, but is not required. Optionally, the devices and face plates can be replaced and the raceways moved to inside the walls to freshen up the space.

Figure 83. Typical wall showing orange isolated ground receptacles and surface mounted raceway
