# UTQIAGVIK IPALOOK ELEMENTARY SCHOOL

# MECHANICAL AND ELECTRICAL BUILDING ASSESSMENT AND INVENTORY SURVEY REPORT

August 19, 2024

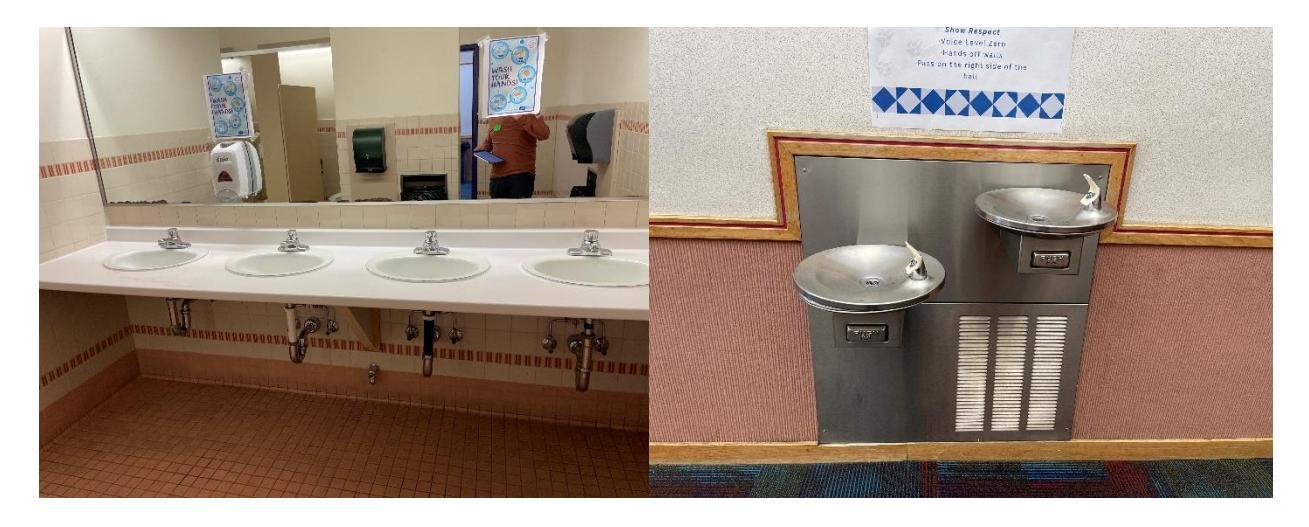
The condition of the sanitary sewer is good. The condition of the domestic water piping is fair. The plumbing fixtures vary in condition from fair to poor and need to be replaced. The piping under the lavatories is not insulated and does not have anti-scald valves. In the multiple stall restrooms, most of the toilets and urinals in the high use areas have automatic flush valves. The lavatories in the multiple stall restrooms have manual metering faucets. It is recommended that any remaining higher use toilets and urinals be converted to automatic flush valves. The lavatories are in especially poor condition and should be replaced.

The plumbing fixtures are in fair to poor condition and need to be replaced.

Drinking fountains are old style and should be replaced with bottler fill type.

Photo M1 – Restroom Lavatories

Photo M2 – Old Style Drinking Fountain

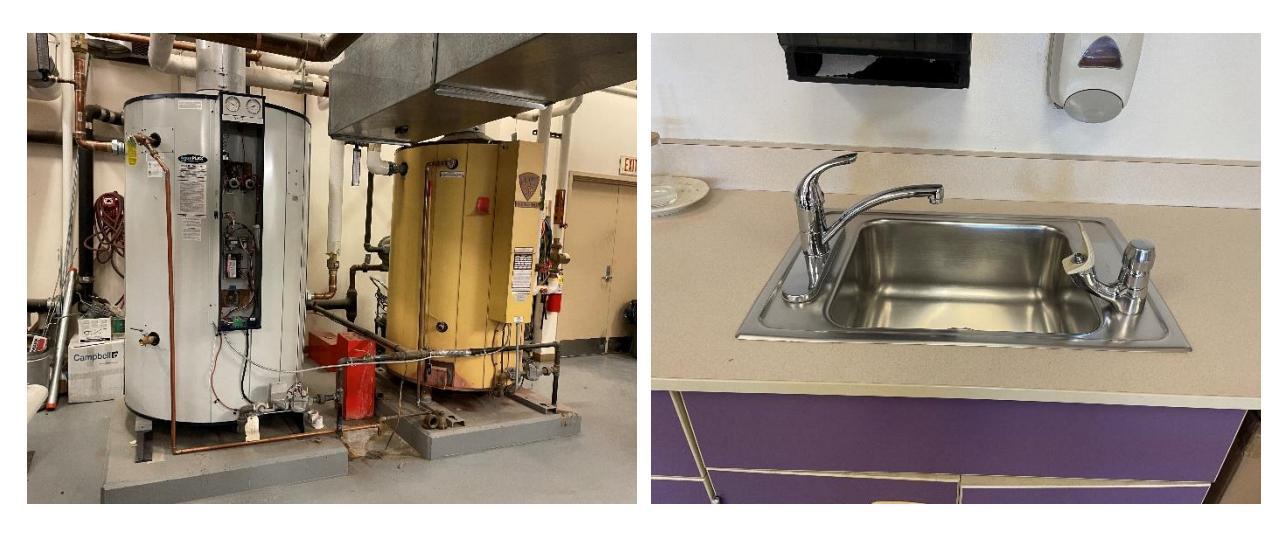
Domestic hot water is provided by two gas fired 250-gallon hot water heaters. One of the heaters is recently installed. The other is original and due for replacement.

The new hot water heater installed around 2017 is out of service and needs to be repaired. Currently, the school is currently running on the older gas fired water heater. A replacement water heater is on hand and is scheduled to replace the older water heater. The newer hot water heater will still need to be repaired.

Photo M3 – Water Heaters

Photo M4 – Classroom Sink

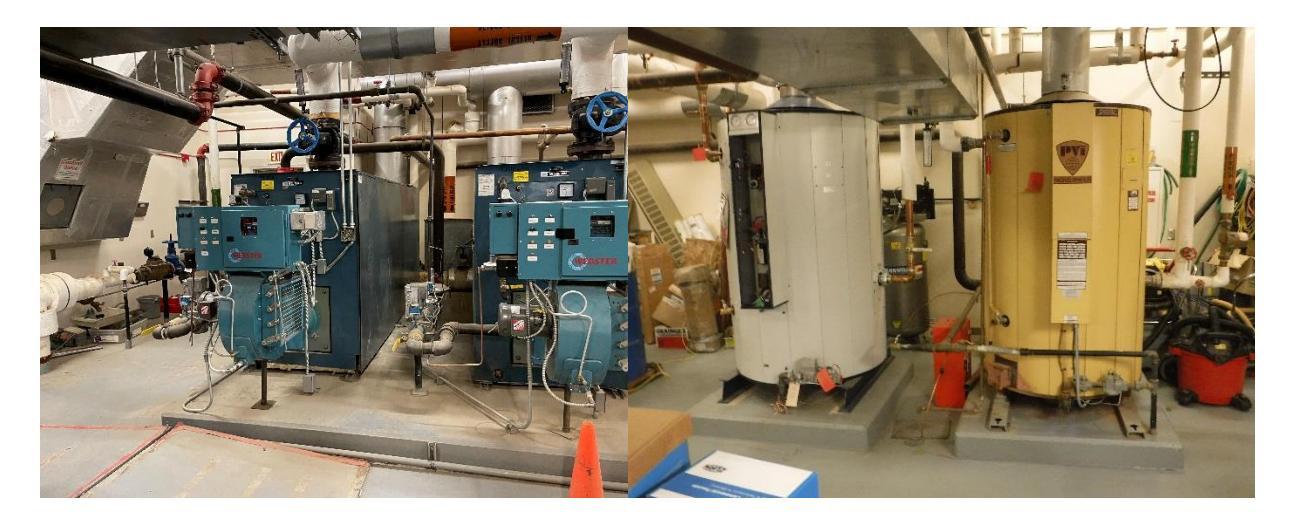
The heating boilers were rebuilt in 2020 and are in good condition. The rebuild including new section gaskets and new burners.

<u>Photo M5– Boilers</u>

Photo M6 – New and old hot water generator

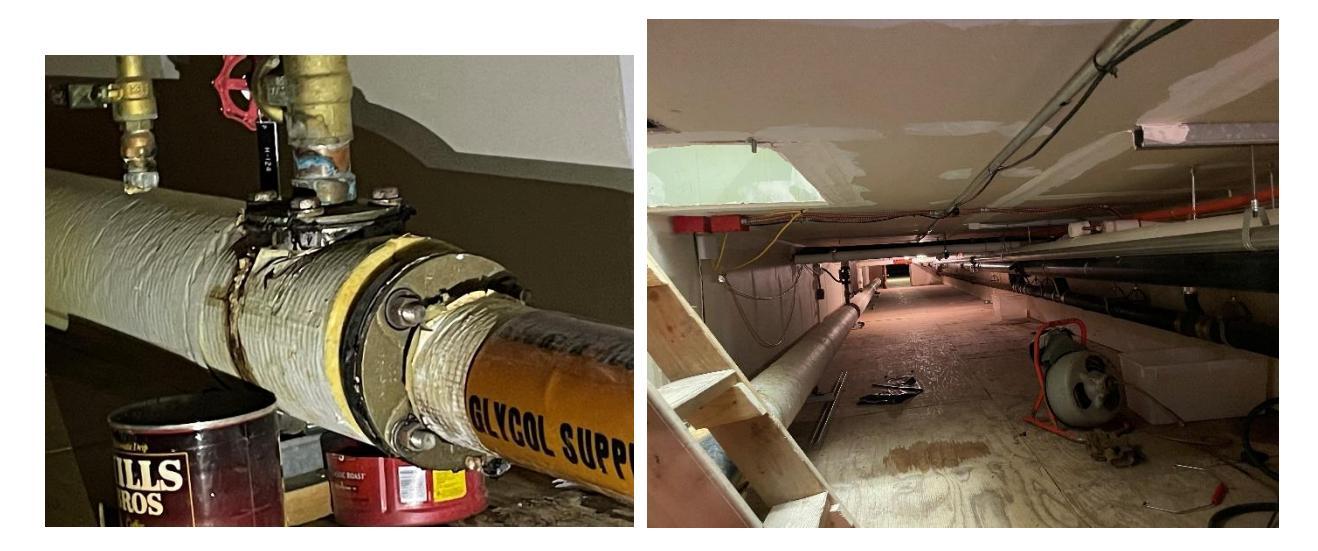
The utilidor space needs additional heat to keep the underfloor piping from freezing during very cold days. Additionally, the utilidor heat mains have signs of leaks where flanges are used to transition to copper piping or branch piping. The utilidor piping is difficult to repair due to lack of isolation valves on the heating mains; recommend additional isolation valves be added to help facilitate the replacement of the leaking flange gaskets.

Photo M7- Utilidor Leaking Gaskets

Photo M8 - Utilidor

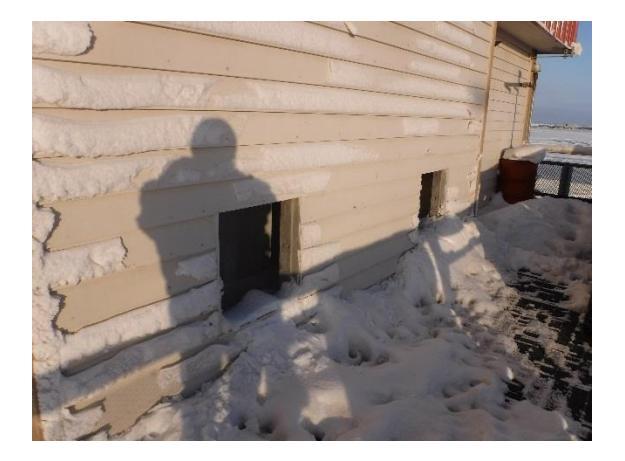
<u>Photo M9– Boiler room combustion air handler</u> <u>intakes – not filtered or screened</u>

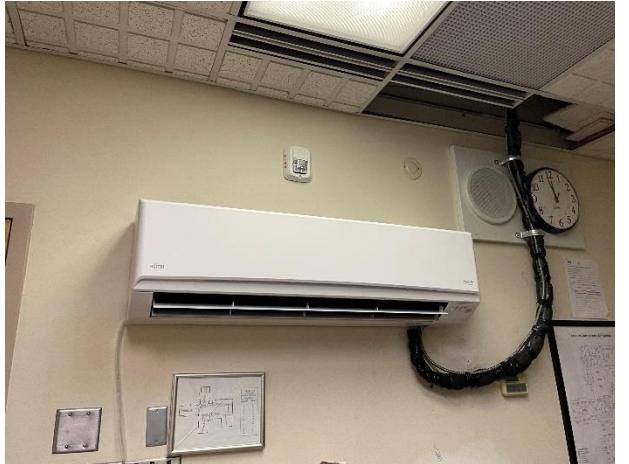
The server room had a spilt system cooling system recently installed and is in good condition. The condensate for the unit is currently draining into a bucket; a condensate pump needs to be installed and piped to any appropriate drain. Additionally, the old AC unit is still in the ceiling and needs to be remove.

Photo 11 – Server Room AC Unit

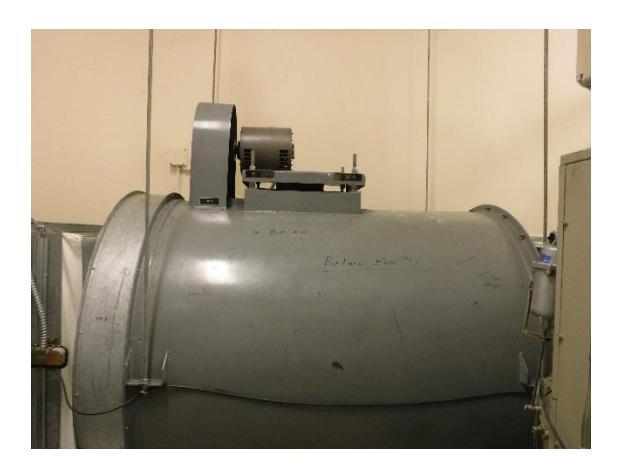
<u>Photo M10 – Air handler return fan with bad</u> <u>bearing that cannot be accessed for repair</u>

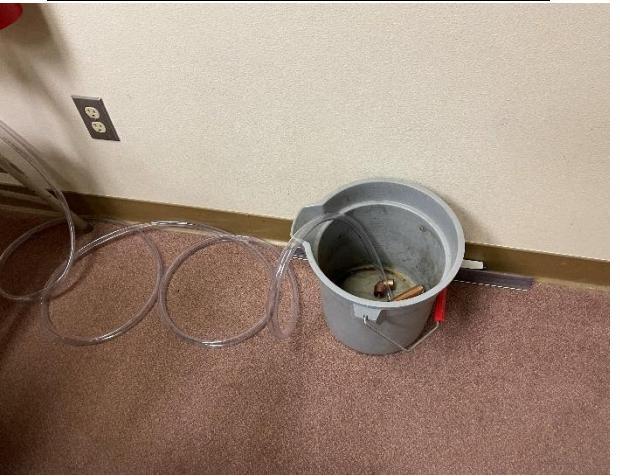
Photo 12 – Server Room Condensate

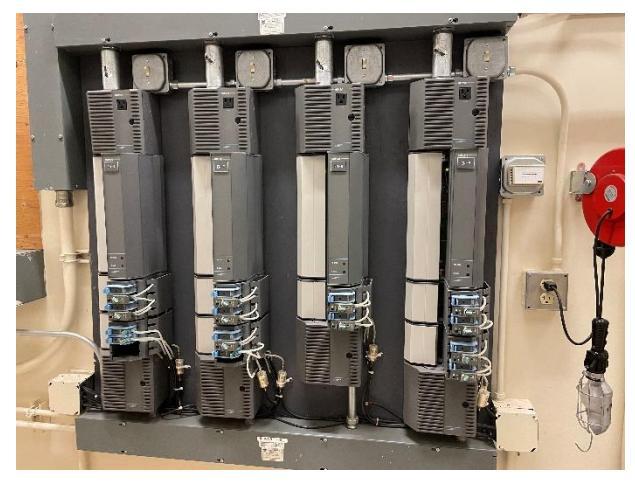
The HVAC control system is mostly non-functional causing many of the heating control valves to fail open. This leads to the overheating of many spaces which must be controlled manually by shut off heating isolation valves and pumps or by opening windows. Consequently, more energy is being used by the heating system than is necessary.

Photo M13- Out Dated DDC System

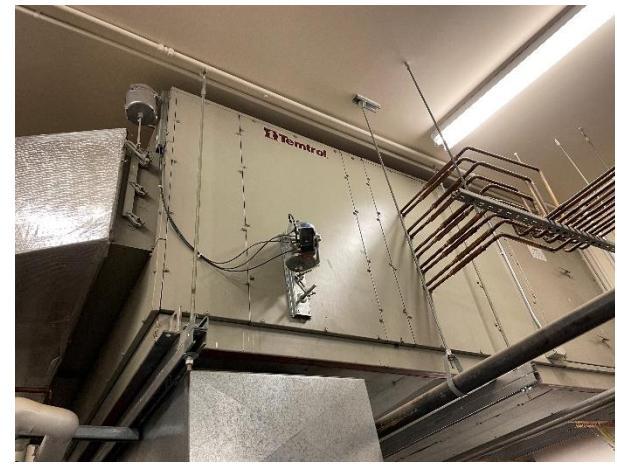
Due to the age and condition of the pneumatic control system the air compressor runs almost continuously and will fail at some point.

Photo 13– Out Dated Pneumatic Controls

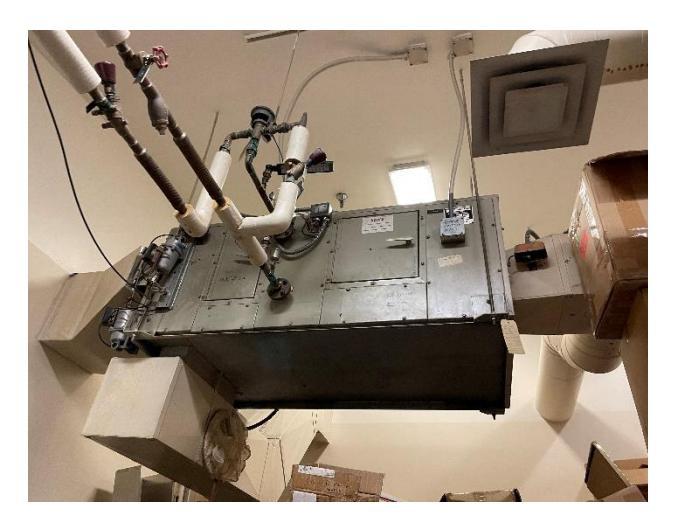
<u>Photo M12– Outdated Pneumatic Damper</u> <u>Actuators</u>

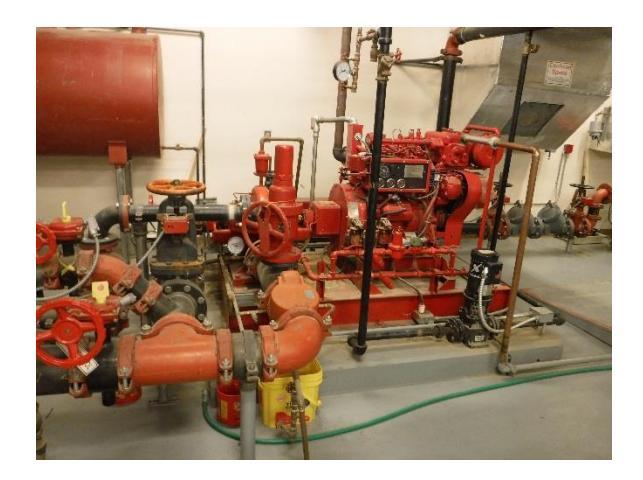
The fire protection system is a wet sprinkler system and is supplied from the city water utility. The sprinkler system is pressurized from a diesel operated fire pump and a dedicated fuel tank. The system is in fair condition.

Photo M5 – Diesel powered fire pump.

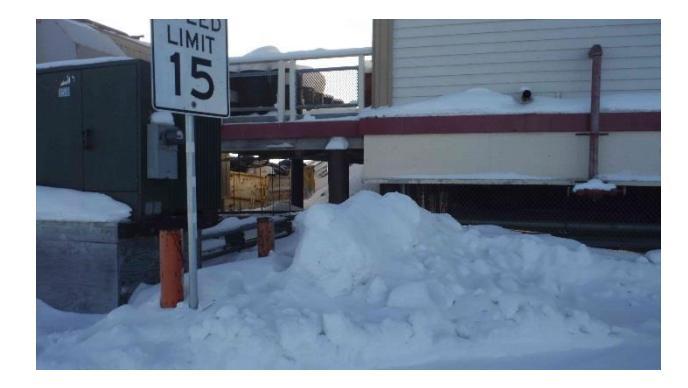
Photo E1–Service Transformer

The existing service is fed from a platform-mounted transformer (Photo E1) under the building into the service entrance gear. The service entrance equipment and distribution equipment are older style equipment, but spare parts are still available from the manufacturers.

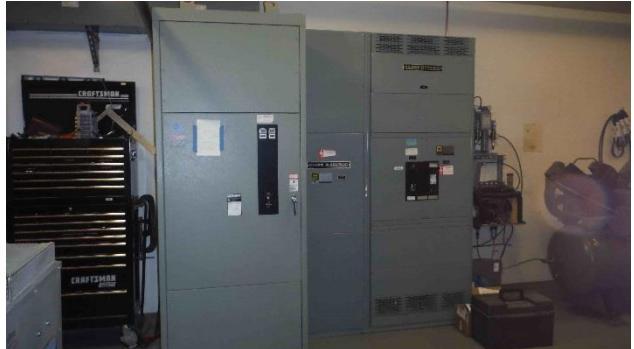
Photo E2- Service Entrance Equipment

The existing service entrance equipment consists of a 1600A piece of switchgear with an Automatic Transfer Switch (ATS) which feeds from the standby system (Photo E2). The switchgear is no longer manufactured, and replacement parts are difficult to obtain. As the existing equipment appears to be functioning no replacement is required but as mechanical equipment is replaced or upgraded, we recommend providing individual motor starters for each equipment.

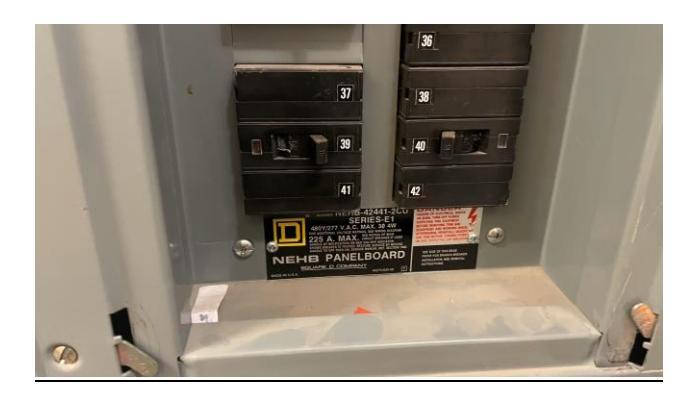
Photo E2a-277/480V panel

The 277/480V branch circuit panels are Square D type NEHB panels (see Photo-E2a which are no longer manufactured or supported. Replacement breakers are no longer available and if new are required a panel upgrade would be required. The existing may remain until such time as that happens.

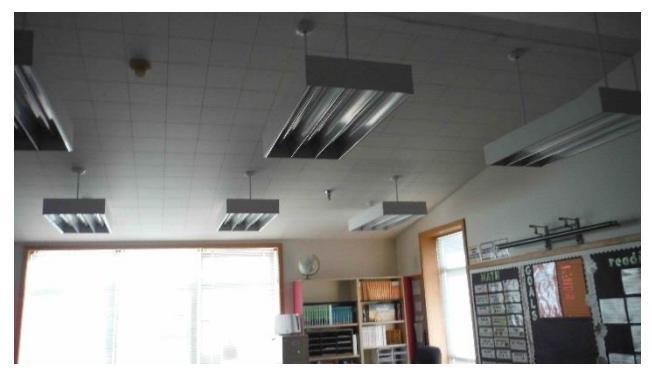
The facility lighting system consists mostly of linear T8 fluorescent fixtures (Photo E3). The gym lighting is high-bay Metal Halide fixtures with LED replacements. Some incandescent bare bulb porcelain bases are in the crawl space but have burned out and need to be replaced. Fluorescent or LED replacement bulbs are recommended to reduce time between replacement and lower energy use. Some occupancy sensor switches have been installed in storage closets. Some of these storage closets have electrical equipment in them and occupancy sensors will need to be replaced as automatic controls do not comply with NEC.

Photo E3–Typical Classroom Lighting

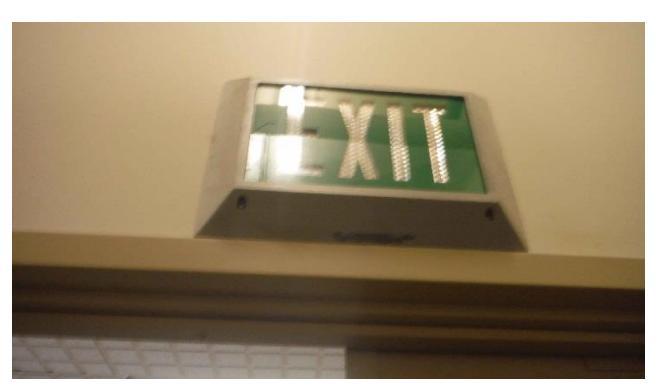
The exit signs are tritium type fixtures which have expired and need to be replaced (Photo E4). Our recommendation is for new LED type with battery back-up. Additional wiring would be required and where there is no accessible ceilings surface raceway would be used to run circuits.

Photo E4- Nuke Type Exit Sign

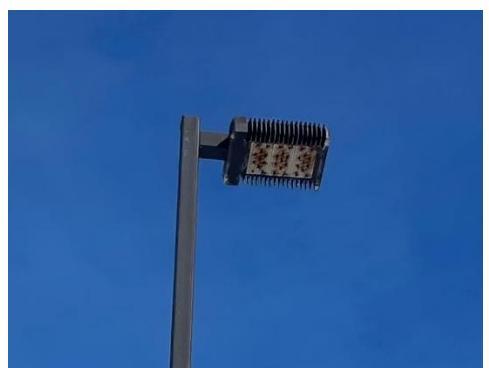
Photo E4a–Area Lighting

Area LED lights are rusting out and the underground branch circuits are starting to fail, see photo E4a.

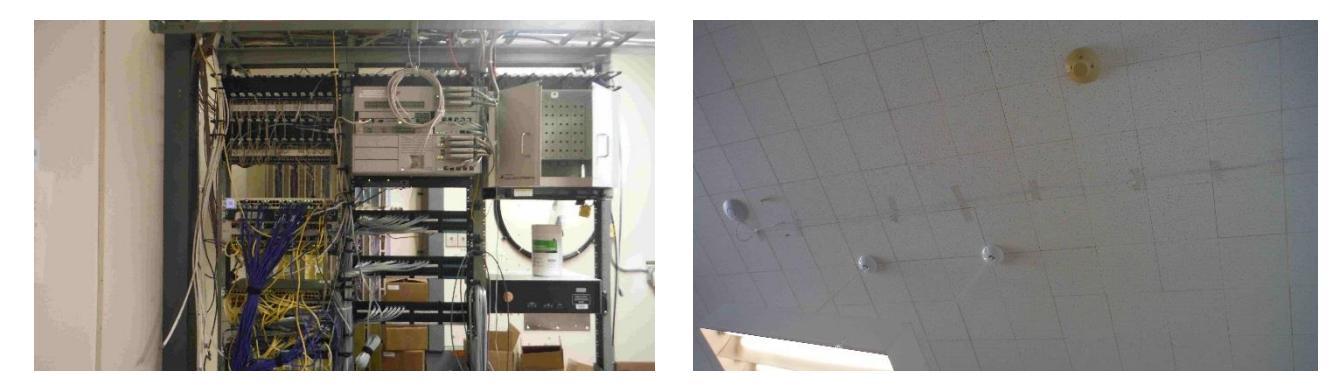
The building has a dedicated room for the telecommunication system. The system consists of a fiber optic rack which provides connectivity between racks in the building and other NSB sites in Utqiagvik (Photo E5). The room also has a telecom rack which is used for Voice Over Internet Protocol (VOIP) phone system and data (Photo E5). This system consists of CAT 5e cabling to data outlets for the Wireless system, administrative offices, and classrooms. Based on conversations with IT personnel additional data drops would help in the classrooms considering the data needs of the students. They also explained that the VOIP system in place is not functional at this time. Although the current infrastructure appears to be close to capacity the existing racks have adequate capacity for expansion to allow for additional equipment. Some additional organization and labelling of the existing cabling would help with installation of any new systems.

Wireless Access Points (WAP) in classrooms have cabling taped to the ceiling (Photo E6). We recommend a surface raceway system as a more permanent wiring method and to help protect wiring.

Photo E5– Telecomm Racks

Photo E6- WAP Cabling

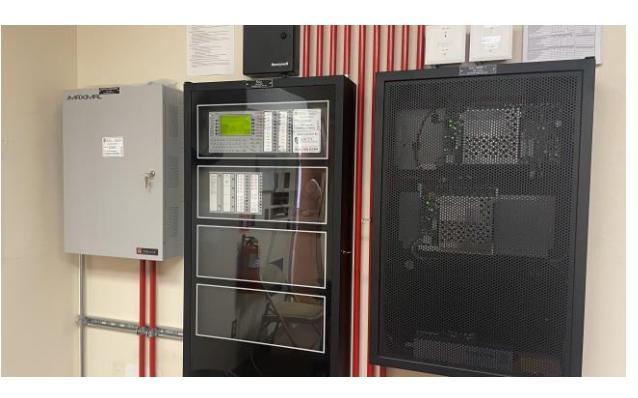
Photo E7a- Fire Alarm Control Panel

AFC has upgraded the Johnson Controls FACP to a new Notifier control panel (Photo E7a) which is compatible with the existing smoke detectors while the annunciating system have all been replaced and upgraded. Additional devices and wiring will be required to update to a voice evacuation system, but the new FACP can support this upgrade.
