FACILITY AUDIT BOYCEVILLE COMMUNITY SCHOOL DISTRICT APRIL 2023

PREPARED BY: CESA 10 Facilities Management 725 W Park Avenue Chippewa Falls, WI 54729 888-947-4701 http://facilities.cesa10.org

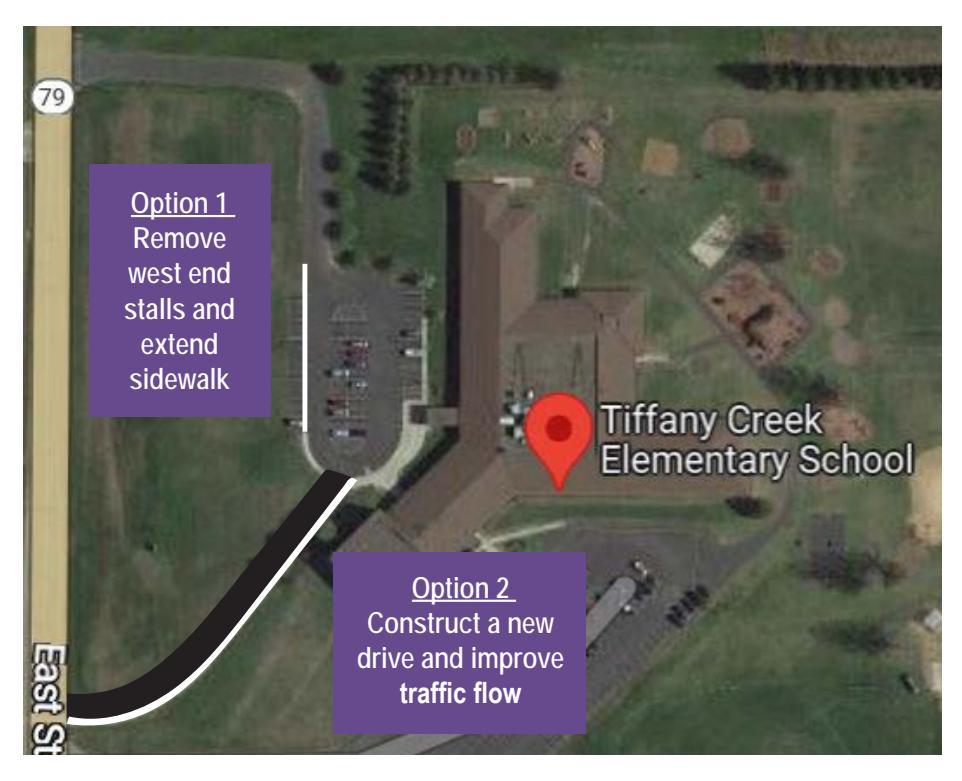
The Parent pick-up and drop-off situation at Tiffany Creek Elementary School is congested and unsafe. Parents line up around the parking lot's perimeter to pick up students. The line gets so long it almost extends into Highway 79. This is unsafe and could cause a car accident for vehicles backed up on the road.

- <u>Option 1</u> Extend the sidewalk on the west side of the parking lot to allow more vehicles to park along this section of the lot. While the school would lose parking spots in this scenario, it would be a cost-effective option to deal with the ongoing problem.
- Option 2 Construct a drive off Highway 79 that would become a new parent entrance. The new drive would run along the existing sidewalk, allowing students a place to wait before entering parked vehicles. This entrance would be one way, changing the existing drive to an exit only. An extended drive and having traffic flow in one direction would relieve congestion in the current area.

Project	Estimated Cost
Option 1 - Remove asphalt outside of sidewalk footprint, install new sidewalk, repair base, and patch asphalt.	\$40,000
Option 2 - Survey and fill with base, install culverts for water flow, install sidewalk and curbs, and pave asphalt.	\$275,000

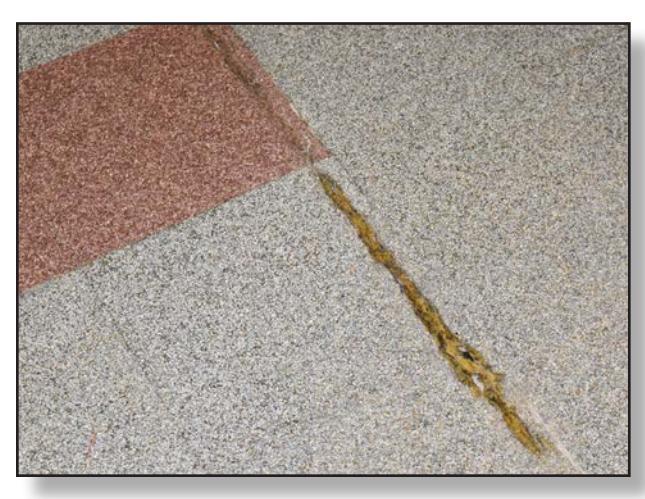
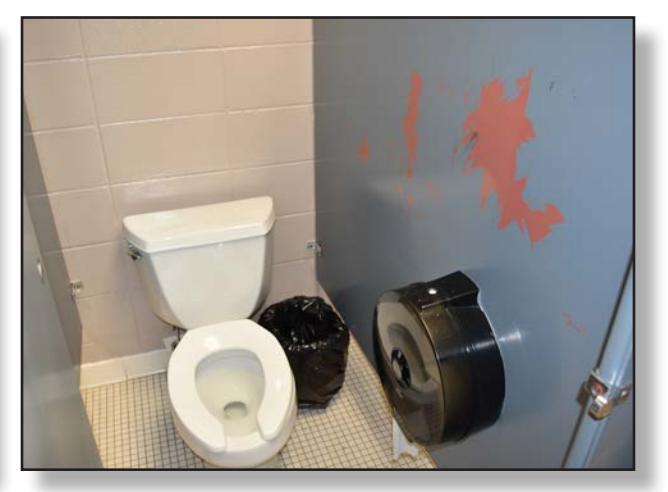
Restrooms	The doors, toilets, sinks, and partitions are dated and aging in numerous bathrooms. The number of bathroom fixtures available to students is deficient in several restrooms.	CESA 10 recommends updating existing bathrooms as the budget allows, including installing low-flow toilet tanks, urinals, and automatic valves to save water and energy. The handwashing stations are also in need of replacement.	7	8	7	7	29	3	\$325,000
Restroom Shower	The school currently does not have a working shower. The District must rely on sinks and wet wipes if a student needs to be cleaned.	The District should add a shower to accommodate staff if they need to clean up a student. A good location for this shower is in a special education bathroom.	8	7	8	6	29	2	\$13,000

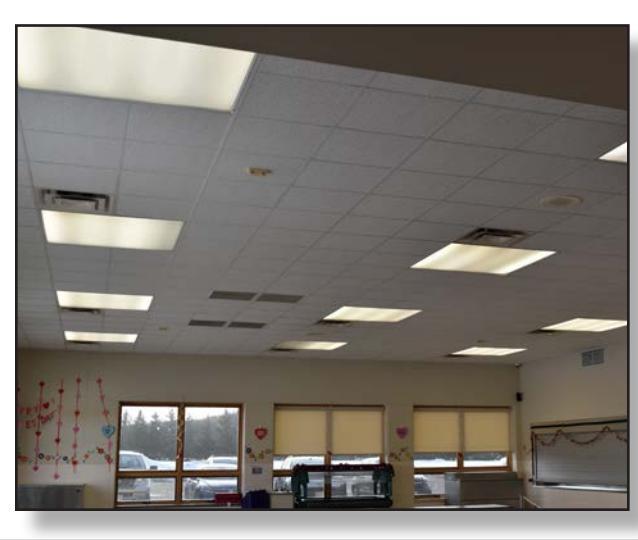
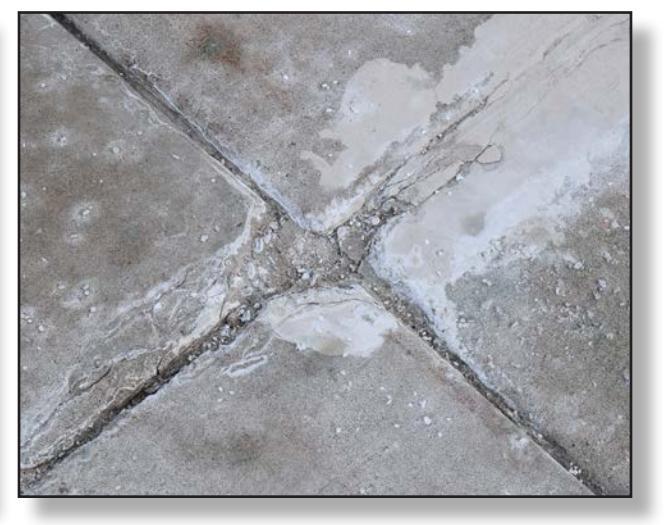
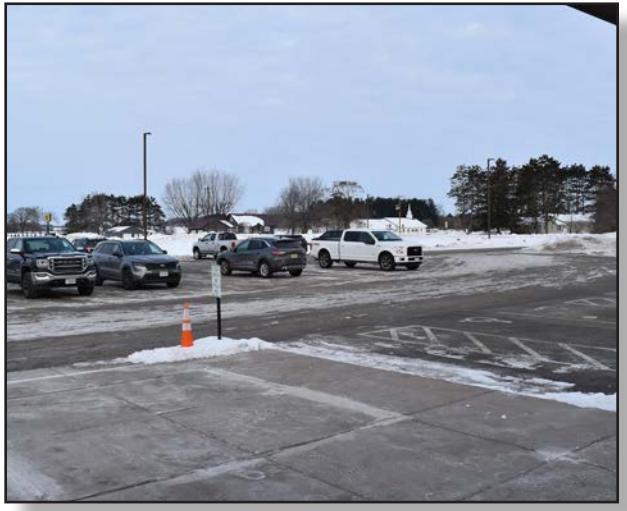
Hardscapes	The District should seasonally remove vegetation on and around the perimeter of concrete, asphalt, and other hardscape structures. They should also annually inspect, crack clean, and crack fill as needed. Creating an inventory and lifecycle replacement schedule for all asphalt areas will even out maintenance costs and extend the life of the materials.	The District should look at resurfacing and crack slurry the back parking lot and basketball court.	7	7	6	7	27	3	\$60,000

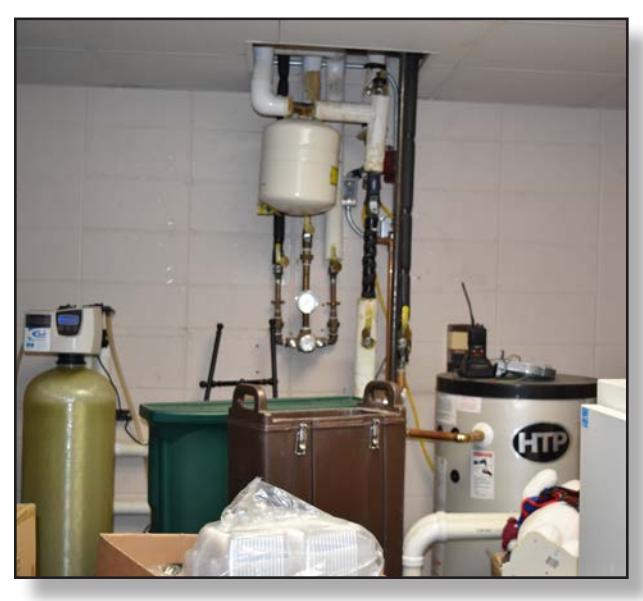
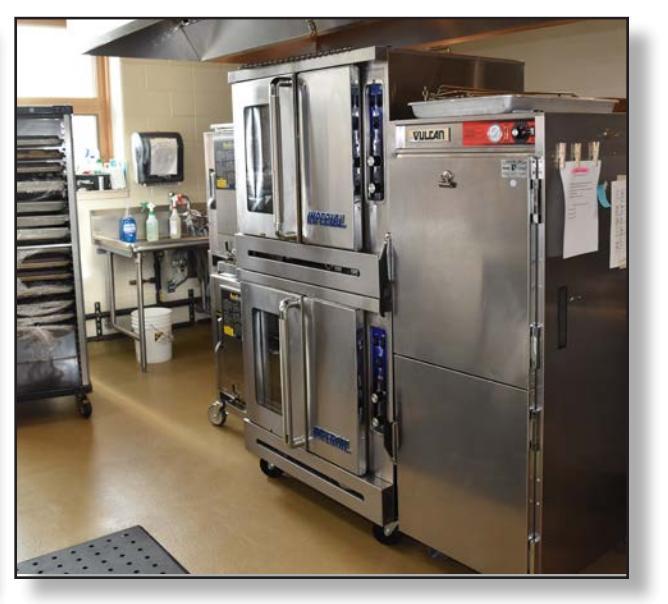
Kitchen Equipment	The kitchen equipment is lacking and should be updated, including replacing the exhaust fan, installing an acid neutralizer on the water heater, adding a walk-in freezer and cooler, establishing storage space, moving the dishwasher next to the three-compartment sink, updating the steamtable and adding a water hookup. The District should also consider adding a server line, so there are two people to help with flow issues.	The District currently prepares most of the food in the Middle/High School and transports it to the Elementary School. This requires temperature checks and staff time. By updating kitchen equipment and storage options, the District can increase the safety and efficiency of this operation.	7	6	6	7	26	2	\$85,500

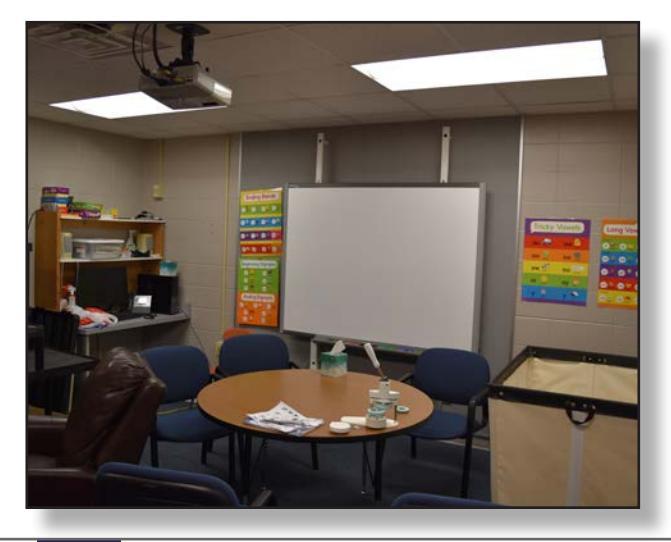
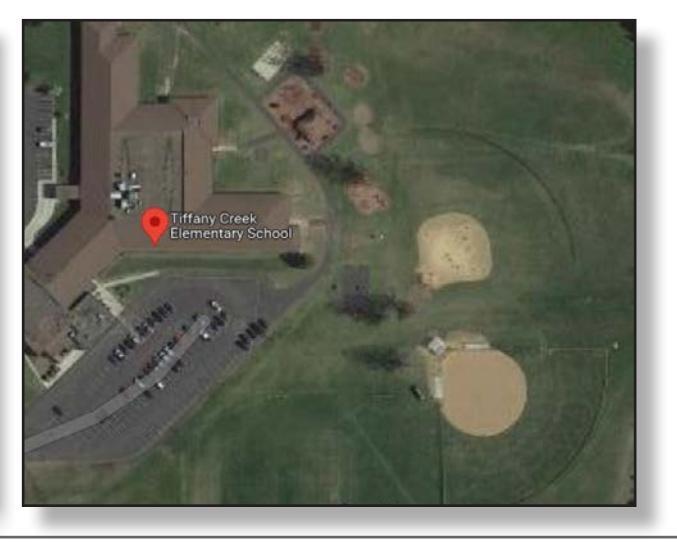
Athletic Field	Staff requested several athletic field upgrades, including finishing field #2 with fences and dugouts, adding trees and water lines around the concession stand and ball fields, replacing ag lime with Shakopee dirt, adding a flag pole between fields, and adding a storage container at the football field.	Estimated costs include \$58,000 for fences/dugouts, \$9,000 for trees, \$14,000 to add water lines to the fields and concession stand, \$35,000 for irrigation, \$18,000 for Shakopee dirt, \$3,000 for a flag pole, \$8,000 for a storage container, and \$10,000 for a batting cage	7	7	6	5	25	3	\$155,000

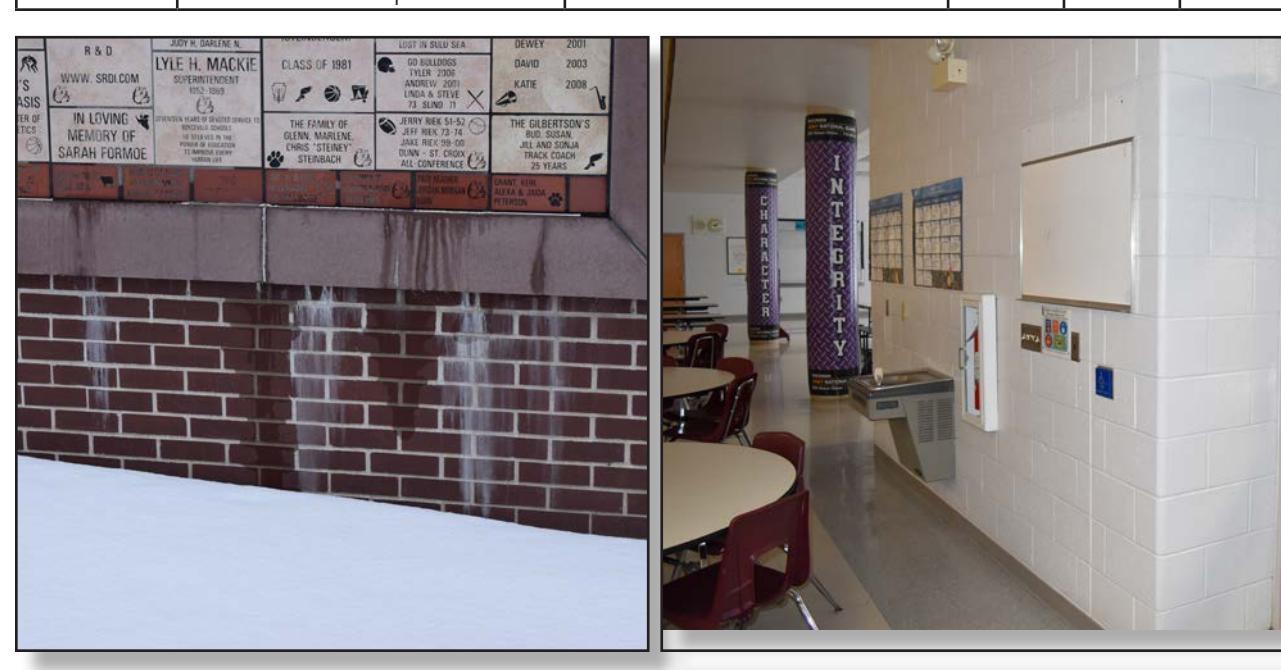
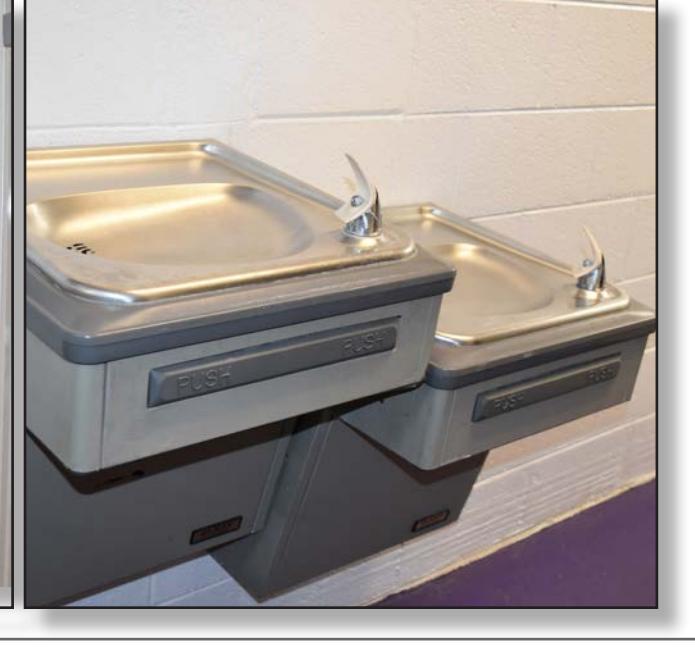
Drinking Fountains	Drinking fountains were found to be in various states, including two stations that were inoperable.	The District should replace drinking fountains with bottle fill stations.	7	7	7	7	28	2	\$15,000
