Geneva Community Unit School District #304
Operations and Maintenance
7 Year Capital Improvement Plan

Finance Advisory Committee

March 8, 2021

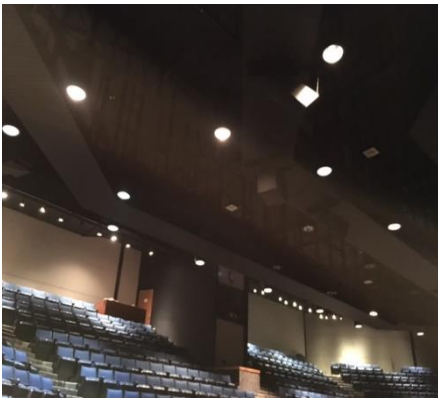
Auditorium Lighting Replacement

Parts for lighting panel are becoming obsolete and starting to fail.

Replace with energy efficient fixtures and lighting panel.

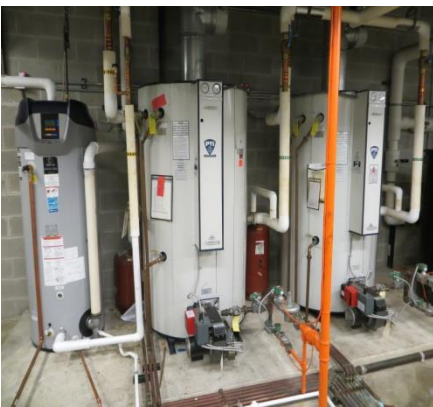
Hot Water Heaters

The two 500 gallon PVI water heaters are nearing the end of their life cycle.

Replacement will be needed within the next four years.

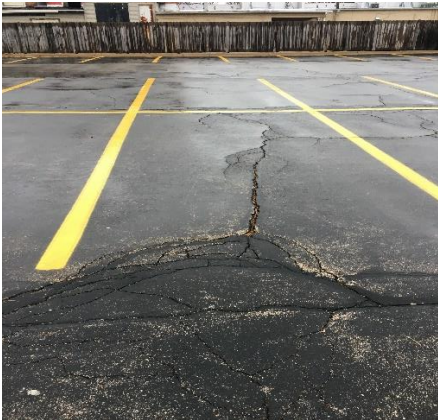
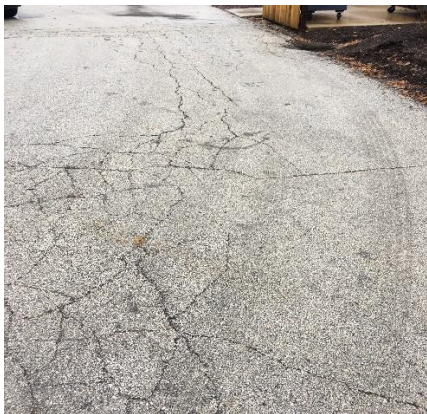
Parking lot

Several areas with extreme cracking.

Sealcoating and crack filling will be needed.

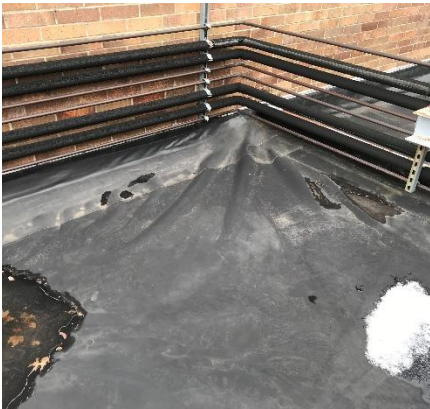
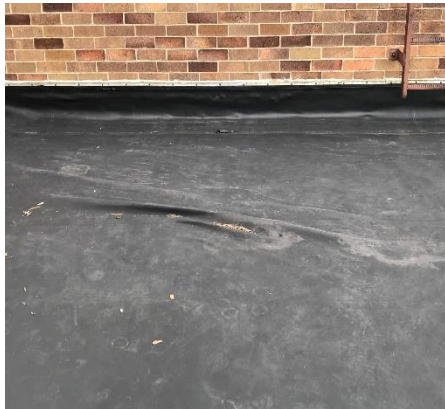
The roof is 20 years old and many sections are in poor condition and need repair.

Roof replacement/restoration will be needed in the next one to three years.

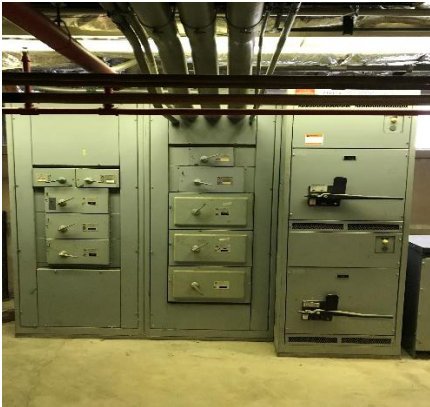
Switchboard

The 2,500 amp switchboard is 46 years old and does not operate properly.

The switchboard will need to be replaced or rebuilt.

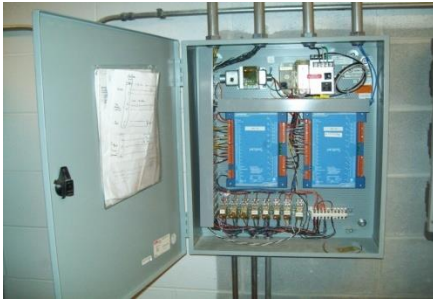
Lon Controller

Lon controls throughout the building.

Outdated and costly to repair.

Replace Lon to BACnet.

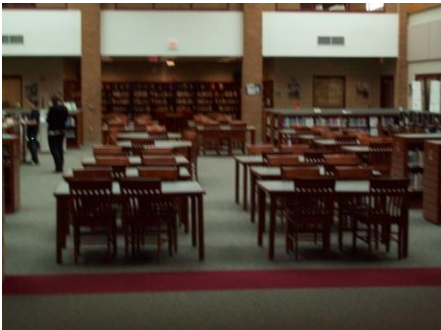
LMC

AHU is undersized for space.

Only two VAV boxes serving the space.

Recommend increasing the capacity of the AHU and adding four to six VAV boxes with controls to increase comfort and control humidity.

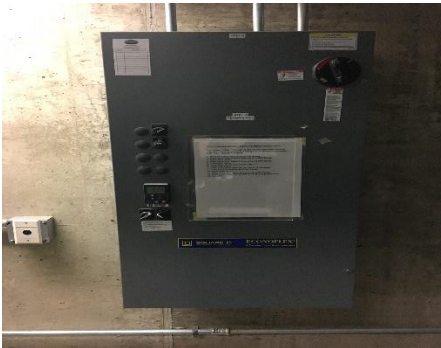
Variable Frequency Drive (VFD)

Needs replacing in the next 2 years.

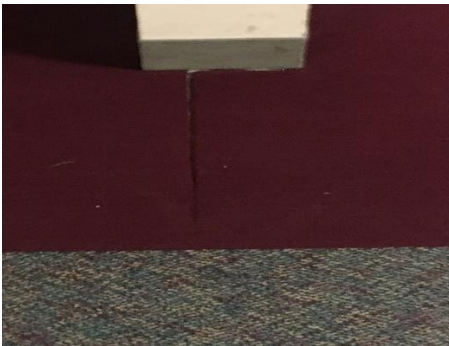
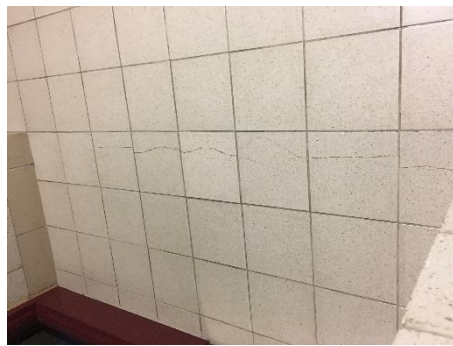
Flooring Replacement

Carpet is starting to show wear and seams are starting to pull apart.

Life cycle of carpet is 12-20 years.

Tile is lifting and cracking in several areas.

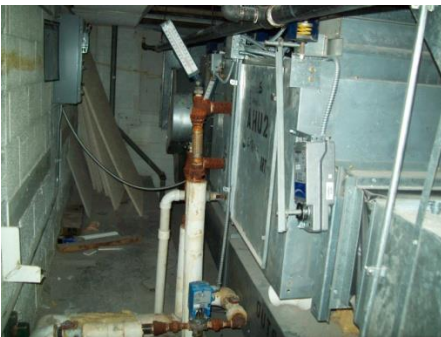
Air Handling Unit

Needs rebuilding or possible replacement.

New motor, shaft, bearings and controls needed.

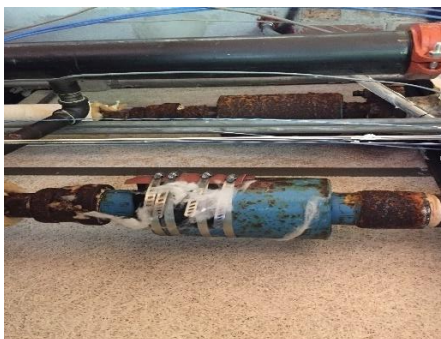
HVAC Piping Replacement

Chilled and hot water HVAC piping is original to the building.

Showing excessive rust and starting to leak.

Replace with new dual temperature piping and insulation.

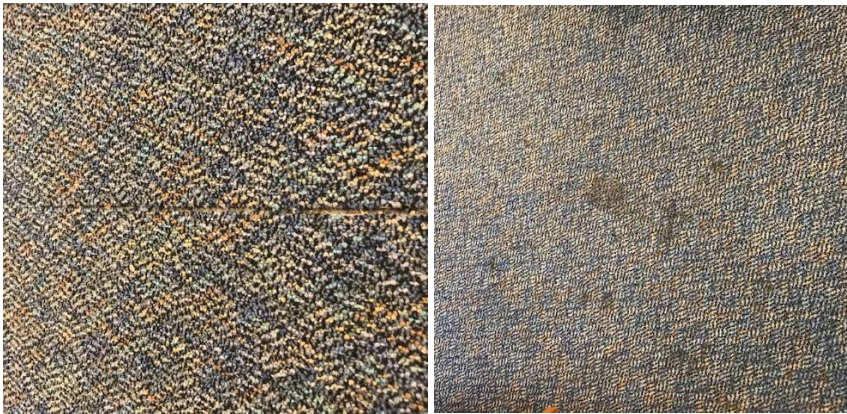
Flooring Replacement

Carpet is starting to show wear and staining that we are unable to remove.

Life cycle of carpet is 12-20 years.

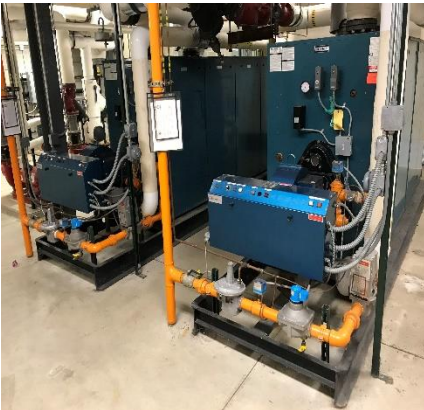
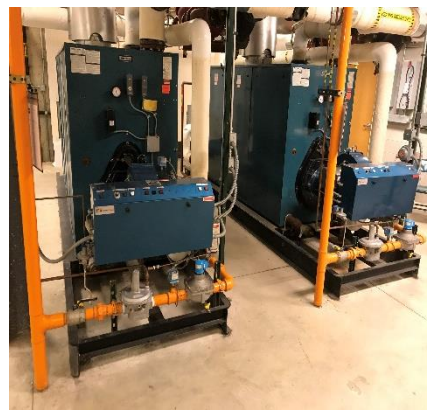
Boilers and Primary Pumps Replacement

Boiler and primary pumps are 19 years old and original to the building.

Replacement will be needed within the next two to five years.

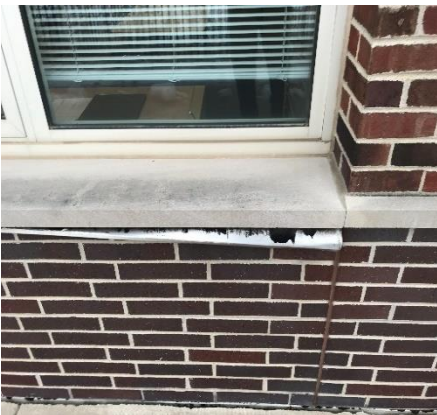
Tuckpointing/ Masonry Repairs

Cracked and missing mortar joints and drip edge repairs.

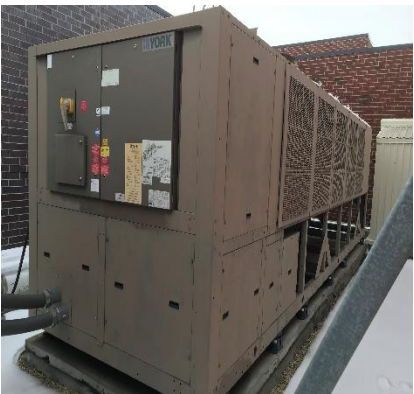
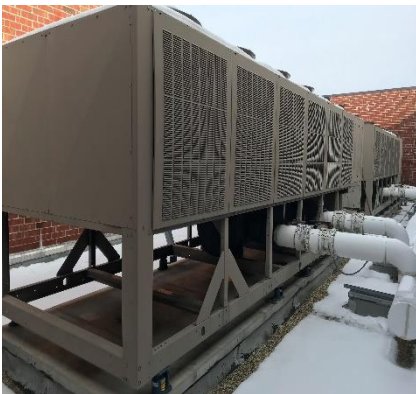
York Chillers

12 years old chillers are nearing the end of their service life as per ASHRAE.

Replacement will be needed within the next three to seven years.

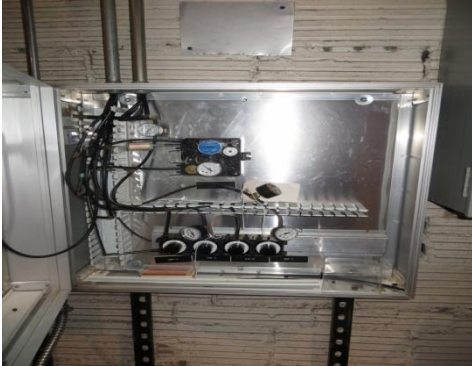
HVAC Controls

Upgrading the discontinued pneumatic controls with Direct Digital Controls.

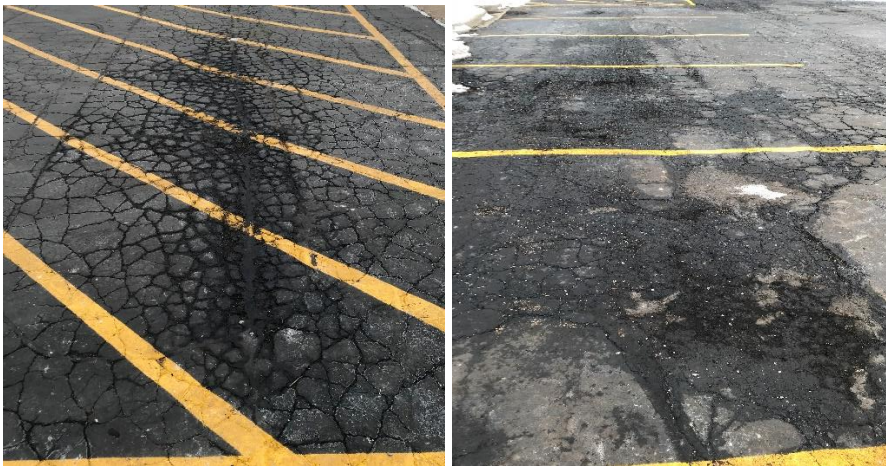
Parking Lot

Several areas with extreme cracking.
Resurfacing will be needed.

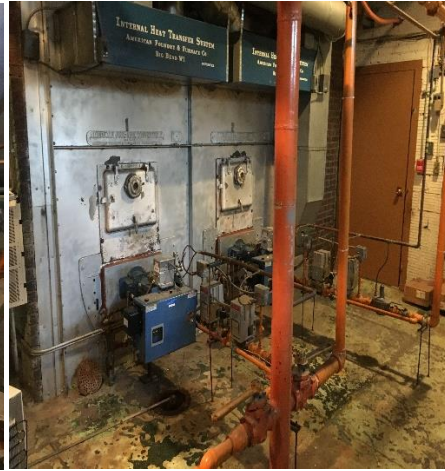
Forced Air Furnace Burners

Burners are 21 years old.

Nearing the end of their estimated service life as per ASHRAE.

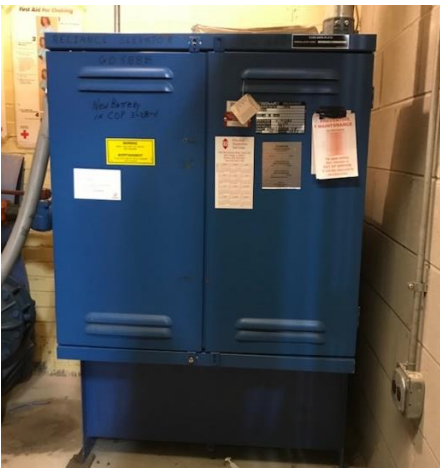
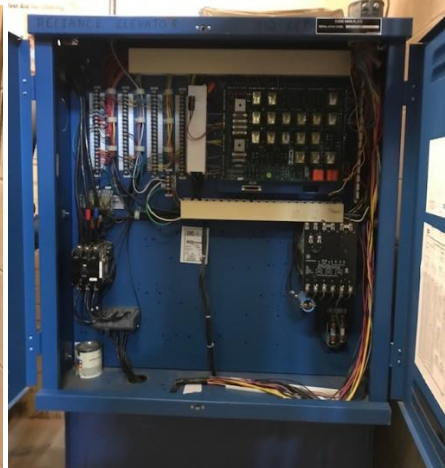
Elevator Control System Upgrade

The current elevator control system parts are becoming obsolete and no longer available for repairs.

Control upgrades will be needed in the next two to three years.

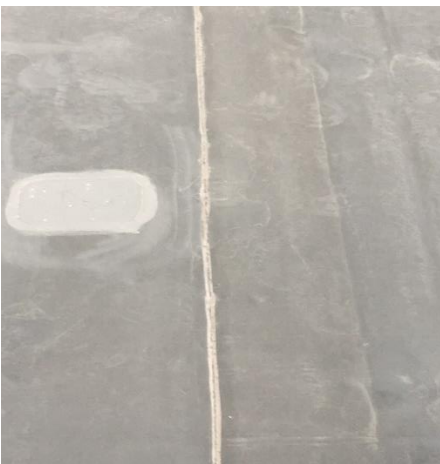
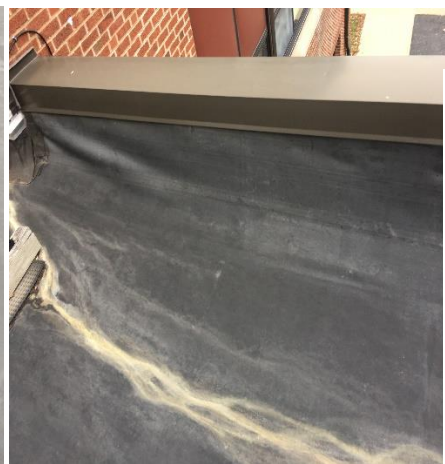
The roof is 19 years old and many sections are in poor condition.

Roof replacement/restoration will be needed in the next two to four years.

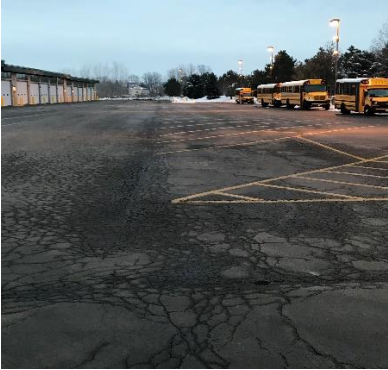
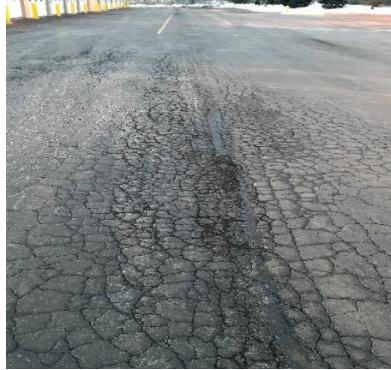
Parking Lot

Pavement starting to crack and breakdown.

Resurfacing and drainage improvements will be needed in the next four years.

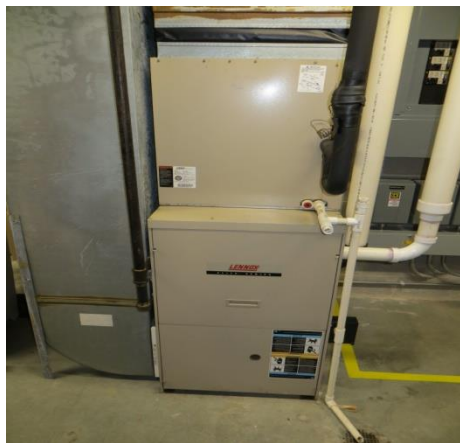
HVAC Split System

The 3 Lennox split systems are nearing their ASHRAE recommended service life.

Replacement will be needed within the next three years.

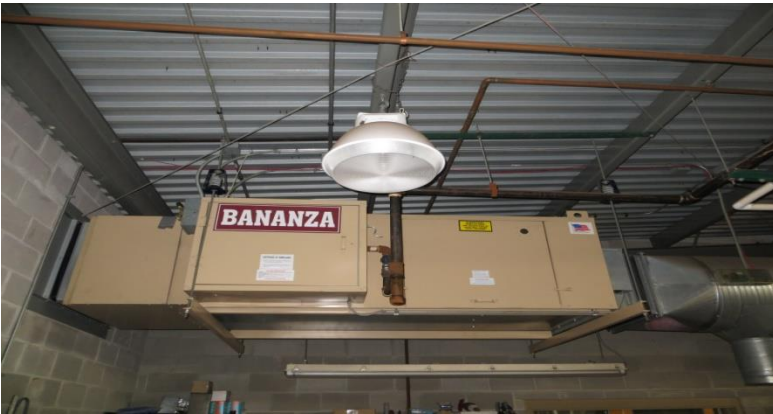
Air Handling Unit

The three Bananza make-up air units are nearing their ASHRAE recommended service life.

Replacement will be needed within the next three years.

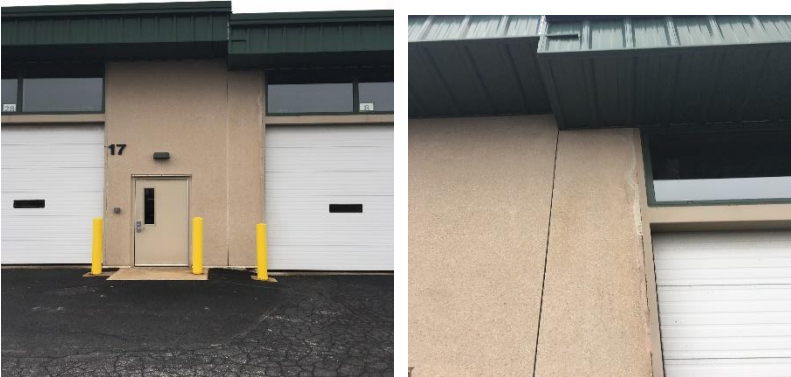
Architectural Precast Wall Panel

The exterior architectural precast wall panel has cracked and will need to be replaced.

Replacement will be needed within the next two years.
