Geneva Community Unit School District #304
Operations and Maintenance
7 Year Capital Improvement Plan

April 12, 2021

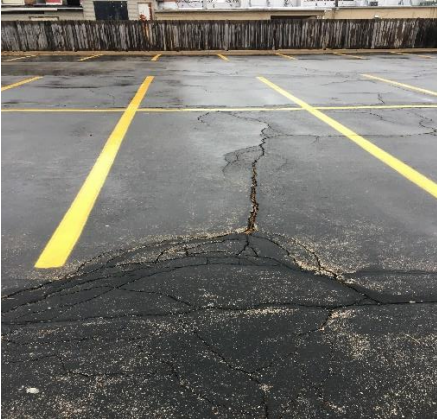
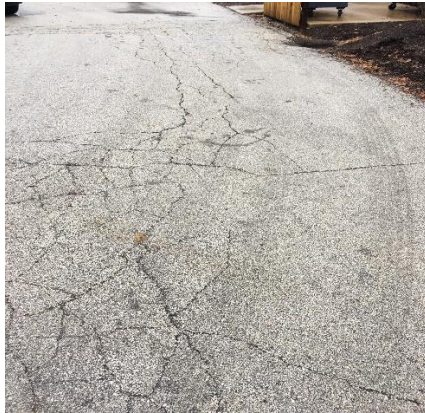
Parking lot

Several areas with extreme cracking.

Sealcoating and crack filling will be needed.

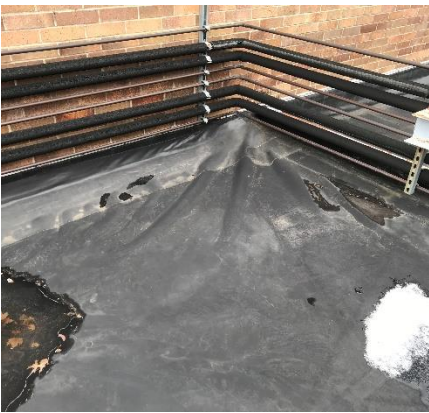
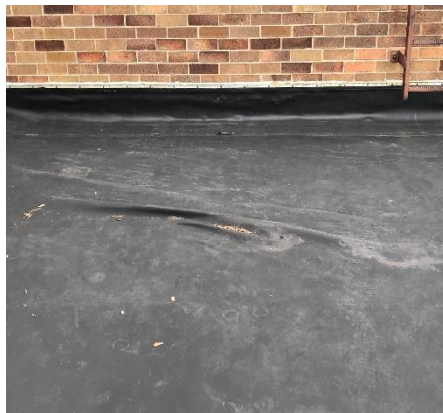
The roof is 20 years old and many sections are in poor condition and need repair.

Roof replacement/restoration will be needed in the next one to three years.

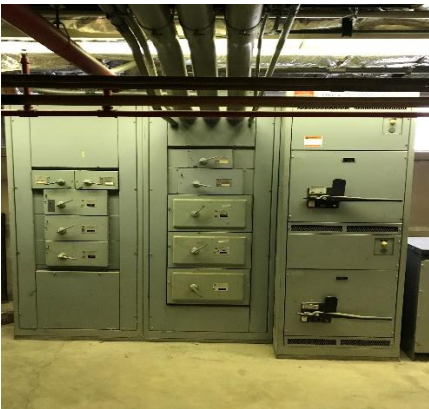
Switchboard

Several additional capital improvements are needed in the next seven years. The 46 year old 2,500 amp **switchboard** will need to be replaced. Several of the current disconnects do not operate and this causes a safety issue. The seven **air handlers** that serve the library, Mack Olson Gym, cafeteria, kitchen, auditorium and weight room are all over 46 years old and are in need of updating. Since they all are housed inside the building, the shells of the units are in good condition. We recommend replacing the bearings, shafts and motors to improve reliability and efficiency. Any new equipment will be installed with new **DDC controls** to continue the conversion of the high school from pneumatic controls. The Quincy **air compressor** that operates the pneumatic HVAC control system is 20 years old and is near the end of its life and will need to be replaced in the next seven years. **Air conditioning** needs to be added to the Athletic Area to maintain a comfortable environment for students and staff. **Flooring** has been an ongoing concern for several years. The existing carpet is at least 20 years old and, in some areas, even older. The Fritz quartz tile that was installed in 2000 has not performed well. It is cracking throughout the building and has faded considerably. We are replacing small sections of flooring in phases due to budgeting restrictions. The **stagecraft and cafeteria bathrooms** are over 46 years old and showing significant wear. We need to update the bathrooms which would include new flooring, update plumbing, fixtures, sinks and toilets. The **stage and house lighting in the auditorium** is starting to fail and the parts for the lighting panel are becoming obsolete and no longer available. We will need to update the entire lighting system. FGM Architects conducted a Roof Assessment in the summer of 2018 and found several failing sections of the roof. The **roof** of the building was installed in 2001 and the typical life cycle of a roof is 25 years. Several sections of the roof will need to be repaired this year. Also, the Boiler Room **roof** will need to be replaced due to age and condition. The rest of the high school roof will need to be replaced or a waterproof restoration coating added in the next three years. The **parking lots** were resurfaced the summer of 2013. Crack filling and sealcoating will be needed in the next two to four years. The two **500 gallon PVI hot water heaters** will need to be replaced within the next four years. Additional **office space** will be needed in the Deans and Counseling & Advising areas. There is not enough space for staff that needs to be in a confidential environment. The Kewanee steam **boilers, installed in 2000, 1967, 2 in 1957**, that supply heat to the high school are inefficient and becoming increasingly costly to maintain. Kewanee stopped

The 2,500 amp switchboard is 46 years old and does not operate properly.

The switchboard will need to be replaced or rebuilt.

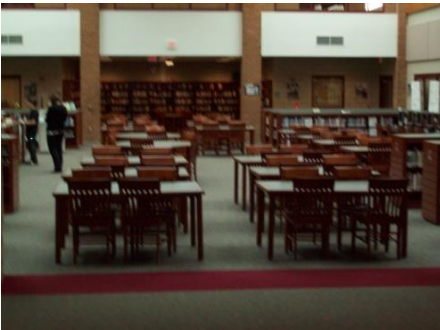
LMC

AHU is undersized for space.

Only two VAV boxes serving the space.

Recommend increasing the capacity of the AHU and adding four to six VAV boxes with controls to increase comfort and control humidity.

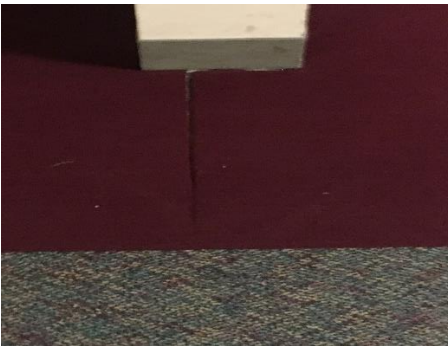
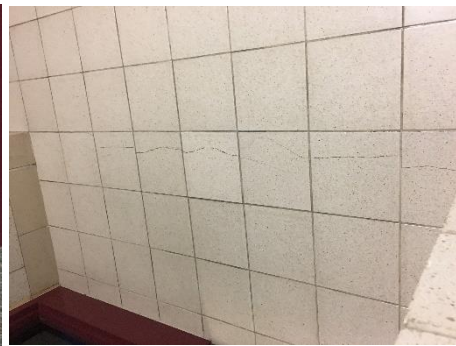
Flooring Replacement

Carpet is starting to show wear and seams are starting to pull apart.

Life cycle of carpet is 12-20 years.

Tile is lifting and cracking in several areas.

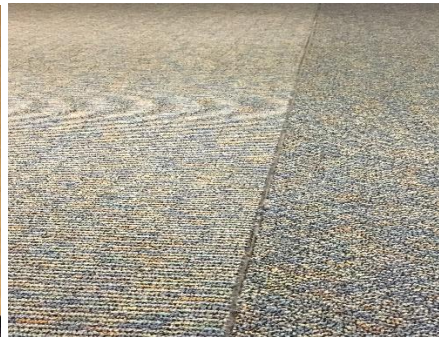
Flooring Replacement

Carpet is starting to show wear and seams are starting to pull apart.

Life cycle of carpet is 12-20 years.

Tile is lifting and cracking in several areas.

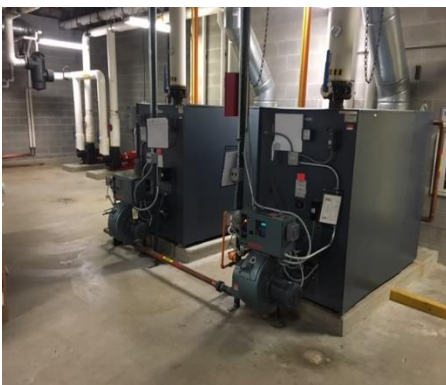
Boiler and Secondary Pumps Replacement

22 years old boilers and pumps nearing end of their estimated service life as per ASHRAE.

Need to be replaced with energy efficient design.

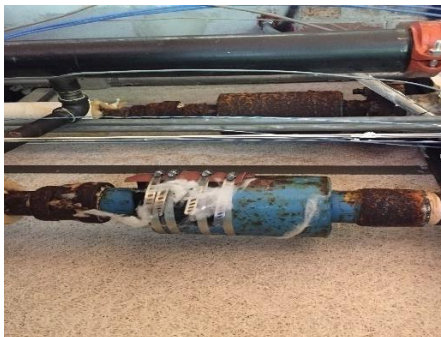
HVAC Piping Replacement

Chilled and hot water HVAC piping is original to the building.

Showing excessive rust and starting to leak.

Replace with new dual temperature piping and insulation.

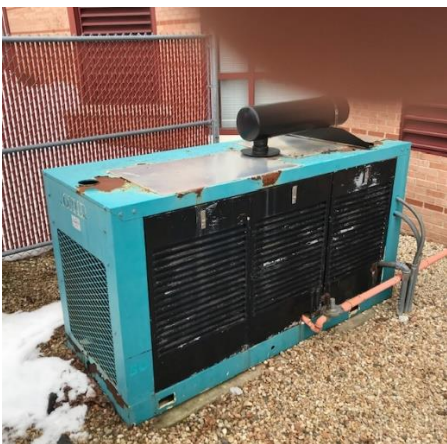
Generator Replacement

100KW generator is 25 years old and needs to be replaced in the next two to three years.

Escalating repair costs and consistent breakdowns.

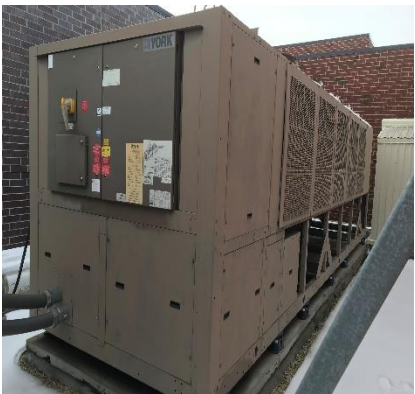
York Chillers

12 years old chillers are nearing the end of their service life as per ASHRAE.

Replacement will be needed within the next three to seven years.

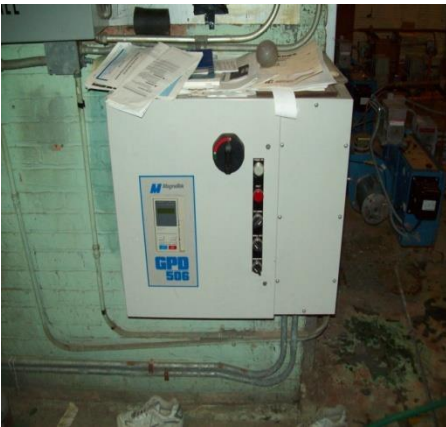
Variable Frequency Drive

VFD has failed and needs to be replaced.
