**DENTON ISD  
PLAYGROUND  
EQUIPMENT  
REPLACEMENT CYCLE  
PHASE I**

# PHASE I

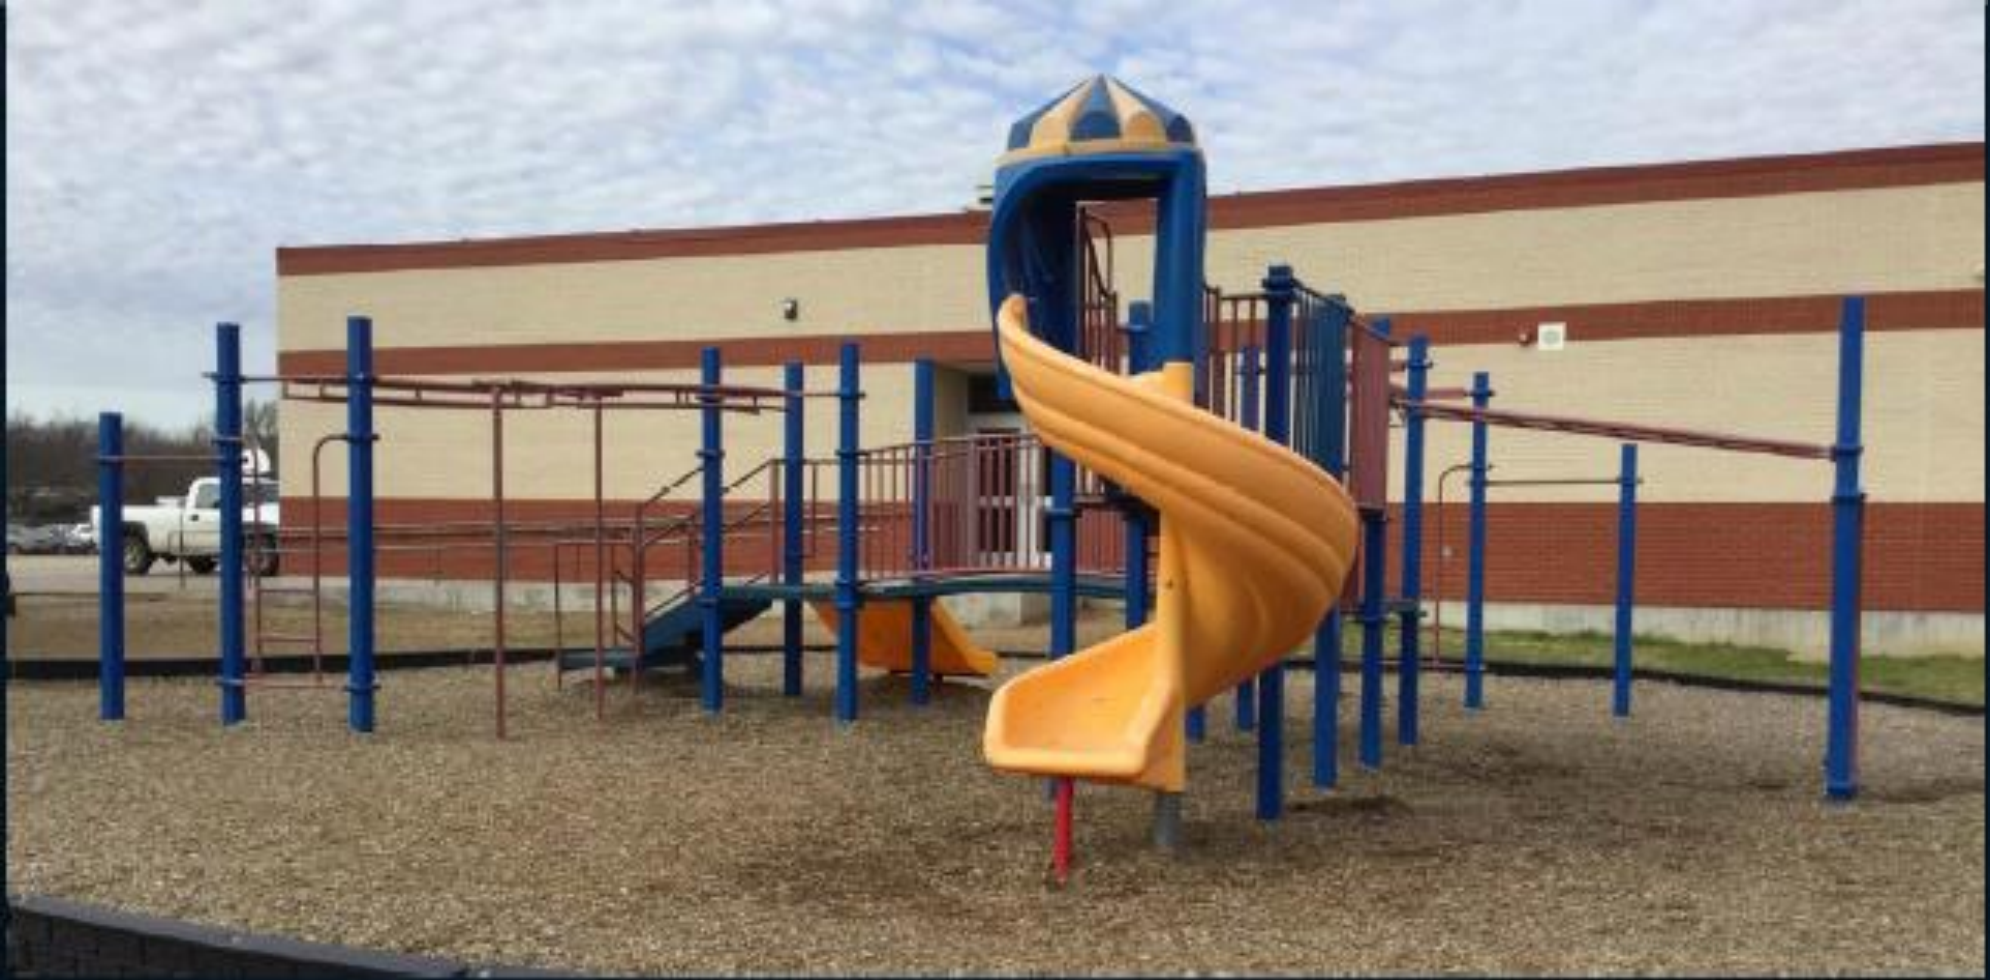
- Manufacturer: Miracle 1995 or Older
- Condition: Poor

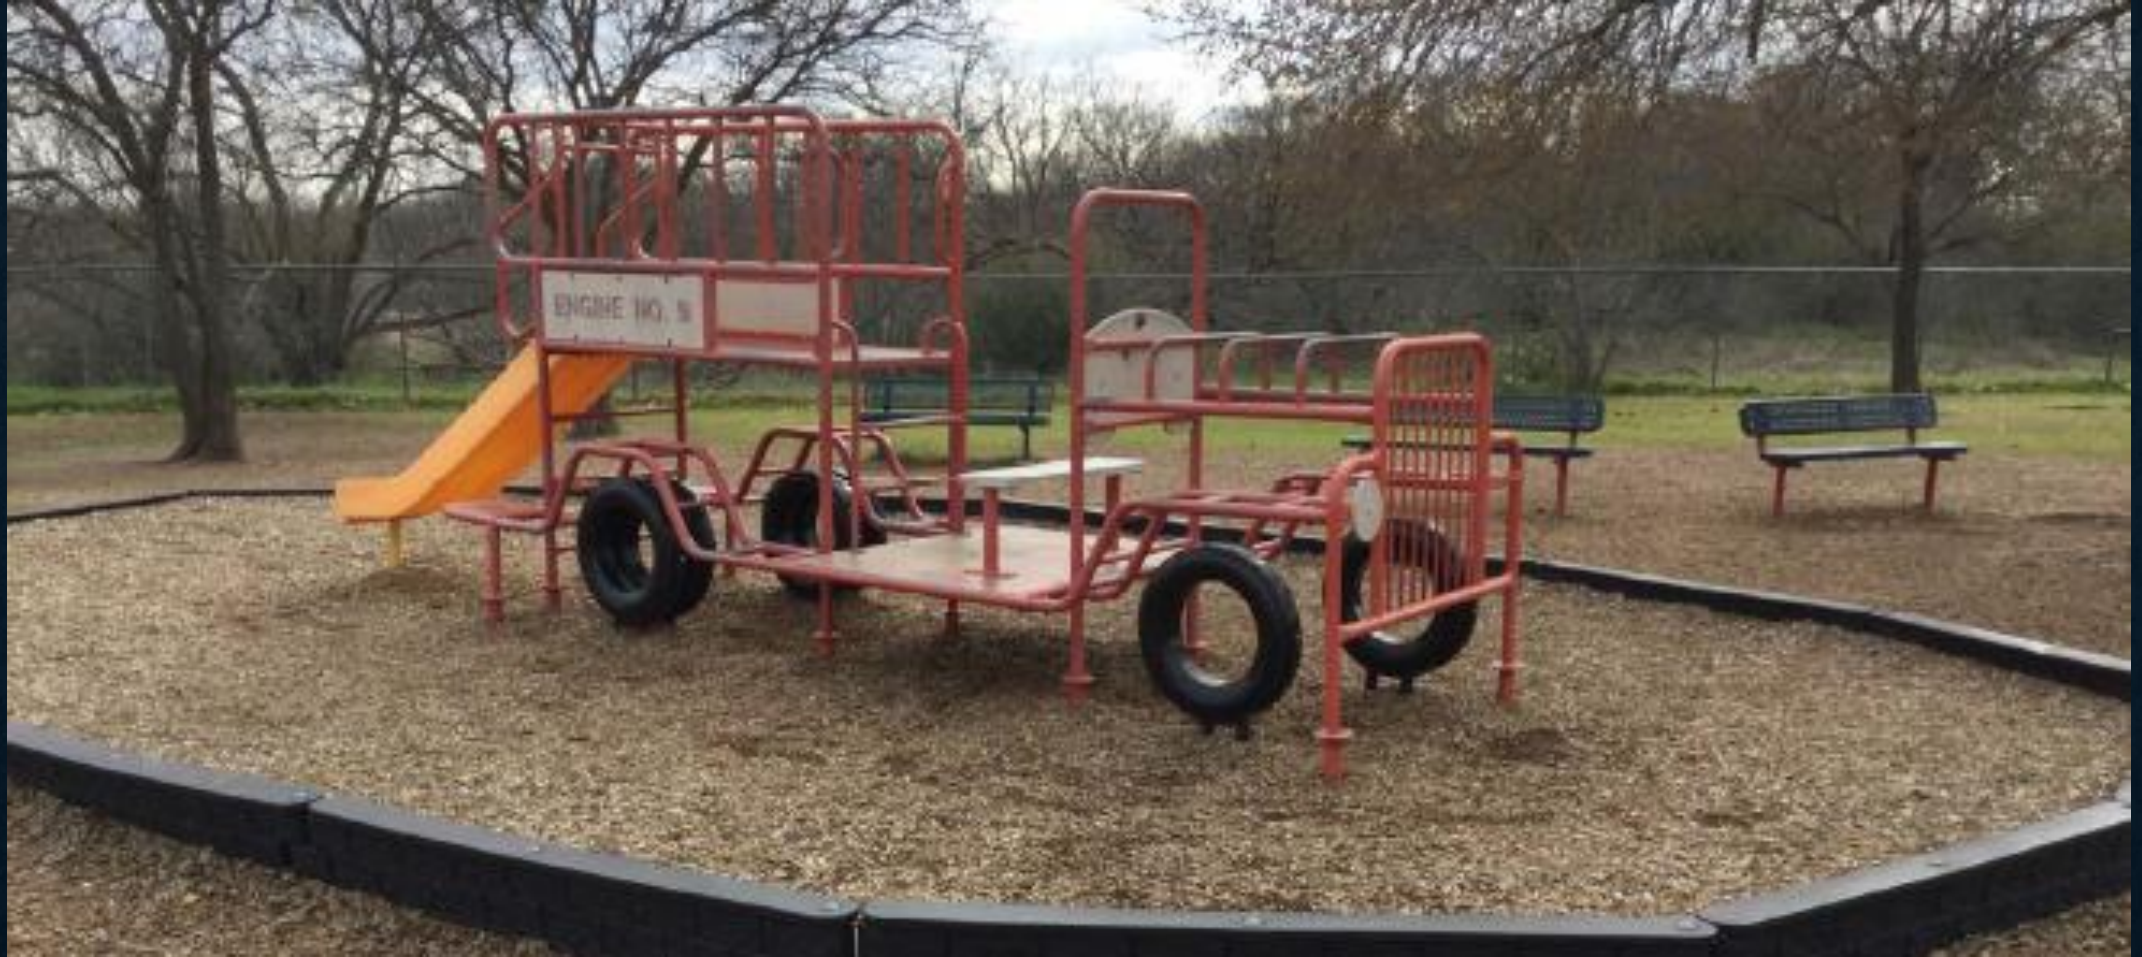
- Manufacturer: Landscape Structures Inc 1992
- Condition: Poor

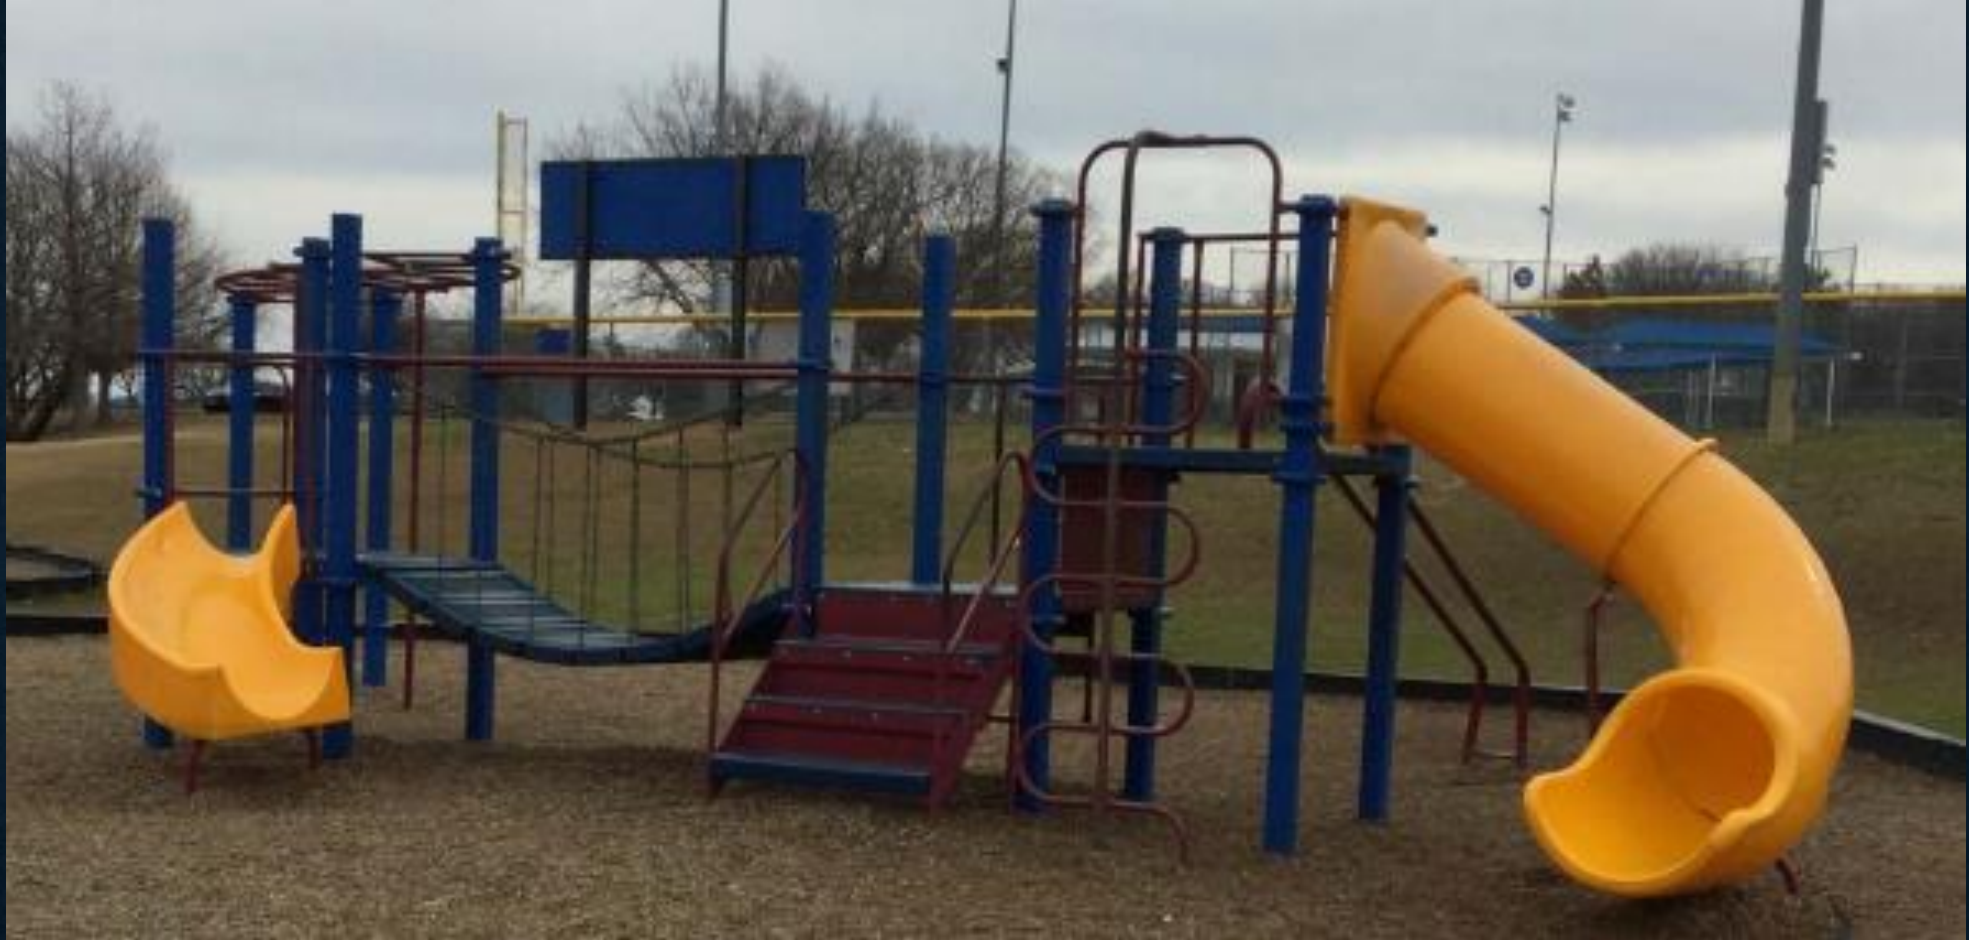
- Manufacturer: Miracle 1995 or Older
- Condition: Poor

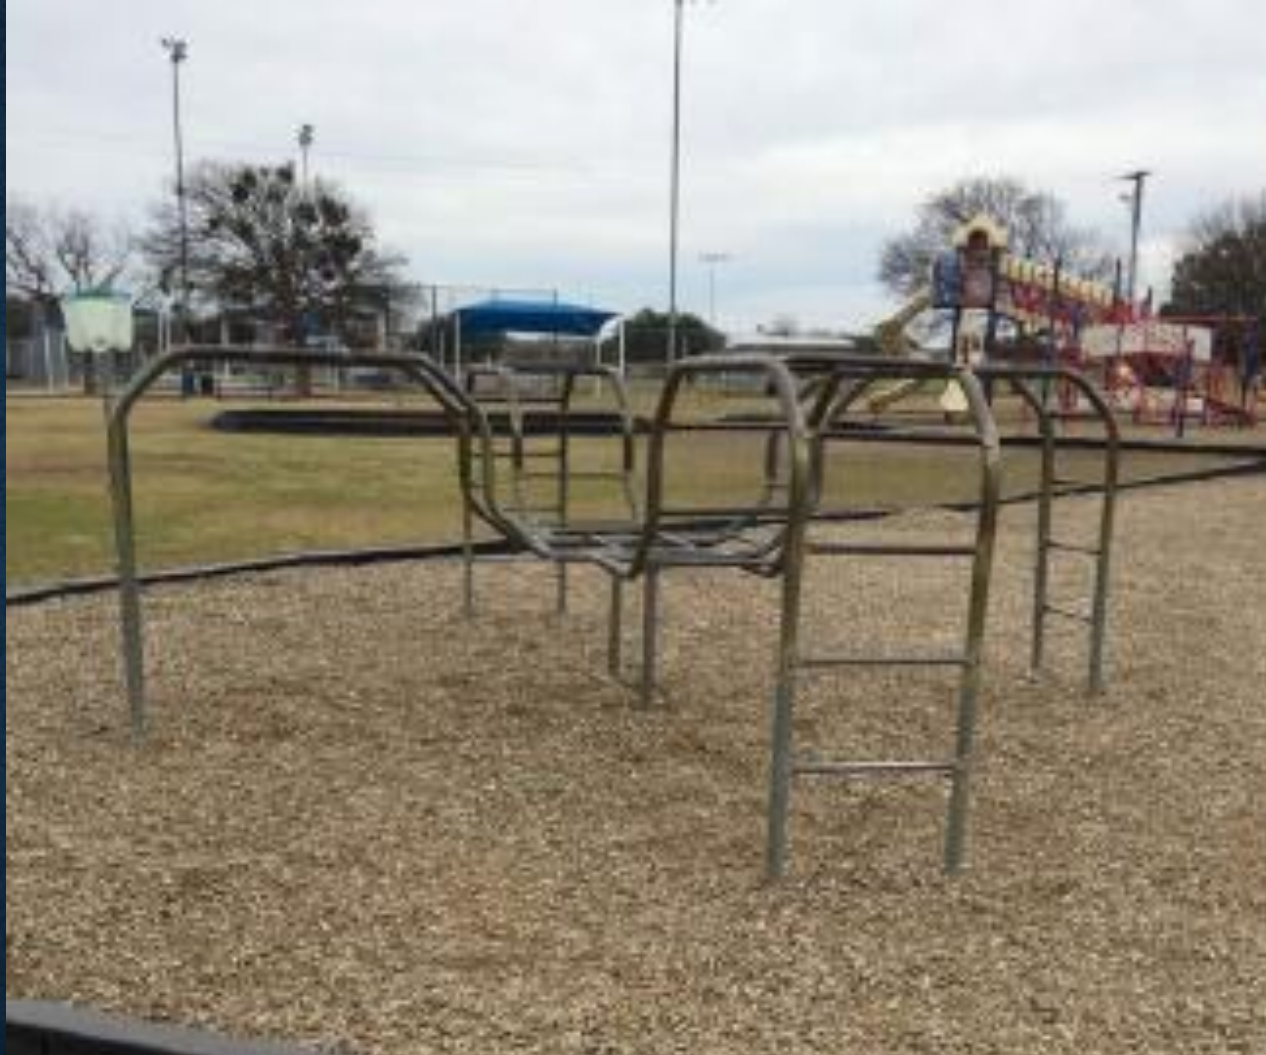
- Manufacturer: Unknown
- Condition: Poor

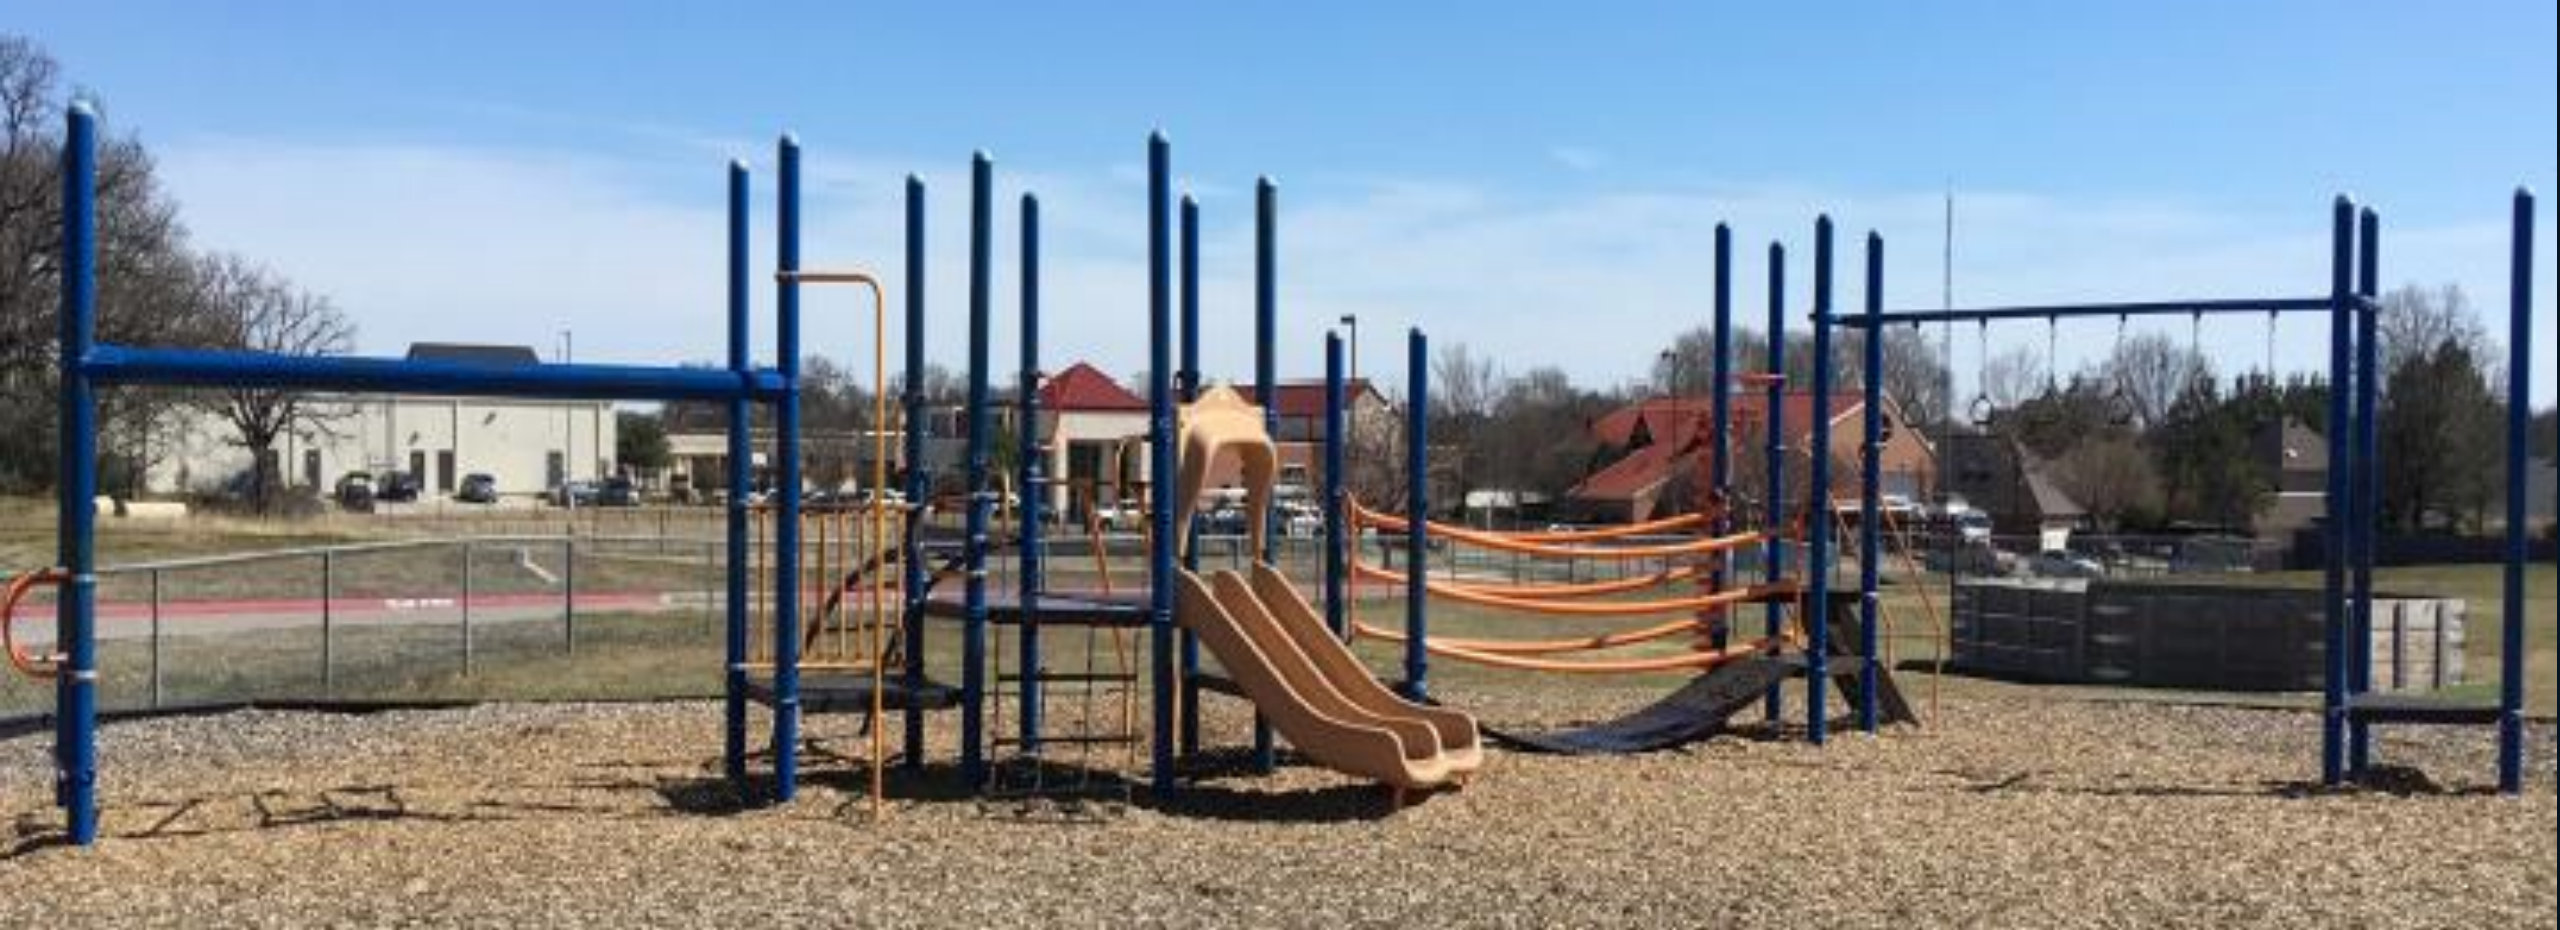
- Manufacturer: Little Tikes 1995 or Older
- Condition: Poor
