Geneva Community Unit School District #304  
Operations and Maintenance  
7 Year Capital Improvement Plan

April 25, 2022

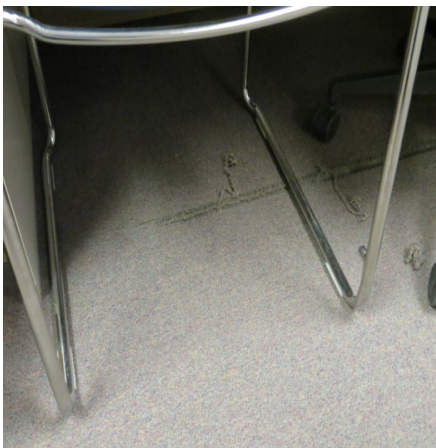
## Carpet

The carpet is starting to fray and cause trip hazards.

Carpet will need to be replaced.

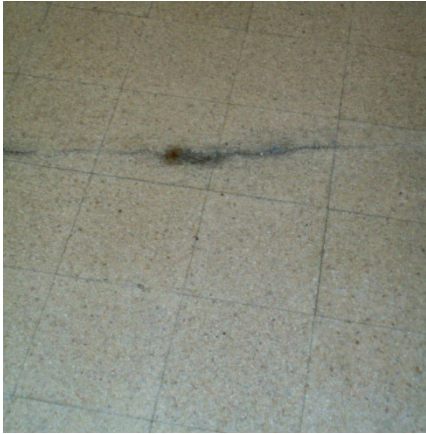
## Flooring

Existing quartz tile is cracking and has faded.

Replace tile in phases.

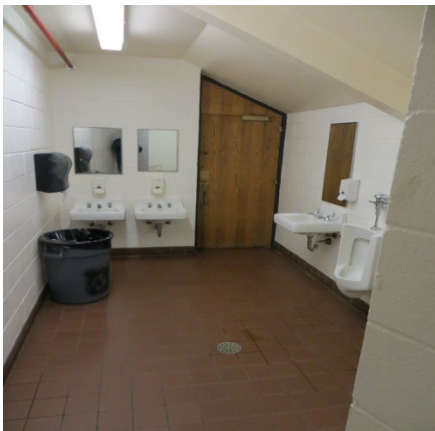
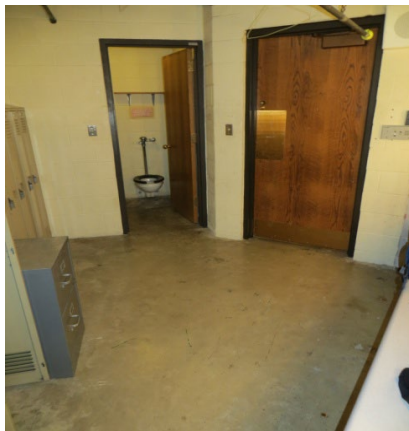
## Cafeteria and Stagecraft Bathrooms

Bathrooms are 47 years old.

Showing significant wear.

Need to update.

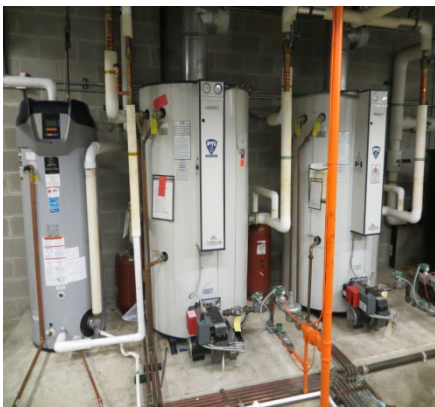
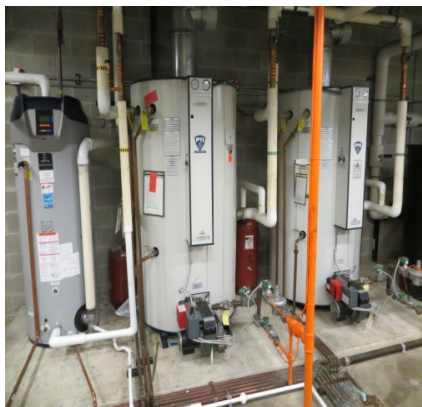
## Hot Water Heaters

The two 500-gallon PVI water heaters are nearing the end of their life cycle.

Replacement will be needed within the next four years.

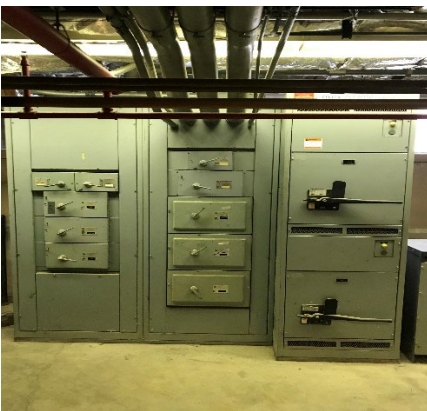
## Switchboard

The 2,500-amp switchboard is 47 years old and does not operate properly.

The switchboard will need to be replaced or rebuilt.

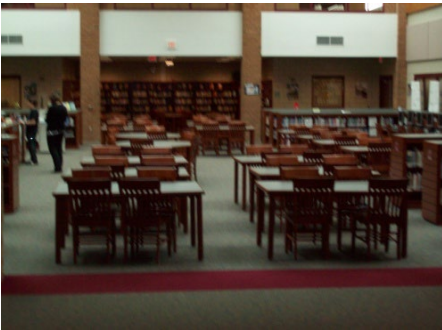
### LMC

AHU is undersized for space.

Only two VAV boxes serving the space.

Recommend increasing the capacity of the AHU and adding four to six VAV boxes with controls to increase comfort and control humidity.

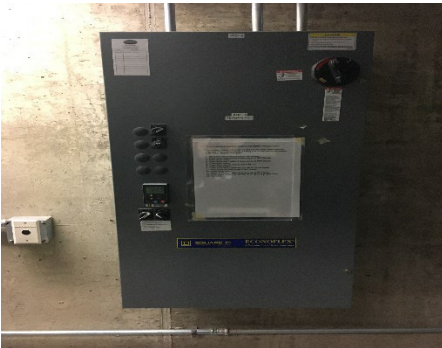
### Variable Frequency Drive (VFD)

Needs replacing in the next 2 years.

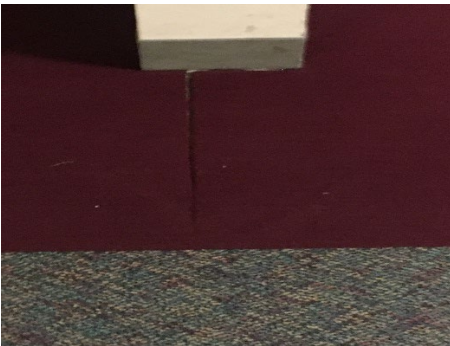
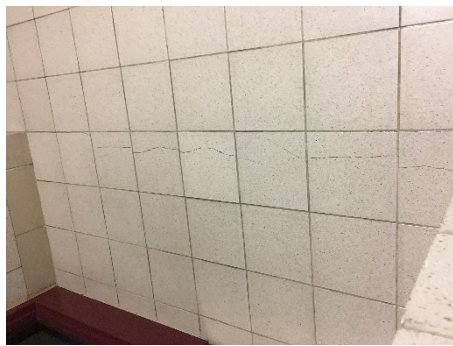
### Flooring Replacement

Carpet is starting to show wear and seams are starting to pull apart.

Tile is lifting and cracking in several areas.

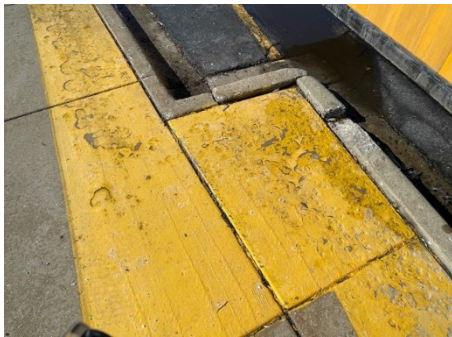
### **Concrete Sidewalk/Curb Replacement**

Several sections are heaving, cracking, and spalling.

Replace sections for safety concerns.

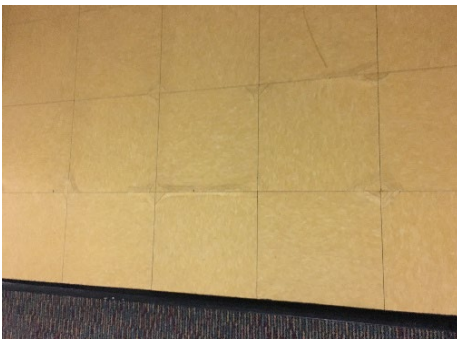
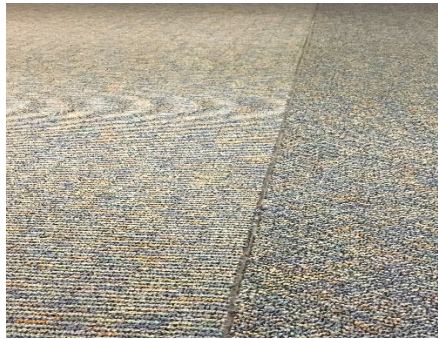
### **Flooring Replacement**

Carpet is starting to show wear and seams are starting to pull apart.

Tile is lifting and cracking in several areas.

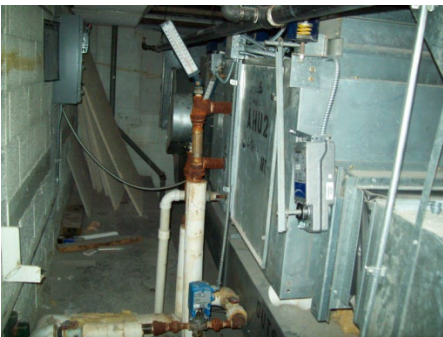
## **Air Handling Unit**

Needs rebuilding or possible replacement.

New motor, shaft, bearings and controls needed.

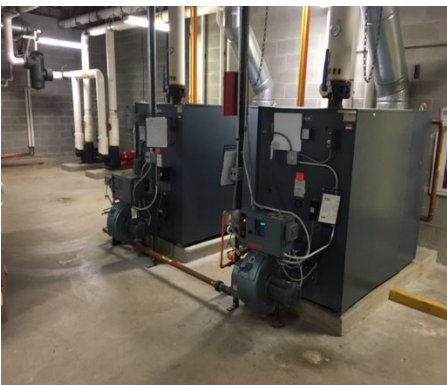
## **Boiler and Secondary Pumps Replacement**

23 years old boilers and pumps nearing end of their estimated service life as per ASHRAE.

Need to be replaced with energy efficient design.

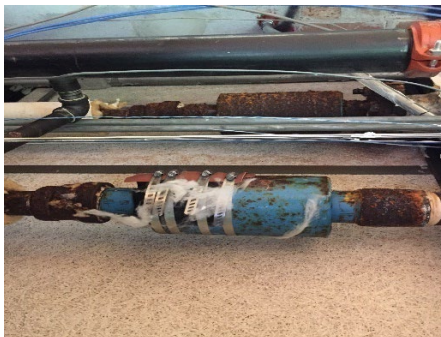
## **HVAC Piping Replacement**

Chilled and hot water HVAC piping is original to the building.

Showing excessive rust and starting to leak.

Replace with new dual temperature piping and insulation.

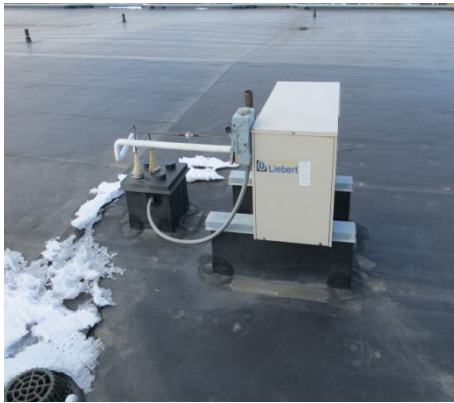
## **Air Handling Unit**

Air handling unit is nearing the end of its life cycle.

Will need to be replaced this year.

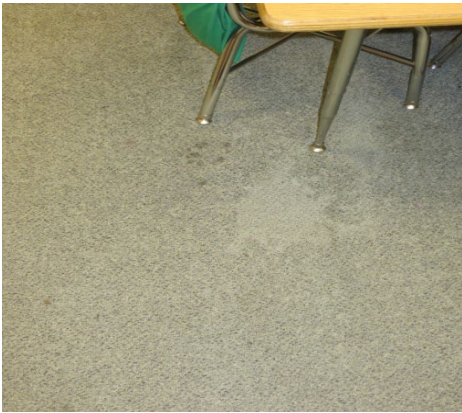
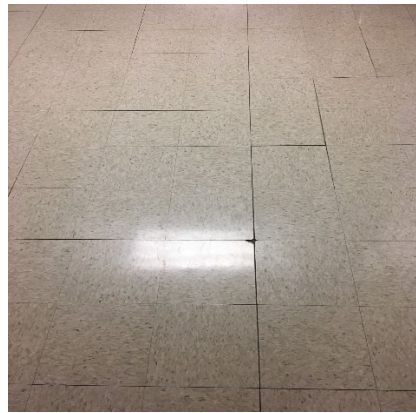
## **Flooring Replacement**

Carpet is starting to show wear and staining that we are unable to remove.

Tile is lifting and cracking in several areas.

Flooring will need to be replaced.

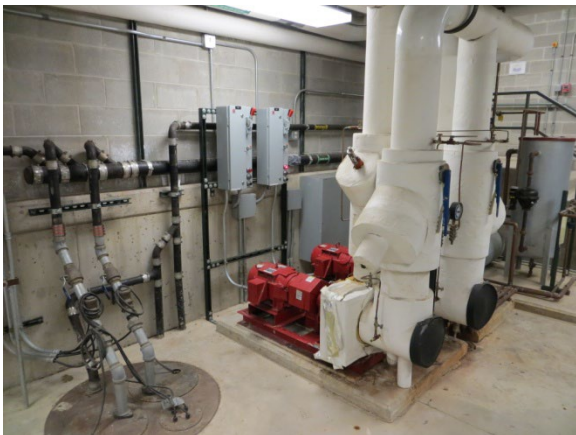
## **Chilled Water Pumps (2) – Add VFD**

Original to the building.

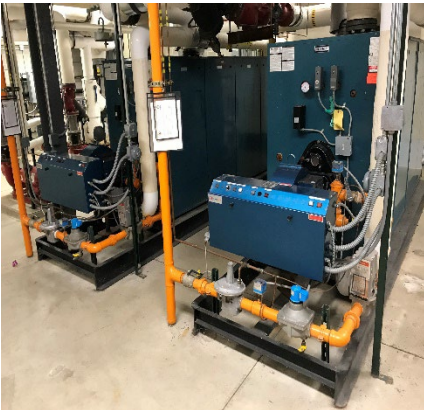
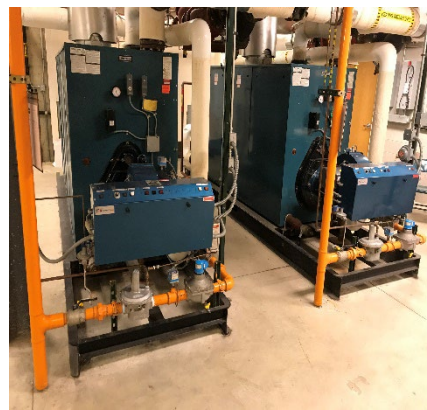
## Boilers and Primary Pumps Replacement

Boiler and primary pumps are 20 years old and original to the building.

Replacement will be needed within this year.

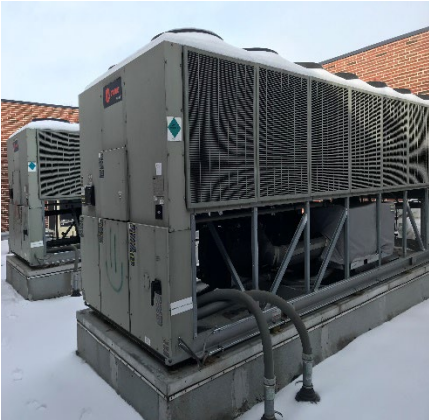
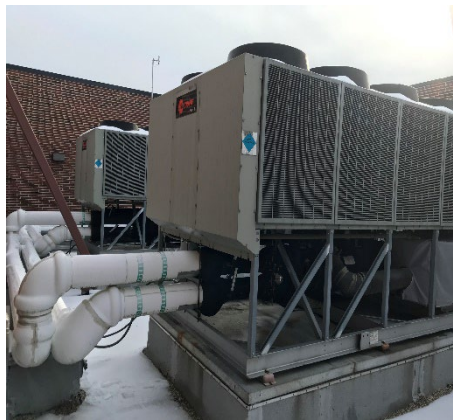
## Trane Chillers

14 years old chillers are nearing the end of their service life as per ASHRAE.

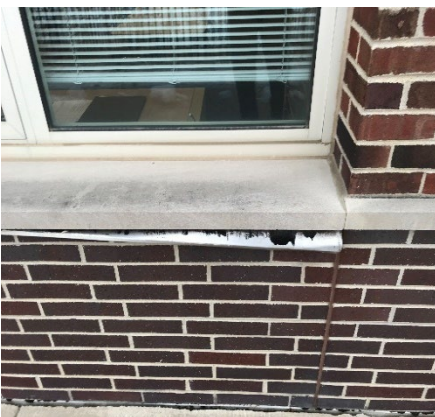
## Tuckpointing/ Masonry Repairs

Cracked and missing mortar joints and drip edge repairs.

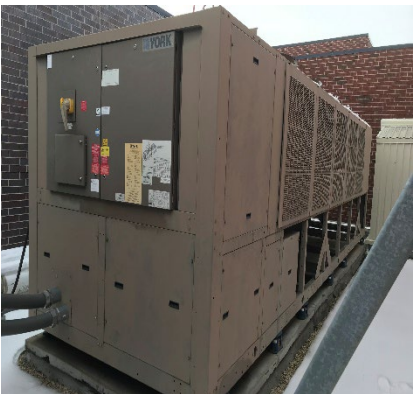
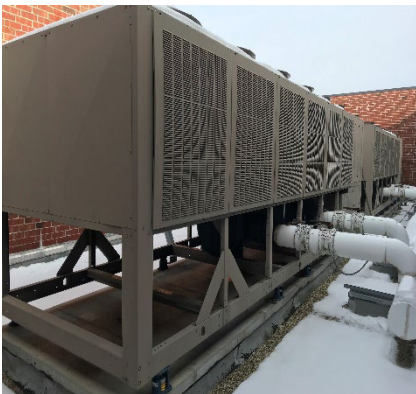
### York Chillers

13 years old chillers are nearing the end of their service life as per ASHRAE.

Replacement will be needed within the next two to five years.

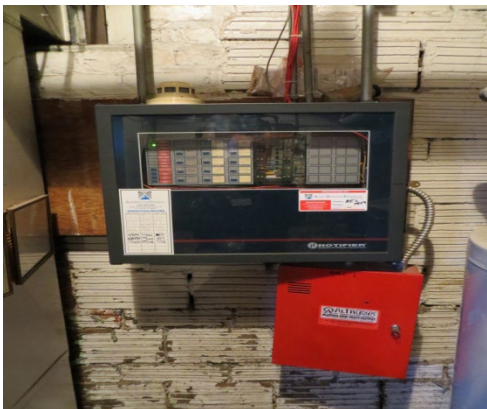
## Fire Alarm System

Notifier 5000 fire alarm panel will need to be updated to meet current NFPA code requirements.

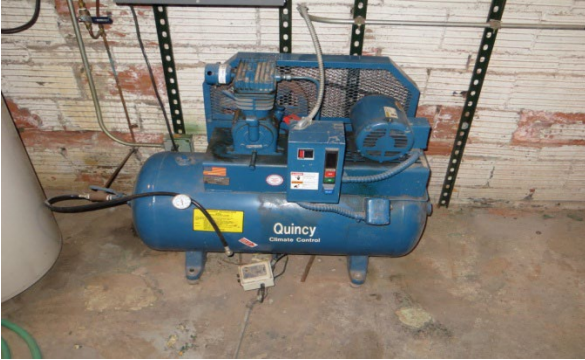
### Air Compressor

26 years old and needs to be replaced.

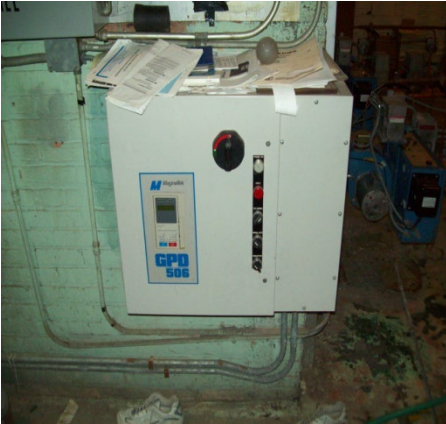
### Variable Frequency Drive

VFD has failed and needs to be replaced.

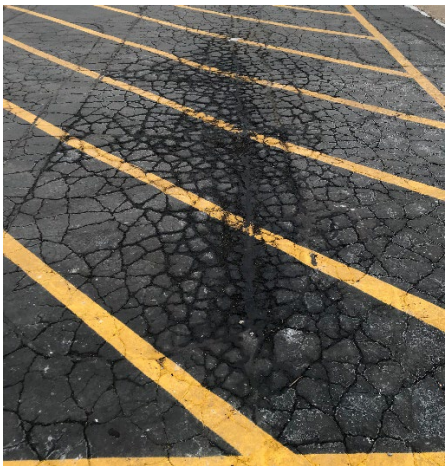
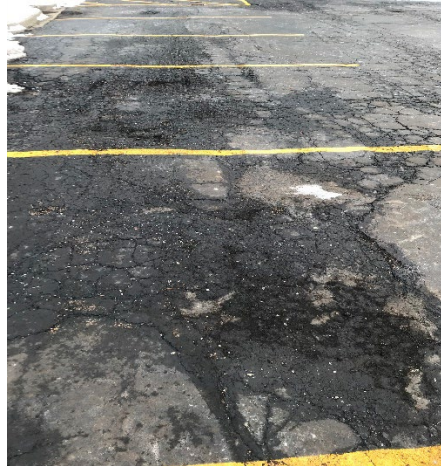
### Parking Lot

Several areas with extreme cracking.

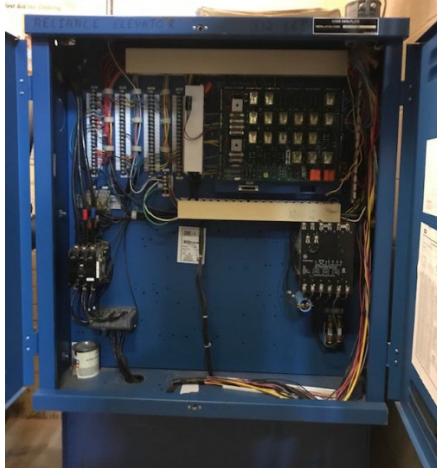
### Elevator Control System Upgrade

The current elevator control system parts are becoming obsolete and no longer available for repairs.

Control upgrades will be needed in the next two years.

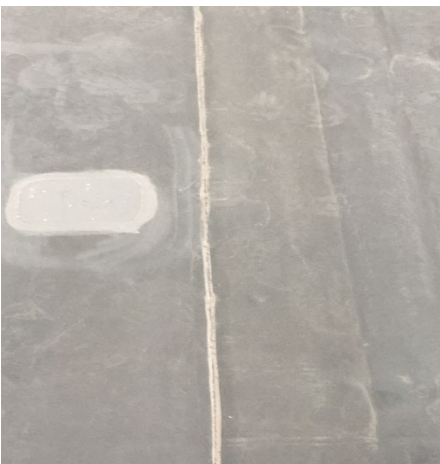
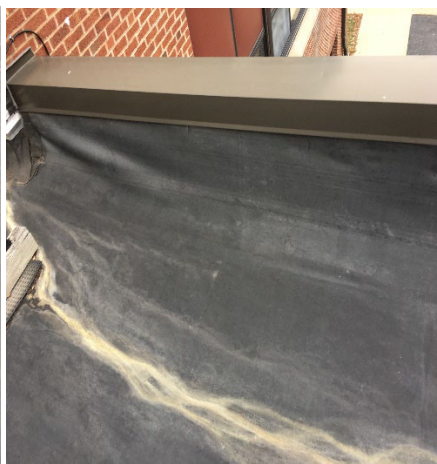
### Roof

The roof is 20 years old and many sections are in poor condition.

Roof replacement/restoration will be needed in the next two to four years.

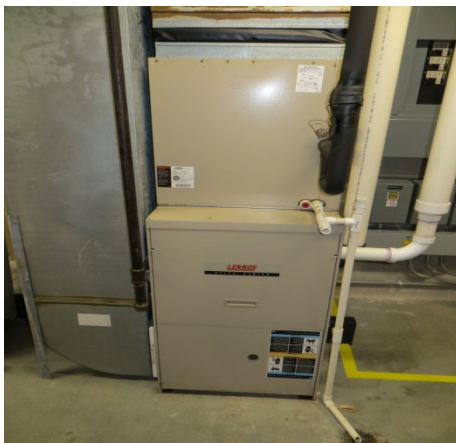
## HVAC Split System

The 3 Lennox split systems are nearing their ASHRAE recommended service life.

Replacement will be needed within the next two years.

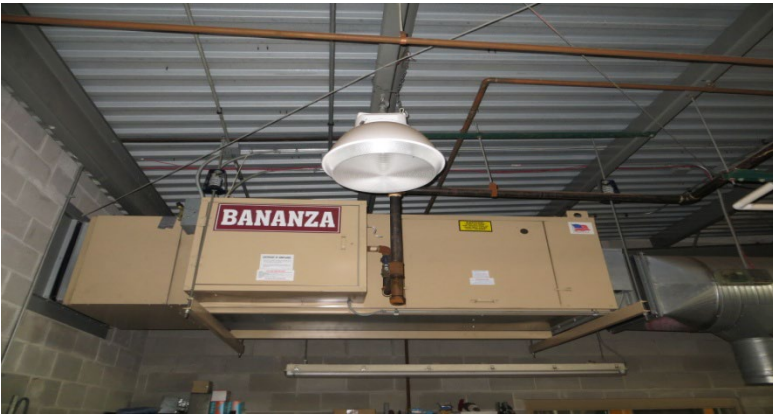
## Air Handling Unit

The three Bananza make-up air units are nearing their ASHRAE recommended service life.

Replacement will be needed within the next two years.

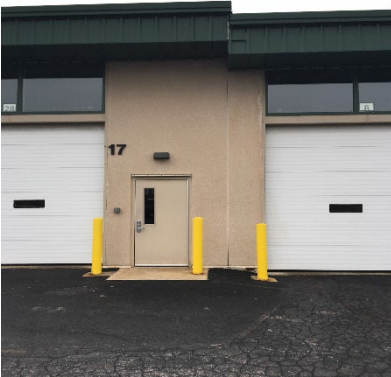
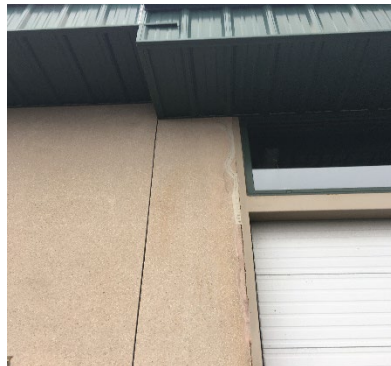
## Architectural Precast Wall Panel

The exterior architectural precast wall panel has cracked and will need to be replaced.

Replacement will be needed in the next two years.
