Geneva Community Unit School District #304
Operations and Maintenance
7 Year Capital Improvement Plan

April 10, 2023

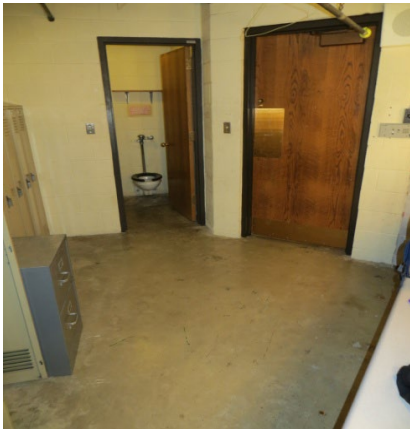
Cafeteria and Stagecraft Bathrooms

Bathrooms are 48 years old.

Showing significant wear.

Need to update.

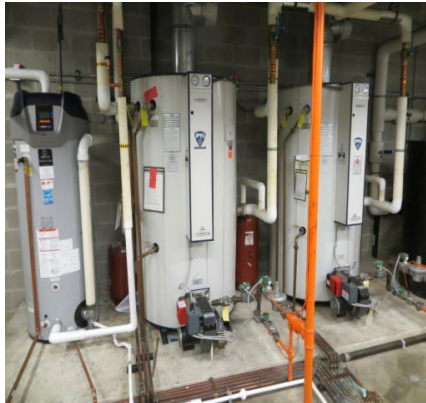
Hot Water Heaters

The two 500-gallon PVI water heaters are nearing the end of their life cycle.

Replacement will be needed within the next four years.

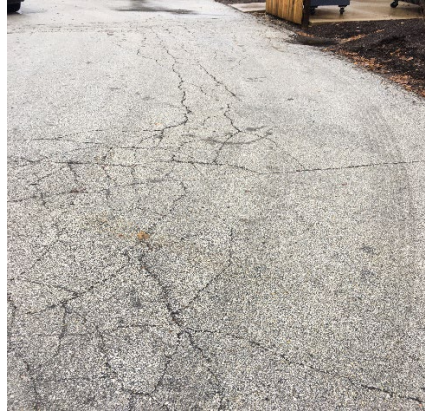
Parking lot

Several areas with extreme cracking.

Sealcoating and crack filling will be needed.

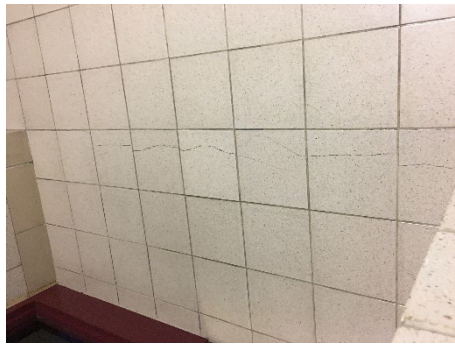
Flooring Replacement

Carpet is starting to show wear and seams are starting to pull apart.

Life cycle of carpet is 12-20 years.

Tile is lifting and cracking in several areas.

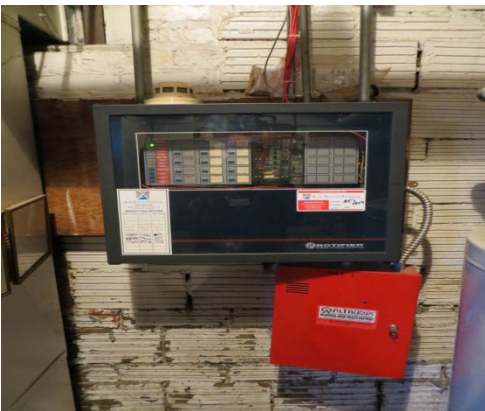
Fire Alarm System

Notifier 5000 fire alarm panel will need to be updated to meet current NFPA code requirements.

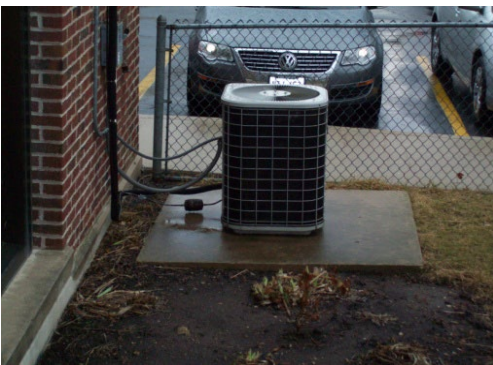
Fan Coil and Condensing Units

The entire building is cooled with fan coil units.

Several are beginning to fail and most will need to be replaced in the next two years.
