Geneva Community Unit School District #304  
Operations and Maintenance  
7 Year Capital Improvement Plan

February 12, 2018

## Introduction

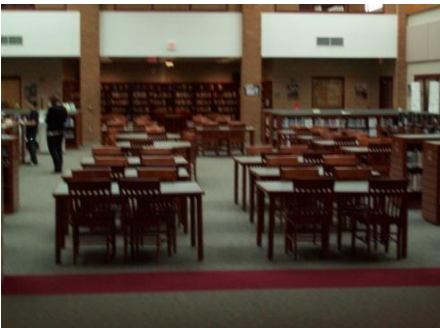
## LMC

AHU is undersized for space.

Only two VAV boxes serving the space.

Recommend increasing the capacity of the AHU and adding four to six VAV boxes with controls to increase comfort and control humidity.

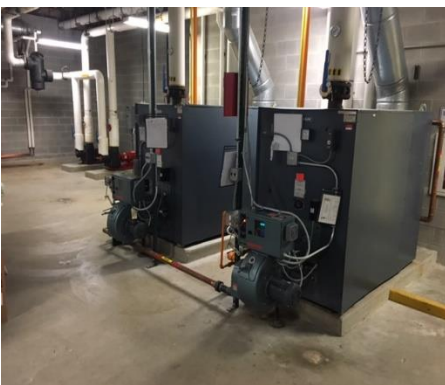
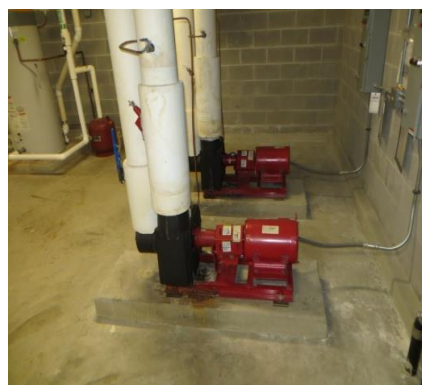
## Boiler and Secondary Pumps Replacement

19 year old boilers and pumps nearing end of their estimated service life as per ASHRAE.

Need to be replaced with energy efficient design.

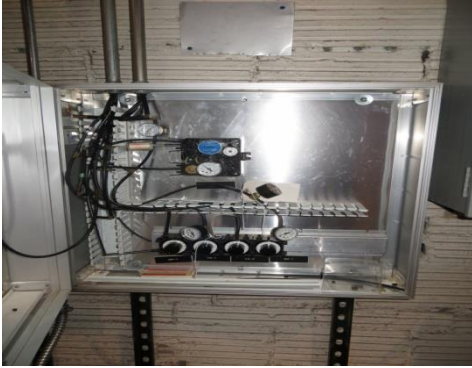
## HVAC Controls

Upgrading the discontinued pneumatic controls with Direct Digital Controls.

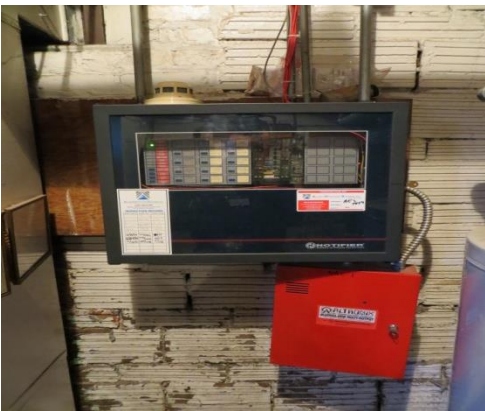
## Fire Alarm System

Notifier 5000 fire alarm panel will need to be updated to meet current NFPA code requirements.

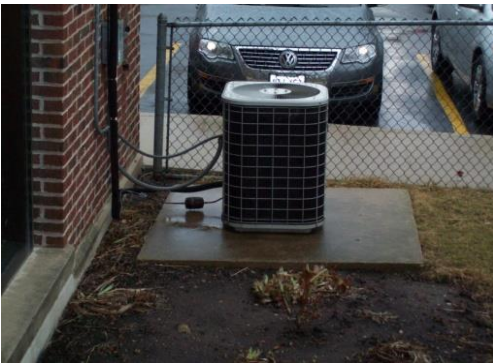
## Fan Coil and Condensing Units

The entire building is cooled with fan coil units.

Several are beginning to fail and most will need to be replaced in the next two to seven years.

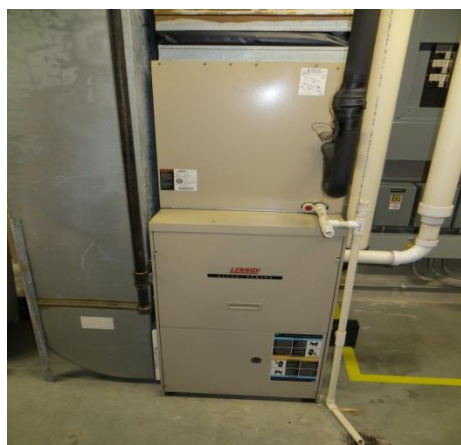
## HVAC Split System

The 3 Lennox split systems are nearing their ASHRAE recommended service life.

Replacement will be needed within the next seven years.
