**AGENDA
OURAY CITY COUNCIL**

Monday, June 2, 2025 - 4:00 PM

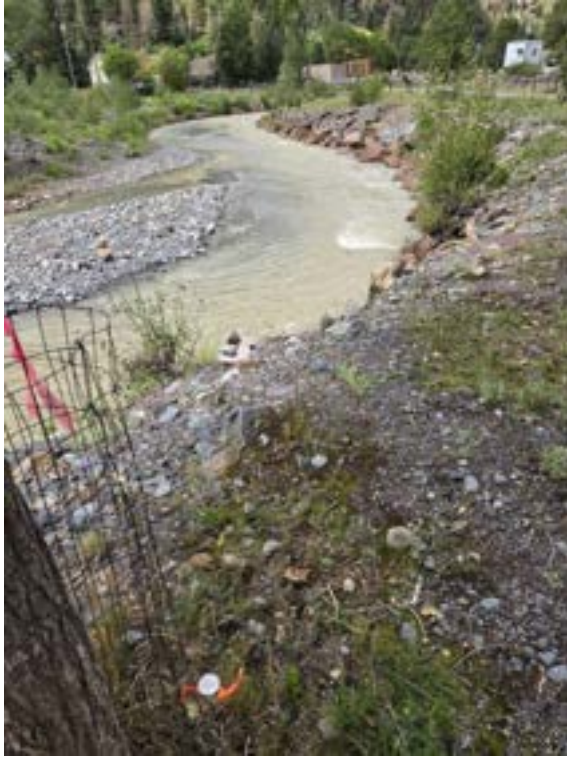
WSW 5 Monitoring Monument is located on the east side of the Uncompahgre River, (survey cap with orange flagging), adjacent to a tree with protective fencing. This monument location looks north, downstream, monitoring the excessive erosion to the stream bank on the right side of the river below the river trail. Deposition is significant center channel which exacerbates erosive shear stress by narrowing the channel.

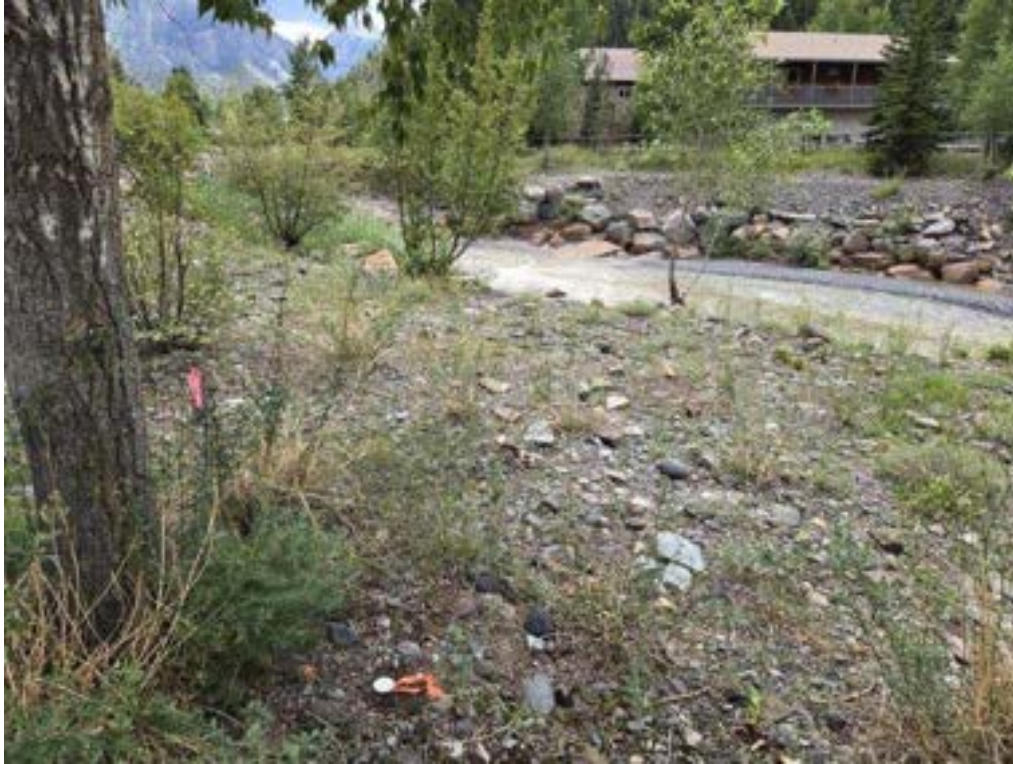
WSW 6 Monitoring Monument is on the east side of the Uncompahgre River on the floodplain (survey cap with orange flagging). It provides observation for mitigation and monitoring over an exposed utility line, San Miguel Power electrical, that crosses the river into the Biota Building. The Josey Diversion Structure upstream may 'starve' the channel downstream of alluvium or bedload transfer, similar to a dam, prohibiting a natural grade transition in the stream channel. Another possibility is the unregulated extraction of alluvium downstream of this area caused by the significant head cut.

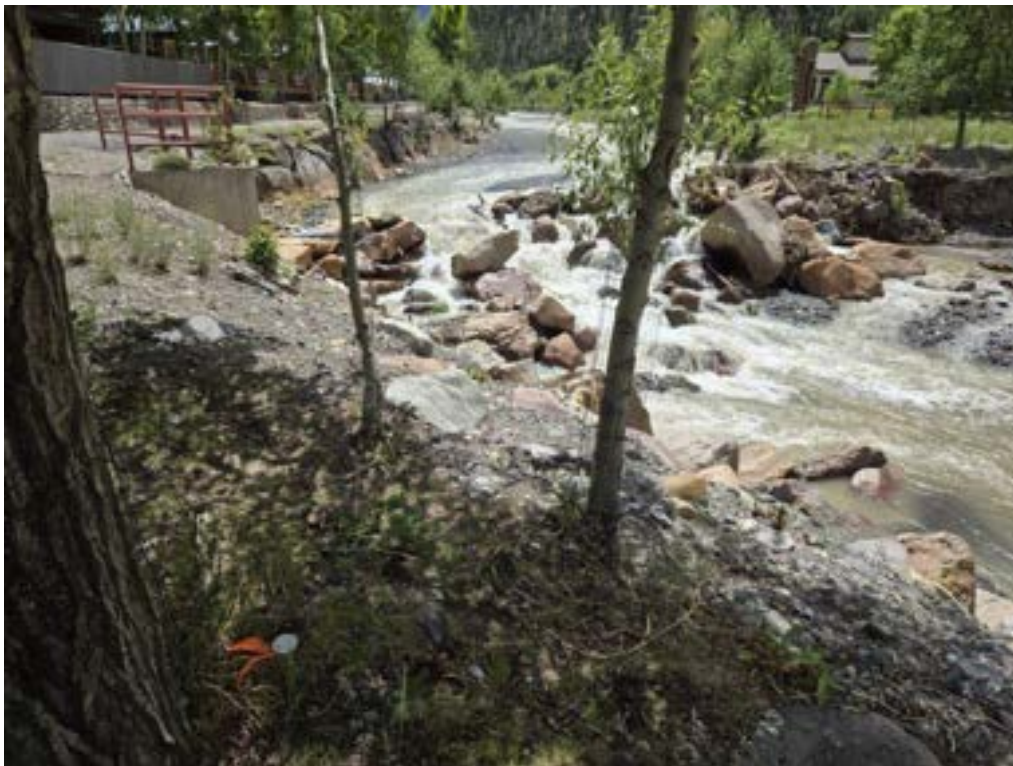
WSW 7 Monitoring Monument is located on the northeast side of the Uncompahgre River, (survey cap and orange flagging) next to a large tree overlooking the Josey Ditch Diversion Structure.

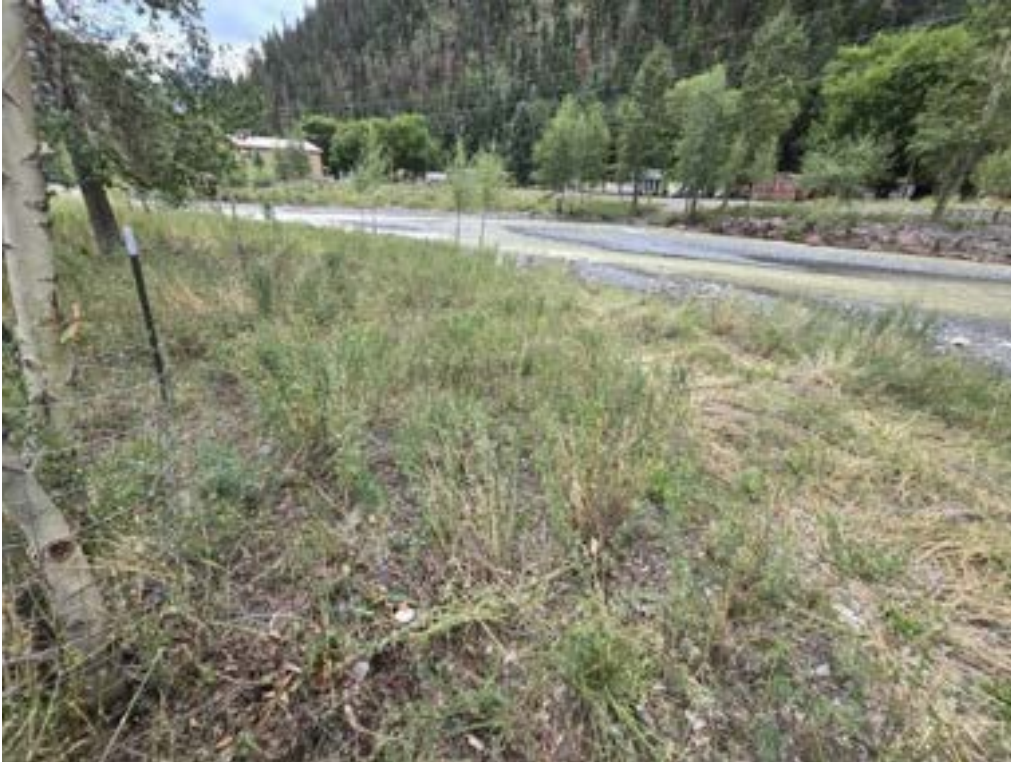
WSW 9 Monitoring Monument location on floodplain (survey cap and orange flagging) on east side of Uncompahgre River. This low gradient stream reach experienced significant deposition from Summer 2024 rain events, caused by tributary flooding and colluvial material transfer to main channel.

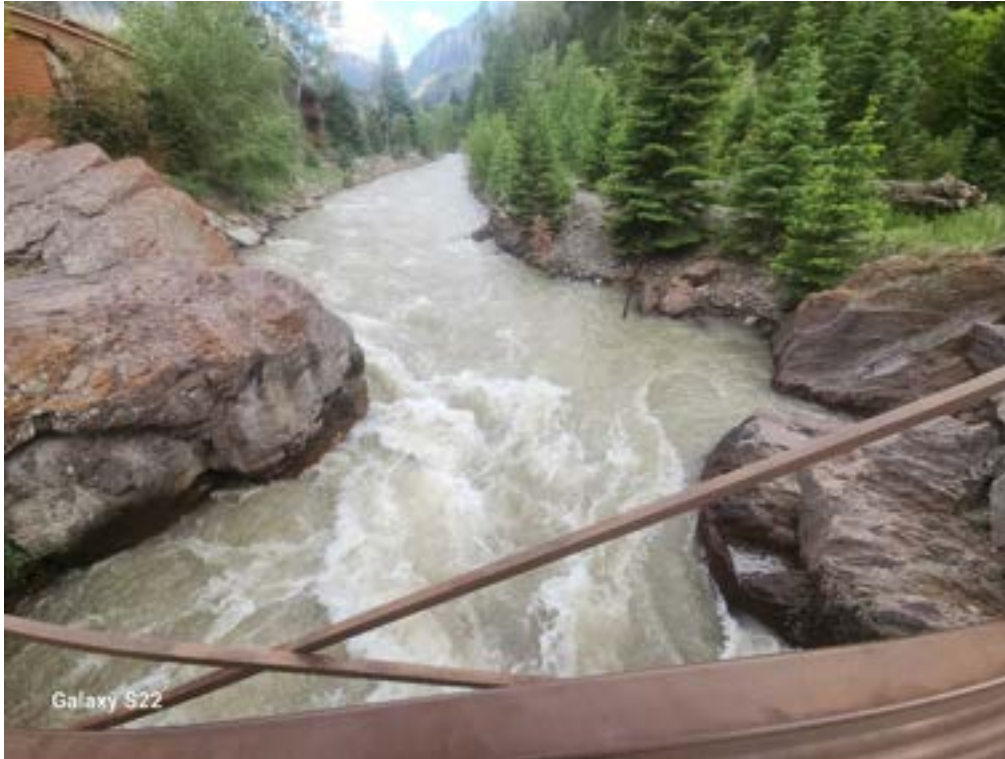
WSW 11 photo of Uncompahgre River flowing through bedrock channel below bridge.

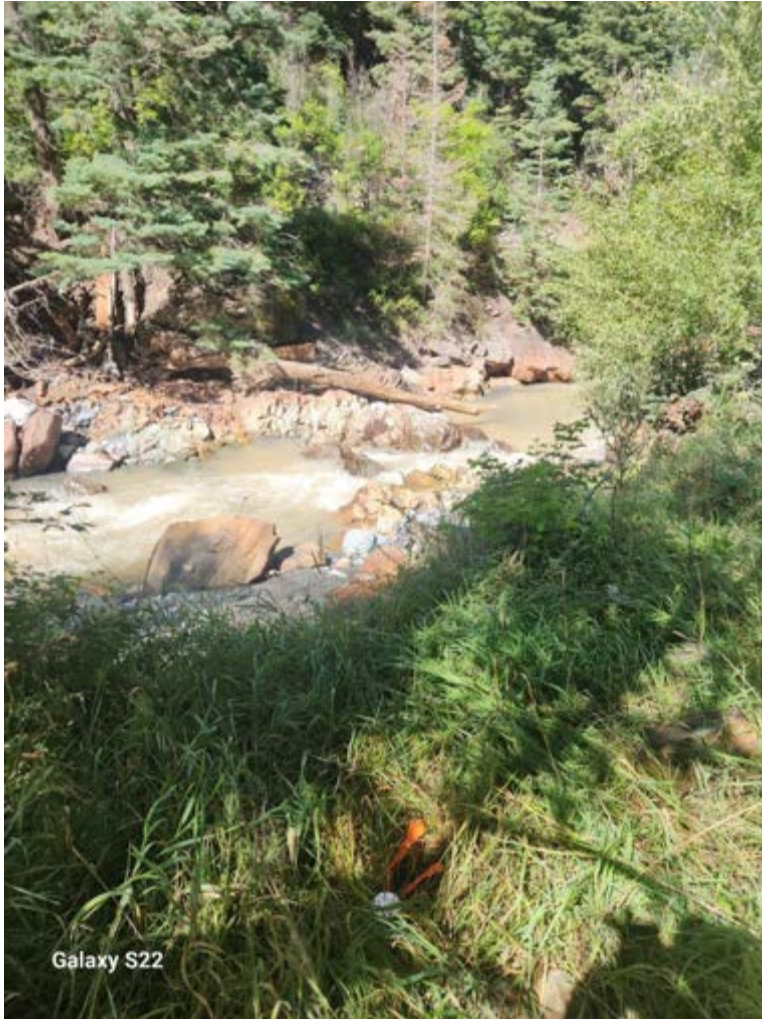
WSW 12 Monitoring Monument (survey cap with orange flagging) is located in thick grass on the floodplain to the east of the Uncompahgre River. The monument was intentionally placed at a suitable location to provide a monitoring benchmark during a flood discharge event within the river.

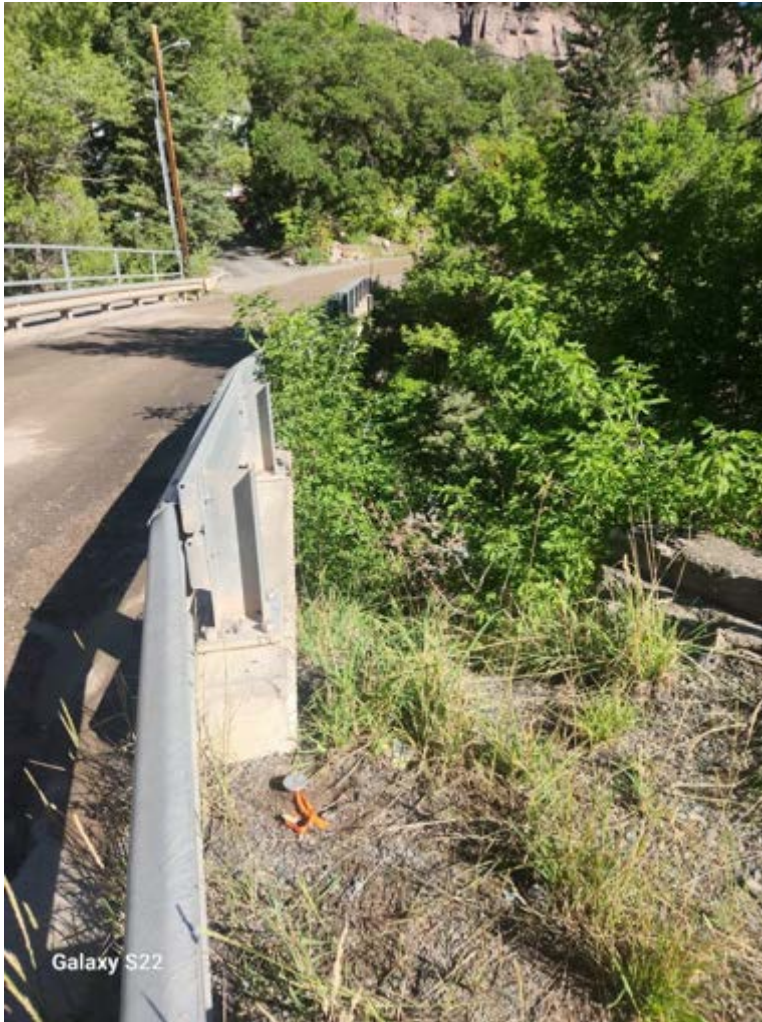
WSW 15 Monitoring Monument, (survey cap with orange flagging), is the furthest upstream monitoring location, located downstream of Oak Creek and Canyon Creek confluence with Uncompahgre River. The bridge at 3rd Avenue and Oak Street is the first span structure across the river downstream of Uncompahgre River Canyon.

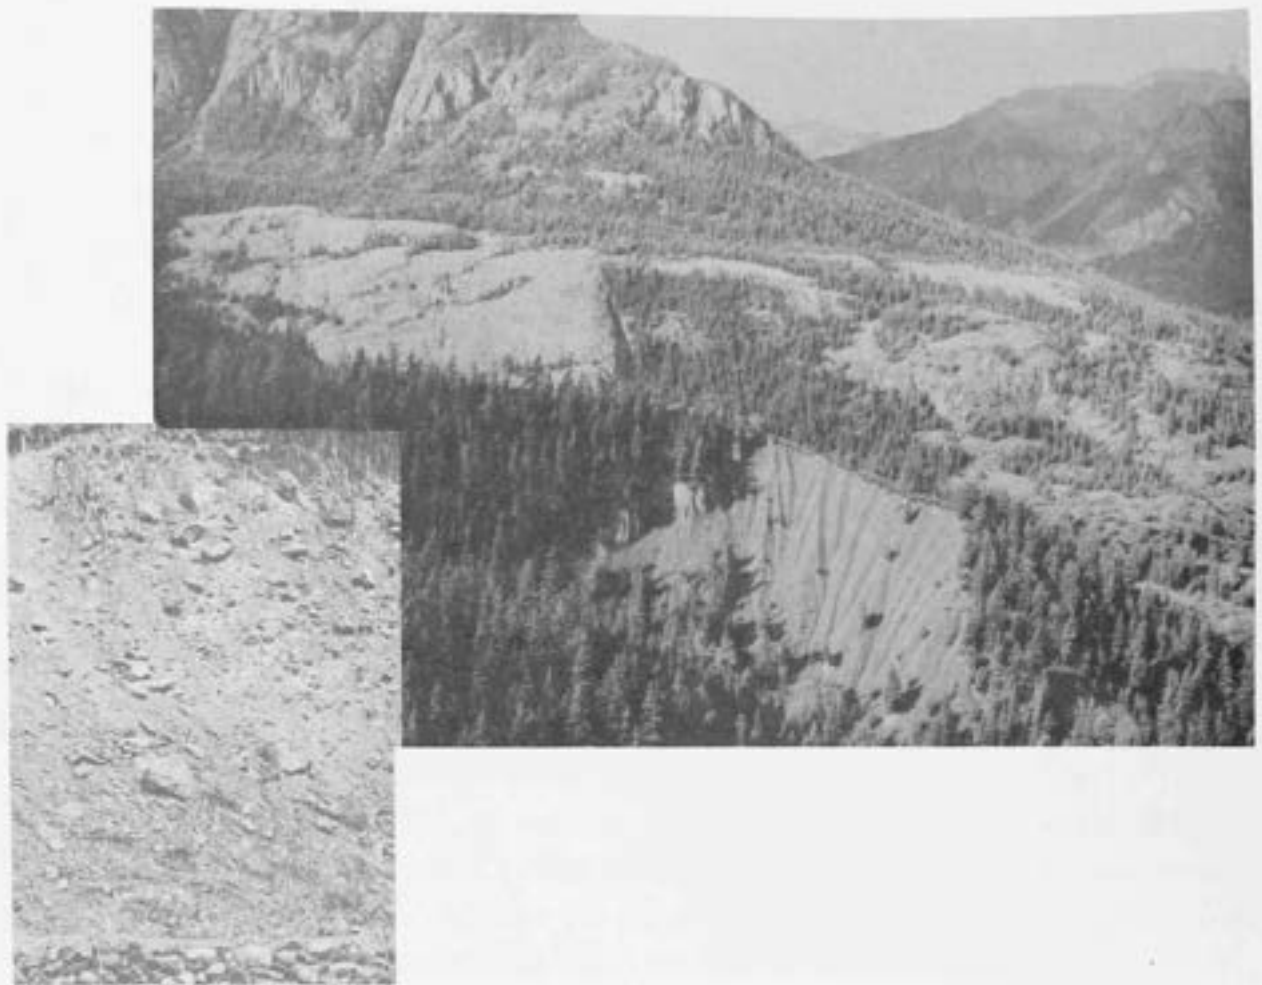
Figure 4. Glacial drift deposit in Portland Creek basin. Boulders shown in inset average about one foot in width.

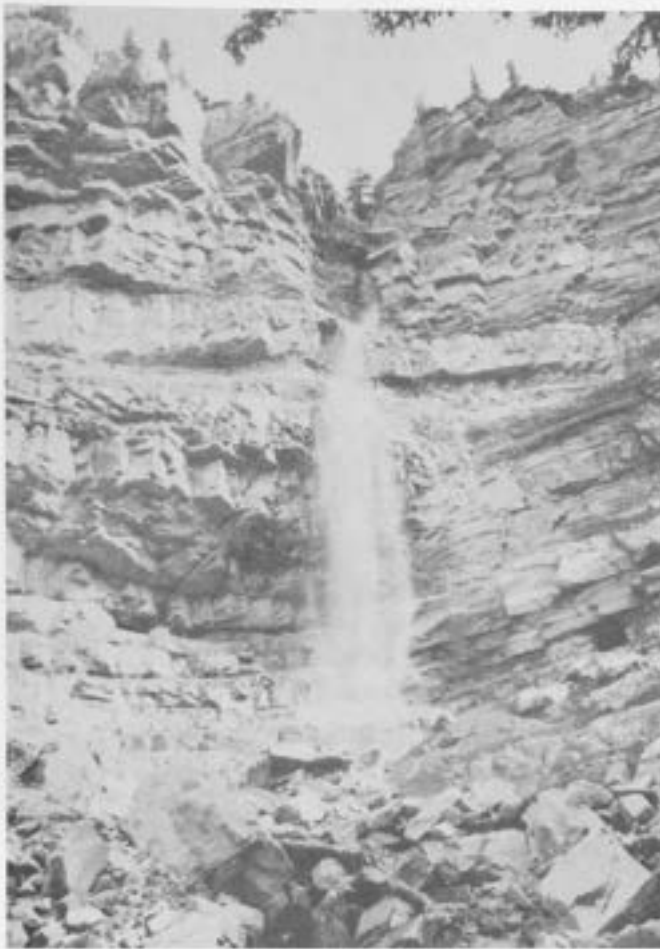
Figure 5. Cascade Falls (photo courtesy CWCB).

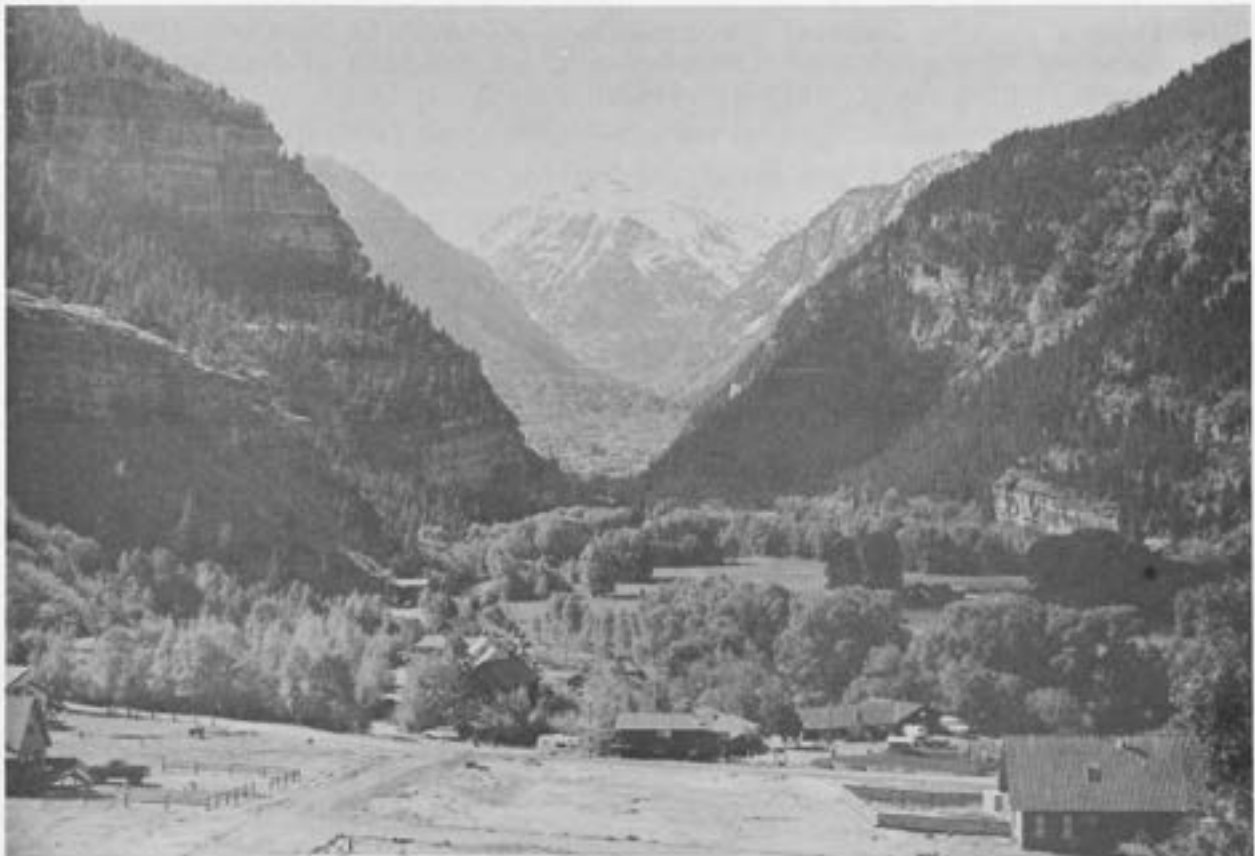
Figure 7. View looking south toward Ouray, Colorado, 1982.

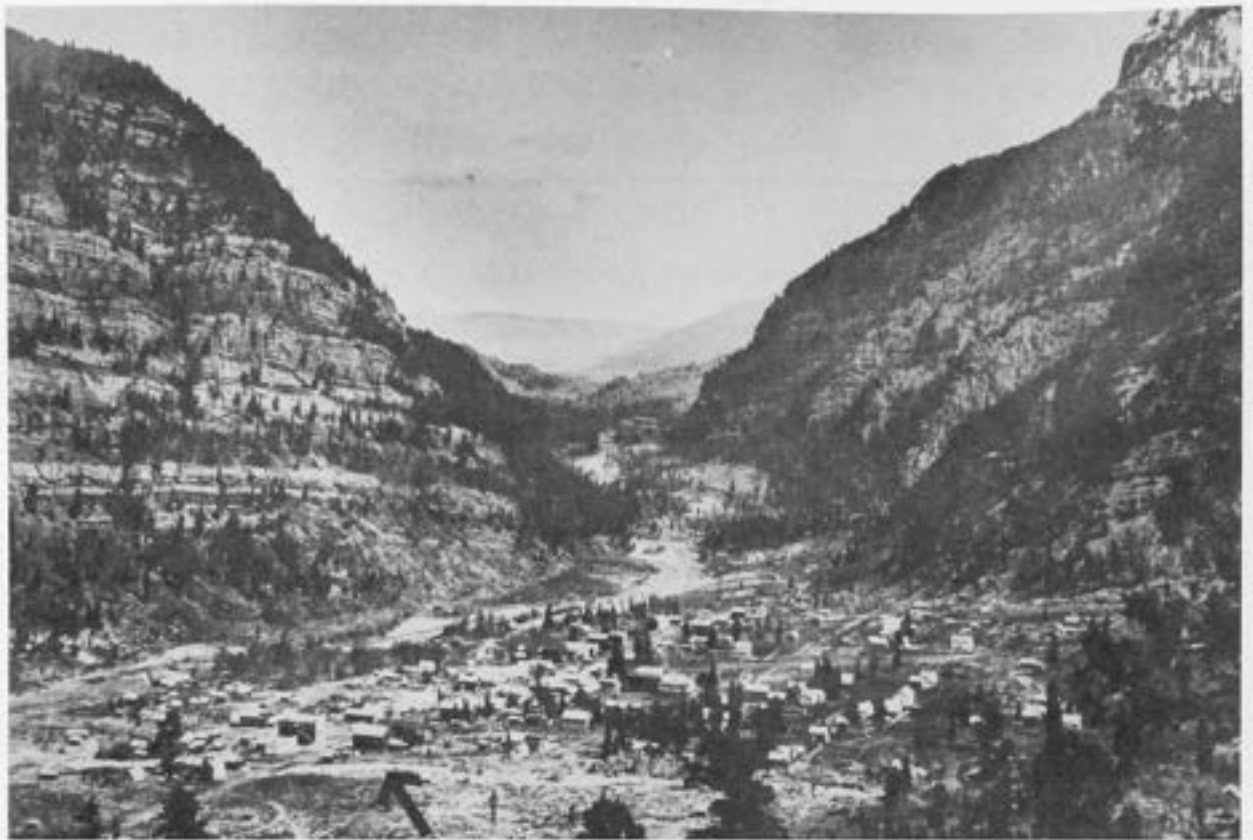
Figure 9. Ouray, Colorado, before 1886. Portland Creek in foreground.
(Photo courtesy Colorado Historical Society)

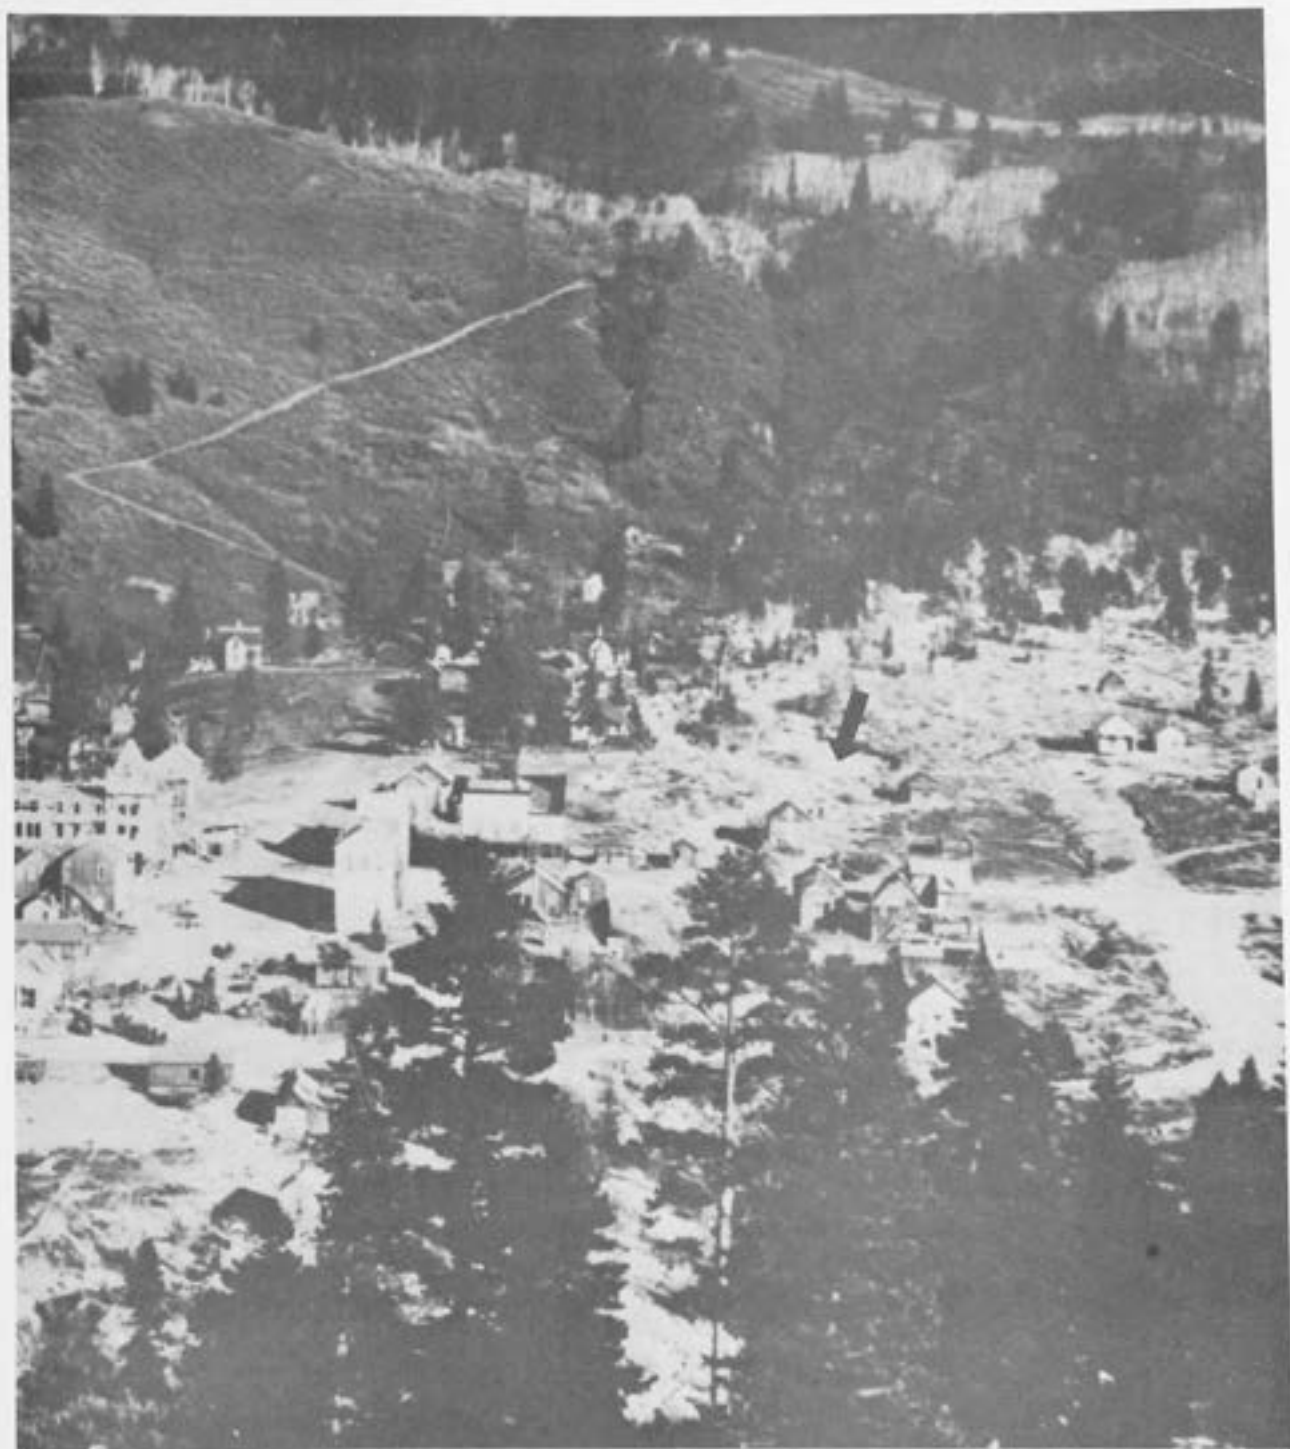
Figure 10. Ouray, Colorado, 1886. Portland Creek center (see arrow).
(Photo courtesy Colorado Historical Society)

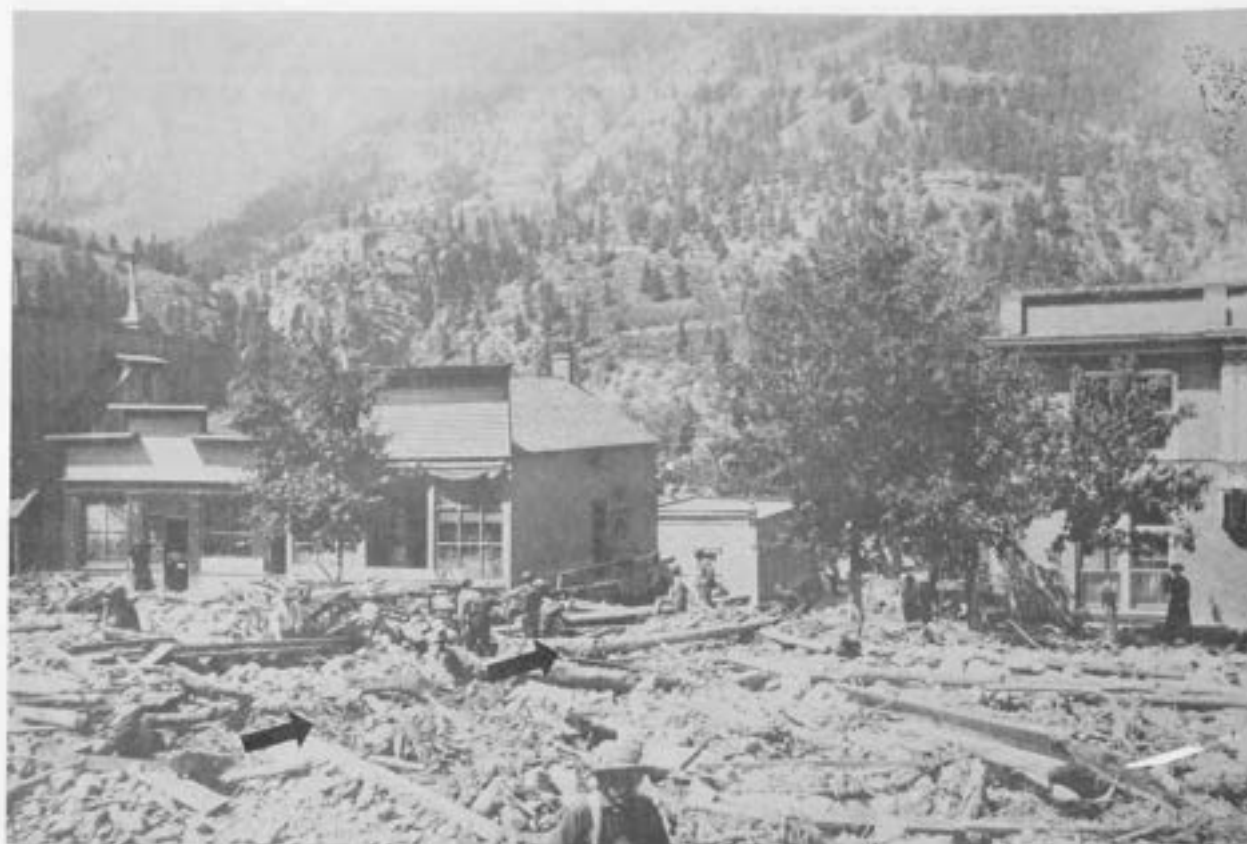
Figure 11. Debris flow on Portland Creek, 1909. Looking west across Main Street. Flume passes between buildings on left and tree (see arrows). (Photo courtesy Denver Public Library Western History Collection)

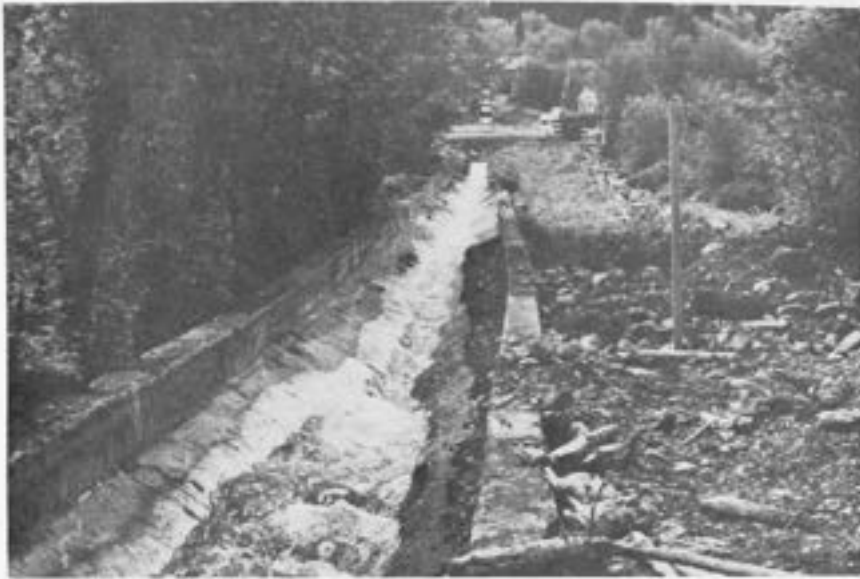
During this storm Oak Creek changed its course, cutting a new path east of its old outlet into Canyon Creek. Cascade Creek blocked at the mouth and filled with large boulders and timber. The debris backed-up three blocks, causing the water to form a new channel outside the flume and flooding many homes. Skyrocket ran so heavily that it pushed a dam of rocks and mud across the Uncompahgre, forcing the river to use the railroad tracks as a temporary channel. The Radium Springs fish ponds and pool were filled with mud. Corbett Creek tore out a section of the railroad tracks and a bridge before joining Dexter Creek and the Uncompahgre River to wash out the road to Ridgway (US 550). The pipeline conveying water from the big reservoir was broken and for several days residents used the limited supply from the old Oak Creek reservoir.

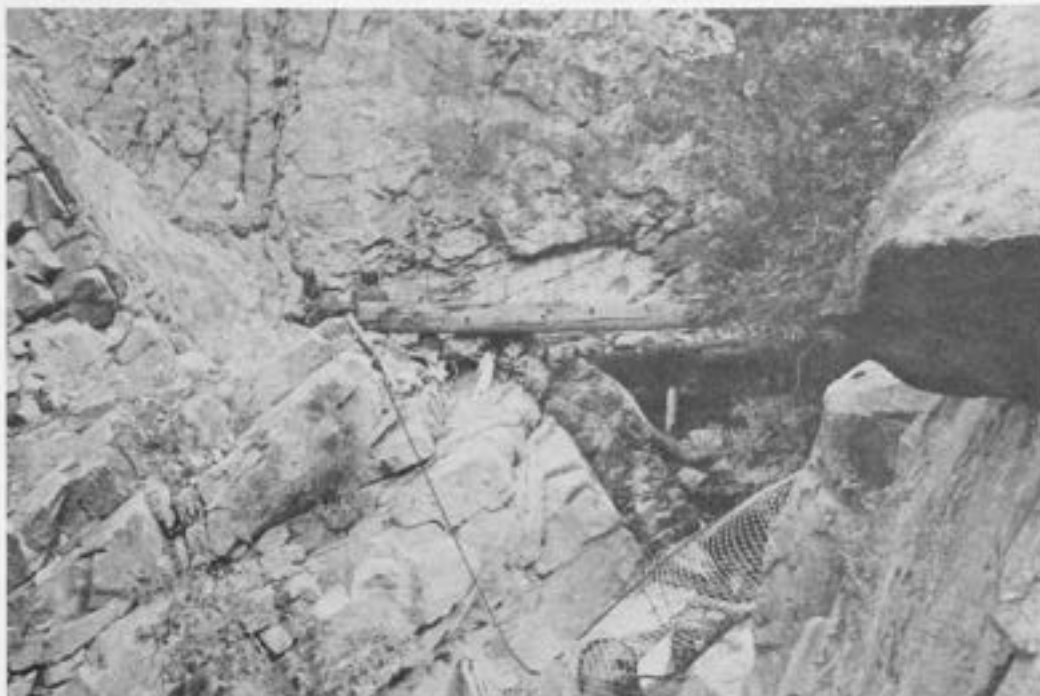
Figure 13. Remains of wooden diversion dam constructed on Skyrocket Creek in 1929. (Photo courtesy William P. Stanton, CWCB)

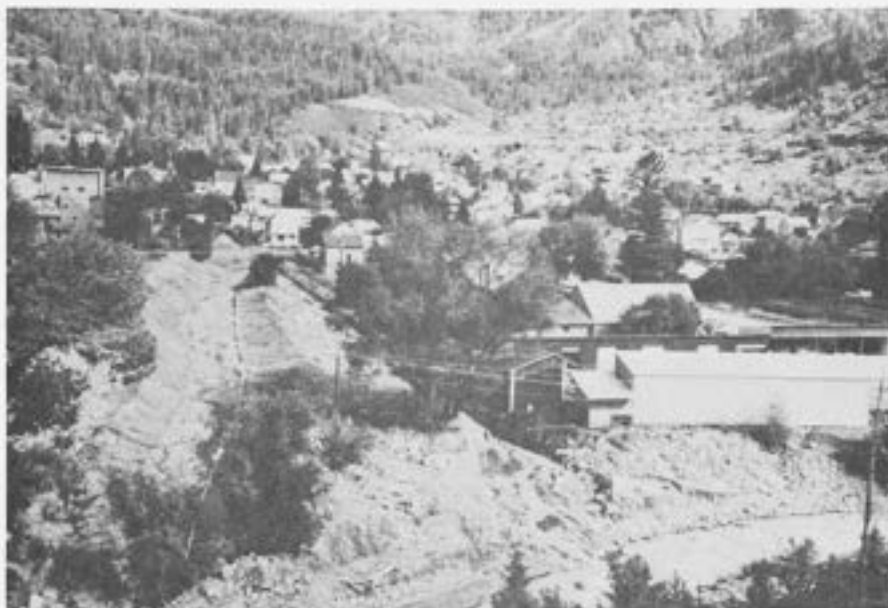
Figure 14. Portland Creek flume after 1982 event. Looking east from Oak Street. Debris is spread out where flume was broken in 1981.

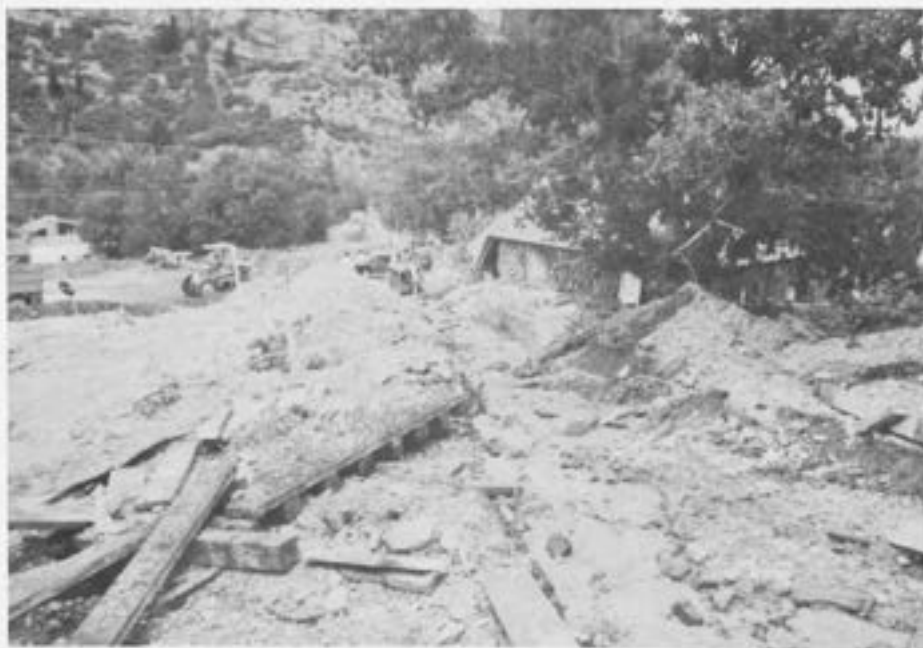
Figure 16. Debris back-up caused by plugged culvert on Cascade Creek at intersection with Highway 550, 1982 Looking west. (Photo courtesy William P. Stanton, CWCB)

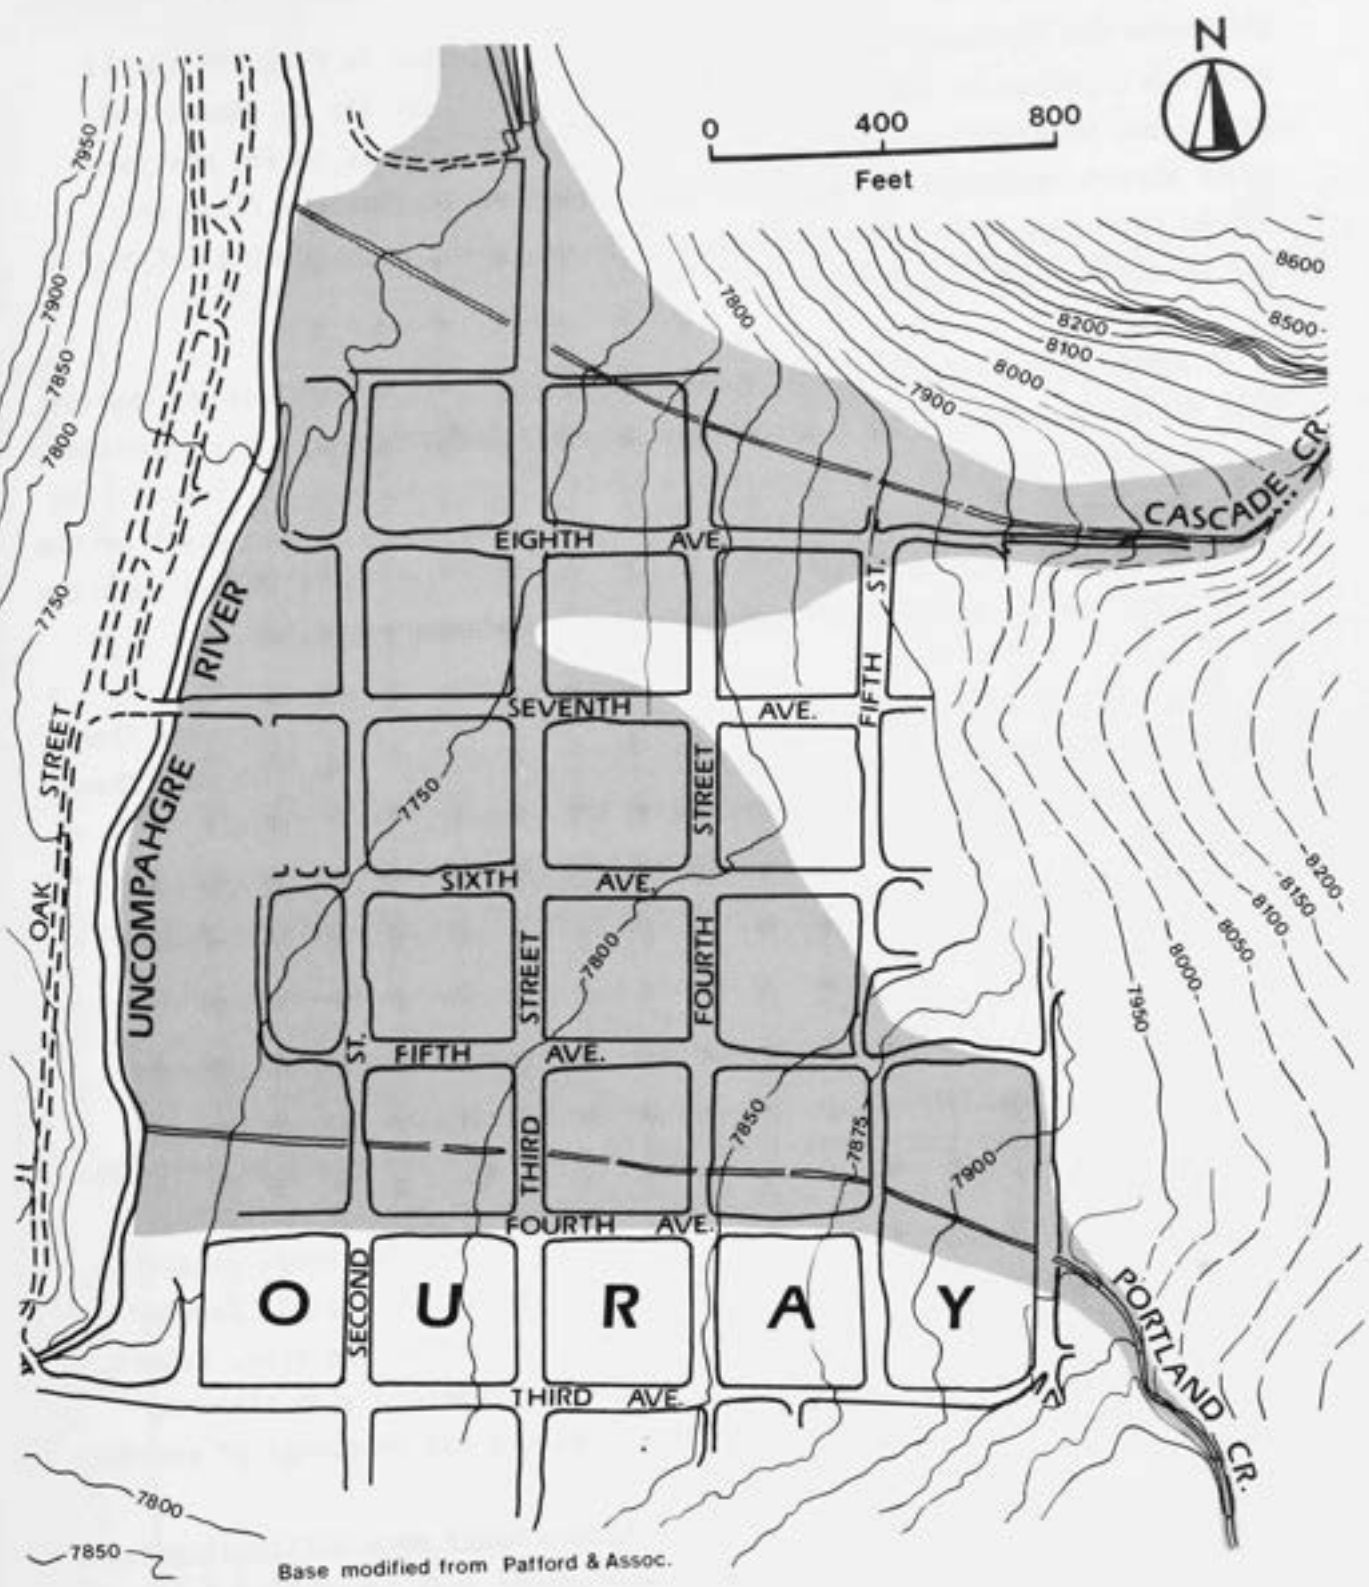
Figure 17. A & S "envelope of hazard due to flooding" for Portland and Cascade Creeks. (A & S Consultants, 1978)

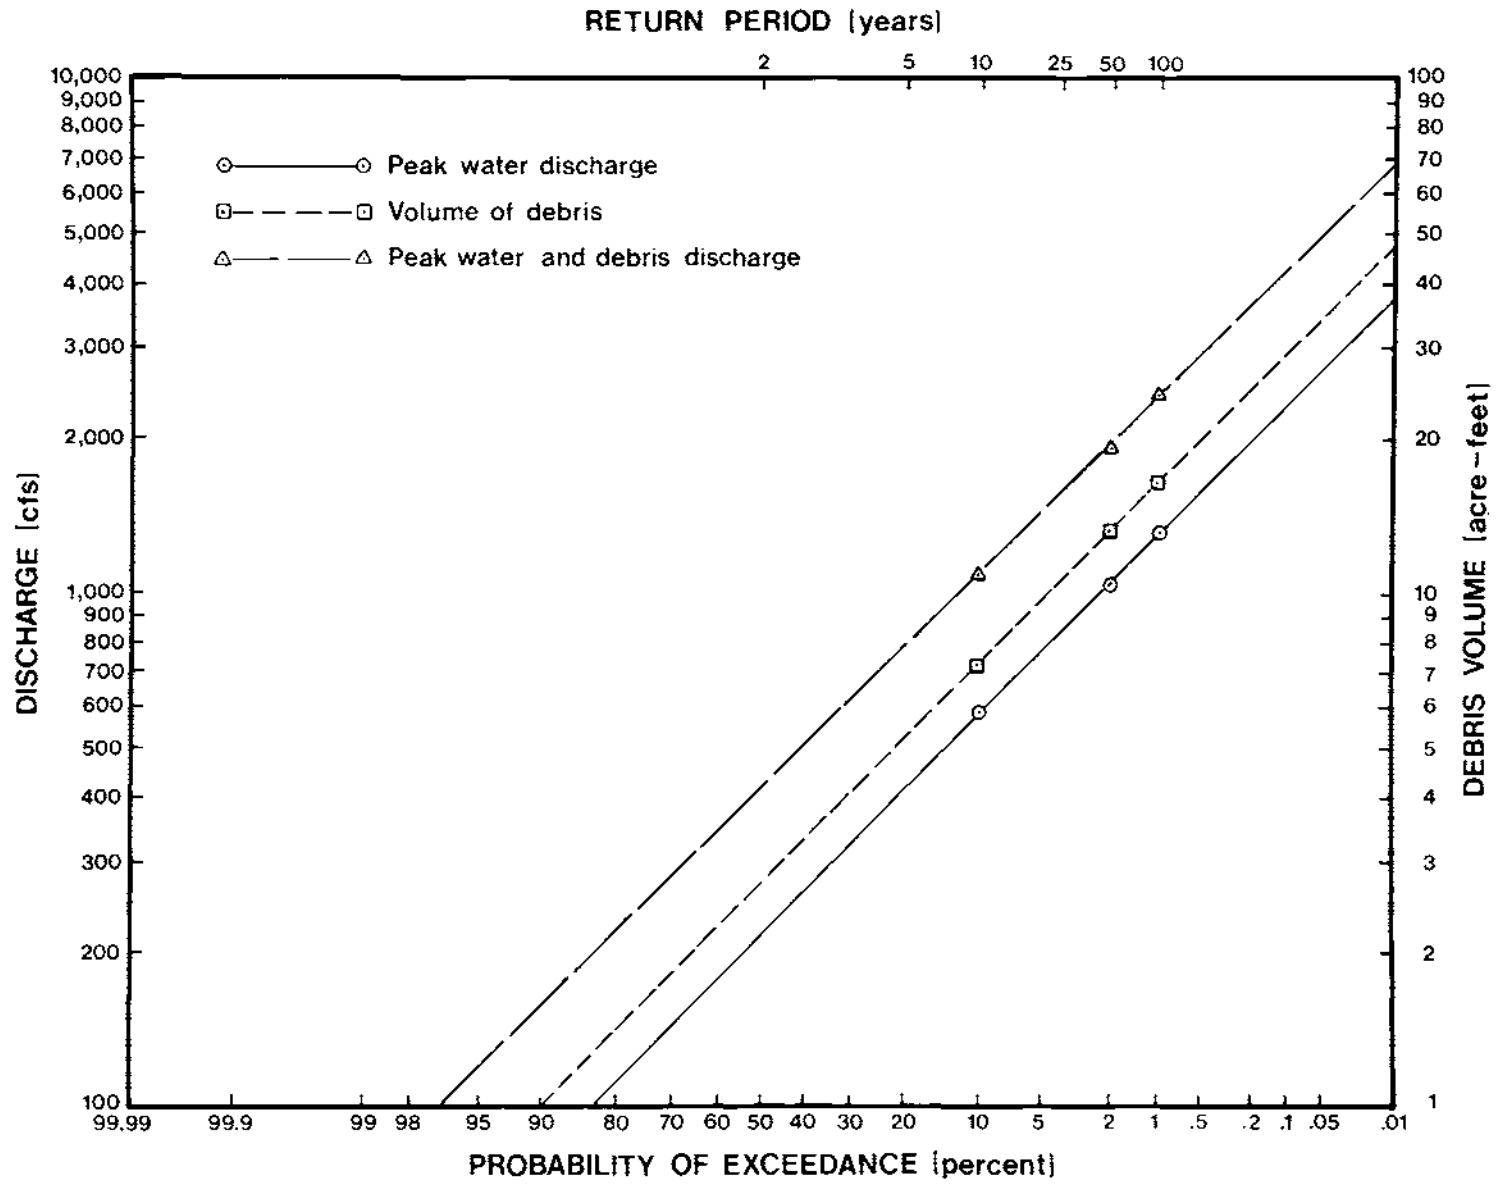
Figure 18. Portland Creek debris/flood frequency curve. (Simons, Li & Assoc., Inc., 1982)

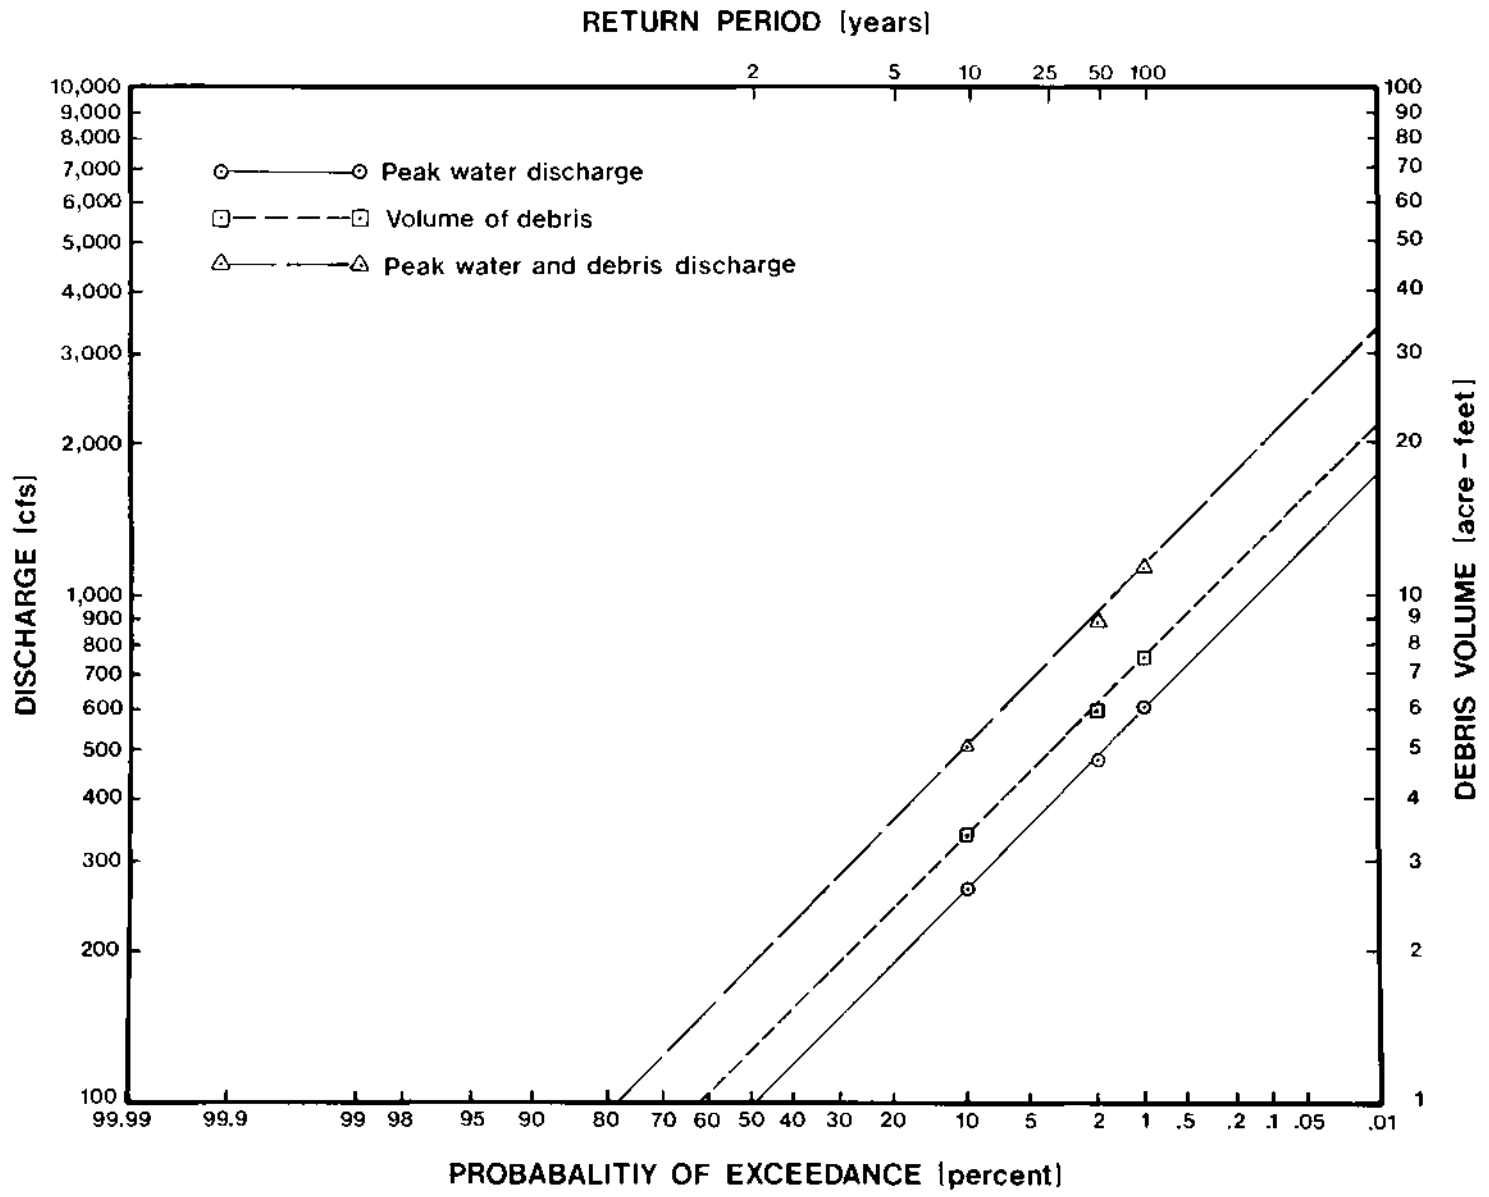
Figure 19. Cascade Creek debris/flood frequency curve. (Simons, Li & Assoc., Inc., 1982)

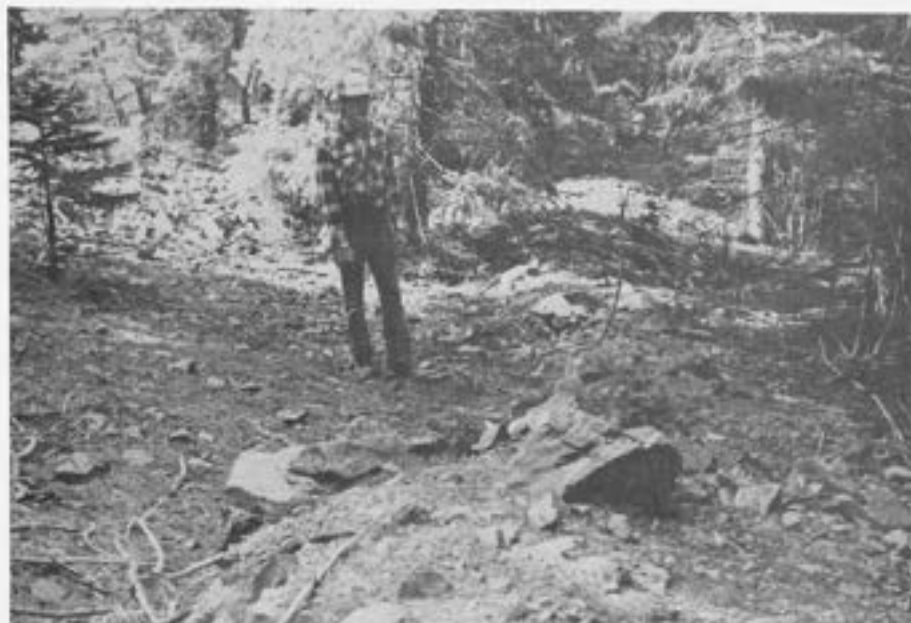
Figure 24. Debris-flow levee on Bridalveil Creek fan.

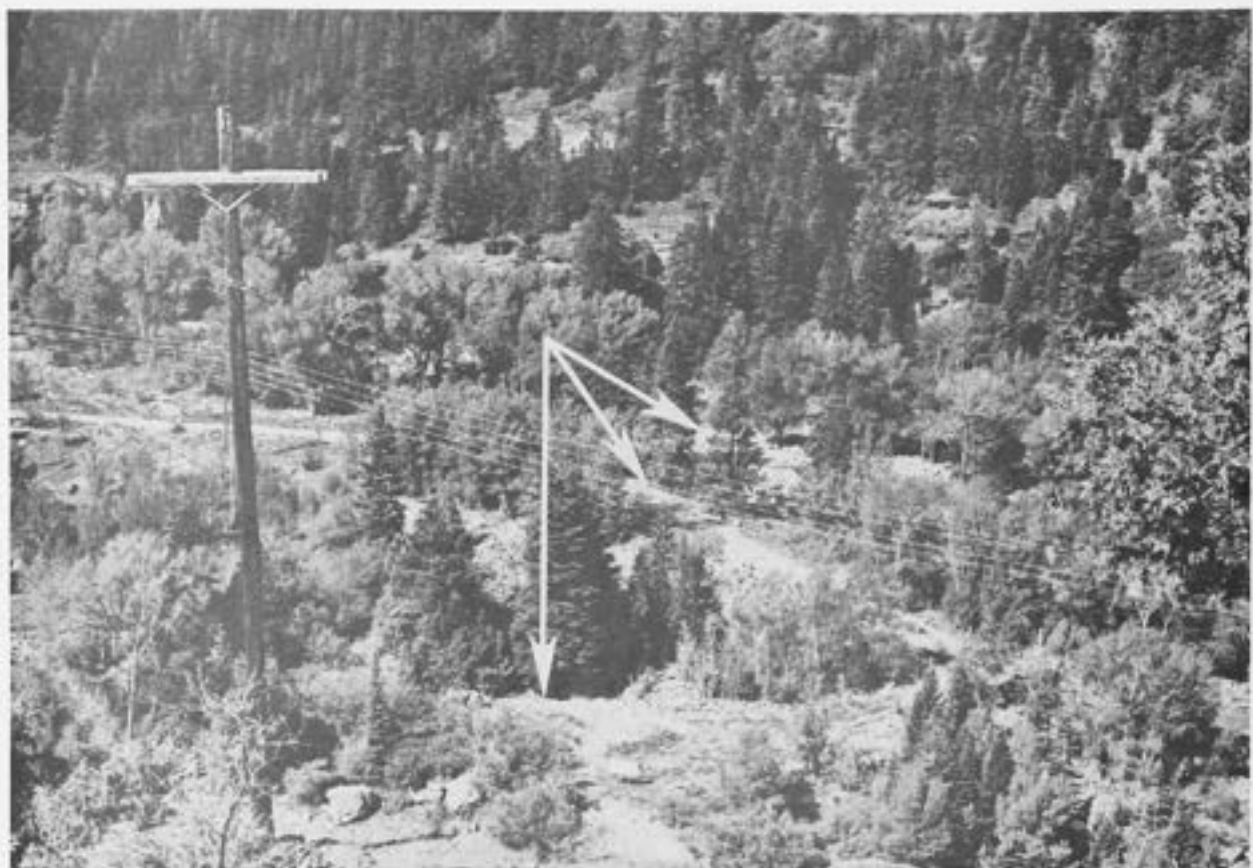
Figure 26. Debris-flow levees on Corbett Creek fan.
