**AGENDA
OURAY CITY COUNCIL**

Monday, June 2, 2025 - 4:00 PM

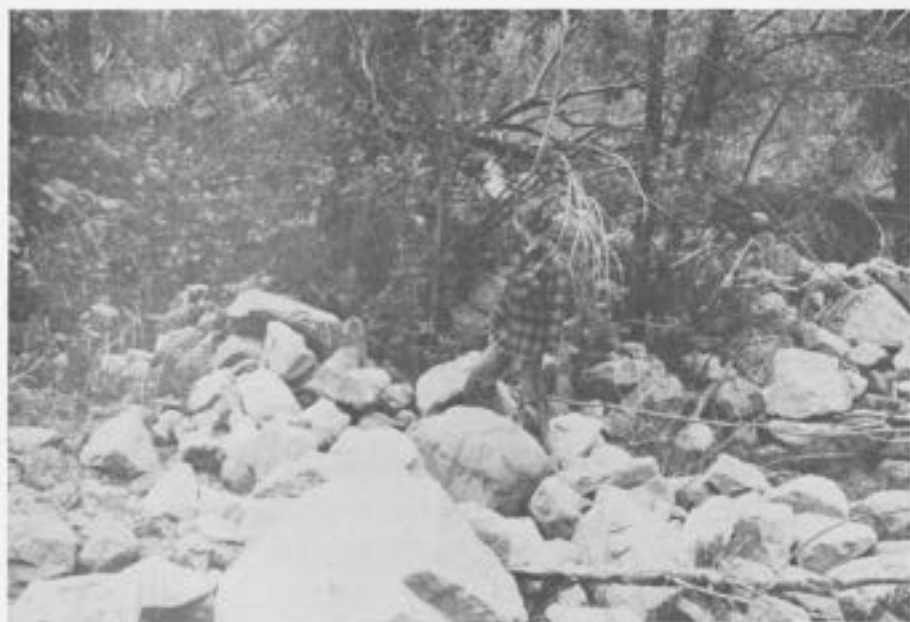
Figure 27. Debris-flow levee on Corbett Creek fan.

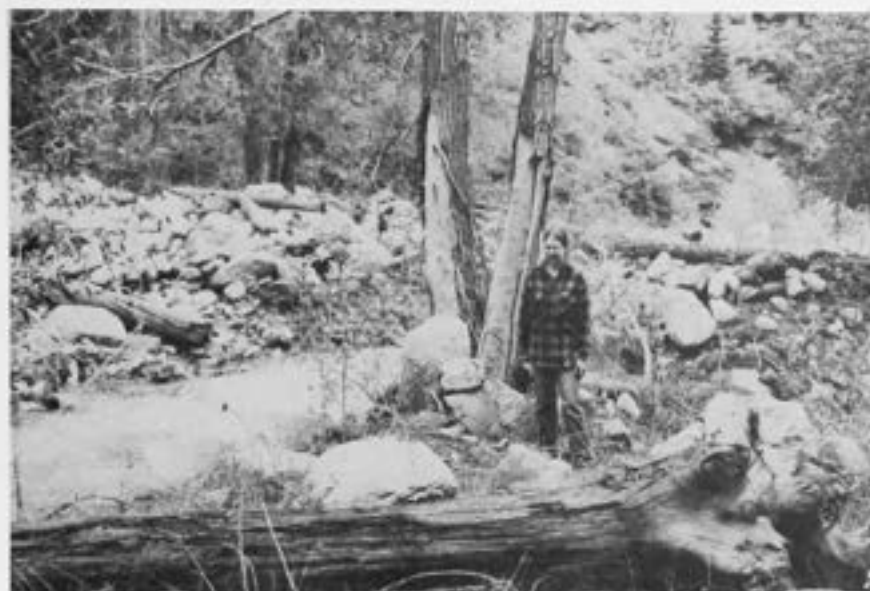
Figure 28. Tree scarring on and boulder wedged between tree trunks adjacent to Corbett Creek, 1982.

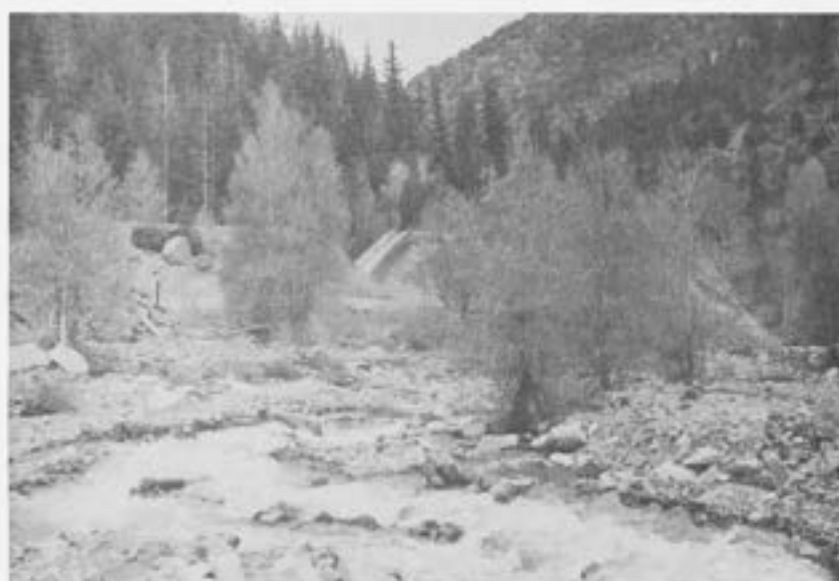
Figure 30. Mine tailings near the Bachelor Mine in Dexter Creek basin.

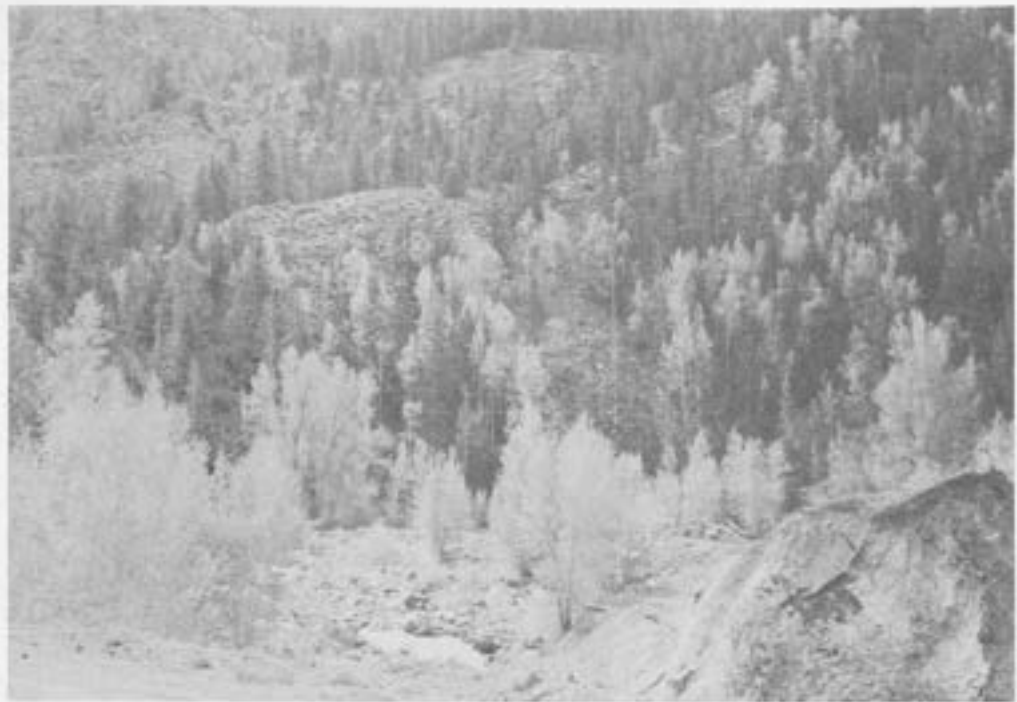
Figure 31. Debris available for mobilization in the Dexter Creek basin.

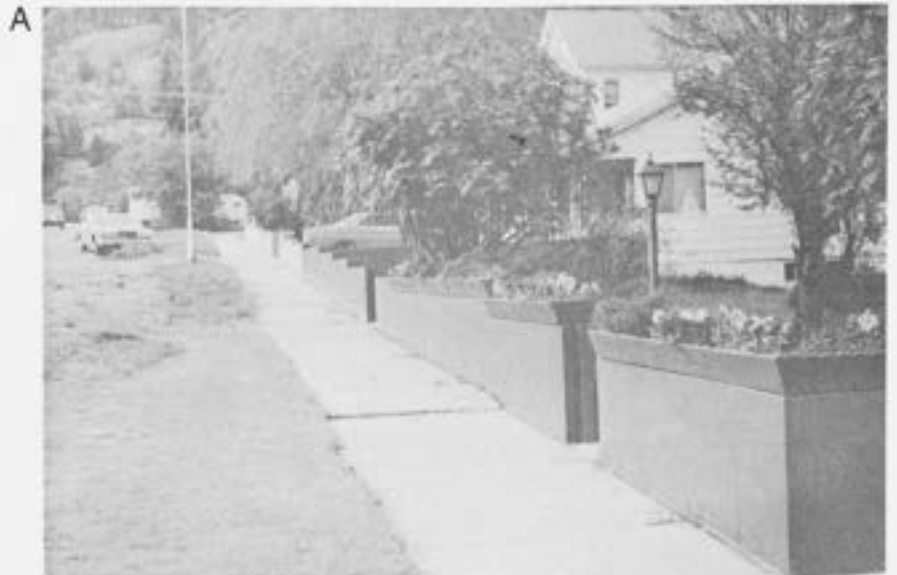
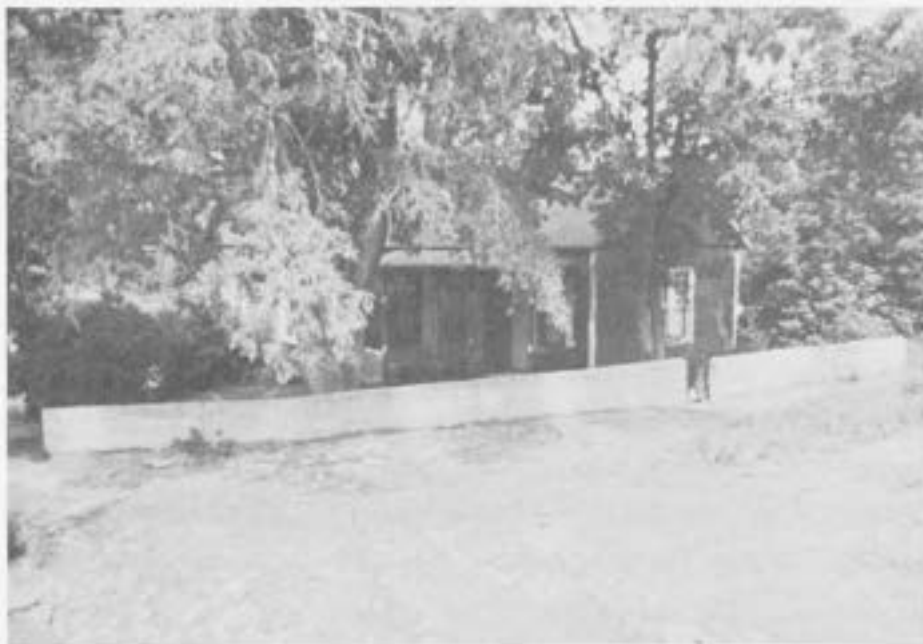
Figure 32. A, Deflection walls around houses near Portland Creek flume.
B, Deflection wall around house near Cascade Creek flume.

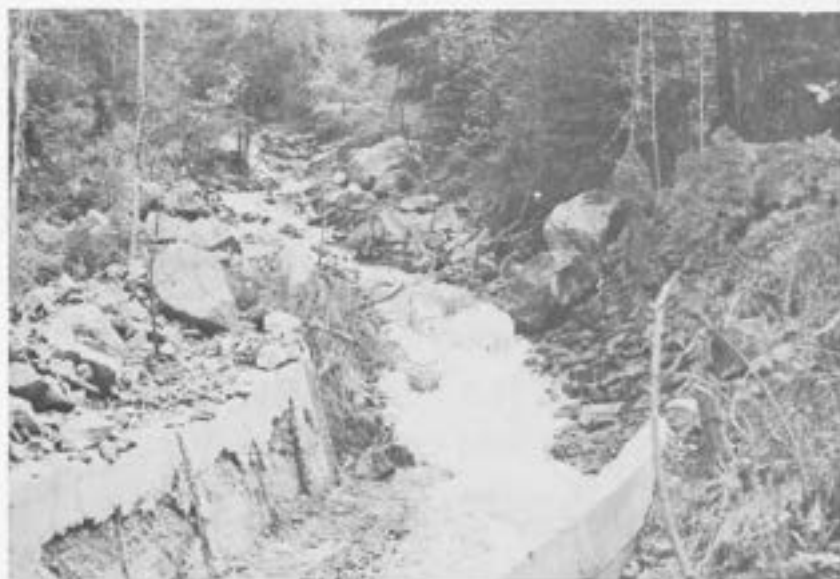
Figure 33. Cascade Creek flume entrance, 1982, before modification.

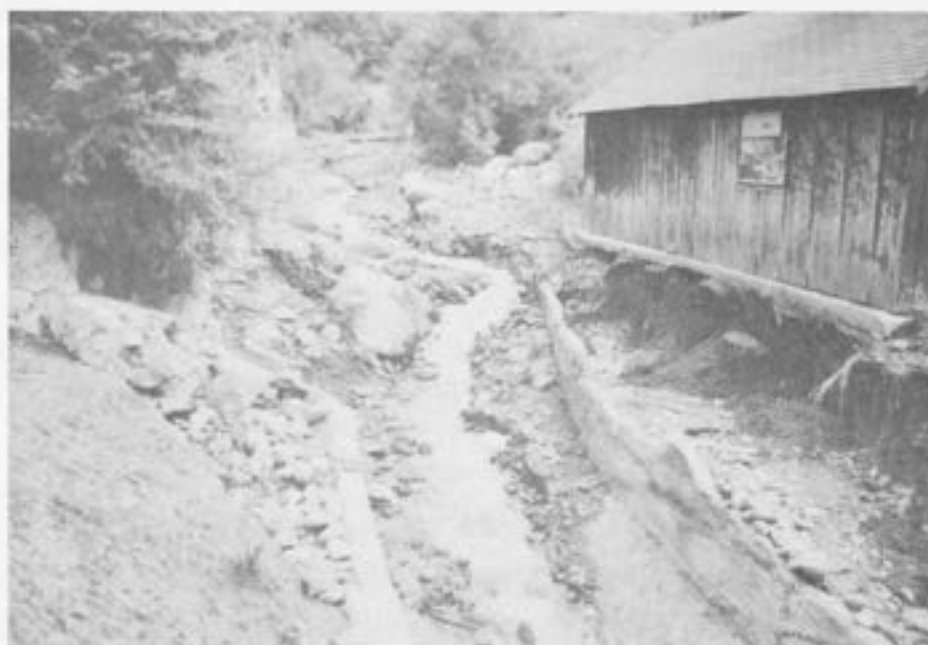
Figure 34. Portland Creek flume entrance, 1982. The flume shows damage from past events. The building on the right is spattered with mud from the 1982 event.

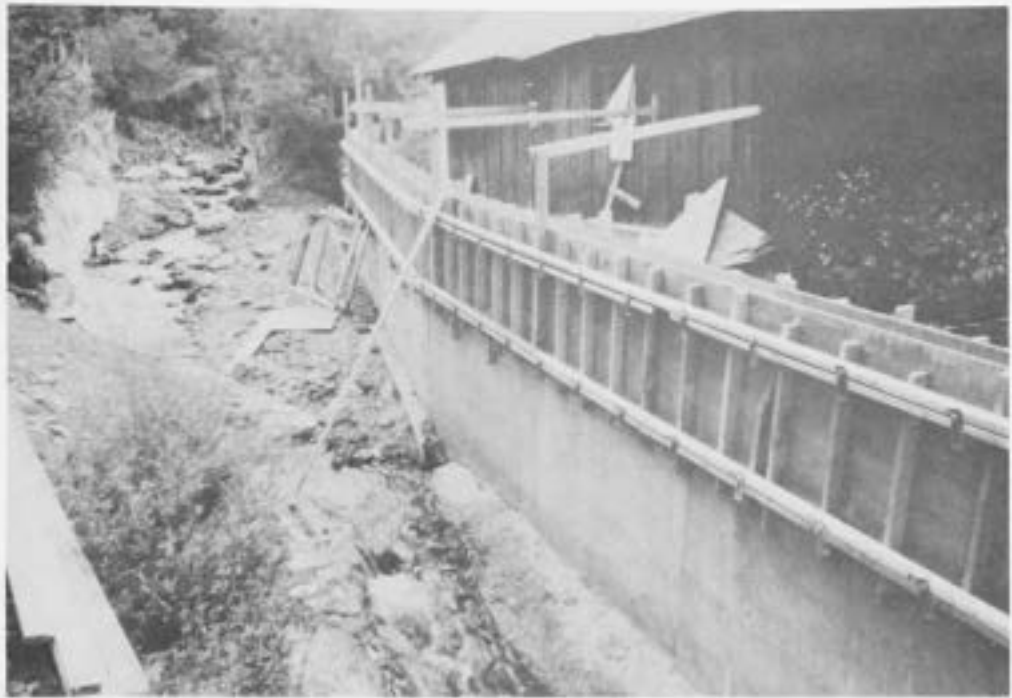
Figure 35. Improved Portland Creek flume entrance. Construction in 1984 to increase flume wall height (photo courtesy of William P. Stanton, CWCB).

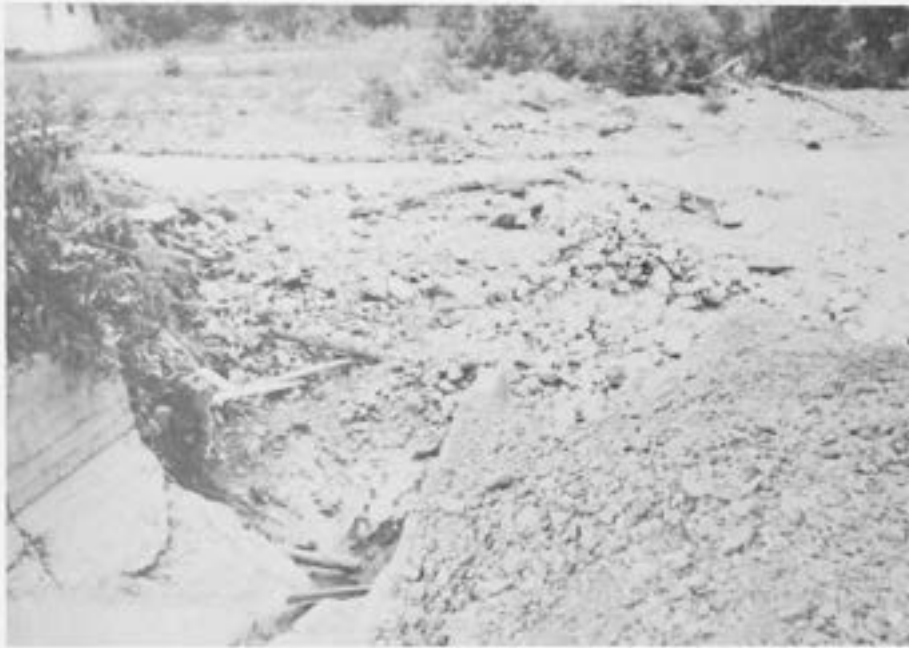
Figure 36. Debris accumulated at mouth of Portland Creek flume after 1982 event. (Photo courtesy William P. Stanton, CWCB)

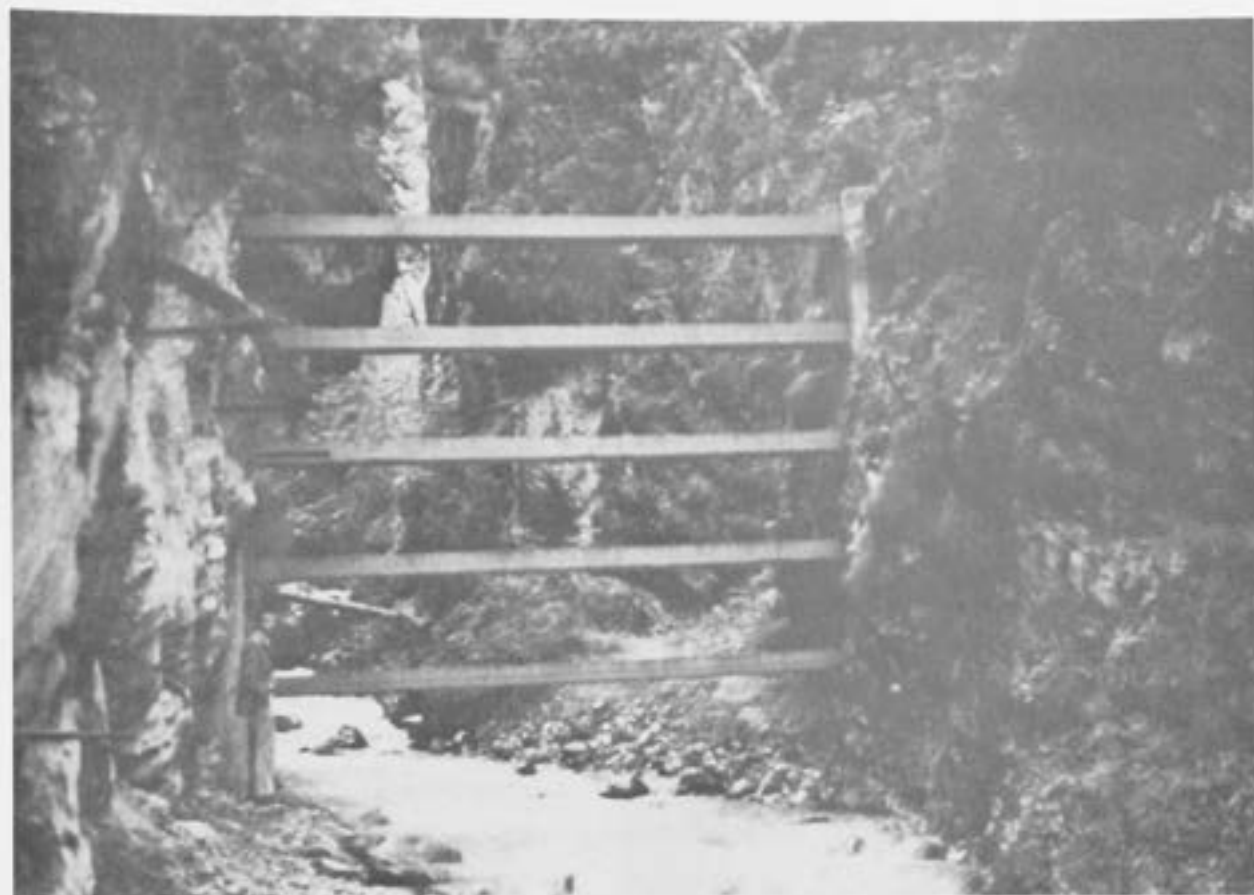
Figure 37. Debris fence. Example from Europe. (Photo courtesy Art Mears)

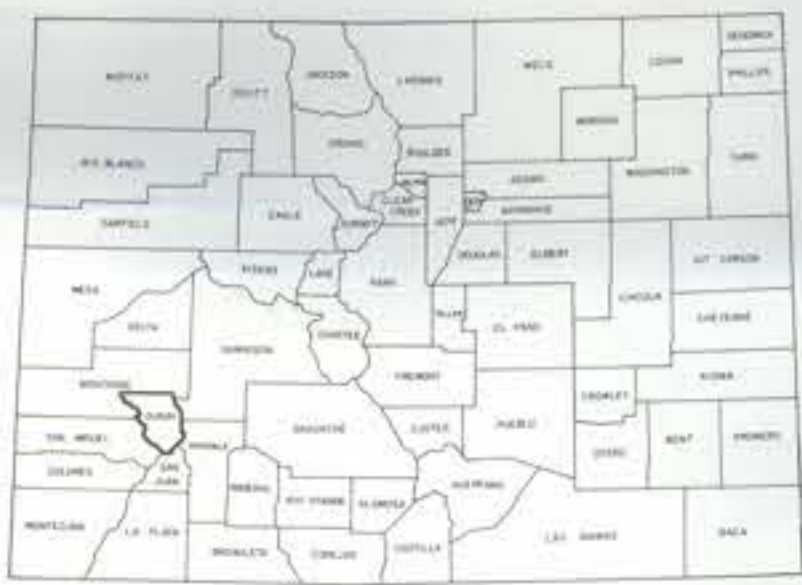
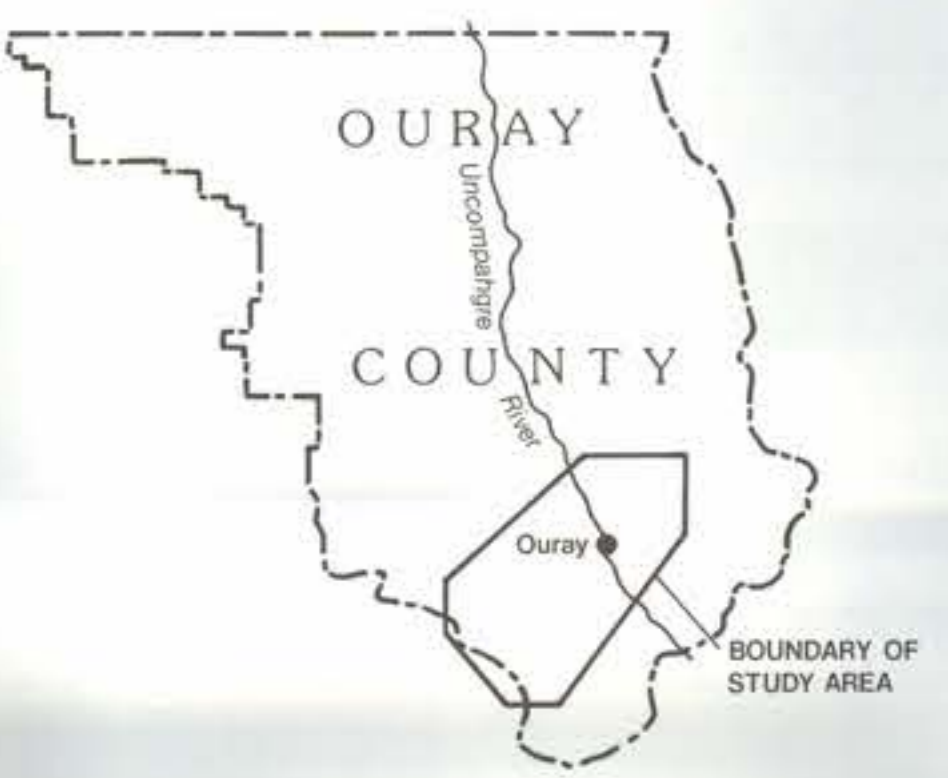
Map B: Map Showing Generalized Hazard Zones for Debris Fans in Study Area

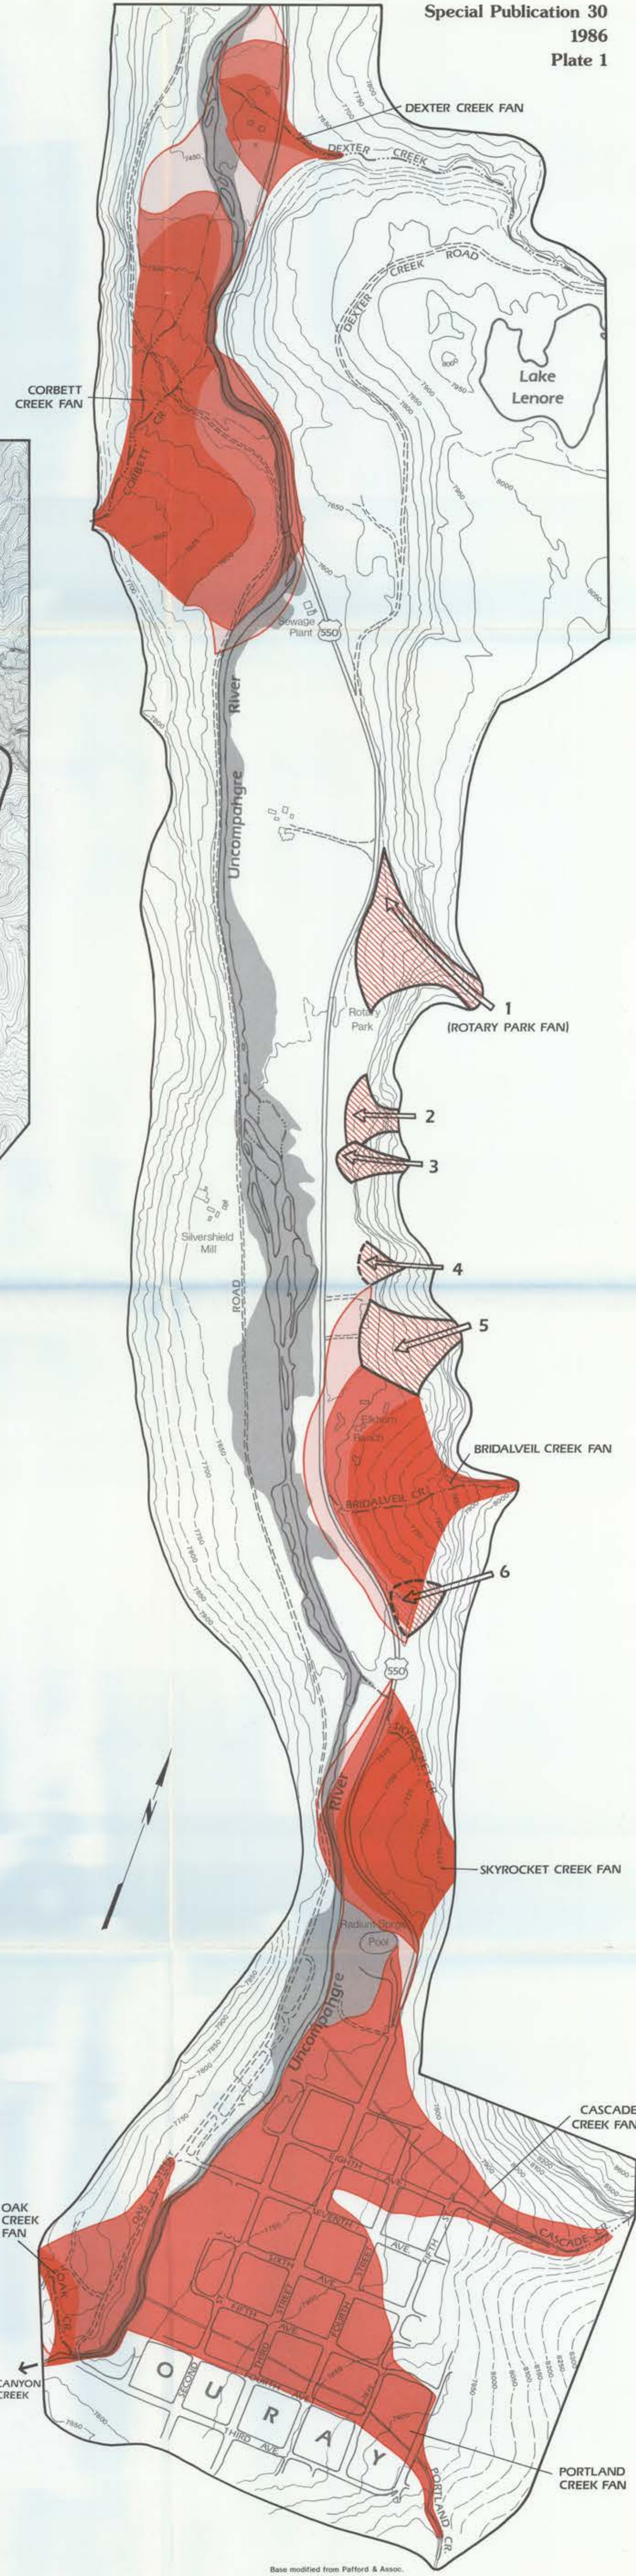
Base modified from Palford & Assoc.
