Property Inspection Report
performed by

for
218 E. Franklin
Hillsboro, TX

PROPERTY INSPECTION REPORT

Concerning: 218 E. Franklin, Hillsboro, TX
(Address or Other Identification of Inspected Property)

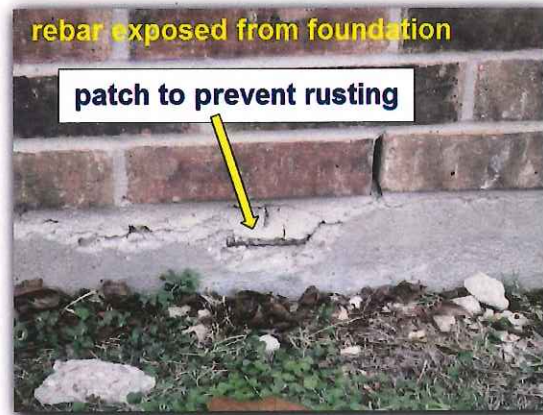
On the the right side of the building , some rebar (metal) was exposed from the foundation. (see photo) Any metal components of the foundation should be covered to prevent them from rusting.

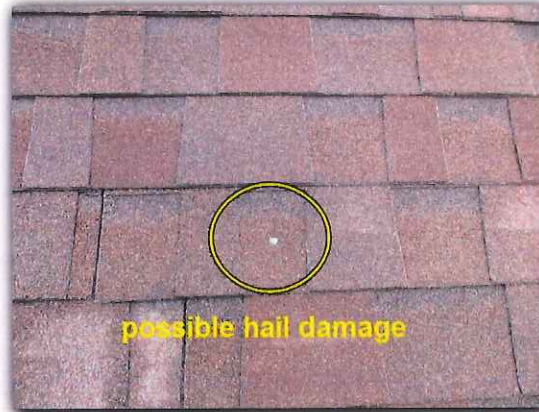
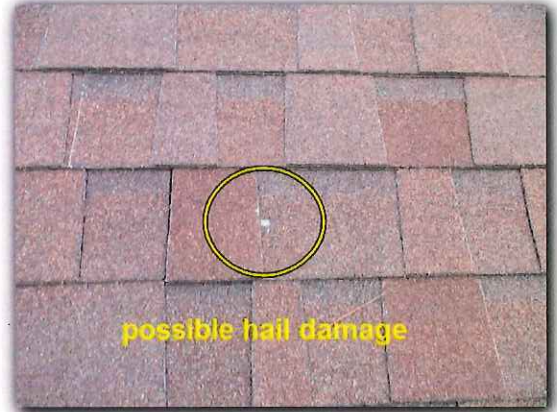
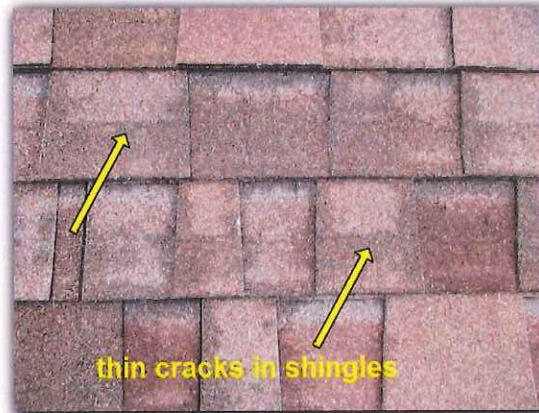
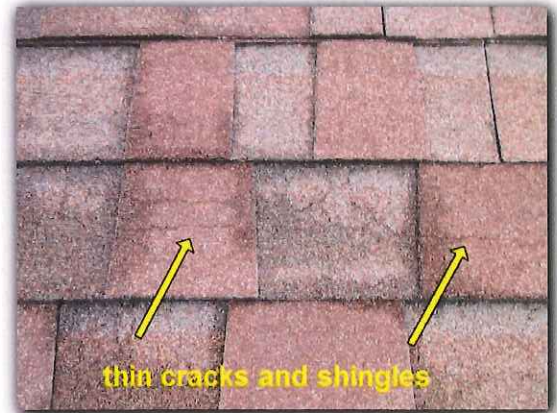
There were conditions with the roof that may suggest it is due for replacement. Due to these issues, it is

suggested to have the roof reviewed by a qualified roofing professional to repair or replace as required. Issues noticed by the inspector include:

- Damage spots on the shingles that may be from hail.
- Thin cracks within the shingles that are often an indication of shingle age and the beginning of shingle failure.(See photos for examples)

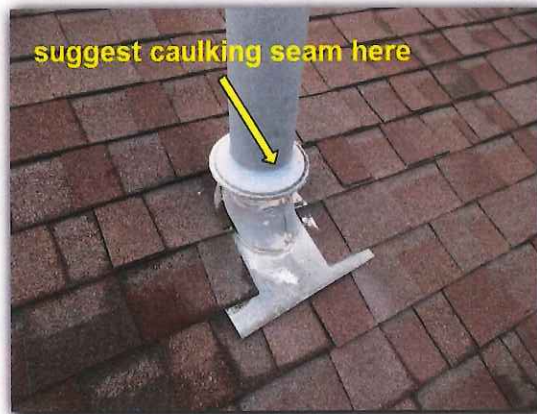
The storm collar for the water heater flue pipe did not have a caulk line around its top edge. This may (or may not) be the cause of water entry that created the water stain on the ceiling. (See photo)

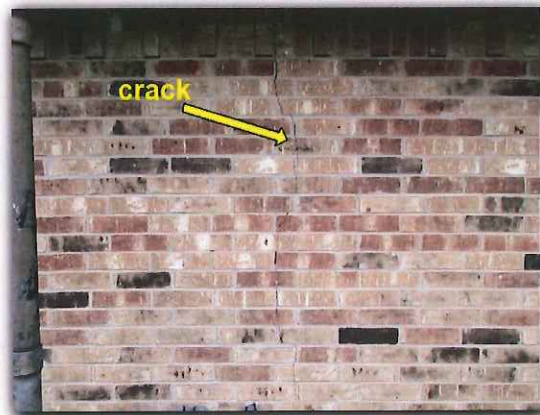
There were a few thin cracks in the exterior brick. The most significant was on the right side of the building. (See photo) It is suggested to patch cracks to deter water entry.

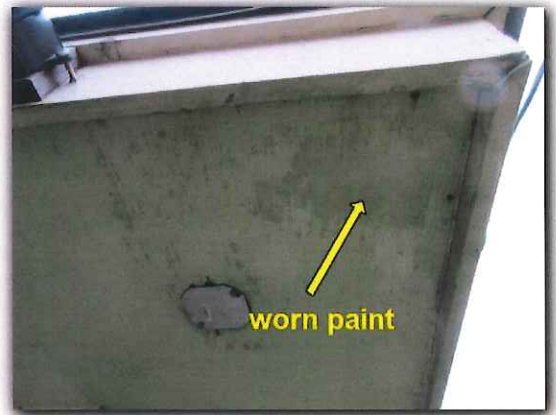
Exterior paint appeared worn in some areas. (see photo above right for one example) Note - Maintaining exterior paint is necessary to deter weathering and water damage. As a general rule of thumb, exteriors should be repainted about every 8 to 10 years.

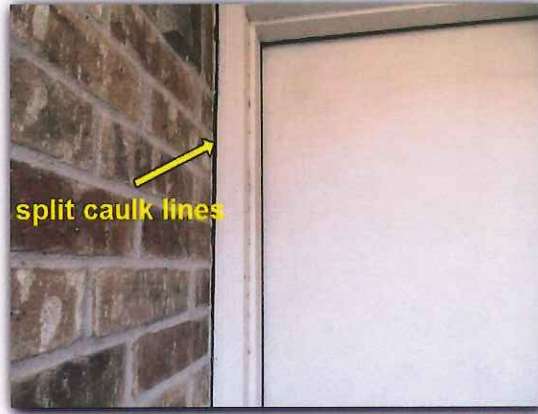
There were split or missing caulk lines in several areas around the exterior. This issue was noticed in areas that include: around the back door, around all windows, plus some other trim areas. *Note-Repainting should include caulking and sealing as necessary.*

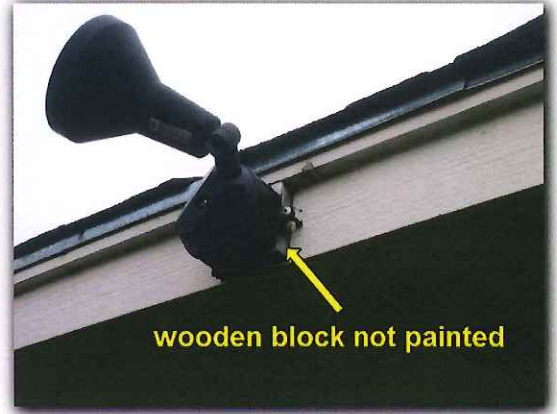
Near the front corner of the building, there was a block of wood behind a light fixture that was not painted. Exterior wood should be painted or otherwise weather protected. (See photo above right)

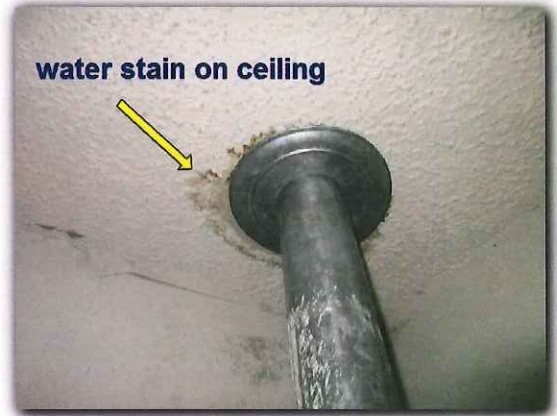
There was a stain on the ceiling of the water heater closet that may indicate a leak (either past or active) from above this area. (see photo above right) *Note - This area tested dry at time of inspection, but this does not guarantee that the leak has been repaired. Suggest inquiry with the seller and/or further review to determine cause and remedy.*

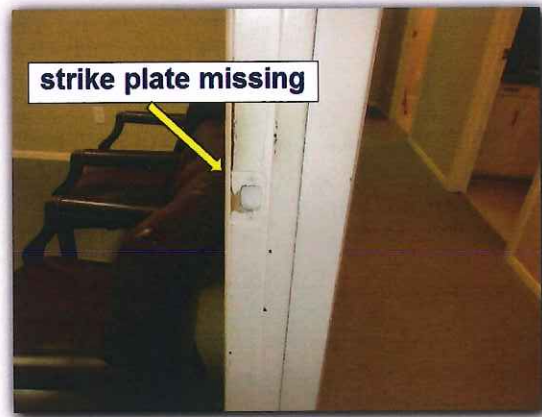
The strike plate was missing from the door to the first office. (See photo)

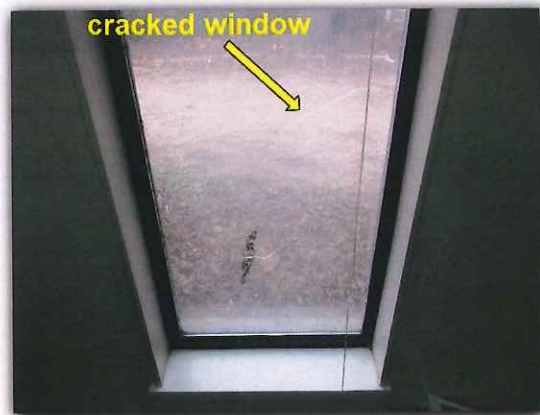
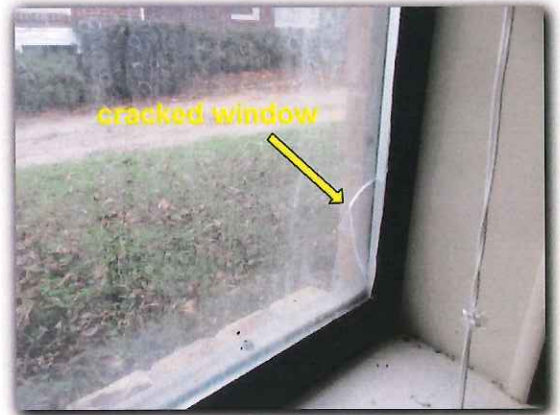
There were two cracked or broken windows. (See photos)

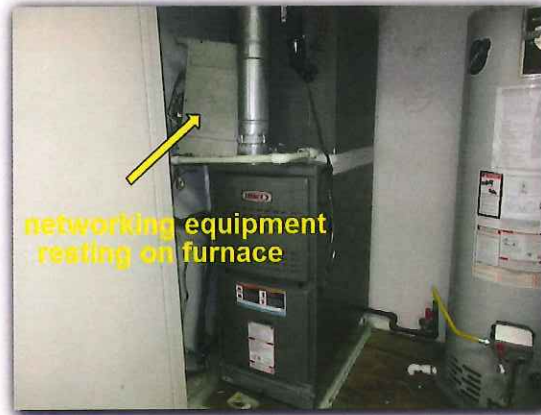
Some type of telephone or networking equipment was resting on top of the furnace. It appeared that this equipment was intended to be mounted on the wall. In the inspectors opinion, this equipment should not be touching the furnace. (See photo)

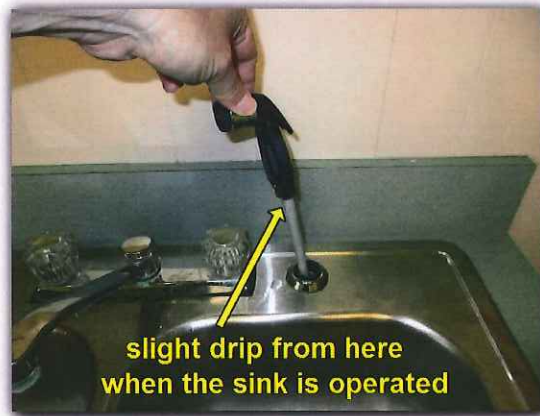
When the kitchen sink was operated, there was a slight drip or leak from the handle of the vegetable sprayer. When the sprayer was in its holster, this leak was dripping below the sink.

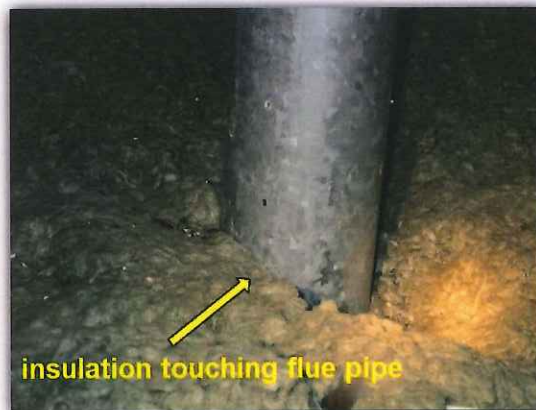
Potential Safety Issue - The water heater flue pipe did not maintain proper clearances from combustible materials. (see photos) The flue pipe was seen touching attic insulation and a rafter. This flue pipe requires a minimum of 1-inch clearance to combustible materials.
