**Nye County School District,
Nevada**

Debt Management Policy

July 2025 thru June 2030 MASTER PLAN UPDATE
FOR THE

NYE COUNTY SCHOOL DISTRICT
AND RELATED FACILITIES

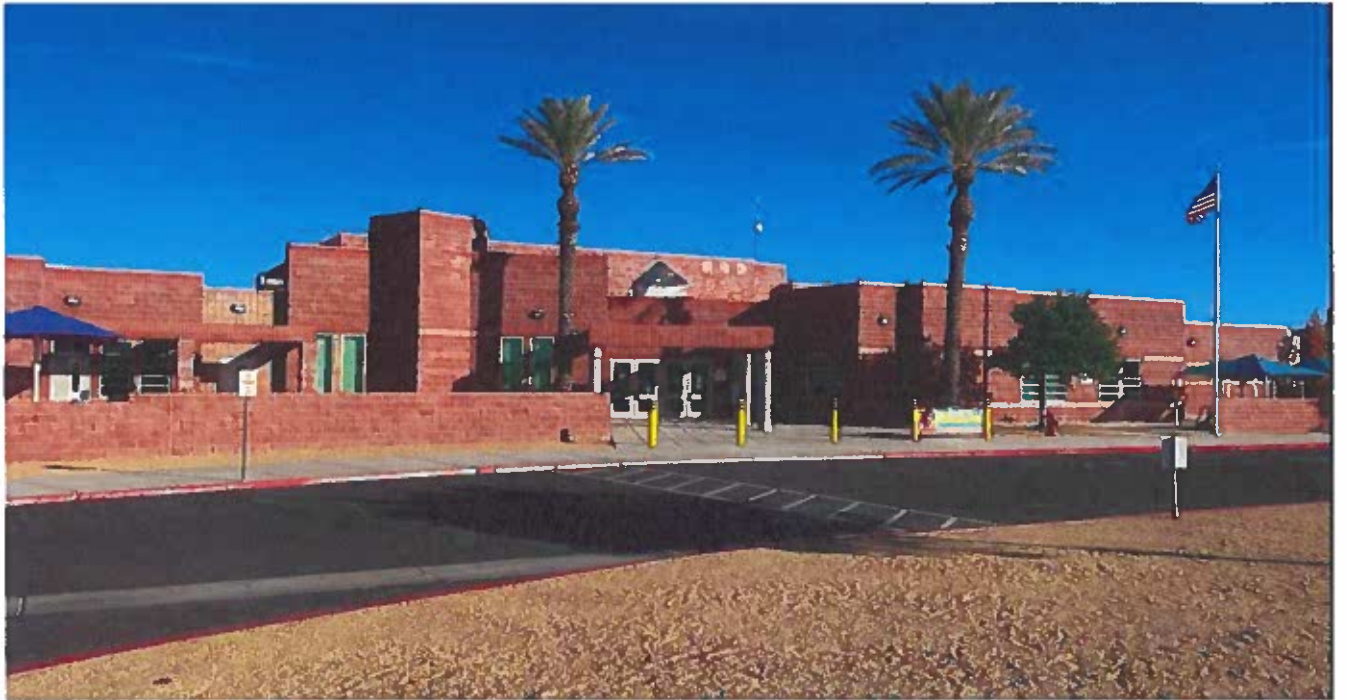
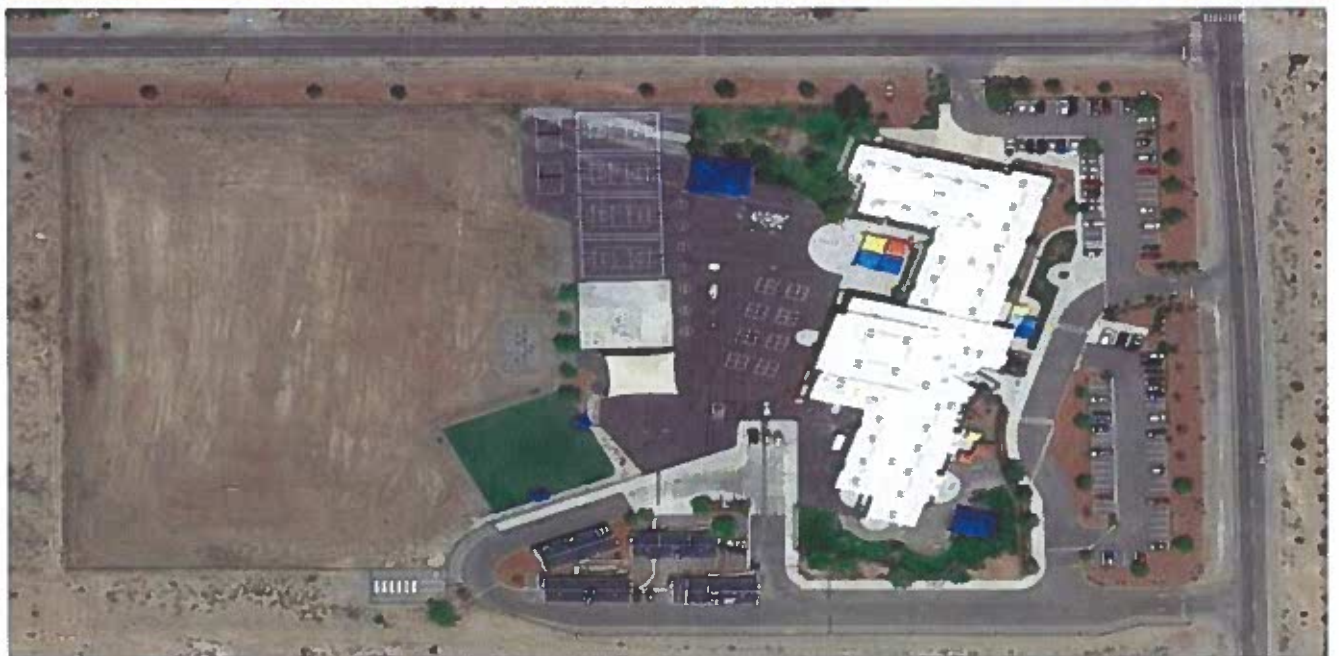
Tim and Jackie Hafen Elementary School

- The rooftop HVAC units contain R-22 refrigerant and must be replaced with updated units as mechanical parts and freon are unavailable. This is tentatively scheduled for the 2025-2026 school year based on the available budget.

- The playground A.C. paving surfaces are scheduled to undergo maintenance in the 2025/2026 fiscal year, including crack repairs, a slurry coating, and restriping. The parking lot was recently recoated in the summer of 2024, ensuring its current condition remains optimal.

- The carpet in the main halls is original and starting to show its age and is in need of replacement. Other options will be considered, such as VCT or polished concrete, and a decision will be made based on cost and maintenance requirements.

- The serving steam table is original and has failed. This is scheduled for replacement with two new tables in 2025. The upgrade will also include an electrical sub panel to handle the new electrical requirements.

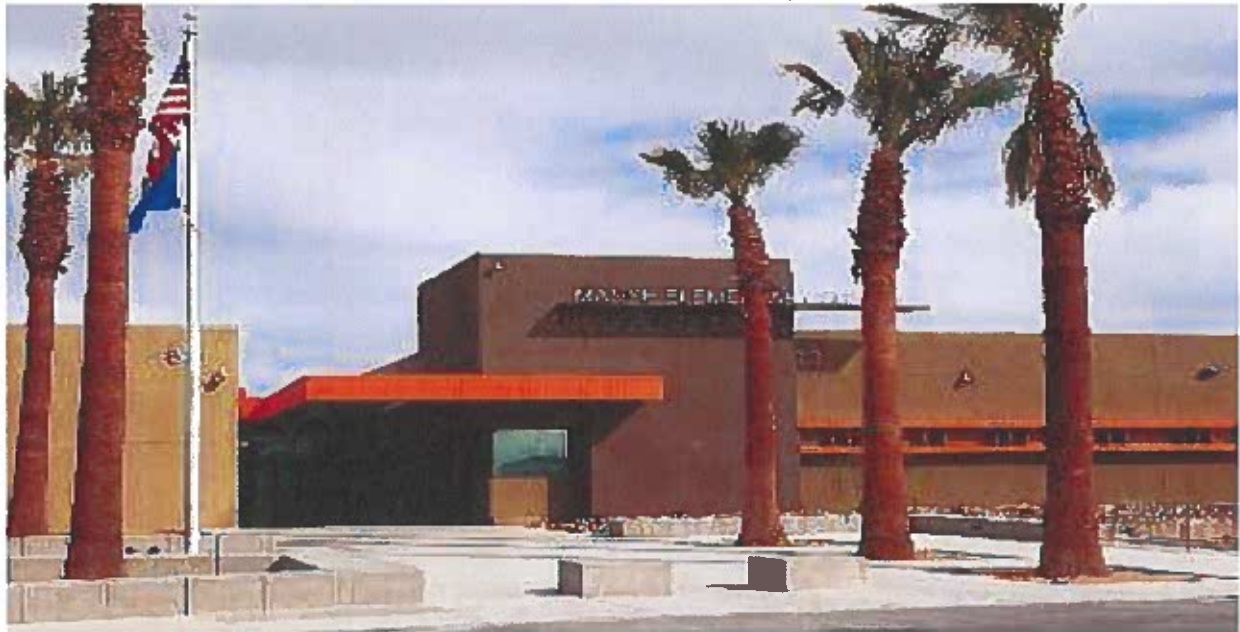
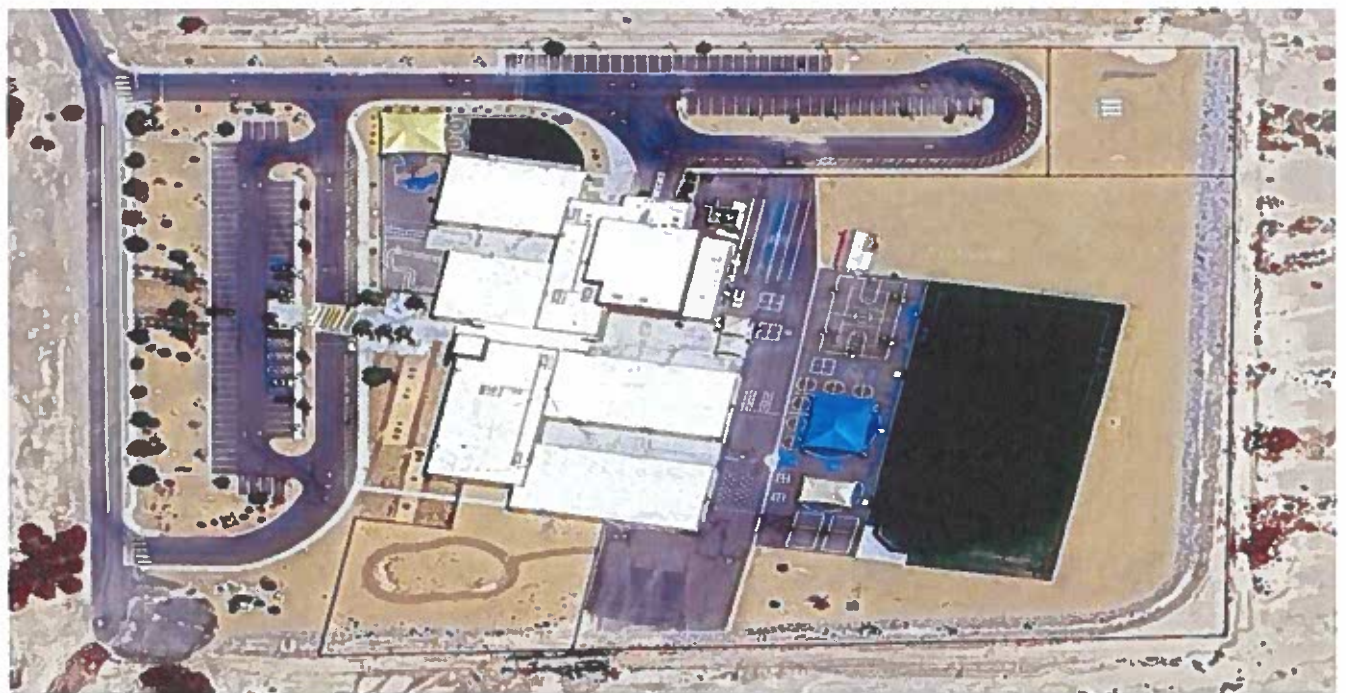
Manse Elementary School

The roofing system is original and not in need of replacement. It requires minimal maintenance. The HVAC geothermal-based system and refrigerant is R410A and should need no major service in the next few years. The interior of the school has been well maintained, painted, and recarpeted as needed.

- The A.C. paving surfaces will undergo maintenance, including crack repairs, a slurry coating, and restriping, scheduled for the 2026/ 2027 fiscal year.

- The Technology Department is set to implement a comprehensive computer refresh across the campus in the summer of 2029.'
- The refrigerator and freezer box has begun to fail due to moisture in between the panels and will require replacements when a window of time is available. The combo will require a window of 6 weeks of availability to replace them. Tentatively scheduled for the summer of 2026-2027 fiscal year.

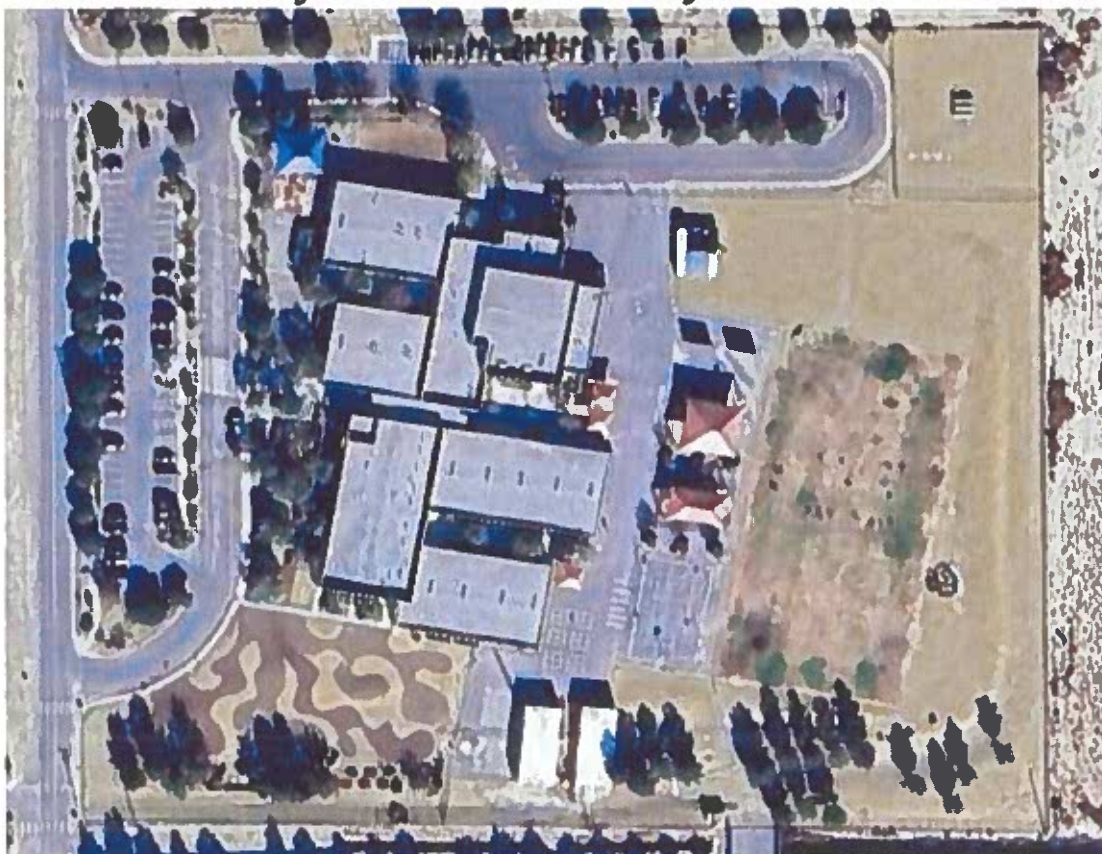
Floyd Elementary School

- The option of an interlocking door system will be reviewed to control both main entry doors. This would ensure visitors can be easily vetted before being allowed into the main school areas. Preventing tailgating, where individuals might attempt to gain entry by closely following an authorized person through the unlocked door.
- The parking lot A.C. paving surfaces will undergo maintenance, including crack repairs, a slurry coating, and restriping in 2025/2026. The playground was recently recoated in the summer of 2024, ensuring its current condition remains optimal.
- The Technology Department is set to implement a comprehensive computer refresh across the campus in the summer of 2026.
- The dishwasher is original and scheduled for replacement during the summer of 2025. It is beginning to show its age and requires multiple repairs, leading to long downtime.

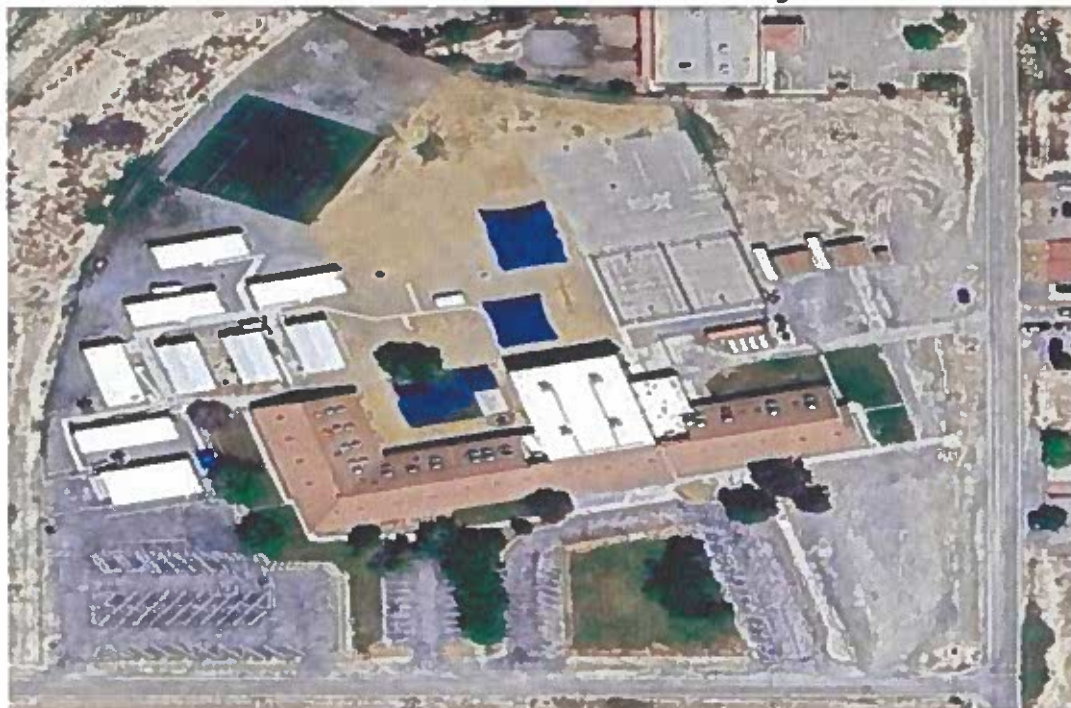
J.G. Johnson Elementary School

- Much of the front landscape areas have been switched to a desert-friendly design. The remaining areas should be evaluated and either overhauled or replaced with desert scape.

- The building-wide communication system is showing its age and has had multiple disruptions. It is currently working, but the system should be replaced to ensure all areas can be alerted to an emergency and emergencies may be reported from multiple areas of the campus.

- The Technology Department is set to implement a comprehensive computer refresh across the campus in the summer of 2027.
- The artificial turf play area was installed using recycled turf and is starting to deteriorate and should be replaced when funds are available.

- The walk in refrigerator and freezer are original and need to be replaced due to age when funding is available.
- The playground basketball court AC surfaces are deteriorated and are original and scheduled to be resurfaced and repaired in the 2025 fiscal year.

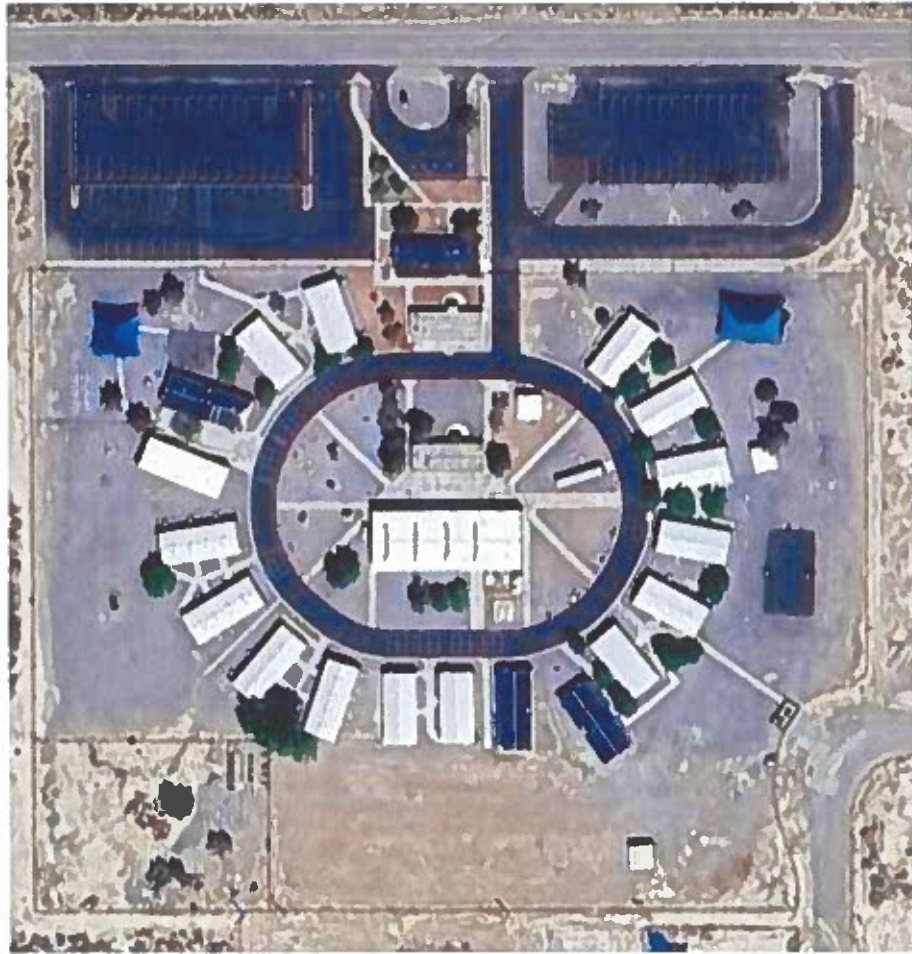
Mt. Charleston Elementary School

In 2009, the entire campus was evaluated for compliance with the Americans with Disabilities Act (ADA), revealing multiple deficiencies. It is assumed that most of these deficiencies have not been remediated. As funds become available, it is recommended that remediation work be initiated to address these issues.

- The building-wide communication is non-operational. This system is the first intercom system that will be replaced in the summer of 2025. The new system will ensure that all areas can be alerted to an emergency, and emergencies may be reported from multiple areas of the campus.

- The school currently utilizes many HVAC units containing R-22 refrigerants. These should be identified and upgraded to refrigerant as failures occur.

- The play area is not age-appropriate, and replacement with an age-appropriate play system that could be utilized should be considered when funds are available.

- The addition of an ADA-compliant ramp at the office exit will be considered when funds permit, ensuring proper visitor flow and compliance with the district's single-point entry protocols.

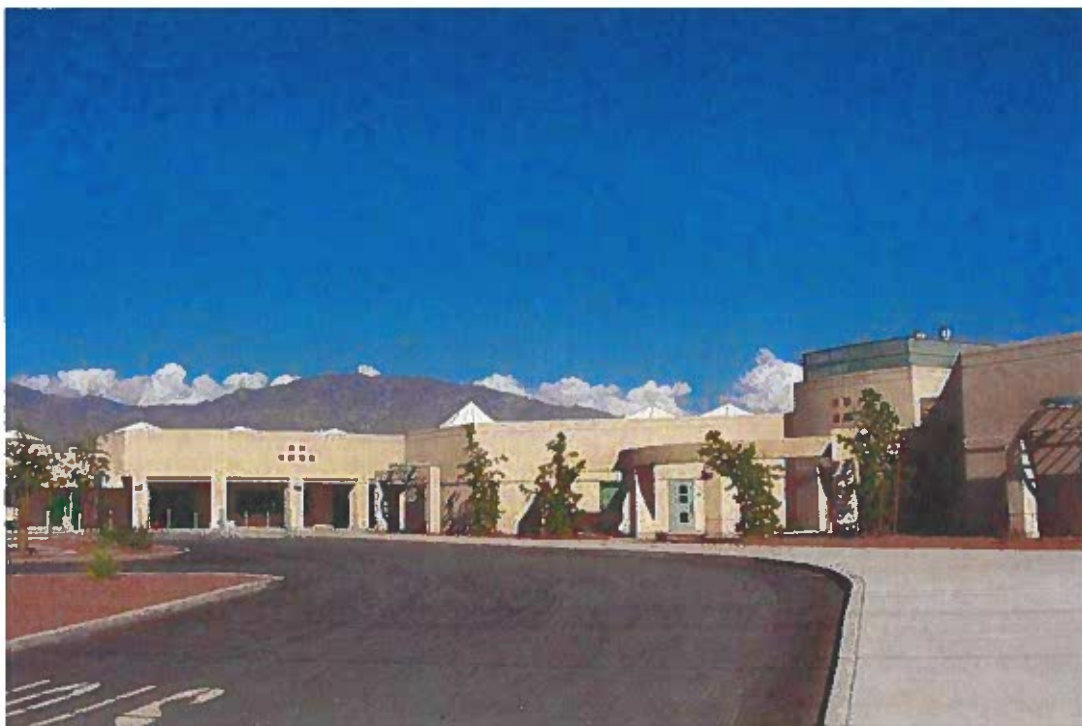
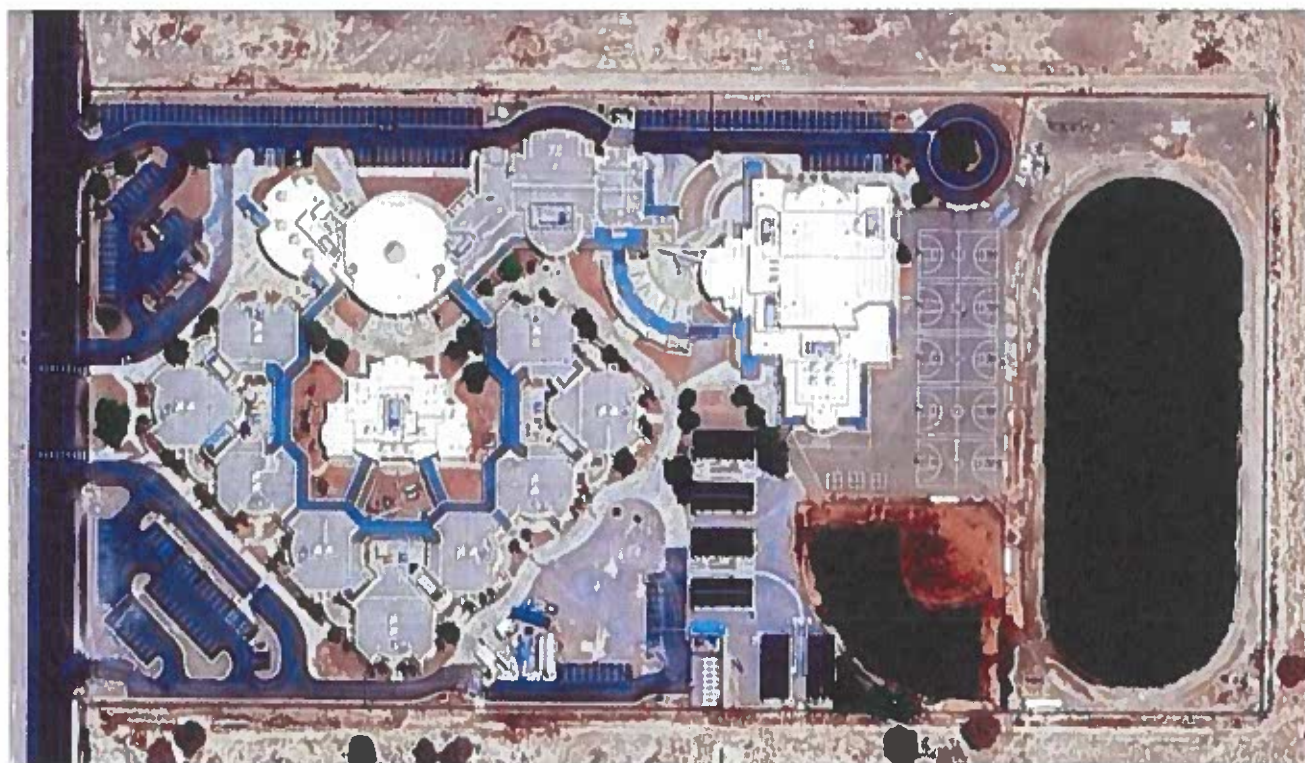
Rosemary Clarke Middle School

The roofing system has been replaced or recoated in two phases, starting in 2023 and completed in the summer of 2024, and is under warranty for 10 - 20 years, depending on the system used. The overall condition of the building is good. Paint and carpet are replaced as needed. Additional concrete will be poured as needed to keep water from infiltrating the base under the building and to prevent buildings from settling due to the collapsible soil.

- The remaining multi-zone rooftop HVAC units are based on R-22 refrigerant and need to be converted to an upgraded freon. The second phase of this replacement is already in progress and is expected to be completed in the summer of 2025.

- The Technology Department is set to implement a comprehensive computer refresh across the campus in the summer of 2025.
- To mitigate future settling, as funds become available, additional concrete should be poured to replace landscape areas throughout the campus.

- Structural settling has caused drywall cracks behind the wallpaper, resulting in peeling and shifting throughout the campus. The wallpaper should be removed, walls repaired and textured, and all affected areas repainted as funding allows.

- The serving speed line equipment is original, and multiple units have already failed and can not be repaired. This has been approved for replacement in the 2025- 2026 fiscal year.

- The reach through hot and cold cabinets are original and have required multiple repairs. Due to their age, parts are not available and will be replaced when funds are available.

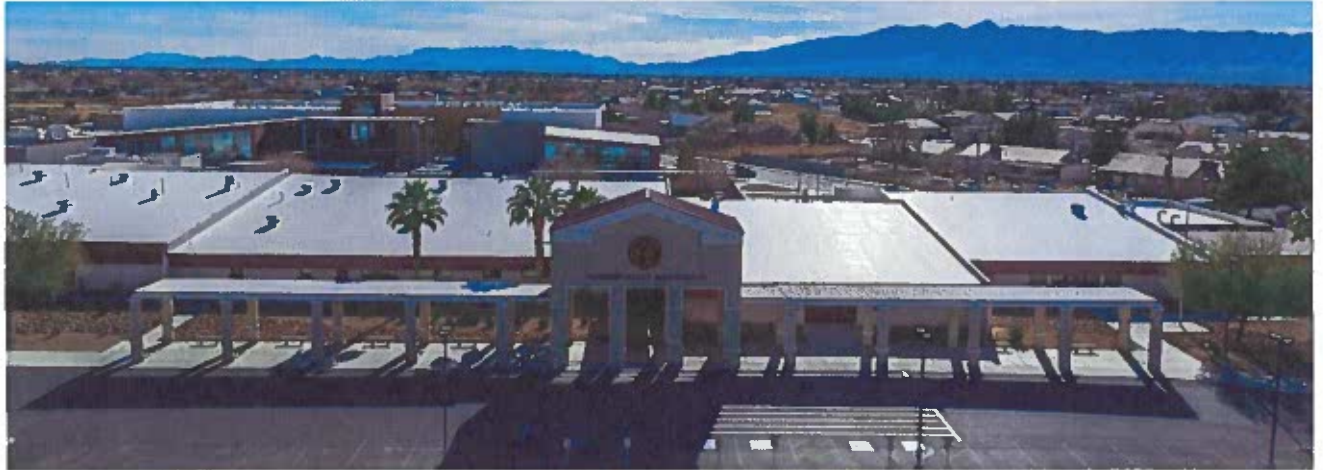
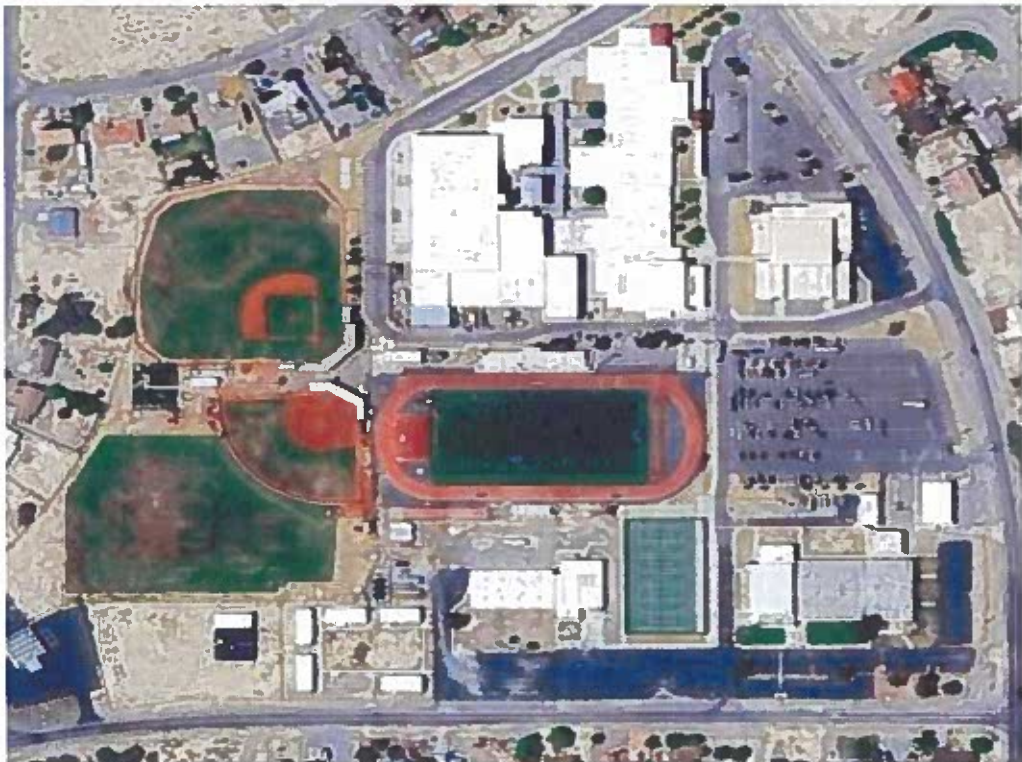
Pahrump Valley High School

- The indoor bleachers used outside on the softball and baseball field need to be replaced with proper exterior bleachers that meet ADA and other code requirements.

- The A.C. paving surfaces will undergo maintenance, including crack repairs, a slurry coating, and restriping, scheduled for the 2028/ 2029 fiscal year.

- The running track around the field should be evaluated for replacement or resurfacing due to cracking and repaired when the budget is available
- The option of artificial turf will be looked at for the baseball and softball fields, and a decision will be made based on funding

- Pathway/ Adult Ed roof is original and scheduled to be replaced based on the budget in the 2025- 2026 fiscal year
- When PVHS has heavy rains, water pools on the softball field. This has been an issue since the field has been there. When funds are available, the addition of drainage should be considered.

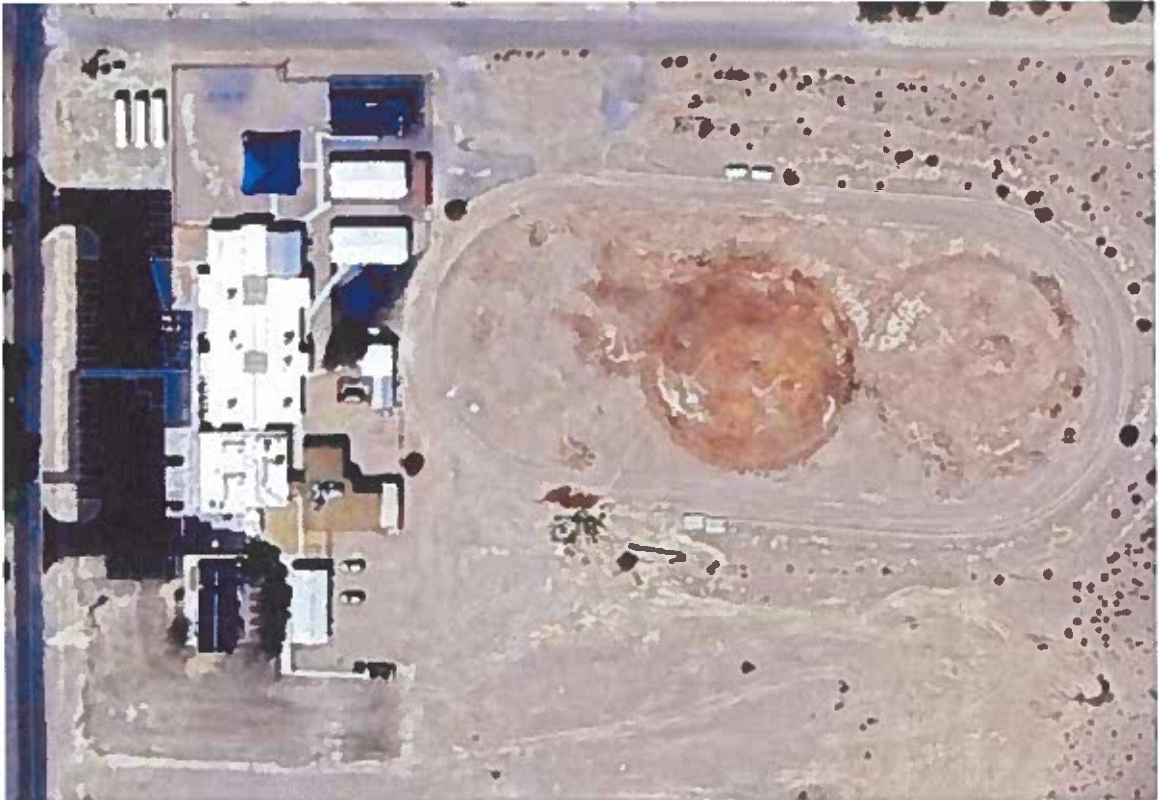
Amargosa Elementary School

In 2009, the entire campus was evaluated for compliance with the Americans with Disabilities Act (ADA), and several deficiencies were identified. The full scope of deficiencies is outlined in the report provided by PSWC Architects. Remediation of these deficiencies should be prioritized once funding is available.

The school is situated on an approximately 10-acre site with minimal slope for drainage. A large, fully paved parking and driveway area provides access to the southern main building entrance. In 2023, the parking lot underwent a complete replacement to address previous deterioration and drainage concerns. As part of this project, the grading and drainage systems were improved to prevent water buildup. The newly paved lot now provides ample parking capacity and meets ADA accessibility standards, ensuring safe and convenient access for all visitors, staff, and students.

- The building's wide communication is original, and parts are limited. This system will be scheduled for replacement after Mount Charleston is complete. The new system will ensure that all areas can be alerted to an emergency, and emergencies may be reported from multiple areas of the campus.

- The roofing systems over several classrooms are starting to show their age and require multiple repairs. It is scheduled to be recoated in the 2027- 2028 fiscal year.

- The Amargosa kitchen is all original, and multiple pieces of equipment are outdated, and procurement of replacement parts is not possible. Equipment to be replaced in the duration of this 5-year plan are the kettle, double oven, warming cabinet, and serving table.

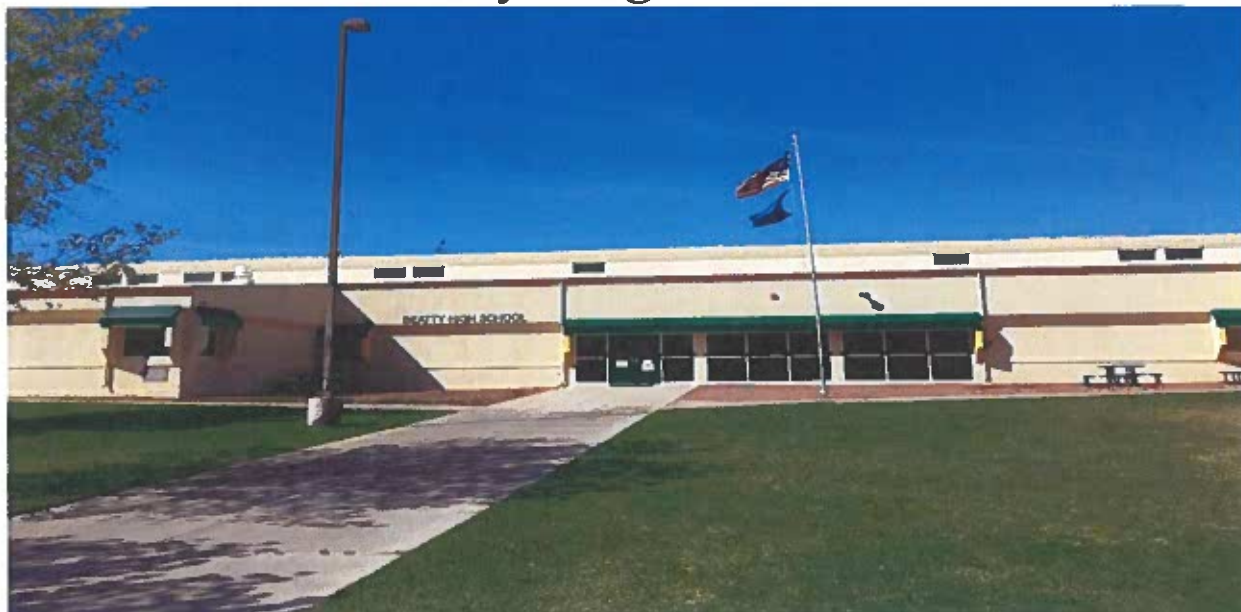
Beatty High School

All buildings on campus, including the main high school building, the shop buildings, and the multi-purpose building, are pre-engineered metal structures with steel panel exterior wall siding. In 2009, the entire campus was evaluated for compliance with the Americans with Disabilities Act (ADA), revealing multiple deficiencies. A report provided by PSWC Architects outlines the full scope of these issues. Most deficiencies remain unresolved, and remediation should be prioritized as soon as funding becomes available.

- The Technology Department is set to implement a comprehensive computer refresh across the campus in the summer of 2025.
- The school currently utilizes several HVAC units containing R-22 refrigerant and is scheduled to be upgraded in the summer of 2025 by Emcor Service Nevada.
- Paint around the trim area near the floor is starting to peel due to rust and should be repaired and painted as well as the awnings to match when funds are available.
- The serving tables are original and require heat lights and will be replaced with the district standard tables to improve safety when the funds are available.
- The addition of home and away dugouts for baseball should be considered if funds are available as the current dugouts are deteriorating and do not offer any shelter from the weather.

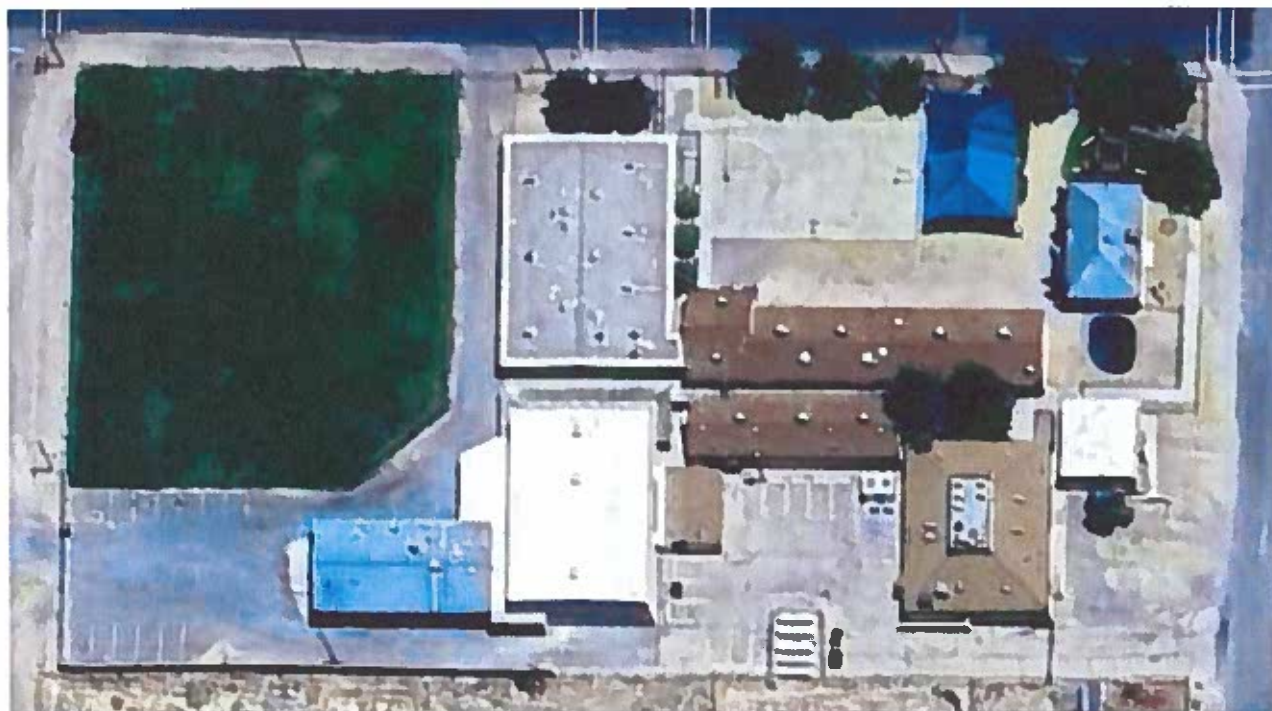
Beatty Elementary & Middle Schools

In 2009, the entire campus was evaluated for compliance with the Americans with Disabilities Act (ADA), revealing multiple deficiencies. A report provided by PSWC Architects outlines the full scope of these issues. It is assumed that most deficiencies remain unresolved, and remediation work should be prioritized as soon as funding becomes available.

- Roofing systems vary and include asphalt composition mineral-surfaced shingles. It is starting to show its age with recurring problems. The gym and middle school roof replacement project has been approved and will be completed in 2025.
- The Technology Department is set to implement a comprehensive computer refresh across the campus in the summer of 2025.
- The fire alarm infrastructure is original and does not allow for individual classroom notification. This system is slotted for replacement in 2025.
- The serving table is original and has failed. It will be replaced with the district standard table to improve safety when the funds are available.

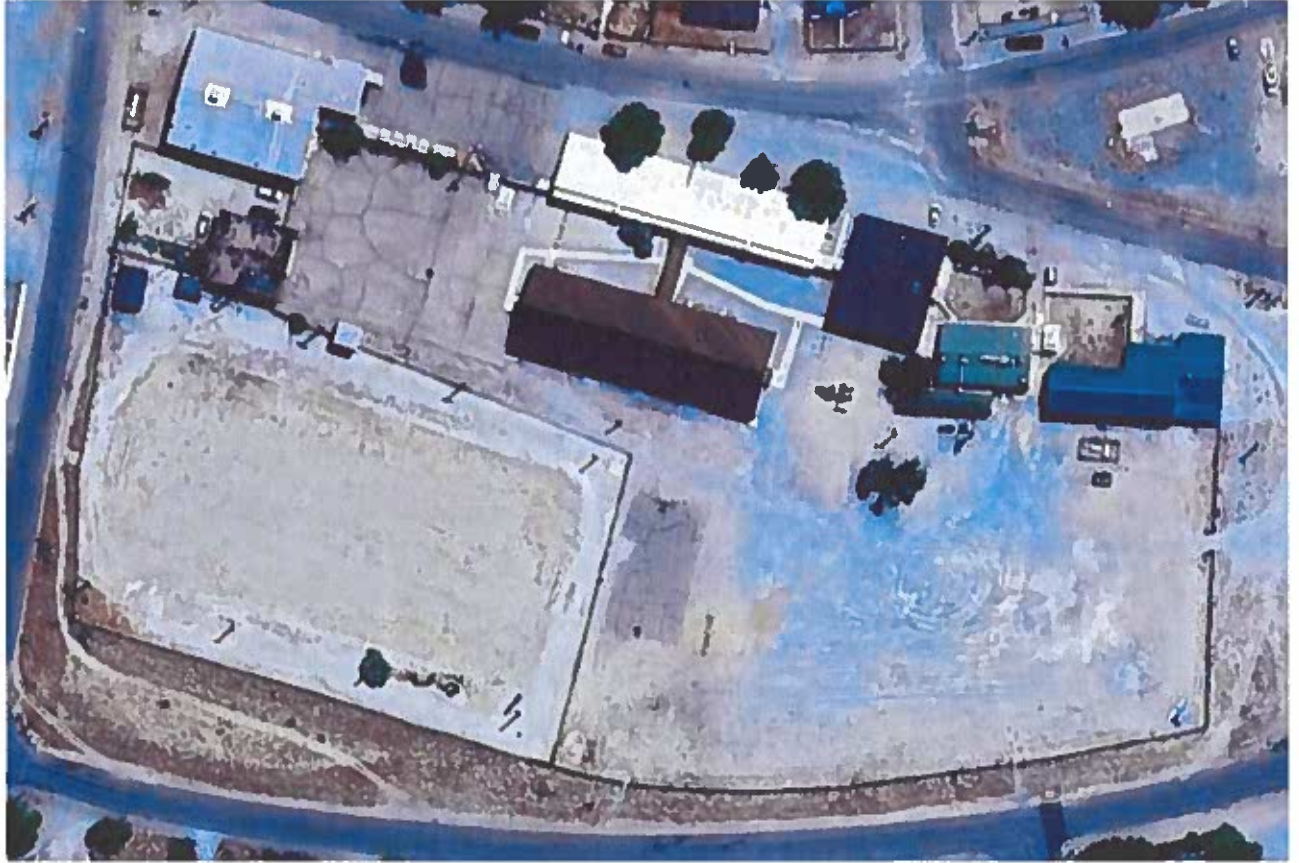
Gabbs School is a campus-style facility consisting of seven separate buildings totaling 42,725 square feet. The school originated in the 1940s, with the masonry elementary school built in 1942, followed by the high school in 1955. In 1975, additional construction expanded the facility to include a gymnasium, a home economics room, and three new classrooms. Since then, several modernization projects have been completed, including the installation of a new wood gymnasium floor, air conditioning systems, and a walk-in refrigeration unit for the cafeteria. The school serves students from Gabbs, the Reese River Valley, the Yomba Indian Reservation, and surrounding ranches. At this time, there are no plans to expand the facility or increase student capacity within the next five years.

In 2009, the school underwent an ADA compliance evaluation conducted by PSWC Architects, which identified multiple deficiencies. It is assumed that most of these issues remain unresolved, and remediation efforts should be prioritized as funding becomes available. In 2021, a separate evaluation was conducted to assess the feasibility of demolishing certain buildings. However, it was determined that refurbishment and exterior painting would be more cost-effective than demolition and disposal, given the high costs associated with tearing down the structures. Additionally, with the possibility of the adjacent mining operation expanding in the future, the town's population may increase, leading to a rise in school enrollment.

Several facility improvements are planned, including the demolition of the sports field house and abandoned HVAC equipment, as well as the removal of deteriorated asphalt in the play area. The asphalt will be replaced with compacted chat or decomposed granite sourced from the local mine, with the possibility of repaving with asphalt if funding allows. The existing playground also requires refurbishment or complete replacement, depending on available funds, to ensure compliance with modern safety codes.

- The A.C. paving surfaces will undergo maintenance, including crack repairs, a slurry coating, and restriping, scheduled for the 2029/ 2030 fiscal year.
- The Technology Department is set to implement a comprehensive computer refresh across the campus in the summer of 2027.
- The gym building needs to be repainted to help with longevity and mitigate the peeling paint around the building and is scheduled for 2025/2026.
- The serving table and milk cooler require replacement due to their age and the availability of replacement parts.

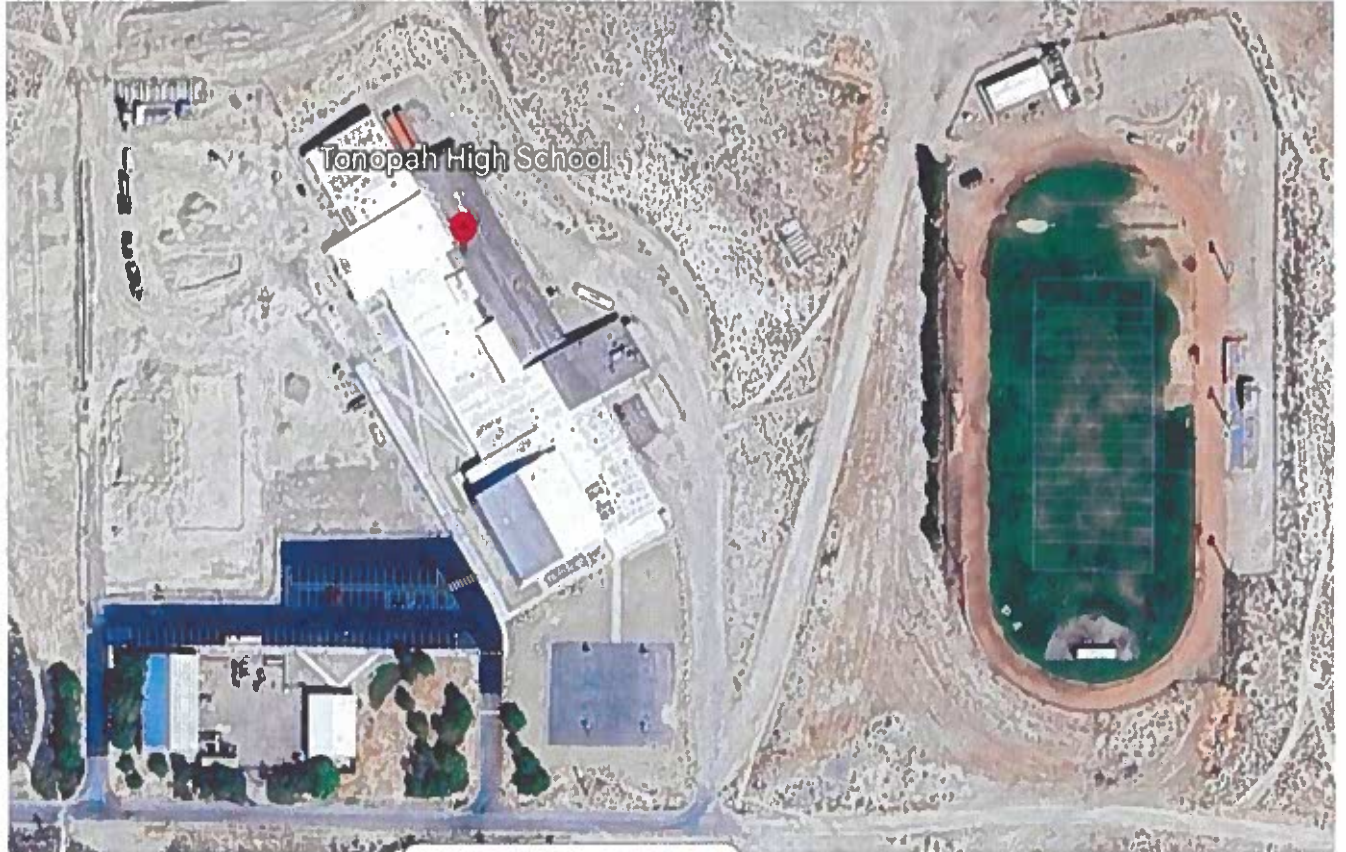
Tonopah Middle/High School

In 2009, the entire campus underwent an evaluation for compliance with the Americans with Disabilities Act (ADA), which revealed multiple deficiencies. A report provided by PSWC Architects details the full scope of these issues. It is assumed that most of these deficiencies remain unaddressed, and remediation work should be prioritized as soon as funding becomes available. The school's HVAC systems were upgraded to R-410a refrigerant in 2024 to comply with modern standards. In addition, the heat exchanger plates were replaced at the same time to ensure maximum efficiency.

- The Technology Department is set to implement a comprehensive computer refresh across the campus in the summer of 2026.
- The District is moving forward with a new sports complex currently under design with KNIT. Its completion date is scheduled for 2027, pending available funds.

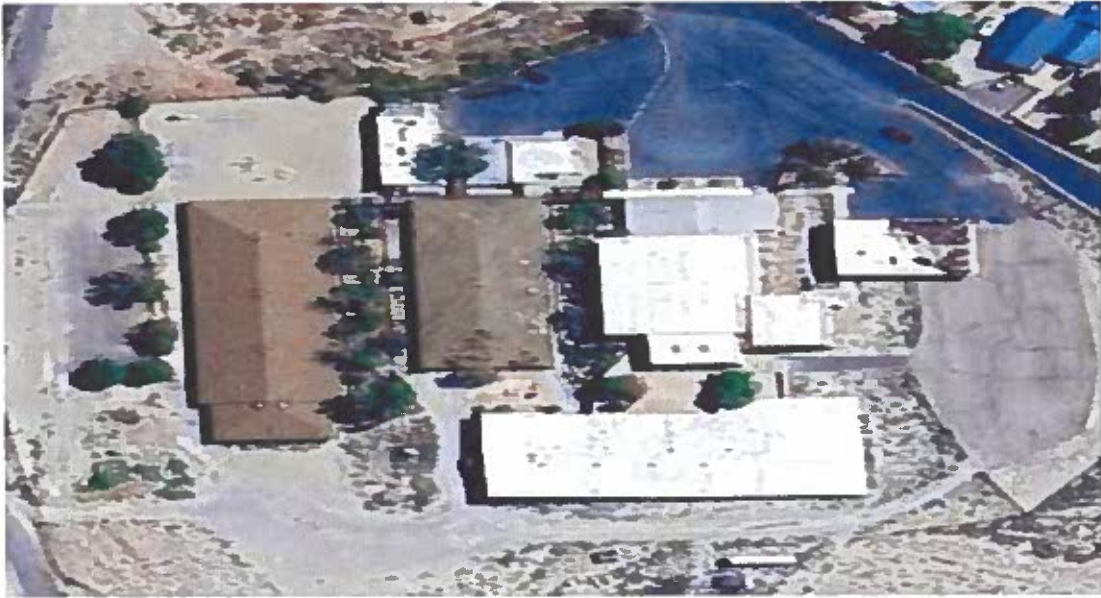
Tonopah Elementary School developed over time through a series of additions and modifications to existing structures, eventually expanding into a 74,531-square-foot complex consisting of multiple individual buildings. In 2009, the entire campus was evaluated for compliance with the Americans with Disabilities Act (ADA), revealing multiple deficiencies. A report provided by PSWC Architects details the full scope of these issues.

- The Technology Department is set to implement a comprehensive computer refresh across the campus in the summer of 2026.
- A new Tonopah elementary facility is currently under construction in the old parking lot of Tonopah High School. We are on schedule to start school when students return from winter break in January 2026.

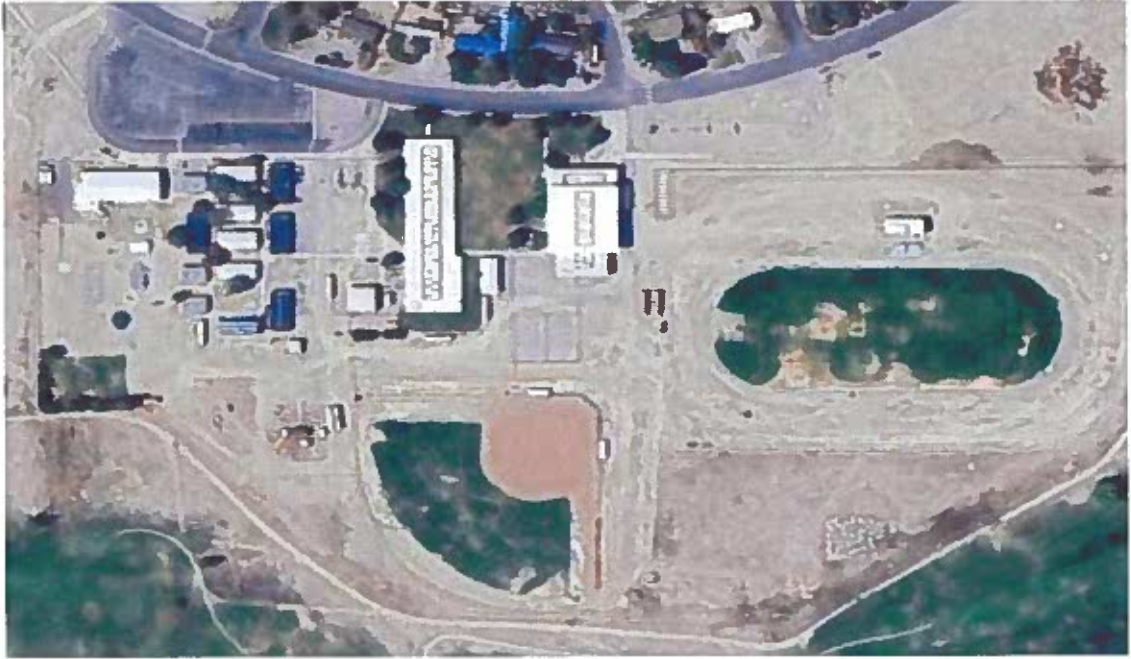
Round Mountain Schools

Round Mountain Junior/Senior High School reveals that the facility consists of pre-engineered metal structures. In 2009, both the building and the immediate surrounding site were evaluated for compliance with the Americans with Disabilities Act (ADA), and multiple deficiencies were discovered. It is assumed that these deficiencies have not been addressed, and it is recommended that remediation work begin as soon as funding becomes available.

The elementary school also showed several ADA-related deficiencies during the 2009 evaluation. These site deficiencies are assumed to remain unaddressed, and remediation is recommended as soon as financial resources are available.

The Junior/Senior High School, the surrounding site was also evaluated for ADA compliance in 2009, with multiple deficiencies identified. Like the building, it is assumed that these deficiencies remain unremediated, and corrective action should be prioritized as funds become available.

*Both the Junior/Senior High School and the Elementary School share a cafeteria/multi-purpose building, which was also evaluated for ADA compliance in 2009. Multiple deficiencies were discovered within the cafeteria, and it is assumed these issues have not been remediated. As with the other buildings and site areas, it is recommended that these deficiencies be addressed once funding permits.

- Sidewalks are deteriorating due to the use of ice melt and should be replaced as funds are available.
- Roofing is original; the Jr./ Sr. High and gym have been approved for replacement in 2025

- The rooftop HVAC units on the High School contain R-22 refrigerant and must be replaced with updated units as mechanical parts and freon are unavailable. This is tentatively scheduled for the 2026- 2027 school year based on the available budget.

- The kettle is starting to show its age and was installed in 1990 and will be replaced in the next 5 years.
- The serving table was installed in 2000 and is used daily and should be replaced if funds are available as it is an essential part of serving lunch and breakfast.

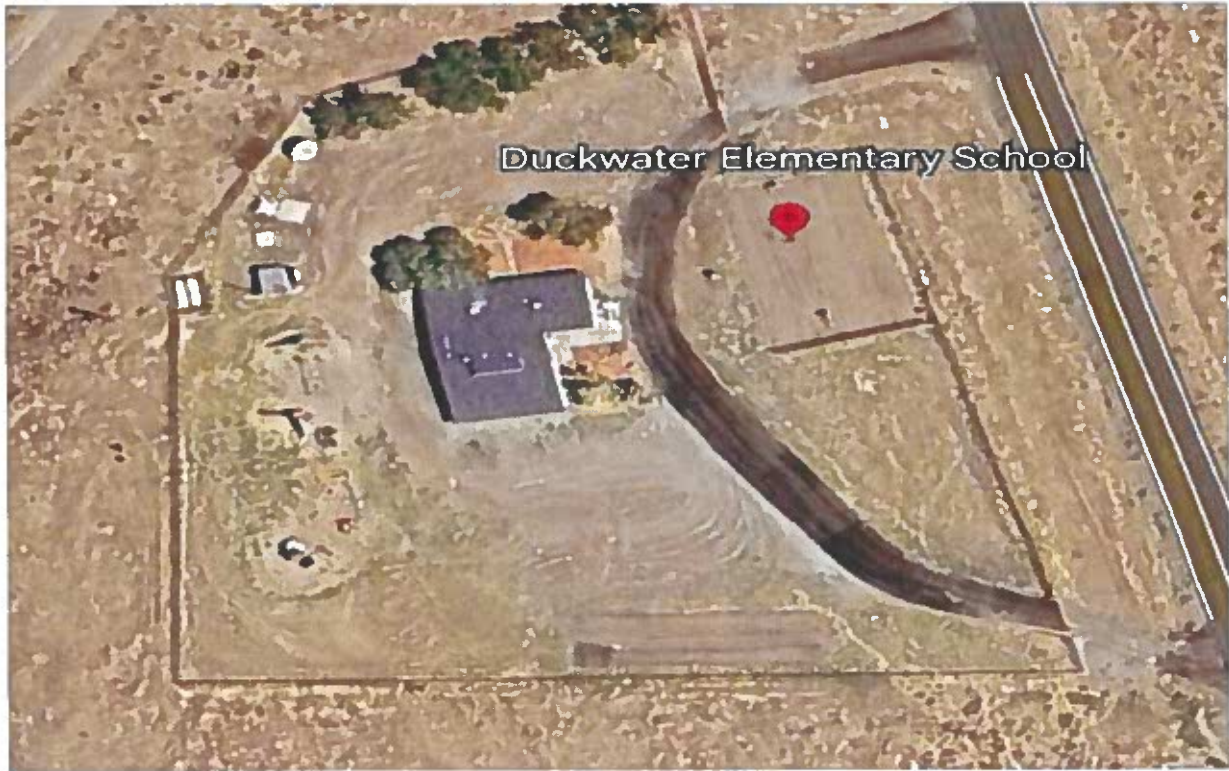
Duckwater School

The Duckwater School, originally built in 1954, is made up of multiple buildings with varying construction types. These include wood frame, metal frame, and masonry structures, with roofing systems that also vary. Over the years, the school has seen new additions and modernizations, but there is no adherence to a consistent architectural theme. The school's building(s) and immediate site were evaluated in 2009 for compliance with the Americans with Disabilities Act (ADA), uncovering multiple deficiencies. It is assumed that most of these deficiencies remain unremediated. The recommendation is that remediation work should begin as soon as funding becomes available to address these issues and ensure the building meets ADA standards.

- Continue to keep the property maintained as the school is closed.

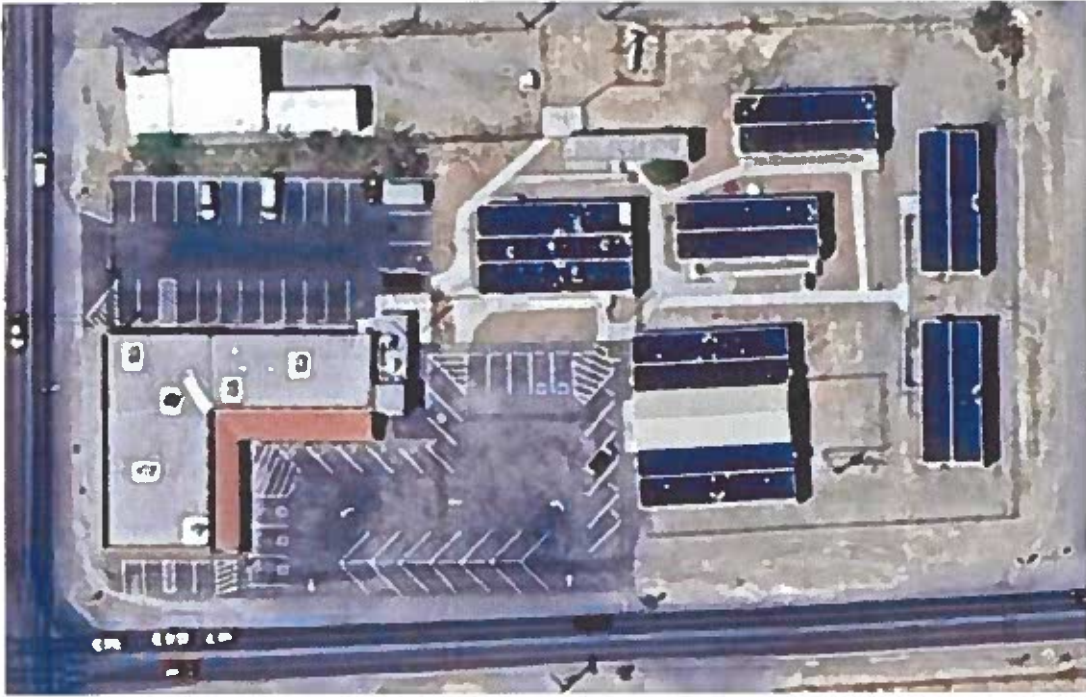
Southern District Office

- A rekey of the property should be scheduled when funds are available so that the property is under the district's master key program.
- The A.C. paving surfaces will undergo maintenance, including crack repairs, a slurry coating, and restriping scheduled for the 2029/ 2030 fiscal year.
