**Nye County School District,
Nevada**

Debt Management Policy

July 2025 thru June 2030 MASTER PLAN UPDATE
FOR THE

NYE COUNTY SCHOOL DISTRICT
AND RELATED FACILITIES

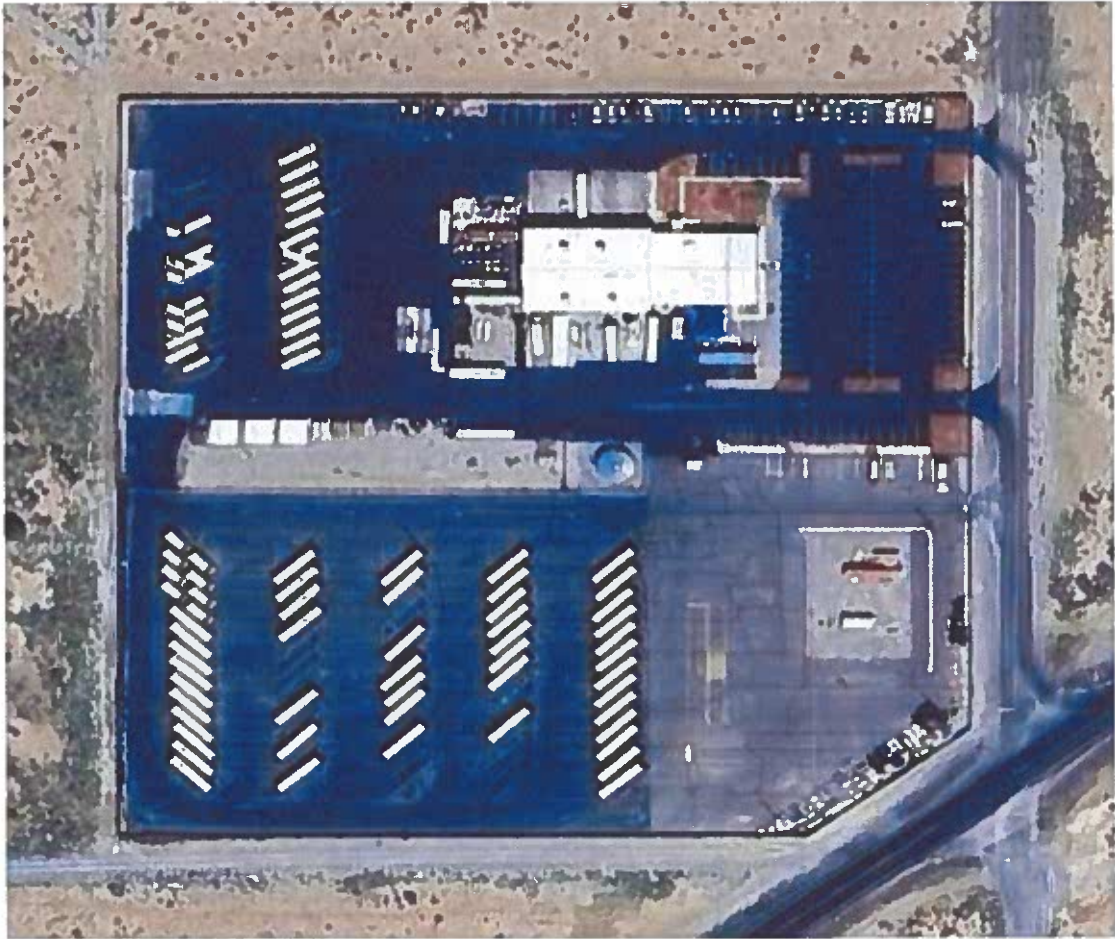
The Transportation Building was originally constructed in 2001, with a major addition built in 2008. The main structure of the building is a pre-engineered metal construction, which includes a 3,200-square-foot administration area and a 5,075-square-foot full-service shop area. The building is in generally good condition, though there were two areas on the westerly boundary where the paving has failed at the end of a drain swale. These areas have been repaired to prevent further damage. The facility was designed to comply with the Americans with Disabilities Act (ADA).

- The A.C. paving surfaces will undergo maintenance, including crack repairs, a slurry coating, and restriping, scheduled for the 2027/ 2028 fiscal year.
